HPC 20-83

8049, 8055, 8059, 8061 (Tiber Park) and 8069 Main Street; Vicinity of Maryland Avenue and Main Street; Vicinity of 3711 Maryland Avenue along Patapsco River, Ellicott City

Photos / Documentation of Stream Channel Walls

Prepared by Howard County Department of Public Works

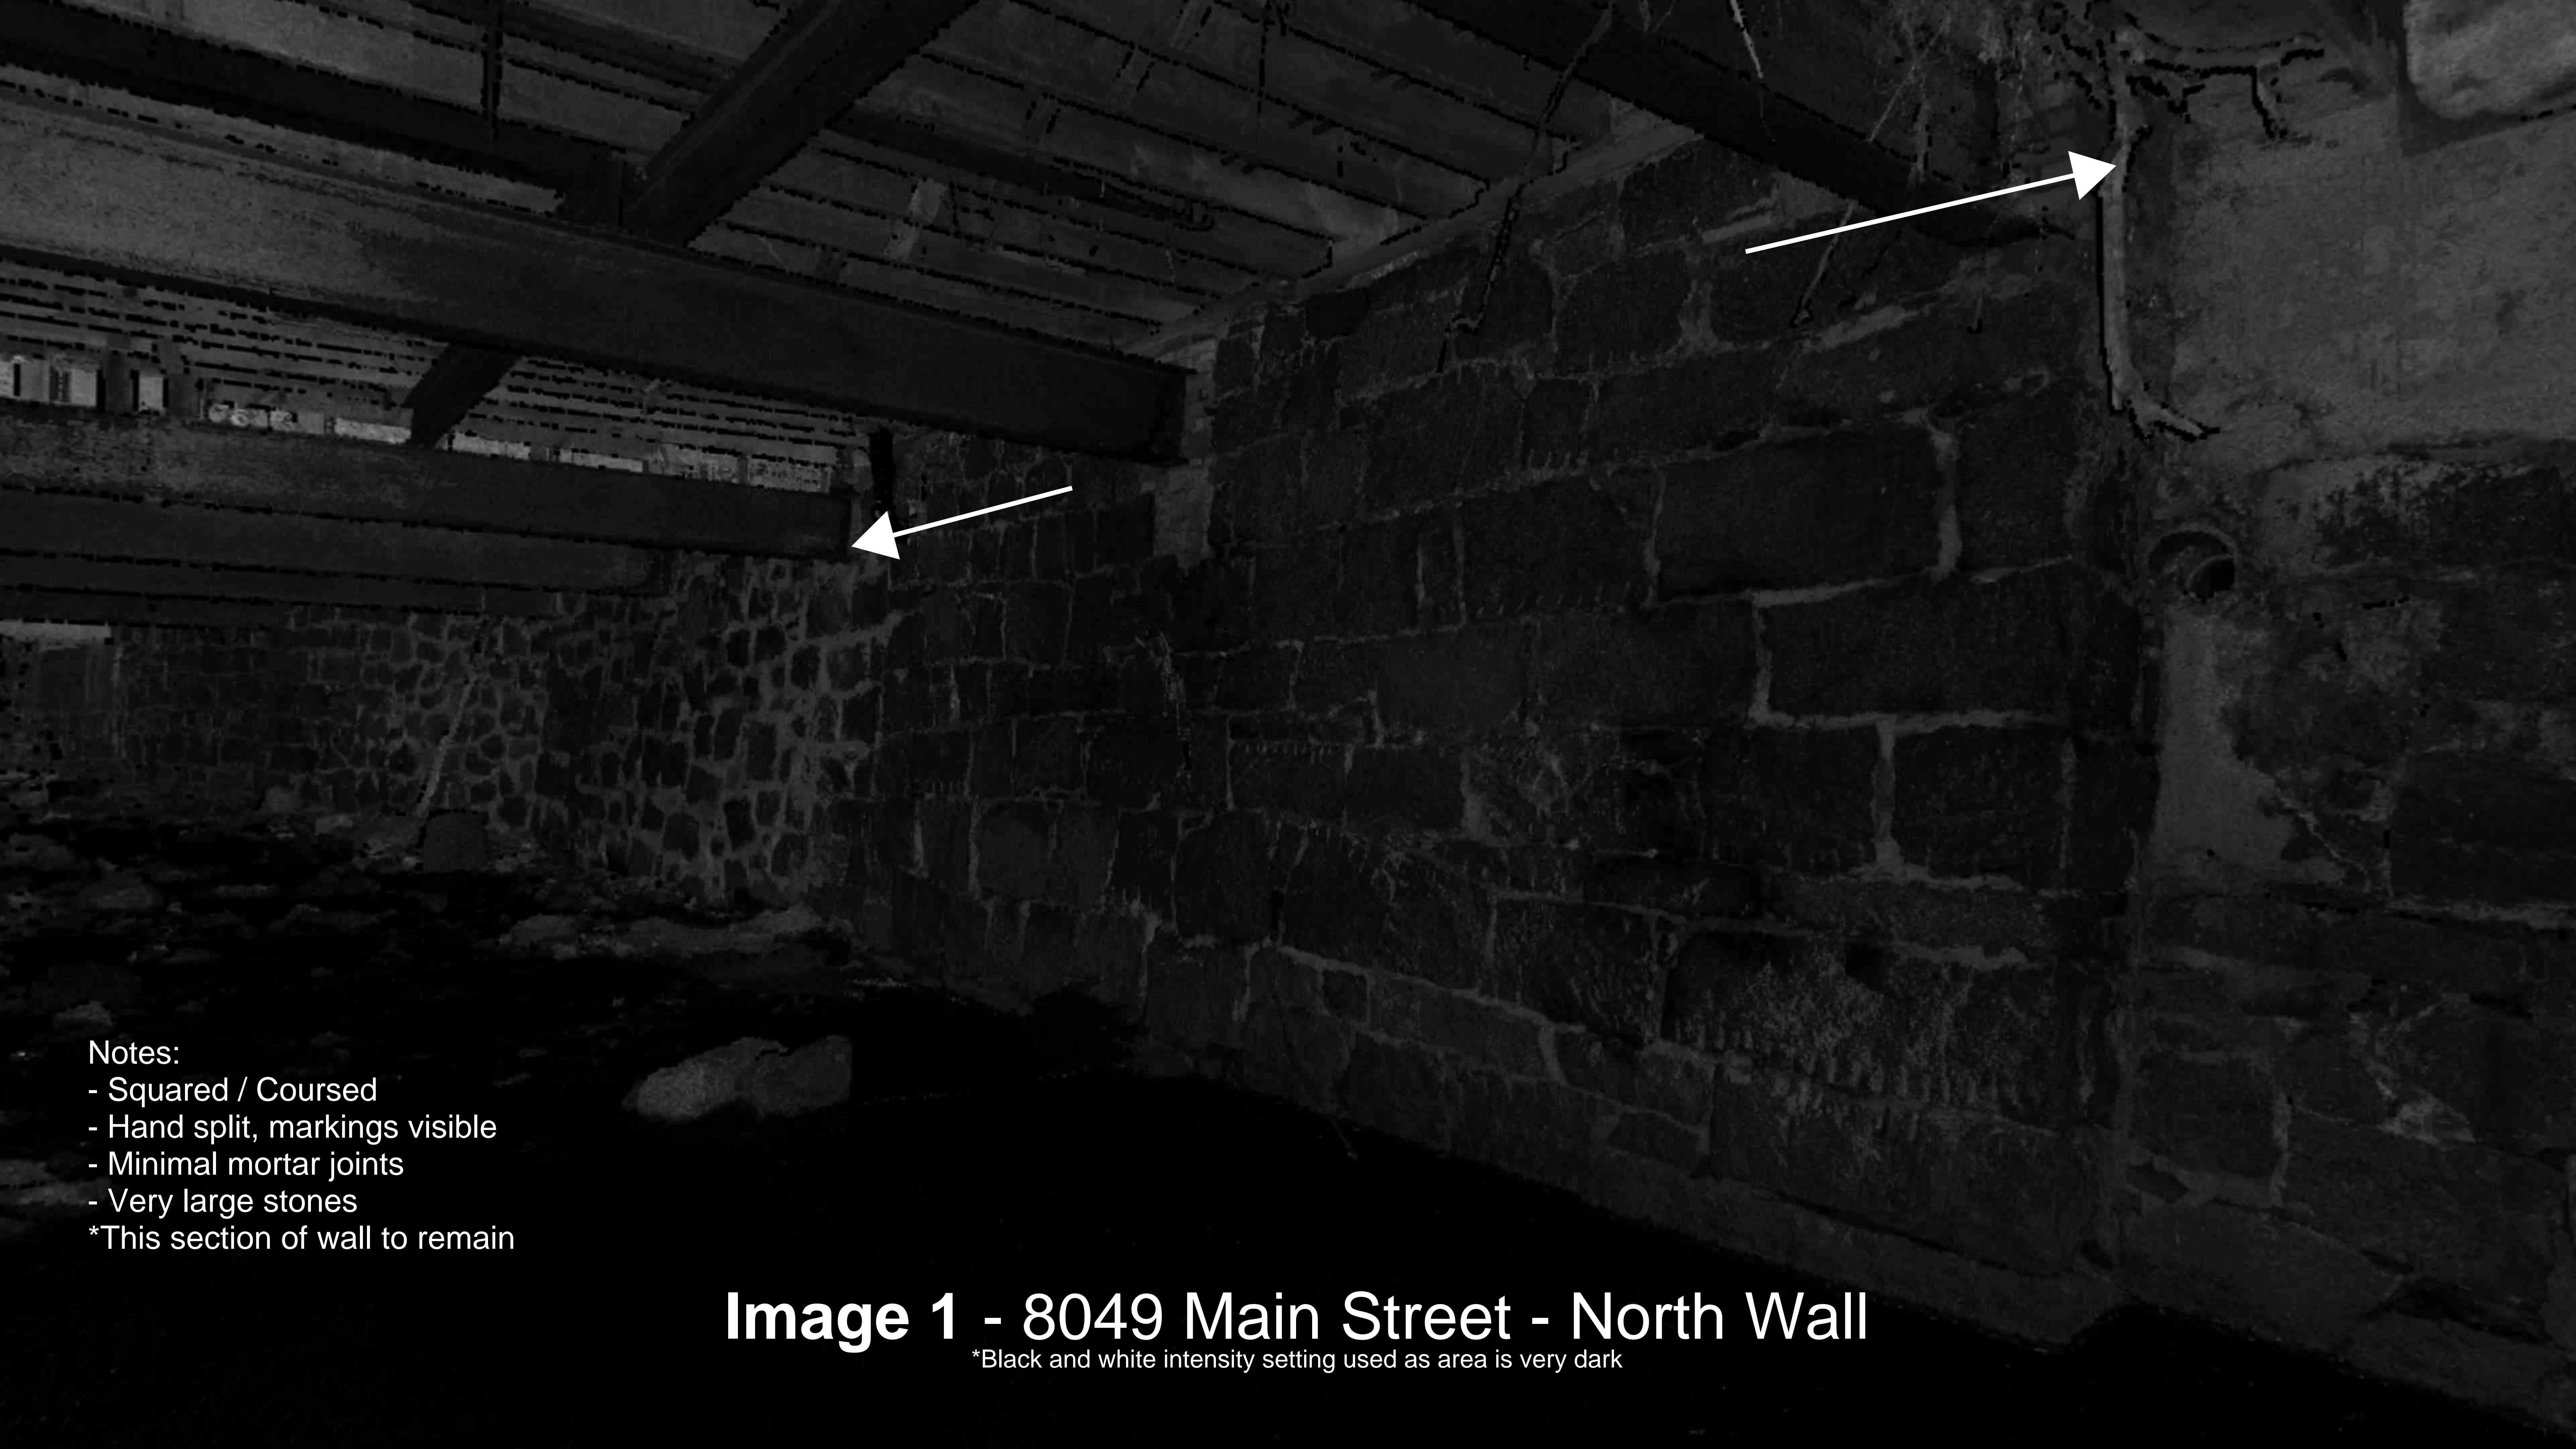
Image 1 - 8049 Main Street - North Wall

- Squared / Coursed
- Hand split, markings visible
- Minimal mortar joints
- Very large stones
- *This section of wall to remain

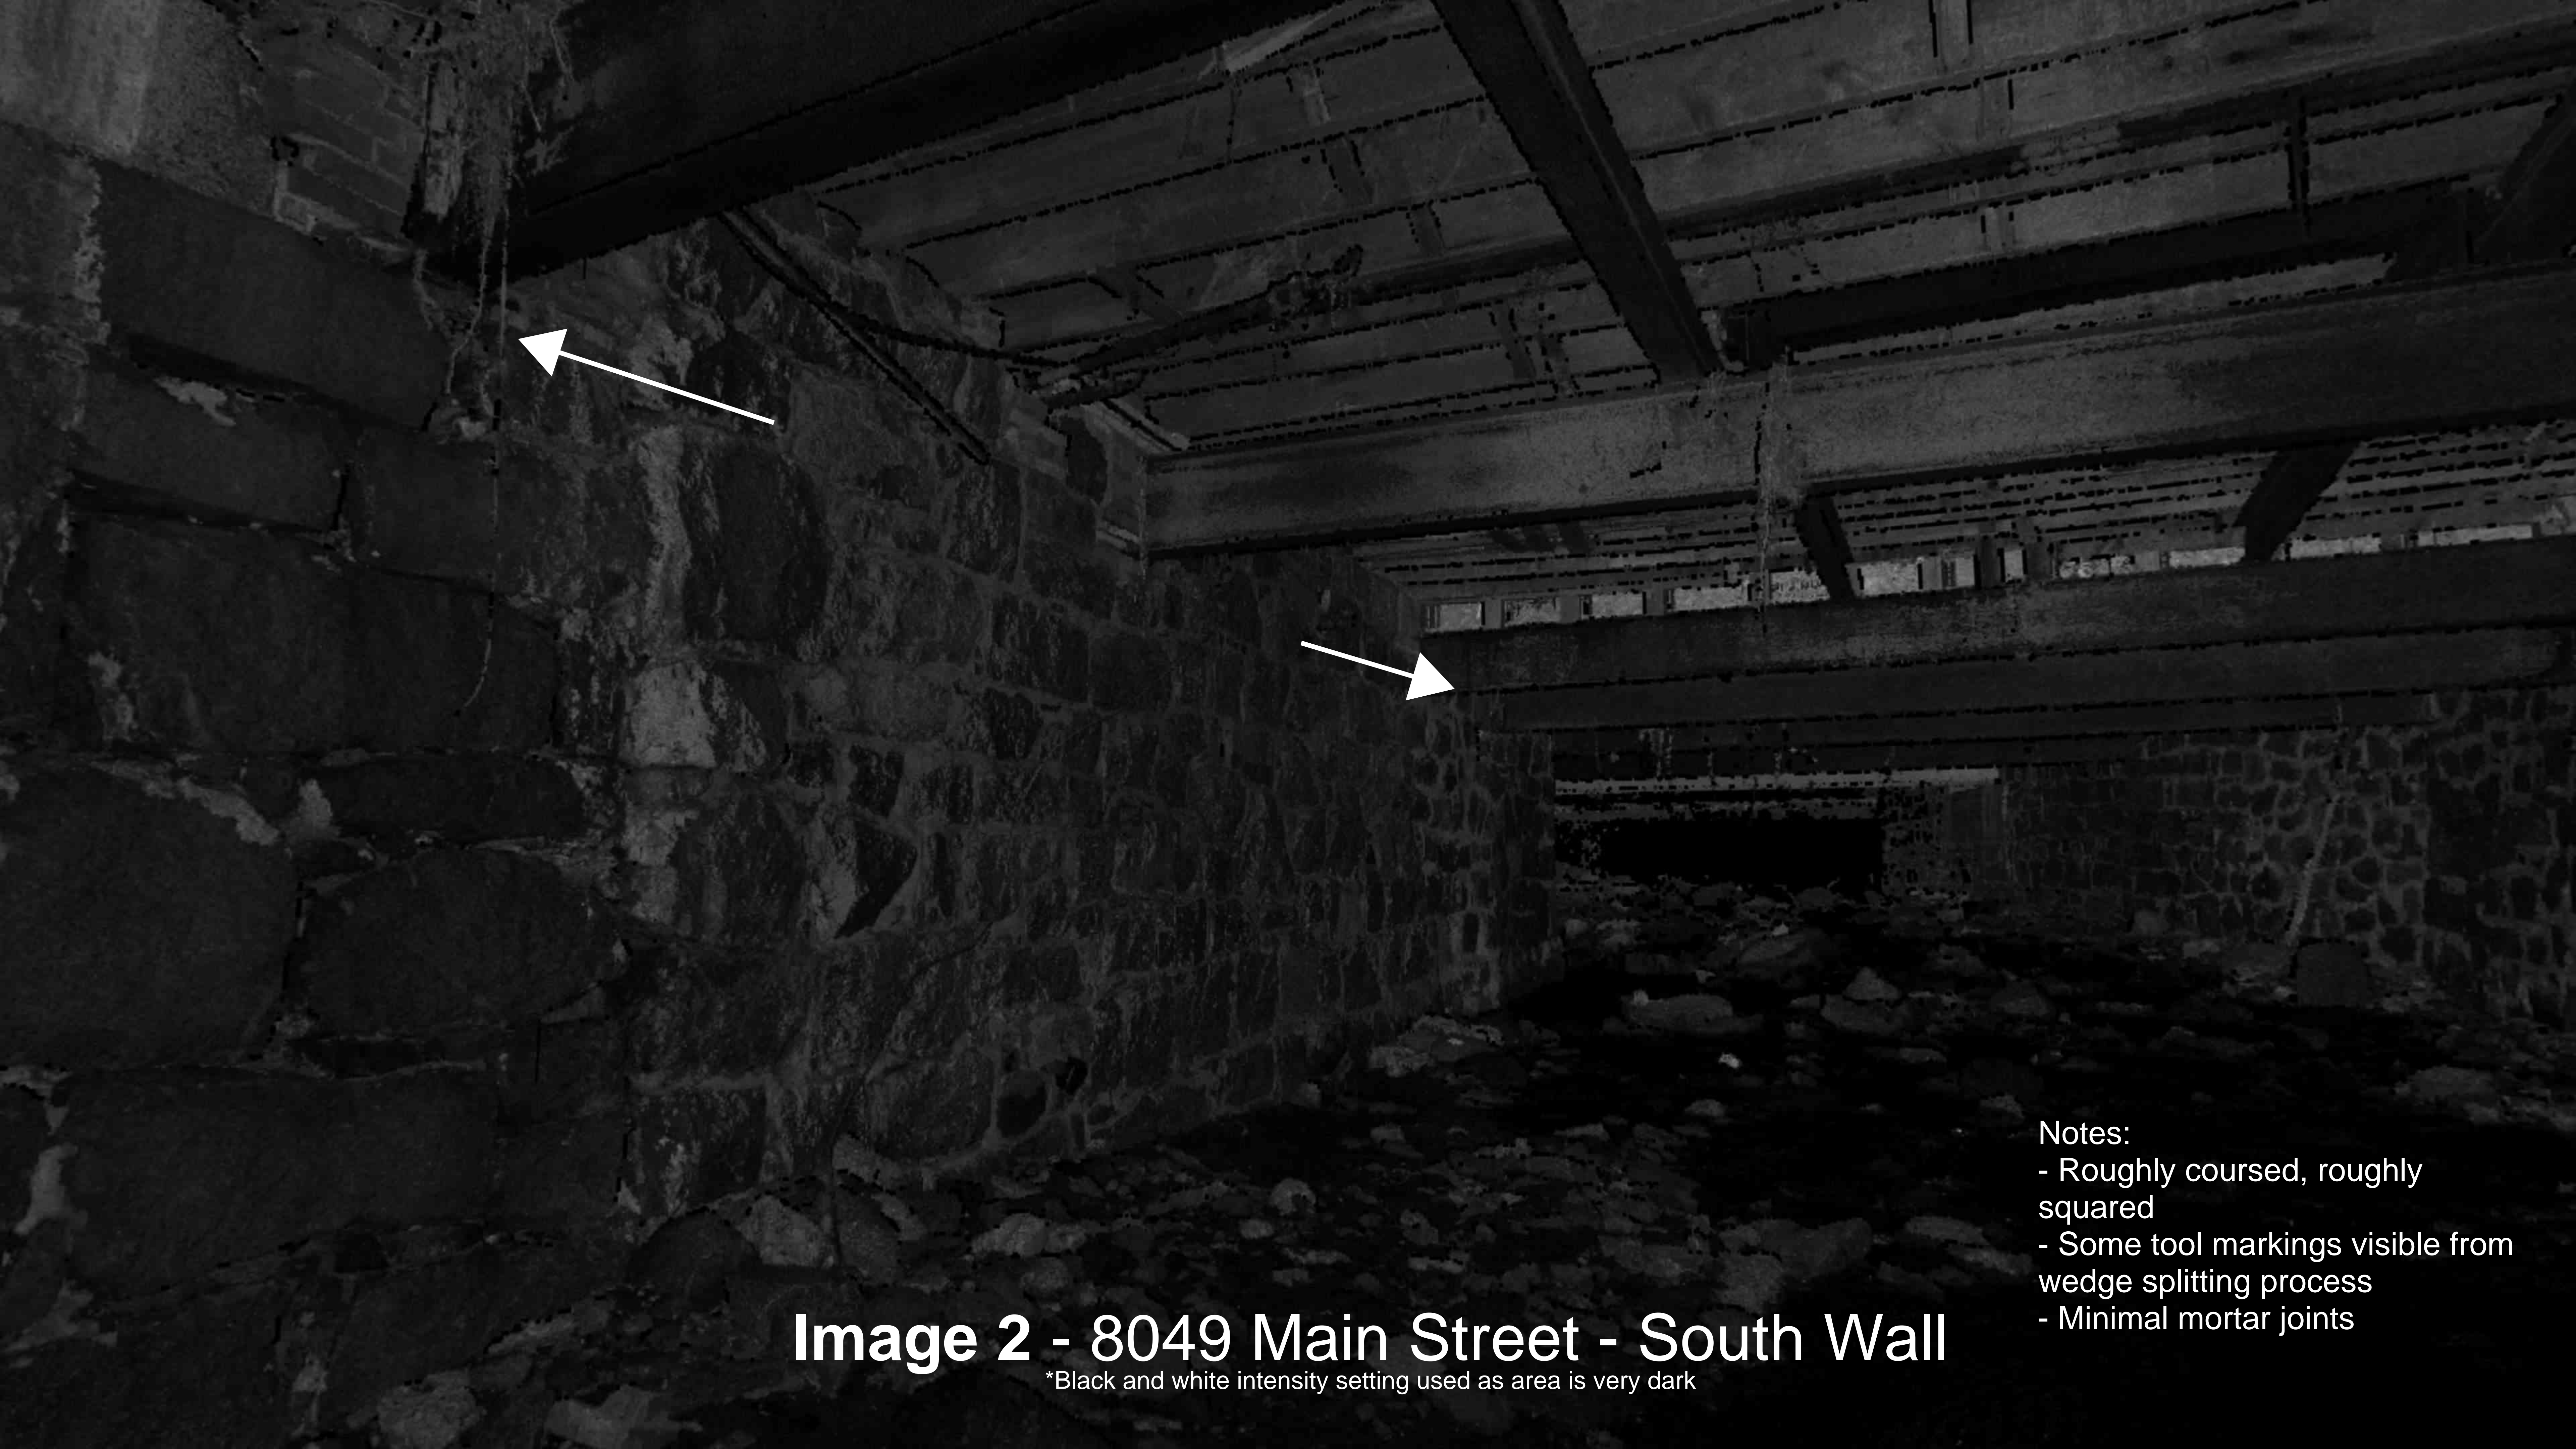
Image 2 - 8049 Main Street - South Wall

- Notes:
- Roughly coursed, roughly squared
 - Some tool markings visible from wedge splitting process
 - Minimal mortar joints

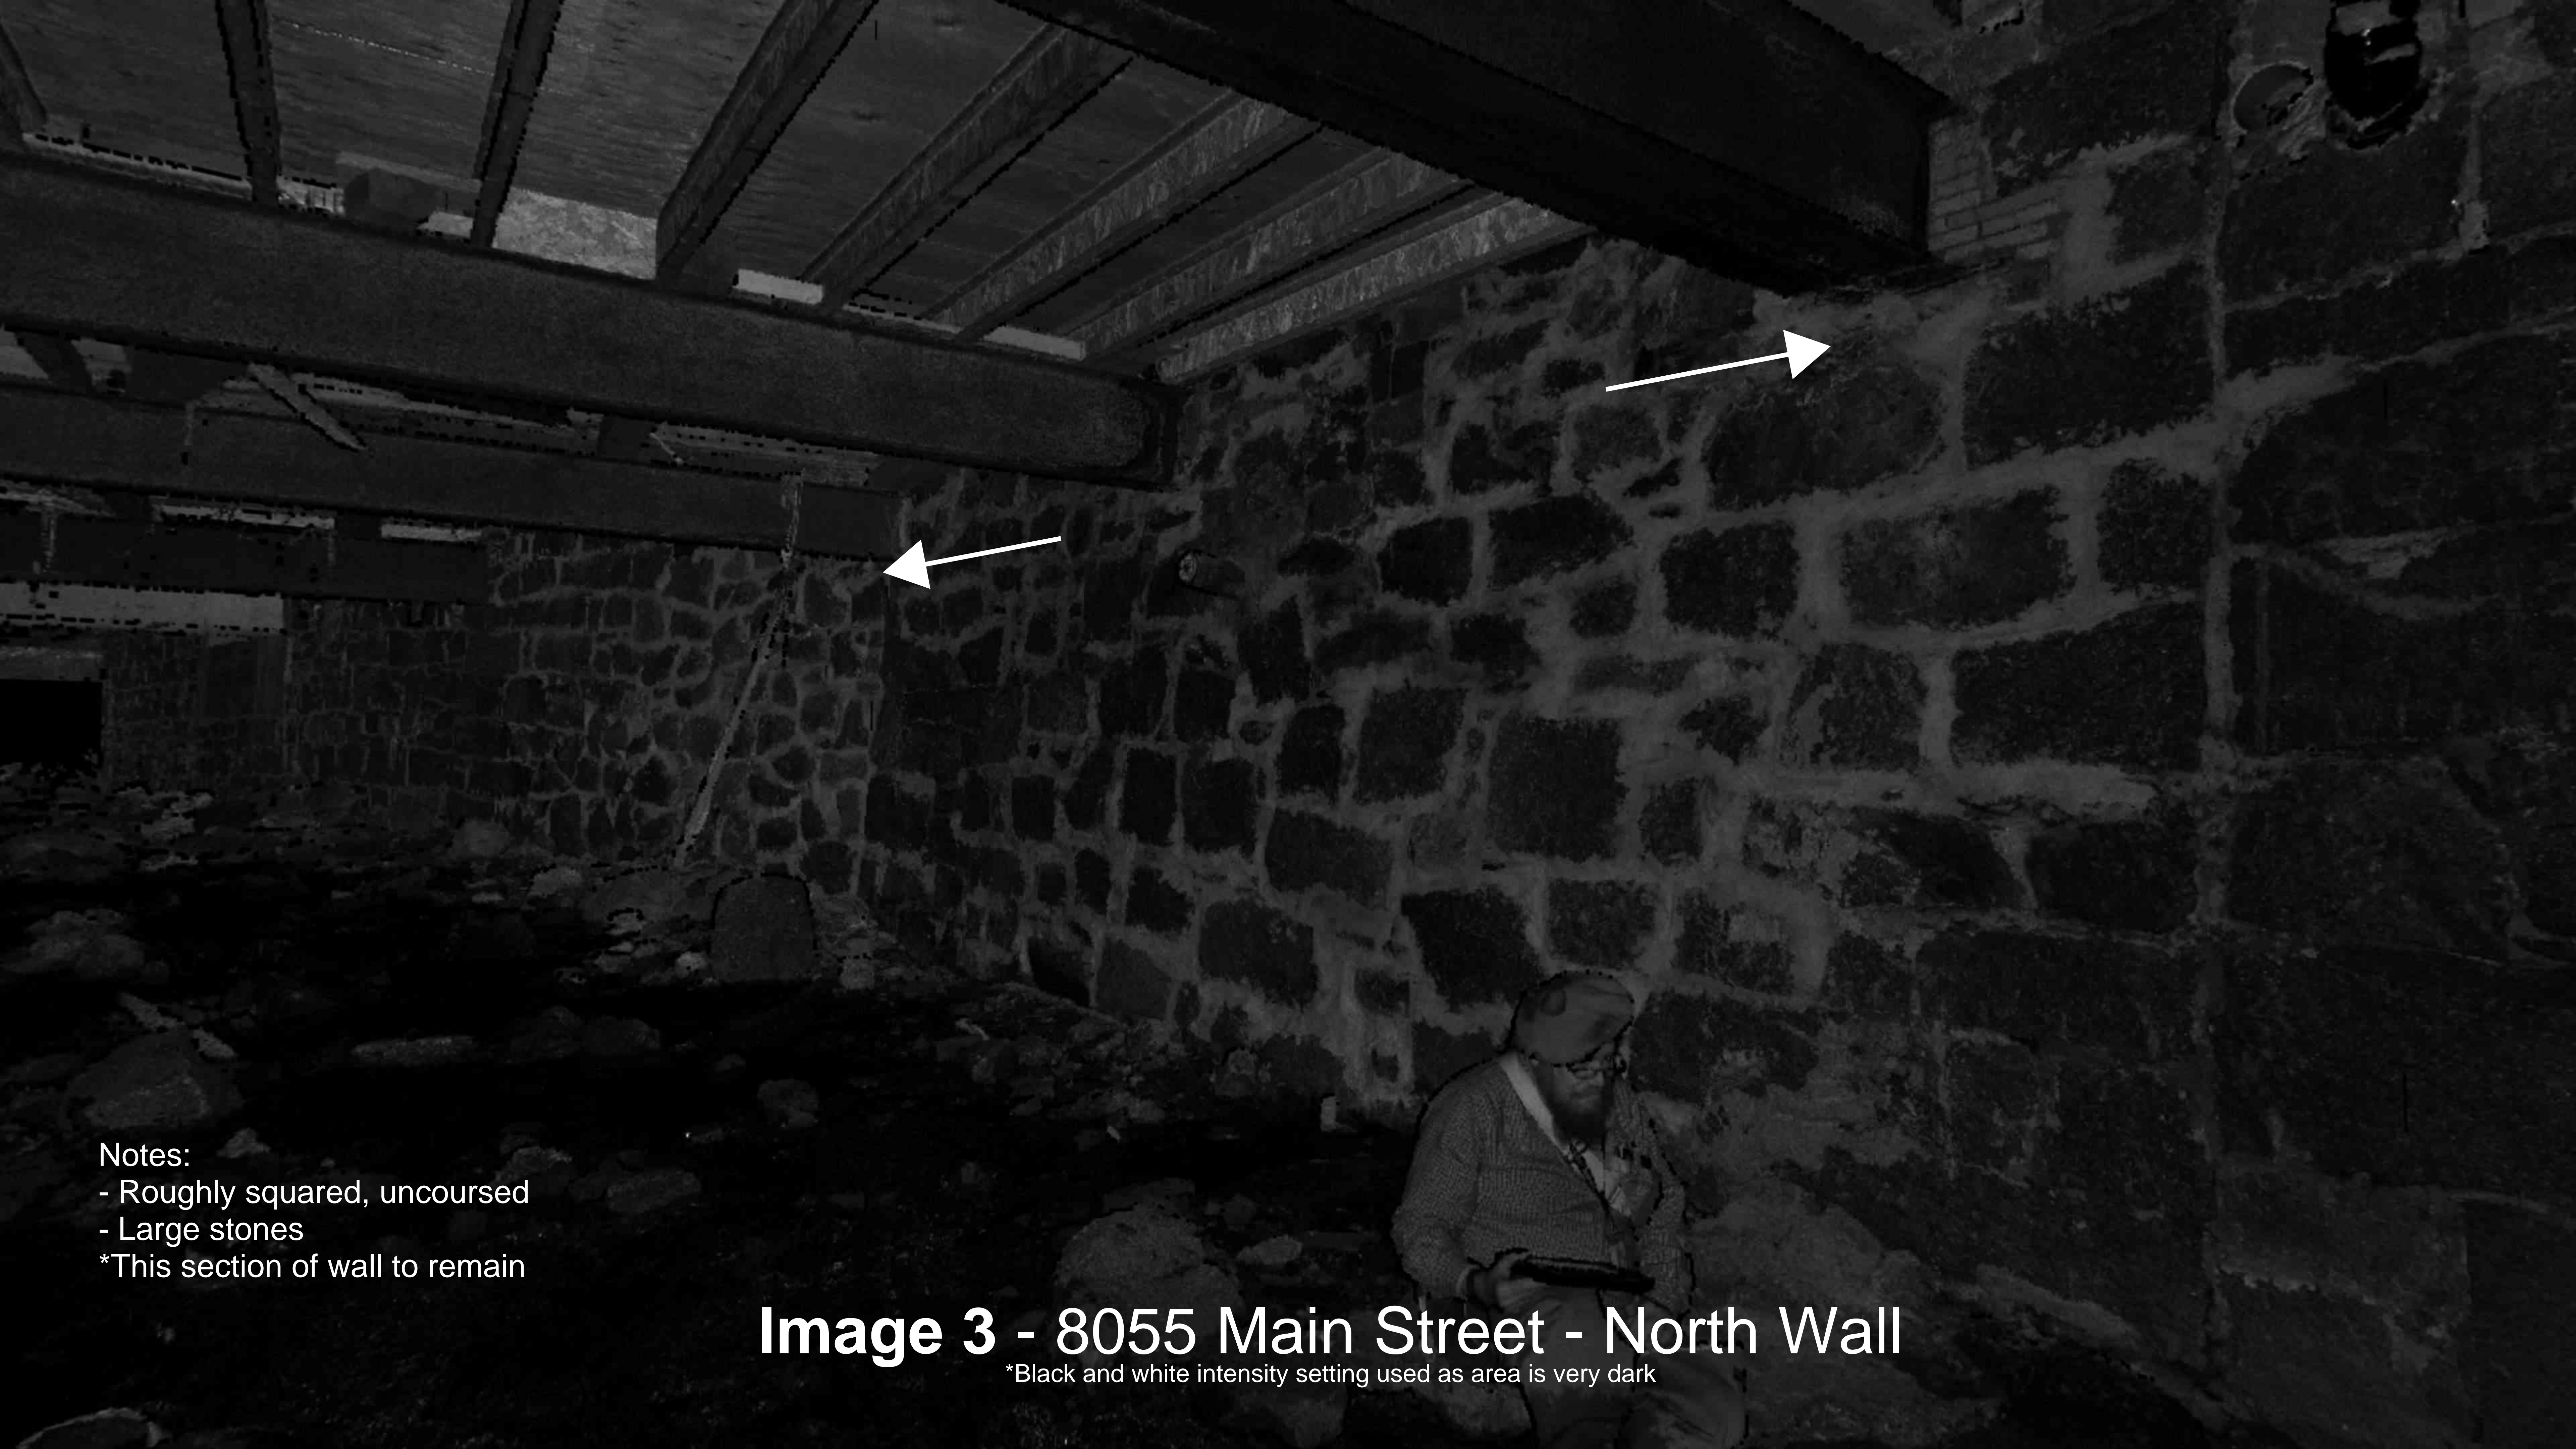
Image 3 - 8055 Main Street - North Wall

- Roughly squared, uncoursed
- Large stones

*This section of wall to remain

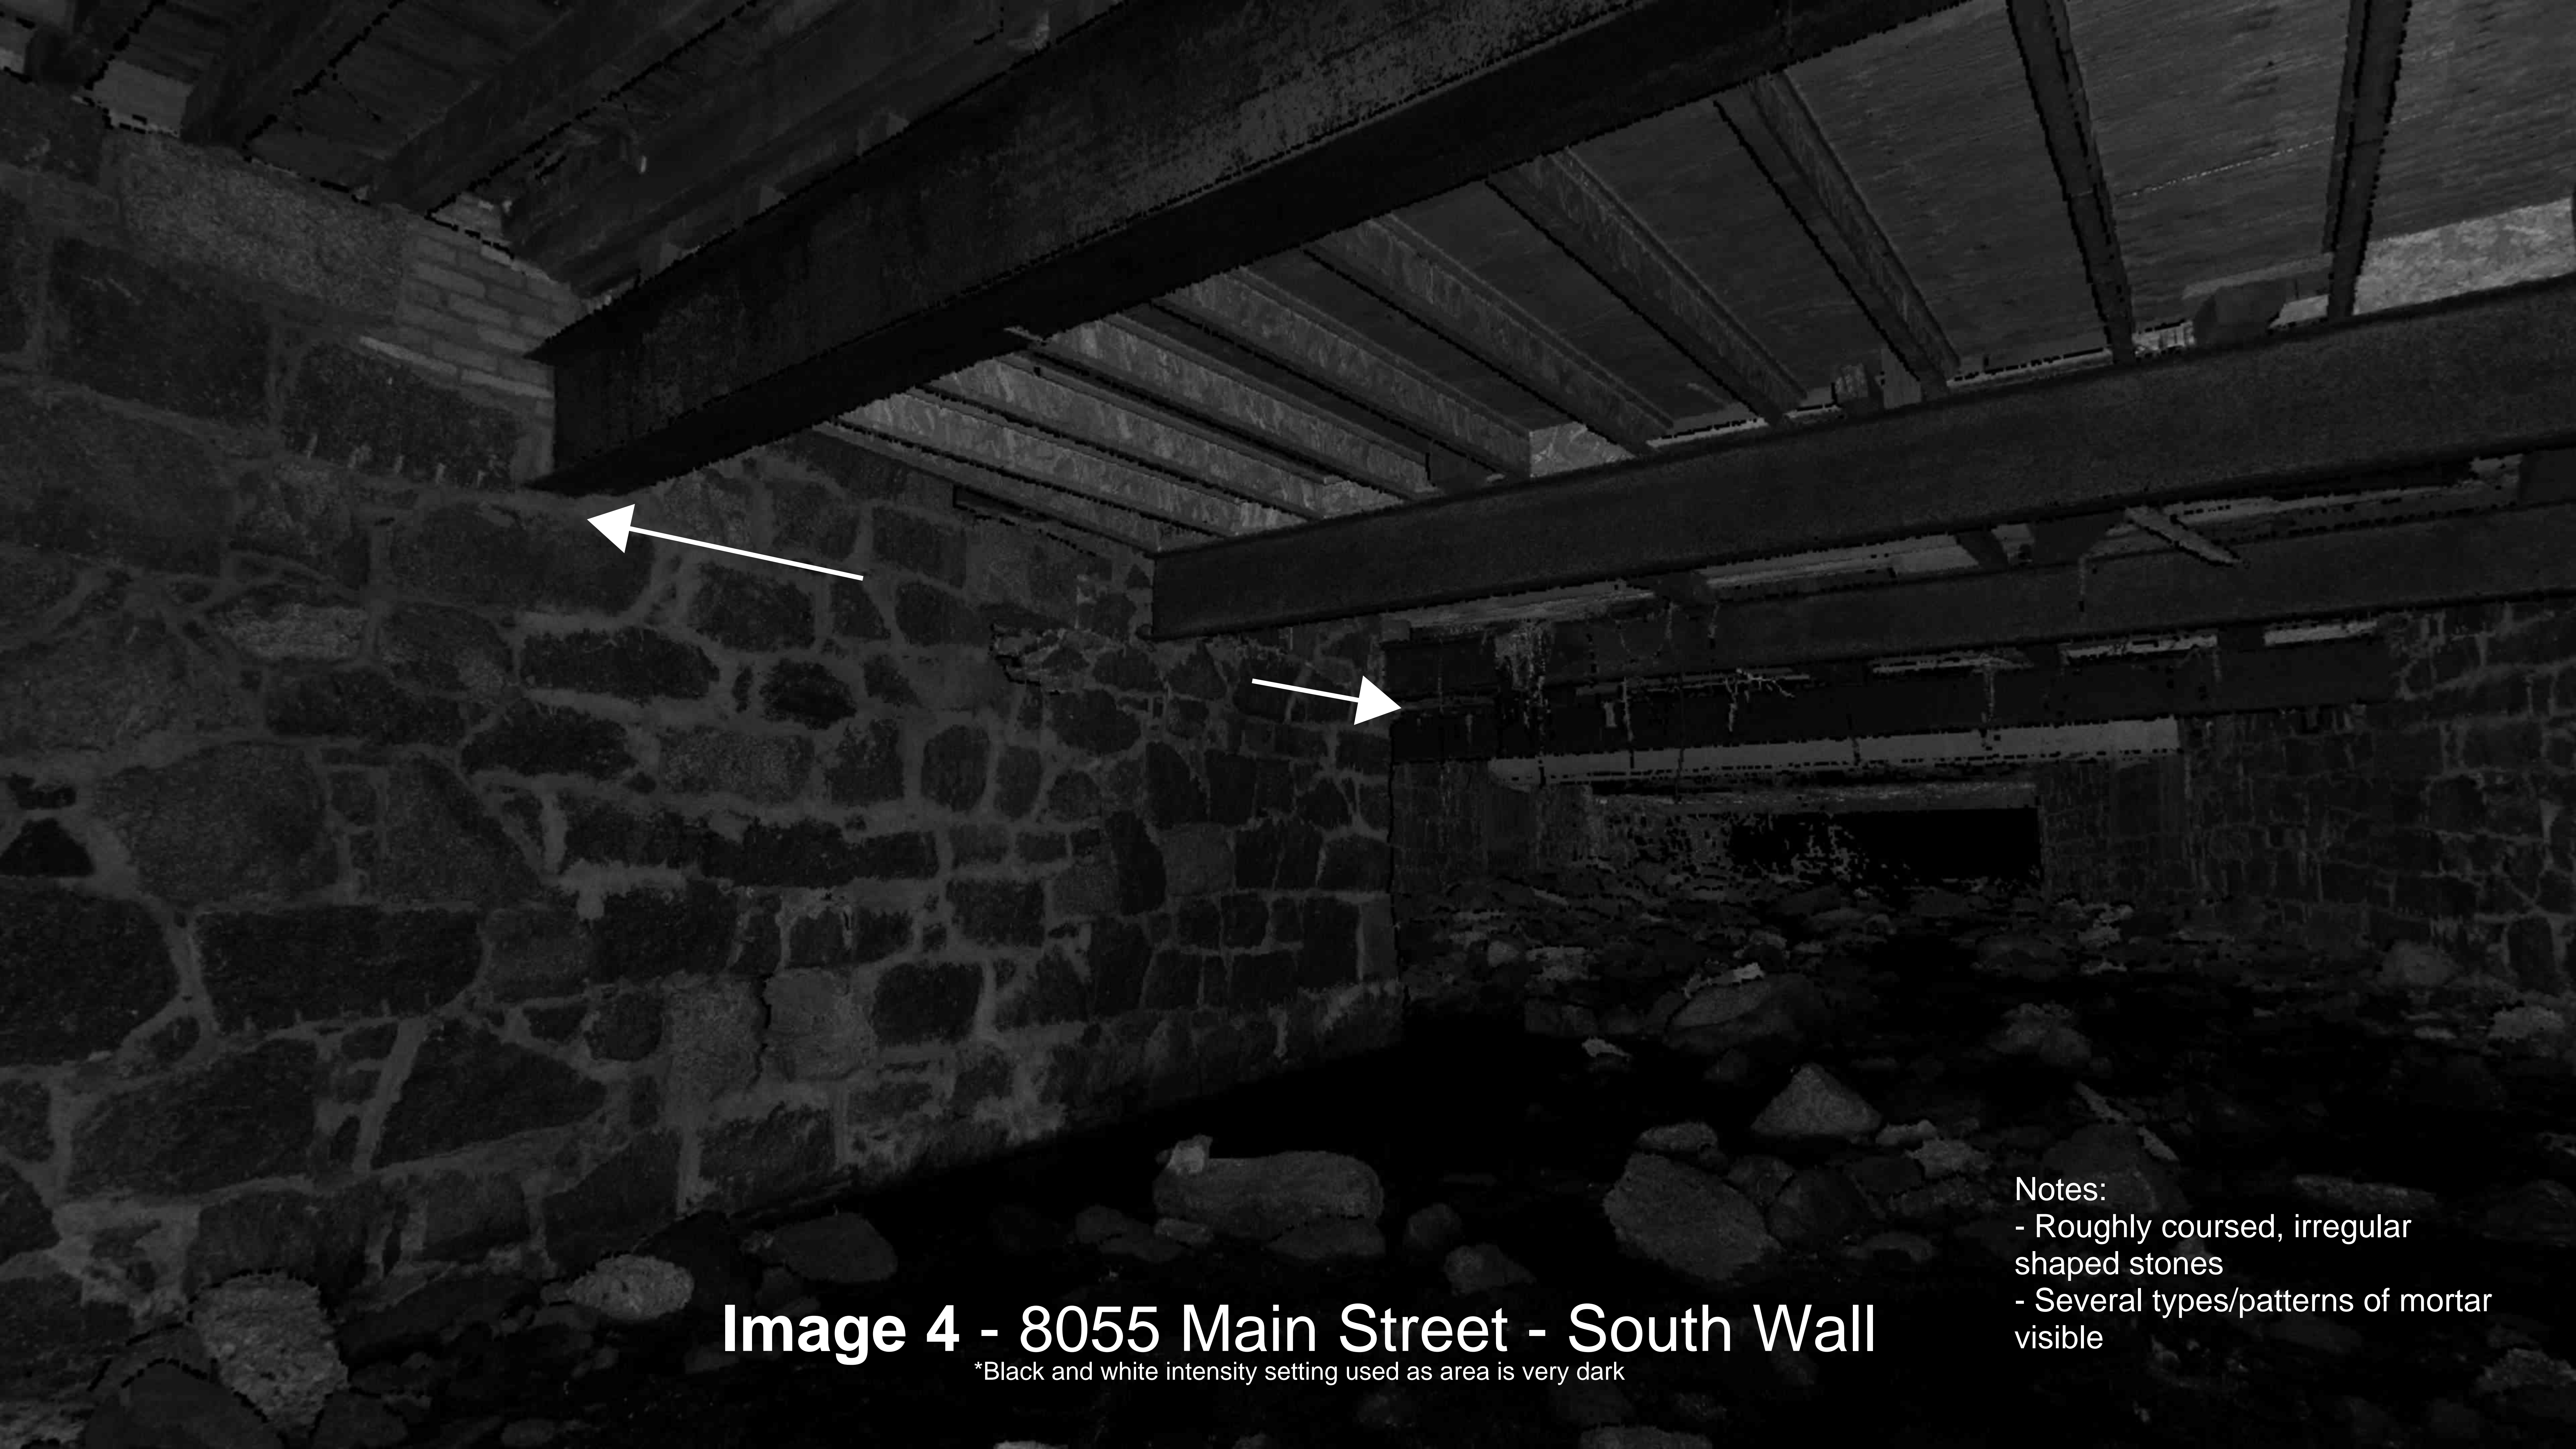
Image 4 - 8055 Main Street - South Wall

- Notes:
- Roughly coursed, irregular shaped stones
 - Several types/patterns of mortar visible

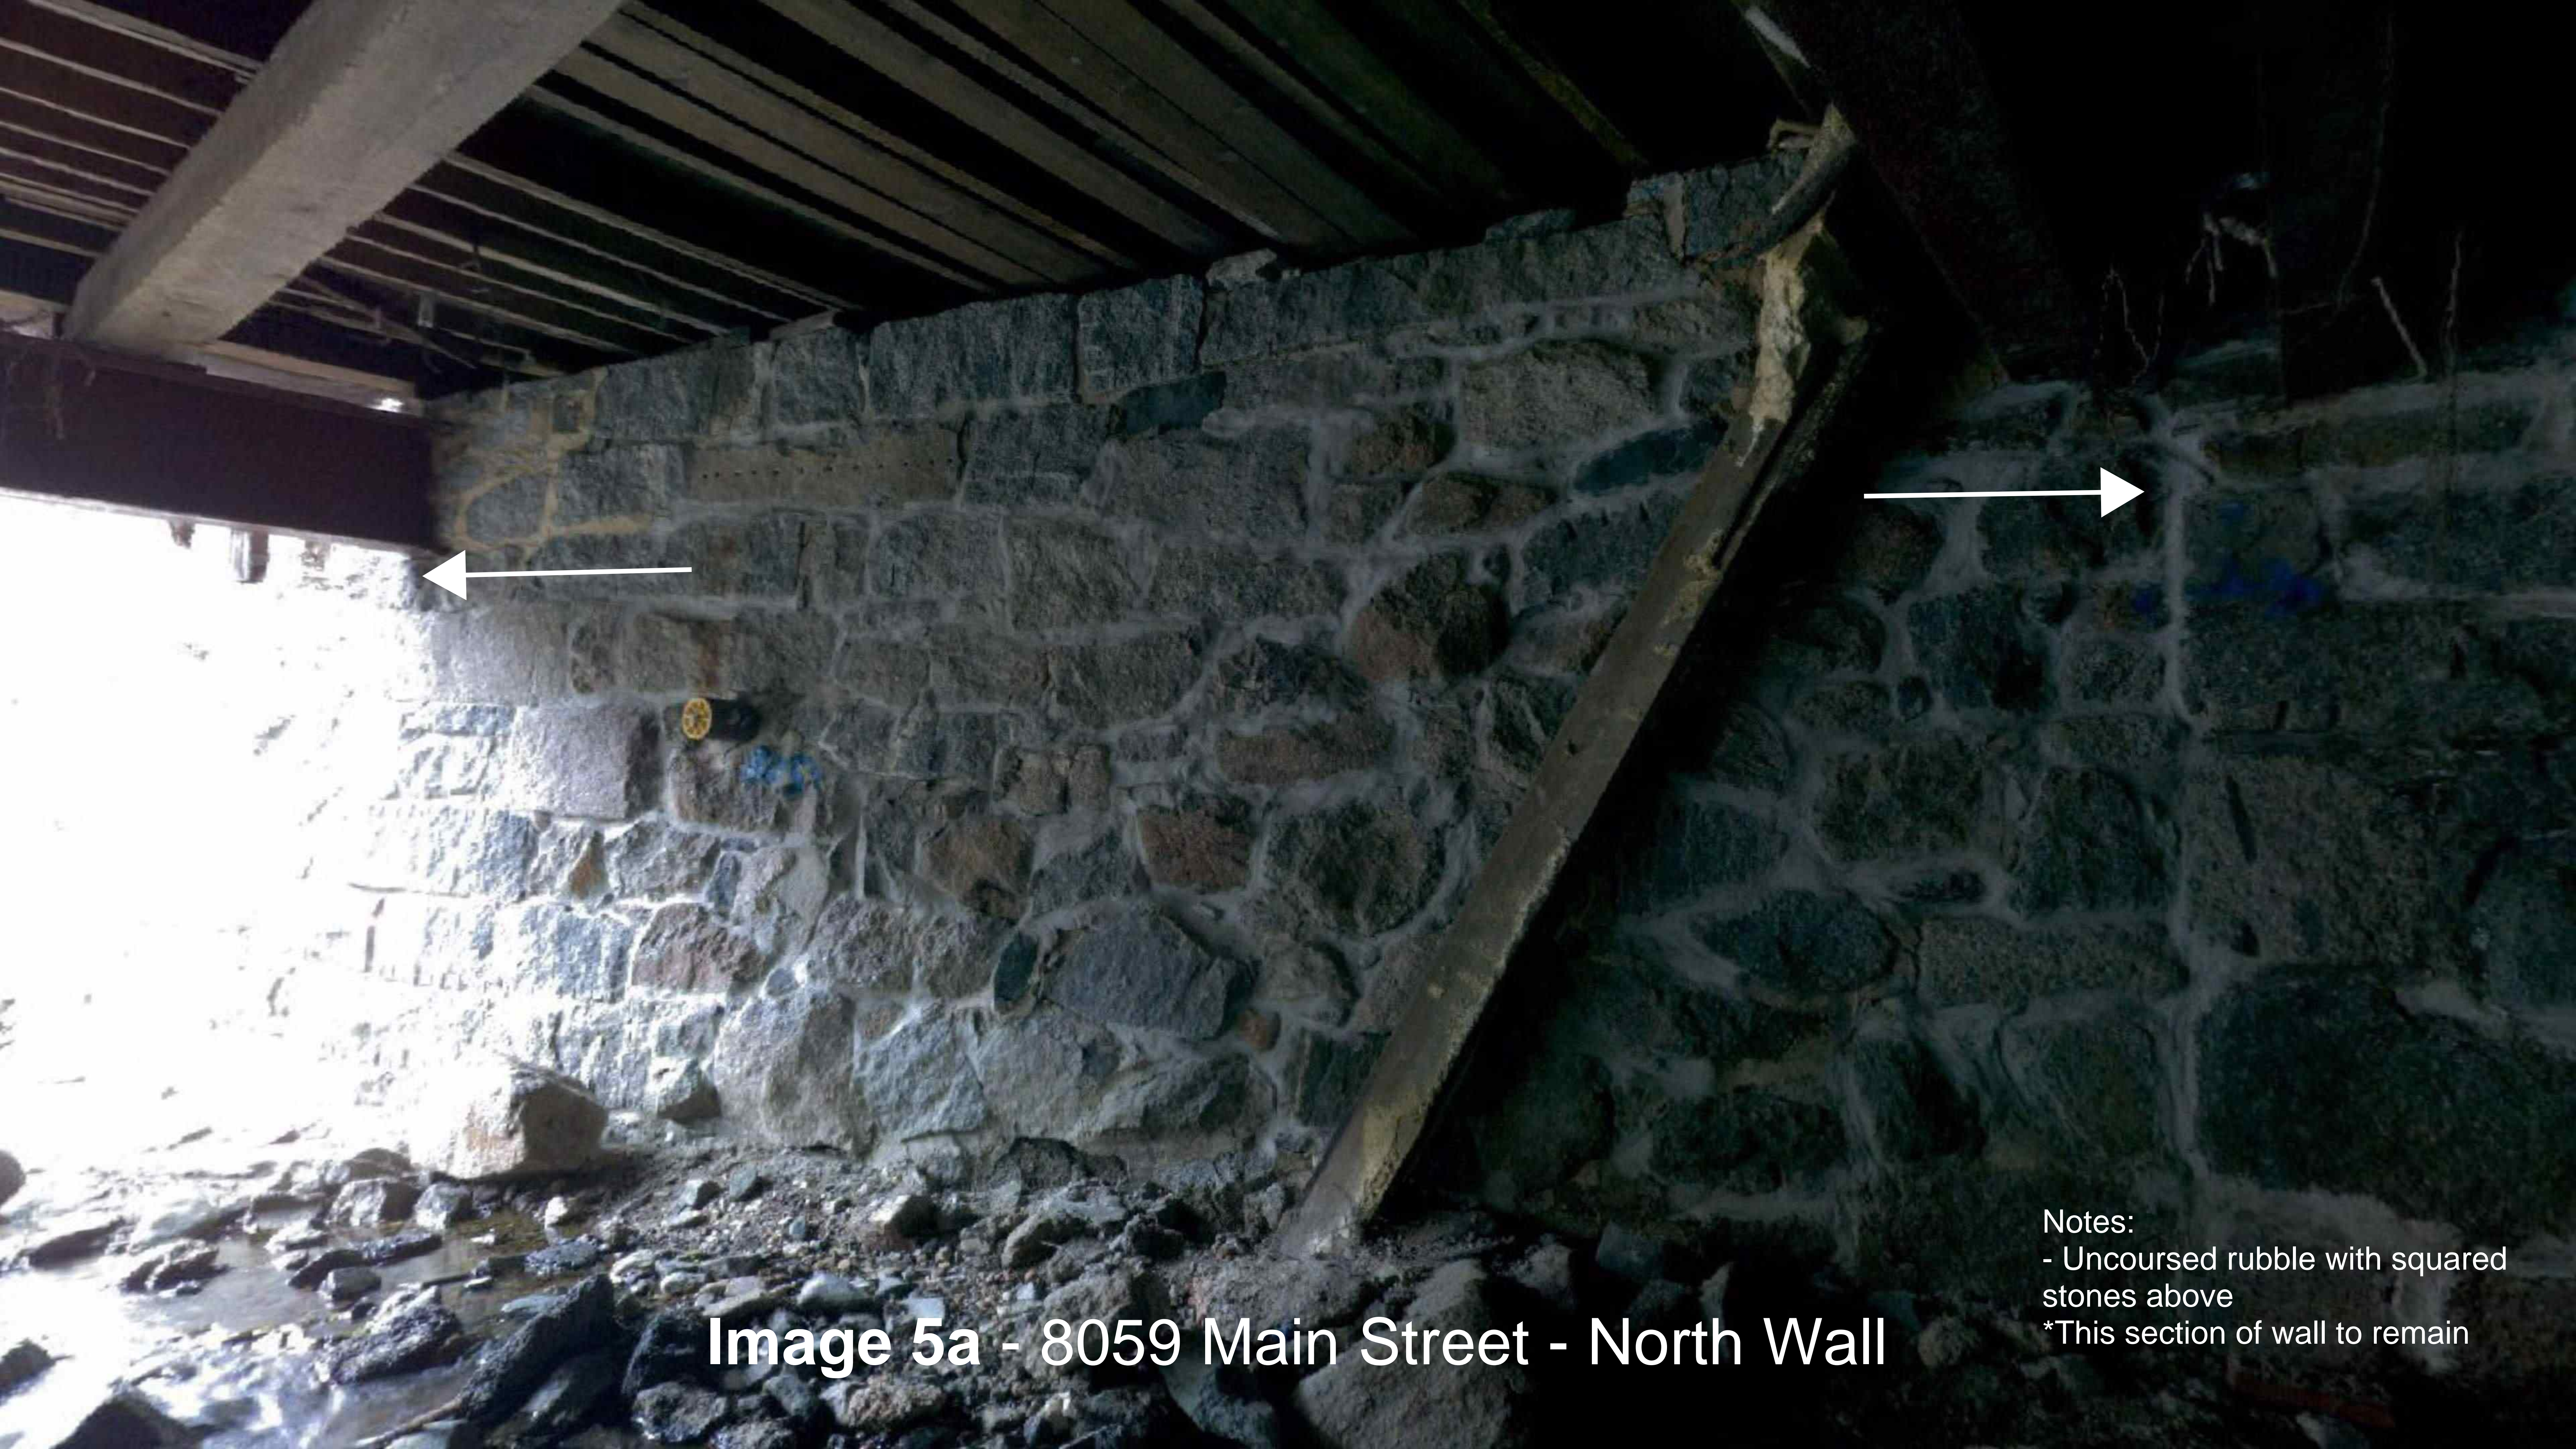
Image 5a - 8059 Main Street - North Wall

Notes:
- Uncoursed rubble with squared stones above
*This section of wall to remain

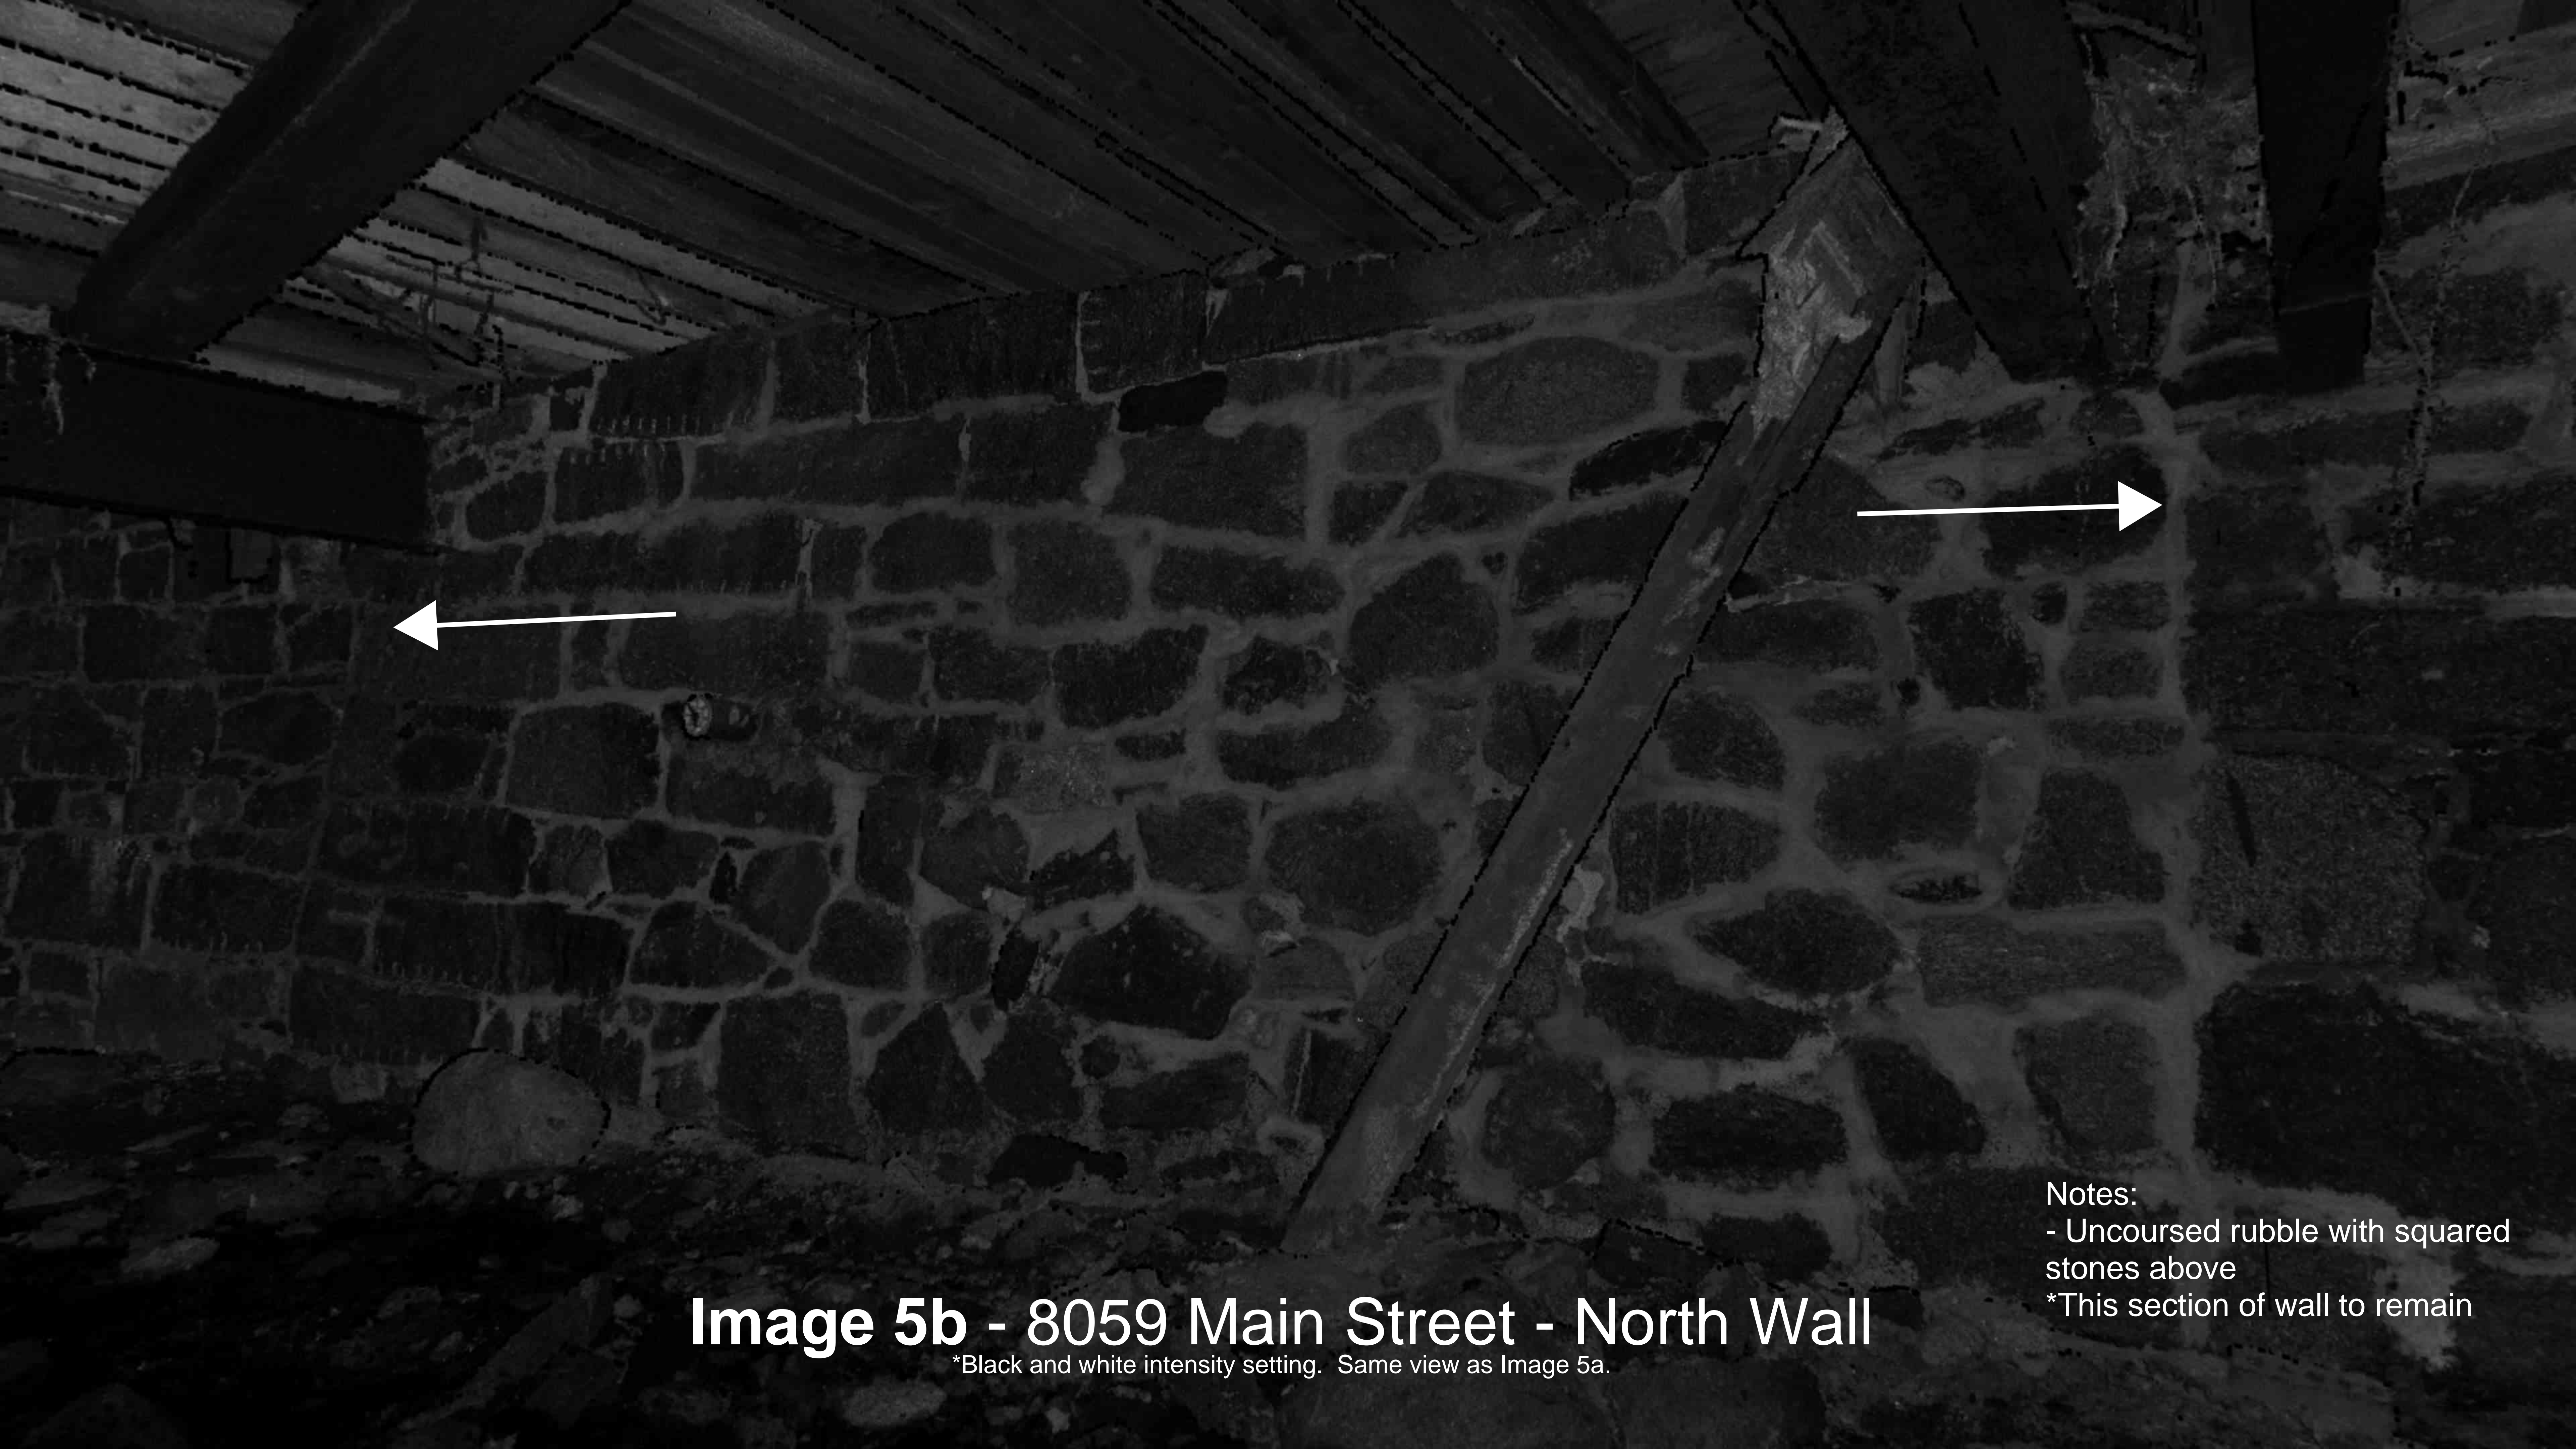
Image 5b - 8059 Main Street - North Wall

Notes:
- Uncoursed rubble with squared stones above
*This section of wall to remain
