HPC 20-83

8049, 8055, 8059, 8061 (Tiber Park) and 8069 Main Street; Vicinity of Maryland Avenue and Main Street; Vicinity of 3711 Maryland Avenue along Patapsco River, Ellicott City

Photos / Documentation of Stream Channel Walls

Prepared by Howard County Department of Public Works

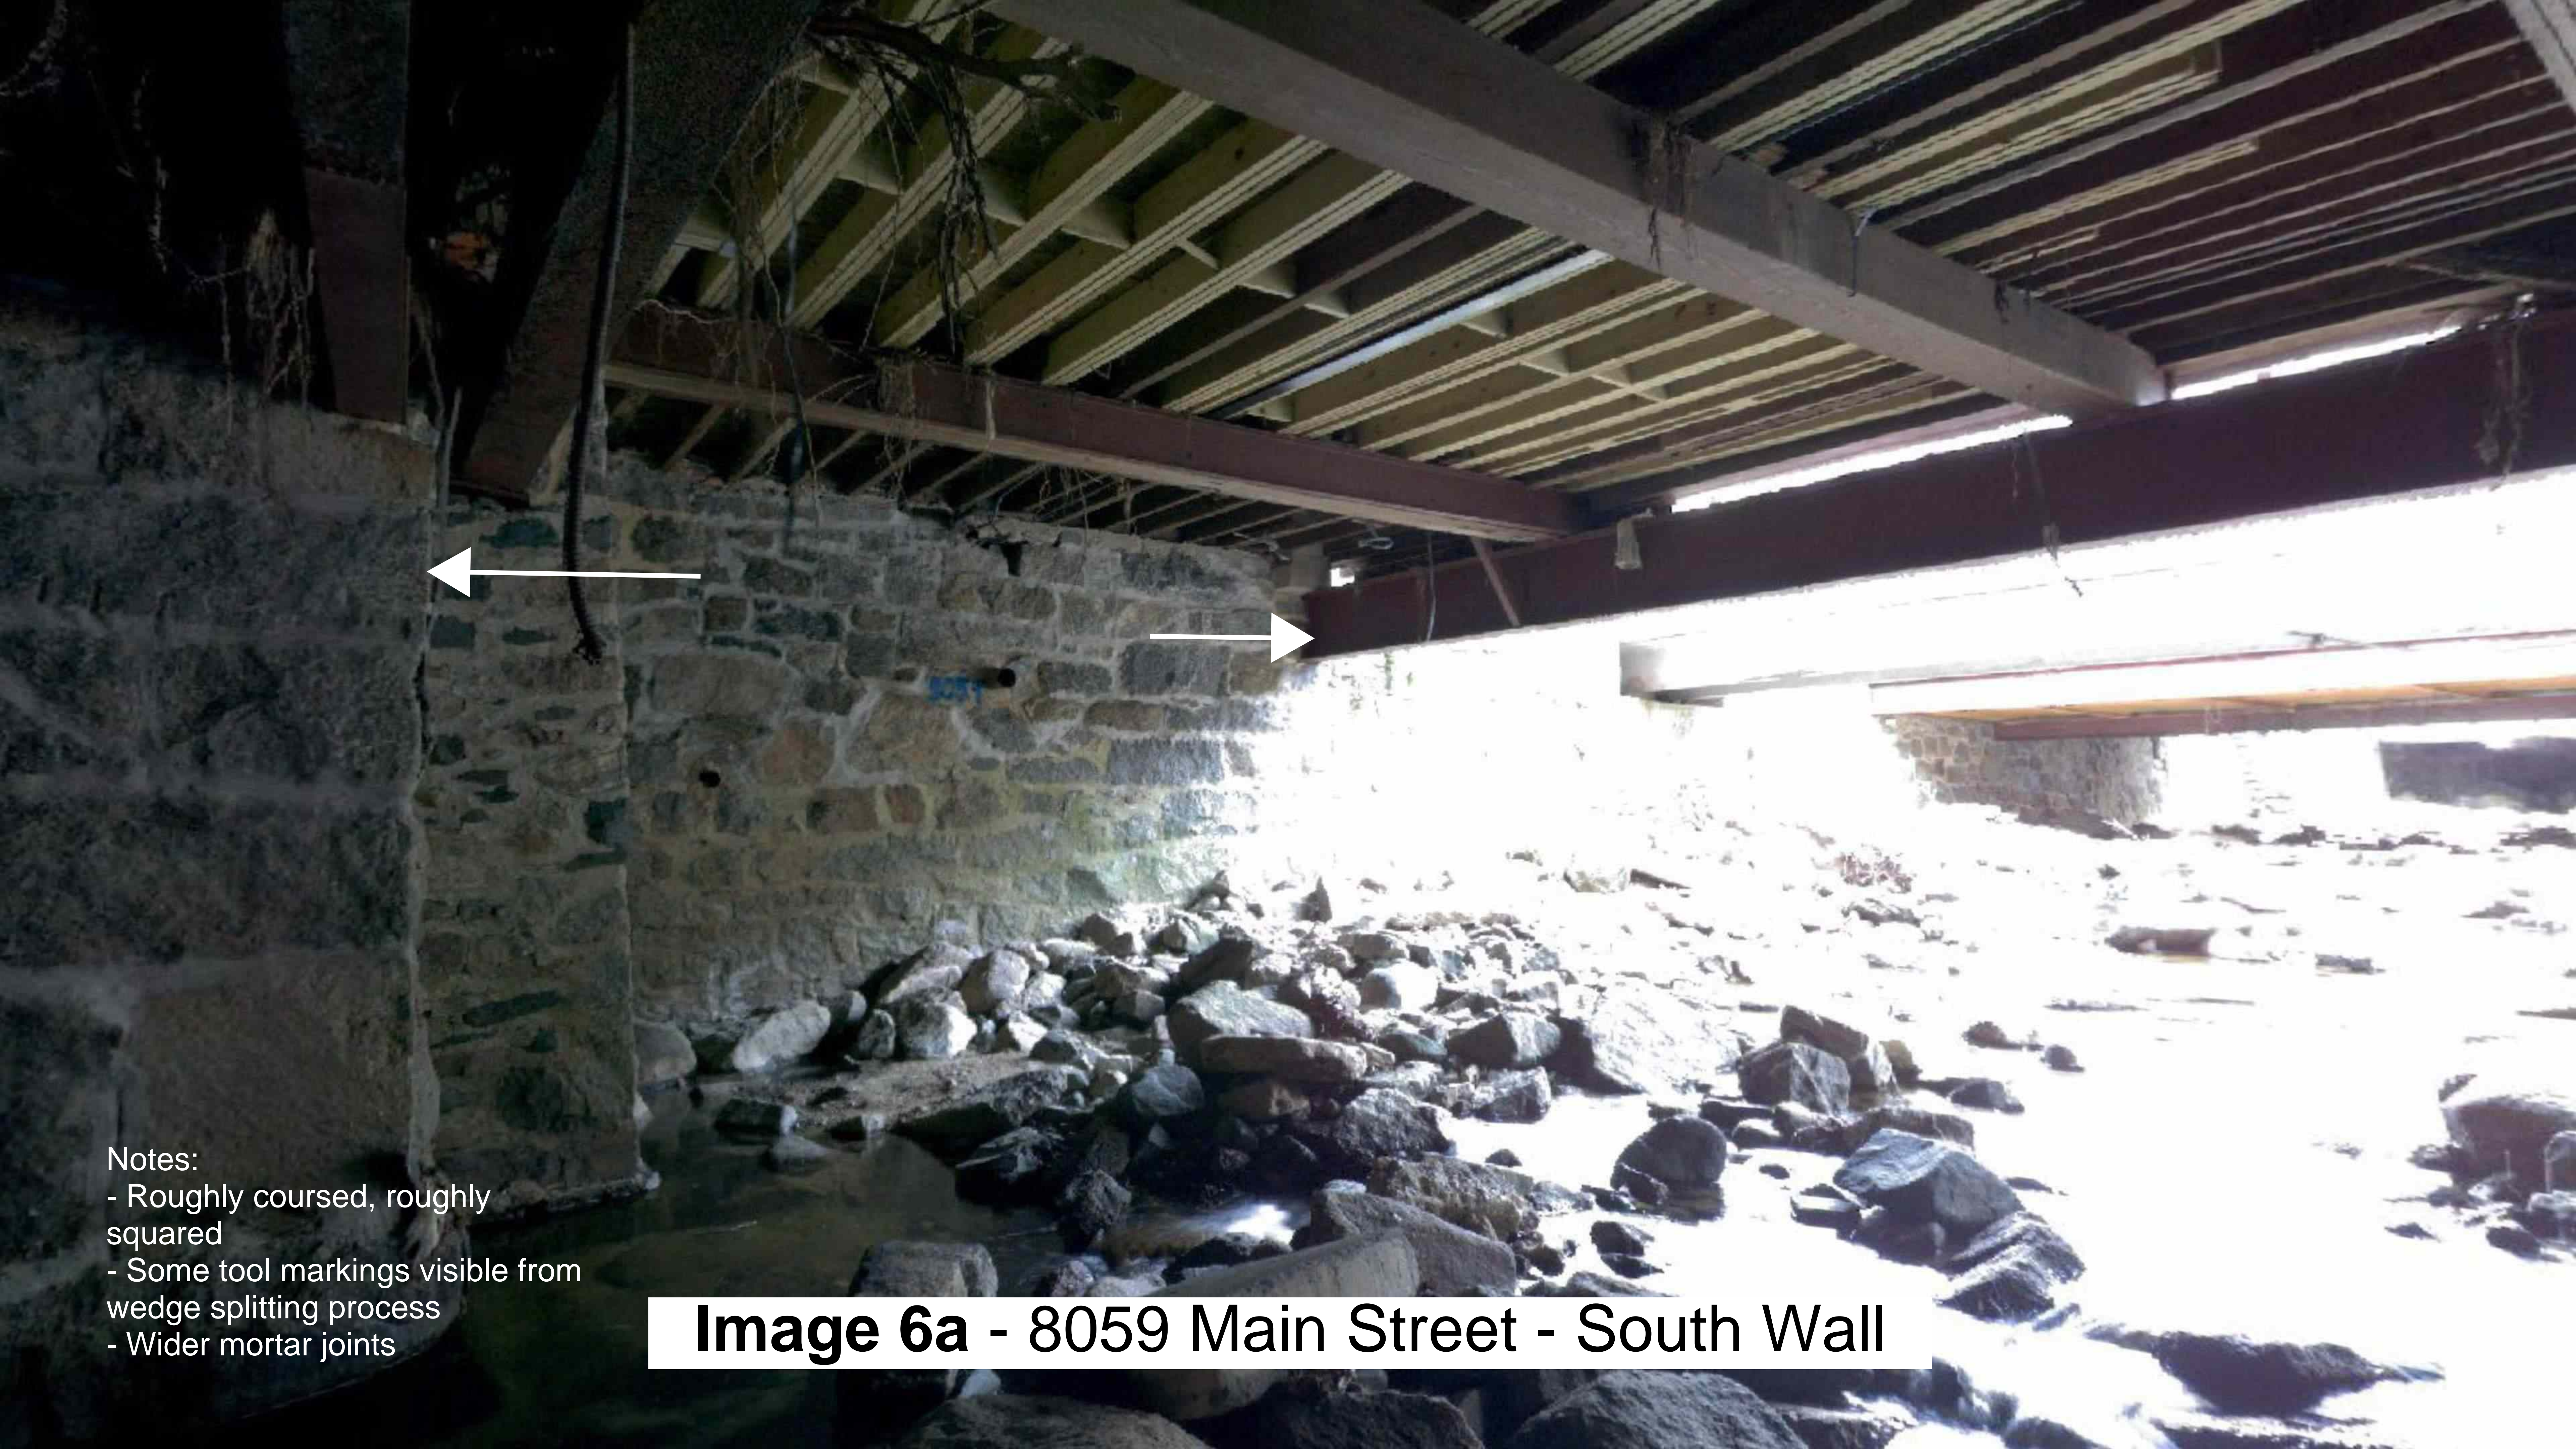
Image 6a - 8059 Main Street - South Wall

- Notes:
- Roughly coursed, roughly squared
 - Some tool markings visible from wedge splitting process
 - Wider mortar joints

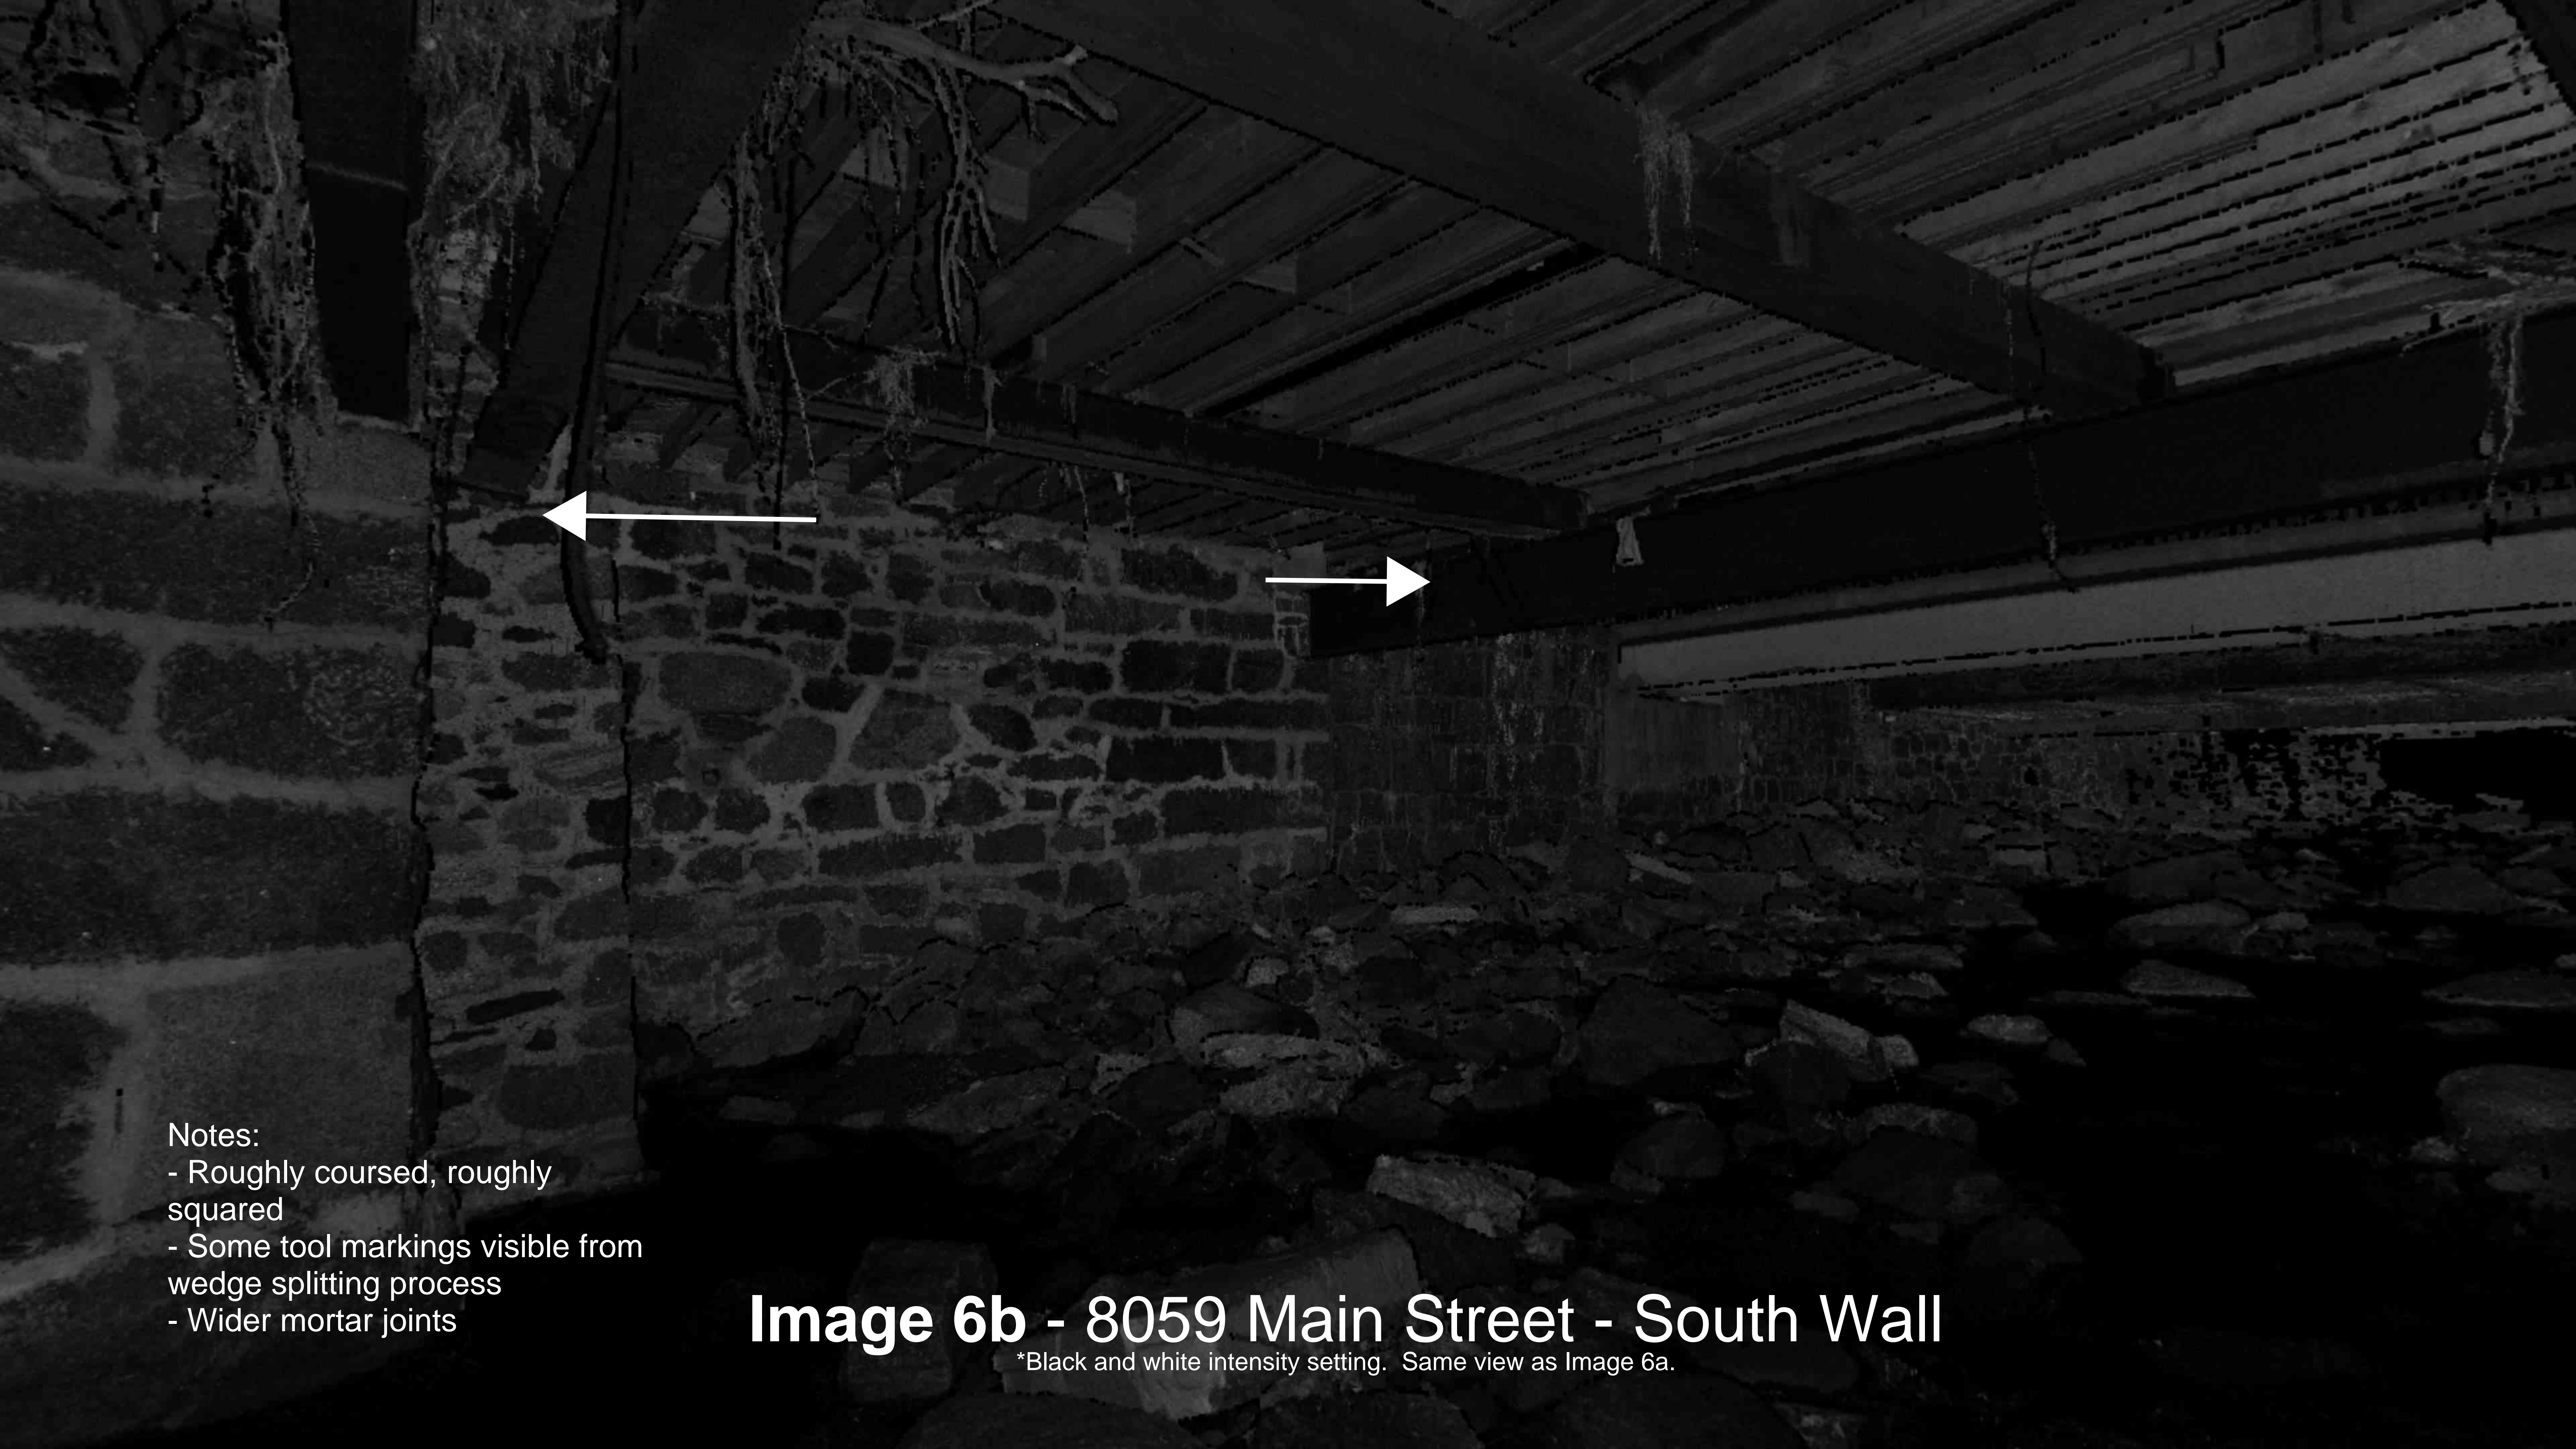
Image 6b - 8059 Main Street - South Wall

- Roughly coursed, roughly squared
- Some tool markings visible from wedge splitting process
- Wider mortar joints

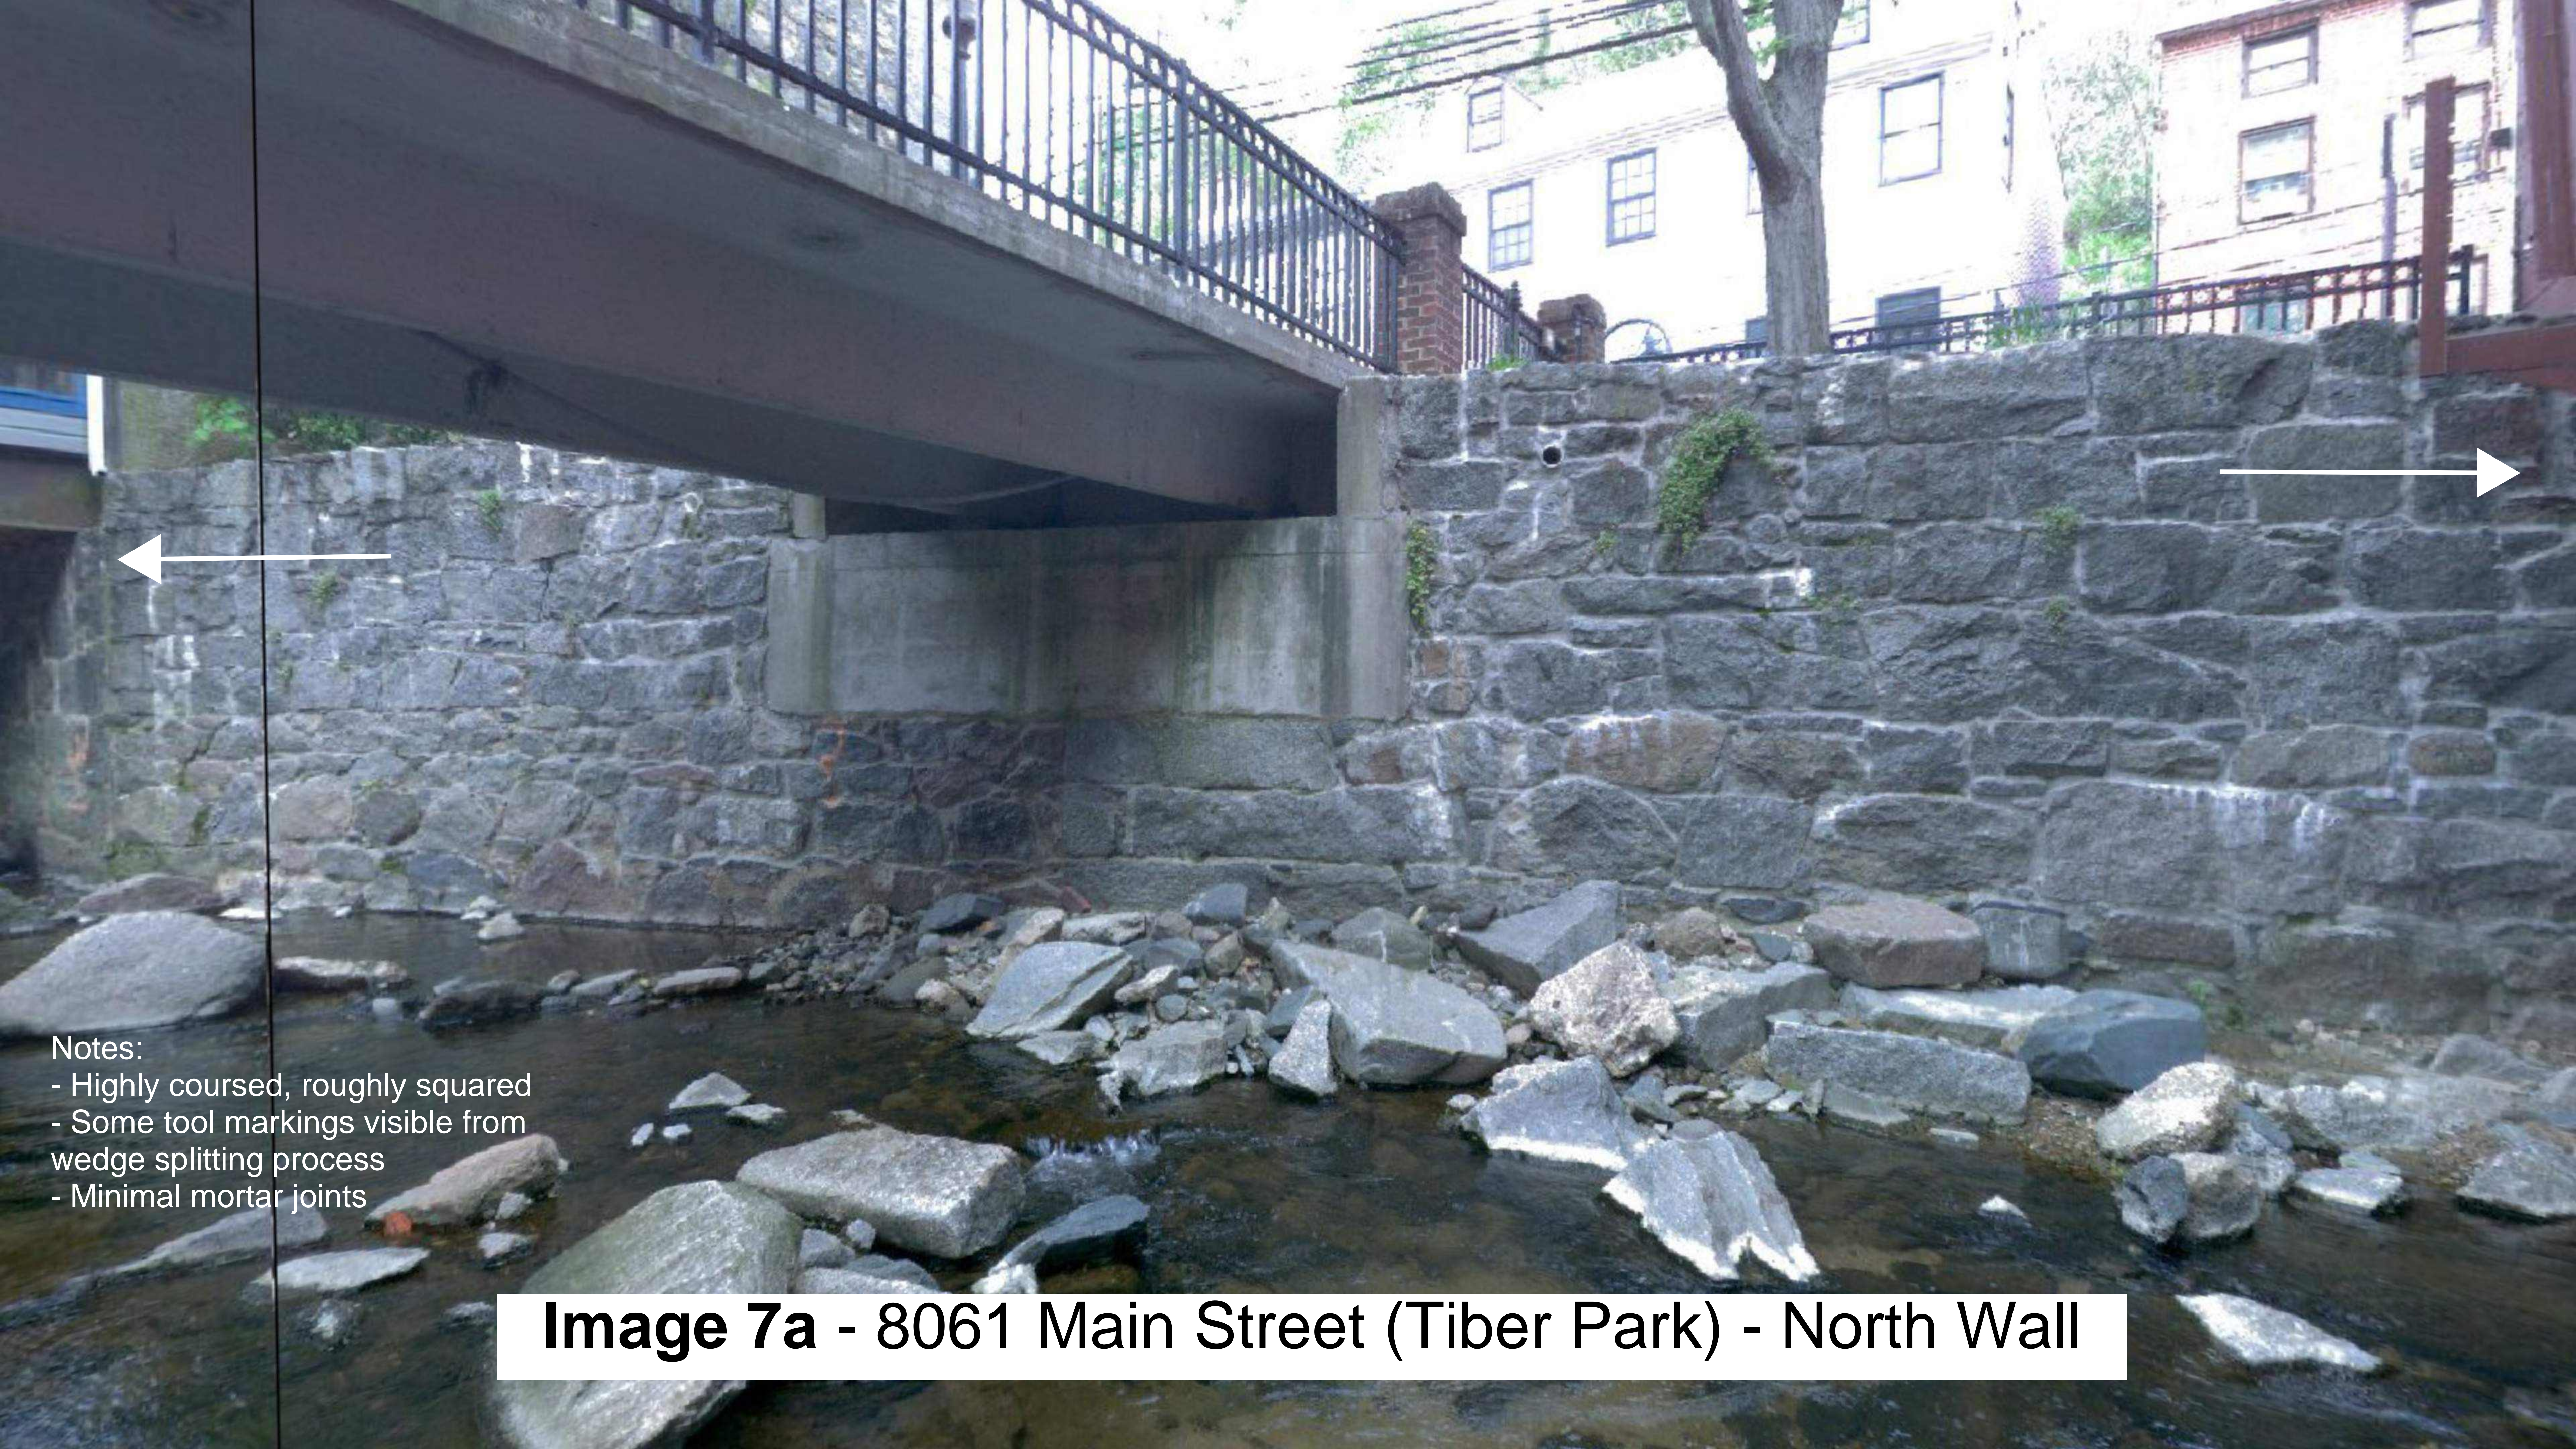
Image 7a - 8061 Main Street (Tiber Park) - North Wall

- Notes:
- Highly coursed, roughly squared
 - Some tool markings visible from wedge splitting process
 - Minimal mortar joints

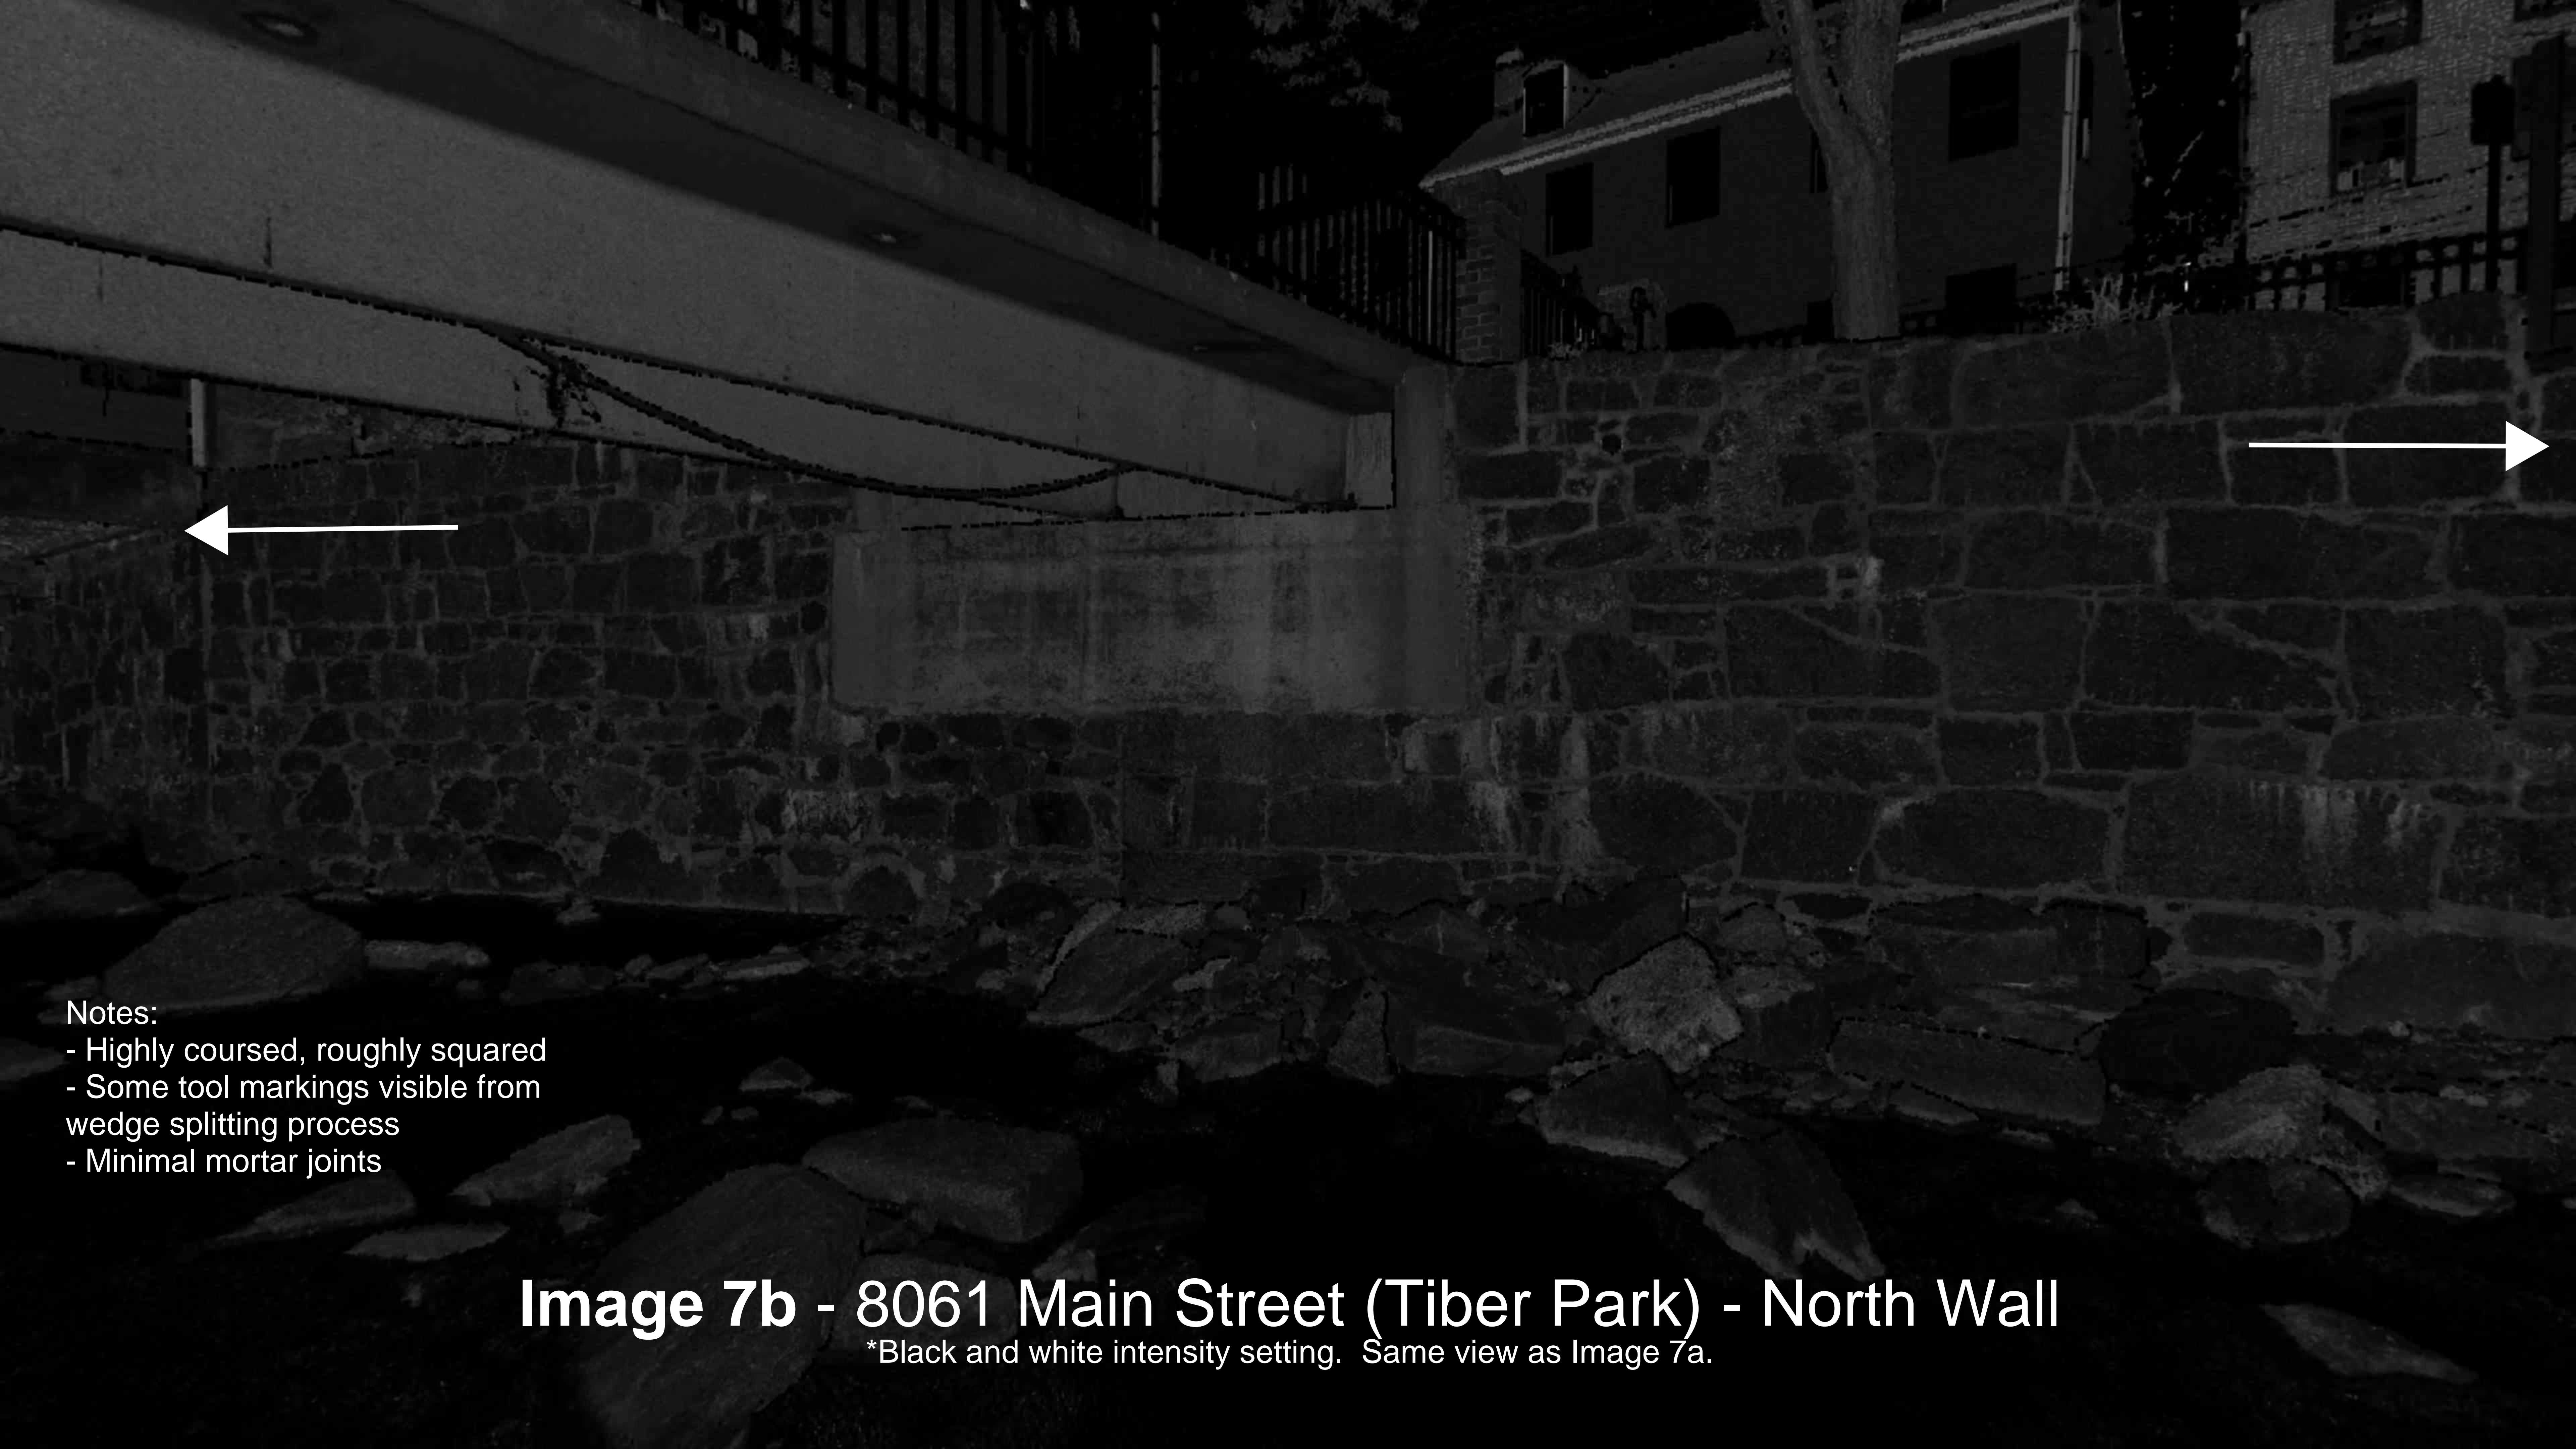
Image 7b - 8061 Main Street (Tiber Park) - North Wall

- Highly coursed, roughly squared
- Some tool markings visible from wedge splitting process
- Minimal mortar joints

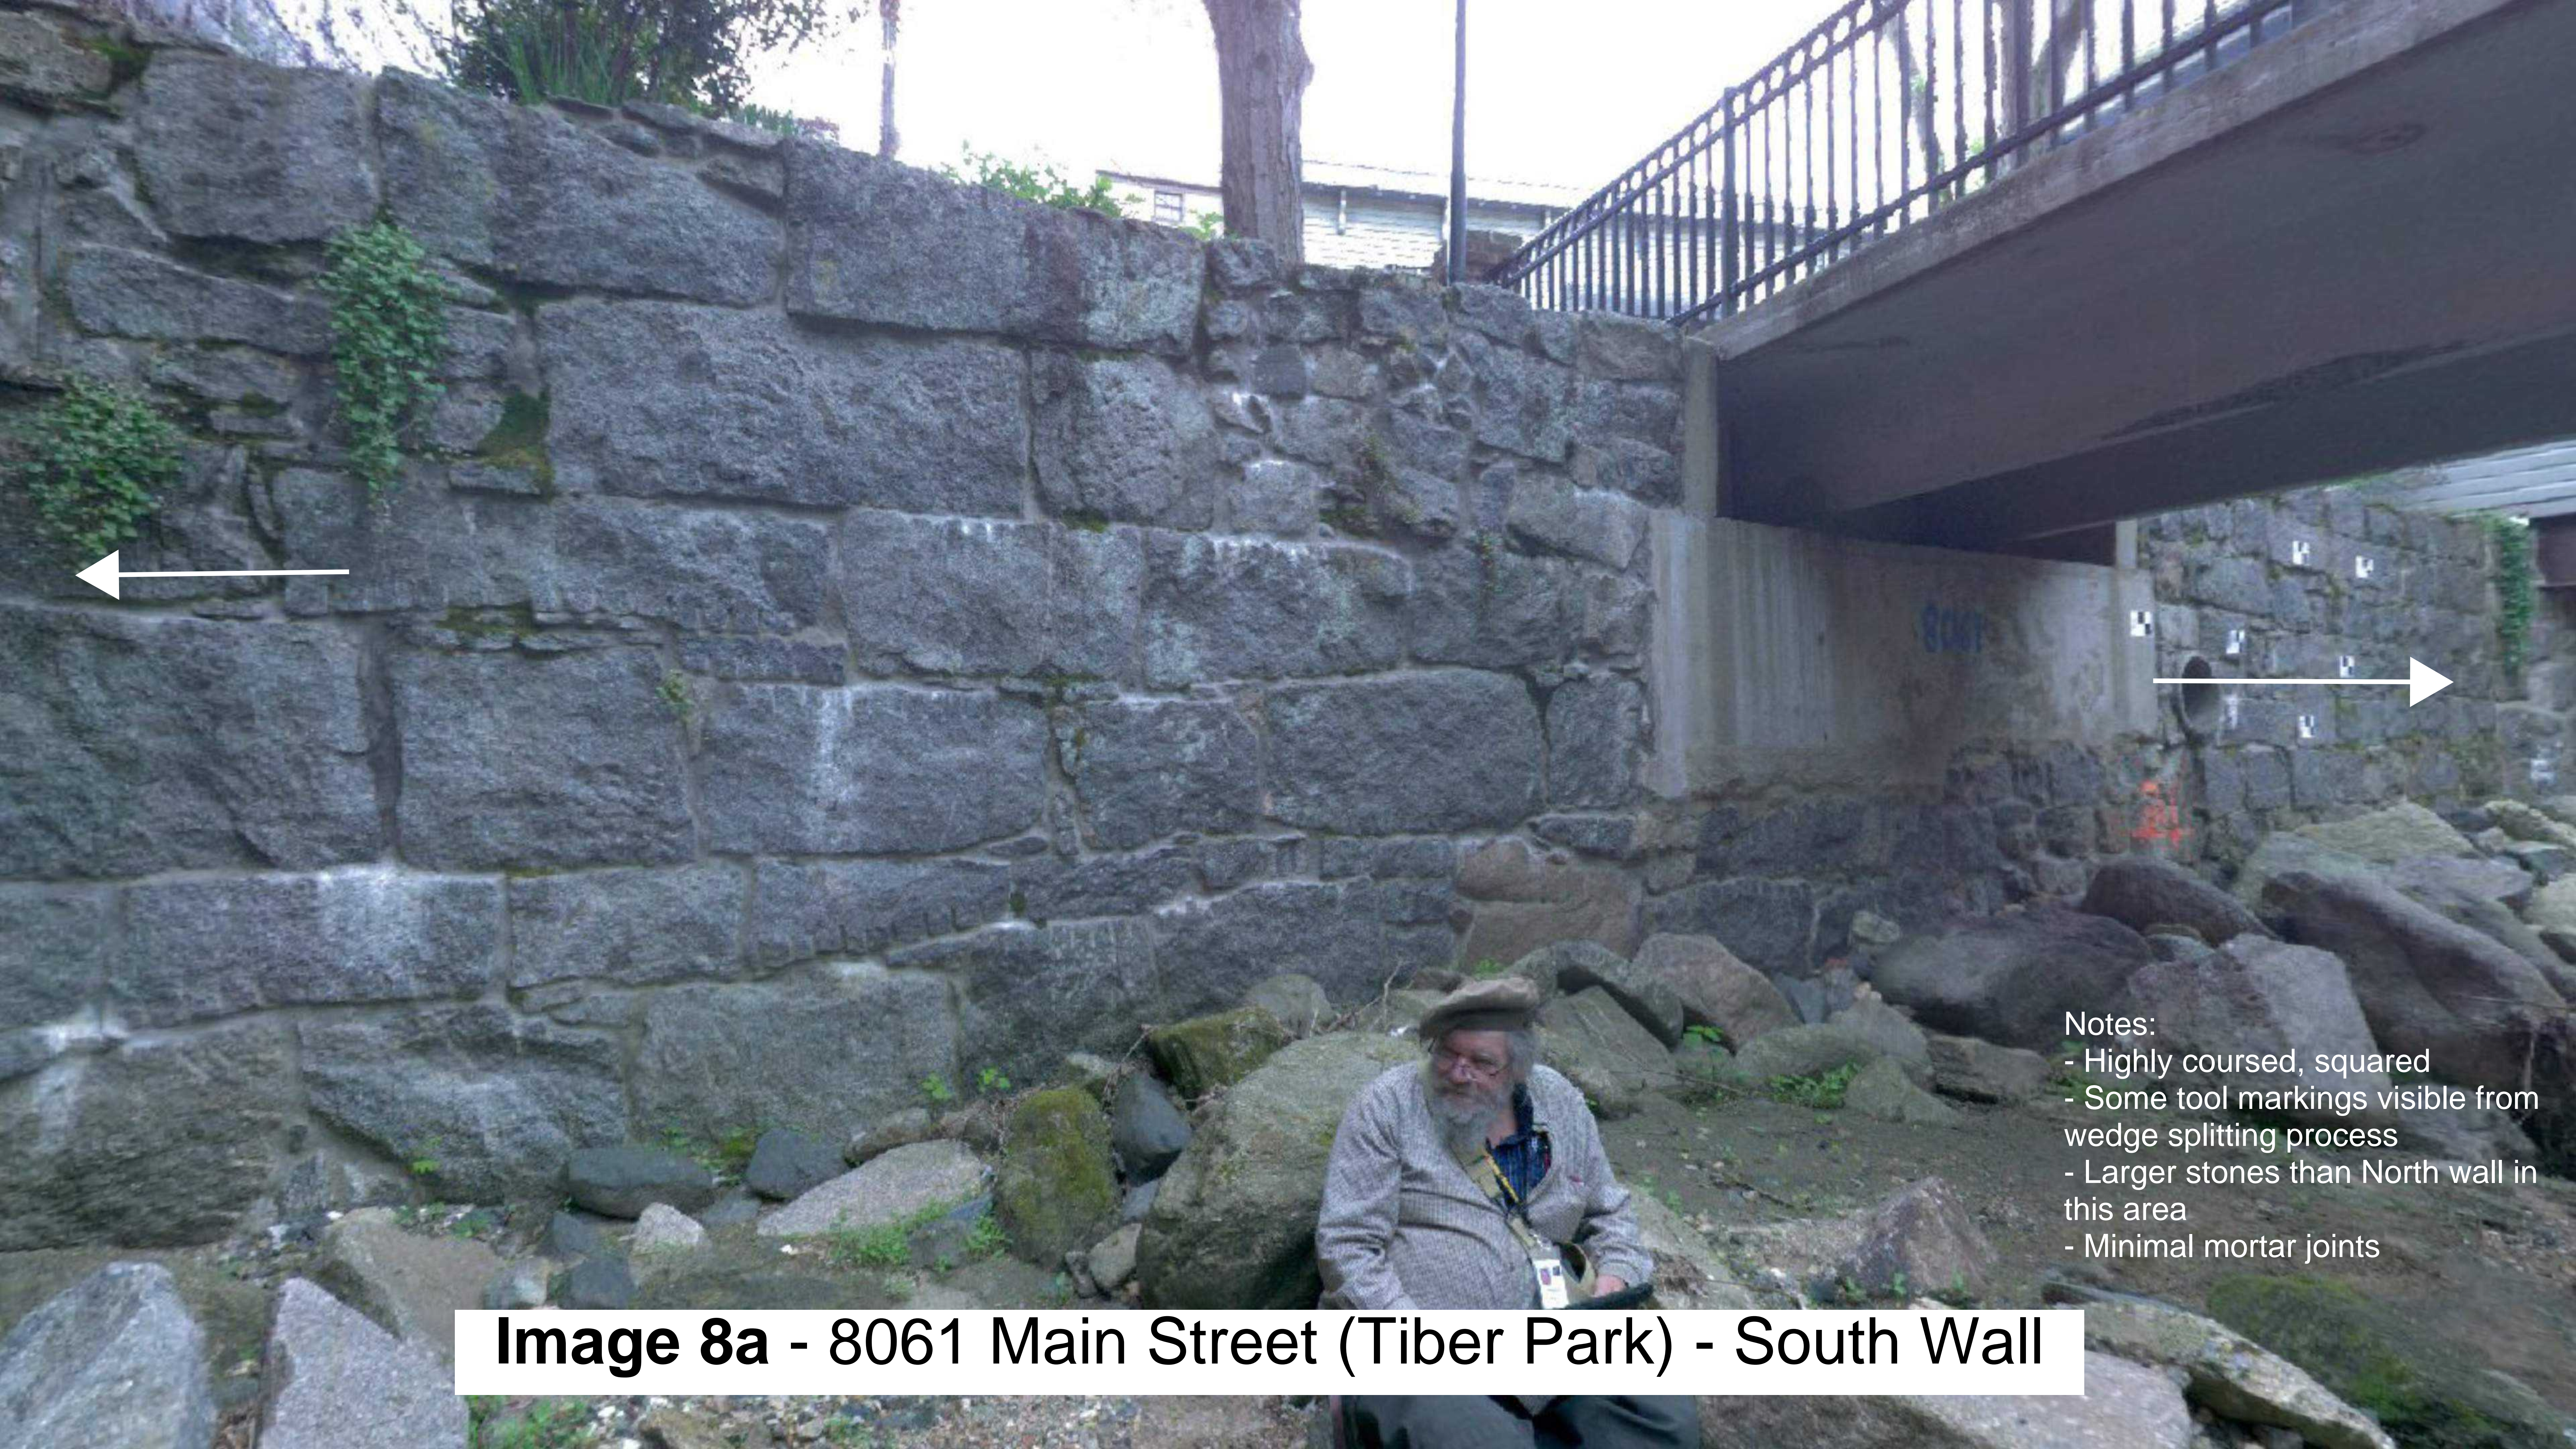
Image 8a - 8061 Main Street (Tiber Park) - South Wall

- Notes:
- Highly coursed, squared
 - Some tool markings visible from wedge splitting process
 - Larger stones than North wall in this area
 - Minimal mortar joints

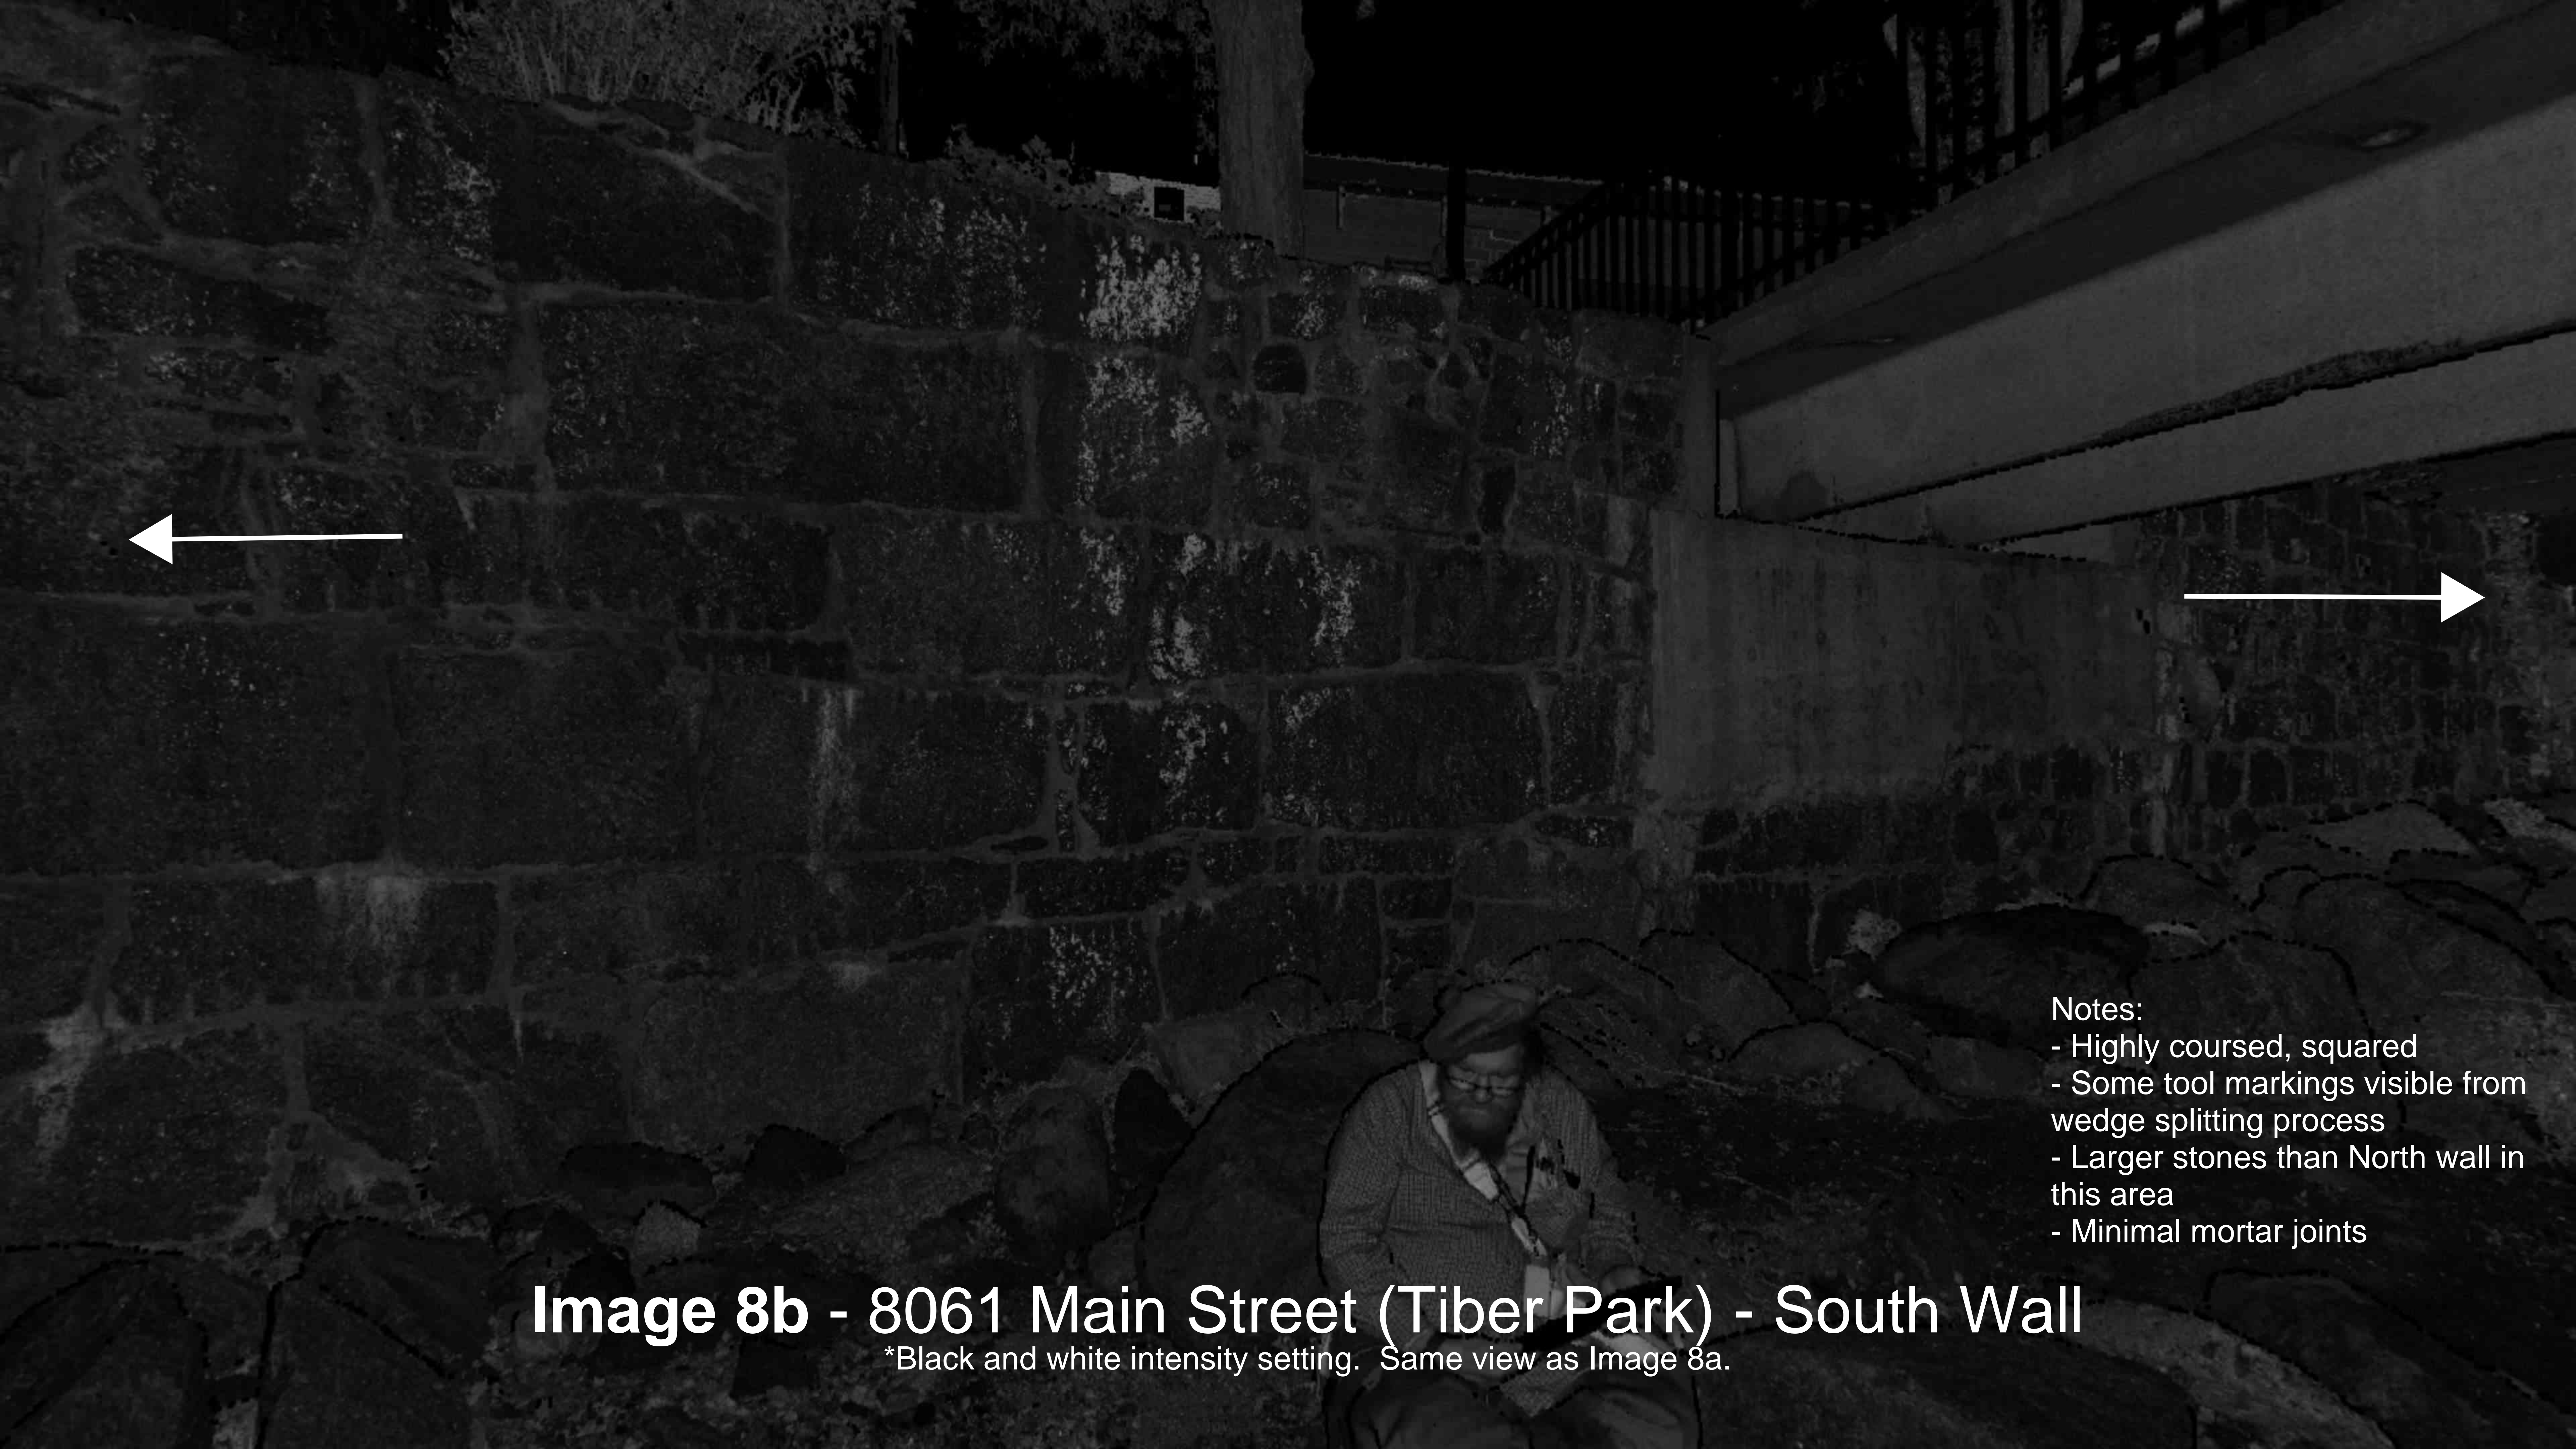
Image 8b - 8061 Main Street (Tiber Park) - South Wall

- Highly coursed, squared
- Some tool markings visible from wedge splitting process
- Larger stones than North wall in this area
- Minimal mortar joints
