HPC 20-83

8049, 8055, 8059, 8061 (Tiber Park) and 8069 Main Street; Vicinity of Maryland Avenue and Main Street; Vicinity of 3711 Maryland Avenue along Patapsco River, Ellicott City

Photos / Documentation of Stream Channel Walls

Prepared by Howard County Department of Public Works

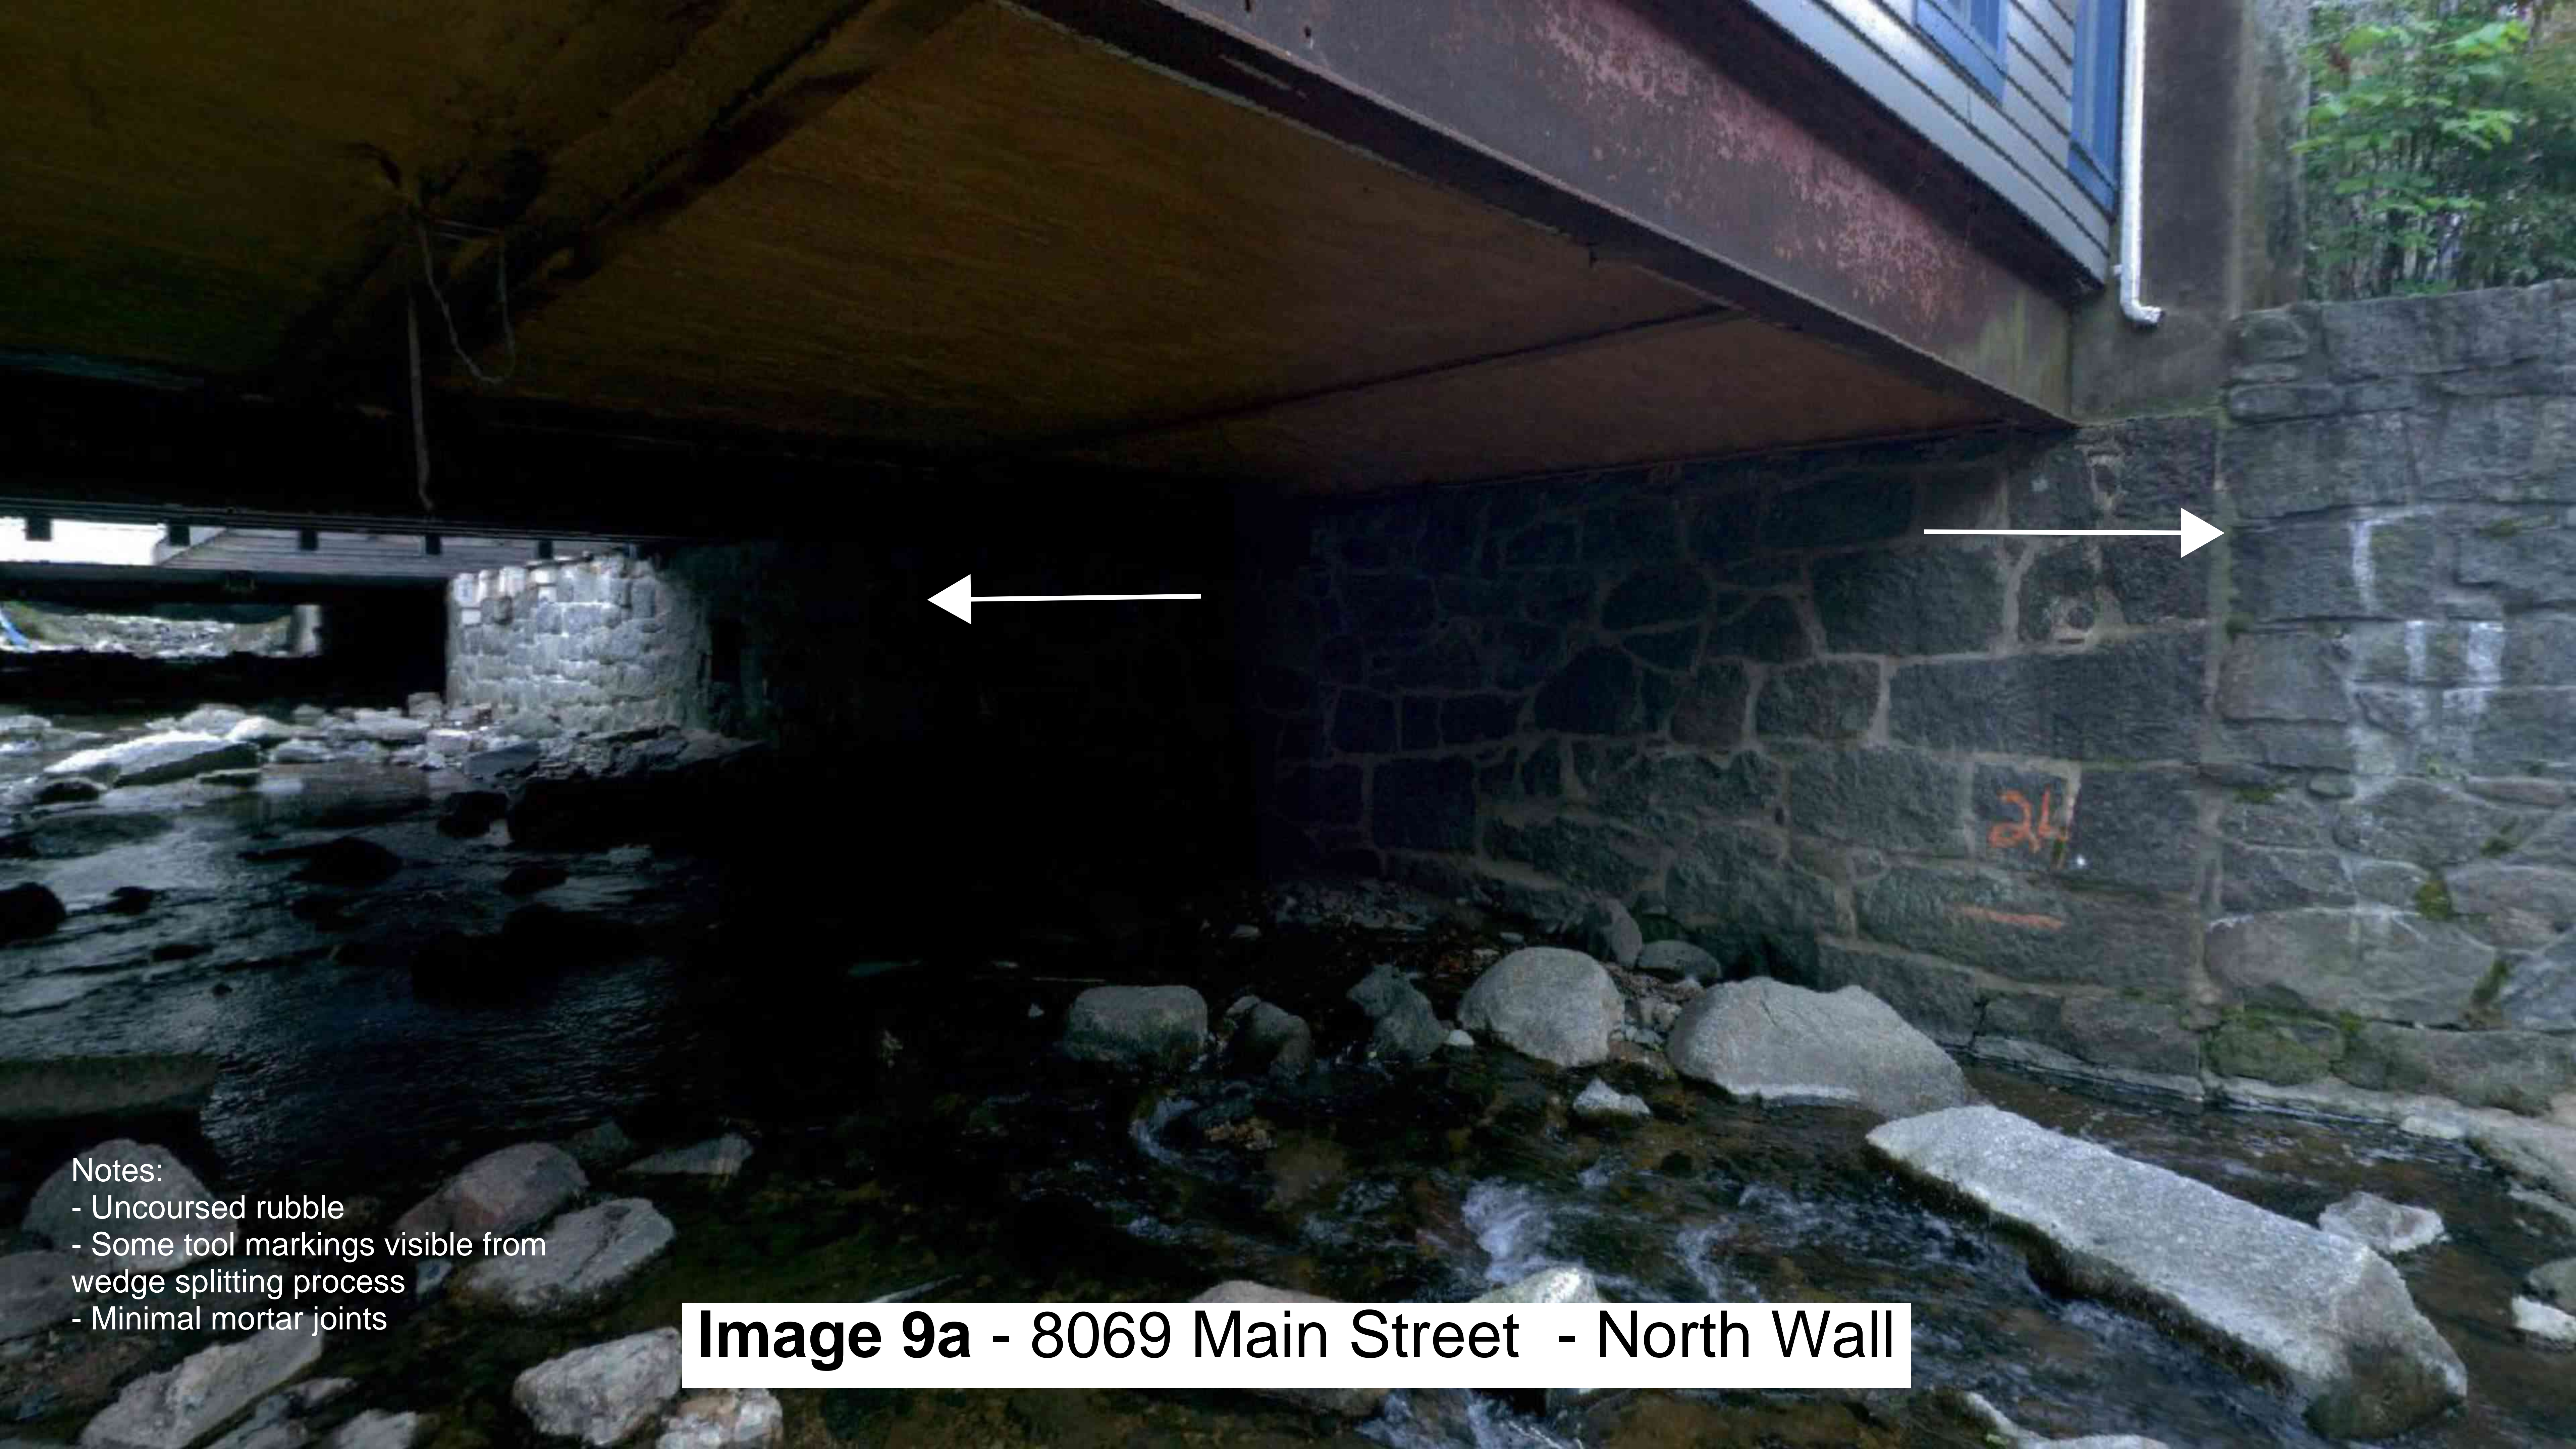
Image 9a - 8069 Main Street - North Wall

- Uncoursed rubble
- Some tool markings visible from wedge splitting process
- Minimal mortar joints

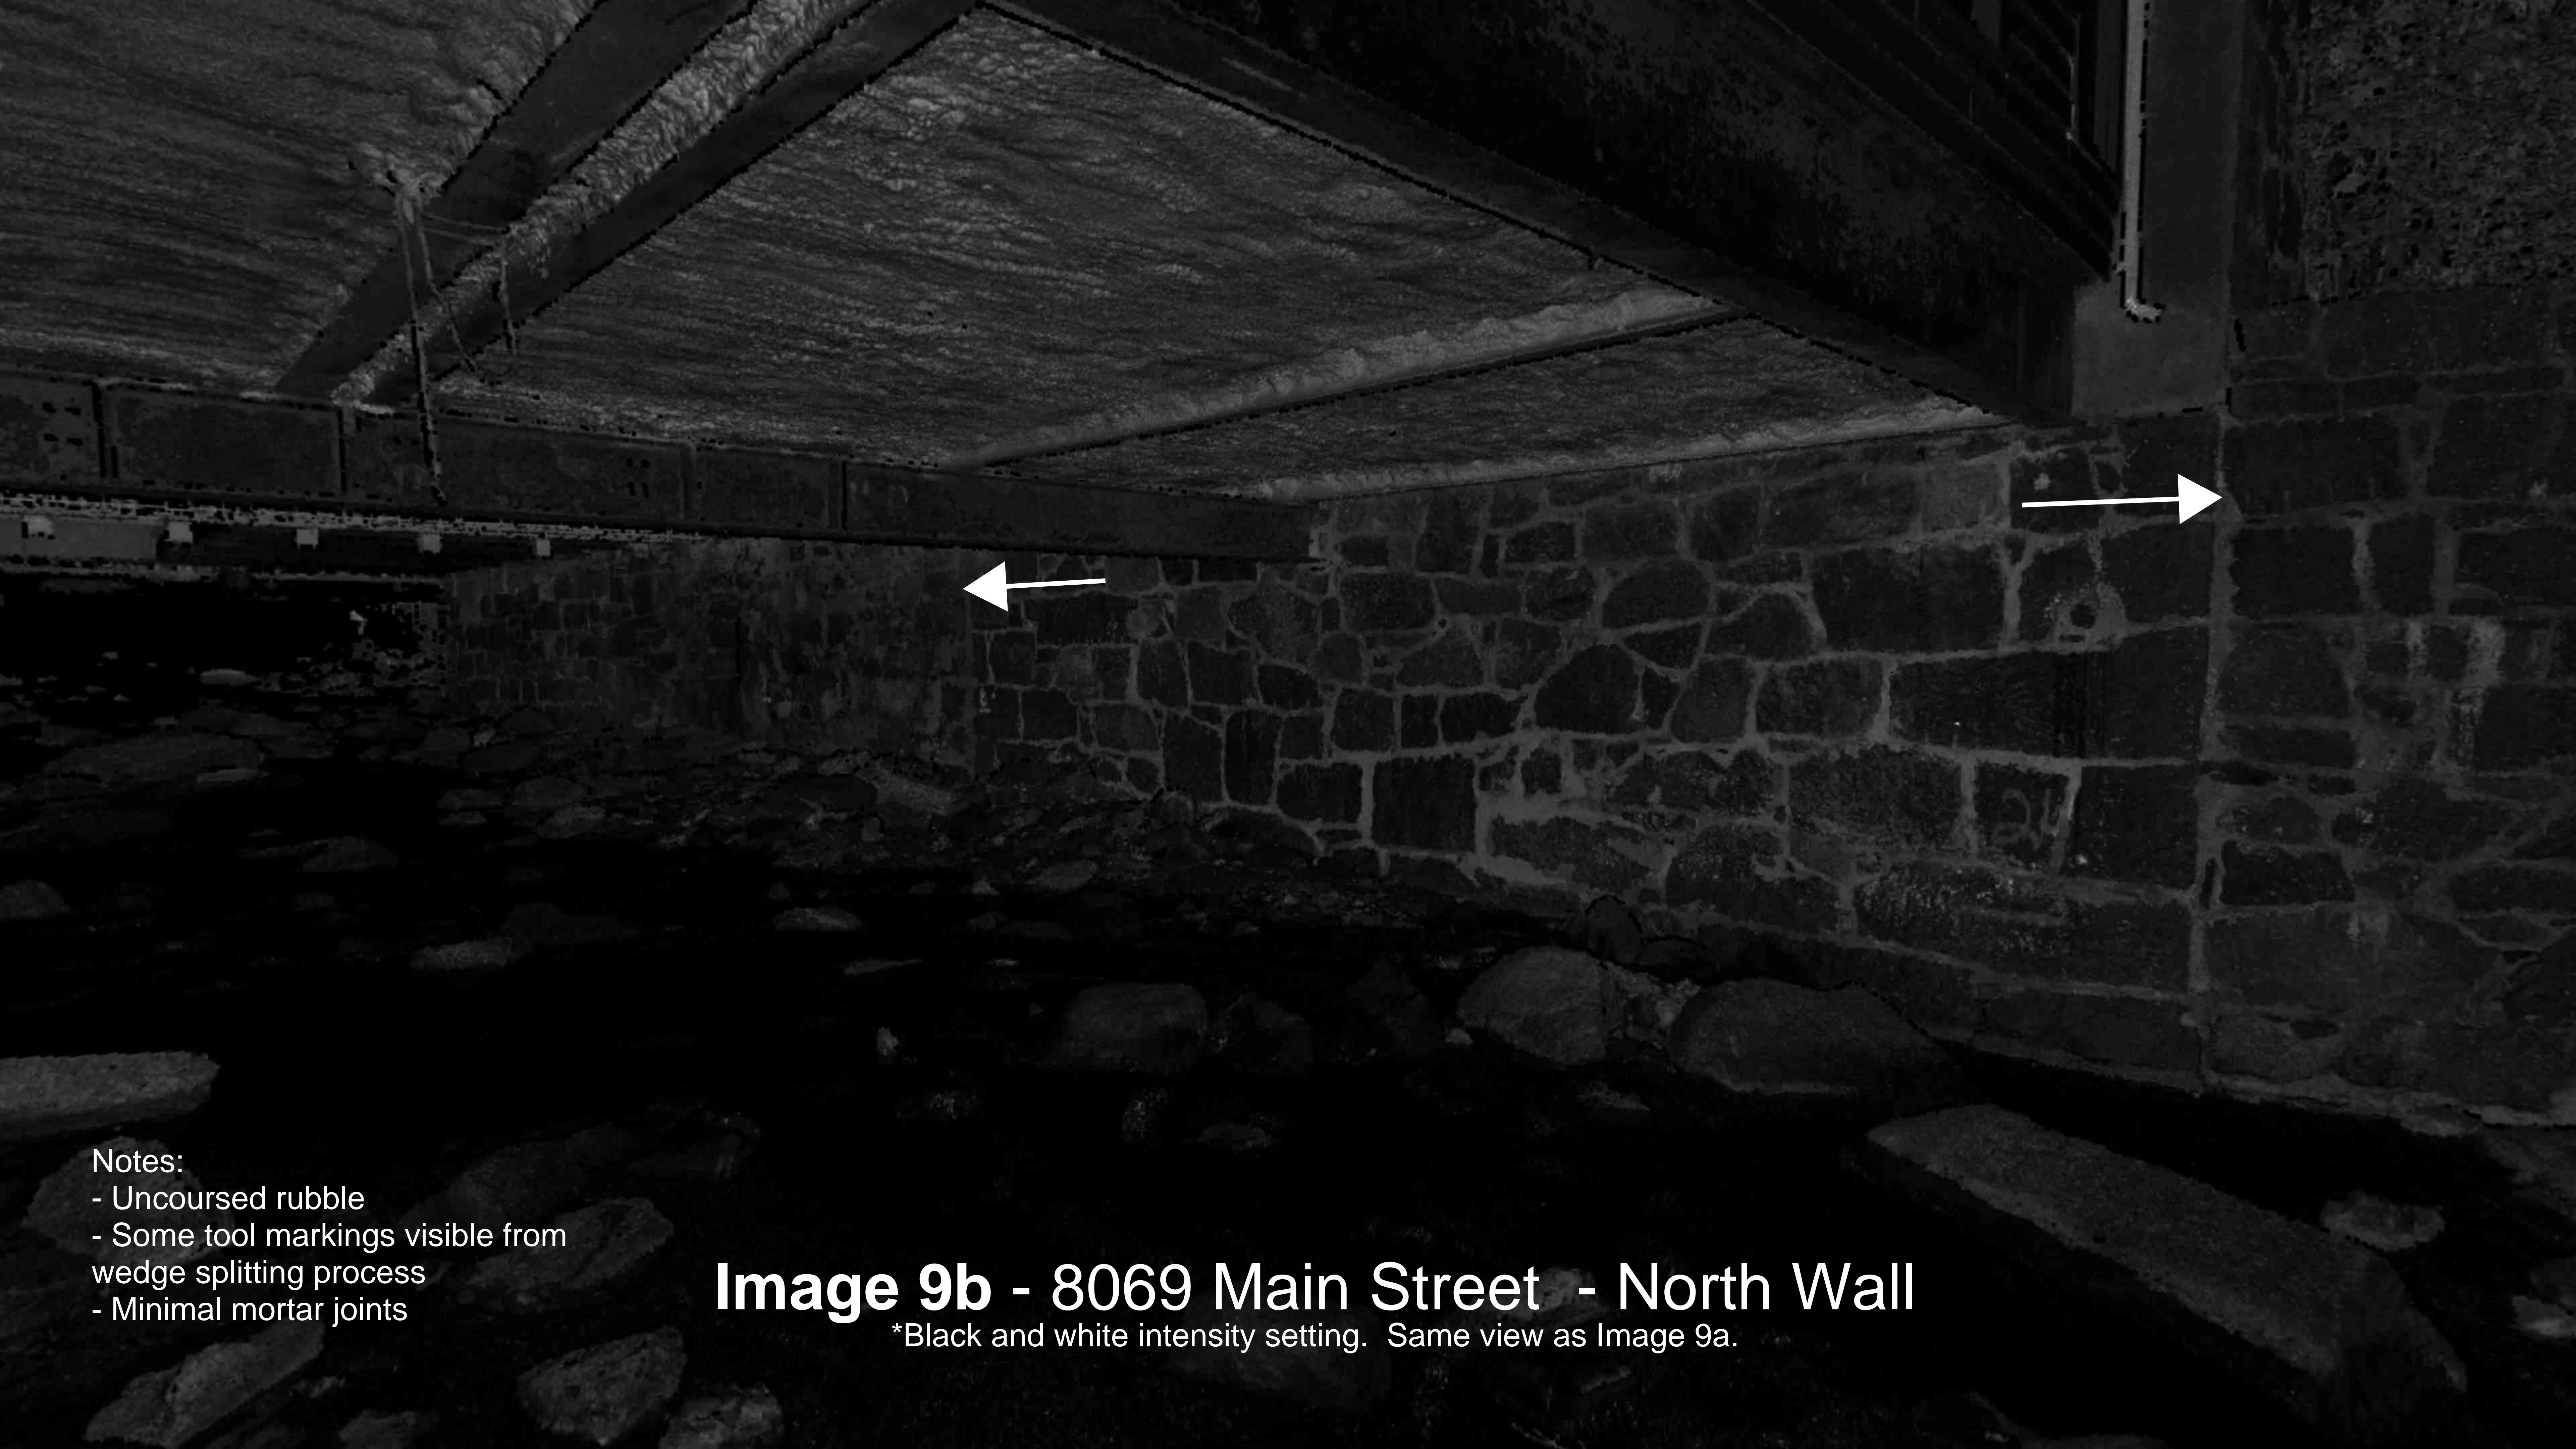
Image 9b - 8069 Main Street - North Wall

- Uncoursed rubble
- Some tool markings visible from wedge splitting process
- Minimal mortar joints

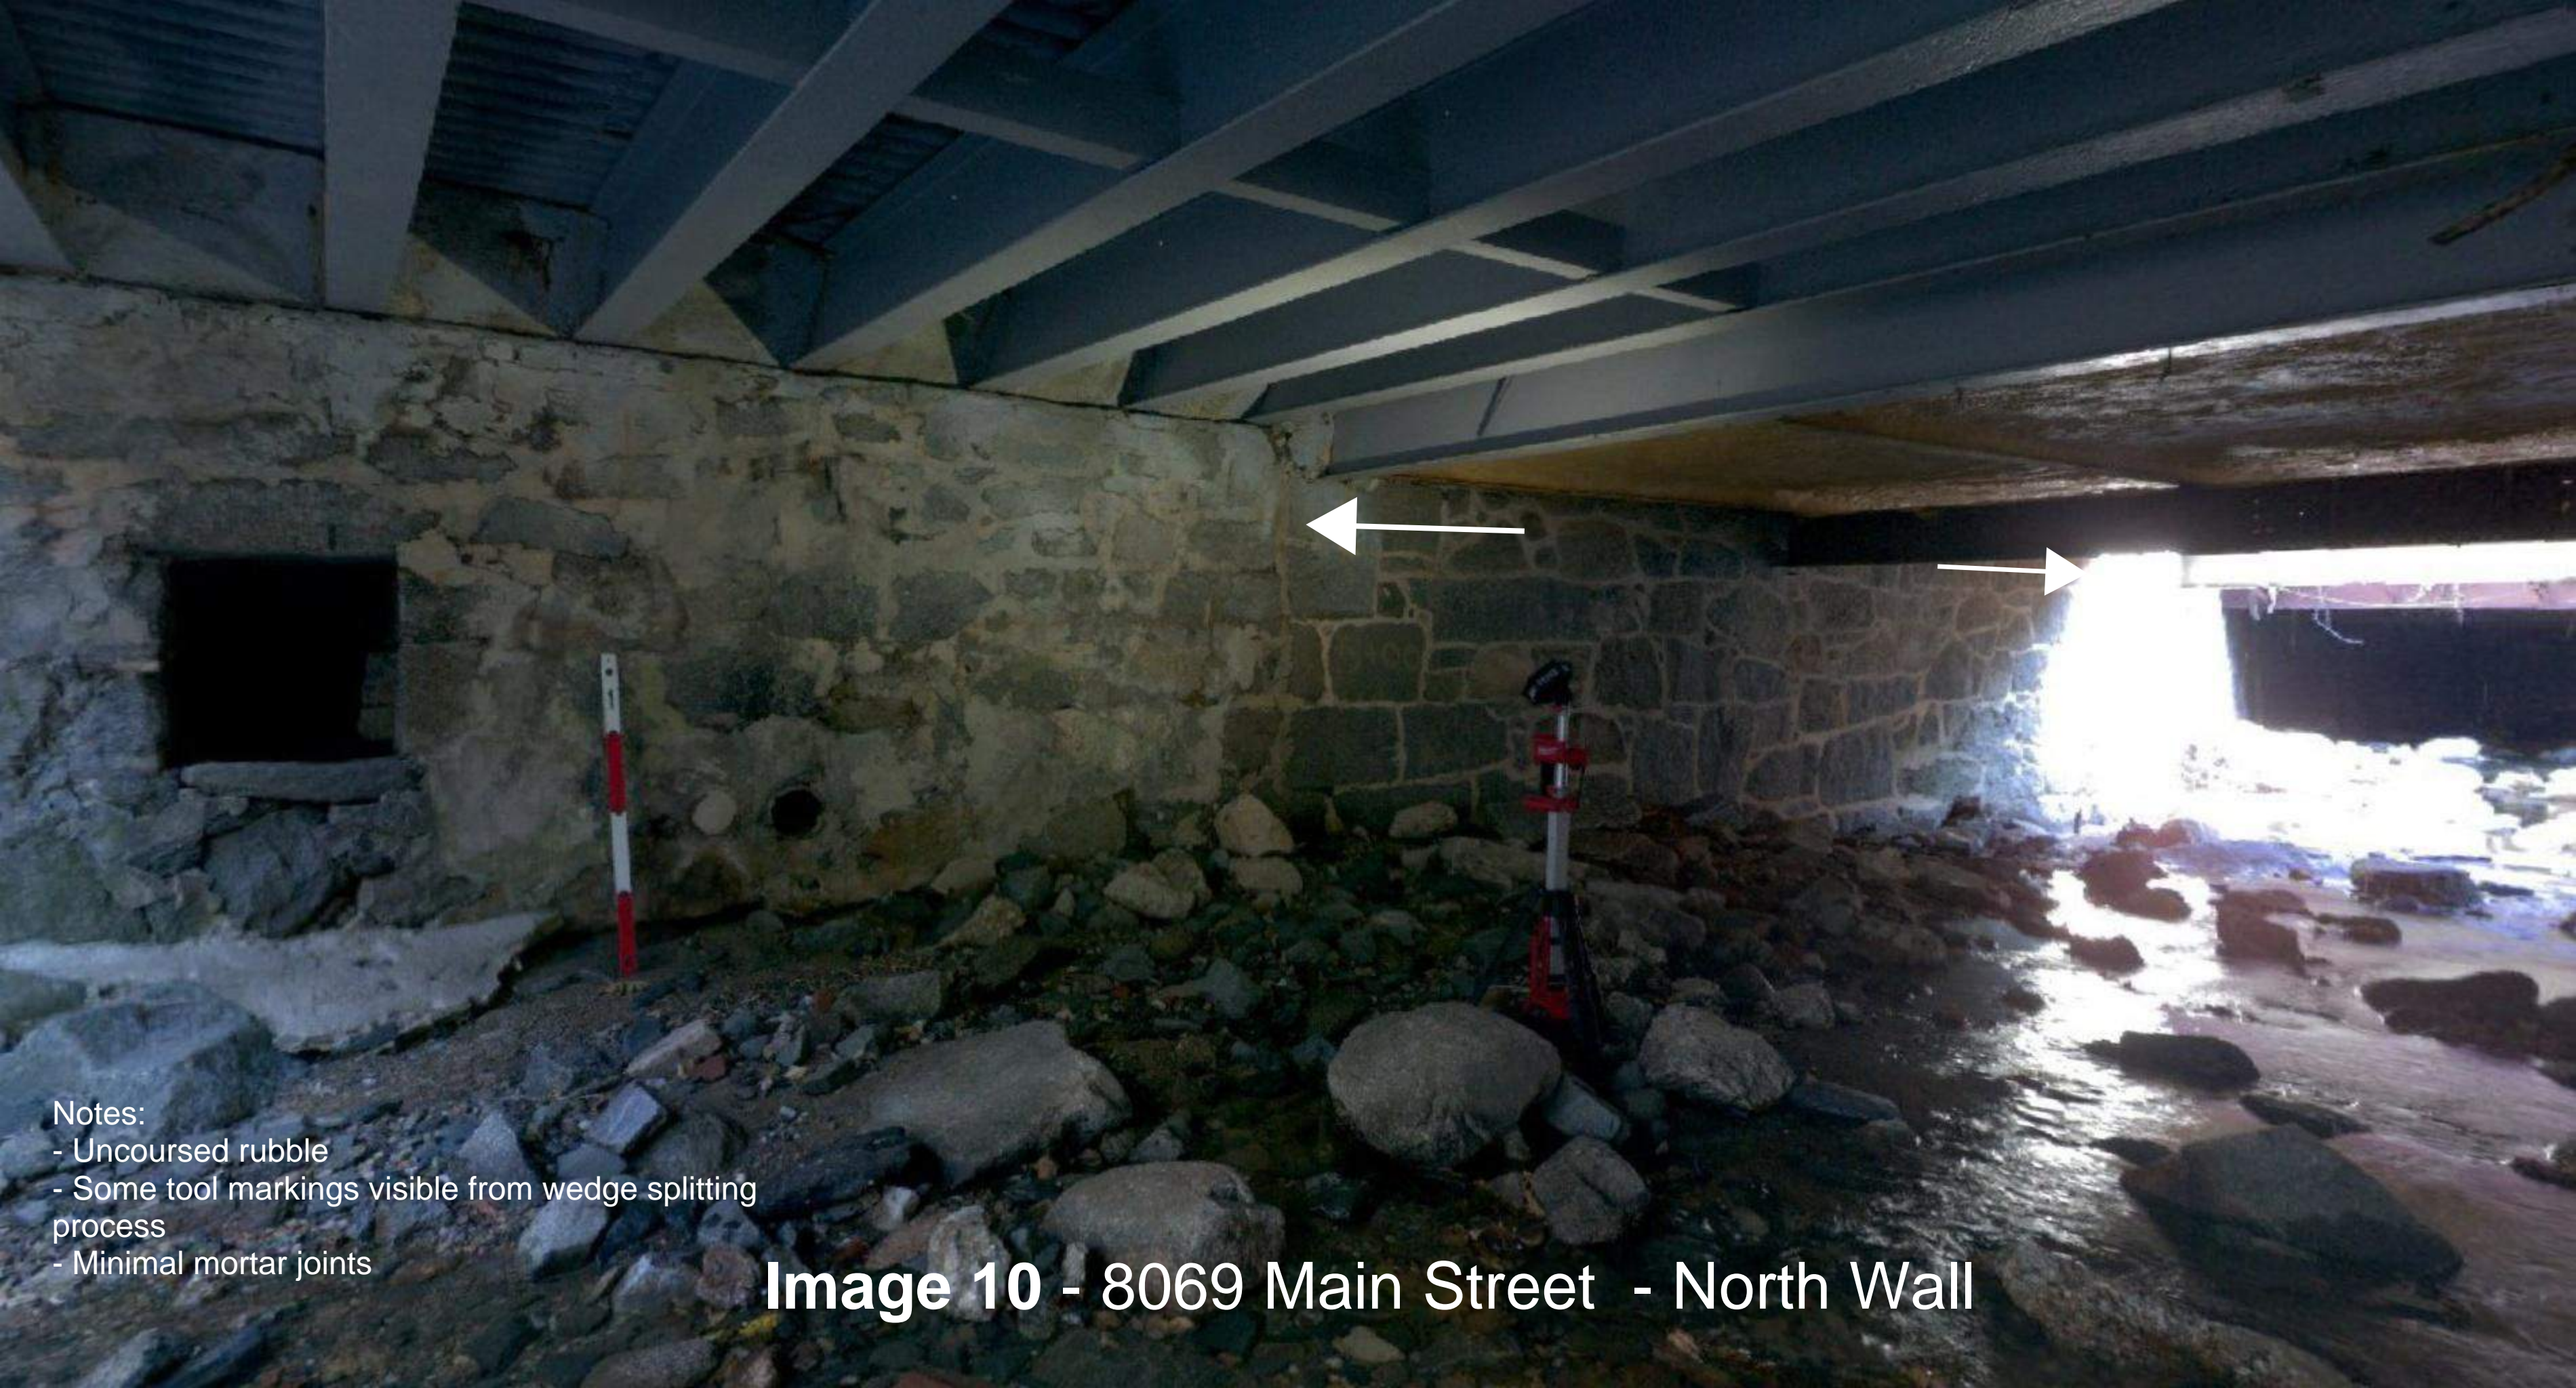
Image 10 - 8069 Main Street - North Wall

- Notes:
- Uncoursed rubble
 - Some tool markings visible from wedge splitting process
 - Minimal mortar joints

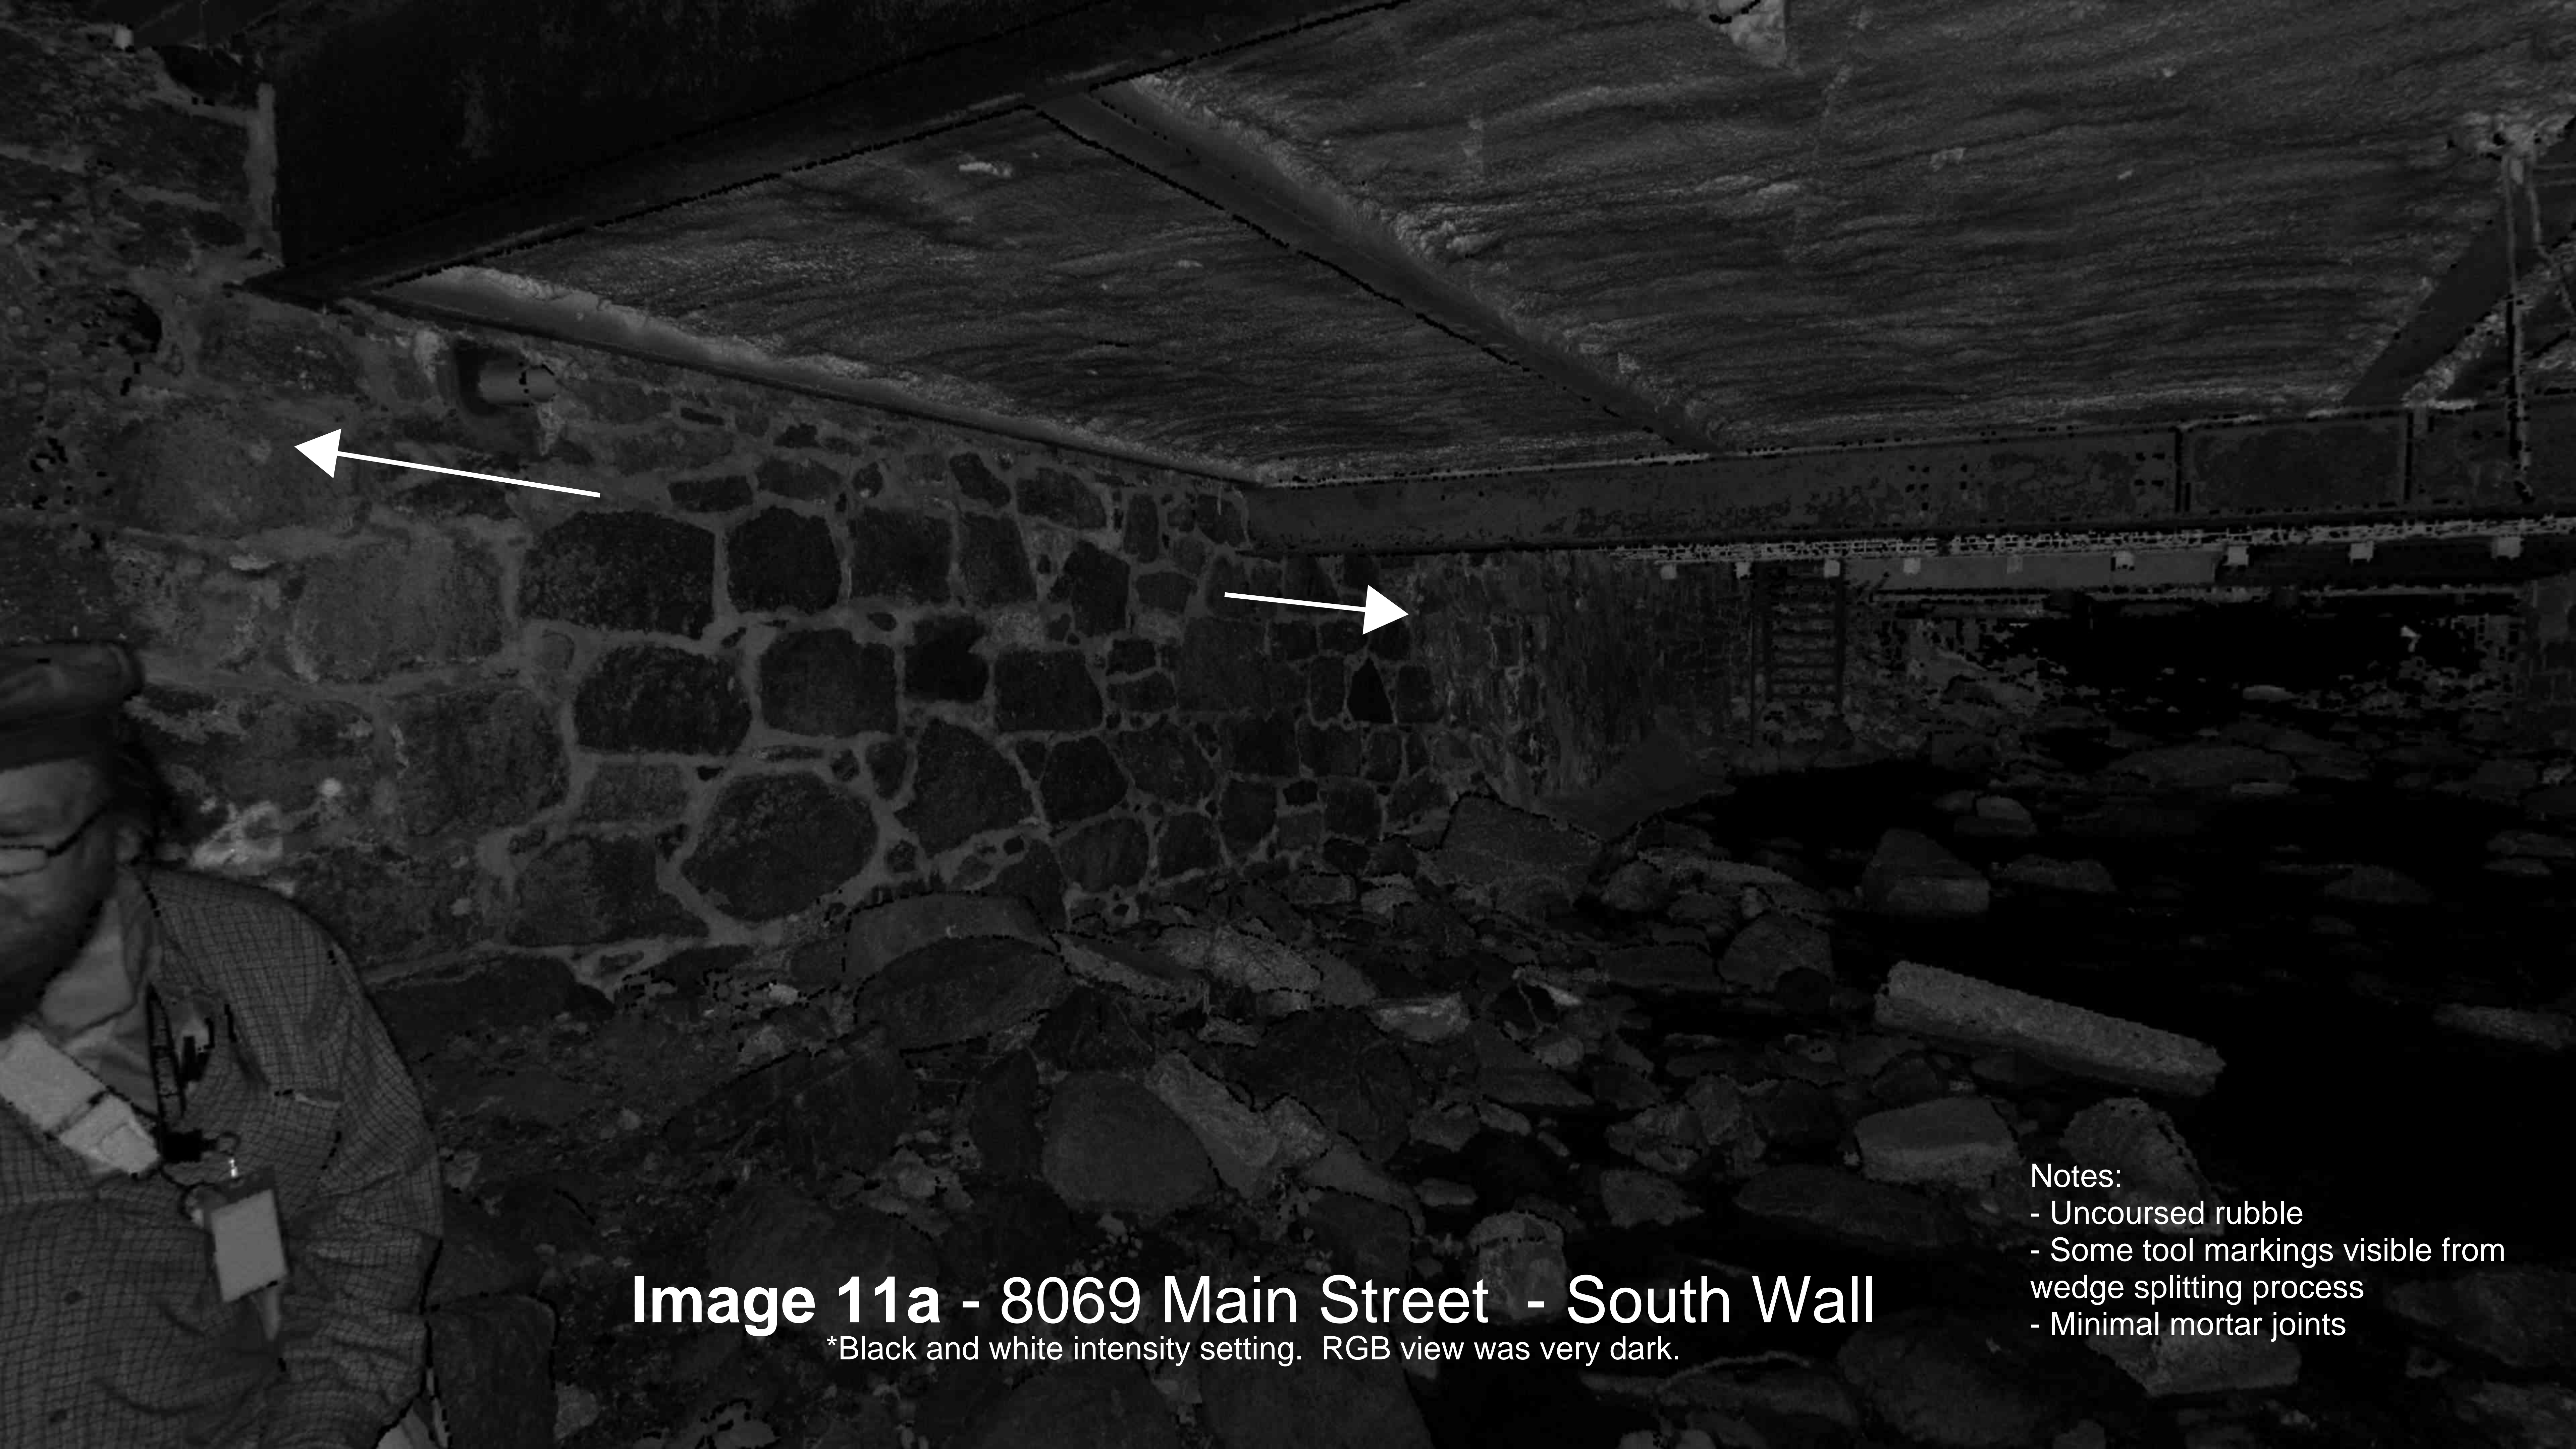
Image 11a - 8069 Main Street - South Wall

- Uncoursed rubble
- Some tool markings visible from wedge splitting process
- Minimal mortar joints

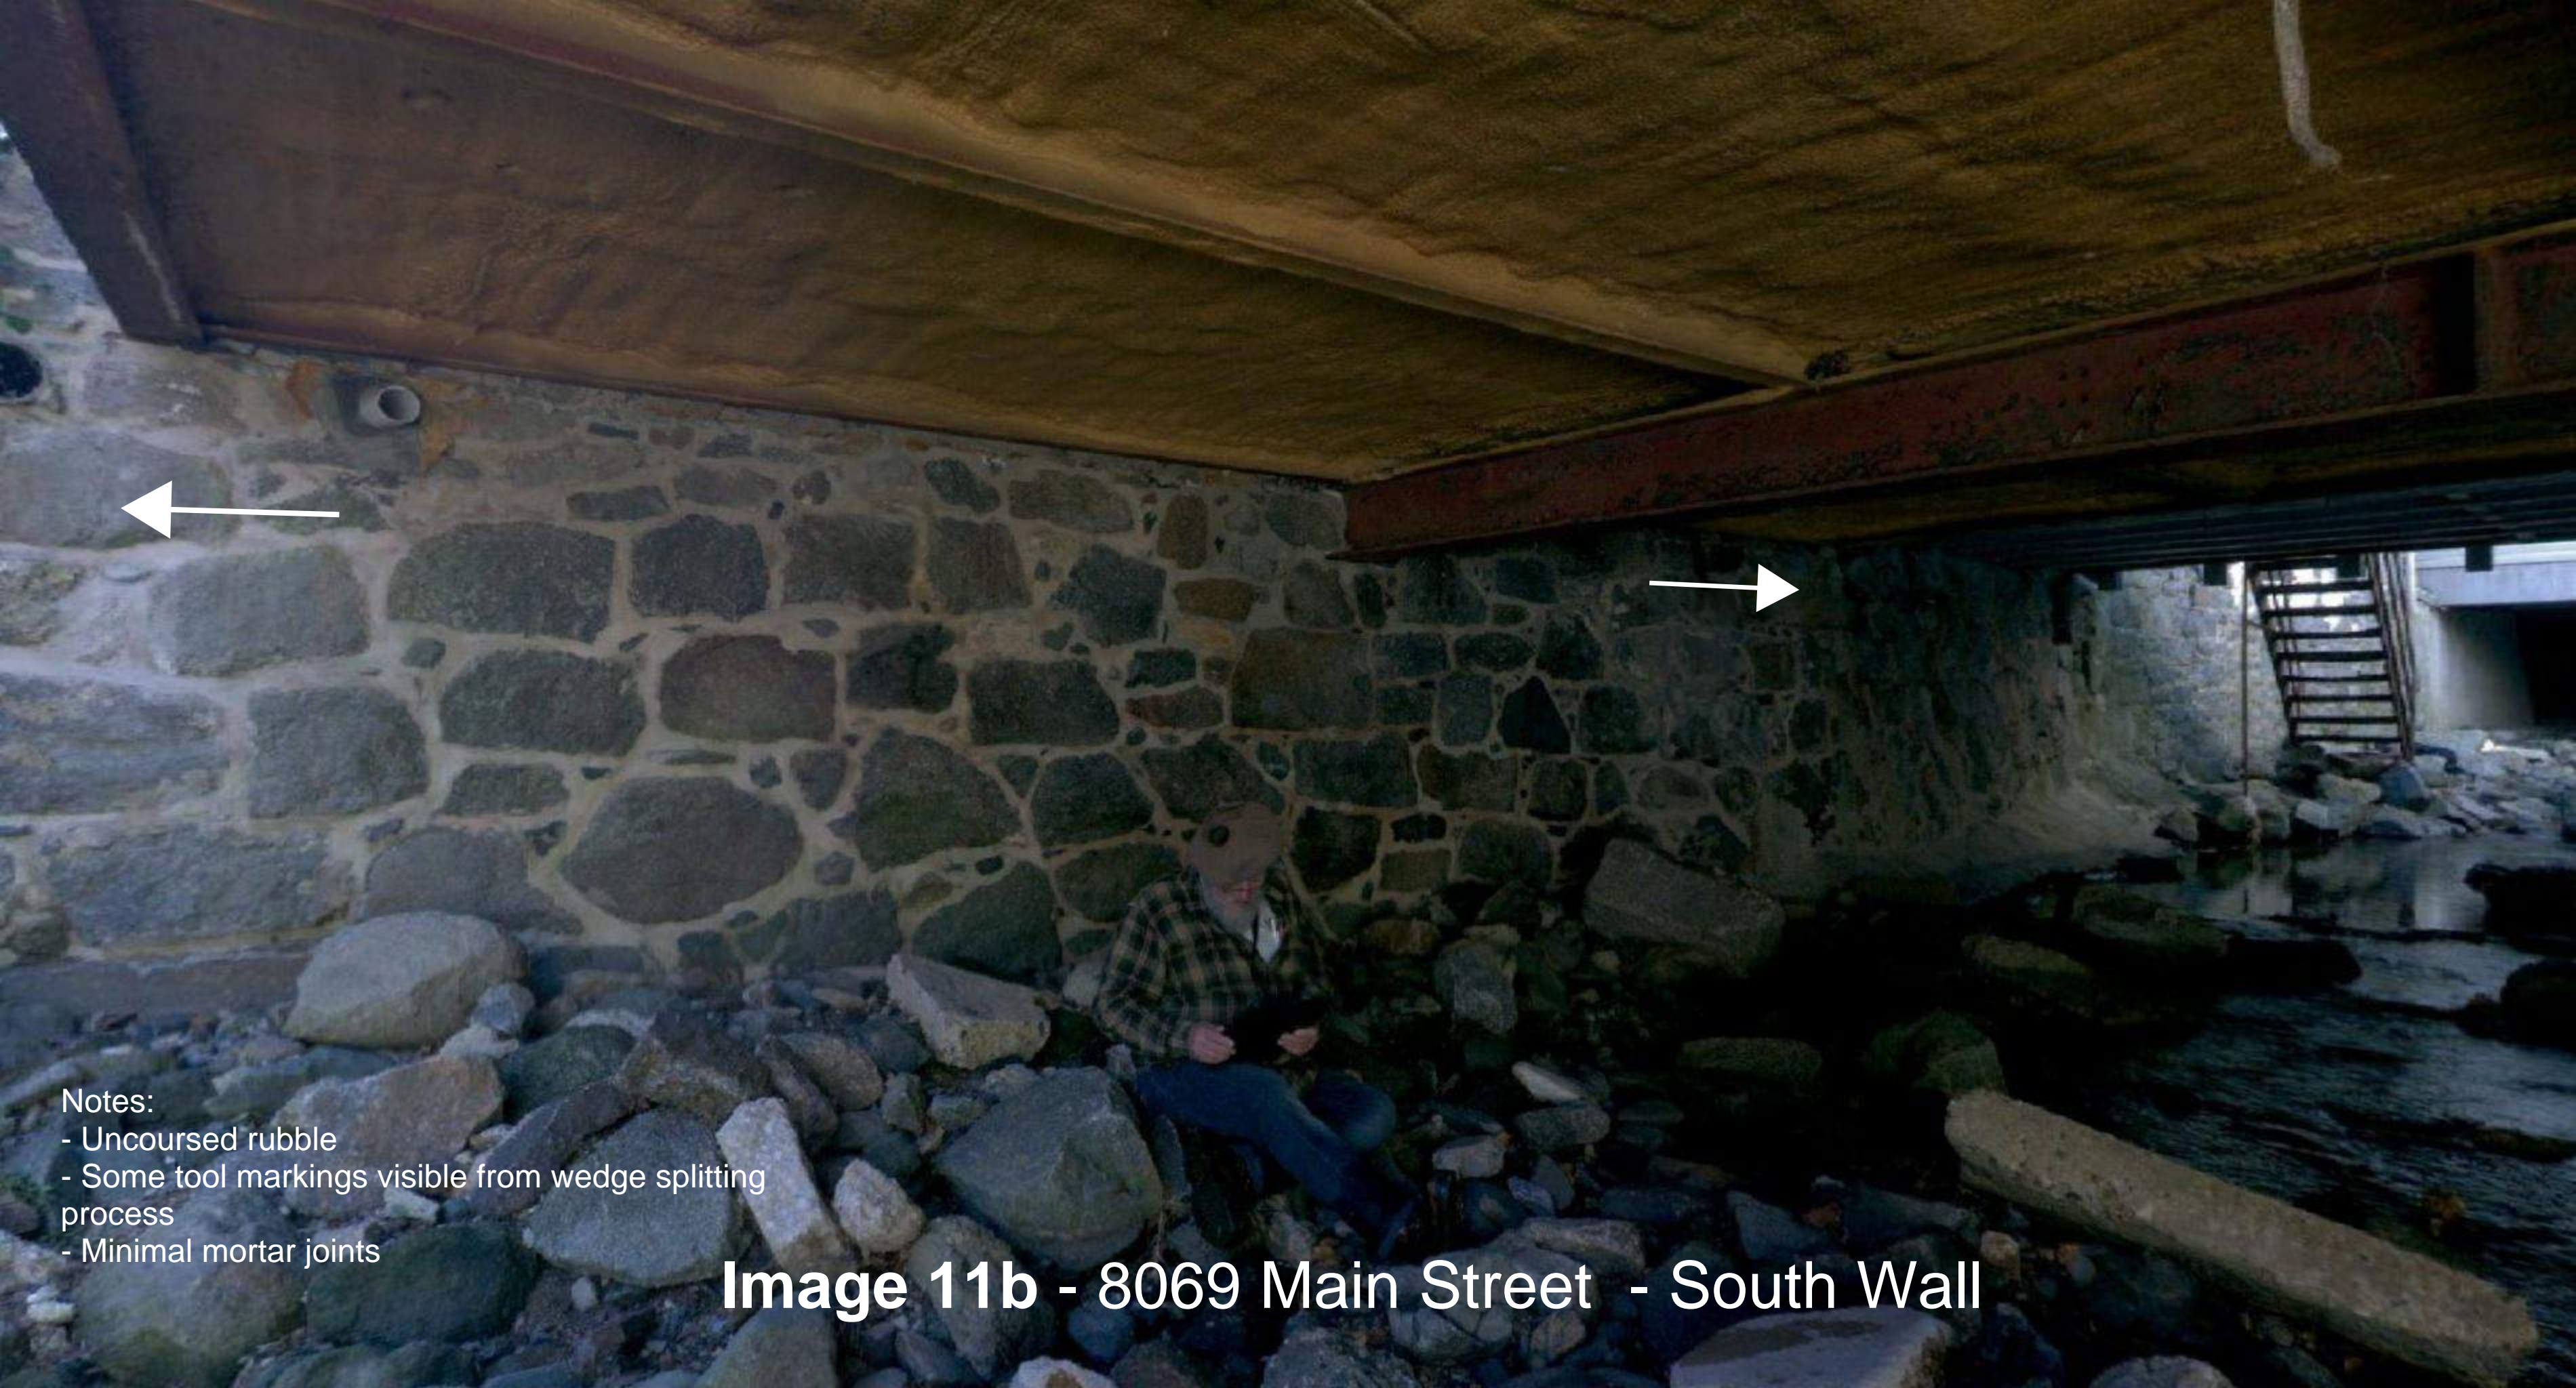
Image 11b - 8069 Main Street - South Wall

- Uncoursed rubble
- Some tool markings visible from wedge splitting process
- Minimal mortar joints
