## Case Study: Valley Mede-Ellicott City Tropical Storm Lee Flood Event

Case Study-2011 Valley Mede-Ellicott City Tropical Storm Lee  
Flood Event

S&S Planning and Design, LLC.

6/28/2012

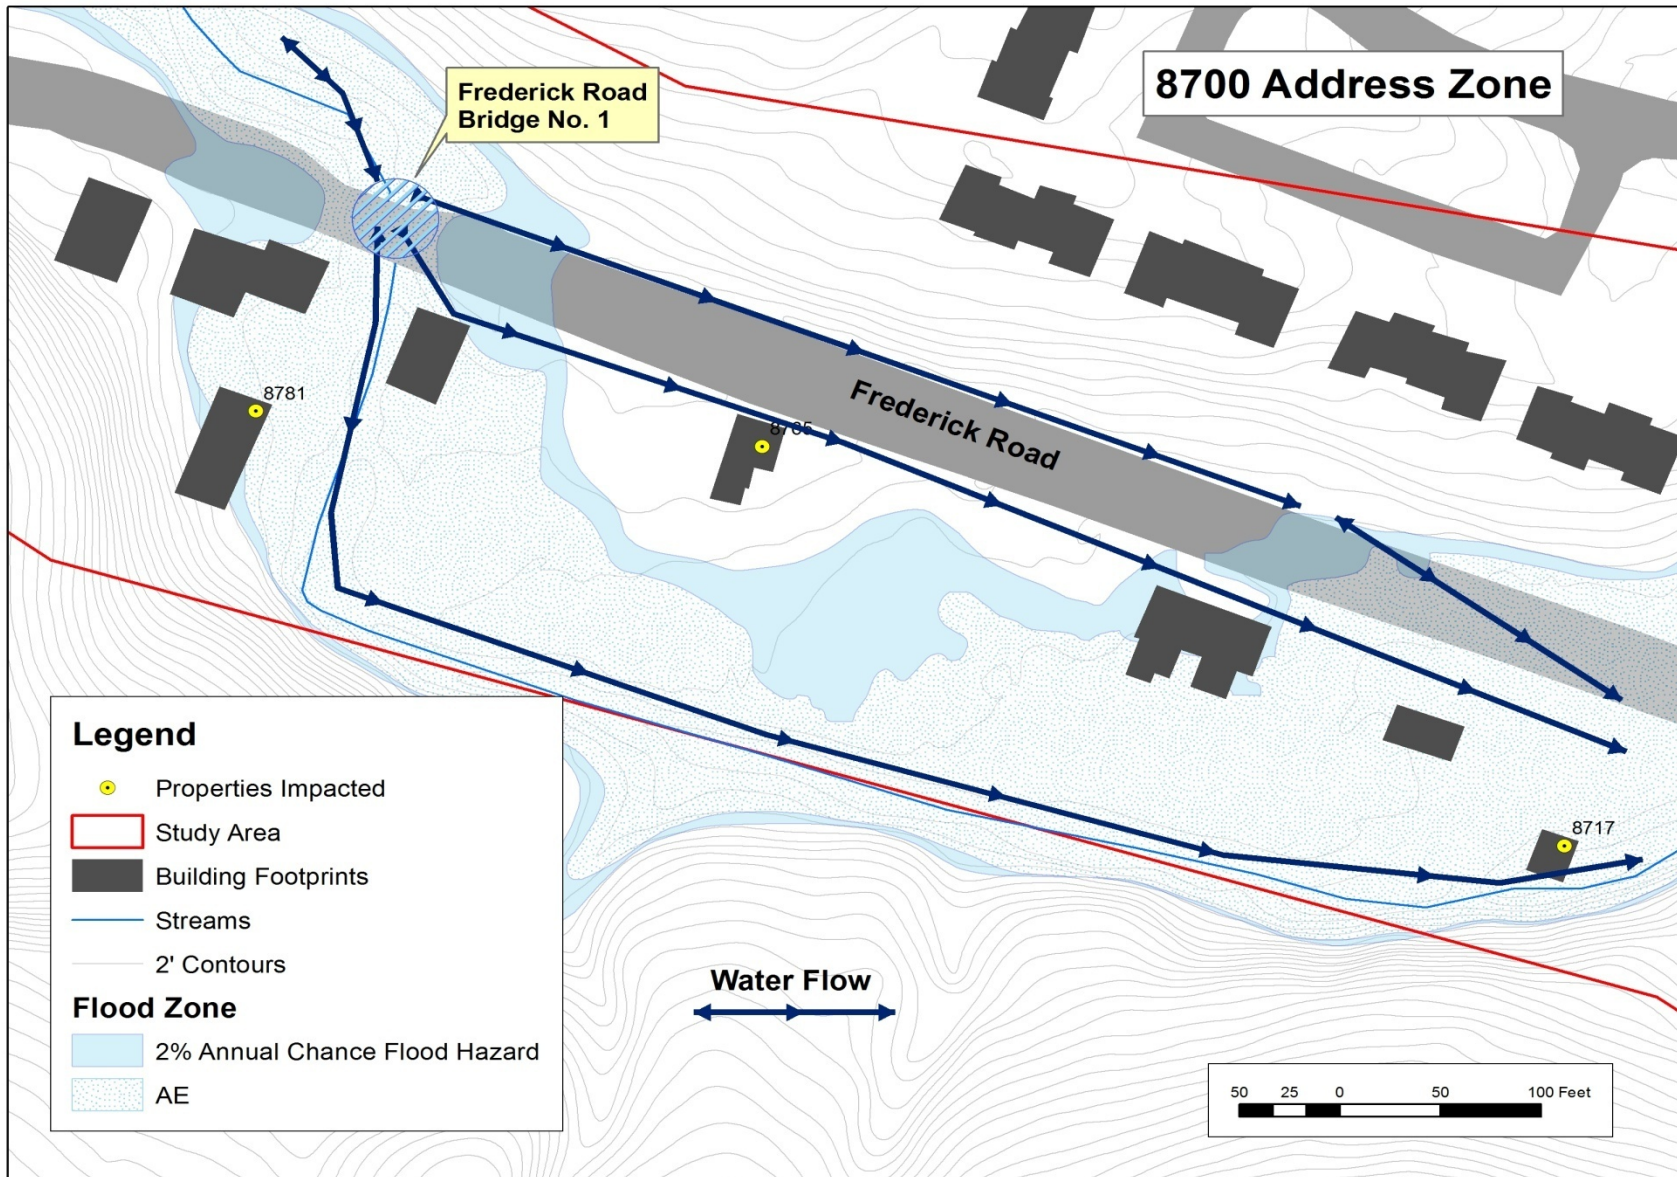
### **8700 Address Zone**

Structures within the 8700 zone were impacted by flooding from the creek and flood waters that escaped the channel and utilized Frederick Road as a flood conveyance. All of the structures within this zone are located on the south side of Frederick Road. Flood waters 'jumped' out of the channel at the Frederick Road Bridge No. 1 as indicated on the map. It is likely that a debris accumulation may have occurred at the upstream edge of the bridge, thereby resulting in or exacerbating the flood waters leaving the channel. Flood waters then flowed east along the northern side of the road, somewhat contained by the road crown and a swale feature on the northern side of the road; however, flood water was continuously cresting the road crown and flowing back toward the actual floodplain and creek channel. The majority of the flood flow then crossed to the south of Frederick Road at a low point immediately west of the Rogers Avenue intersection. The section of Hudson Branch immediately across from the Rogers Avenue intersection consists of a rectangular concrete channel. Observers noted that some flood water continued to flow down Frederick Road.

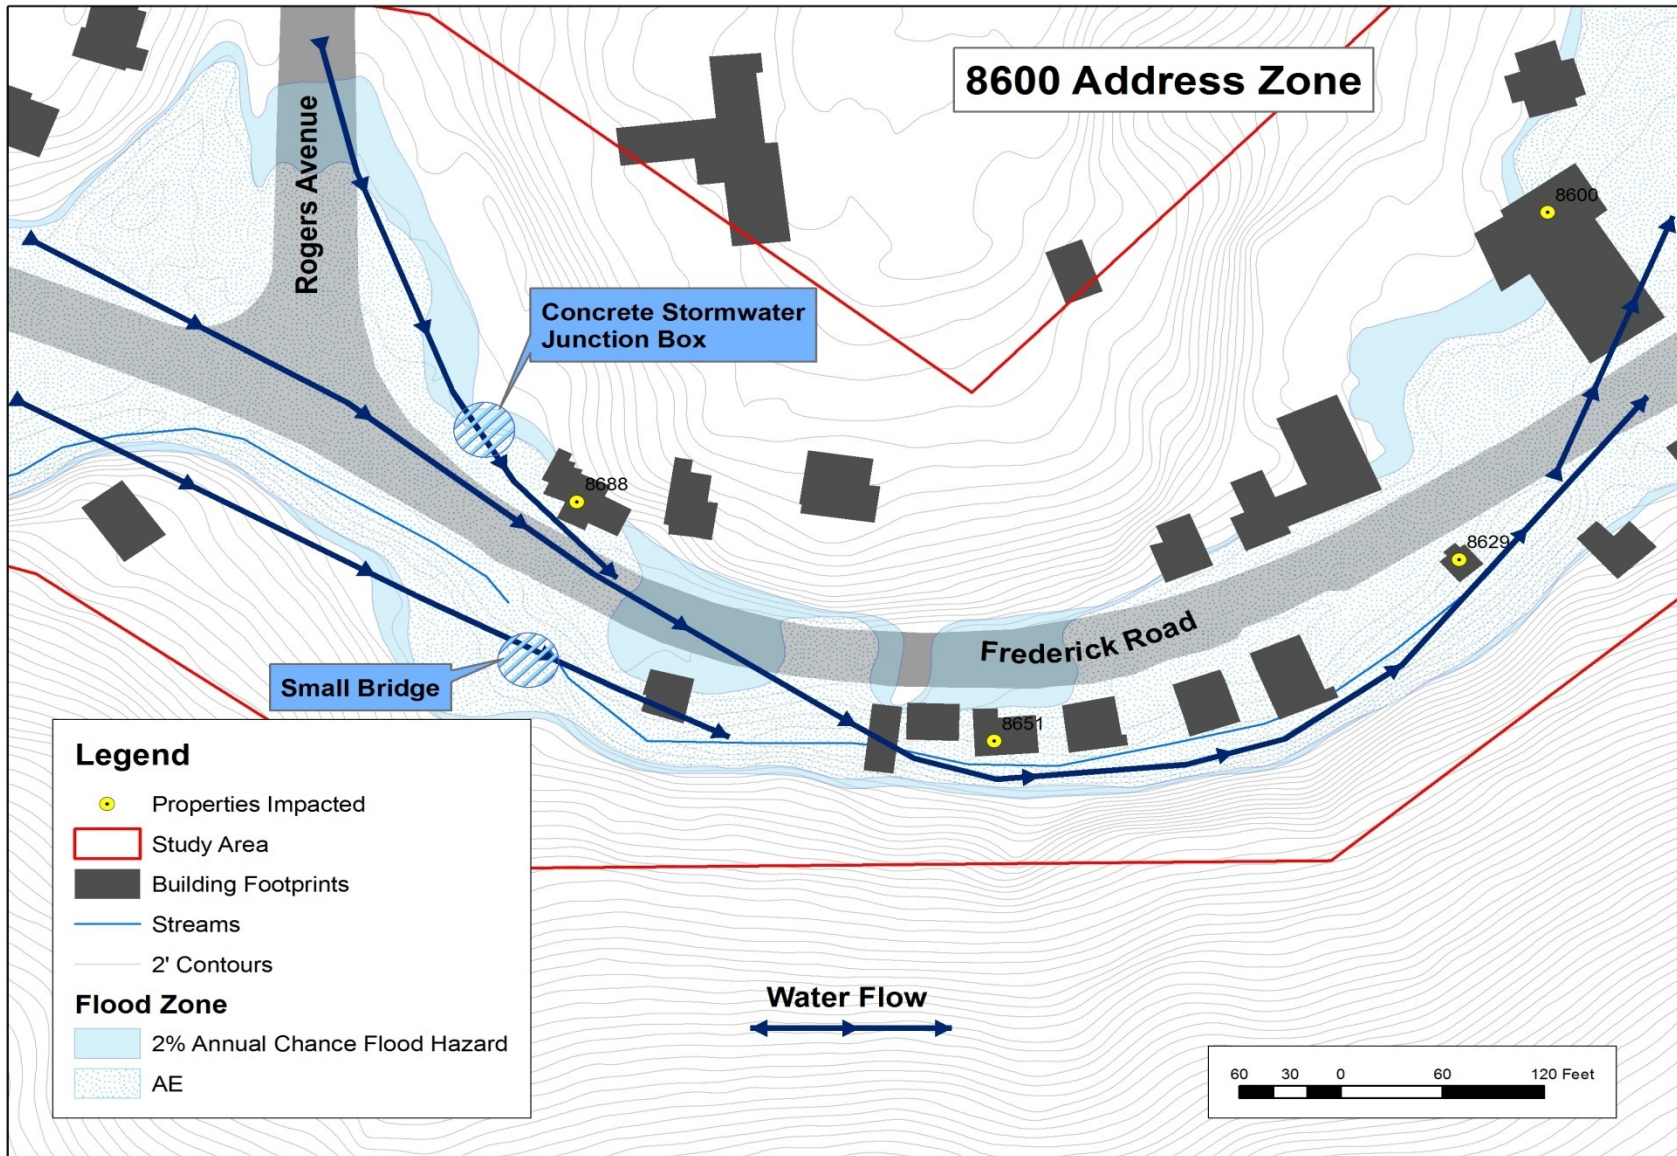
### **8600 Address Zone**

Structures within the 8600 zone experienced flooding from the creek and what witnesses described as excessive stormwater runoff down Rogers Avenue. A concrete stormwater junction box is located to the northeast of the Rogers Avenue/Frederick Road intersection. Witnesses reported that the manhole access cover was 'blown off' the lid of the box. Additionally, they reported that the concrete top was being elevated. This observation would indicate that the junction box and the stormwater pipes leading to it were at capacity, creating sufficient hydraulic pressure to lift the top and remove the manhole cover. With the stormwater system at capacity, excess stormwater would utilize the roadways as the storm conveyance.

The combined flows from the creek channel/floodplain, Frederick Road, and Rogers Avenue, in conjunction with the low, flat topography of the area, created a large area for floodwater to accumulate. It was reported that the water was over the guardrail of the bridge leading to the small parking lot across from the intersection. Immediately downstream of the intersection, the topography constricts the valley again and the gradient gets steeper. At approximately the middle of this zone, it was reported that the flow depth over the road was estimated at 12-18 inches. The structures immediately adjacent to the creek experienced water in the basements due to the elevated creek levels. The rear of many of these structures terminate at the stacked stone flood wall along the creek, with some structures overhanging the creek, or completely bridging the creek to the far bank.

This zone extends downstream to just beyond the inlet of the large culvert that conveys flow under Frederick Road and several commercial properties. Witnesses reported that floodwaters were overtopping the culvert inlet and continuing down Frederick Road.

It is possible that debris accumulation or blockage at the culvert inlet resulted in flood waters overtopping the culvert headwall and continuing down Frederick Road.

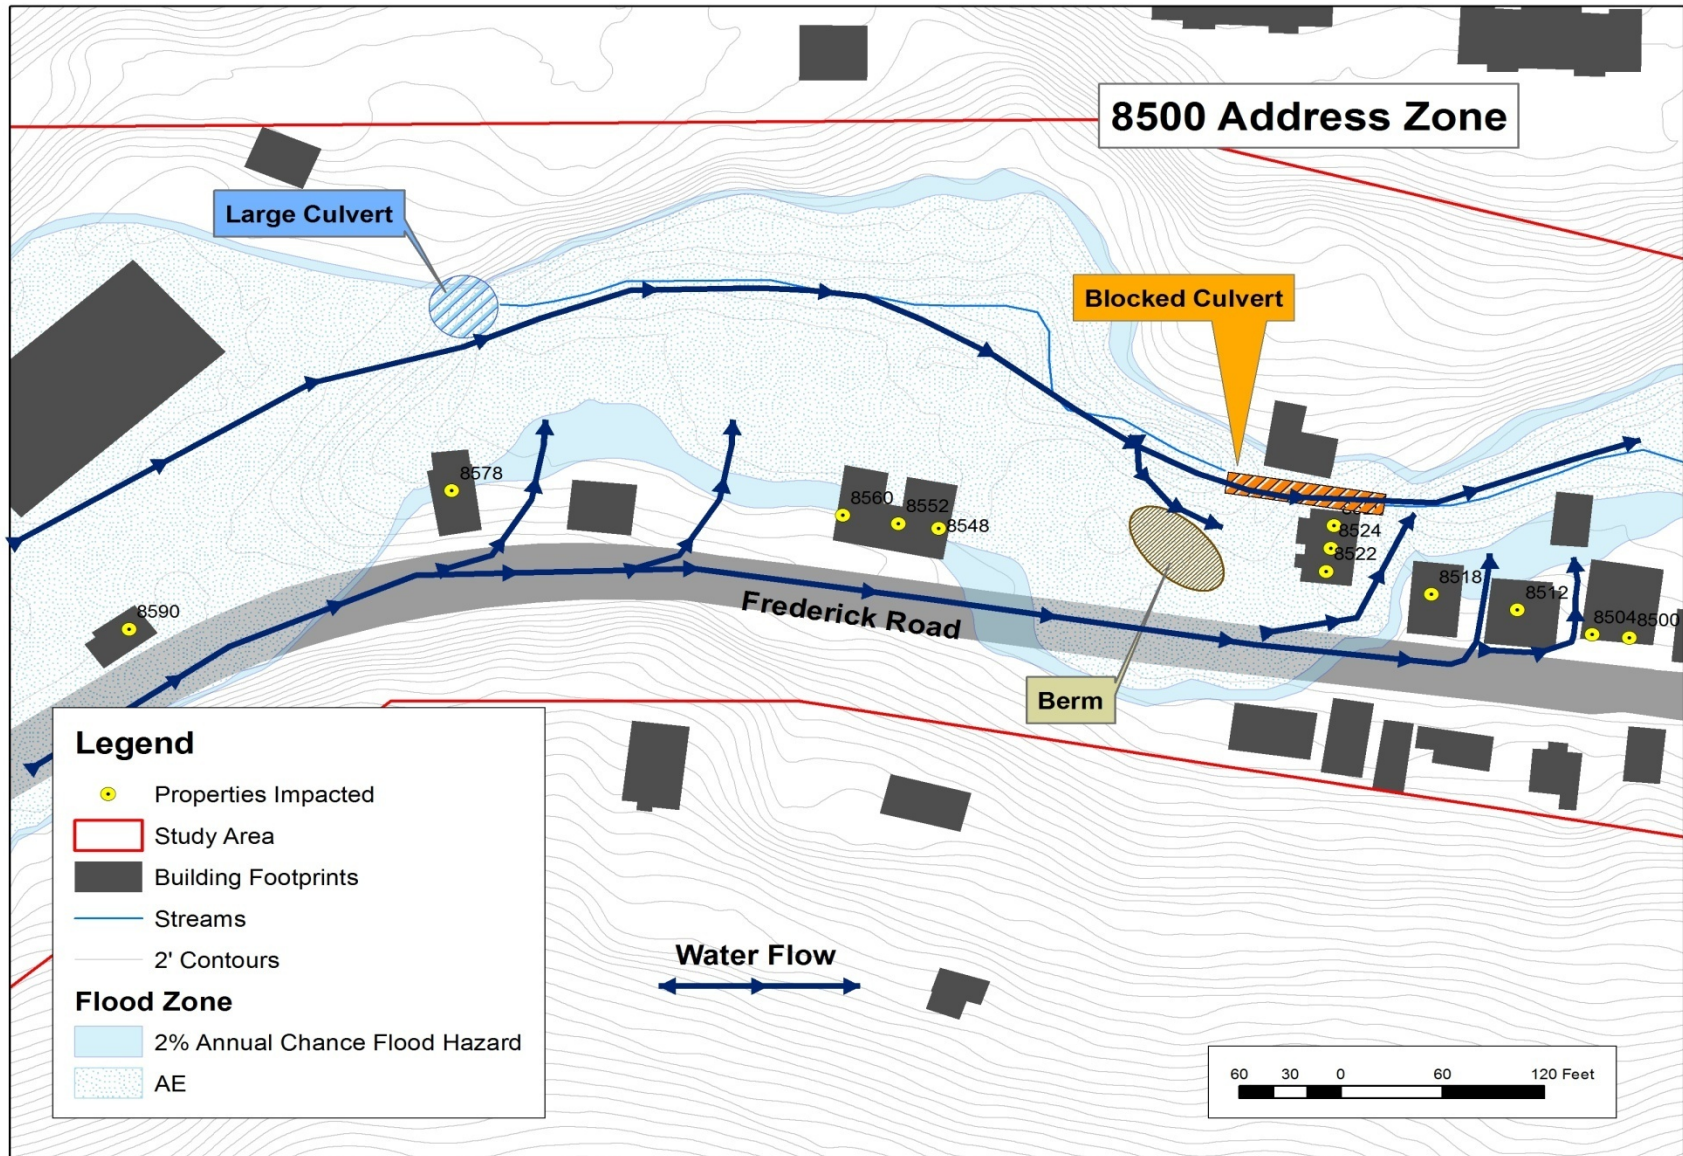
### **8500 Address Zone**

Flooding within the 8500 zone was the result of both flood waters from the creek and roadway. Witnesses reported significant flood flow down Frederick Road. A very large and long culvert conveys flow (9' diameter x 600' length) under Frederick Road and several commercial businesses. Observers stated that during the flood a significant amount of water was flowing down Frederick Road. Some flood flow re-entered the floodplain around property identifier 8560 on both sides of the structure. Downstream of this structure and within the floodplain, a berm had been installed within the last several years. The presence and orientation of this berm redirected flood flow from Frederick Road, thereby preventing flow from returning to the channel. This berm effectively transferred flood flow downstream into an area with additional structures.

An additional culvert is located within this zone. The channel approaching the culvert inlet is armored with gabions in a trapezoidal shape. A preponderance of Japanese Knotweed is located along both banks. An eye witness stated that an approximately 8-10" Red Maple had been leaning diagonally across the culvert inlet during the flood event. Witnesses stated that the inlet was almost completely blocked with debris. Therefore, this culvert inlet also created additional backwater and another location where flood flow 'jumped' from the channel.

Many witnesses to the flood stated that at one point, it appeared as though a 'wall of water' came down the channel. Near Property ID 8500 a small wooden footbridge existed prior to the flood event. An eye witness stated that water and debris was piling up behind this footbridge, then suddenly, one side of the bridge/abutment connection failed and the footbridge swung open like a gate, releasing the backed up water and debris. The rushing water at this location resulted in severe bank erosion, with some streambanks losing 10-12 feet of lateral material. Severe erosion and land loss occurred throughout this reach. Some sections within this zone lost 10-12 feet of streambank.

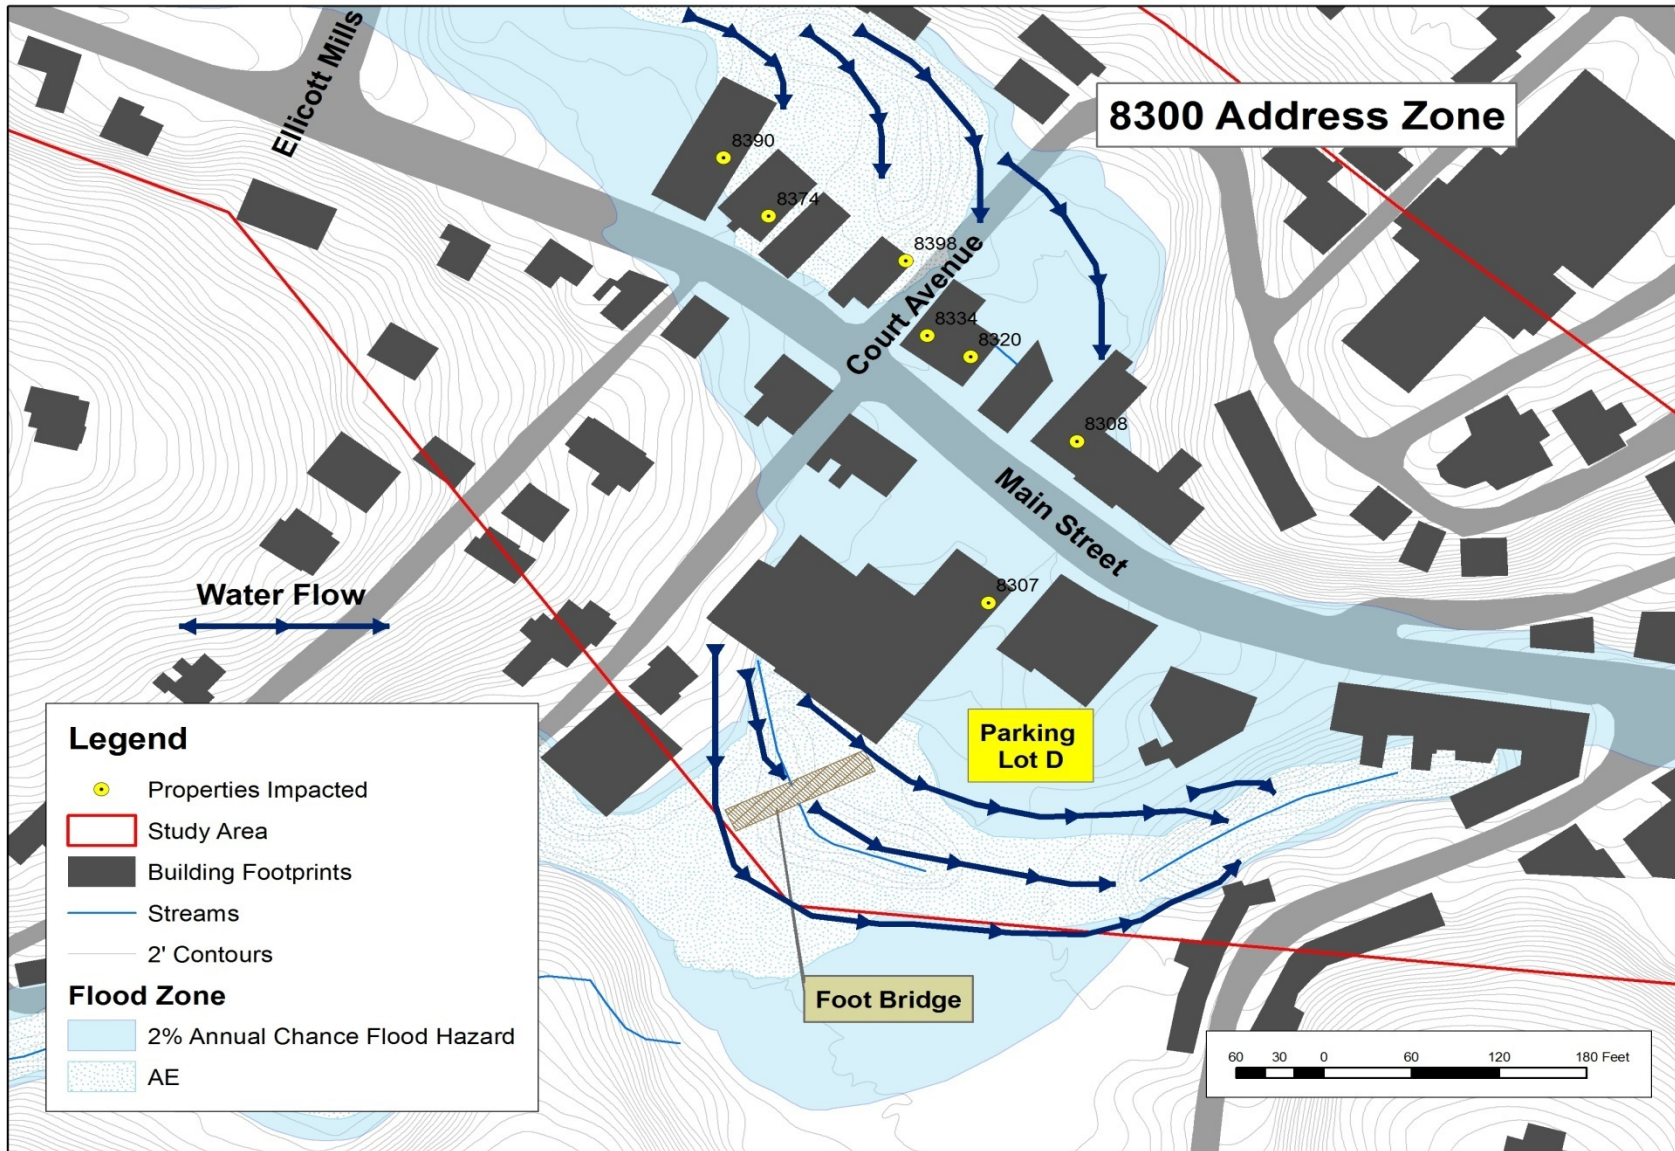
### **8300 Address Zone**

The 8300 zone demarcates the beginning of the Downtown Ellicott City section and consists predominantly of commercial properties. At the top end of the zone, the stream outfalls from a large, approximately 400 foot long culvert. This section experienced damages due to the flood event. The flooding was primarily located within the principal channel and floodway area. This stream section is nearly entirely contained within stacked stone or block flood walls. Properties located immediately adjacent to or over the channel experienced basement flooding due to the water elevation cresting over one of the channel walls. In several locations, the southern stacked stone wall and the nearby properties are at a lower elevation, thereby resulting in the reported basement flooding.

Additionally, a channel constriction, or reduction in channel cross-sectional area, within the conveyance under Main Street most likely created backwater conditions through this reach exacerbating the flood elevations.

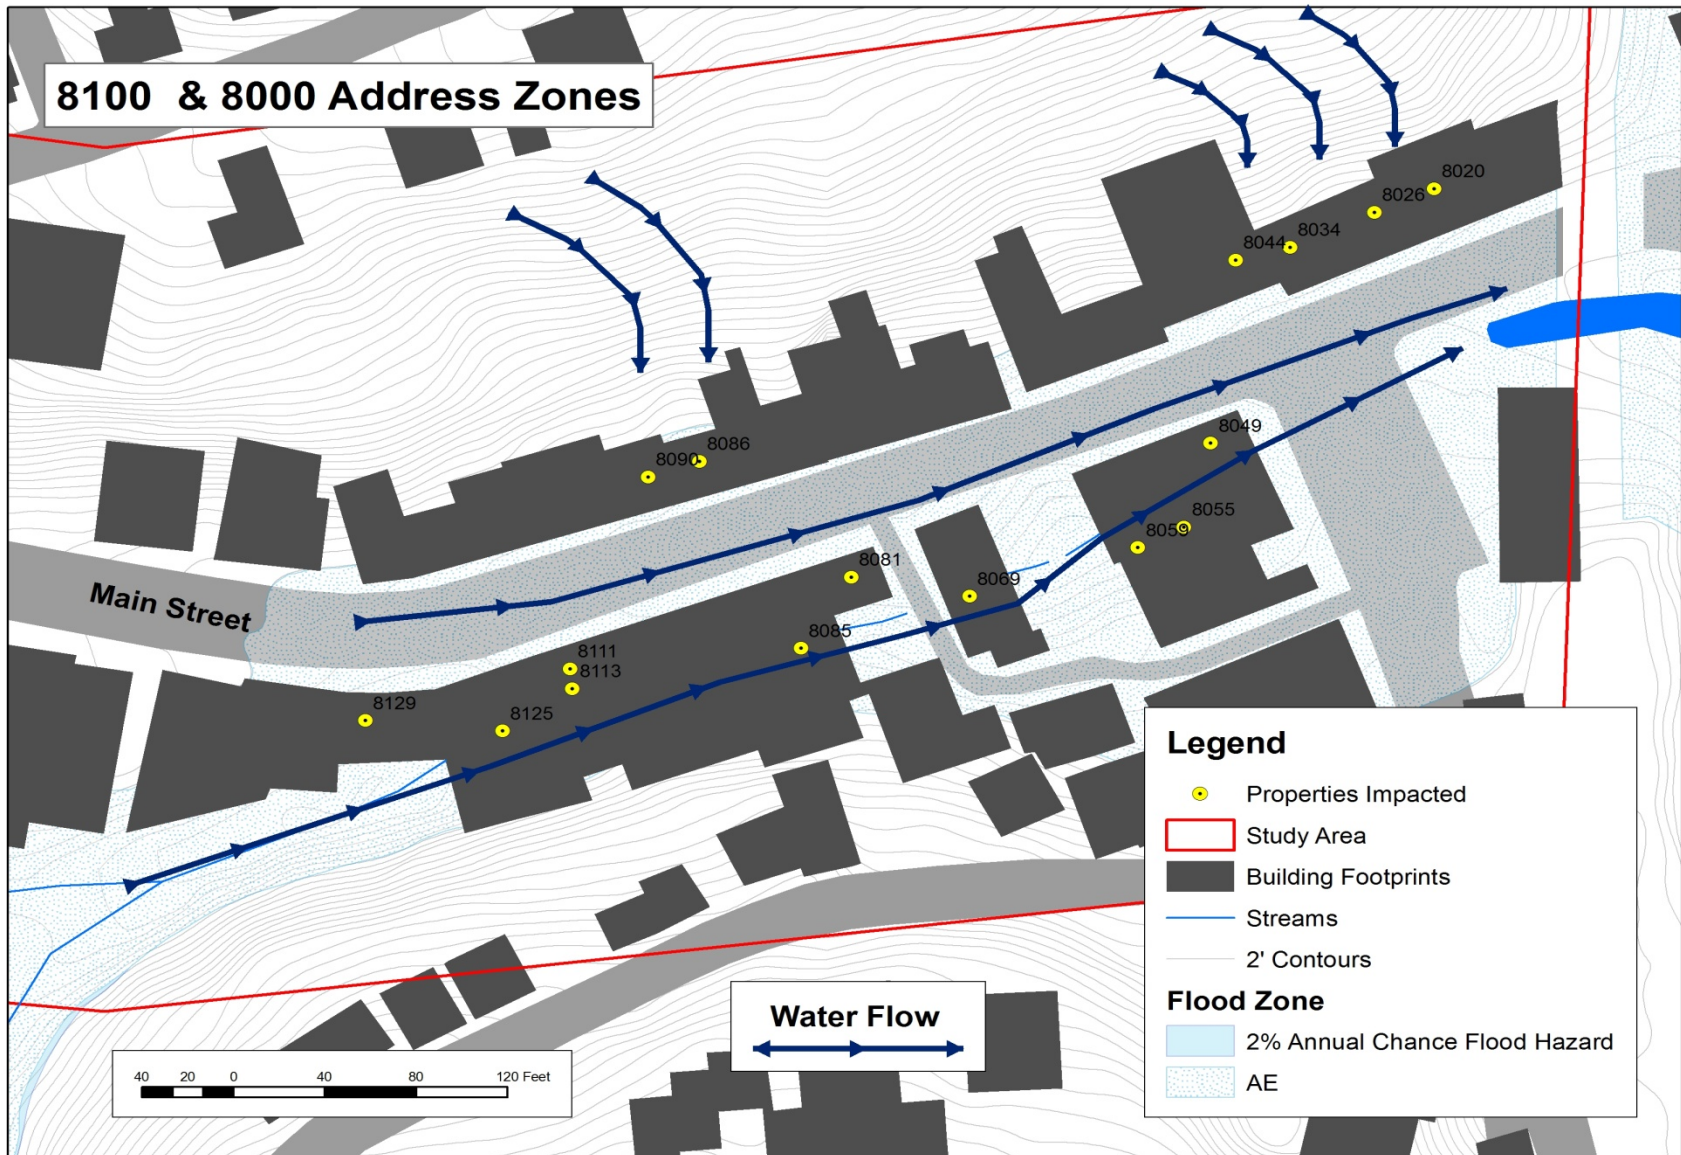
### **8100 Address Zone**

The 8100 zone experienced primarily basement flooding due to the elevated water levels within the primary creek channel. More than fifty percent (50%) of the channel through this zone is bridged by buildings, with stone flood walls on each side of the channel. An unnamed tributary to Tiber Branch confluences with Tiber Branch in this zone. Several properties reported five to six feet of water within the basement. Minor damages were reported, including problems such as general clean-up and HVAC servicing. Several properties reported that water entered through the front door, the result of excess stormwater within the street system.
