Maryland Department of Natural Resources  
Watershed Services  
Technical and Planning Services  
April 2005

# **DEEP RUN AND PATAPSCO RIVER STREAM CORRIDOR ASSESSMENT SURVEY In Howard County**

PREPARED BY  
Robin Pellicano and Kenneth T. Yetman

WATERSHED SERVICES  
TECHNICAL AND PLANNING SERVICES  
MARYLAND DEPARTMENT OF NATURAL RESOURCES  
ANNAPOLIS, MARYLAND

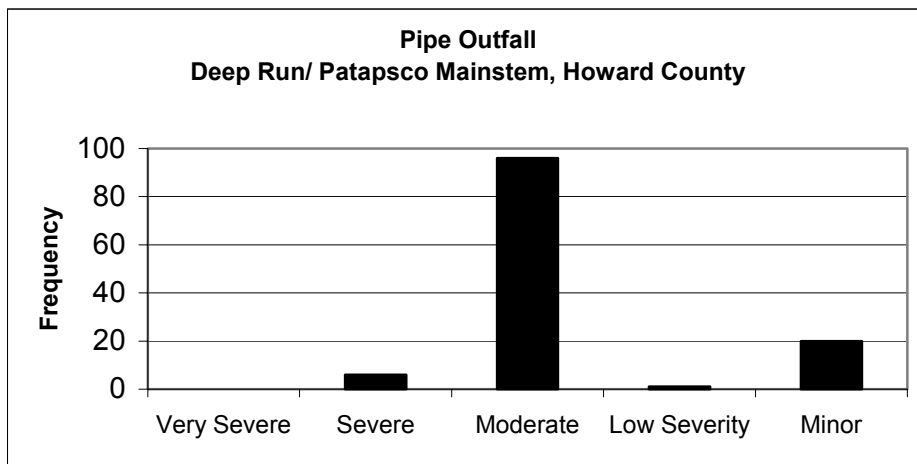
Eighty-three percent or 102 of the 123, of outfall pipes observed during the survey released a discharge. Of these, ten had a discharge with some coloration or smell associated with it (Appendix B) at the time of the survey. Several sites were rated as severe (PR407101, PR417201, PR431207, PR439201). They all had an unusual coloration to them.

**Figure 4a. Histogram showing the frequency of severity ratings given to pipe outfall sites during the Patapsco SCA survey in Howard County**

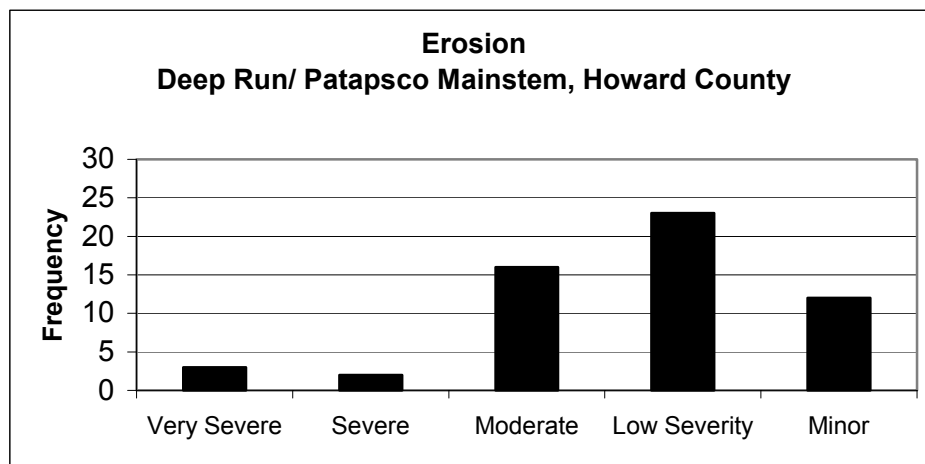
This survey found 56 unstable eroding banks sites with a total length of approximately 4.7 miles of stream (Appendix B). Figure 5a shows the frequency of the severity rating given to erosion sites. Within this watershed, there were three very severe erosion sites (PR406204, PR417106, PR418111) and two severe sites (PR416205, PR444103). The majority of erosion sites were minor- to moderate-in severity. The lengths of stream segments with unstable banks varied from 20 feet to 3,300 feet of stream (Appendix B).

**Figure 5a. Histogram showing the frequency of severity ratings given to erosion sites during the Patapsco SCA survey in Howard County.**

Twenty-one of these sites are within a 100 foot distance of an inadequate buffer. Tree plantings may help alleviate the erosion problem. However, in areas where streams are going through major readjustments, tree planting alone will not stop the erosion. Headcut erosion, for example, occurs when the streambed drops suddenly, indicating a continuous readjustment of the stream channel due to stream hydrology and/or sediment supply changes.

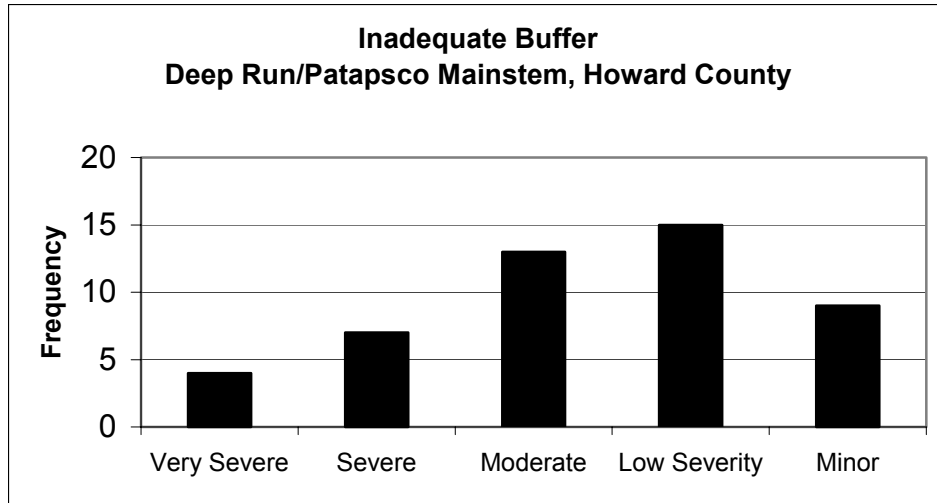
There are four very severe and seven severe inadequate buffers sites in this watershed. Two of the four inadequate buffer sites rated as very severe are categorized as pasture. The very severe sites are (PR430201, PR435101, PR453102, PR438109). The combined length of the very severe sites is 7,500 feet. The severe sites are (PR411401, PR431206, PR433205, PR439203, PR442212, PR461201, PR464104). The combined length of the severe sites is 11,050 feet.

**Figure 6a. Histogram showing the frequency of severity ratings given to inadequate buffers during the Patapsco SCA survey in Howard County.**

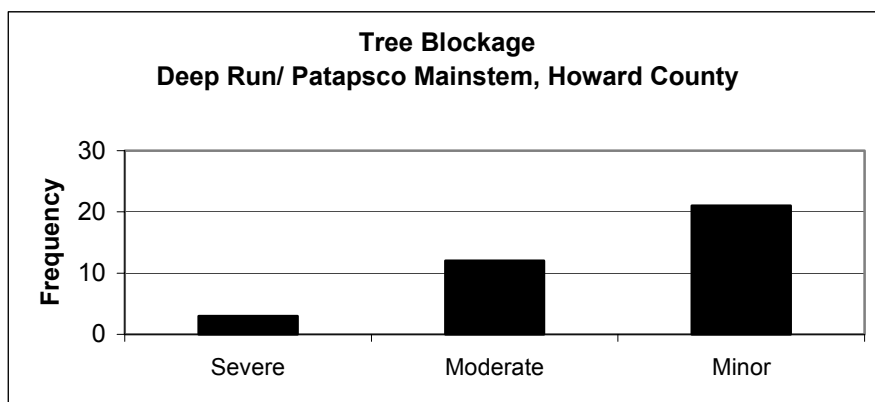
The survey crew recorded 36 tree blockage sites. The locations of tree blockages are shown in Figure 7b. There are 12 sites with a severity rating of “moderate” and 21 sites rated as “minor.” Twenty of the recorded blockages have had some impact on the stream bank or bed and are collecting some amount of debris (32 sites).

Figure 7a. Histogram showing the frequency of severity ratings given to tree blockage sites during the Patapsco SCA survey in Howard County.

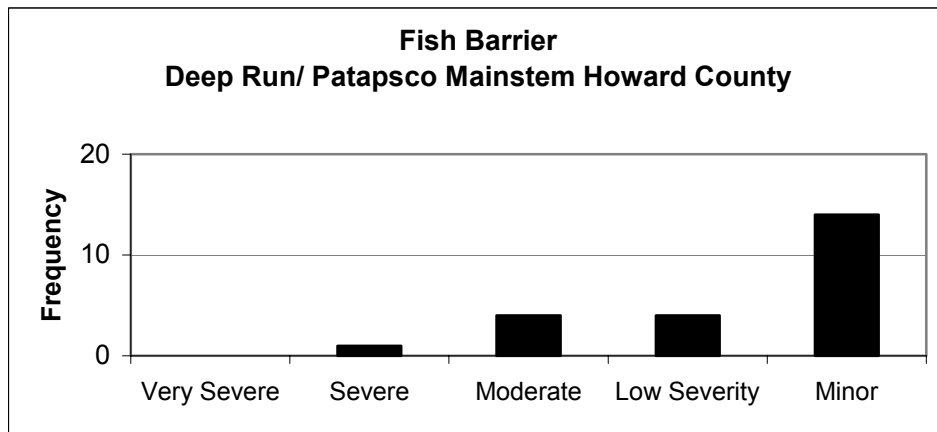
The Patapsco SCA survey observed 23 fish migration barriers. The locations of fish blockages are shown in Figure 8b-c. The fish barriers are due to natural falls (5), road crossings (7), channelized stream sections (2), debris dams (5), Beaver dams (1), pipe crossings (1), and constructed dams (2). The majority of fish migration barriers are moderate to minor in severity, with one severe site recorded (Figure 8a). This site (PR317101) was located on the main stem approximately 600 feet below Route 40.

**Figure 8a. Histogram showing the frequency of severity ratings given to fish migration barrier sites during the Patapsco SCA survey in Howard County.**

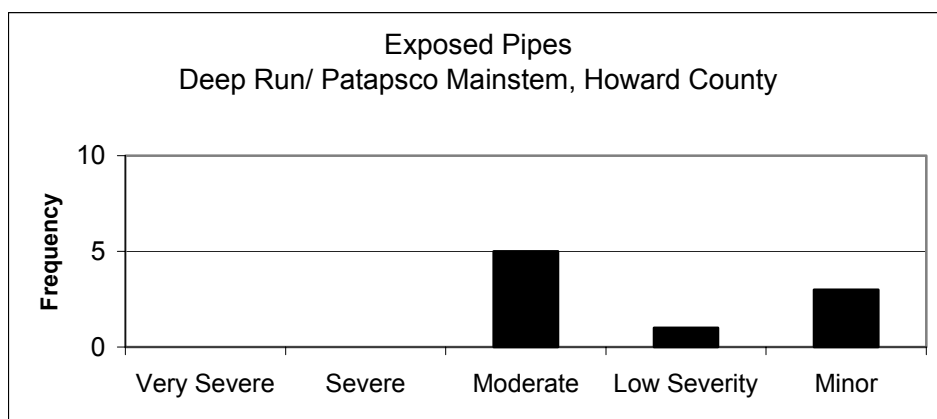
Field crews observed nine exposed pipes during the survey, all moderate to minor in severity (Figure 9a). Locations of these sites are shown in Figures 9a-b. Four pipes were recorded as being sewage. The remaining exposed pipes are recorded as unknown in purpose.

Survey crews did not observe any exposed pipes releasing a discharge at the time of the survey. There also were no signs that the stream may undermine or break any of the pipes in the near future. Therefore, all the sites have a moderate to minor severity rating. Photographs of the exposed pipes observed can be reviewed by public works officials and follow-up visits made to the sites based on their evaluations.

Figure 9a. Histogram showing the frequency of severity ratings given to exposed pipe sites during the Patapsco SCA survey in Howard County.

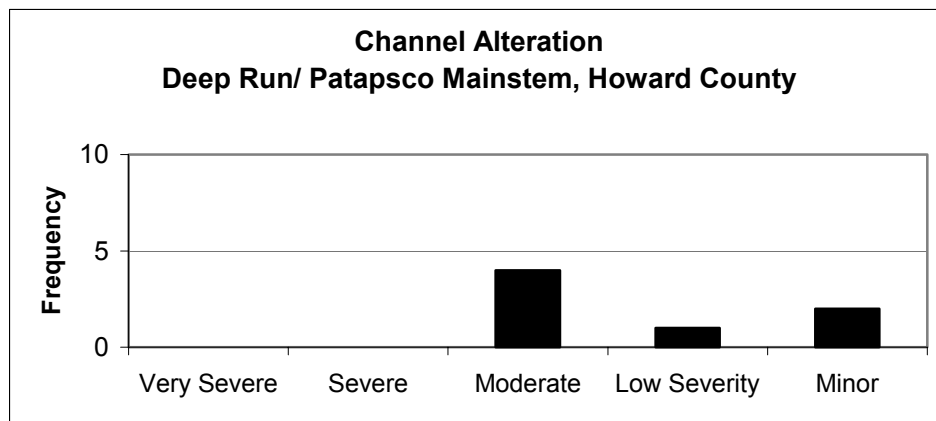
Results of this survey show recognizably altered stream channels at seven sites. The severity and location of channel alterations are shown in Figure 10b-c. The total length of stream affected by channelization is estimated to be 2,580 feet (0.48 miles).

The channel alteration in this watershed is most often over a short stretch and constructed of a variety of materials, from concrete to earth channels. All of sites are rated as moderate to minor in severity (Figure 10a). These channel alterations are a made of earth channels, gabion baskets, rip-rap, and concrete.

Figure 10a. Histogram showing the frequency of severity ratings given to channel alteration sites during the Patapsco SCA survey in Howard County.

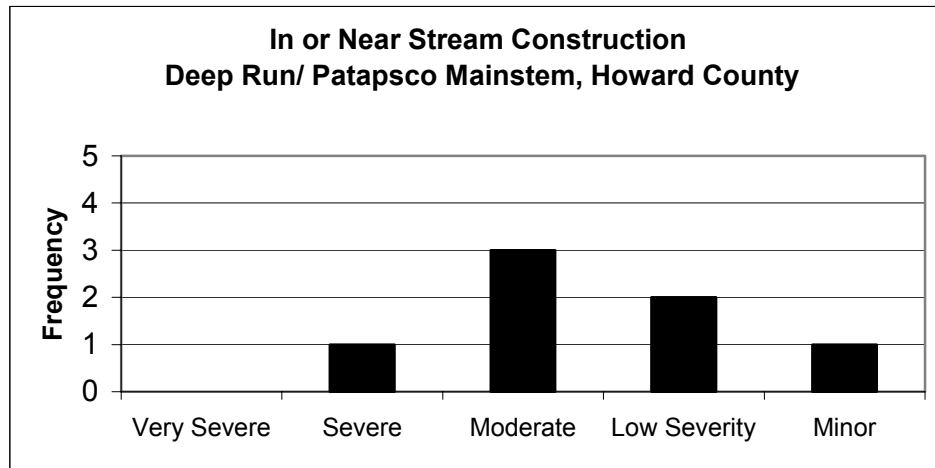
Seven construction sites affected a nearby stream during the time of the survey. Types of construction included: residential construction (2), a golf course (1), road crossings (2), industrial construction (1) and an unknown (1). All but one site was rated as moderate to minor in severity (Figure 11a).

The one site rated as severe, PR445128, was depositing much sediment into the tributary. No silt fence was present.

Figure 11a. Histogram showing the frequency of severity ratings given to in or near stream construction sites during the Patapsco SCA survey in Howard County.
