## **SECTION 3 STUDY METHODS AND ASSESSMENT RESULTS**

This section details the results of the fieldwork associated with the Centennial and Wilde Lake Restoration Plans, which includes the Unified Stream Assessment (USA), Unified Subwatershed and Site Reconnaissance (USSR), subwatershed retrofitting, and lake shoreline assessments. Detail includes the areas assessed, a summary of data findings, and associated mapping.

### **3.1 STREAM ASSESSMENT**

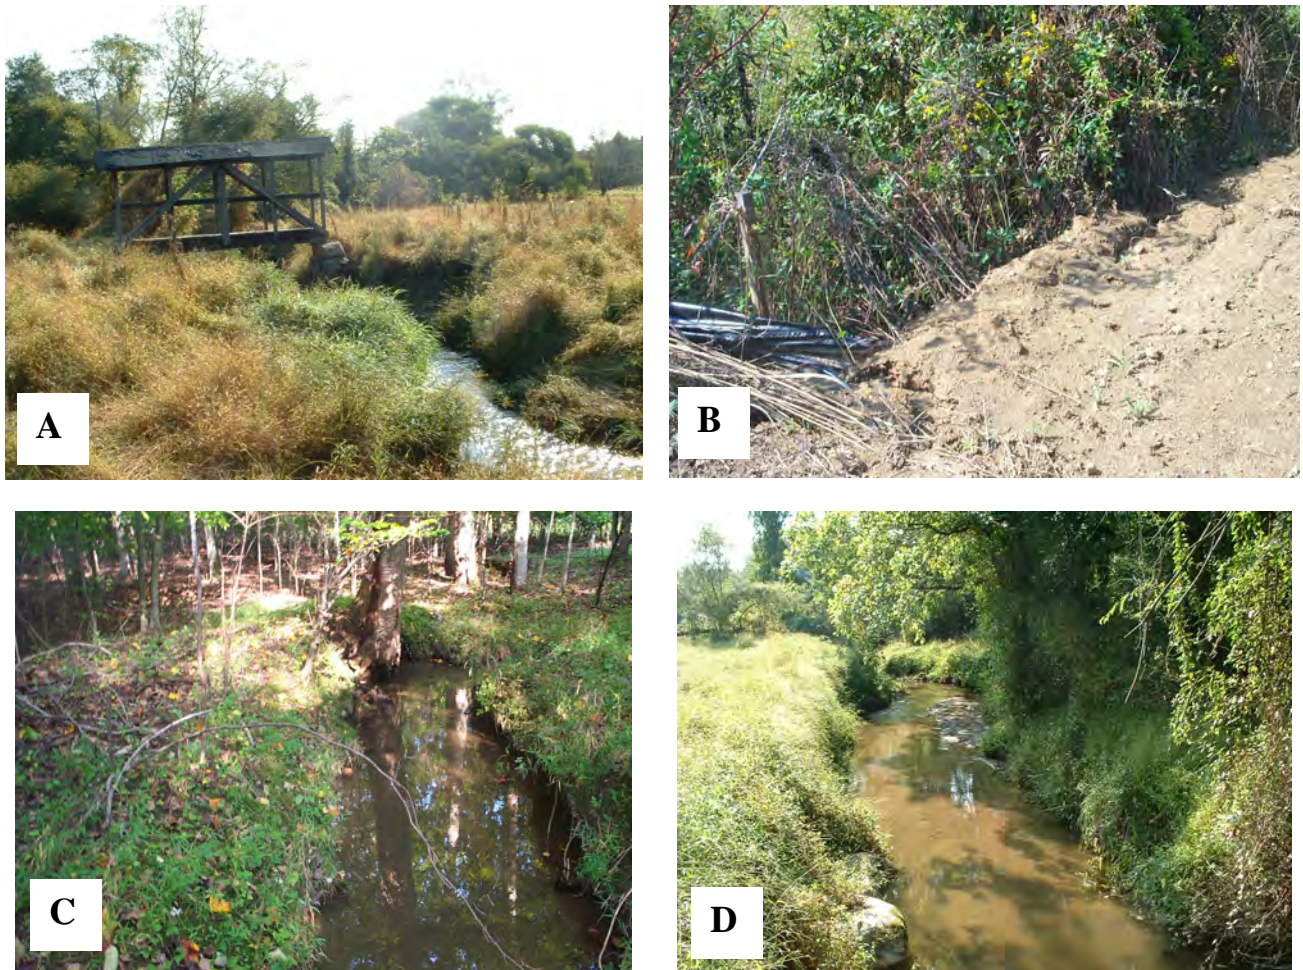
**Figure 3.3** The Centennial Lake USA findings were characterized by generally stable streams in agricultural areas with a few notable areas for improvement. (A) an inadequate buffer site where invasive species have prevented the regrowth of forest resulting in unstable stream banks, (B) a location where erosion and sediment control was inadequate, (C) a typical section of stable stream in the upper portion of the watershed, and (D) some of the in-stream sediment deposition in a reach with unstable stream banks.

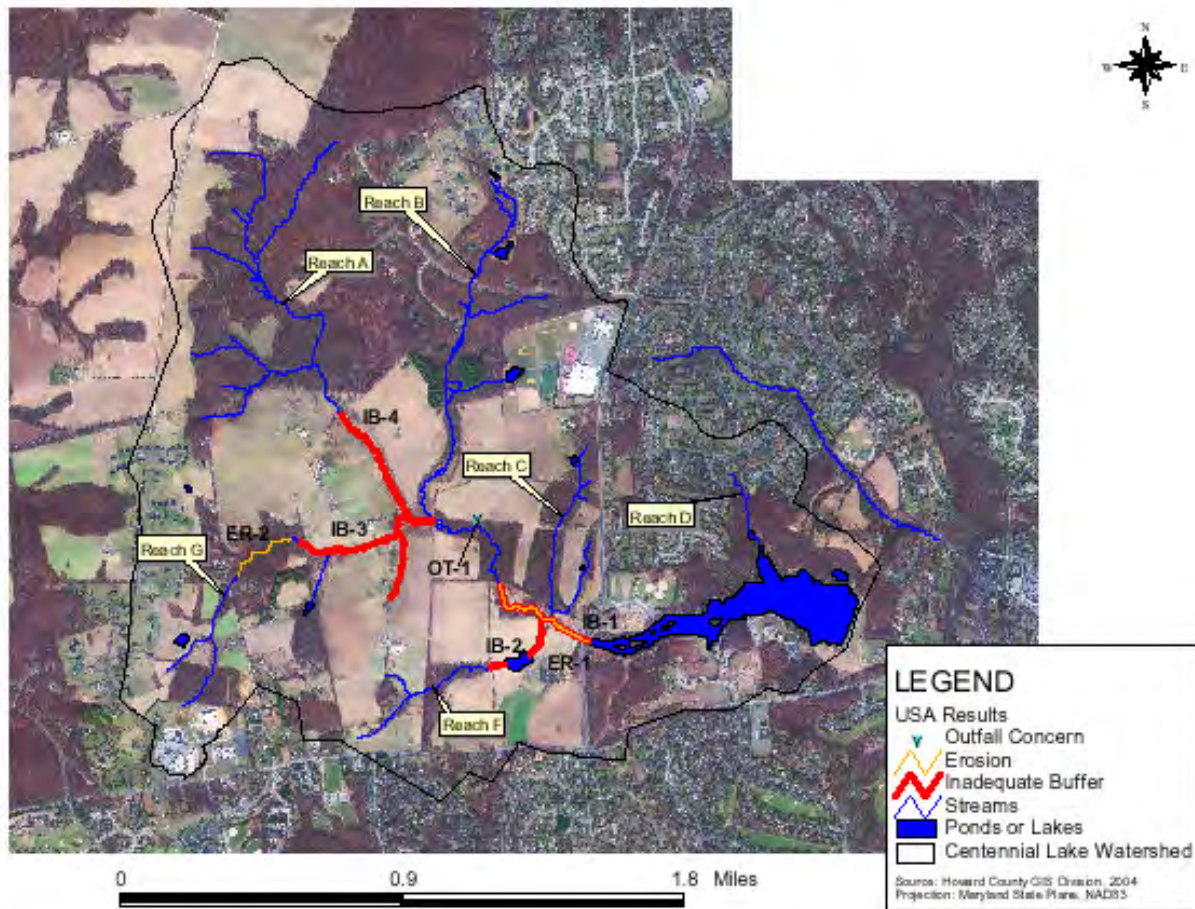
Figure 3.4 USA results for Centennial Lake sub-watershed.

| Table 3.4 Centennial Lake Watershed USA Results | | | |
|---|---|---|---|
| Centennial Lake | A and F | IB-1/ER-1 | Inadequate riparian buffer, lack of stream shading, and eroding stream |
| | A | OT-1 | Outfall conveyance through floodplain creating a headcut beginning at stream; consider use of a level spreader |
| | A | IB-4 | Inadequate riparian buffer due in part to invasive species |
| | F | IB-2 | Inadequate riparian buffer |
| | G | IB-3 | Inadequate riparian buffer due in part to invasive species |
| | G | ER-2 | Small eroding reach through forested section below Manor Lane |
| | E | OT-2/3 | Outfalls that drain directly to stream; consider for retrofit OT-2 almost fully submerged with sediment |

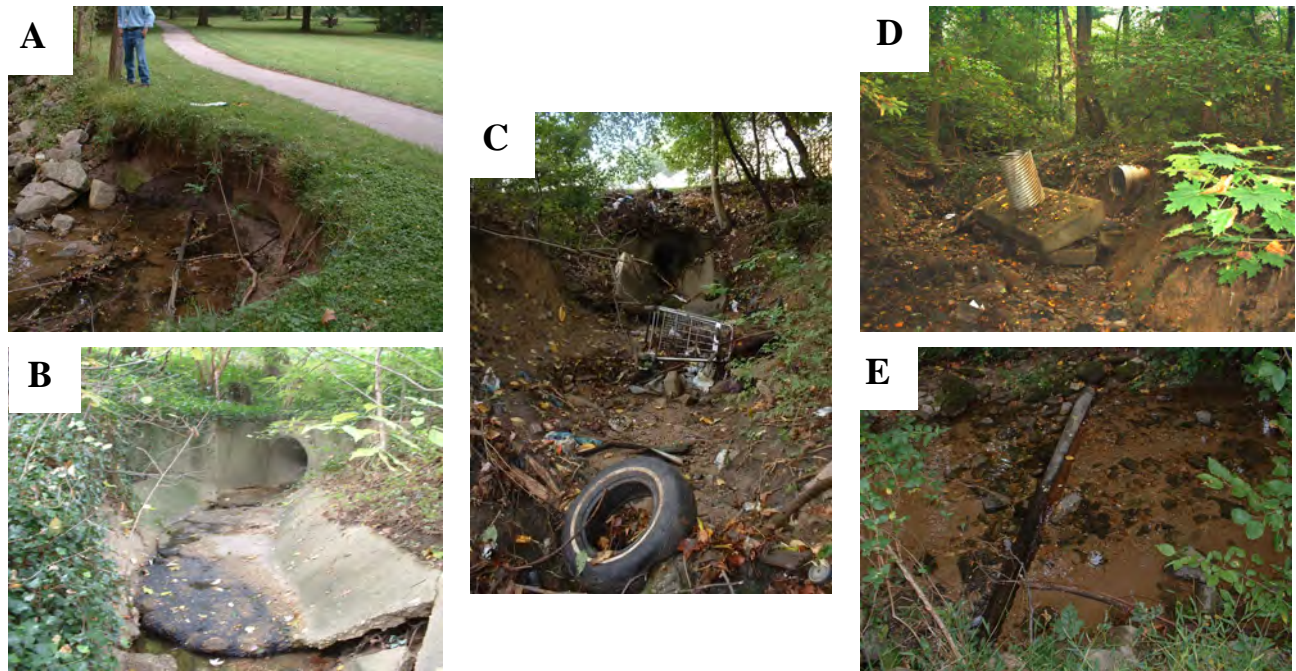
**Figure 3.5** Typical problems identified in the USA assessment of Wilde Lake: (A) erosion and inadequate buffer, (B) potential illicit discharge, (C) trash dumping site, (D) broken outfall with stream erosion, and (E) exposed infrastructure.

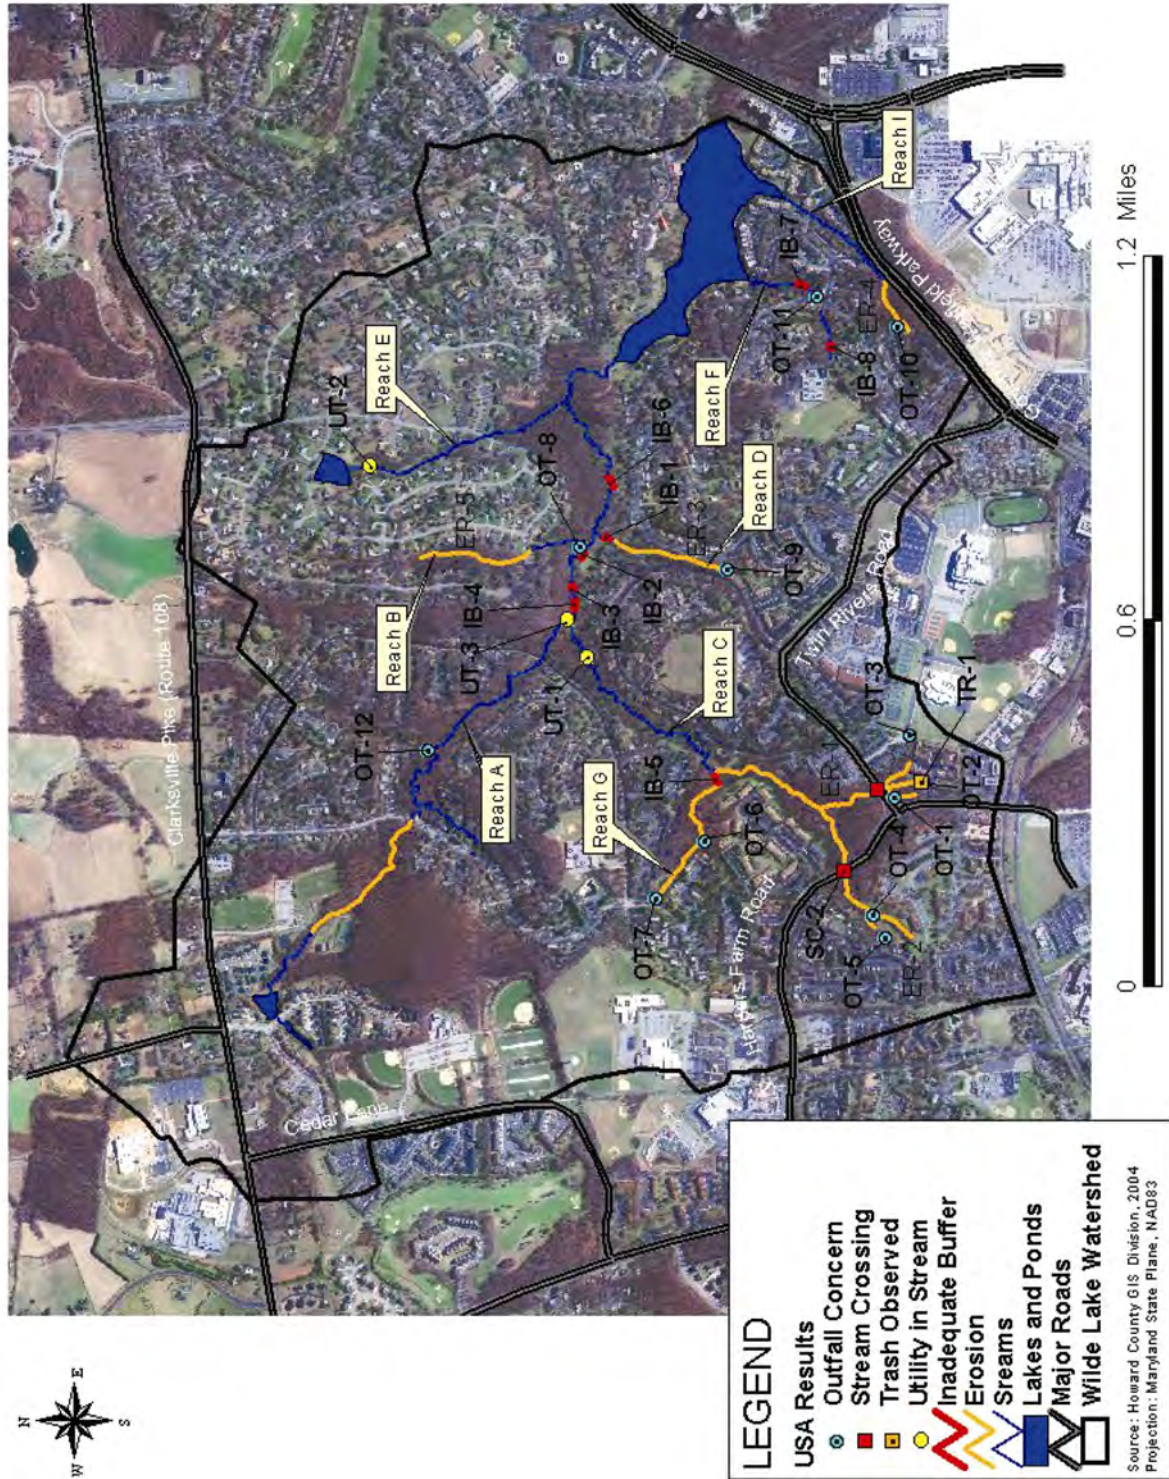
Figure 3.6 USA results for the Wilde Lake sub-watershed.

| Subwatershed | Reach ID | Problem ID | Condition |
|---|---|---|---|
| Wilde Lake | WL-C1 | OT-1 | 18 in outfall in need of stabilization |
| | WL-C1 | OT-2, TR-1 | 18 in outfall potential stormwater retrofit location |
| | WL-C1 | OT-3 | 18 in outfall potential retrofit location |
| | WL-C3 | OT-4 | 42 in outfall potential retrofit location |
| | WL-C3 | OT-5 | 36 in outfall potential retrofit location |
| | WL-G | OT-6 | 24 in outfall 2- to 3-ft drop undermining outfall |
| | WL-G | OT-7 | 27 in possible illicit discharge—yellowish discoloration |
| | WL-G | OT-8 | 27 in outfall infrastructure extends into stream |
| | WL-D | OT-9 | 48 in possible illicit car wash at gas station and reddish benthic growth, apron subsiding, recently fixed with stream rehabilitation project |
| | WL-D | OT-10 | 21 in end of outfall broken, headwall detached and in stream, recently fixed with stream rehabilitation project |

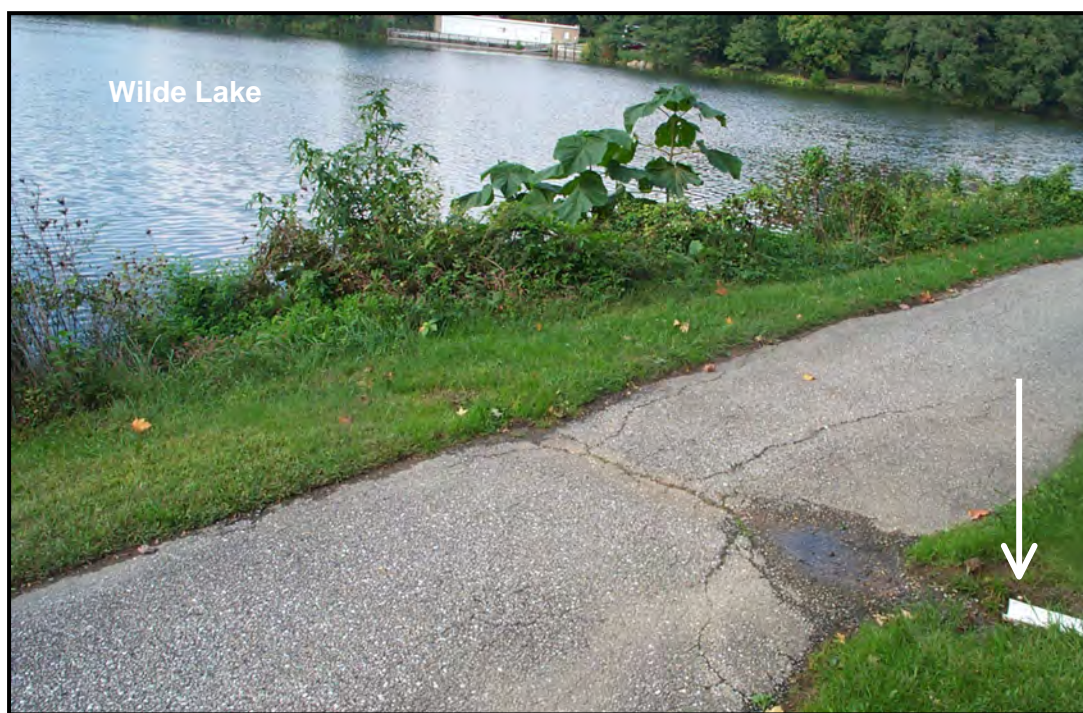
**Figure 3.9** One of the more extreme downspout connections. Connection (see arrow) shown here has worn a small channel across the footpath that surrounds Wilde Lake.

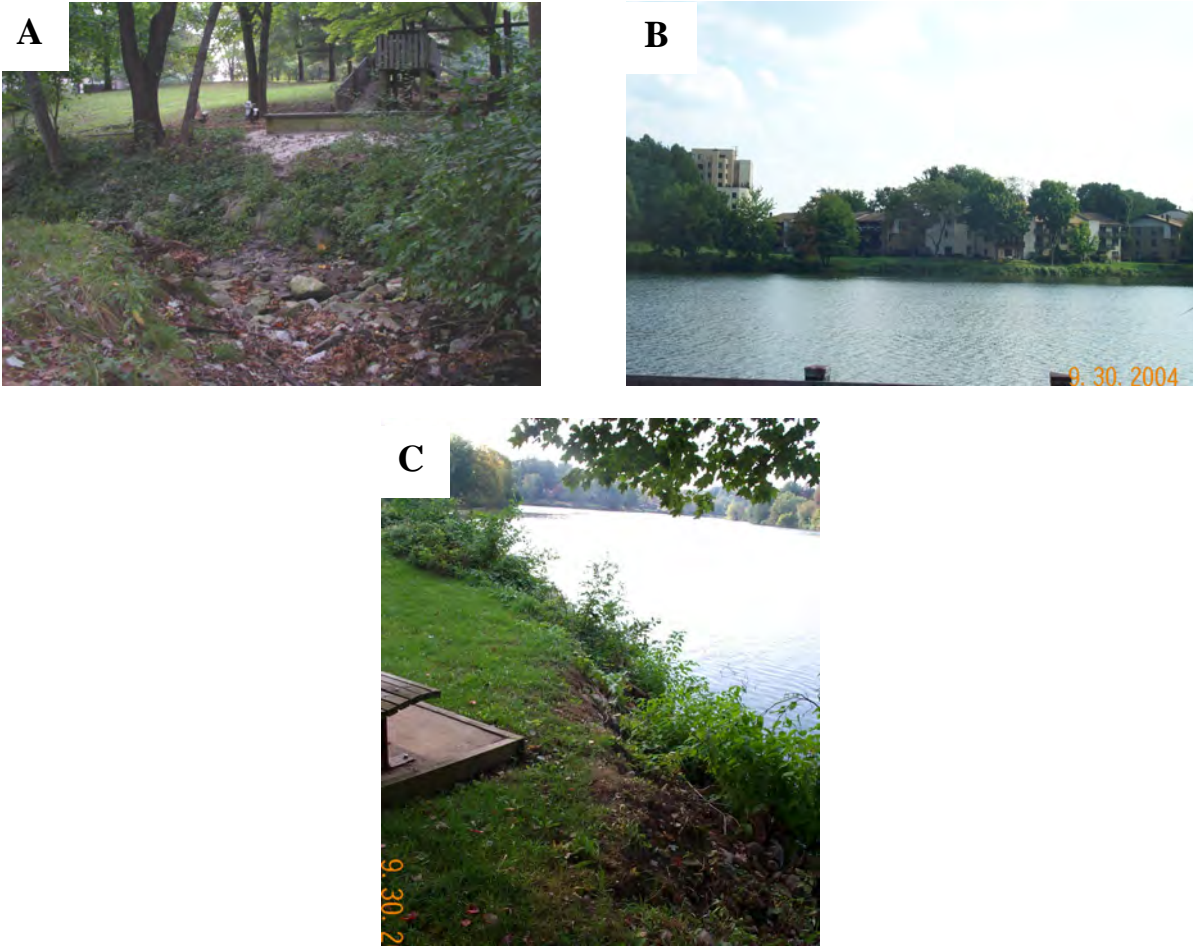
**Figure 3.10** Several streams as well as lakesides in both watersheds (A) and Wilde Lake (B) displayed a lack of buffer and/or buffer encroachment (C). Buffer education and plantings are two strategies to combat these problems.

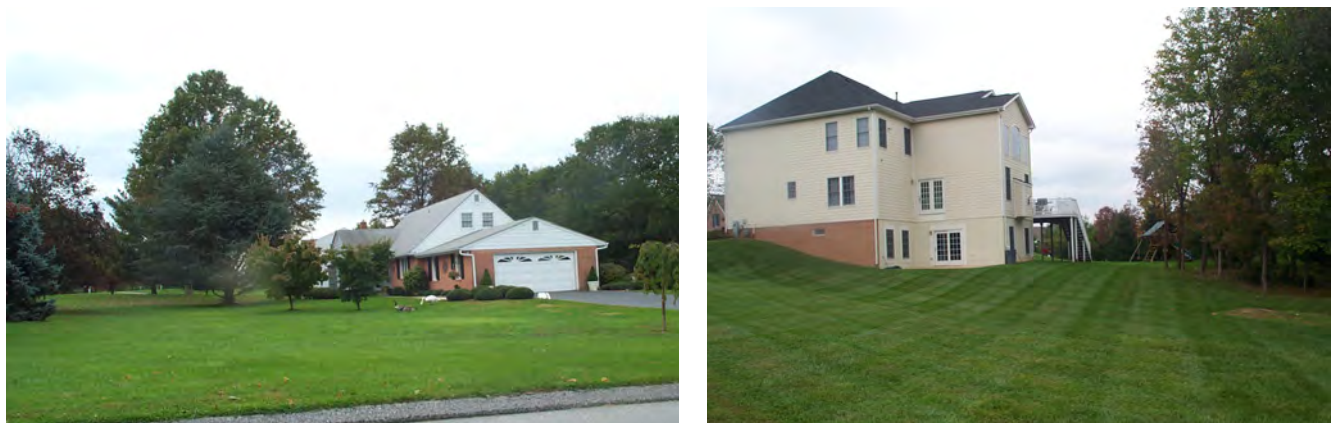
**Figure 3.11** The house on the left shows tell-tale signs of high turf management, including lack of weeds and evidence of fertilizer (bright green grass). The house on the right also shows signs of high turf management, but contains a rain barrel and compost bin, which is evidence of a conservation ethic in the watershed.

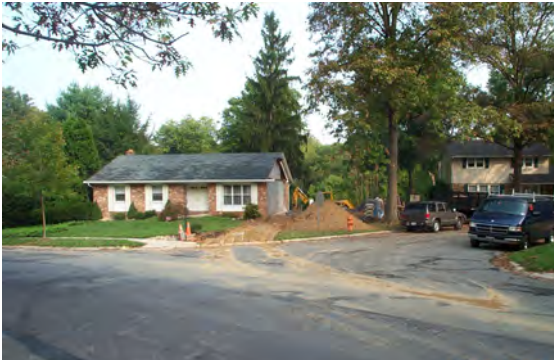
Single lot construction sites can discharge sediment to the streets, which may have an impact on downstream receiving waters.

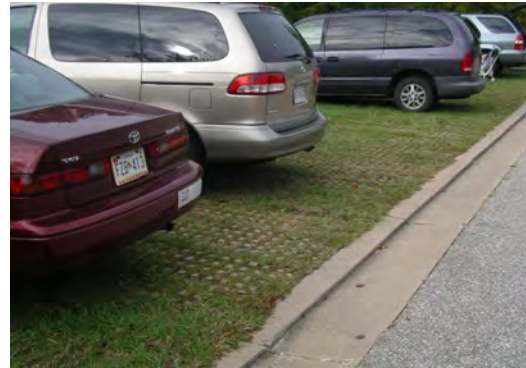
Permeable pavement used in this parking area at Centennial Park off Old Annapolis Road may potentially have more widespread application.

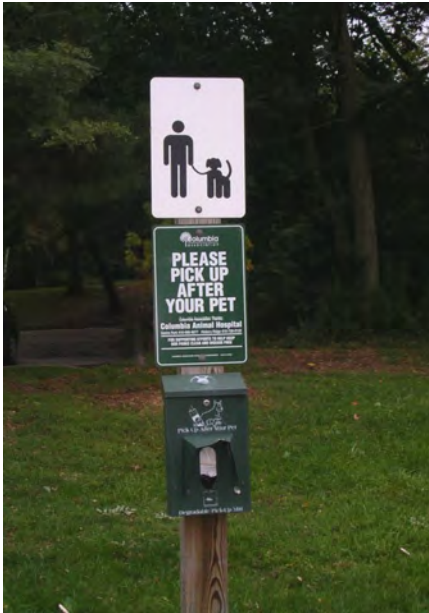
Pet waste pick-up stations were numerous around Wilde Lake and are an inexpensive way to improve water quality and educate residents.

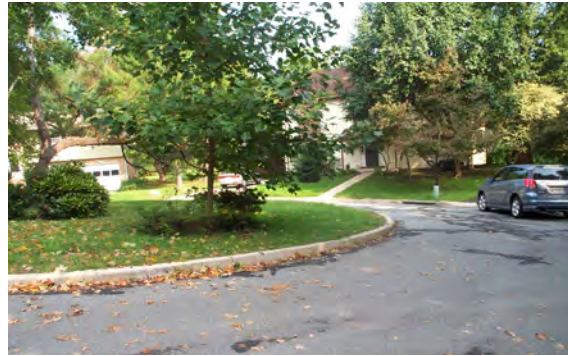
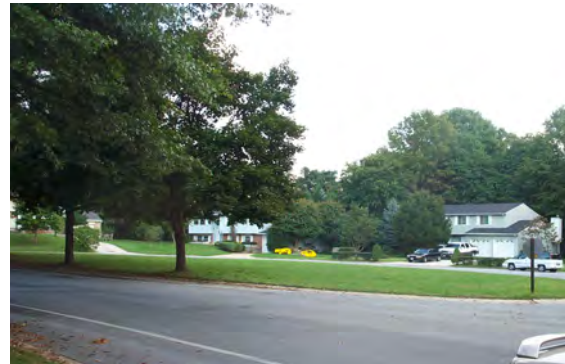
Pervious cul-de-sac islands were frequently found throughout Wilde Lake. While these already slightly reduce impervious cover in the watershed, there may be opportunities to use some of them to treat stormwater.

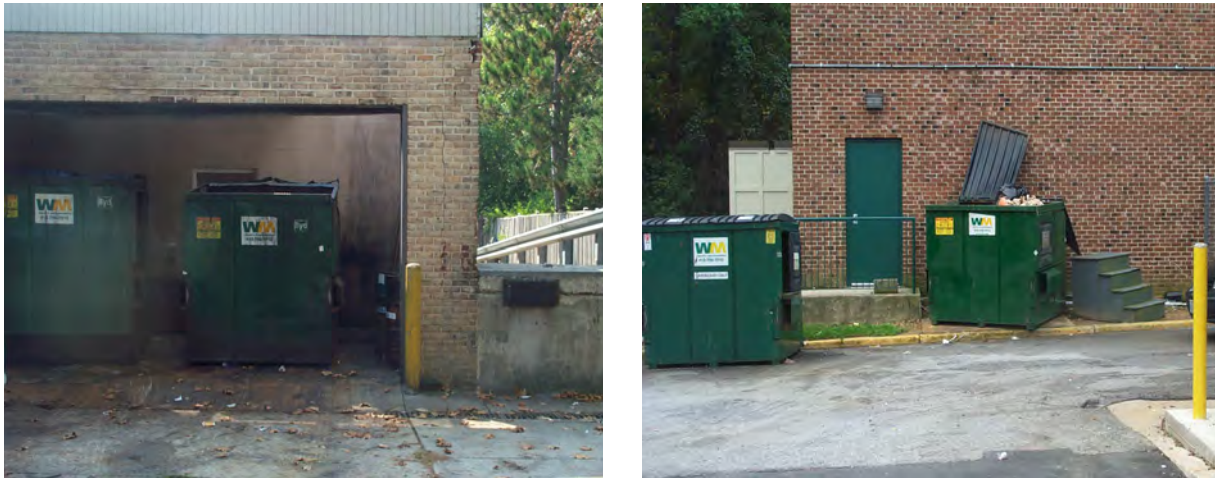
The single biggest observation at each of the potential hotspots surveyed was poor dumpster management. Frequently, dumpsters were in a state of disrepair and were located on an impervious area without any runoff control practices in place (Figure 3.13).

**Figure 3.13** Dumpsters throughout both watershed were frequently located on concrete or asphalt and had no secondary containment present.

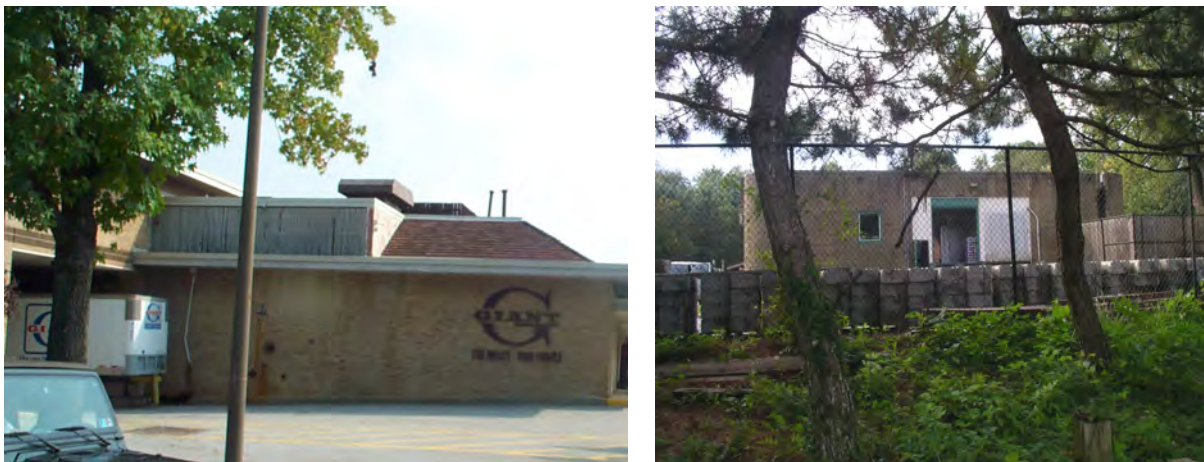
Uncovered storage or loading/unloading areas were a frequent problem as well. The loading area at the Giant store in Wilde Lake Village Shopping Center (Figure 3.14) was a particular problem. At the Centennial Lake Park maintenance building, unlabeled storage drums were found situated on an asphalt parking lot with no secondary containment (Figure 3.14), and an uncovered fueling area had noticeable sheen spreading downgradient.

**Figure 3.14** Poor loading/unloading practices were found at Giant Supermarket in Wilde Lake, while unlabeled storage drums without secondary containment were found at Centennial Lake Park (right).

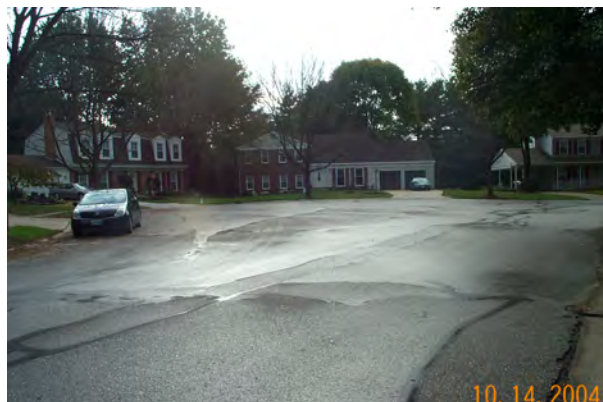
**Figure 3.17** Example of a cul-de-sac retrofit location for the installation of a landscaped island.

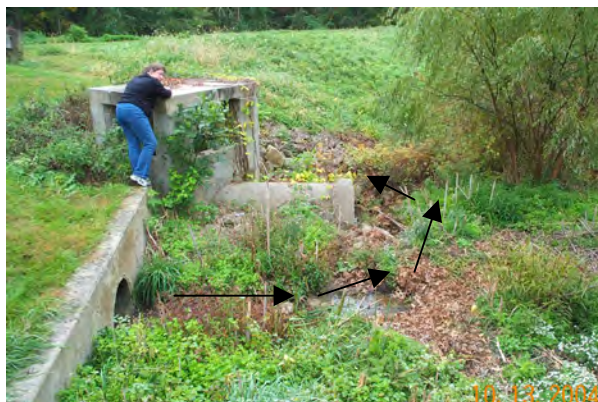
**Figure 3.18** Short-circuiting at Beaverbrook stormwater pond.

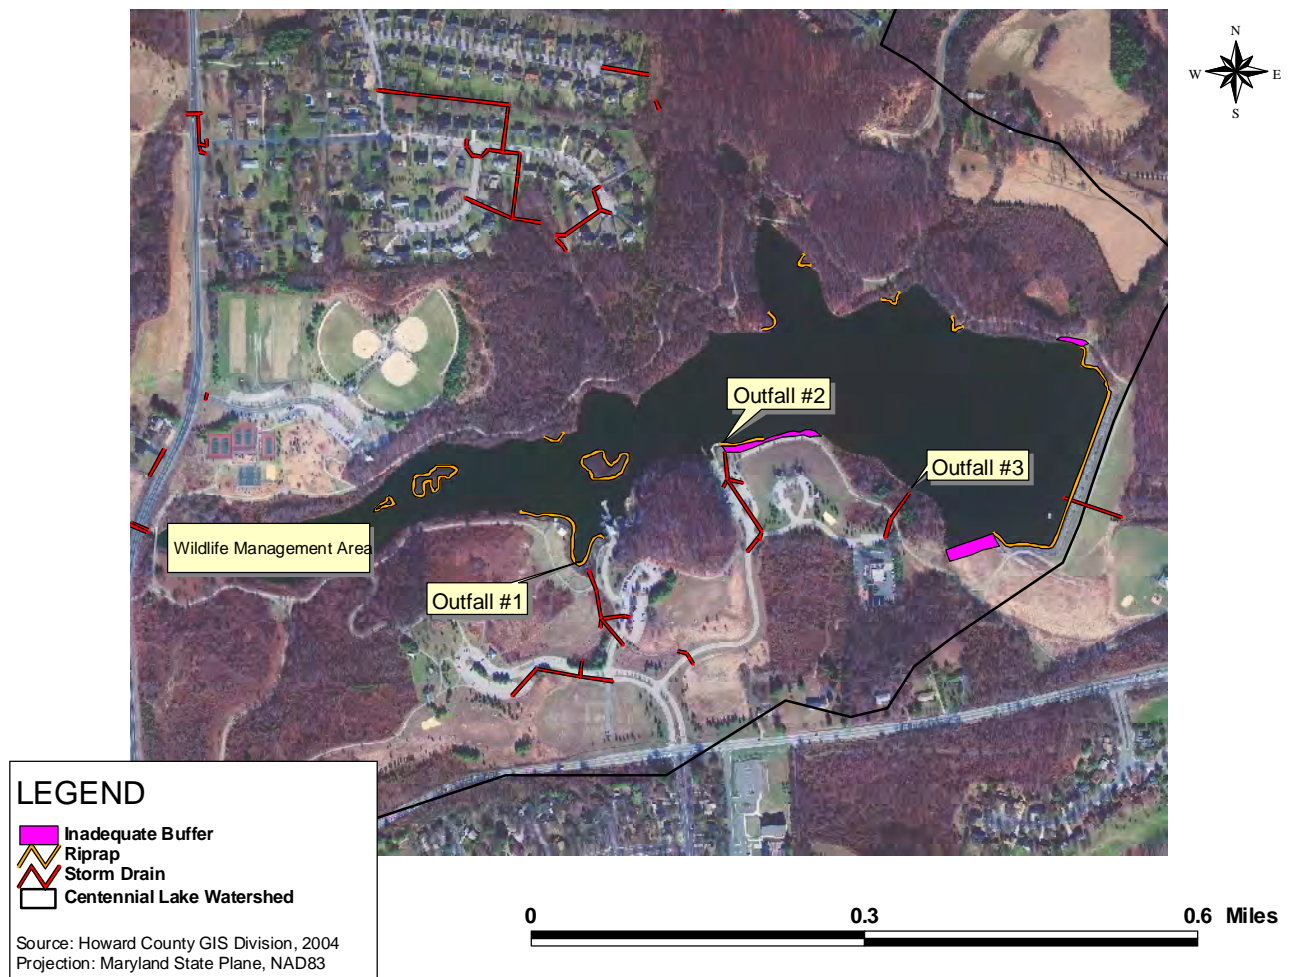
Figure 3.19 Results of the Centennial Lake shoreline assessment.

Maintaining a natural setting within the park has resulted in an adequate buffer zone around a majority of the lake. An inadequate buffer was observed in three specific locations, shown in Figure 3.19. At these locations, mowing to the lake edge was observed in 3 specific locations. At each of the locations, some form of lake buffer is recommended although, because of the need for public access and the fact that one of the locations serves as an emergency spillway, a grass buffer or native nonwoody plantings may be warranted. The reduction in the size and quality of the buffer allows runoff to sheet flow directly to the lake.

Three storm drain outfalls flow directly to the lake. All three convey stormwater runoff from parking lots or park roads. A fourth outfall is likely located on the north side of the lake draining the existing parking areas near the tennis courts, although it was not located in the field because of heavy vegetation and the potential that the outfall is submerged in the lake. An attempt was made to evaluate all three outfalls to determine the condition; their locations are shown in Figure 3.19.

The first outfall was located on a small inlet near the boat rental station. This outfall drains the parking lots and a portion of the road leading to the lots. The actual outfall structure could not be located because of the extensive riprap and vegetation located along the shoreline. This area was also fenced to prevent access to the shoreline by park visitors. There was a storm drain inlet just outside the fencing. It was assumed that this inlet was installed to drain the grassed area between the walking path and the lake. At the time of the shoreline assessment in September 2004, no standing water was observed but the area was saturated and showed signs of erosion. It was assumed there were no structural defects to the outfall and that the significant man-made buffer around the outfall was installed to arrest erosion problems. This outfall is a direct drain to the lake and can convey pollutants deposited on the parking lot directly to the lake.

The second outfall was located next to the boat launch. This outfall drains the boat launch parking lot and a portion of the road leading to the lot. The outfall was in good condition but is a direct drain to the lake. Pollutants deposited on the parking lot and park roads can be washed directly to the lake through the storm drain system.

The third outfall was located near the park maintenance yard. The outfall drains the parking lot located next to the maintenance yard and a portion of the road leading to the parking lot. The actual outfall structure could not be located because of the heavy vegetation located along the shoreline. It was assumed that the outfall structure was in good condition. This outfall is a direct drain to the lake and can convey pollutants deposited in the parking lot and possible contaminated runoff from the vehicle maintenance yard.

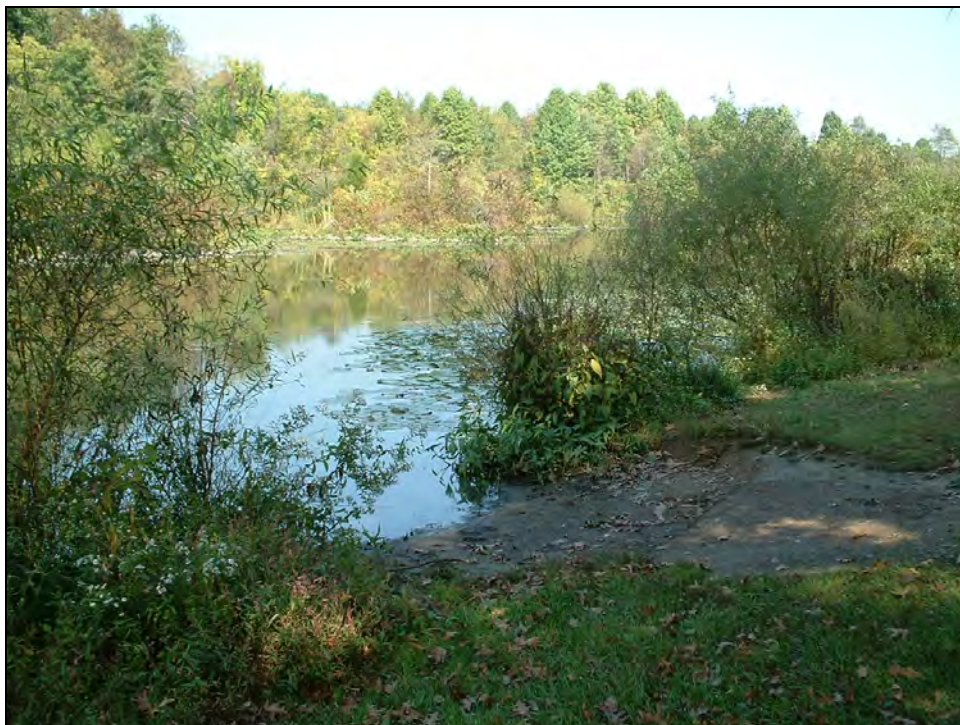
Although there is a paved walking path around the entire perimeter of the lake, unintended paths were observed leading from the paved walking path directly to the shoreline. Figure 3.21 gives an example of the type of unintended path observed. Note that repeated use of this path has resulted in the loss of grass and other vegetation, allowing soil and other debris to be washed off directly to the lake. These areas are not expected to be serious contributors to sedimentation in the lake because of limited size and disturbance.

**Figure 3.21** Example of an unintended path.

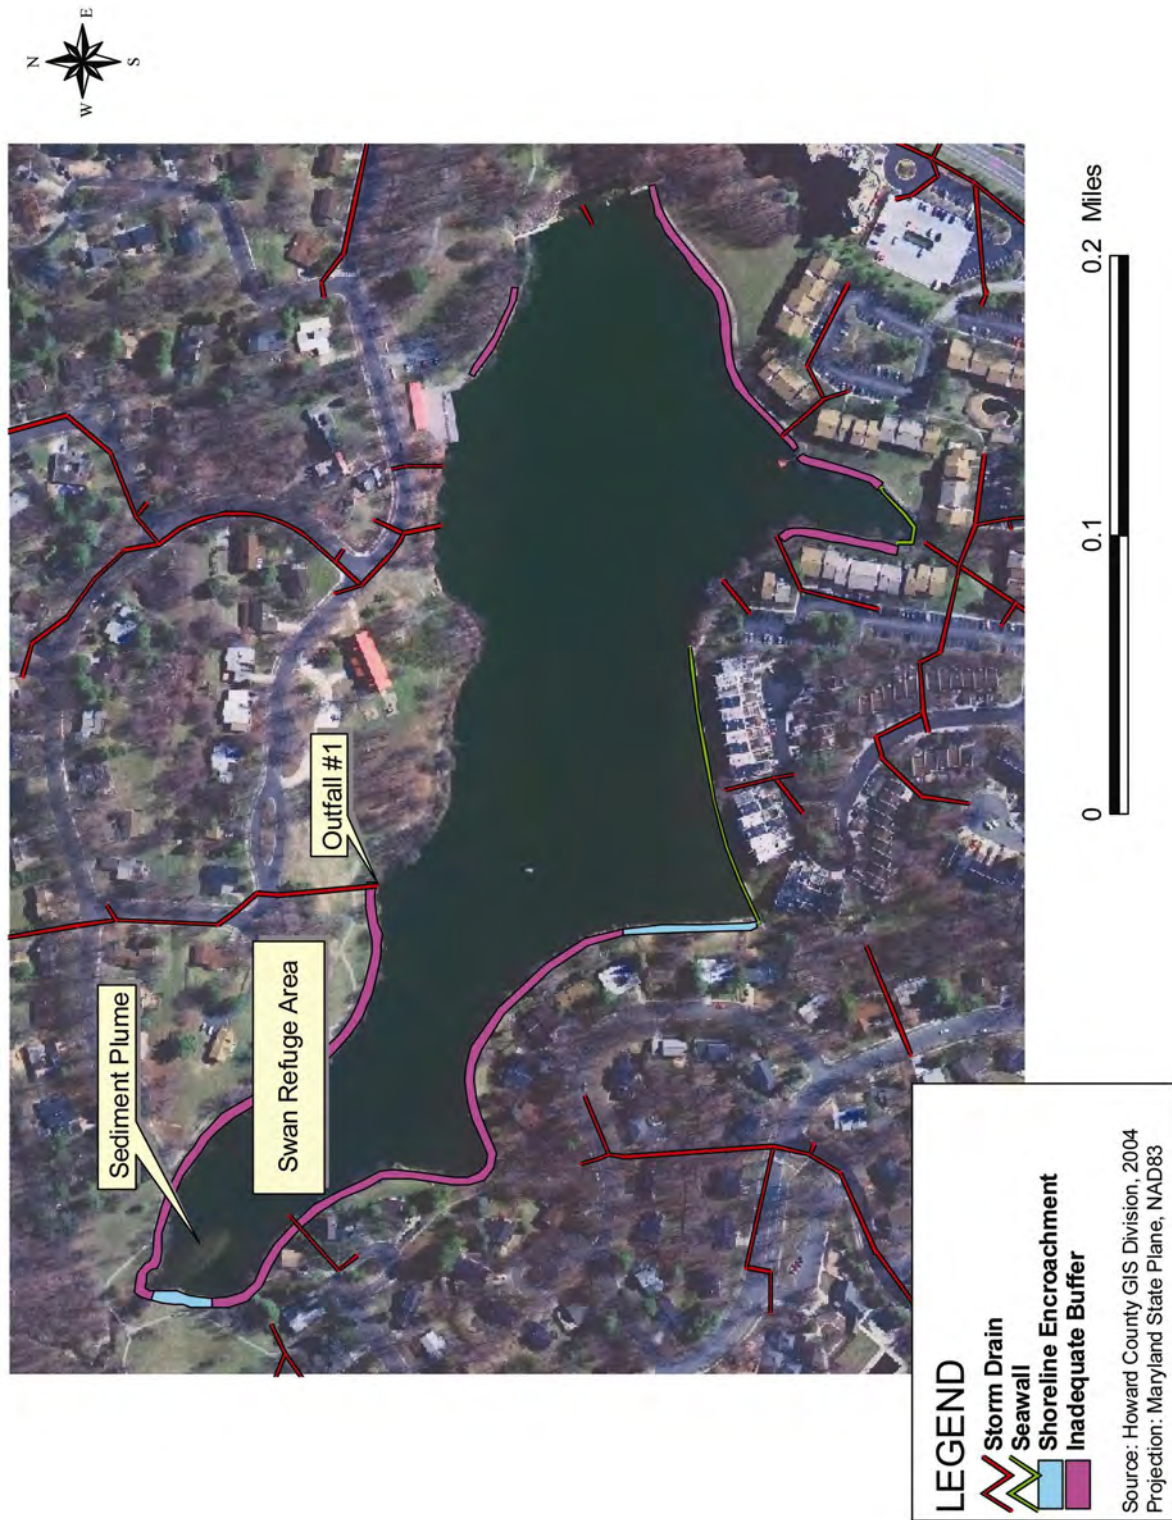
Figure 3.22 Results of Wilde Lake shoreline assessment.

Wilde Lake is relatively urbanized with instances of seawalls along two southern portions of the lake. Two instances of shoreline erosion were observed that also had inadequate buffers. It was also clear that mowing to the lake edge was conducted in these locations, as shown in Figure 3.22.

The majority of the shoreline along the southern shore of the lake is privately owned property. Instances of mowing up to the lake edge were observed. Also observed were instances of extensive landscaping near the lake, as shown in Figure 3.22.

The upper portion of Wilde Lake is designated a swan refuge, and fishing is not allowed in this area, shown in Figure 3.22. In addition to resident swans (nonnative mute swans were observed), Canada geese and other waterfowl were observed during the shoreline assessment. Population estimates for Wilde Lake were not available for resident geese, ducks, and swans.

Sediment buildup has been a problem in the upper reaches of the lake, and a sediment plume is visible in the aerial photos of the lake (Figure 3.22). The excessive sediment washed into the lake has resulted in the formation of islands in the Swan Refuge Area in the upper portion of the lake. Excessive sediment can be expected to be slowly washed further downstream into the lake, reducing its useful depth.
