# Tiber-Hudson & Plumtree Branch Stream Corridor Assessment 2012

Tiber-Hudson and Plumtree Branch Stream Corridor Assessment

S&S Planning and Design, LLC.

12/12/2012

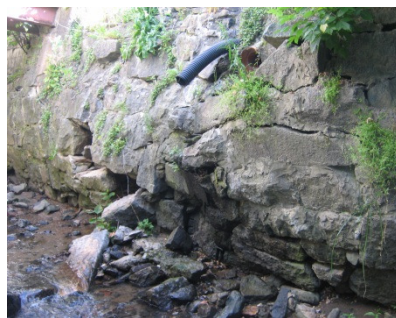
**Point # 1015**

Description: Failing cinderblock wall.

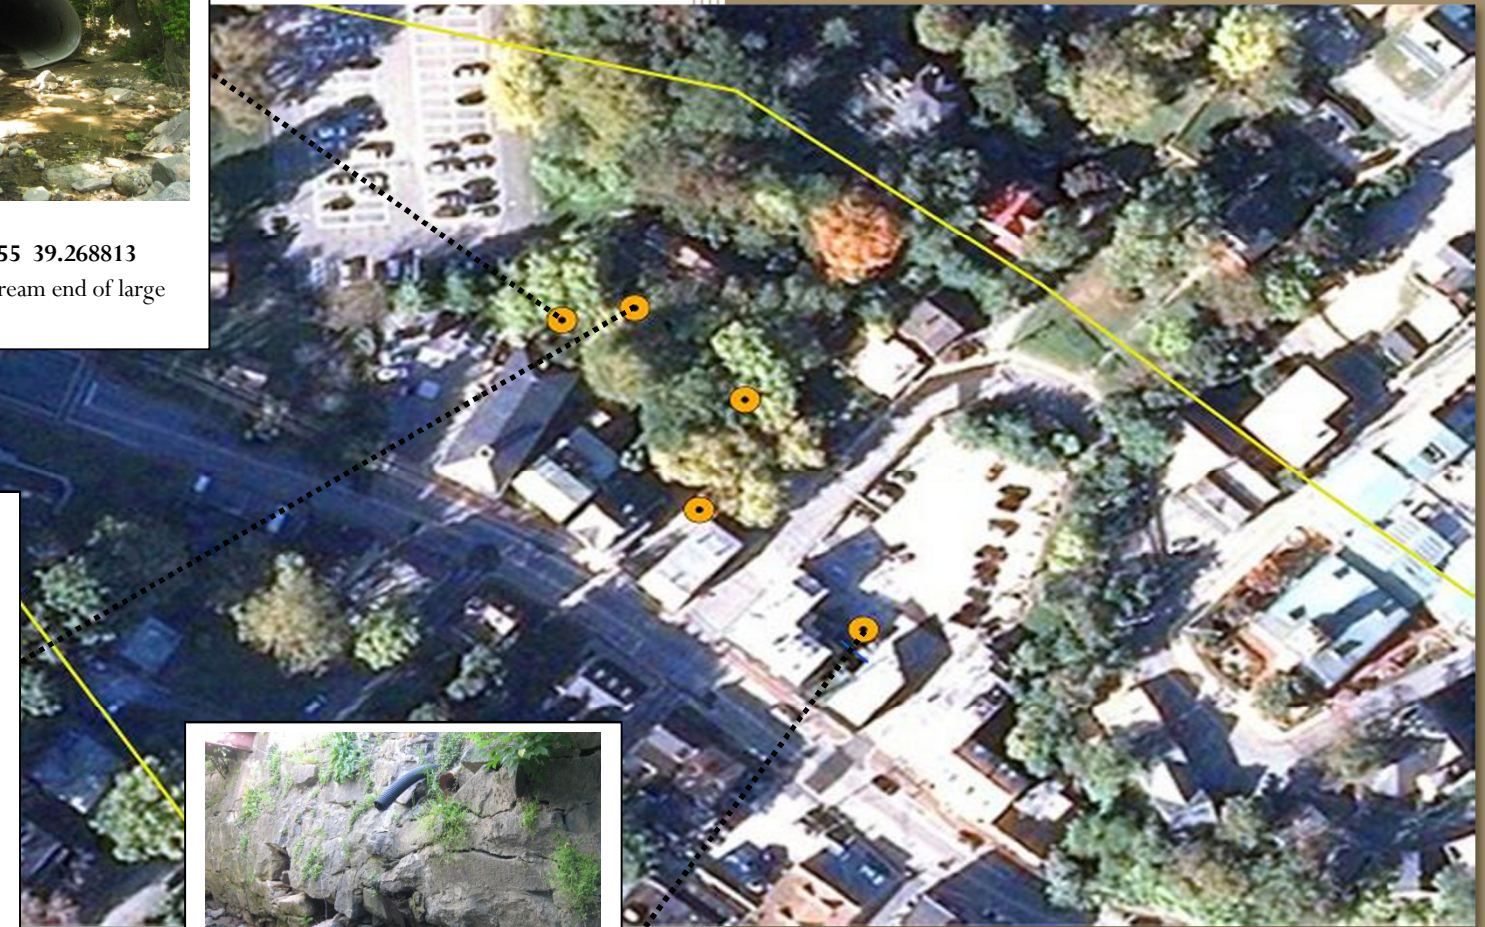
**Point # 1012**

Description: Failing rock wall.

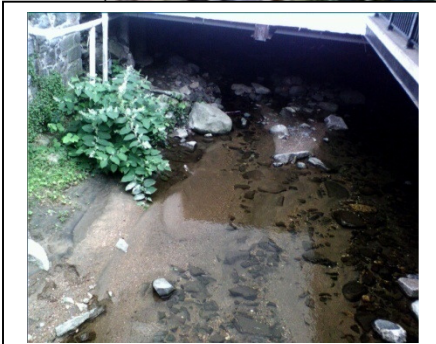
**Point # 1005**  
**Location:** -76.796517 39.267352  
**Description:** Road/building crossing.

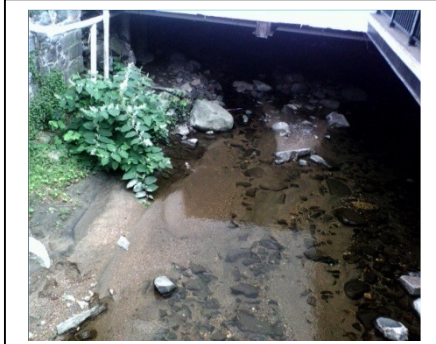
**Point # 1004**  
**Location:** -76.795934 39.267319  
**Description:** Road crossing. Bridge.

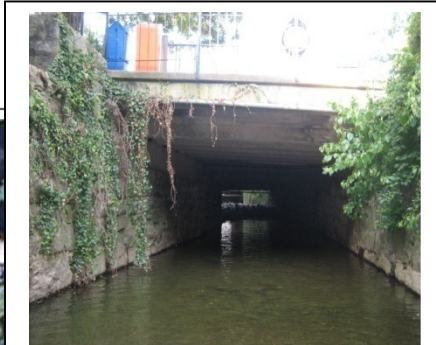
**Point # 1002**  
**Location:** -76.794935 39.267737  
**Description:** Road crossing. Bridge.

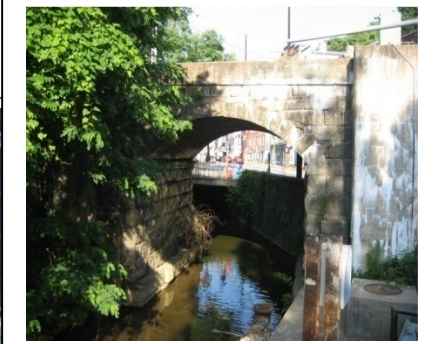
**Point # 1001**  
**Location:** -76.794685 39.267801  
**Description:** Rail road crossing. Bridge; beginning of study area.

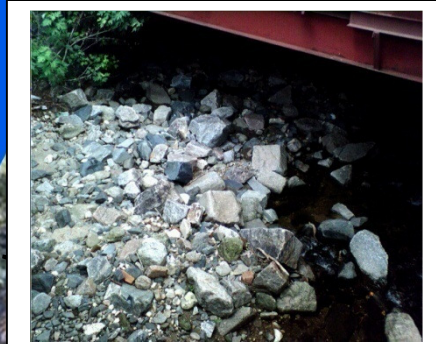
**Point # 1003**  
**Location:** -76.795726 39.267545  
**Description:** Debris blockage. Diverting flow directly into stone wall.

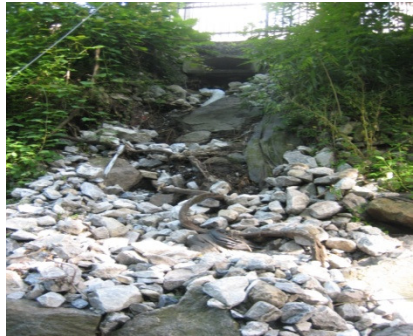
**Point # 1007**  
**Location:** -76.798472 39.267226  
Description: Failing riprap outfall to channel.

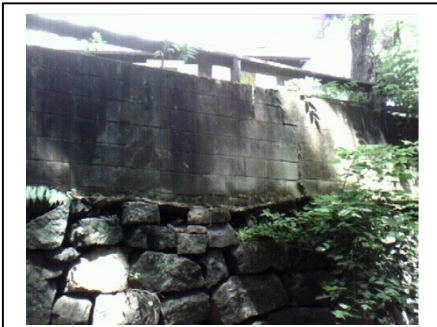
**Point # 1015**  
**Location:** -76.800172 39.268942  
Description: Failing cinderblock wall.

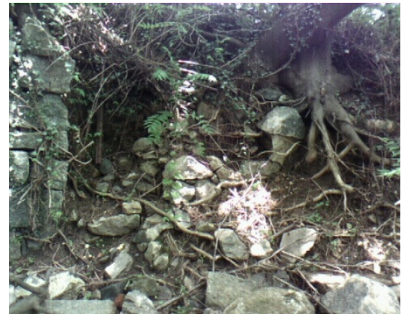
**Point # 1014**  
**Location:** -76.799923 39.268748  
Description: Failing bank, large amount of wall in stream.

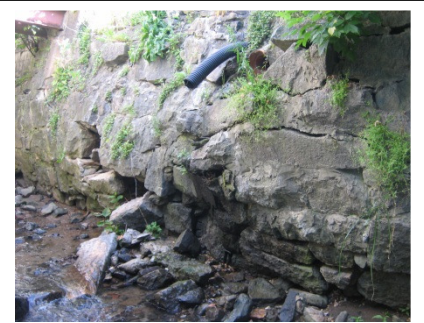
**Point # 1012**  
**Location:** -76.799508 39.268230  
Description: Failing rock wall.

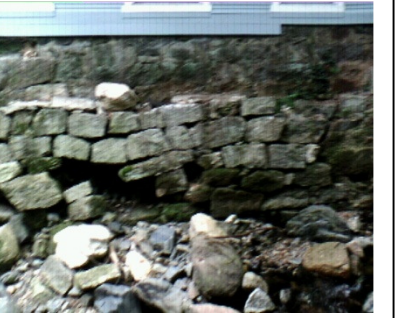
**Point # 1018**  
**Location:** -76.801918 39.269139  
Description: Failing wall below house.

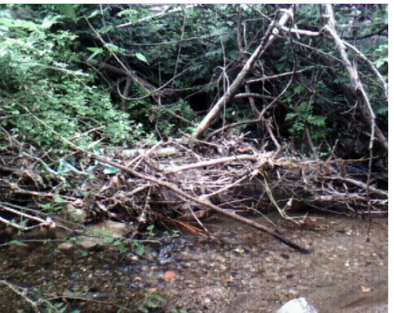
**Point # 1022**  
**Location:** -76.803081 39.269755  
Description: Erosion site. Failing wall and erosion site.

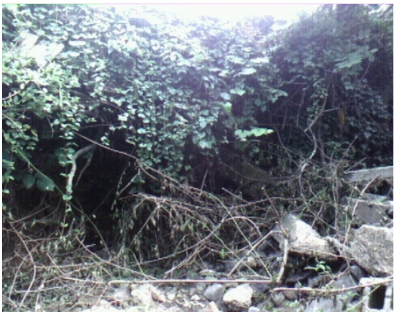
**Point # 1023**  
**Location:** -76.803580 39.269756  
Description: Erosion site. Cinder blocks in stream.

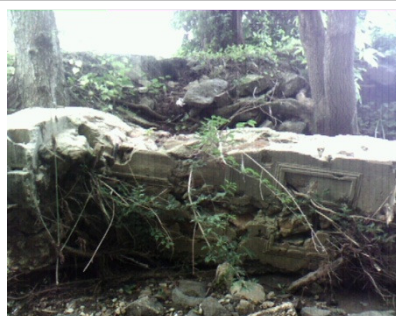
**Point # 1035**  
**Location: -76.809364 39.268570**  
Description: Failed rock wall.

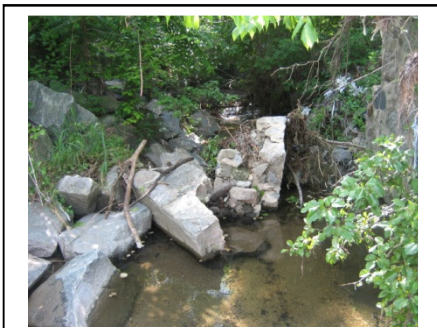
**Point # 1039**  
**Location:** -76.810444 39.269121  
Description: Debris blockage. Pieces of rock wall in middle of channel.

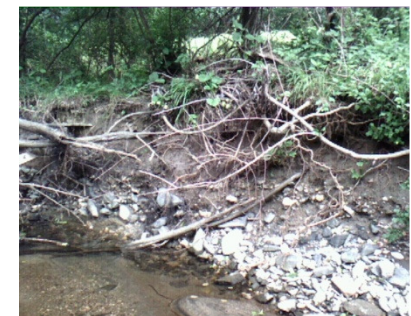
**Point # 1046**  
**Location:** -76.814558 39.270453  
Description: Erosion site/Debris blockage. Outside meander eroding, debris catching on walnut roots nearing failure.

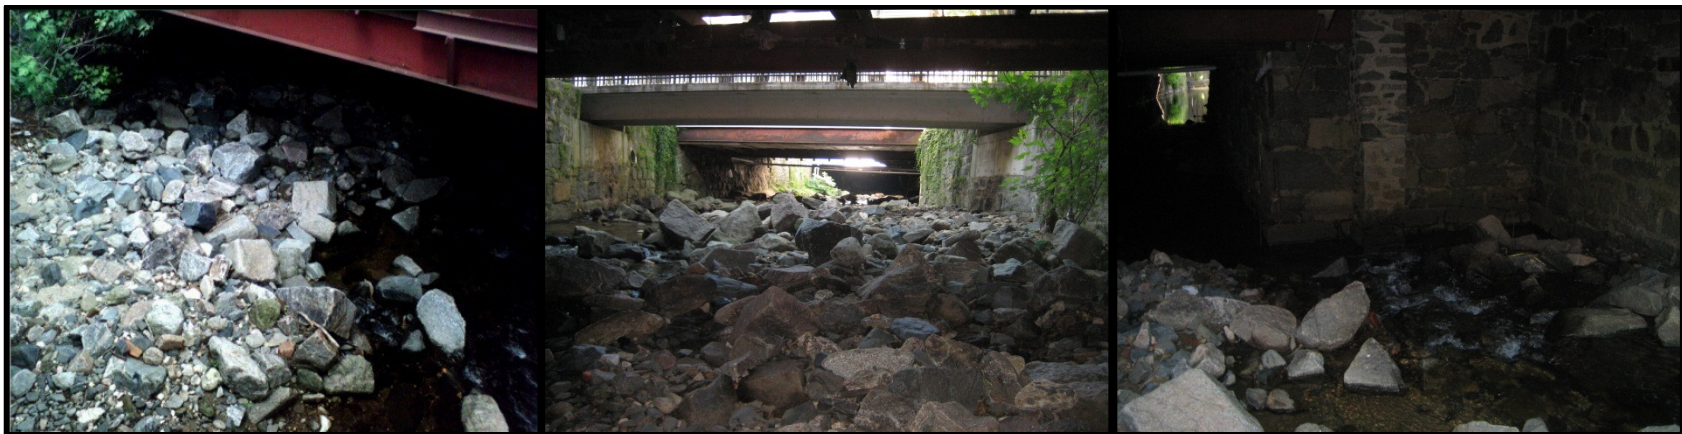
Site 1 is identified as Point 1003 within the SCA and is located in the historic downtown section of Ellicott City. More specifically, it is located immediately downstream of the footbridge at Tiber Park. It is categorized as a debris blockage and consists primarily of boulder and cobble accumulation within the channel. This accumulation is occurring due to the slope reduction at the Tiber-Hudson nears its confluence with the Patapsco River. A reduction in slope reduces stream competence, or the ability of the stream system to carry its sediment load. This site is identified as a potential problem/mitigation area because the boulder/cobble accumulation is shifting stream flow directly into a corner created by a ninety degree bend in the stone flood wall. Over time, the continued assault of flowing water on the flood wall can compromise the grouting within the walls and eventually result in failure. One recommendation would be to clean out some of the accumulated material and grade the channel such that flow is redirected away from the walls. A hydraulic structure could be incorporated; however, access to the channel is very limited at this location.

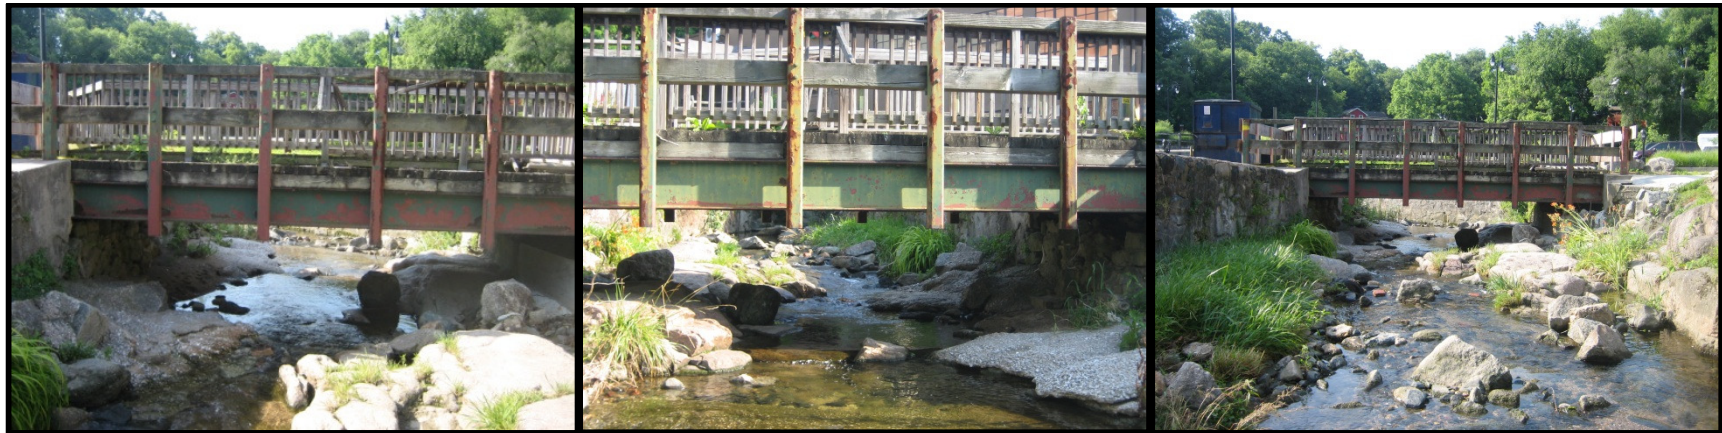
**Site 2**

Site 2 is identified as Point No. 1010 within the SCA and is located between two parking lots in the downtown area, immediately upstream of the Tiber Branch/Hudson Branch confluence; it consists of an I-beam supported, timber-decked footbridge that provided pedestrian traffic to flow between the businesses arranged around the parking lots. This footbridge was damaged during the flood event and is closed to traffic. Visually, the cross-sectional area available to flood conveyance through this structure is not commensurate with the area provided by the rest of the channel or other flow conveyances. The depth at the center point in the channel to the bottom of the I-beam is 4 feet, 8 inches; the depth at the one-third and two-thirds locations along the span is 3 feet, 6 inches, and 3 feet, 8 inches, respectively. Flow depths greater than 4 feet will continue to impact this structure and potentially result in flood water ‘jumping’ into the adjacent parking lots. It is recommended that the footbridge be removed or replaced with a structure that provides greater cross-sectional area for flood conveyance. One potential structure would be an archway.

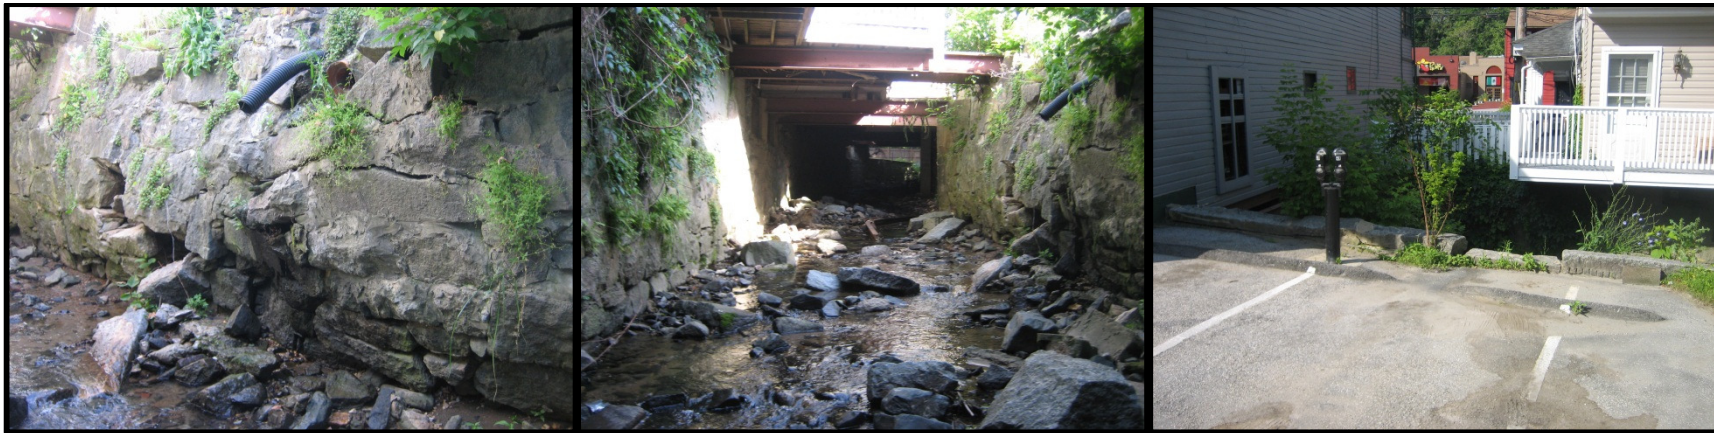
### **Site 3**

Site 3 is identified as Point No. 1012 within the SCA and is located near the upper or western end, of historic downtown Ellicott City. This site encompasses two separate issues; the first is a failing rock wall adjacent to a public parking lot, the second is an archway within and integral to the channel conveyance beneath Main Street.

The failing rock wall is located in a small open channel section that has buildings bridging the channel immediately upstream and downstream, and is adjacent to a public parking lot behind the Ellicott Mills brew pub. In the event of a wall failure, several parking places would likely be included. Additionally, if the wall should fail during a flood event, the introduction of the wall materials, including material behind the wall or near the parking places, would create a ‘slug’ of material immediately upstream of the channel constriction discussed below as part of this site. The structural integrity of this wall should be evaluated and repaired before it deteriorates any further.

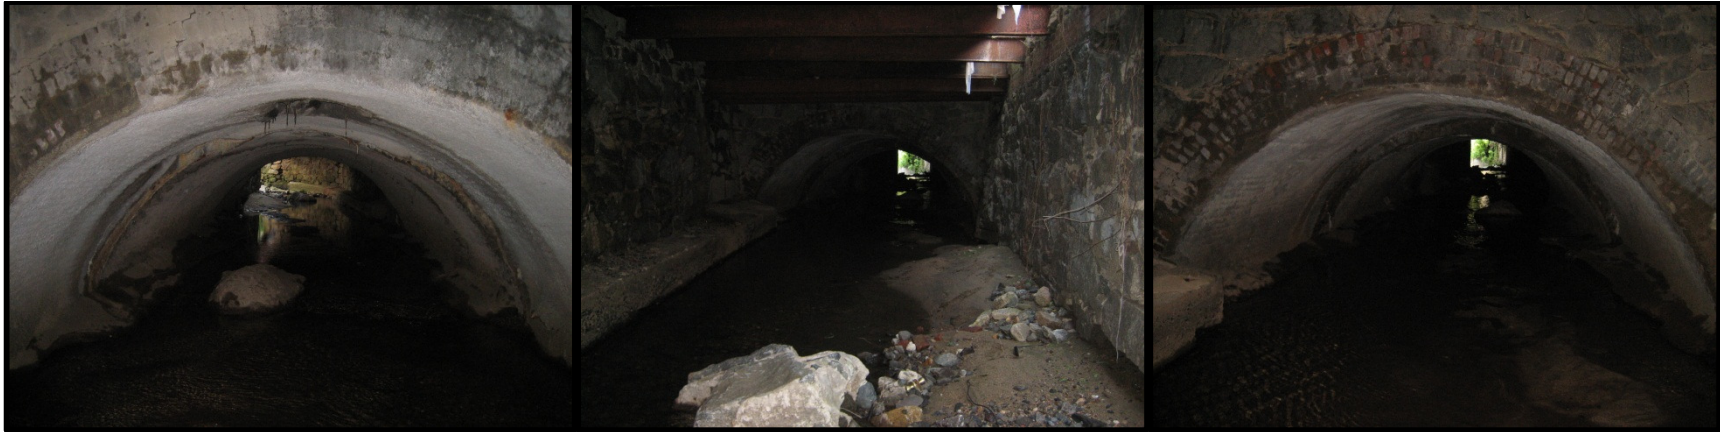
The second issue associated with this site is an archway located within the channel beneath Main Street and several businesses. This archway represents a channel constriction that significantly reduces the cross-sectional area of the potential flood conveyance. Once the flow capacity of the archway reaches its limit during a flood event, it will create a backwater condition within the upstream portion of the channel. Additionally, constriction of the channel increases the possibility that debris can get impinged at the opening, thereby exacerbating the backwater condition and potentially resulting in the flood water ‘jumping’ from the channel into Main Street. It is recommended to have the archway inspected by a structural engineer to evaluate if its removal would jeopardize the structural integrity of the rectangular conveyance or the surrounding buildings built over this location.

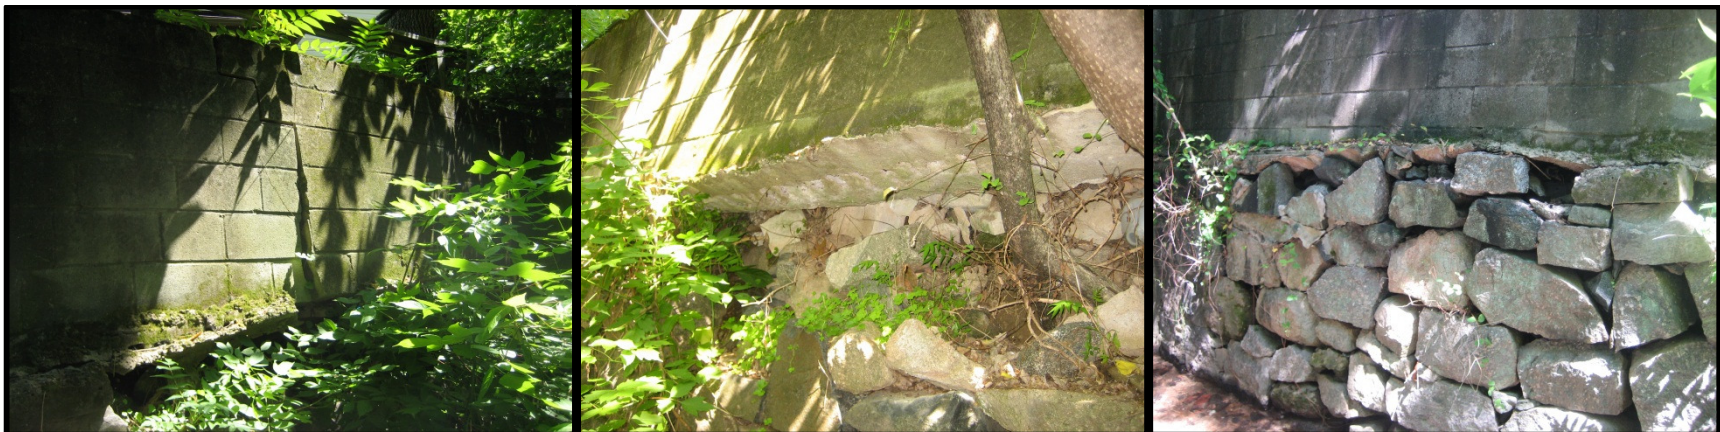
**Site 4**

Site 4 is identified as Point No. 1015 within the SCA and is located adjacent to a parking lot for an apartment complex. It consists of a failing cinder block wall built on a stacked stone wall. The stacked stone wall is not mortared or grouted and it failing in locations as well. Where the stacked stone wall has completely failed, the block wall is ‘hanging’ without any base or support and the bottom of the wall is visible. In the event of a complete wall collapse, a portion of the parking lot above and adjacent to the wall would be compromised as well. This wall should be further evaluated for repair and/or replacement.

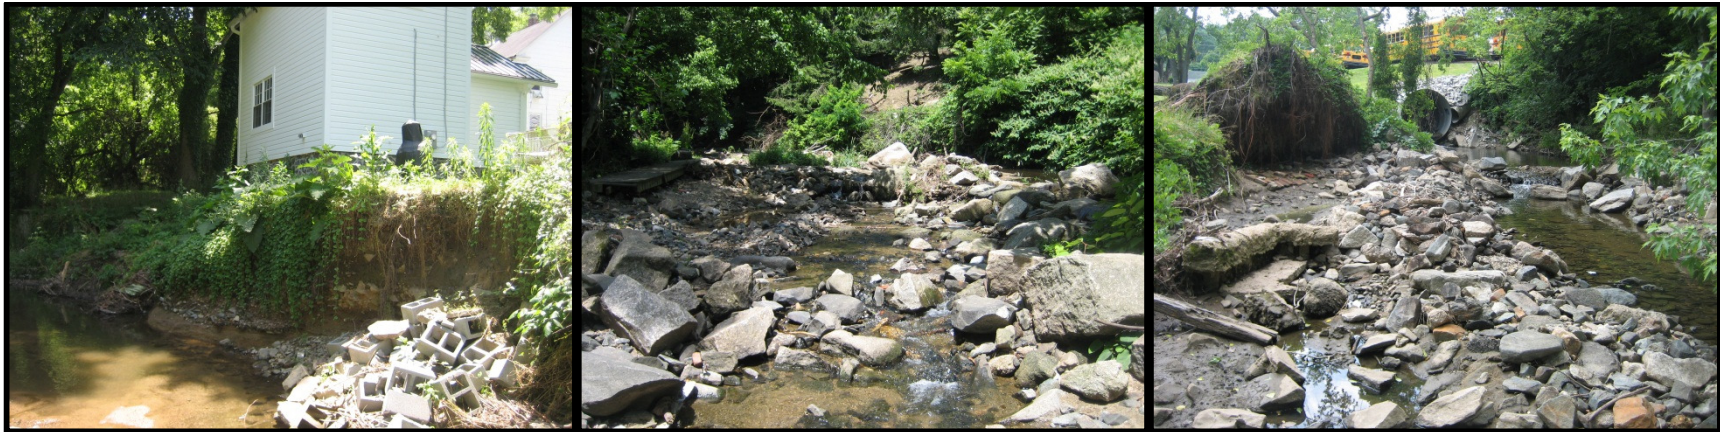
### **Site 5**

Site 5 encompasses the stream reach between Point No. 1021 and Point No. 1031 within the SCA. This reach experienced accelerated bank erosion, losing approximately 10 to 13 feet of streambank laterally in some locations during the September flood event. One house structure in this reach is in jeopardy if accelerated erosion continues. It is recommended that this reach be evaluated for additional stabilization and restoration alternatives.

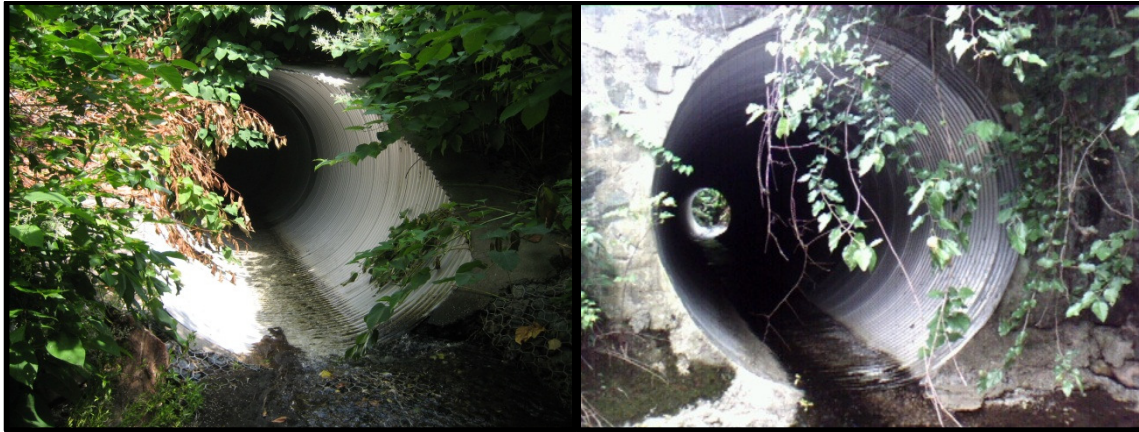
This reach also contains a large corrugated metal culvert described as Points 1026 and 1027 for the downstream and upstream locations, respectively. The following statement is an excerpt from the *Case Study* that compliments this report: “The channel approaching the culvert inlet is armored with gabions in a trapezoidal shape. A preponderance of Japanese Knotweed is located along both banks. An eye witness stated that an approximately 8-10” Red Maple had been leaning diagonally across the culvert inlet during the flood event. Witnesses stated that the inlet was almost completely blocked with debris. Therefore, this culvert inlet also created additional backwater and another location where flood flow ‘jumped’ from the channel.” It is recommended that an H&H analysis be performed for this culvert and the upstream channel to verify its design storm flow capacity. Additionally, an invasive species eradication plan, including revegetation of the streambanks with native species, could be initiated to eliminate the Japanese Knotweed. The aforementioned debris monitoring and maintenance plan could prevent debris accumulations from occurring.

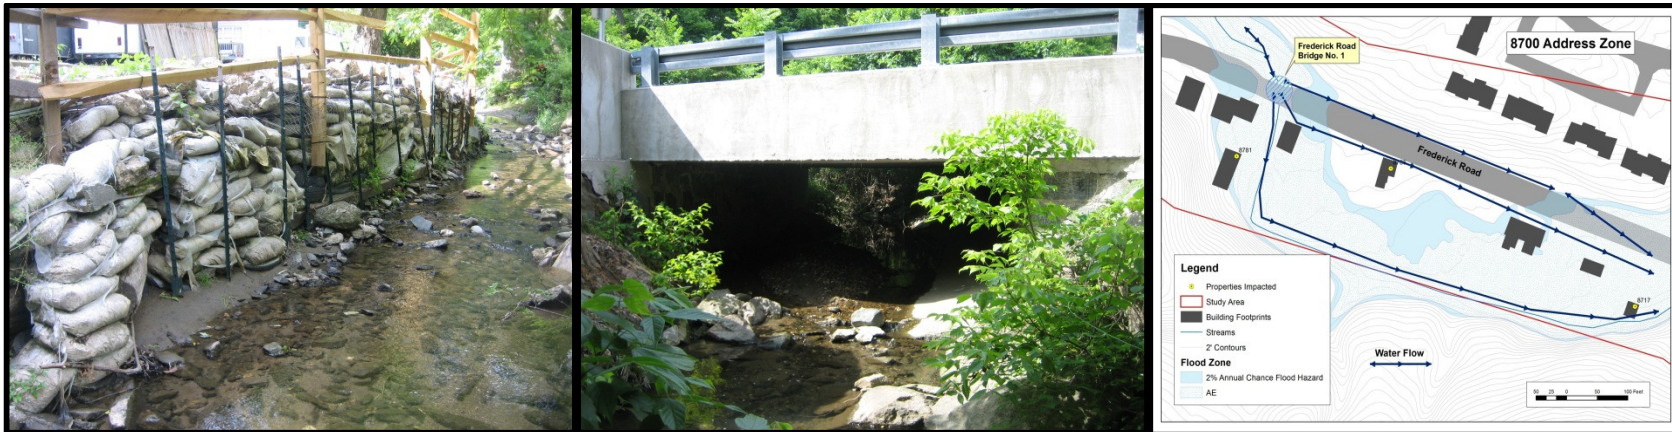
**Site 6**

Site 6 encompasses Point Nos. 1043 and 1044 within the SCA and due to their spatial proximity. Point No. 1043 is a concrete bag retaining wall installed to protect the driveway of a commercial property. It is recommended that this structure be replaced with an appropriate retaining wall. Point No. 1044 is identified in the *Case Study* as Frederick Road Bridge No. 1 and is the reported location where the stream ‘jumped’ the channel and flowed down Frederick Road. It is recommended that an H&H analysis be performed for this crossing location to determine its design storm flow capacity. The debris maintenance and monitoring plan would help minimize debris accumulation at this location.

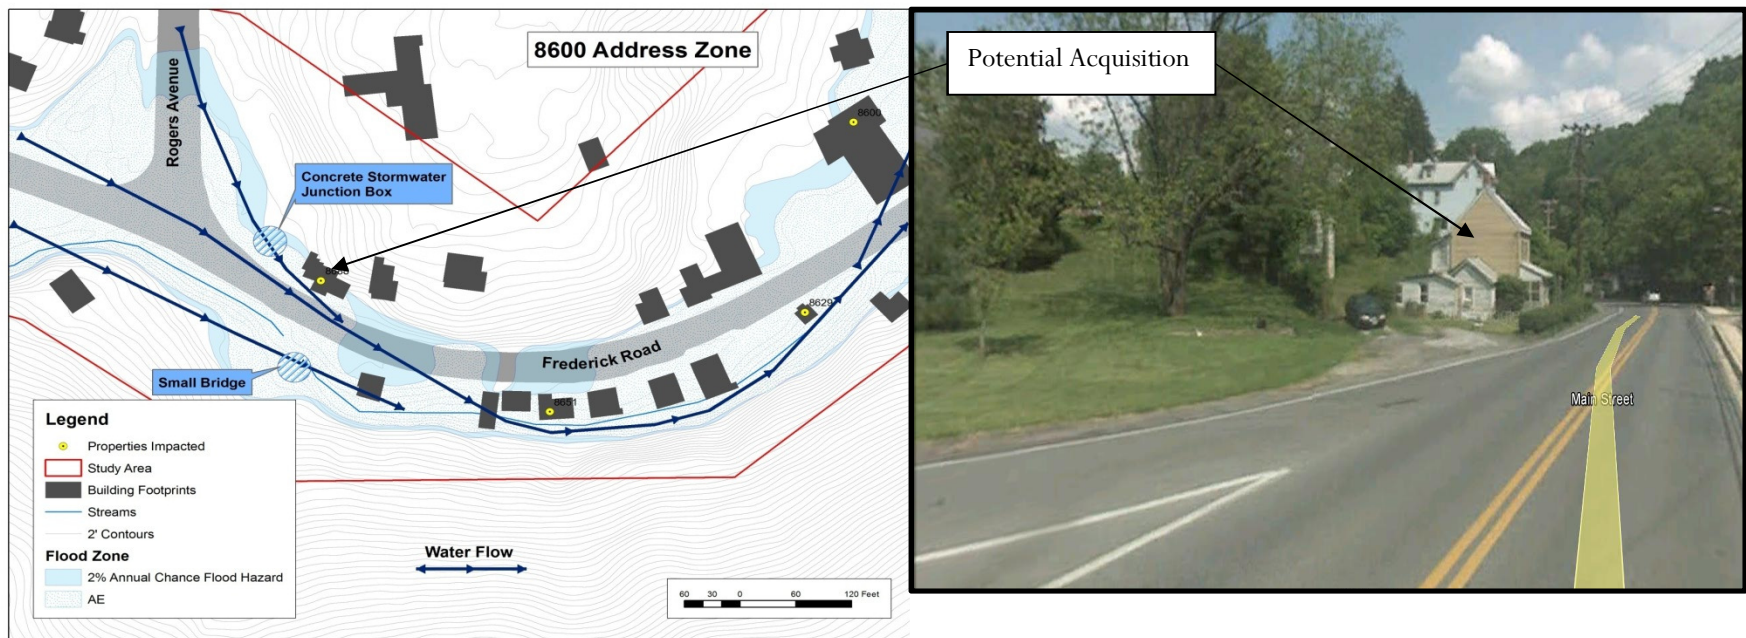
**Site 7**

Site 7 consists of a potential flood acquisition project and a stormwater management investigation in the vicinity of the Rogers Avenue and Frederick Road intersection. This area was identified and described within the *Case Study* as the 8600 Address Zone. One structure in particular, located at 8688 Frederick Road, experienced first floor flooding through the windows at the side of the house approximately 3 feet above grade and is recommended as a flood acquisition buyout candidate. Additionally, it was reported that a significant amount of stormwater was flowing down Rogers Avenue to combine with the flows along Frederick Road. A concrete stormwater junction box is located to the northeast of the Rogers Avenue/Frederick Road intersection. Witnesses reported that the manhole access cover was ‘blown off’ the lid of the box. Additionally, they reported that the concrete top was being elevated. This observation would indicate that the junction box and the stormwater pipes leading to it were at capacity, creating sufficient hydraulic pressure to lift the top and remove the manhole cover. With the stormwater system at capacity, excess stormwater would utilize the roadways as the storm conveyance. It is recommended that a stormwater management investigation be conducted to determine the feasibility of installing additional stormwater management facility(s) within this area.

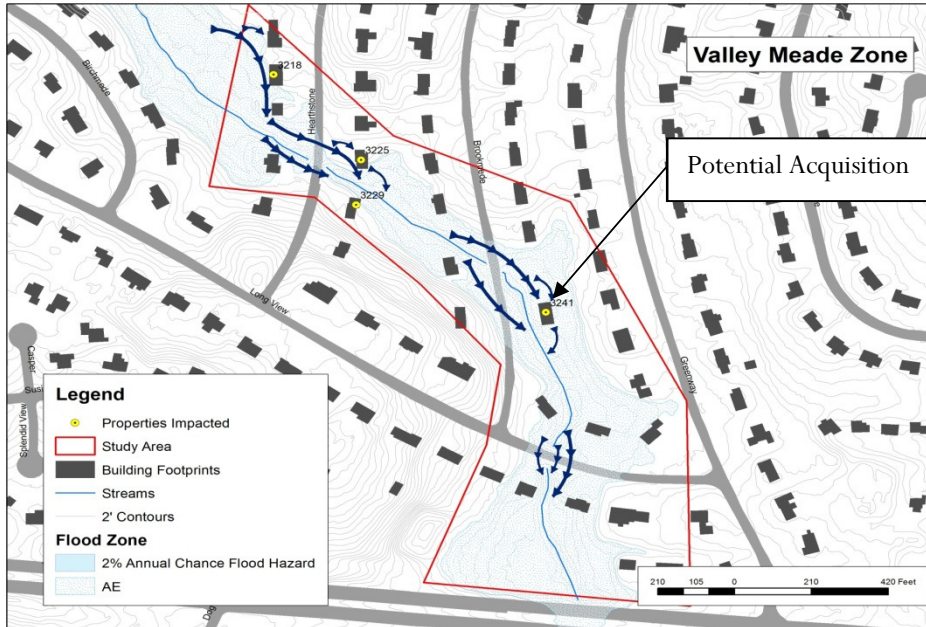
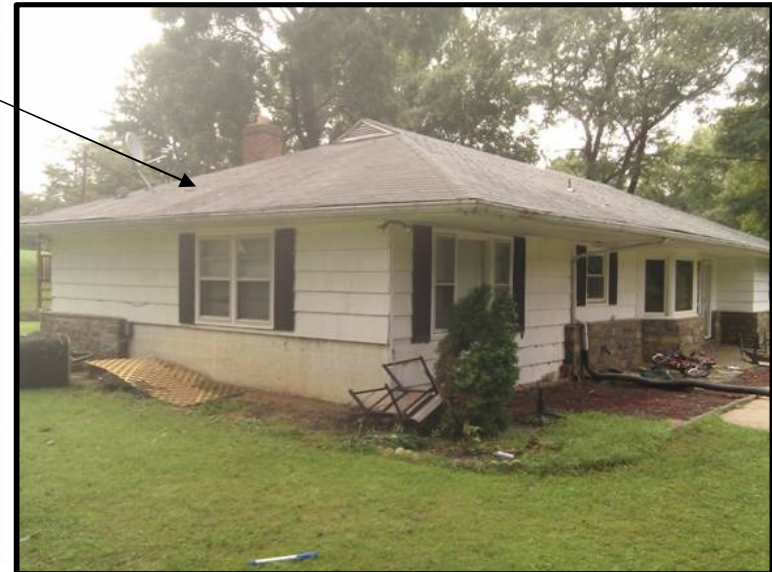
### Site 8

Site 8 consists of a potential flood acquisition project within the Valley Meade subdivision and is located at 3241 Brookmeade Road. This structure was described within the *Case Study* as having four feet of water in the first floor of the dwelling, rendering the entire home uninhabitable and is recommended as a potential flood acquisition buyout.
