Middle Patuxent River Stream Corridor Assessment Survey

Watershed Restoration Division
Chesapeake & Coastal Watershed Services
Maryland Department of Natural Resources
October 2002

MIDDLE PATUXENT RIVER STREAM CORRIDOR ASSESSMENT SURVEY

October 2002

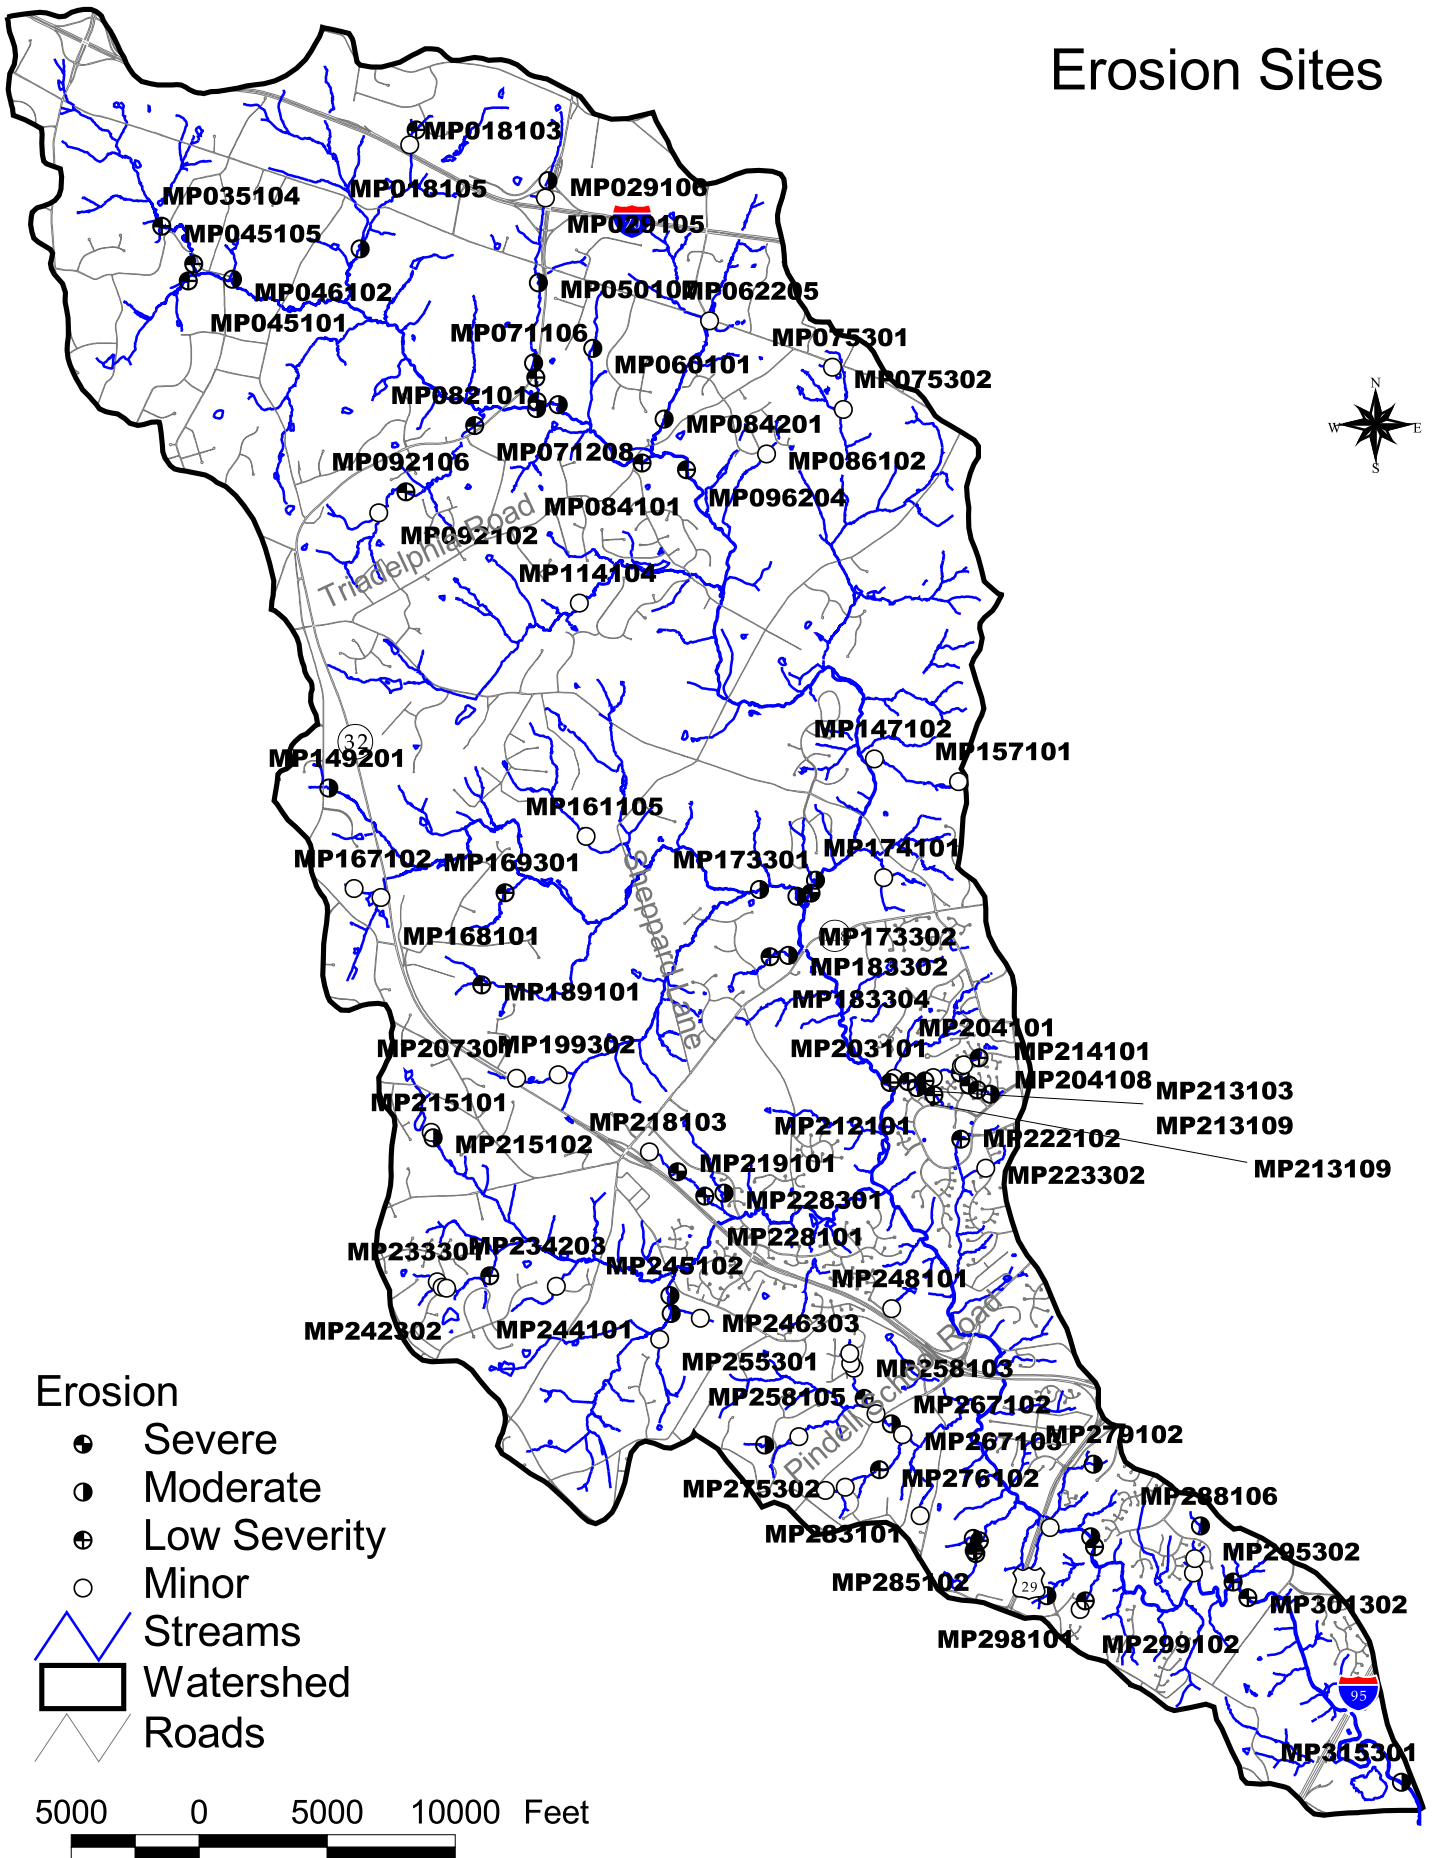
Figure 4a

Unstable eroding streams are areas where the stream banks are almost vertical and the roots from the vegetation along the stream's banks are unable to hold the soil on the banks. Unstable eroding stream banks were reported at 106 sites during the survey (Figure 4a). The majority of the erosion sites showed moderate to minor erosion that extended over long distances. The lengths of stream segments that were recorded as having unstable banks varied from 5 feet in some areas, to other areas where up to 1500 feet of stream was found to have an erosion problem (Appendix B). Overall, results indicate approximately 5.35 miles of unstable eroding banks in the Middle Patuxent watershed. Figure 4b shows the frequency of the severity rating given to erosion sites. Most sites were given a moderate to minor rating. Only three sites (MP173102, MP213101 & MP219101) received a severe rating.

While erosion problems were found throughout the Middle Patuxent River watershed, the Harpers Choice Tributary had a number of severe and moderate rated erosion problems clustered together in a small area. It appears that this area is going through a significant channel readjustment possible caused by residential and commercial development in the upper part of the watershed. Follow up evaluations to determine if this area would be a suitable site for a stream restoration effort should be considered.

The survey also found many erosion sites at or directly downstream of inadequate buffer sites. In some cases, riparian buffer plantings could help reduce erosion over time at some of these sites. In areas where streams are going through major readjustments, however, tree planting alone will usually not solve the problem.

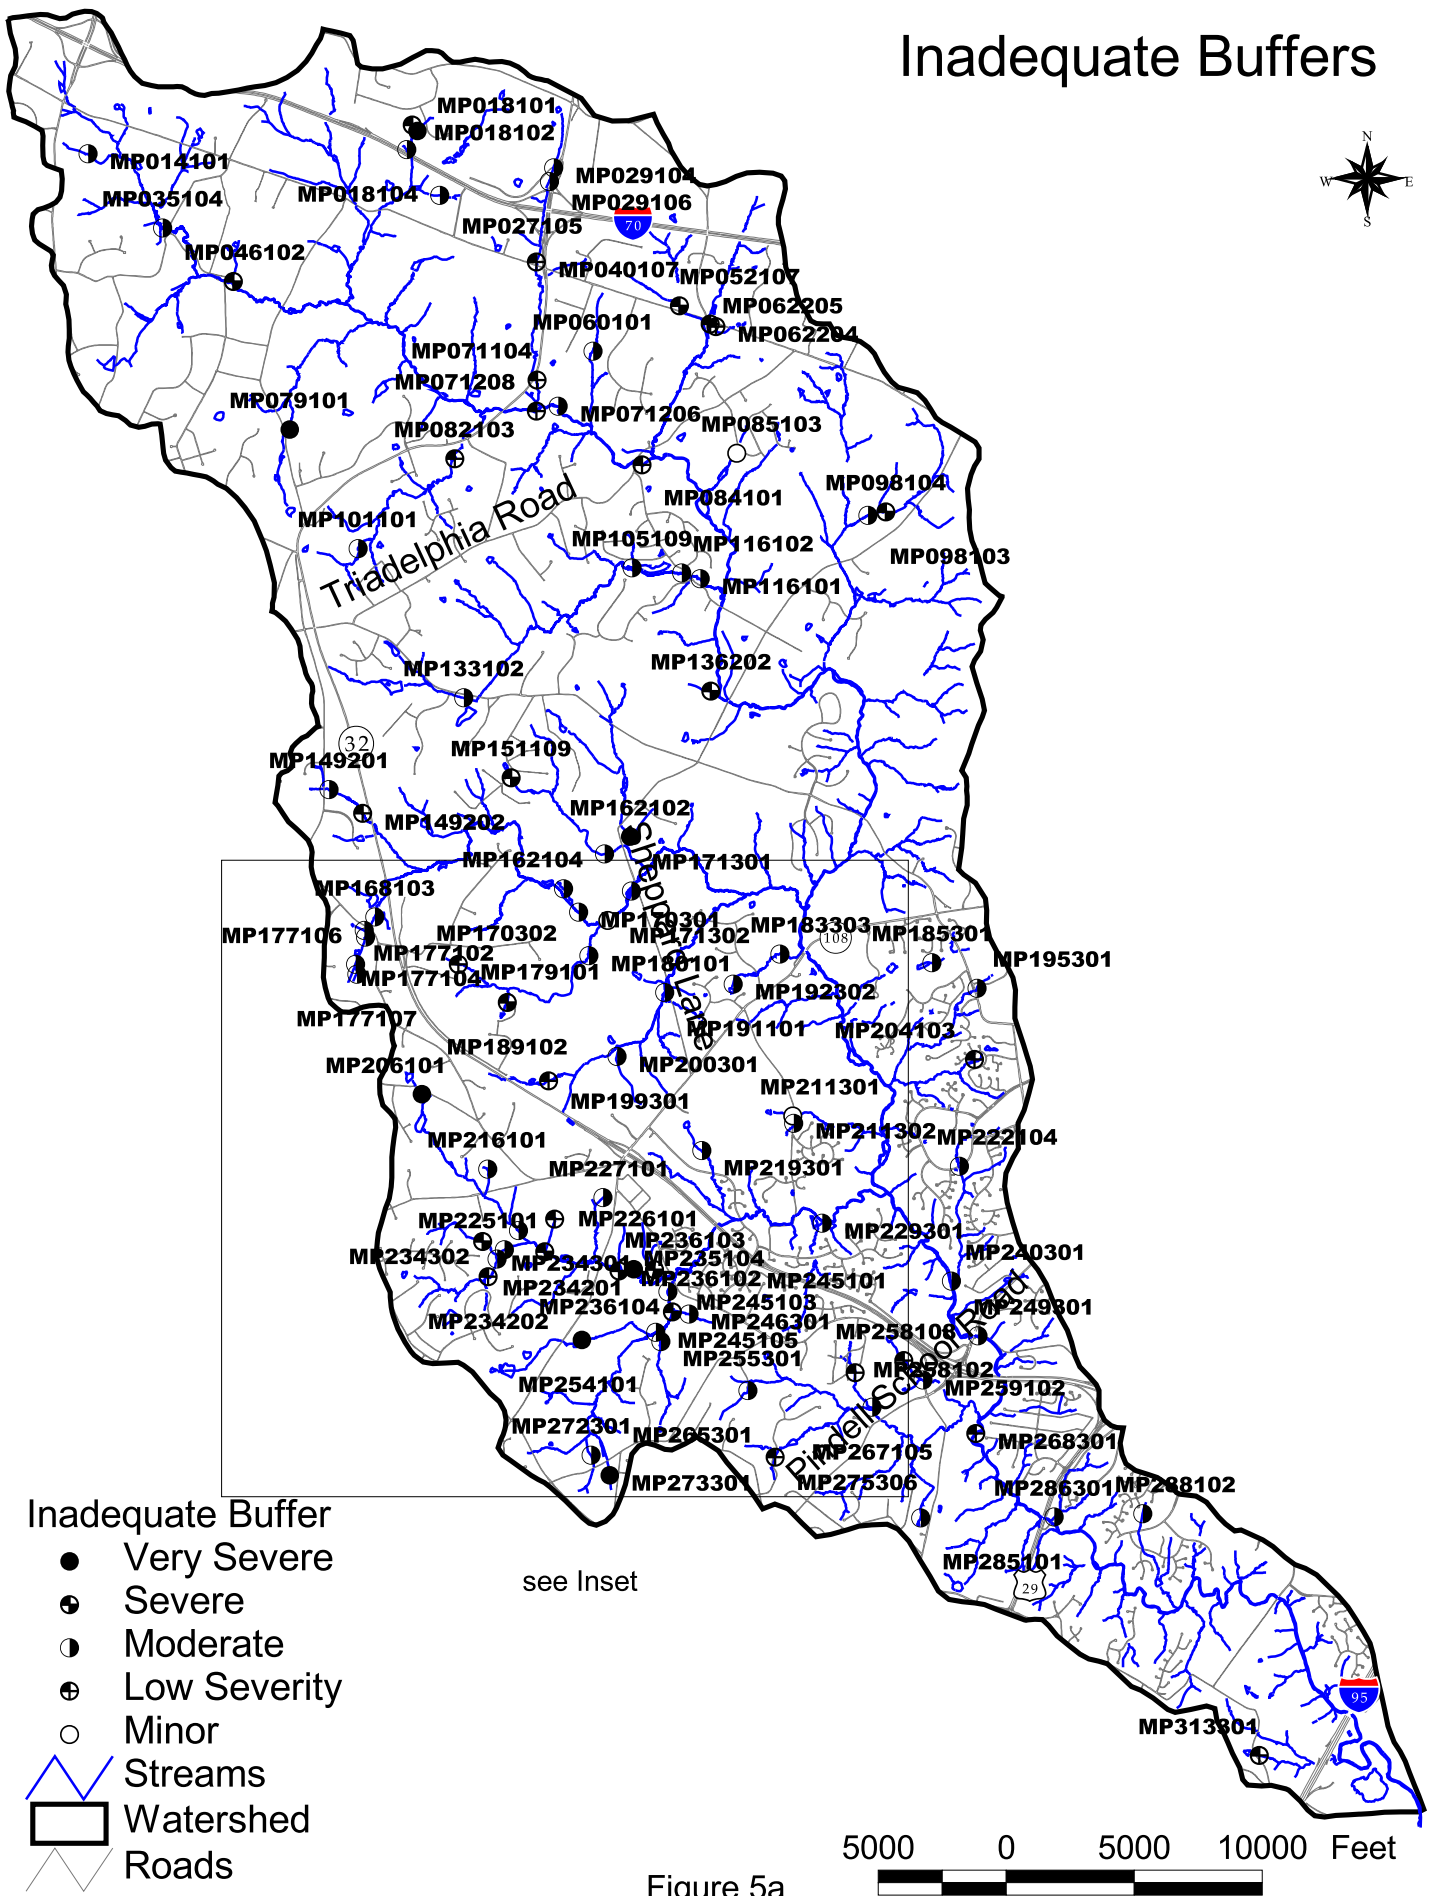
Inadequate Buffers

While there is no single minimum standard for how wide a stream buffer should be in Maryland, for the purposes of this study a buffer is generally considered inadequate if it is less than 50 feet wide, measured from the edge of the stream. Inadequate buffers were reported at 93 sites during the survey and the locations are shown in Figure 5a. The field crew provided a rough estimate of the length of the inadequate stream buffer at all sites and the data is presented in Appendix B. Based on the data that was collected, there are approximately 47,410 feet (8.97 miles) of inadequate buffer in the Middle Patuxent watershed. Field teams found inadequate buffers ranging in distance from 40 feet to 4,400 feet. This survey was done in a urbanized area, with mowed lawn reported as the dominant adjacent land use at inadequate buffer sites, accompanied by a moderate amount of agricultural land (pasture). While a large number of inadequate buffer sites were identified, most sites received a moderate or low severity rating (Figure 5b). This would indicate that most of the stream reaches with inadequate buffers were not very long or some trees were already present at many of the sites.

Survey results indicate that there are several possible locations where forested buffers could be reestablished. Five out of the seven very severe sites were in pastures. In Maryland there are incentive programs aimed at recreating stream buffers on land that is presently in agricultural use. Landowners should be contacted to determine if they had an interest in participating any of these programs. In some locations, including Site MP288102, paths come close to the stream and there may be opportunities to plant trees on either side of the path and the stream to allow for larger buffers in these areas.

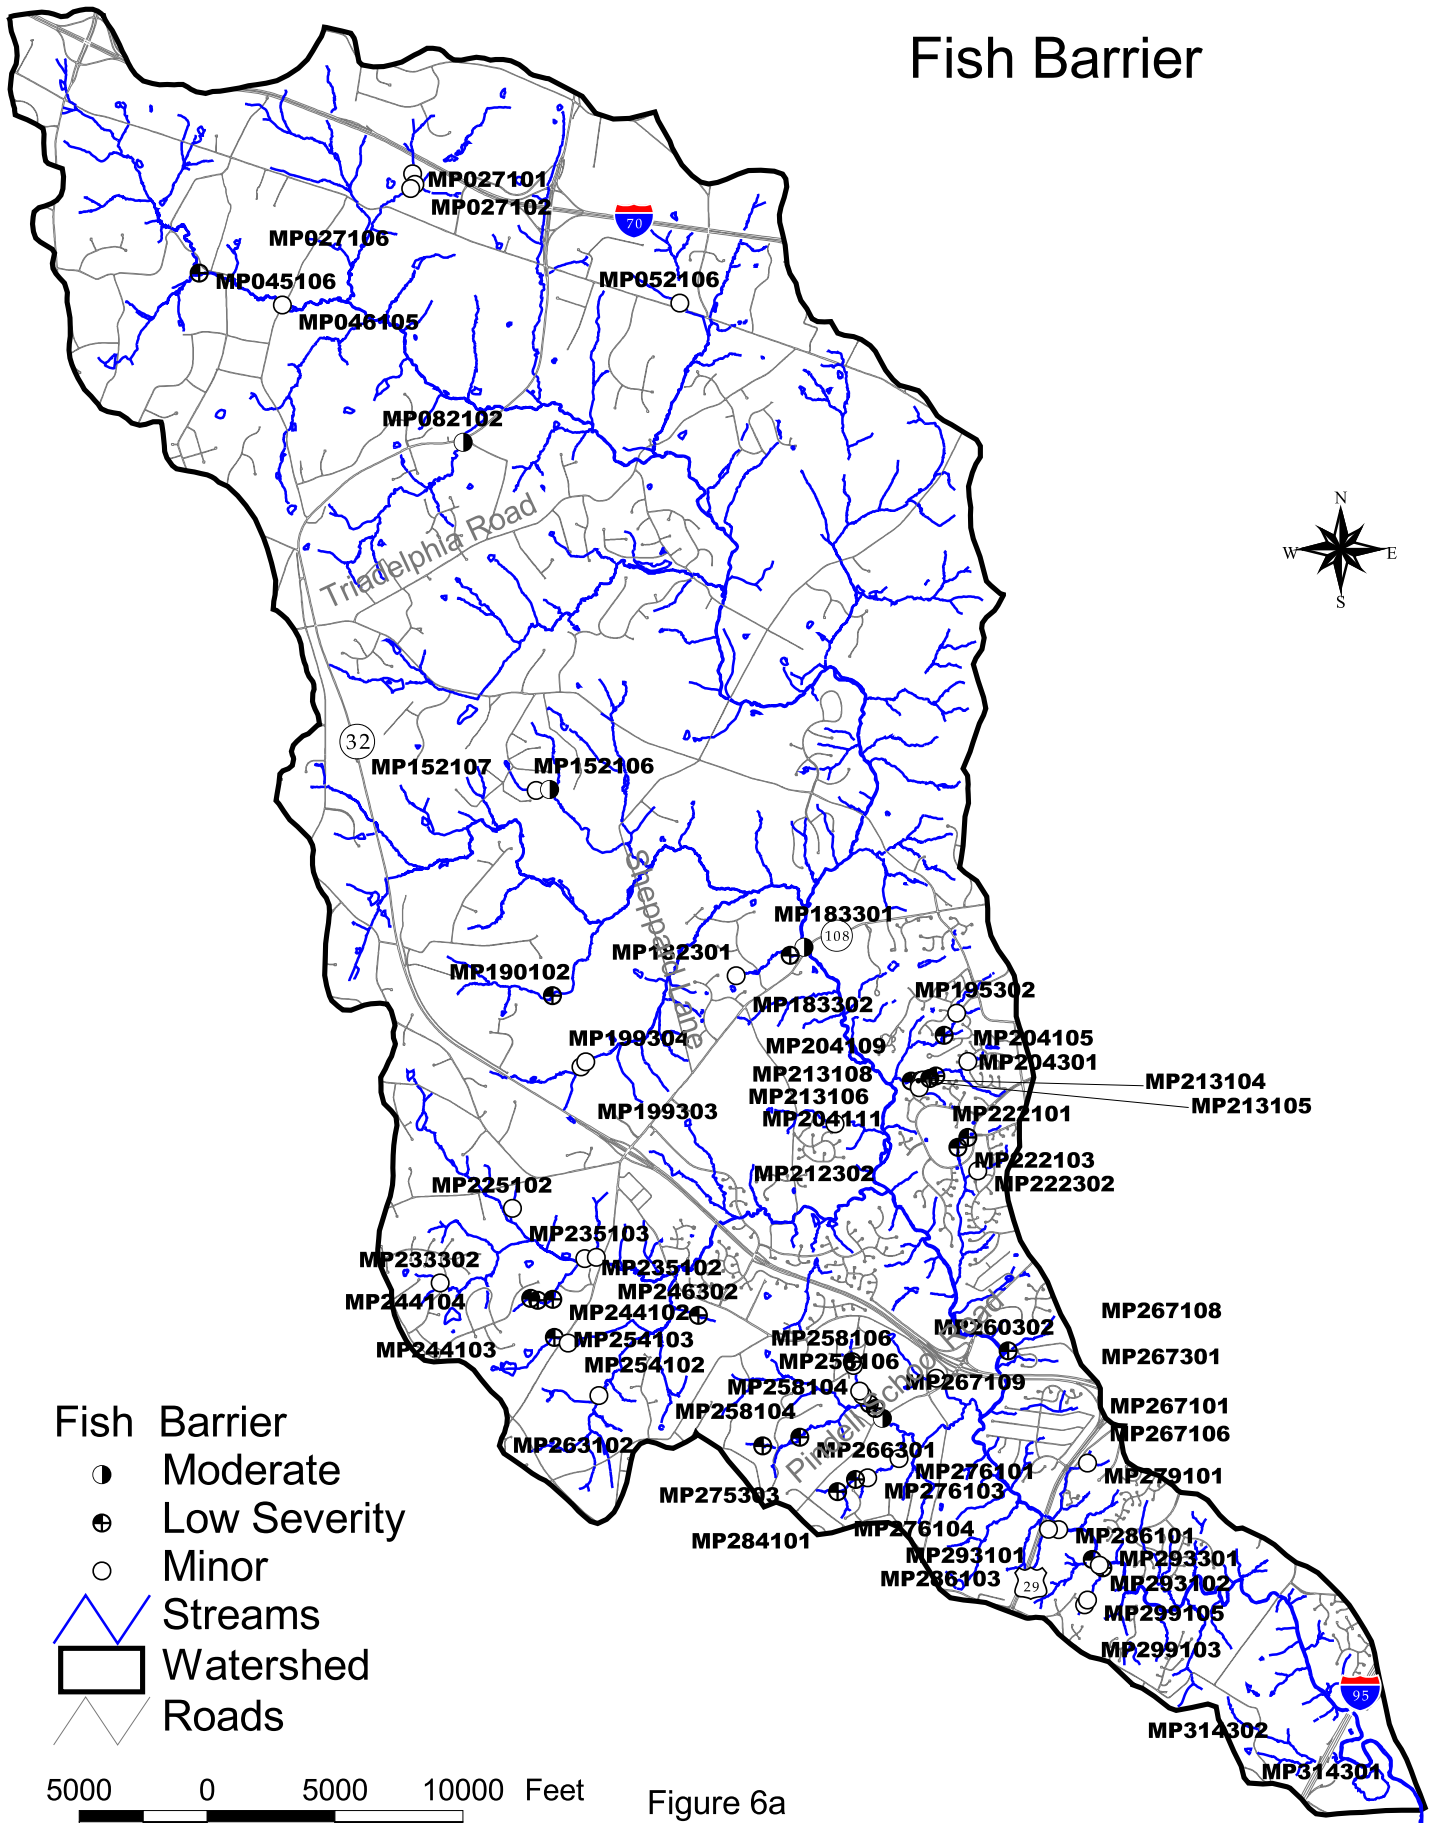
Fish Barrier

Sixty-four fish migration barriers were reported during the survey. The locations of fish migration blockages are shown in Figure 6a. The blockages were due to a number of reasons including beaver dams (5), dams (3), road crossings (7), channelized stream sections (3), natural falls (24), and debris dams (22). All of the sites were given moderate to minor severity ratings (Figure 6b). Overall, the mainstem of the Middle Patuxent River is relatively barrier free. The only barriers are MP046105 and MP2933901. Both are beaver dams and considered temporary blockages.

Any strategy to remove fish migration barriers in the Middle Patuxent River should first attempt to keep the mainstem of the river as barrier free as possible. In addition, barriers that isolate large sections of tributaries from the mainstem, such as Site MP082102, which is at a road crossing for Route 32, and barriers that isolate significant portions of the upper portion of a tributary, such as Site MP267101, a road crossing, a small dam at MP152106 should also be targeted.

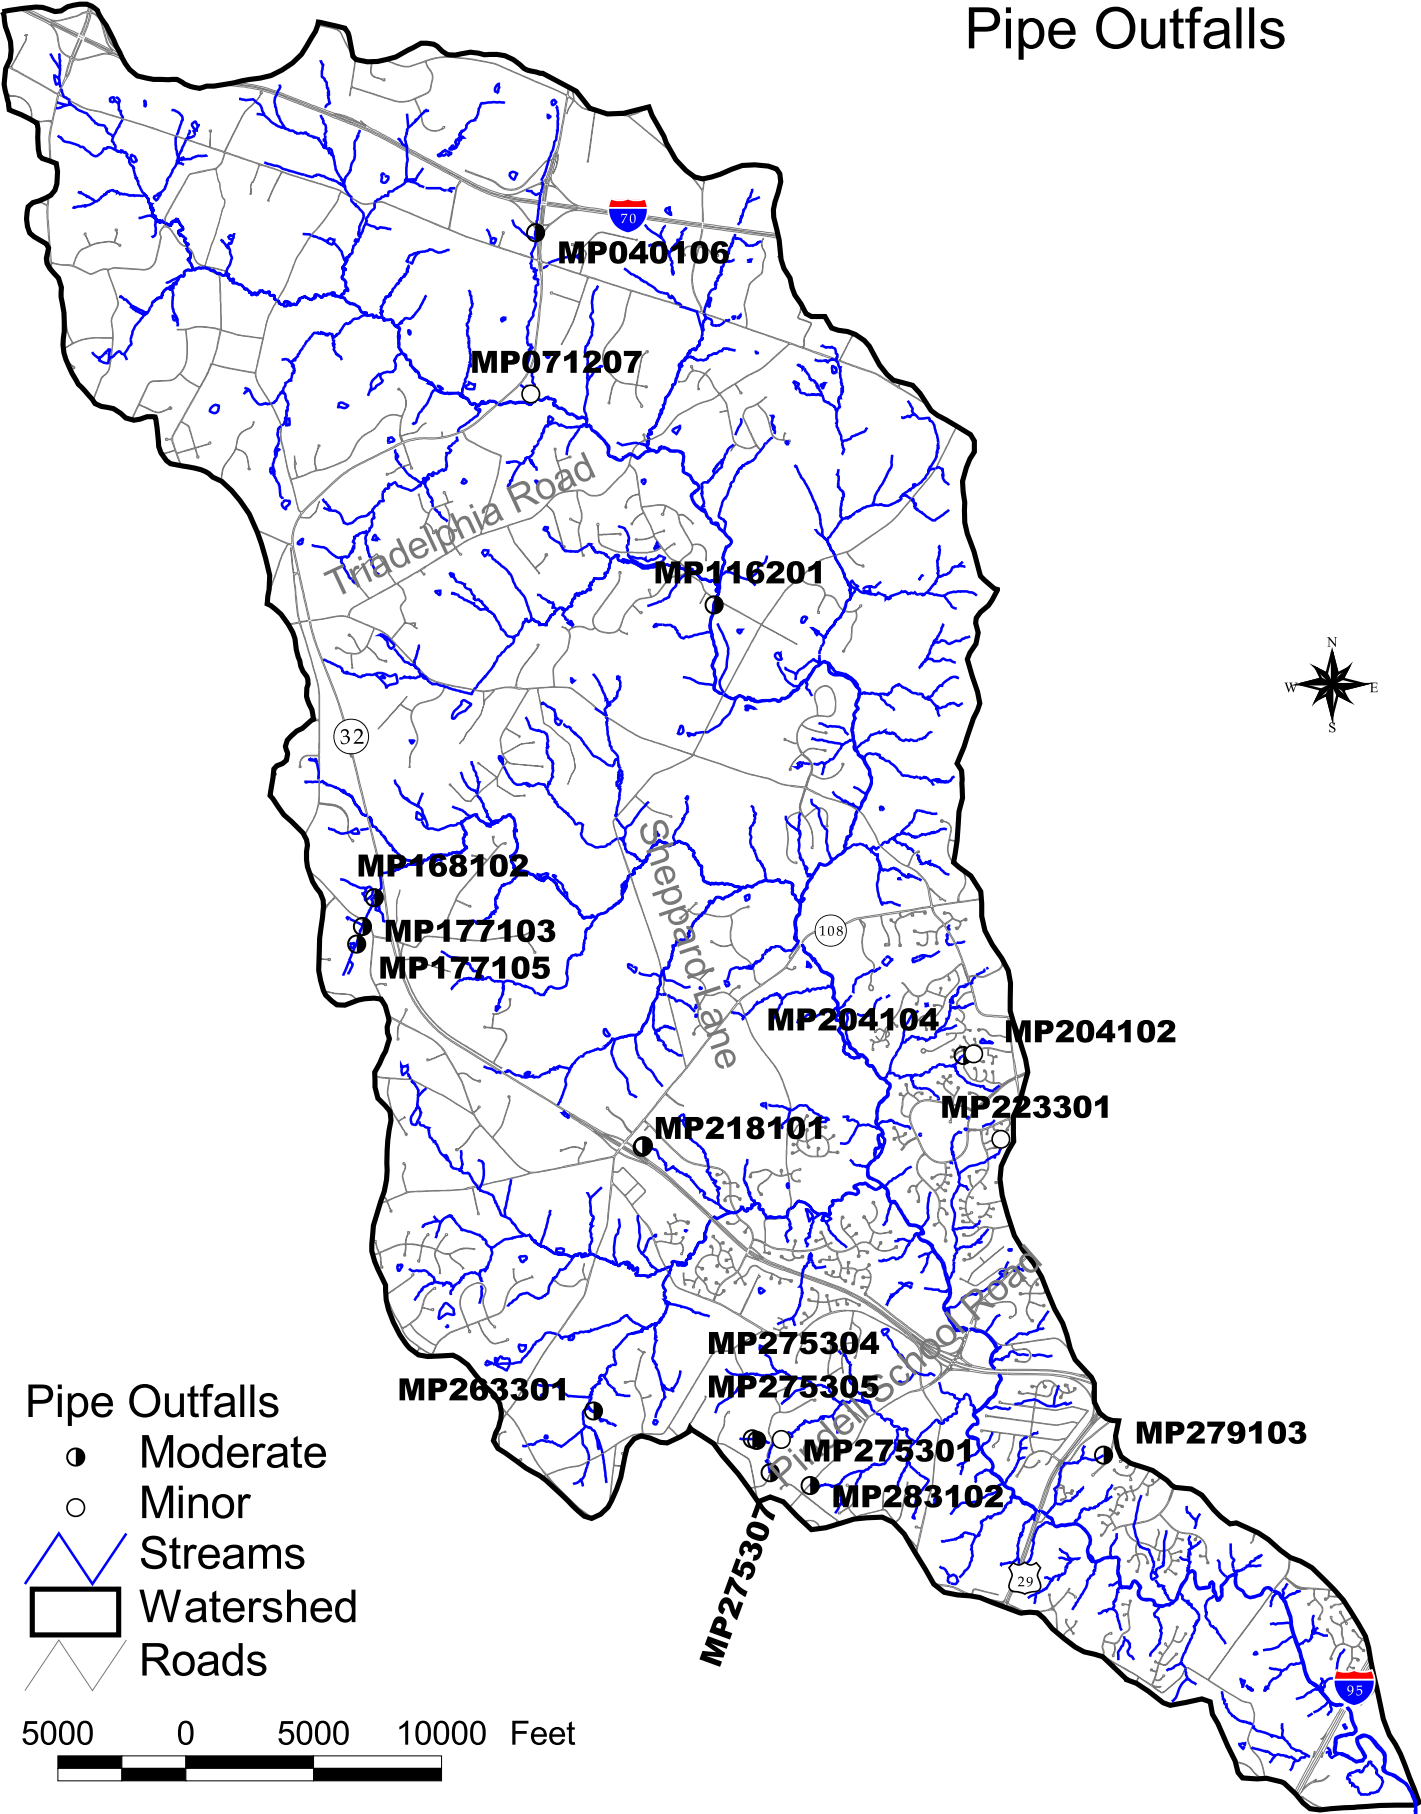
Figure 7a

Pipe outfalls include any pipes or small man made channels that discharge into the stream through the stream corridor. Pipe outfalls are considered a potential environmental problem in the survey because they can carry uncontrolled runoff and pollutants such as oil, heavy metals, toxics and nutrients to a stream system. A total of 18 pipe outfalls were identified during the survey (Figure 7a). The locations of pipe outfalls are shown in Figure 7a. As expected, most of the pipe outfalls are located in the more urbanized portion of the watershed.

Seventy-eight percent or 14 of the 18 outfall pipes observed during the survey were found to have some type of discharge coming out of them. Of these, only one was reported to have a discharge that had some coloration or smell associated with it (Appendix B). No immediate follow up actions were taken as part of this study to determine the source of the color or smell coming from the pipe. In some cases, coloration or smell from a storm drainpipe may be a sporadic occurrence. This is especially true in areas where there is no stormwater management system present. The remaining discharges were recorded as clear with no odor. There weren't any estimates of the amount of fluid coming from the pipes.

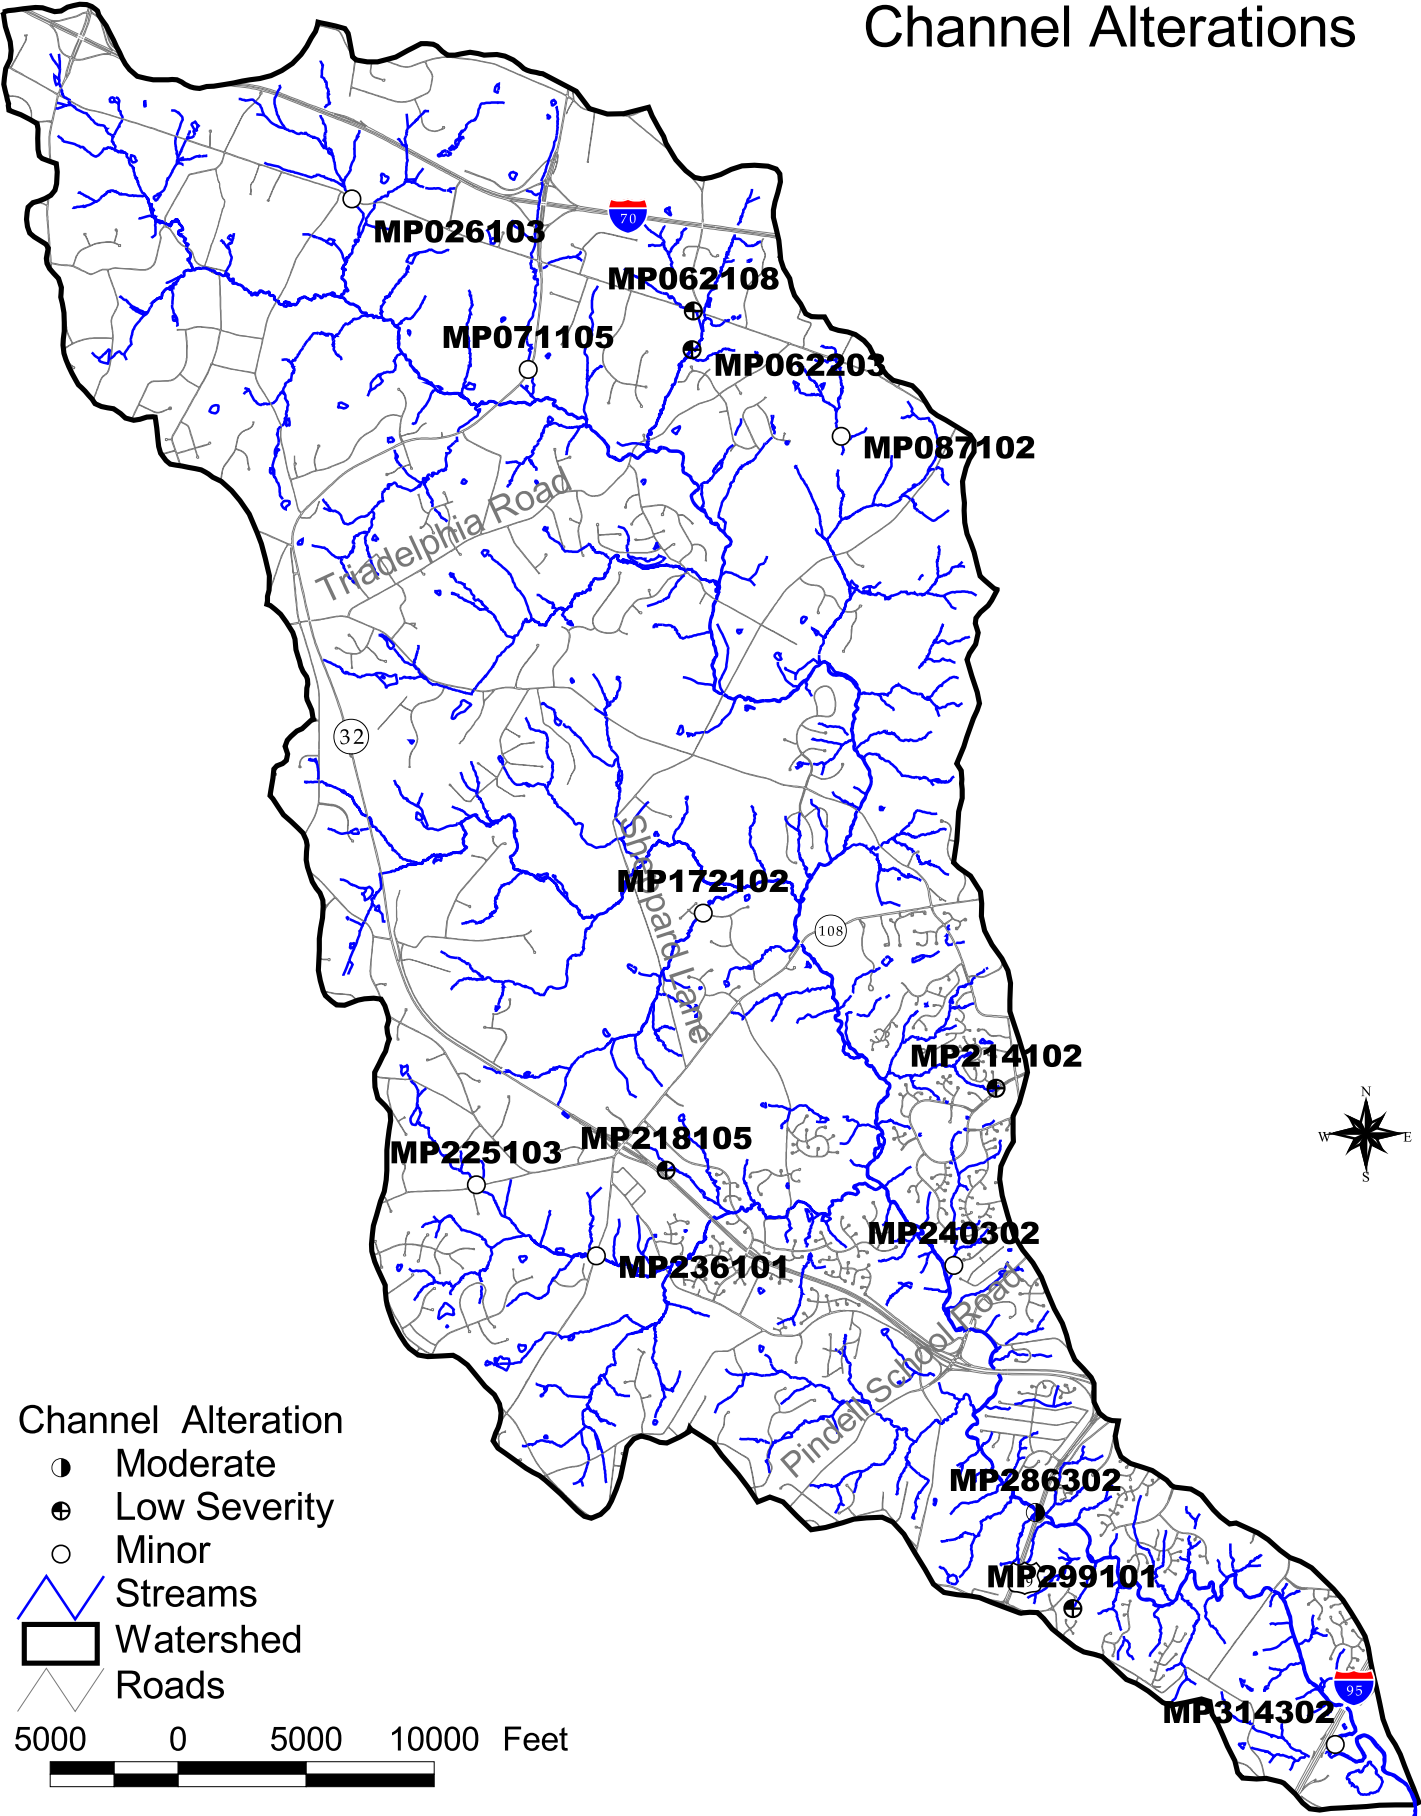
Figure 8a

Results of this survey indicate that the stream has been recognizably altered in 14 areas and their locations are shown in Figure 8a. The total length of stream affected by channelization was estimated to be 2,345 feet or about 0.44 miles. There were no major system wide channelizations reported in the survey. The sites where some channel alteration was reported were given moderate to minor severity ratings (Figure 8b). Most of the sites identified were also on small channels. Six sites were channelized using concrete, one was an earthen channel, one was armored with rip-rap, and four channels were lined with gabion baskets. The correctability rating given for most of these sites were high because of the difficulty and expense of removing the structures.

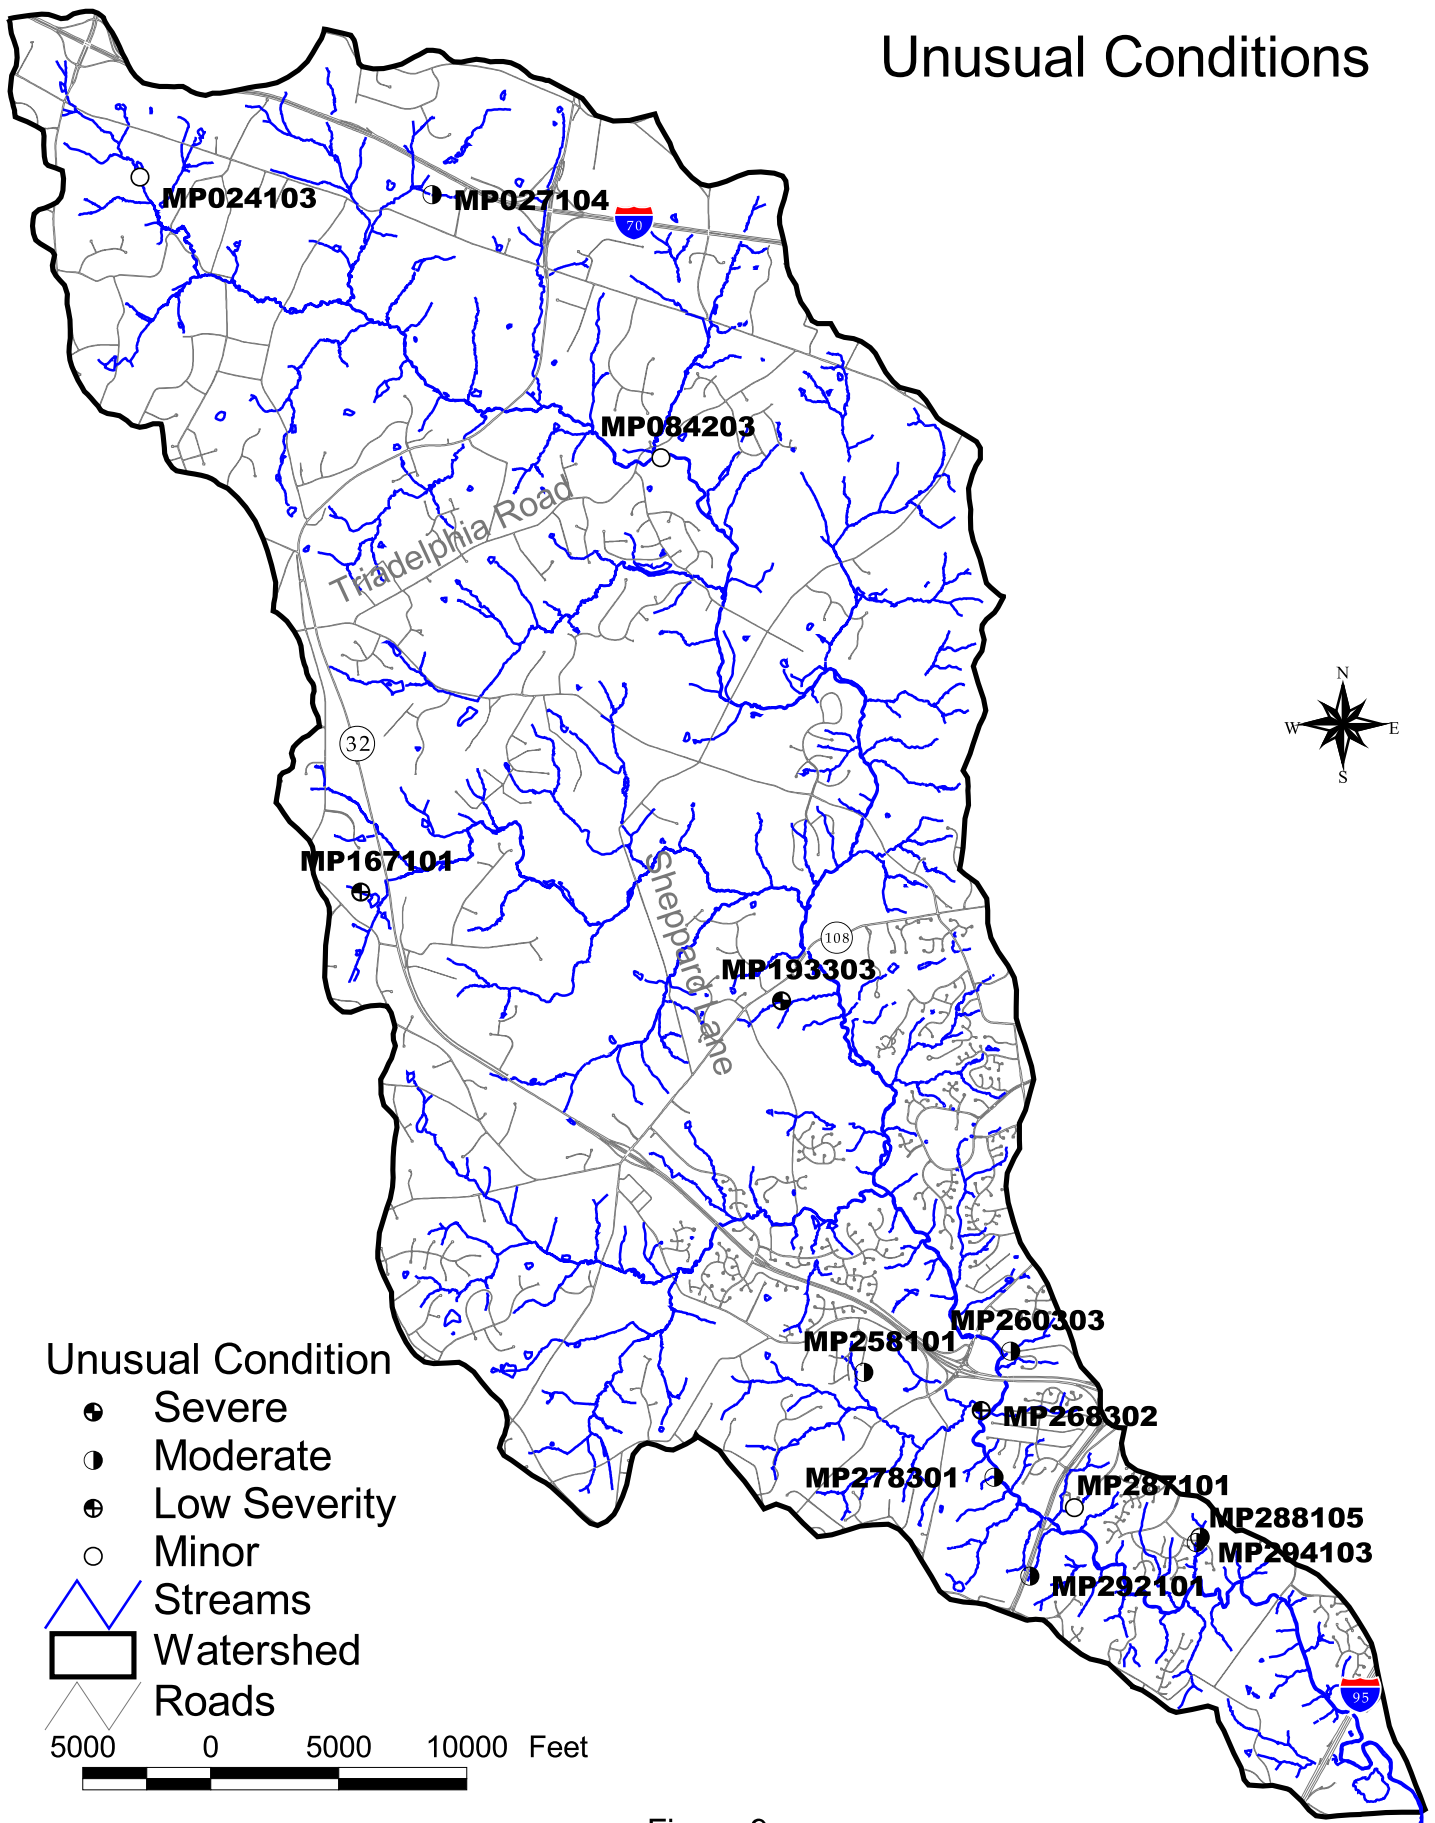
Figure 9a

The unusual condition/comment data sheets are used by survey teams to record the location of anything out of the ordinary seen during the survey or to provide some additional written comments on a specific problem. Fourteen unusual condition sites were found during the Middle Patuxent survey (Figure 9a). Four were places where a small stream had been piped underground for a short distance. The other frequently reported item was the presence of red flock. Red flock in this area is an indication of mobilized iron in the ground water. These sites were given lower severity ratings (Figure 9b).

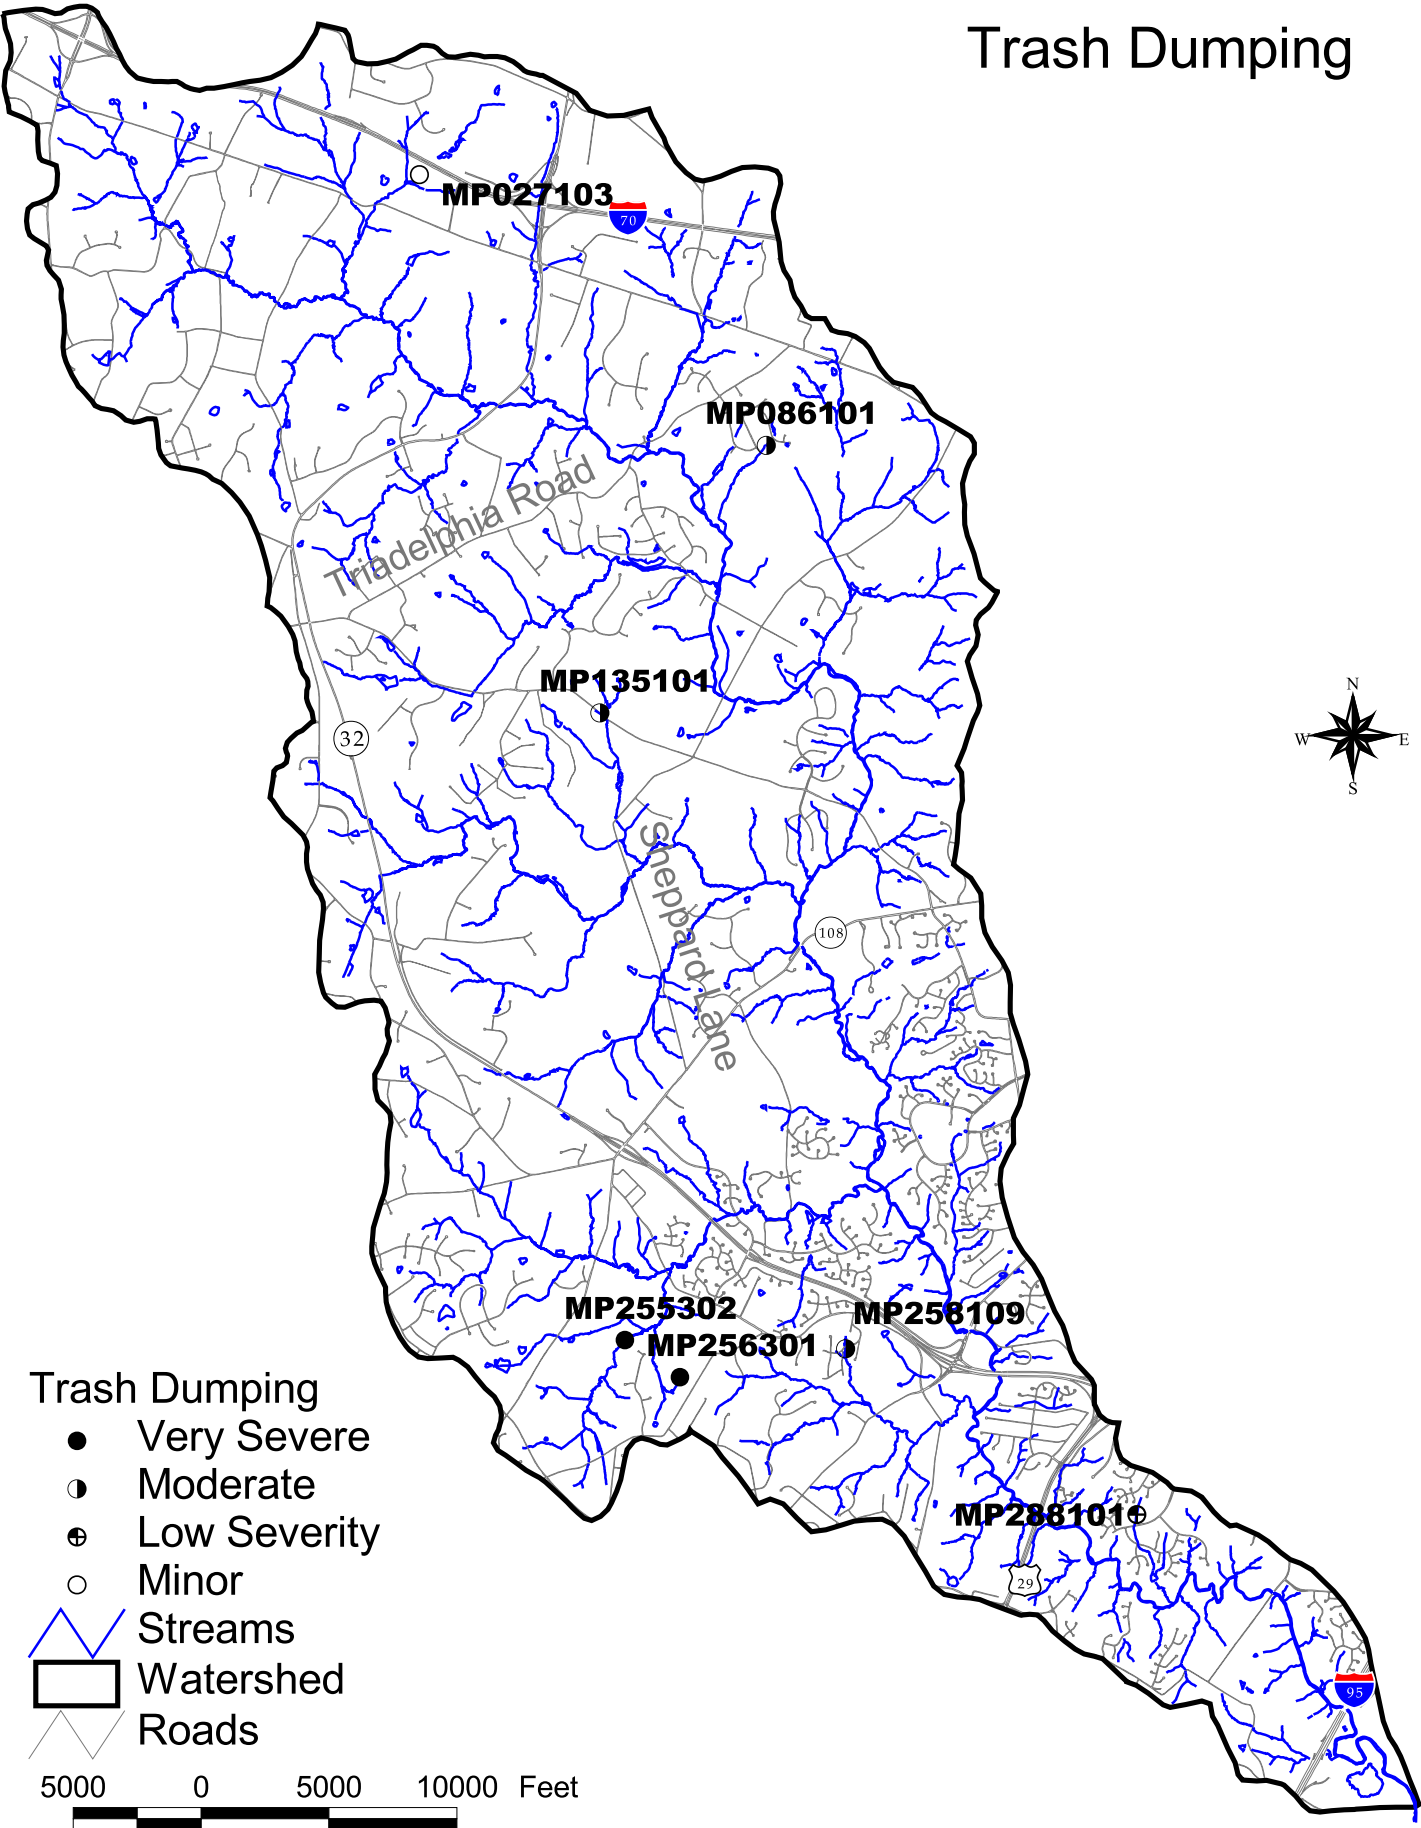
Trash Dumping

The trash dumping data sheets are used to record the location of places where large amounts of trash has been dumped inside the stream corridor or to note places where trash tends to accumulate. The field survey crew found seven sites where there was excessive trash and their locations are shown in Figure 10a. Two sites, MP255302 and MP256301, were reported as very severe and both these sites were junkyards. Estimated truckloads to remove all the trash were not recorded for these sites. Two sites were recorded as having yard waste, one had residential waste and one was recorded as a large pipe. These sites were given severity ratings ranging from moderate to minor (Figure 10b).
