Middle Patuxent River Stream Corridor Assessment Survey

Watershed Restoration Division
Chesapeake & Coastal Watershed Services
Maryland Department of Natural Resources
October 2002

MIDDLE PATUXENT RIVER STREAM CORRIDOR ASSESSMENT SURVEY

October 2002

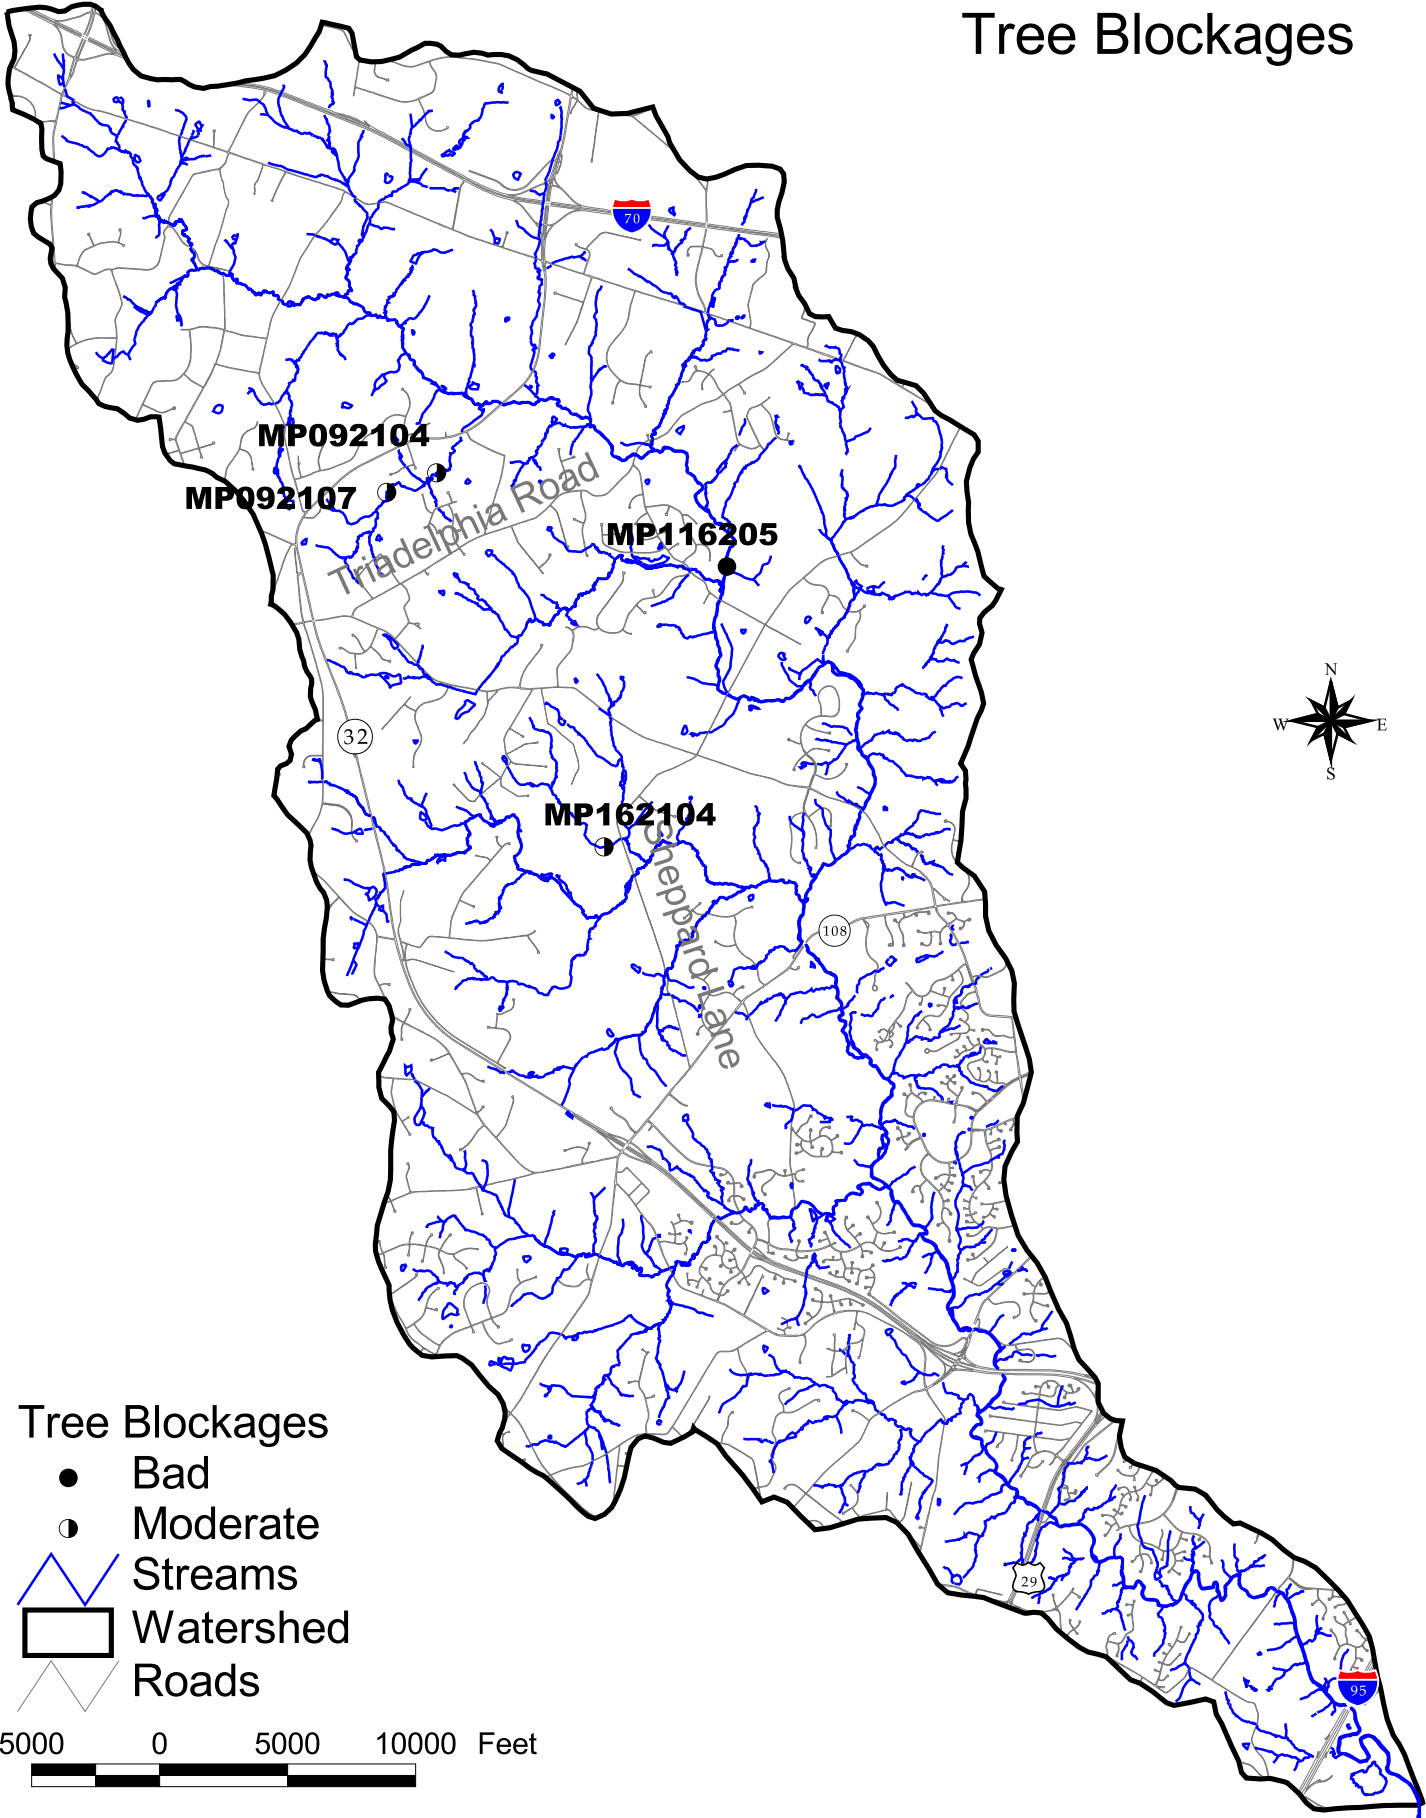
Figure 11

The survey crew recorded four tree blockage sites. The locations of tree blockages are shown in Figure 11. Severity was recorded as “bad” at 1 site, and “moderate” at 3 sites. This severity rating is based to the size of the blockage and the amount of debris present at a site. The tree blockage sites were all located in the upper portion of the watershed.

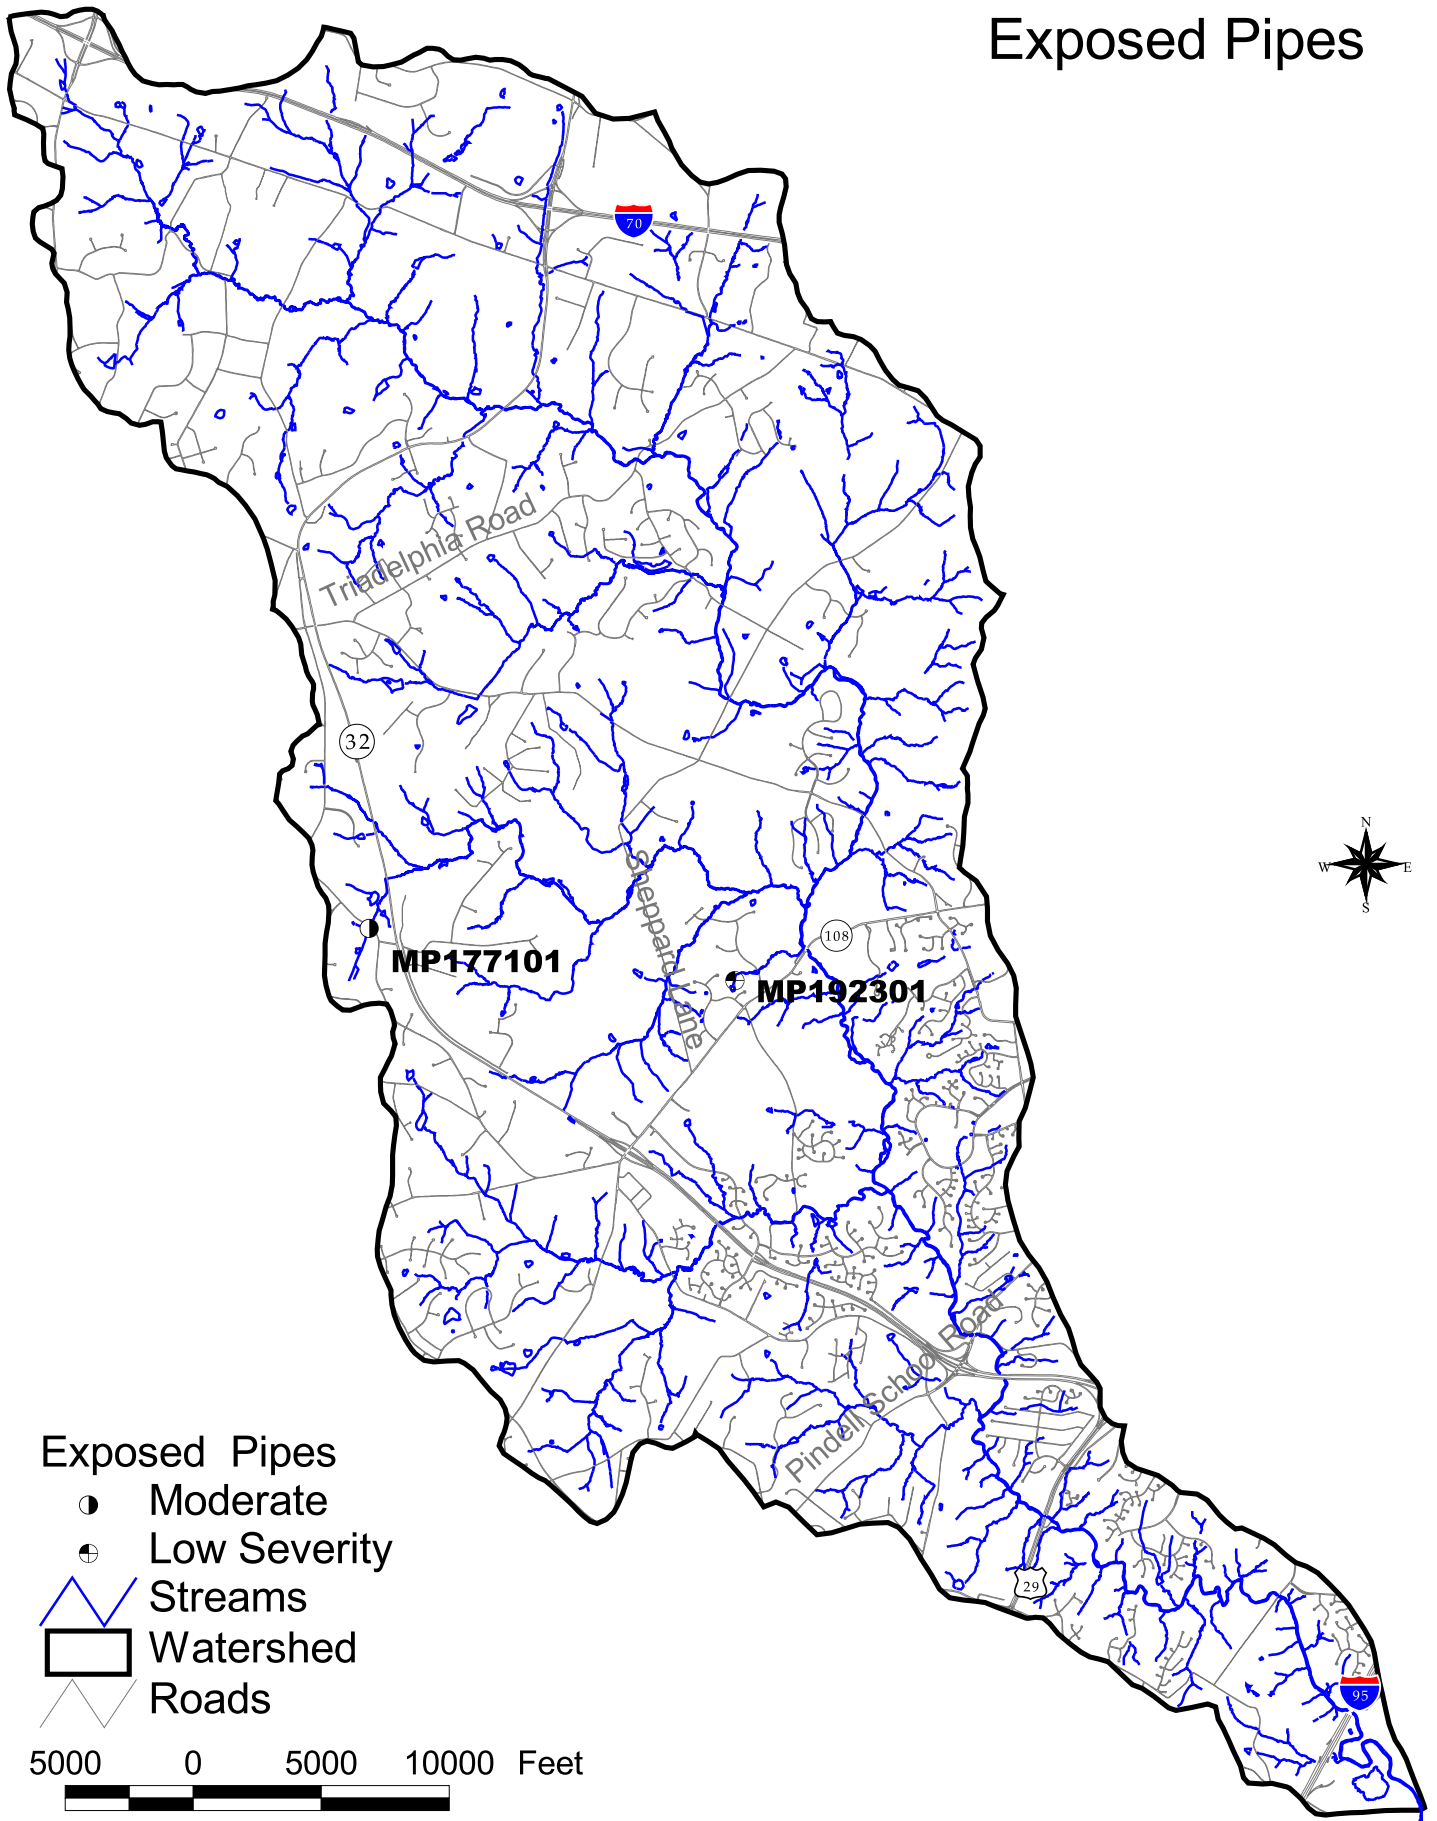
Figure 12

Exposed pipes were reported at two sites during the survey. Locations of these sites are shown in Figure 12. At Site MP177101, a white plastic pipe crossed the bottom of the stream and at Site MP 192301, a smooth metal pipe was seen along the stream's bank. Crews did not observe any discharge coming from the pipe at the time of the survey and the sites were given a moderate and low severity rating, respectively. Both exposed pipe photos should be reviewed by public works officials and follow-up visits done based on their evaluations.

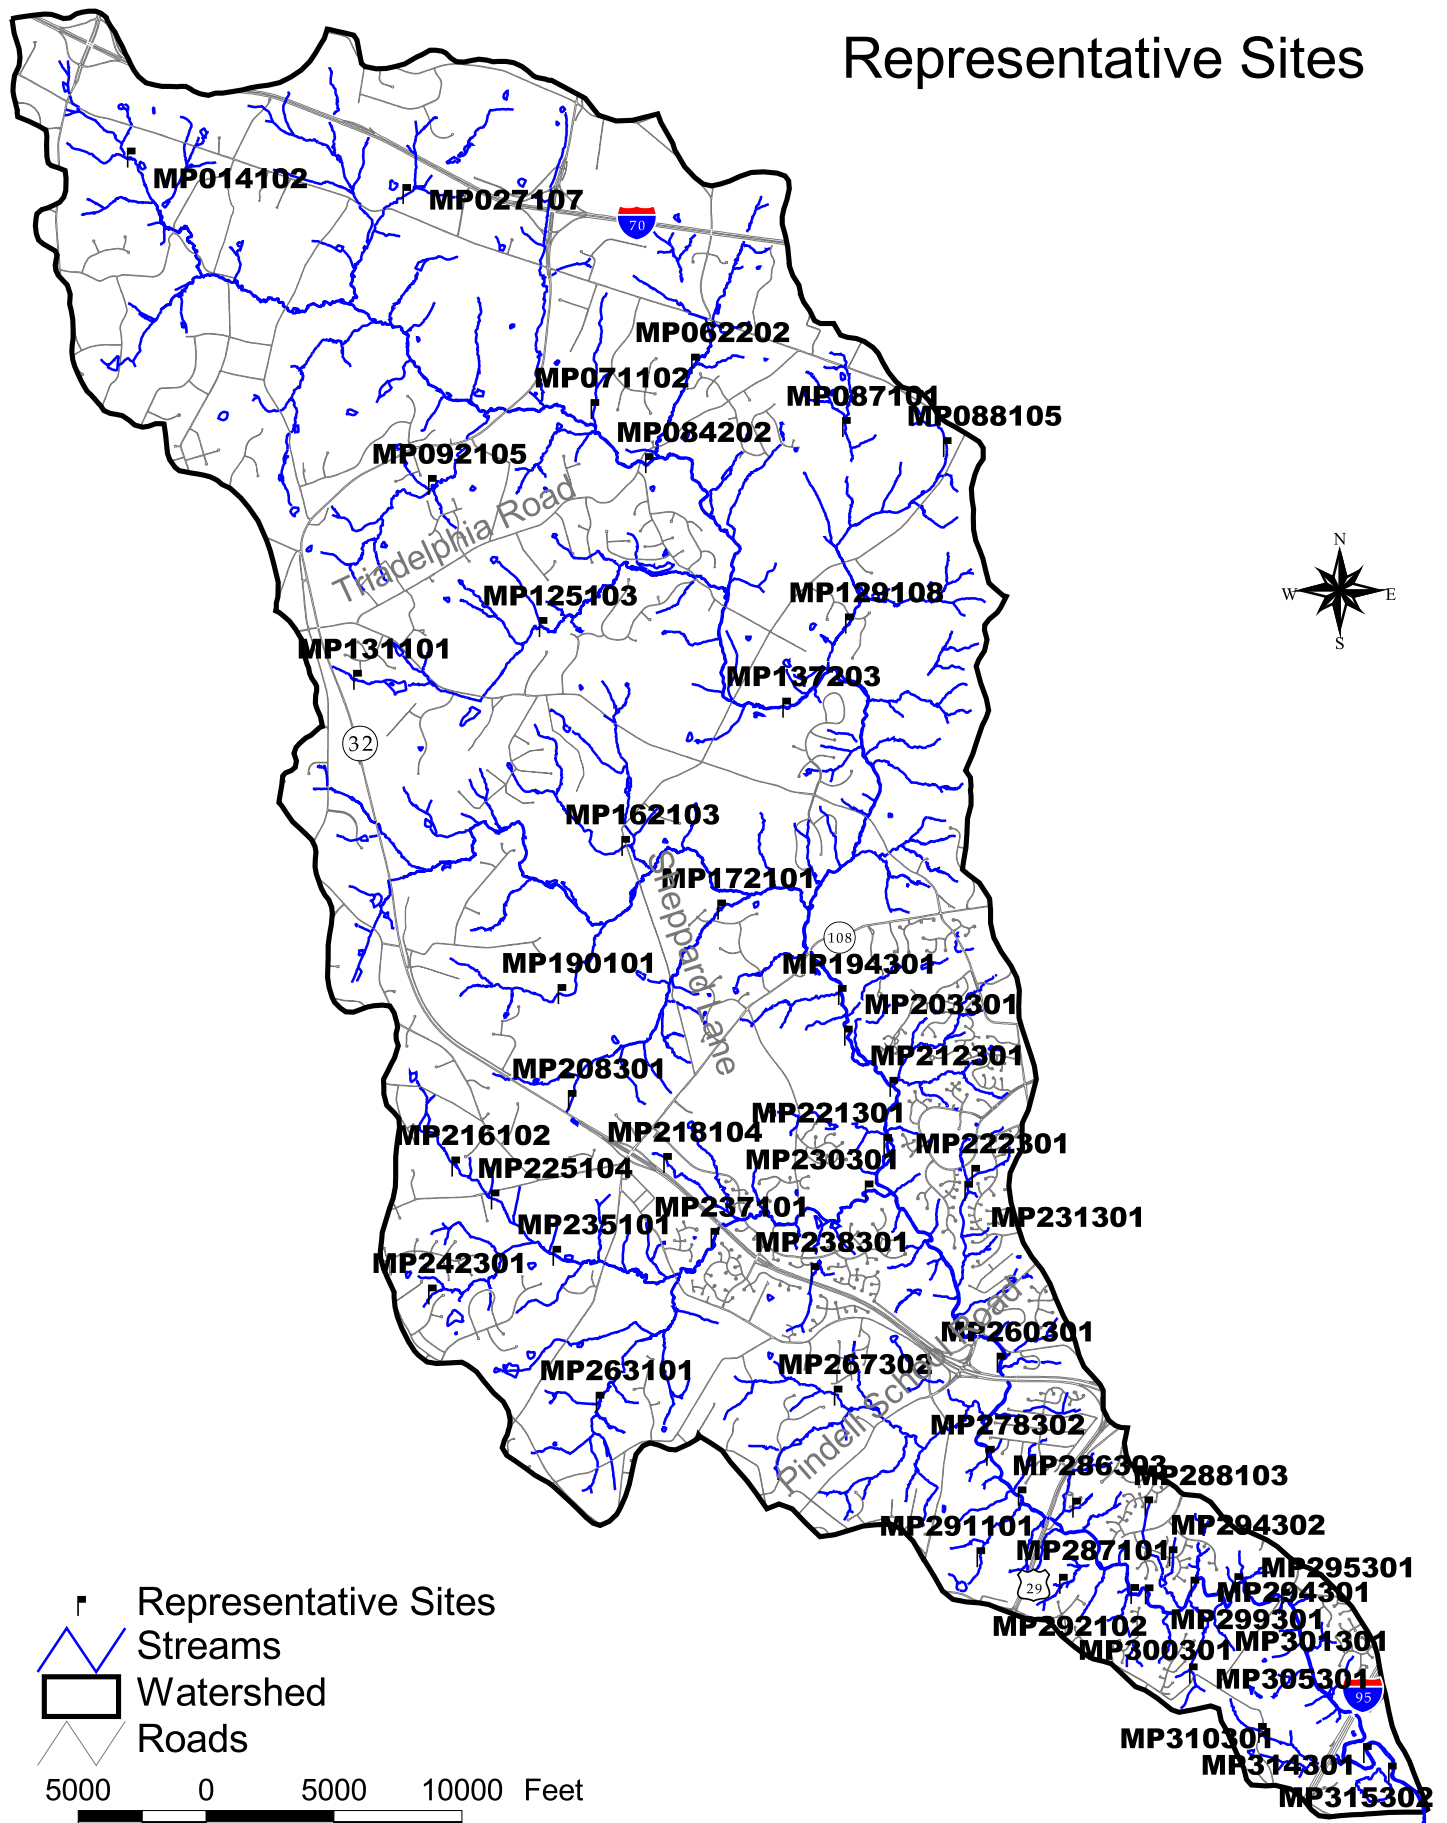
Figure 13

Results indicate that the main stem of the Middle Patuxent River is in fairly good condition, with average ratings of optimal and suboptimal in all categories except for embeddedness. Many stream segments had a bottom substrate that consisted of gravel or cobble.

Harpers Ridge tributary is in an urban section of the watershed, it was the only tributary to receive a rating of suboptimal for channel alteration, while the other tributaries were all optimal. Rover Mill and South Sykesville are both mostly agricultural lands and it is not surprising that they both received marginal ratings for riparian vegetation. Embeddedness and sediment deposition were rated as marginal in nearly all of the tributaries.

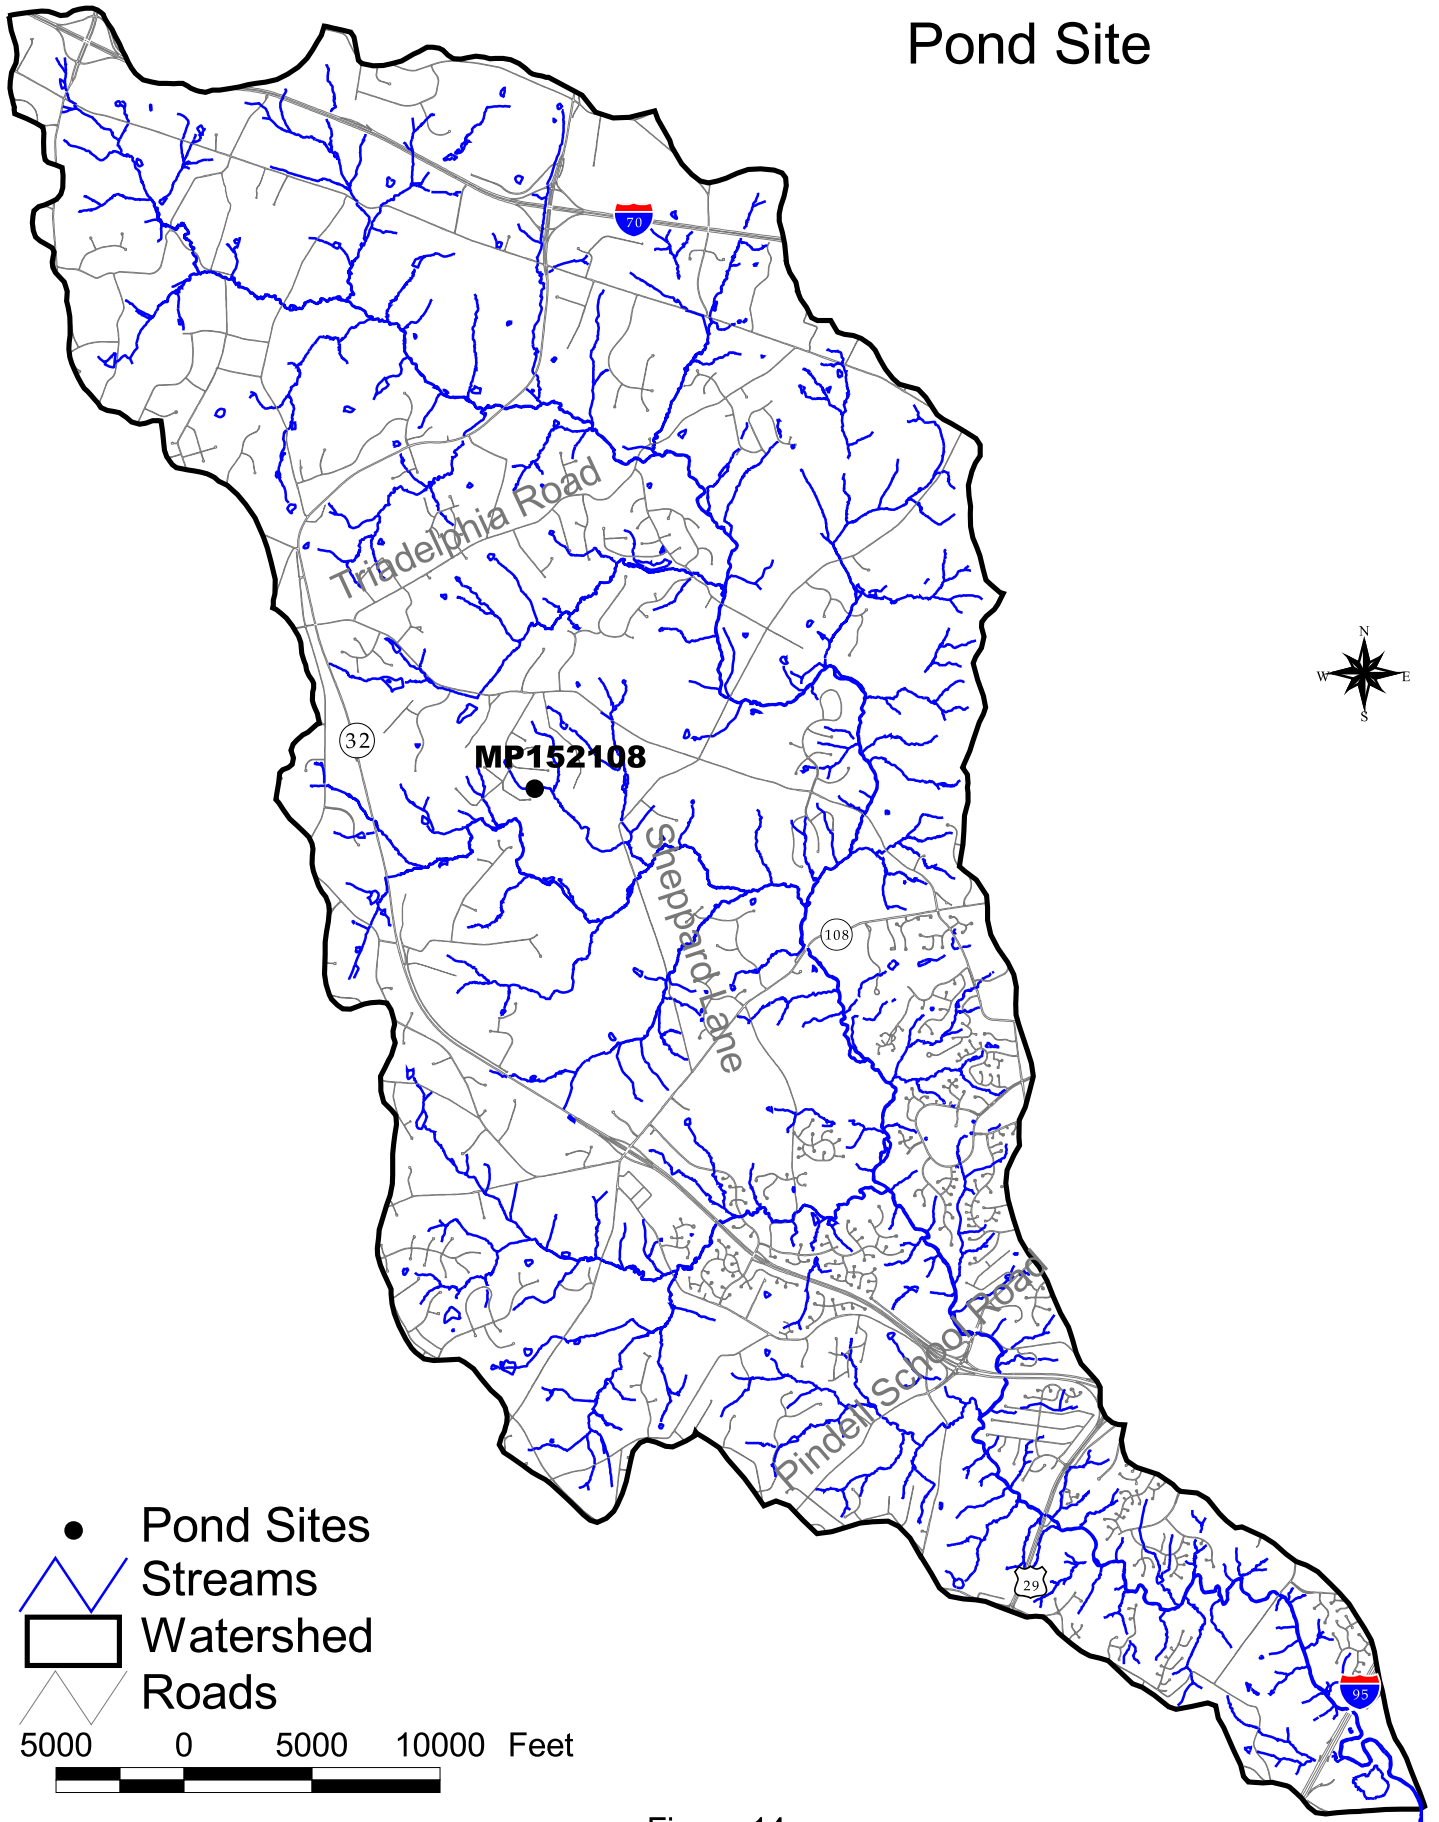
Figure 14

One pond site was recorded during this survey, and its location is shown in Figure 14. It was found to be maintained and without trees or animal burrows on the embankment.
