Assessing the Rockburn Branch Subwatershed of the Lower Patapsco River for Restoration Opportunities

Prepared for:
Howard County, Maryland
Department of Public Works
Bureau of Environmental Services
NPDES Watershed Management Program

Prepared by:
JoAnna Lessard and Sam Stribling, Tt

January 23, 2006
Final Draft

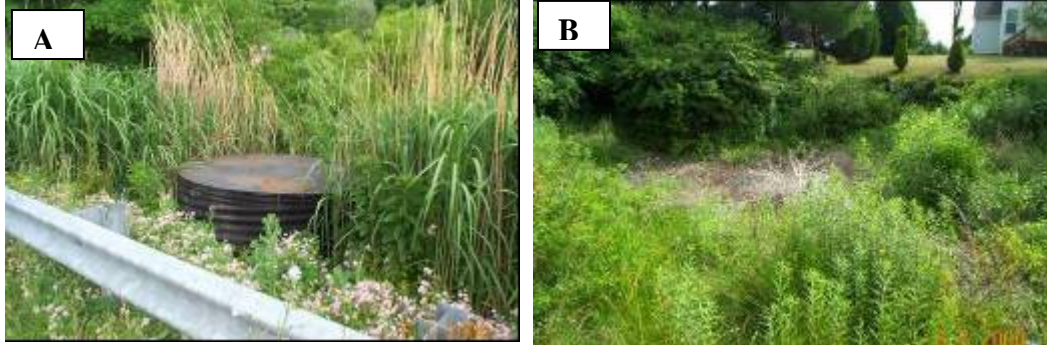
Description: Currently this residential area off Kerger Rd. is bordered by a stormwater wetland and an adjacent dry pond. These two areas do not appear to be hydrologically connected currently.

A) Barrel in front of pond and B) Dry pond next to stormwater wetland

***Recommendation:** This priority project is an opportunity to retrofit the dry pond and incorporate this area into the existing stormwater wetland facility. Invasive vegetation removal and native plantings along with outreach should be included. This type of program may be well received by the public as there was concern expressed by some residents over trash being dumped in the area of the dry pond and that something would happen to the wetland, while field workers were observing these facilities.

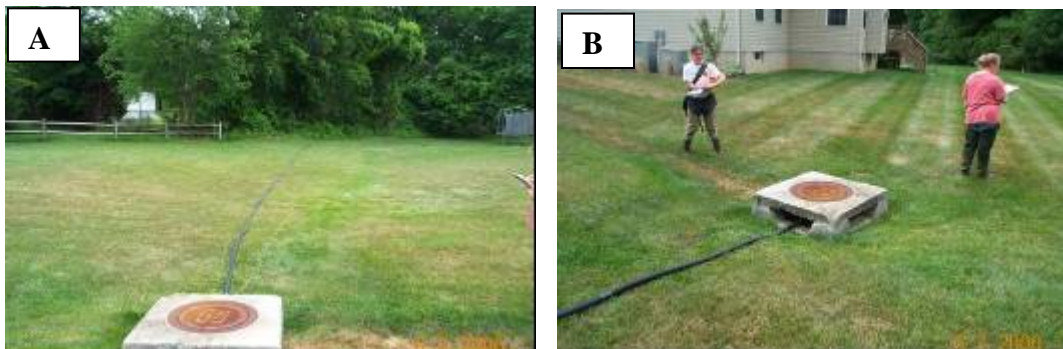
Description: Storm drain inlet near residential area has a small pipe discharging to the inlet that appears to be connected to a pump.

A) Stormdrain front view B) Stormdrain side view

Recommendation: Address stormdrain connection and retrofit stormdrain into a bioretention facility capable of providing water quality treatment. Maintain the existing structure for overflow control. This project would require coordination between the county and property owners.

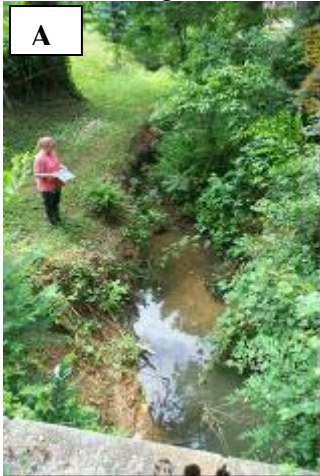
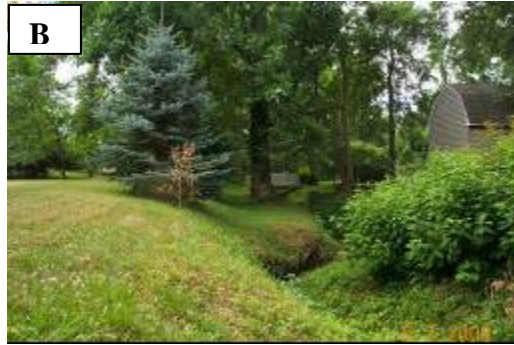
Description: The stream bank is eroding due to lack of riparian vegetation to slow runoff and hold soils together.

A) Top view of bank B) Side view of bank

Recommendation: An outreach/education program should be done to try to maintain a no-mow margin along both banks. There is also potential to replant existing turf grass with native riparian vegetation.

Due to setback constraints bank grading, stream repair, and, revegetation are not possible along the entire restoration reach.

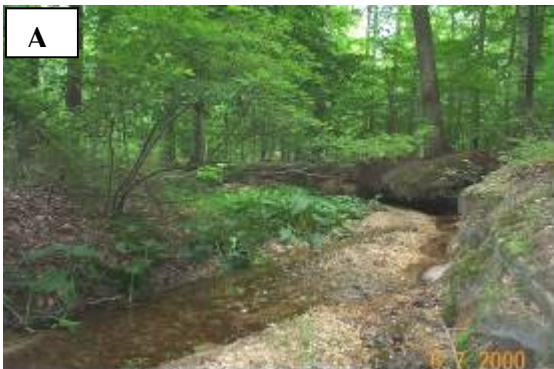
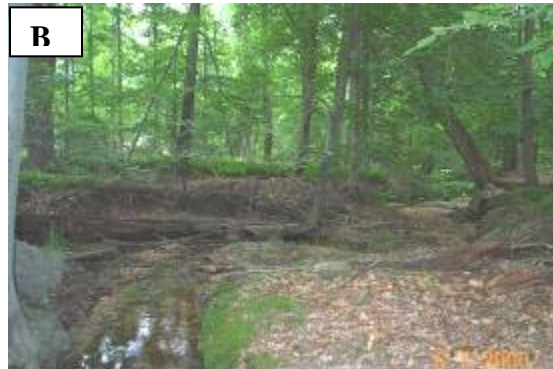
Description: Bank erosion problems were observed along this reach.

A) Fine sediment load and eroding banks along channel B) Another view of eroding banks along channel

Recommendation: Due to access limitations to the erosion site, pursuing upstream volume controls is recommended prior to initiation of stream repair efforts in this area.

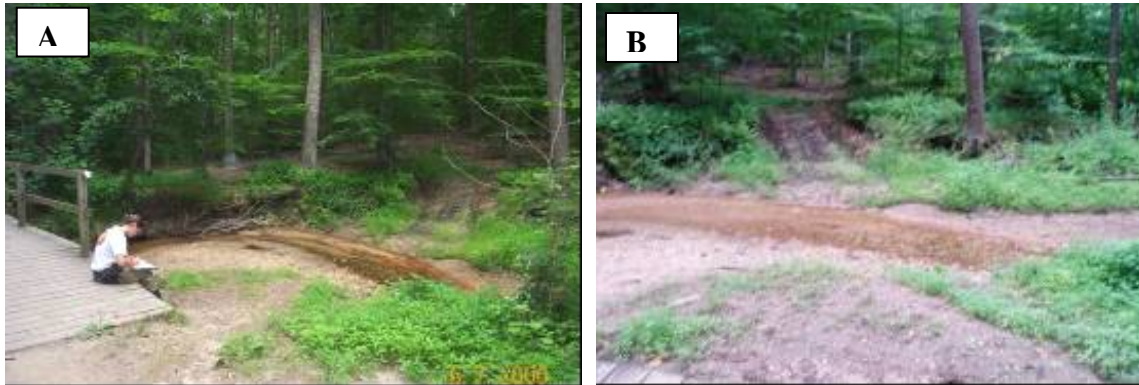
Description: A trail that crosses the stream, assumed to be used by trail users and mountain bikers, is causing erosion and sedimentation.

A) Bridge and trail crossing B) Close-up of trail crossing.

***Recommendation:** This priority project is a candidate for bank repair and revegetation. Trail signage and education/outreach that directs traffic to the adjacent bridge rather than through the stream and that incorporates local trail user groups is recommended. This outreach could be a fairly effective means of increasing awareness and interest in stream restoration by people who value the park.

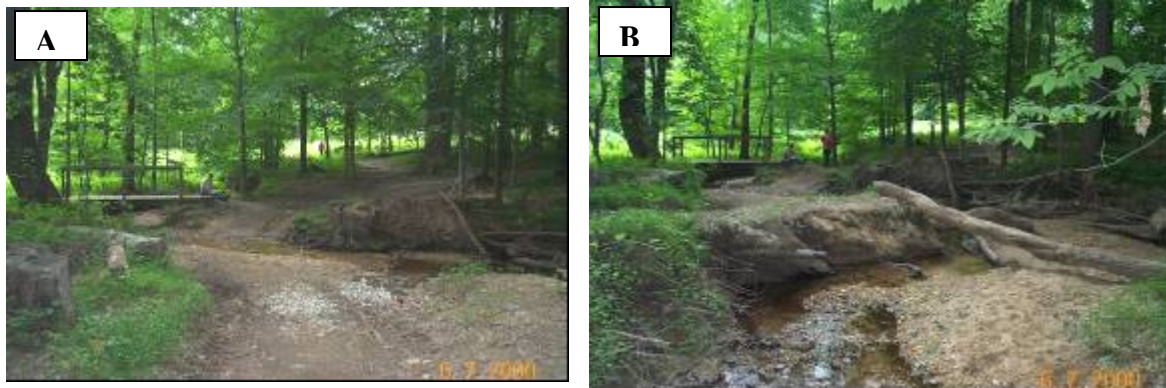
Description: Another stream crossing, assumed to be used by trail users and mountain bikers and is also creating sedimentation and erosion problems.

A) View of trail and erosion B) Eroding banks and sediment load

***Recommendation:** This priority project is also a candidate for bank repair and revegetation. Trail signage and education/outreach that directs traffic to the adjacent bridge rather than through the stream and that incorporates local trail user groups is recommended. This outreach could be a fairly effective means of increasing awareness and interest in stream restoration by people who value the park.

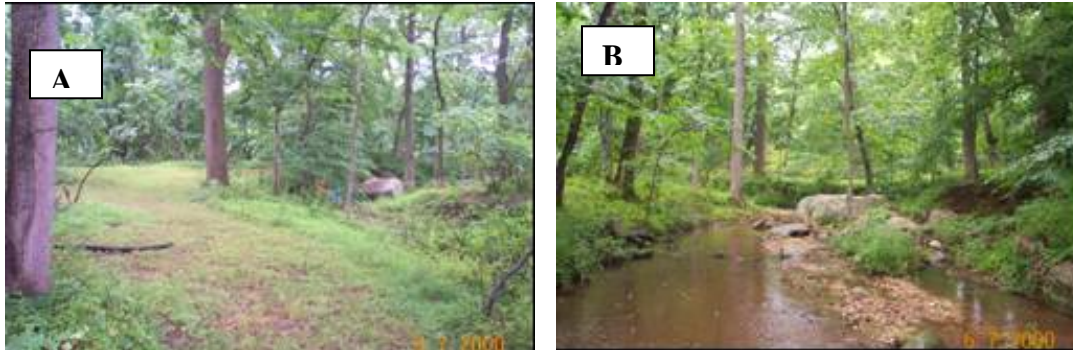
Description: Left bank riparian vegetation is limited at this site and there is some landscape debris in the buffer on the right bank.

A) View of turf grass on left bank B) View of stream, and landscaped areas around it

Recommendation: One bank is public land and other is private, therefore this project will require cooperation with the landowners to replace existing turf grass with native riparian species and remove landscape debris from banks.

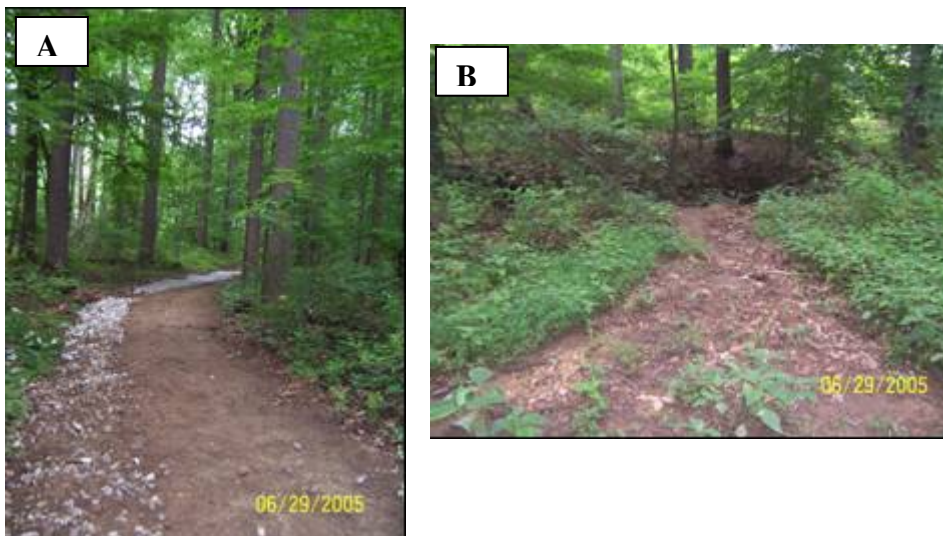
Description: Concentrated flow is eroding the trail and stream bank in this area.

A) View of trail. B) View of eroding trail leading to stream

***Recommendation:** Priority restoration activities include repairing the section of trail where the runoff is eroding it and the downstream channel bank as well. This small-scale project would be ideal for community volunteers and park users.

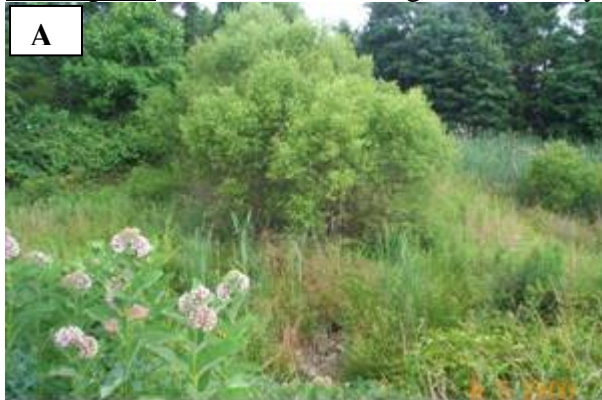
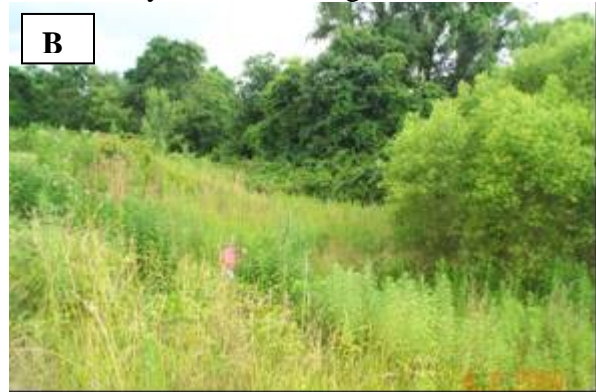
Description: Stormwater management facility dominated by non-native vegetation.

A) View of area with non-native species. B) View of area with more non-native species

Recommendation: Removal of non-native species and replanting with native riparian vegetation. This project is well suited for community volunteers or as an education/outreach effort.

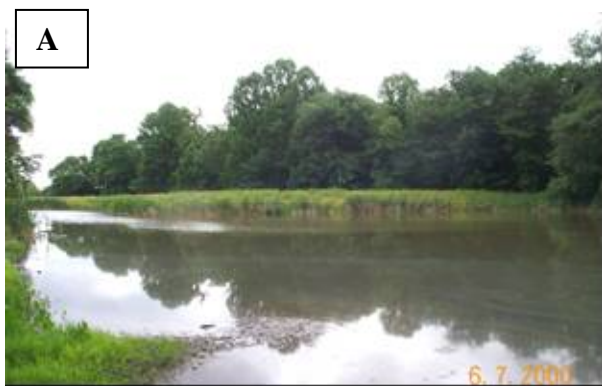
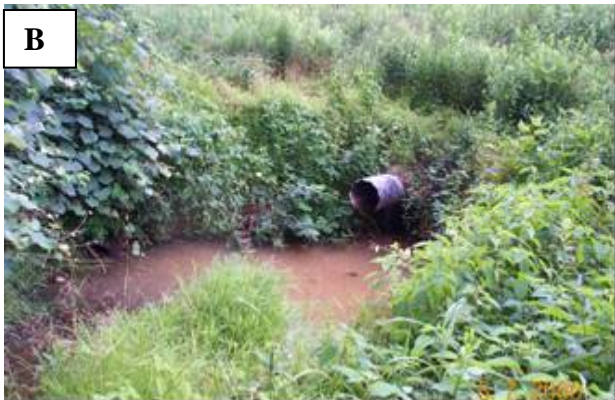
Dunteachin Pond Outfall Repair (Project - RB – 10)

Description: Existing corrugated metal pipe at this outfall shows signs of corrosion and leakage.

A) View of stormwater pond. B) View of corrugated metal pipe at outfall.

Recommendation: Repair the metal pipe at the stormwater pond outfall. Also could be a site for non-native vegetation removal and native plantings.

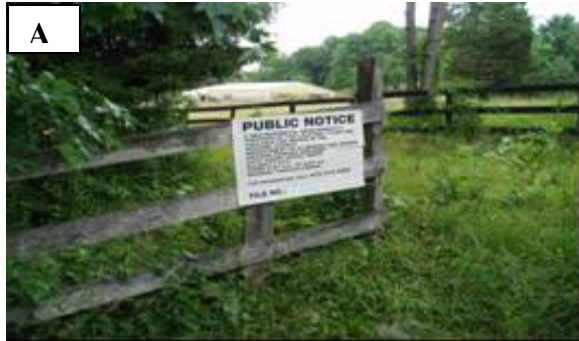
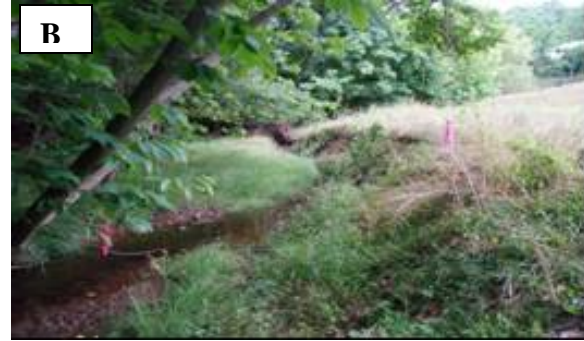
Description: A small tributary that flows north along an agricultural road off Elibank Drive is actively downcutting. The small tributary joins a larger tributary, which is also experiencing active erosion.

A) Public Notice of land to be developed. B) View of eroding bank and areas recommended to be reforested.

Recommendation: Stream repair and buffer planting opportunities exist on these tributaries. This area appears to be slated for development and may be able to include stream restoration/protection in the plans. At a minimum the floodplain/overbank areas should be protected and actively reforested. The larger tributary is not a good candidate for stream repair due to high, uncontrolled flows from upland areas. The smaller tributary has the potential for repair, however, as the drainage does not appear to extend south of I-95.

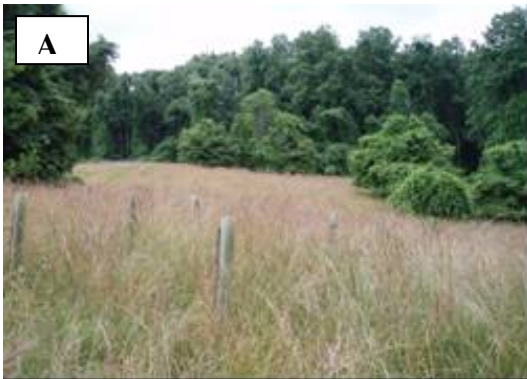
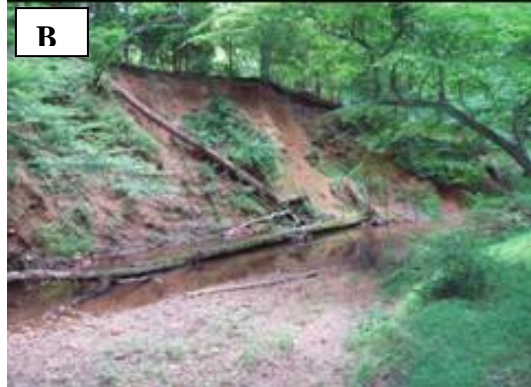
Description: Erosion of a tall bank is occurring at a bend in the river. It is unknown if this is a result of past channel modification activities or natural processes from upland run-off. There is evidence of recent buffer reforestation and upland reforestation in this area.

A) View of reforested areas. B) View of eroded tall bank.

Recommendation: Natural regeneration of the floodplain areas is feasible if left alone. One mowed area exists upstream of a pond and tributary. The purpose of this area is unknown. *No priority recommendations have been set for this project due to difficult access.*

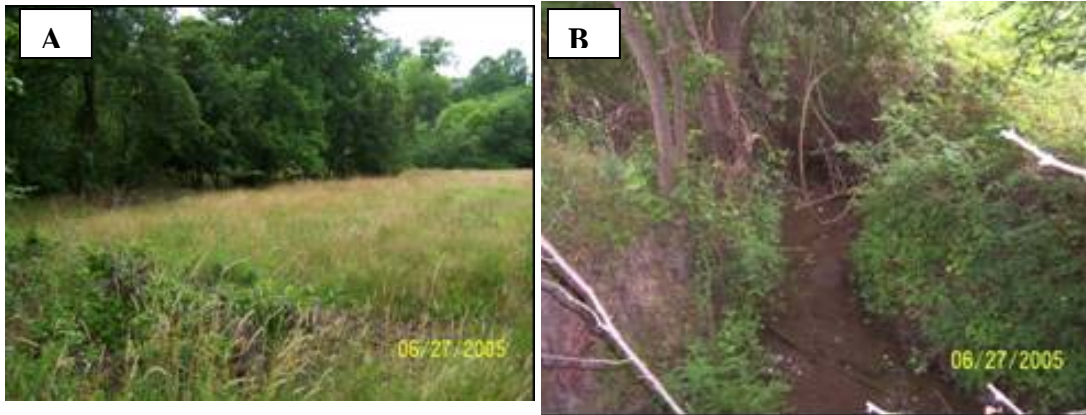
Description: This section of stream currently lacks an adequate buffer.

A) View of buffer on public land. B) View of stream with steep banks.

***Recommendation:** Although a minimal buffer (<10 ft) exists, active replanting of a broader and fully functional buffer on the publicly owned parkland is recommended for this priority project. There may be a utility corridor that would limit the available space, however.

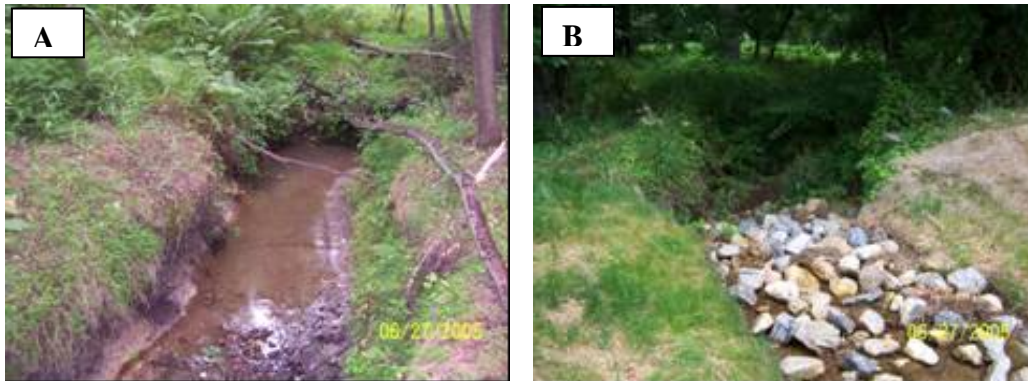
Description: Active downcutting is occurring in the reach downstream of the sewer crossing. This is likely due to upstream urbanization.

A) View of downcutting. B) View of sewer crossing.

Recommendation: On-site retrofits for the upstream neighborhoods are possible, however, road construction may pose a greater threat if this increases runoff to the stream. The sewer crossing also needs additional armoring to stop erosion from undermining and exposing the sewer.

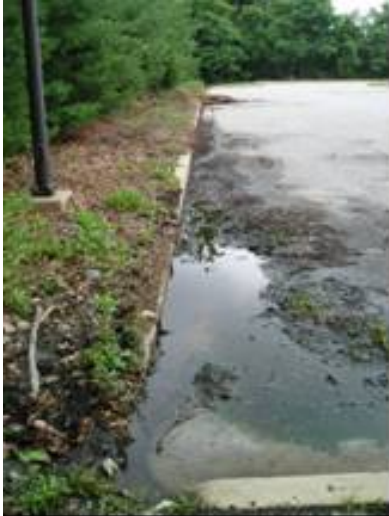
Description: This parking lot near the school entrance drains to two corner curb cuts. The downstream swales are lined with rip rap and meet below the parking lot. These swales join a drainage system collecting runoff from the middle school stormwater management facility. The drainage system is causing downstream erosion and scour.

View of curb on Elkridge Elementary School Parking lot.

***Recommendation:** Install rain garden/biofilters at two existing curb cuts to provide water quality treatment of parking lot runoff. Investigate the school drainage system and determine if redirection or diversion of runoff is possible at this priority site.

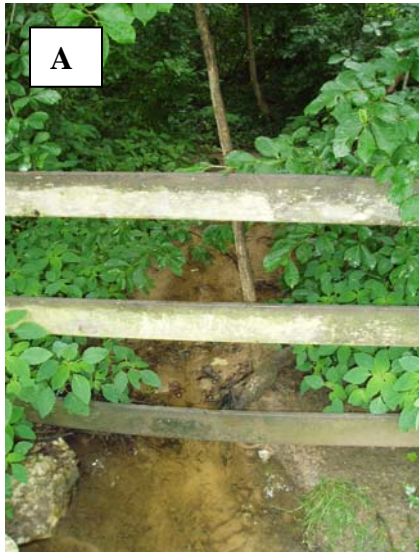
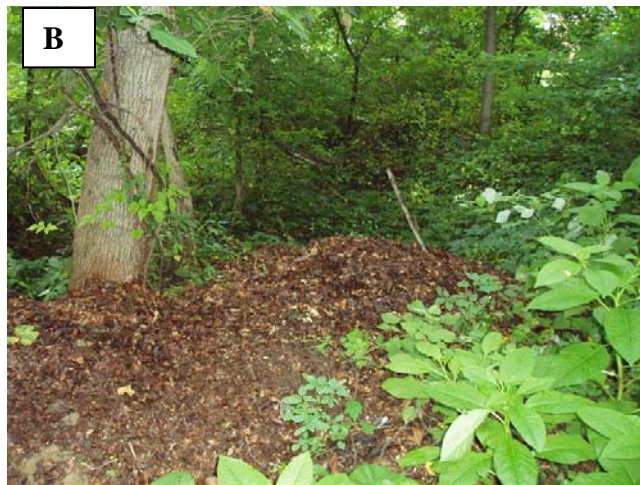
Description: Stream repair is needed on two channels originating from the Elkridge Elementary School, one from the stormwater management pond the other from the entrance parking lot. Yard waste was dumped into channels and erosion/unstable banks from upstream run-off is also a problem.

A) Stream channel. B) Yard waste dumped into stream.

***Recommendation:** Priority repair efforts should include removal of yard waste dumped into the channel, upstream stormwater volume controls (see Project RB-16 and 18), bank stabilization, and education/outreach activities.

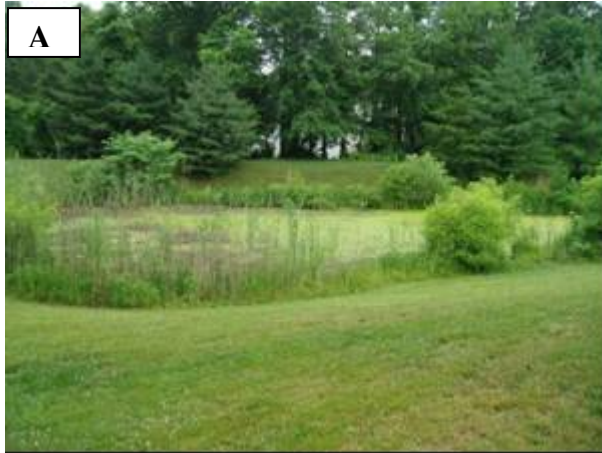
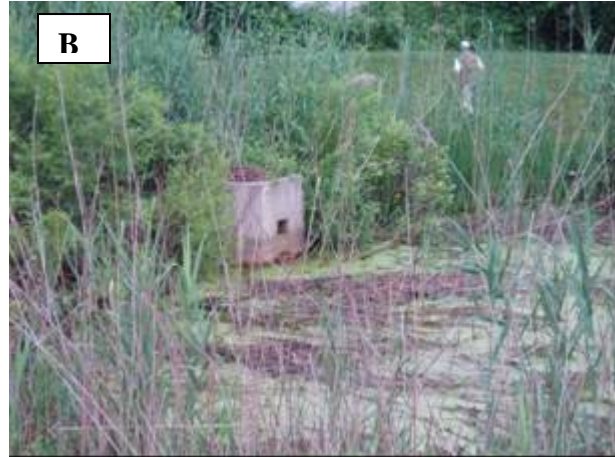
Description: A stormwater treatment facility near the school.

A) View of stormwater pond. B) View of riser structure.

***Recommendation:** This priority project involves retrofitting the existing stormwater pond to provide additional pre-treatment or increase capacity of the facility, by dredging or retrofit the overflow structure. This will improve treatment of first flush events and provide channel protection.

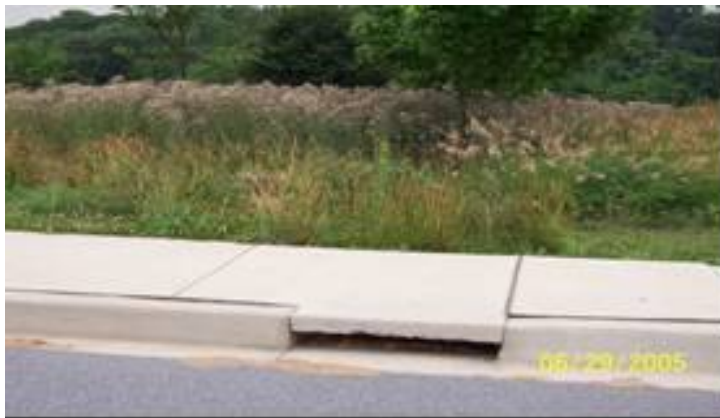
Description: The school has some stormwater treatment but could be used as a demonstration project to increase its effectiveness and local awareness at the same time.

View of parking lot runoff drain and grassy area.

***Recommendation:** Priority projects include incorporating bioretention areas into parking lot medians and turnabouts to provide water quality treatment for a dumpster storage area and parking lot runoff. Incorporating native BayScapes plantings as demonstration/educational projects at the entrance to the school property is also recommended.

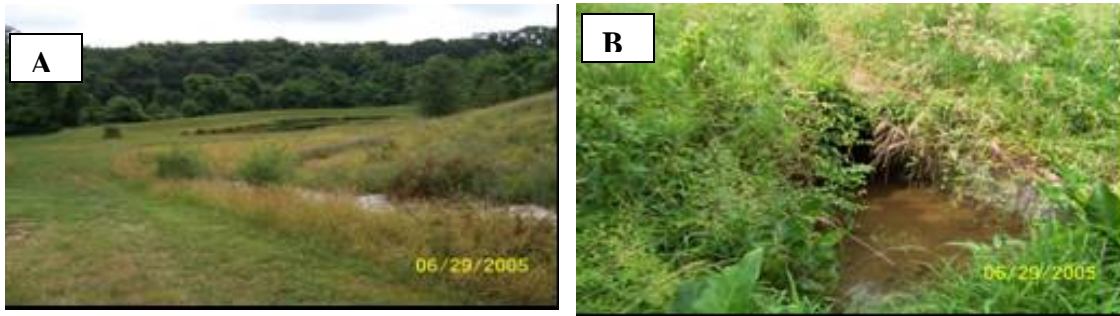
Description: The low flow orifice of the detention dry pond is clogged forming a permanent wet pool, but providing minimal volume protection to downstream channels.

A) Overview of extended detention dry pond. B) View of outfall.

***Recommendation:** Perform maintenance of extended detention dry pond.

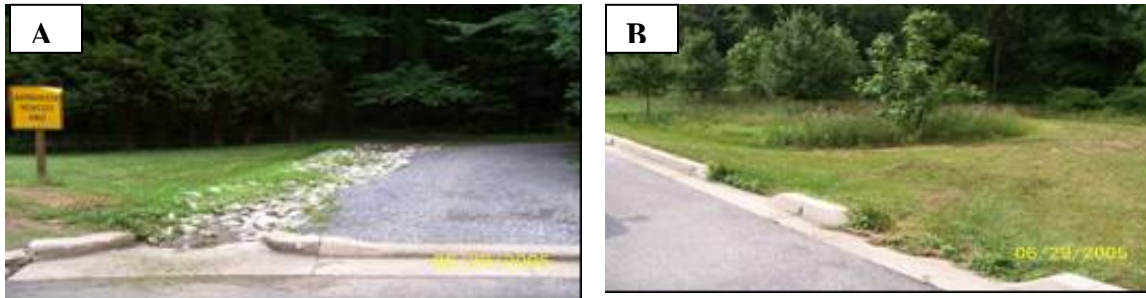
Description: Treatment of roadway and parking area drainage is not adequate and is causing erosion.

A) View of rip rap channel. B) View of roadway drainage area.

***Recommendation:** Improve roadway drainage by conducting stormwater runoff to drainage swales. Improve road and parking lot drainage by removing riprap in channel and creating a bioretention facility designed for channel protection and water quality volume.

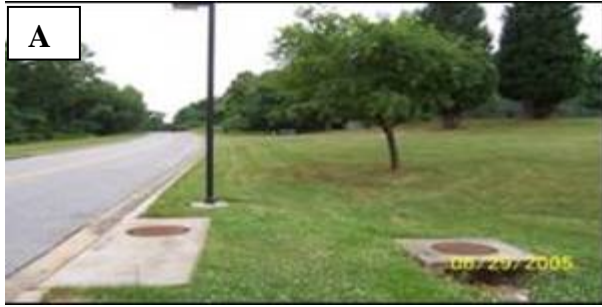
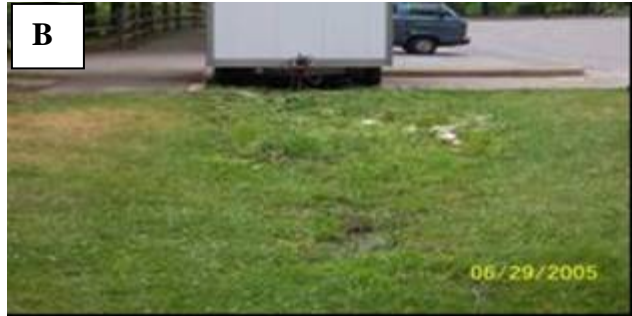
Description: Treatment of roadway and parking area drainage is not adequate.

A) View of entrance road. B) View of parking lot and potential retrofit area.

***Recommendation:** Provide treatment of roadway runoff by constructing a grassed swale parallel to the entrance road, reforest open areas where not specifically managed as open meadow, replace riprap with native plant material and add rain gardens at parking lot curb cuts. Also propose further study of parking lot use patterns to determine if porous paving alternative is feasible.

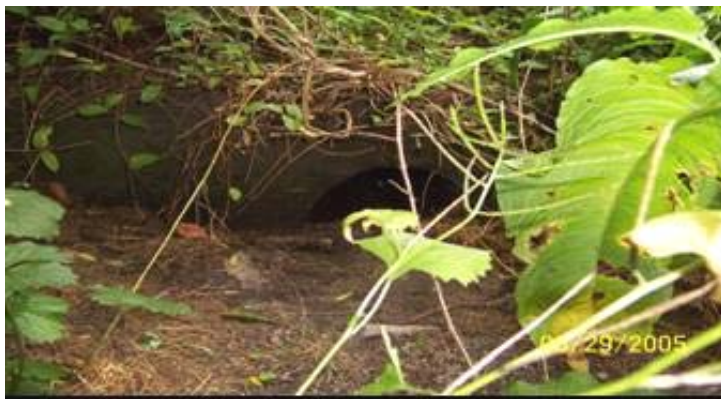
Description: The outfall culvert here is half filled with sediment.

View of culvert and sediment.

***Recommendation:** Priority project should be to perform maintenance on the culvert to remove sediment.

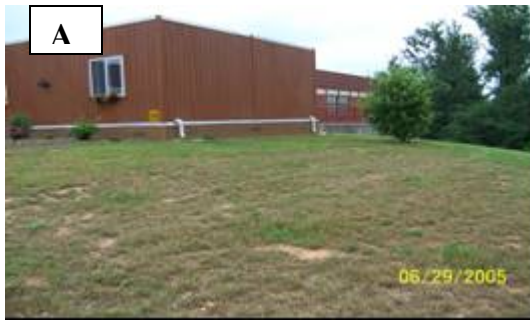
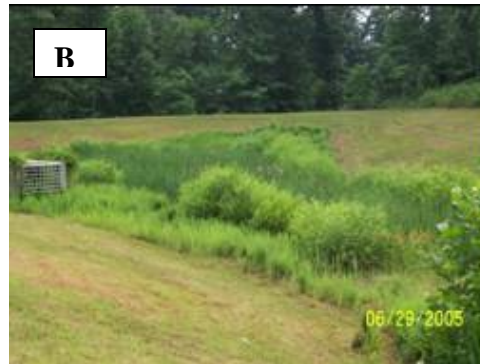
Description: These schools have a new, well-maintained stormwater management pond. The school campuses provide opportunities for several demonstration projects.

A) View of possible rain garden location. B) View of sunken area where second rain garden could go.

***Recommendation:** Install rain gardens as educational/demonstration tools in areas adjacent to an accessory building at the elementary school and/or within an open area near the entrance of the middle school.

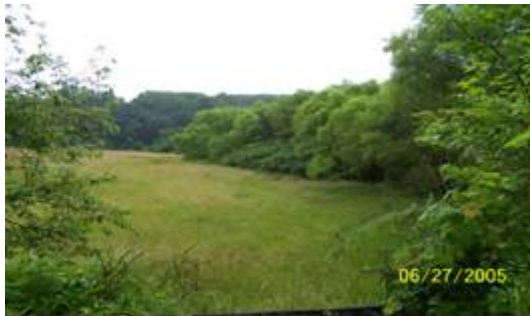
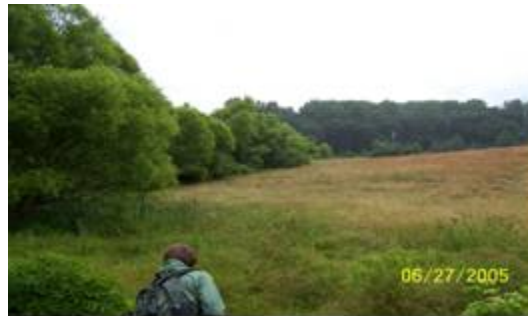
Description: The existing buffer is approximately 10' wide along the stream in this section.

Two views of buffer zones.

Recommendation: Should be approached as an opportunity to expand forested buffer.

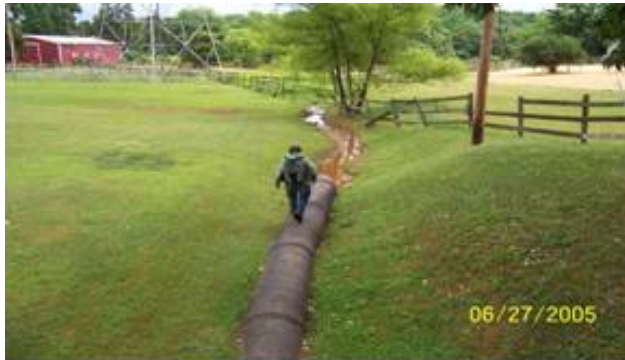
Description: There is no existing buffer of the stream in this section and the stream is piped until it crosses a power easement.

View of piped stream with no buffer zone.

Recommendation: Suggest a no-mow native vegetation area along stream. Investigate rationale for piping stream to see if potential to remove and restore channel.

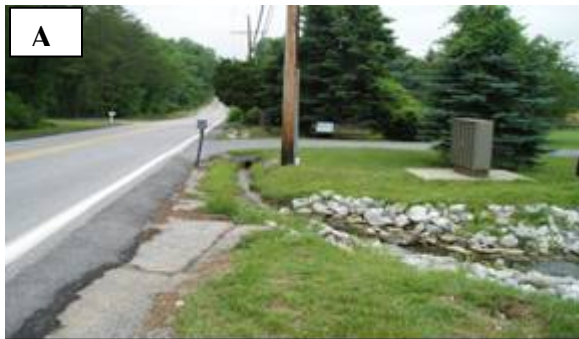
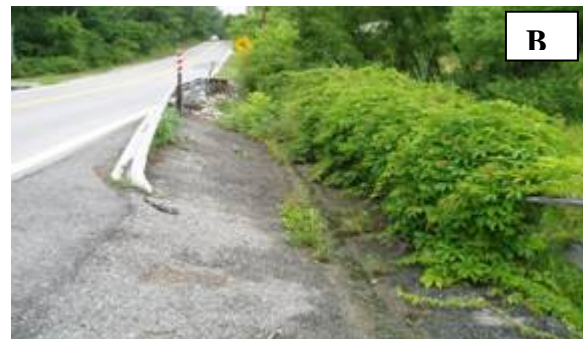
Description: Run-off flows leave a grass swale and new stormwater mangement facility at Grace Episcopal Church, and return to an asphalt channel along side Landing Road.

A) View of water leaving church. B) View of water running to the stream.

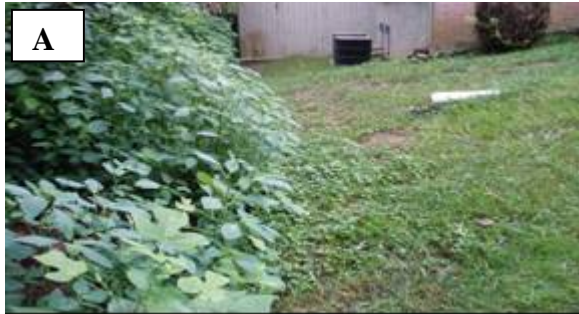
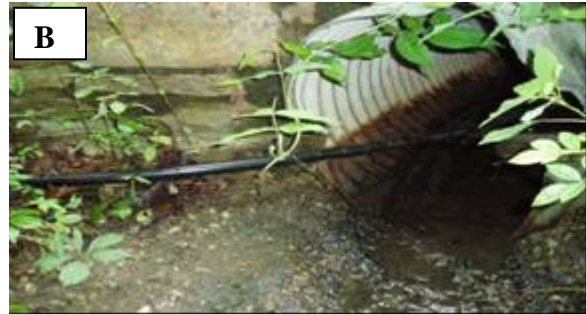
Description: SHA property south of I-95 along a tributary presents an opportunity to provide channel protection control. The downstream channel (north of I-95) is experiencing significant erosion.

A) View of buffer area. B) View of culvert under Lawyers Hill Rd.

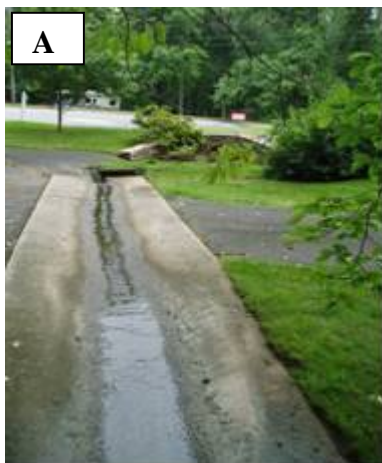
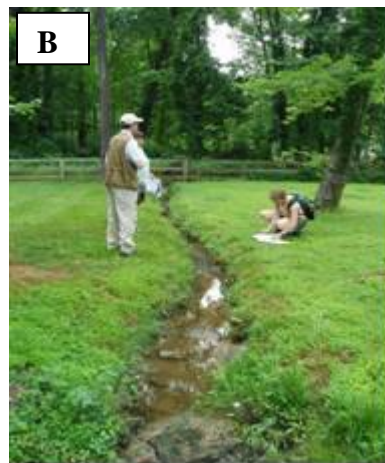
Description: Private home where the stream crosses the first driveway in a concrete channel (vehicles drive through channel). The stream is piped under the second driveway and part of the yard. The stream then enters a channel/ditch that is mowed to the bank.

A) View of stream crossing the driveway. B) View of stream in mowed ditch/channel.

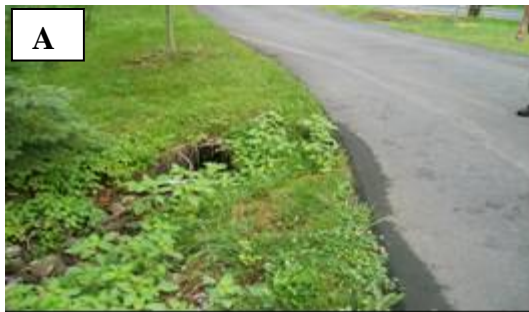
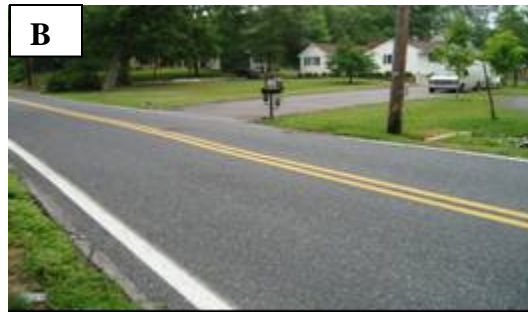
Description: The tributary parallels a driveway off Lawyers Hill Rd. and there is less than 5’ buffer on either side.

A) View of Tributary running underneath a driveway. B) View of Lawyers Hill Rd.

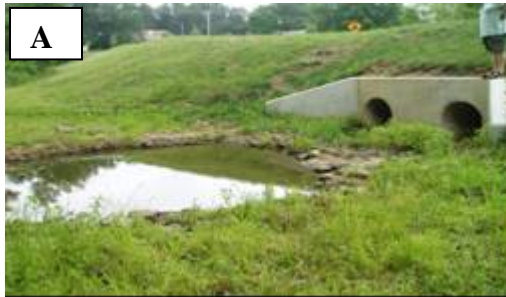
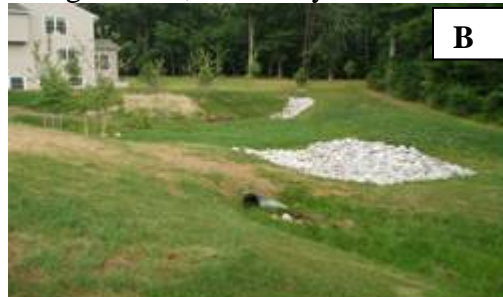
Description: The areas downstream of the outlet from this stormwater management facility are being mowed, and likely fertilized.

A) View of the culvert. B) View of outlet from SWM facility.

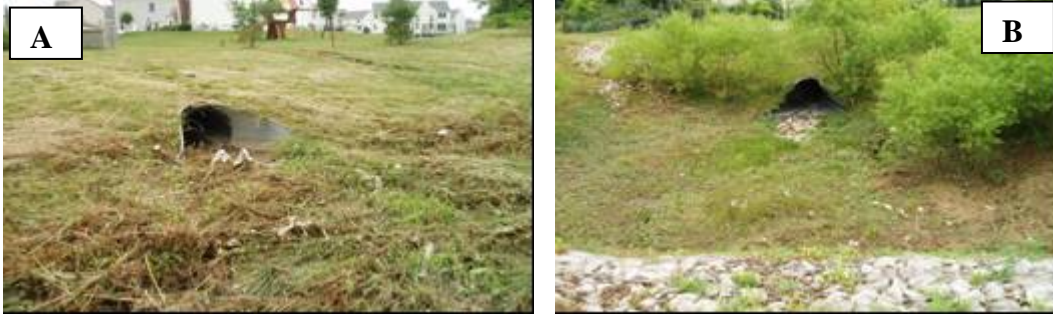
Description: This is a new subdivision that appears to have dry ponds (possibly infiltration basins). The adjacent homeowner complains of flooding.

A) View of outfall to dry pond 1. B) View of outfall to dry pond 2.

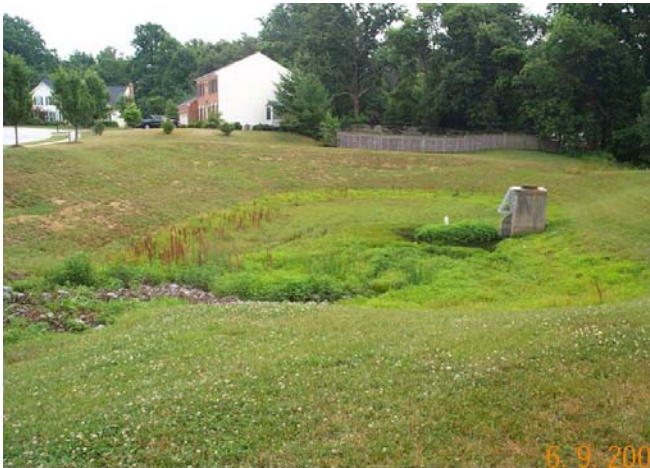
Description: This is an existing stormwater management facility that treats runoff from a residential area.

Picture of the facility
