Assessing the Sucker Branch Subwatershed of the Lower Patapsco River for Restoration Opportunities

Prepared for:
Howard County, Maryland
Department of Public Works
Bureau of Environmental Services
NPDES Watershed Management Program

Prepared by:
JoAnna Lessard and Sam Stribling, Tt

January 23, 2006
Final Draft

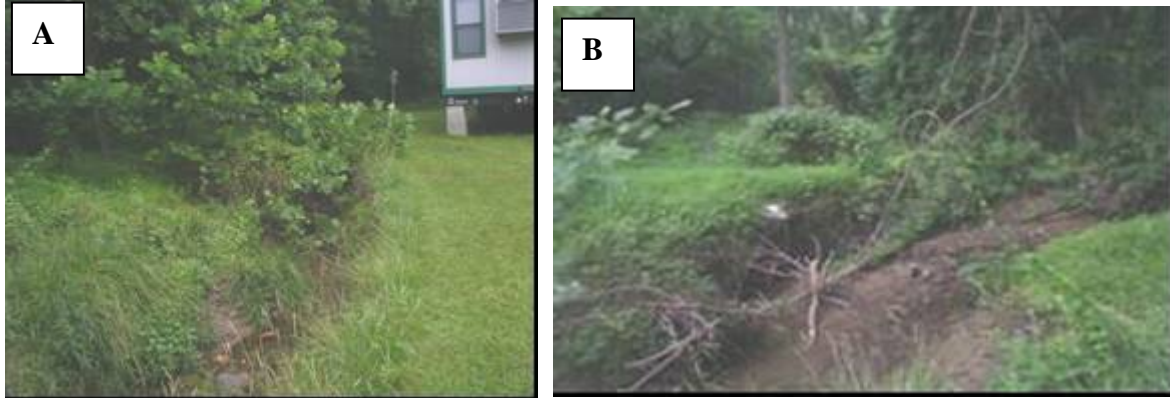
Our Lady of Perpetual Help (Project - SB – 1)

Description: This section of stream is lacking an adequate riparian buffer and the bank channel is showing signs of erosion.

A) View of stream with little riparian buffer. B) View of stream bank.

***Recommendation:** Proposed project is a combination of riparian buffer revegetation and bank stabilization along approximately 500 linear feet of stream channel. On site use for a devotional area, sewer lines, a trailer adjacent to the stream, and the road location constrain potential buffer projects. With these constraints in mind along with cost this project is still considered a priority given its high potential feasibility as it is an institutional area. At the very least it should be targeted for education and outreach to the landowners. There may be the potential for revegetation projects to be undertaken by the community that uses this land.

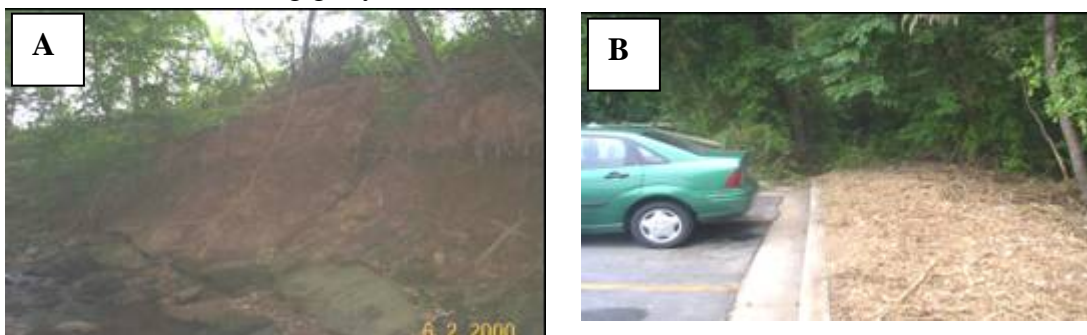
Description: An approximately 20-foot high eroding bank (picture A) was observed on the main stem of Sucker Branch downslope from an apartment complex parking lot. The parking lot is a retrofit candidate, specifically where stormwater leaves the parking lot via a curb cut (picture B) and enters an eroding gully and Sucker Branch.

A) View of high eroding bank. B) View of curb cut from parking lot into the stream.

***Recommendation:** Proposed practices include a parking lot bioretention facility (project SB-2A) and bank stabilization/revegetation measures for the eroding bank (project SB-2B). This site is priority because part of the stream in this section may lie on public land and the erosion is a problem that must be addressed.

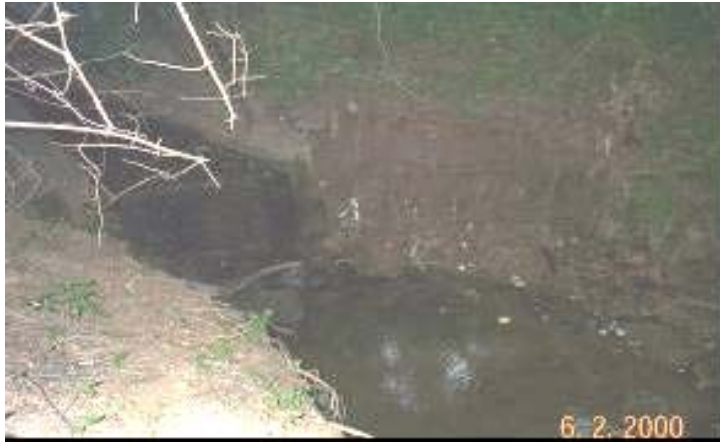
Description: State Highway Administration culvert under Route 40 is undermined and causing bank erosion.

View of eroding bank at the culvert outfall.

***Recommendation:** The end section of the culvert should be repaired and a plunge pool could be added for energy dissipation. The repair of this erosion site is feasible due to its location in the highway right-of-way. The access to the site requires clearing of brush, but tree impacts can likely be avoided.

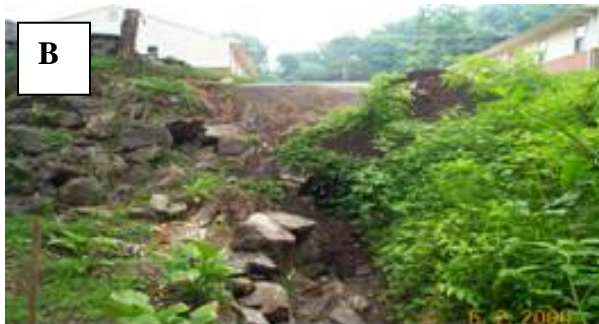
Description: Overall this 4-unit residential complex has poor stormwater management. The apartment building rooftops drain onto the parking lot, which discharges directly to the stream. The stream also has inadequate stream buffers.

View of the asphalt parking lot and outfall.

***Recommendation:** The runoff from the roof drains and asphalt parking lot could be diverted to constructed raingardens in landscaped areas adjacent to the stream. Buffer plantings and bank stabilization should also be encouraged.

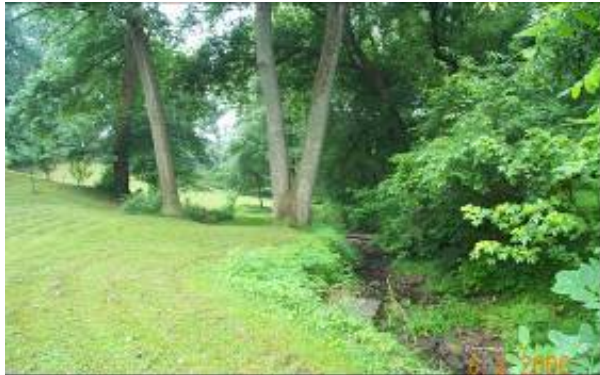
Description: Residential property along left bank of stream adjacent to and downstream of Project-SB-4 is mowed to top of bank.

View of left bank with mowed lawn.

***Recommendation:** This area should be included in the County buffer program and Education/Outreach. There are approximately 300 linear feet of restorable buffer area within this project.

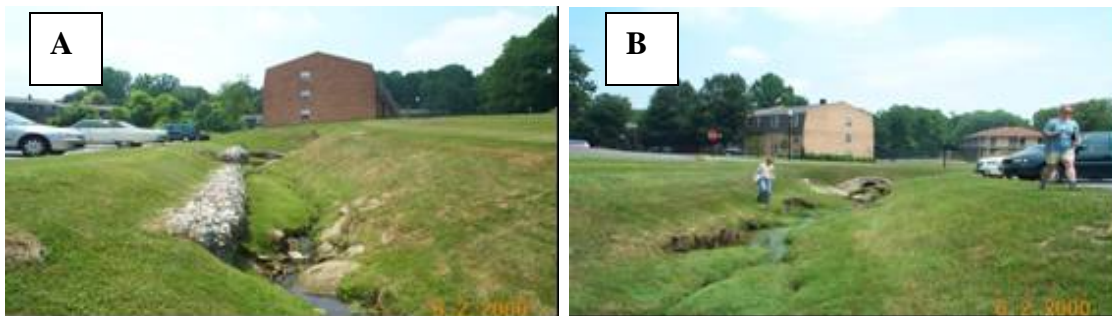
Description: The channel adjacent to 8872-8882 Town and Country Blvd., has severe erosion problems.

A) Upstream view of eroding channel. B) Downstream view of eroding channel.

***Recommendation:** This channel needs structural repair. Hydraulic calculations need to be done to determine if a more natural channel design is an option. This site should be targeted for education on no-mow vegetation to increase water retention. This area may also be a candidate for a bioretention facility for water quality treatment of the parking lot, and would require landowner cooperation. At this time it is in the priority list due to the fact that all the other Howard Crossing projects are priorities, and the county will talk about all potential projects with this landowner.

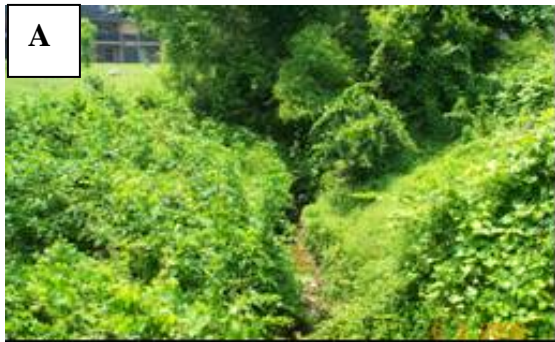
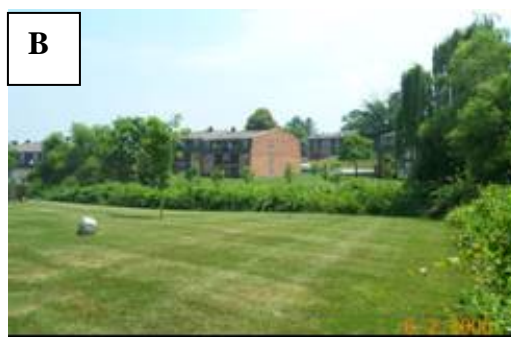
Description: The buffer in this section is dominated by invasive plant species.

A) View of invasive plants on both banks of stream. B) View of invasive plants along stream, and mowed lawn adjacent to stream.

***Recommendation:** Clear invasive plant species from the stream buffer and extend the stream buffer. This will allow the riparian buffer to be more effective at slowing and treating stormwater runoff as well as providing the necessary stream ecosystem functions (for example, shading, cover, organic matter inputs, etc.) that adequate buffers do. This project should be targeted for education/outreach.

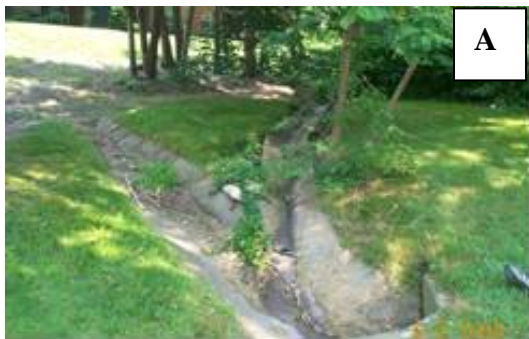
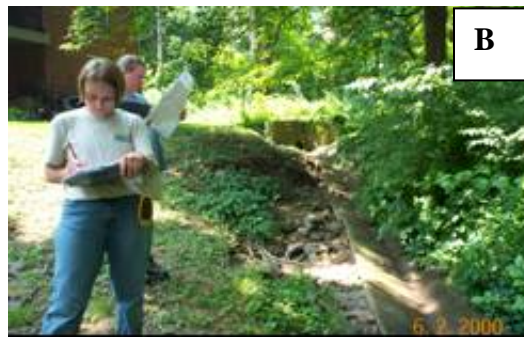
Description: The concrete channel draining stormwater is broken and undermined.

A) View of broken channel. B) Different section of same broken channel and exposed soils.

***Recommendation:** The concrete channel needs repair and, if runoff flows allow, should be replaced with a grassed swale that could provide some water quality treatment. Understory plantings should be initiated to cover bare soils in the adjacent area.

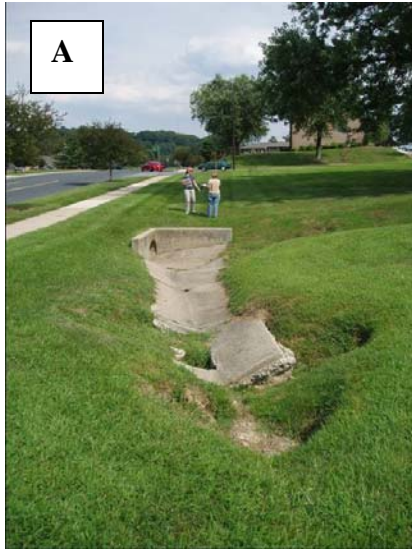
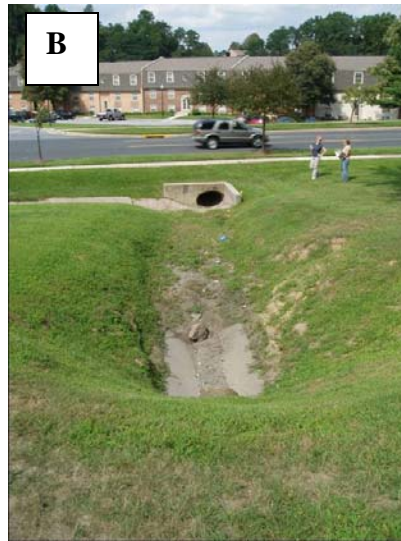
Description: A concrete channel that receives flow from parking lots and buildings near the corner of W. Spring Dr. and Town and Country Blvd., is cracked and there is erosion near the channel.

A) View of broken channel. B) Different view of same broken channel and erosion.

***Recommendation:** Project would involve retrofitting this channel by creating a diversion wall to lengthen the flow path and creating a wet swale/wetland area in the adjacent grass.

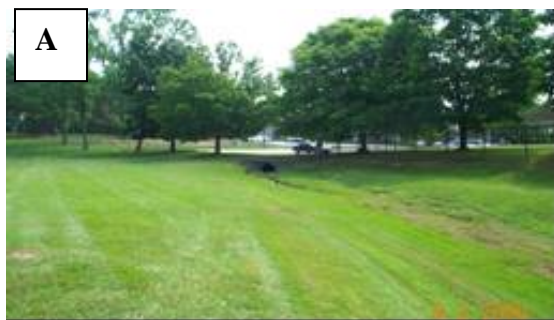
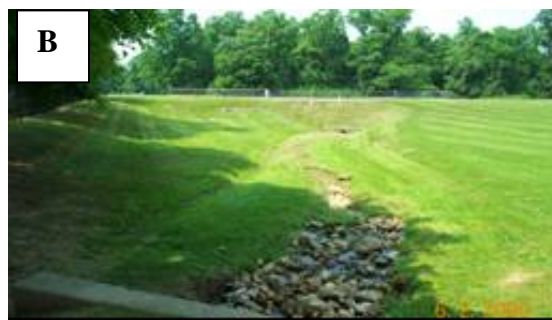
Description: This area is adjacent to the swimming pool, at a visible location near the entrance to the community. Existing stream channel is an 8-10 foot mowed trapezoidal channel. Baseflow is underground and daylight at the entrance to a culvert under Town and Country Blvd.

A) Upstream view of channel. B) Downstream view of channel

***Recommendation:** This area should be targeted with the other Howard Crossing buffer education projects as another opportunity for buffer reforestation (30' on L bank and 100' on R bank). The mowed area appears unused and could be used as stormwater pond if the culvert entrance was modified to become a riser, or for some other type of water quality treatment facility.

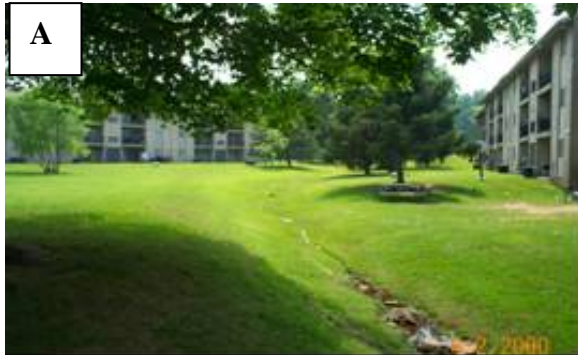
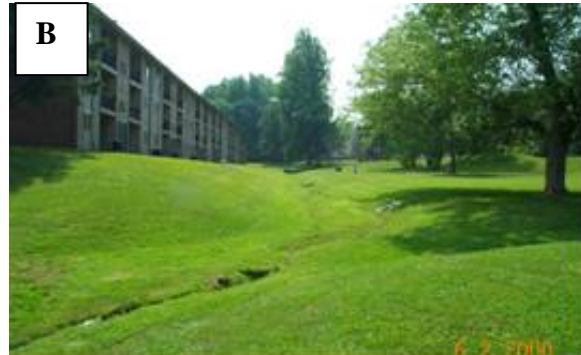
Description: This section of stream channel flows between apartment buildings and is mowed right to the bank. Some areas are marshy.

A) Upstream view 1 of channel. B) Upstream view 2.

***Recommendation:** Establish a 10- to 30-foot stream buffer of no-mow native vegetation. In addition to the filtering and shading benefits of a buffer, this no mow zone will prevent landscapers from fertilizing the stream banks.

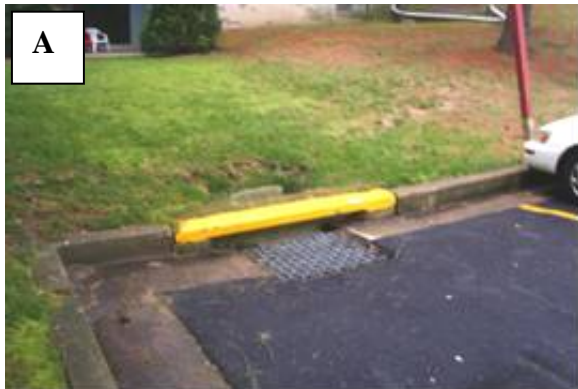
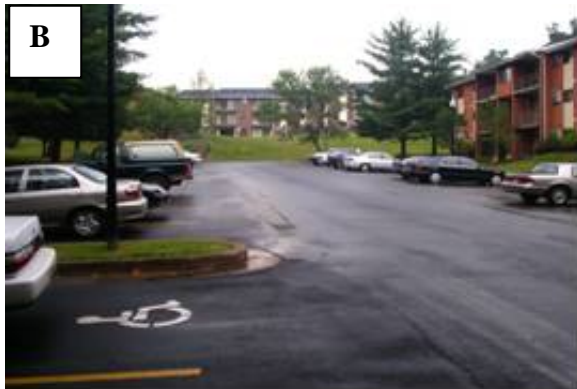
Description: The storm drain network that discharges immediately downstream of this parking lot drains a large commercial and residential area, causing bank erosion downstream.

A) View of storm drain inlet on parking lot. B) View of residential parking lot.

Recommendation: The proposed treatment includes construction of a stormwater wetland or infiltration basin that would capture flows before entering a smaller tributary to Sucker Branch. Flows could be diverted from the storm drain network to an open area adjacent to the outfall. Alternatively, only parking lot runoff could be treated.

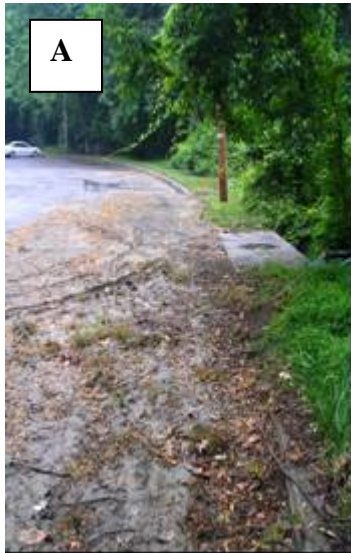
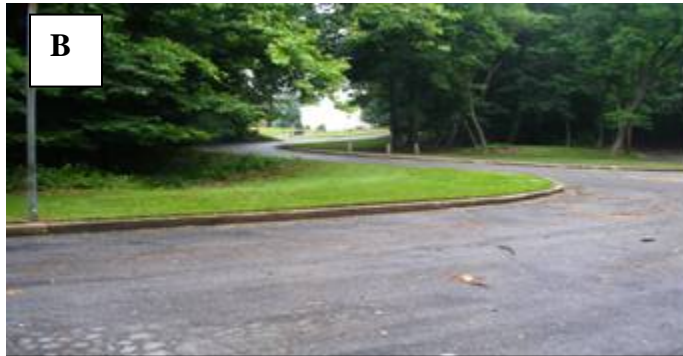
Description: This parking lot drain inlet is clogged with sediment from an eroding gully. A second inlet between this one and the eroding gully is also clogged with sediment..

A) View of clogged drain inlet. B) View of road leading to clogged inlet.

Recommendation: The potential retrofit projects include repairing/stabilizing the eroding gully, removing sediment from the clogged inlets, and redirecting runoff to a new bioretention area within the parking lot where the clogged inlet is located.

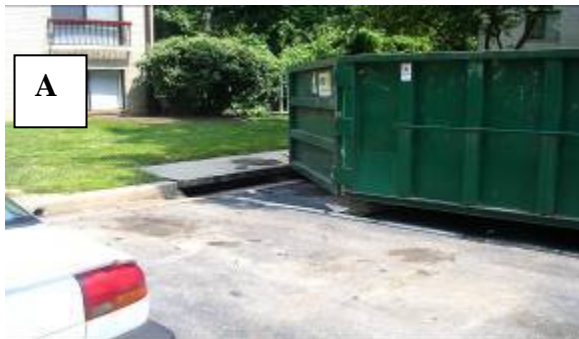
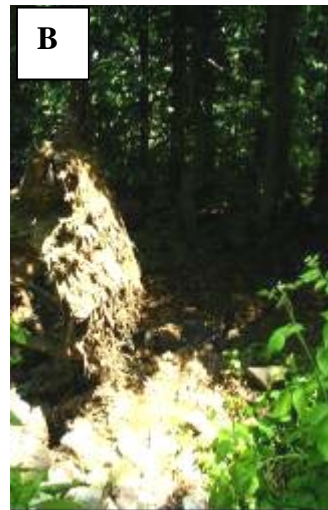
Description: Drain inlet runoff is eroding a steep wooded slope that leads to a tributary to Sucker Branch.

A) View of Drain inlet. B) View of eroding banks.

***Recommendation:** This area should have rooftop drain disconnection and construction of rain gardens to treat the rooftop runoff, as well as a bioretention facility adjacent to the existing drain inlet. These practices would provide flow attenuation and reduce peak flows.

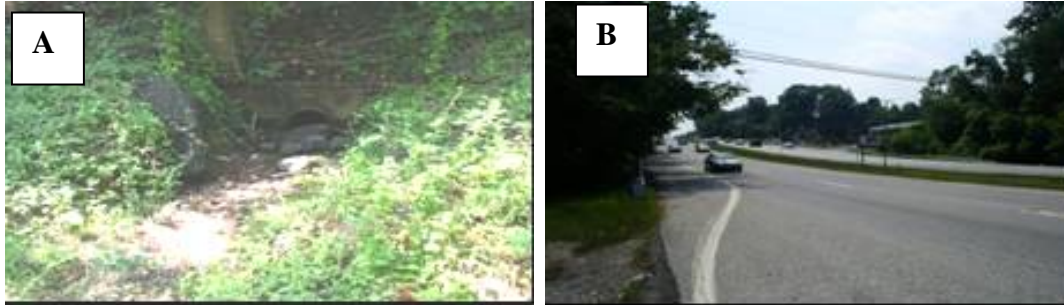
Description: Erosion was observed downstream of the outfall draining a portion of Route 40.

A) View of storm drain outfall. B) View of Route 40, where inlet is located.

***Recommendation:** A bioretention retrofit of the existing storm drain inlet located in the center median of Rte. 40 would encourage infiltration and attenuate peak flows in an attempt to minimize downstream erosion. The Department of Natural Resources has indicated that the State Highway Administration has funds for retrofits and other water quality improvements to treat highway runoff, therefore this project is flagged as a priority.

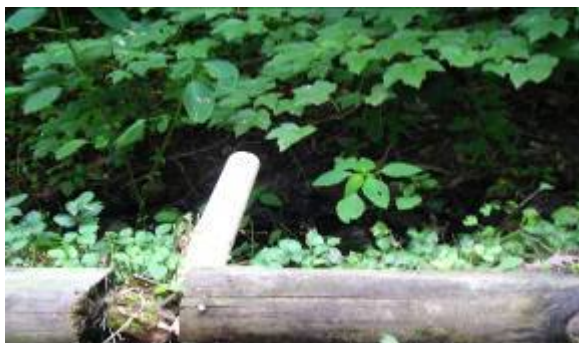
Description: A drain outlet from a residential swimming pool was observed discharging directly to a Sucker Branch tributary.

View of residential swimming pool outlet.

***Recommendation:** An inexpensive outreach/education program could alter the behavior of this residence.

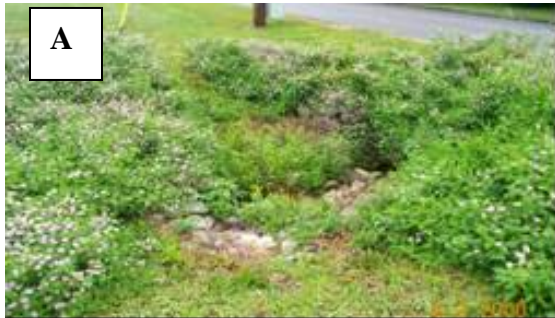
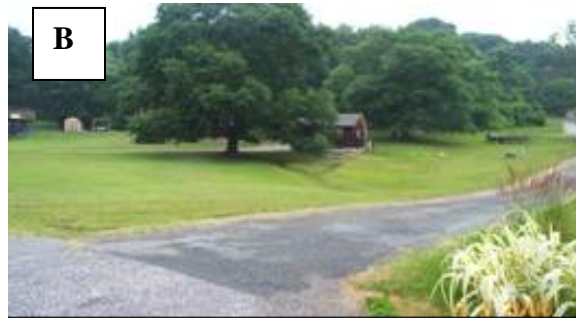
Description: Stream sections upstream of the intersection of Rogers Ave and High Ridge Road are either piped or treated as ditches.

A) View of intersection (Rogers Ave. and High Ridge Road). B) View of stream running through mowed lawn.

Recommendation: An ambitious program would work with homeowners northeast of this intersection to daylight and buffer the stream through their yards. A less intense alternative is education about nutrient management and creation of no-mow zones for unbuffered streams.

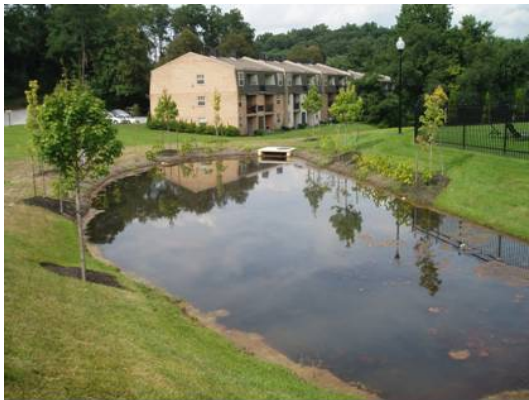
Description: The stormwater management facility is not functioning as it should as evidenced by the outlet level during dry weather. This facility appears to be an infiltration basin or bioretention cell.

Picture of malfunctioning stormwater facility. The stream runs in behind this facility and the pool on the north side of Town and Country Blvd.
(Note: No field sheets were made for this site)

***Recommendation:** This facility should be immediately tended to by maintenance personnel. Howard County enforcement should contact the property owner to ensure maintenance is performed. In the grass area behind and downhill of the pool, it may be feasible to daylight an additional section of stream channel or employ a flow-splitter at the upstream road crossing to divert low flows. The grass area could be converted to a stormwater wetland for water quality benefits. A less costly alternative is reforestation of this turf area.

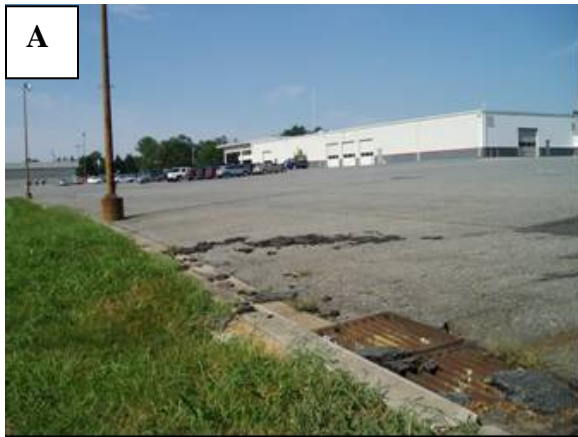
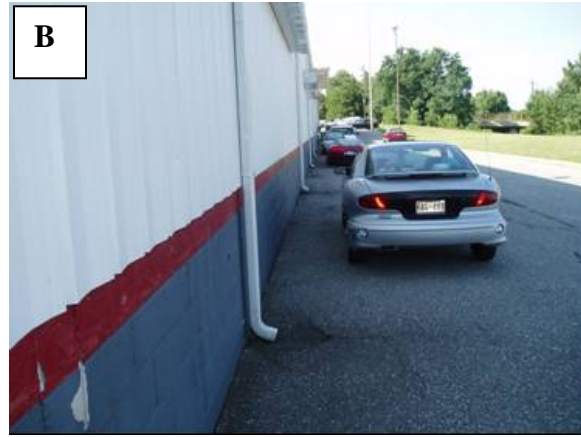
Description: Large car dealer with little stormwater management. Roof downspouts discharge to the asphalt lot and staining is seen off areas where cars are washed and from the dumpster. The parking lot drain is clogged with sediment and the stream below this area has erosion problems.

A) View of parking lot and drain inlet. B) View of roof downspouts.

***Recommendation:** The parking lot could have vegetated areas put in to break up the impervious areas, and a bioretention strip could be installed along the edge of the parking lot to slow and treat the stormwater runoff before it gets to the stream.

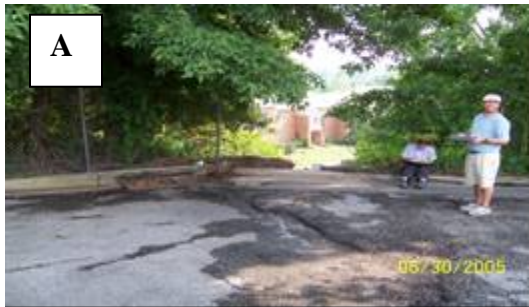
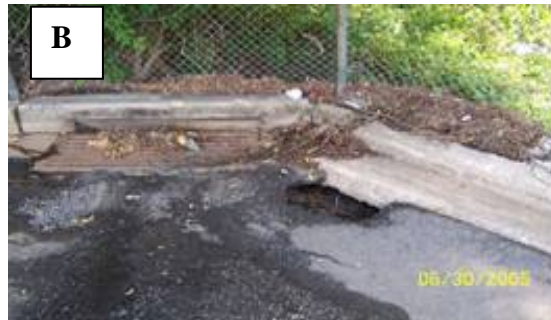
Description: This parking lot shows signs of undercutting and downslope erosion occurring where runoff currently leaves this site.

A)View of parking lot. B). Drain inlet in corner of parking lot.

Recommendation: This site should be included in education outreach program for business owners. Treatment should be provided for parking lot runoff and car washing facility. A sand filter could be installed to treat and slow runoff as well.

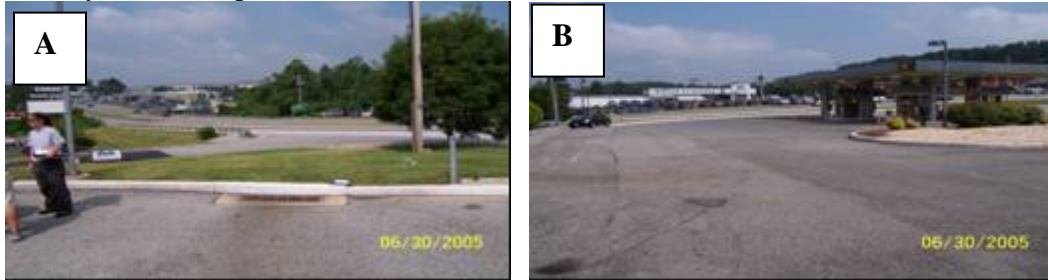
Description: Staining observed at downstream outfall possibly from gas station runoff, which is a likely source of pollutants to stream.

A) View of stormwater drain on parking lot. B) View of gas station where downstream staining may be coming from.

Recommendation: Along with education and outreach, construct an oil/grit separator at the entrance to the existing drain inlet to treat stormwater runoff prior to entering the storm drain system.

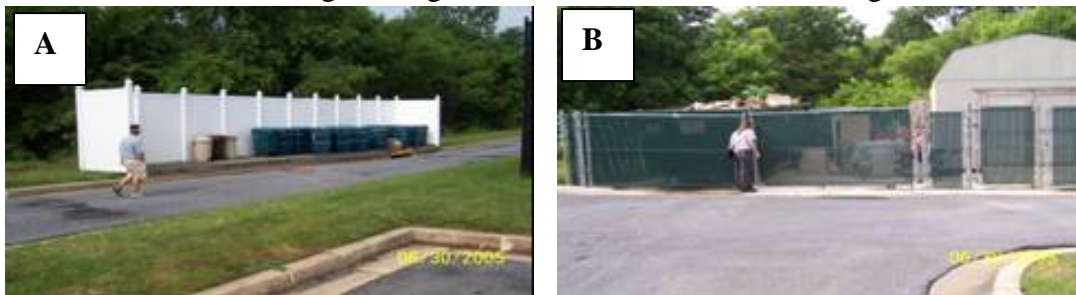
Description: This parking lot is near the tennis court and has room for a small stormwater management facility to offset some of the impacts from parking lot and rooftop runoff in this area. The runoff discharges to a grassed/wooded area and is causing downstream scour/erosion.

A) View of parking lot. B) Different view of same parking lot.

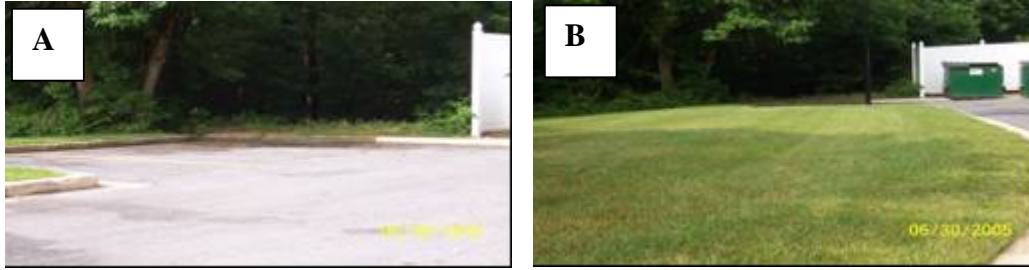
Description: A residential parking lot in this housing complex past the pool area.

A) View of parking lot median. B) Side view of same area of parking lot.

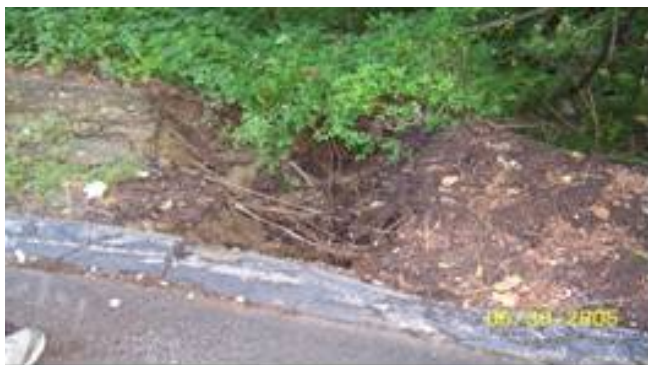
Description: This area has parking lot and curb failures that are not functioning to route water as designed. Runoff should flow to a single drain inlet at the rear of the property, but at one location runoff flows over an eroded curb, causing downstream erosion.

View of eroded curb where runoff bypasses drain inlet and causes erosion.

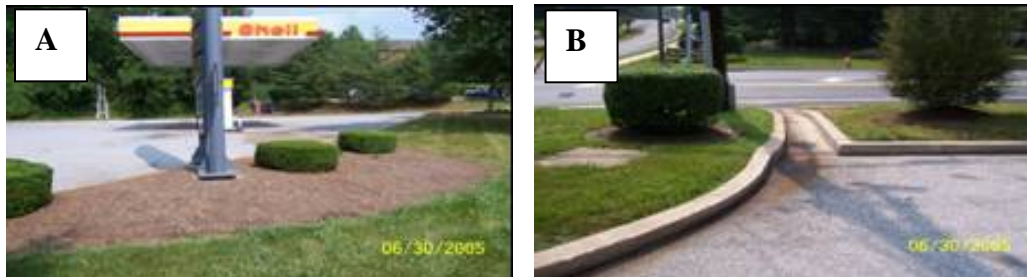
Description: Fueling area runoff drains across the lot, through a curb cut to a storm drain inlet on the road. This is a likely pollutant source to the stream.

A) View of fueling area. B) View of current drainage area from gas station.

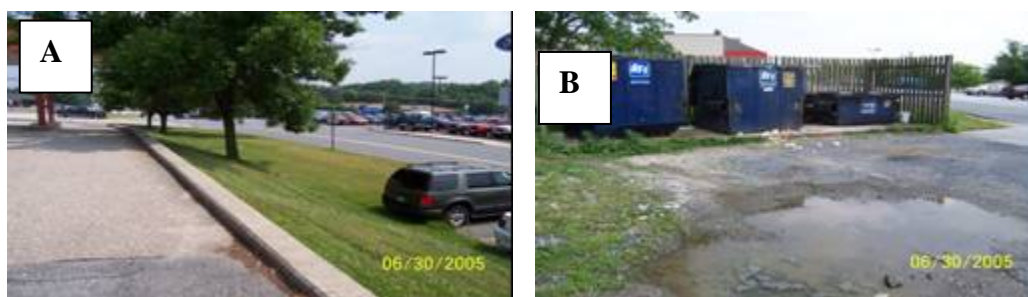
Description: This area is a large complex of stores and parking lots with minimal stormwater management in place.

A) View parking lot median. B) View of parking area at rear of building.

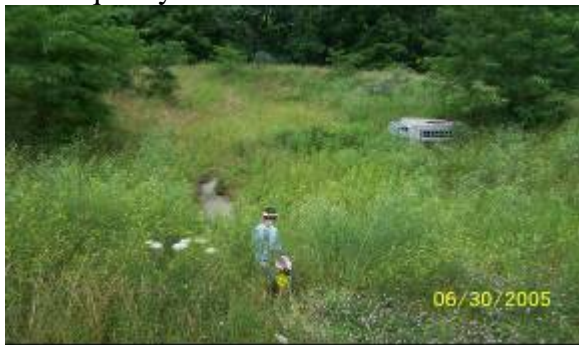
Description: An existing stormwater pond onsite has a concrete low flow channel that directs low flows directly to overflow structure, preventing any infiltration and minimizing potential water quality benefits.

View of concrete low flow channel in stormwater pond.

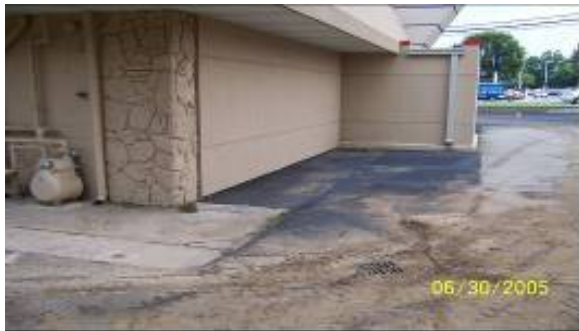
Description: This was recently remodeled and expanded. A new storm drain has been directed to a steep slope leading to a channel where scouring and erosion was observed.

View of newly constructed building, with new storm drain.

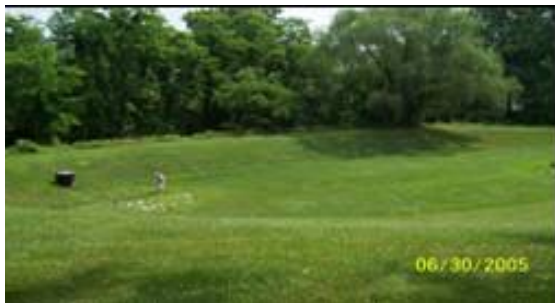
Description: This site has a stormwater pond that is a good opportunity for improving water quality treatment at an existing facility.

Overview of stormwater pond.

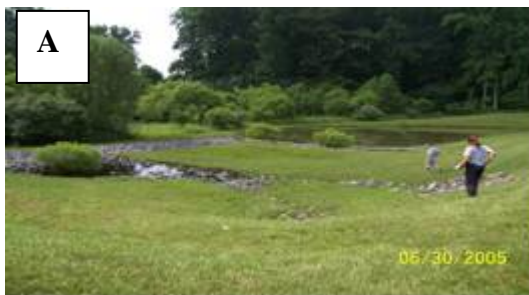
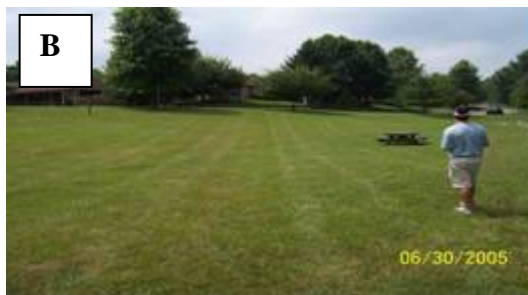
Description: Two ponds located onsite could be improved with minor retrofits.

A) View of the two ponds. B) View of area surrounding the ponds.

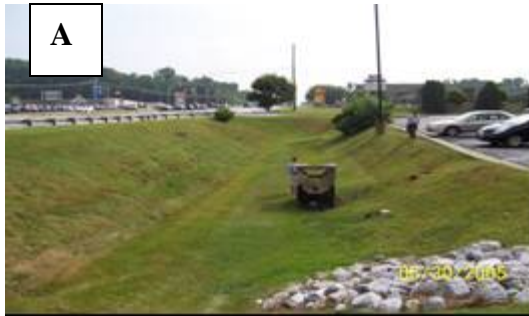
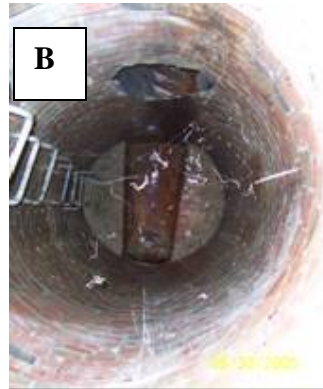
Description: This site has a treatment pond that may be able to be retrofitted to treat more area.

A) View of pond parallel to Route 40. B) View inside low flow orifice.

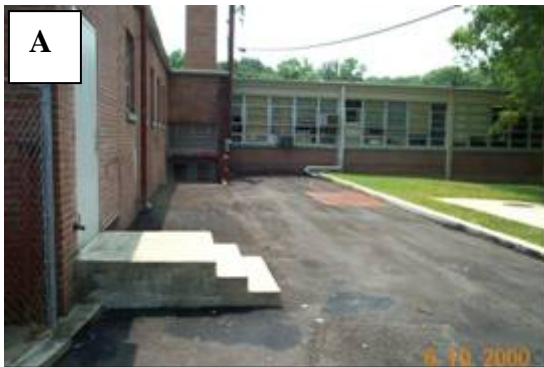
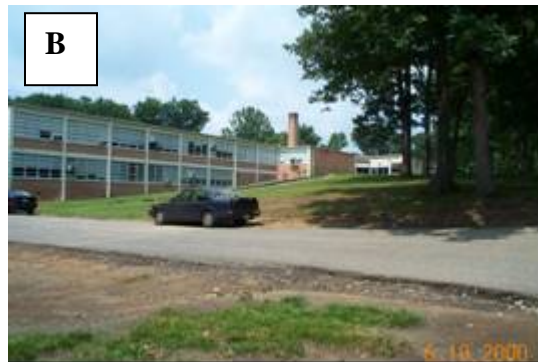
Description: Parking lot does not have treatment and roof drains discharge to pavement.

A) View of roof discharging to pavement, B) View of driveway with erosion along edge of paving
