# **PATAPSCO RIVER**

## **SOUTH BRANCH AND LOWER NORTH BRANCH**

## **WATERSHED ASSESSMENT**

## January 2017

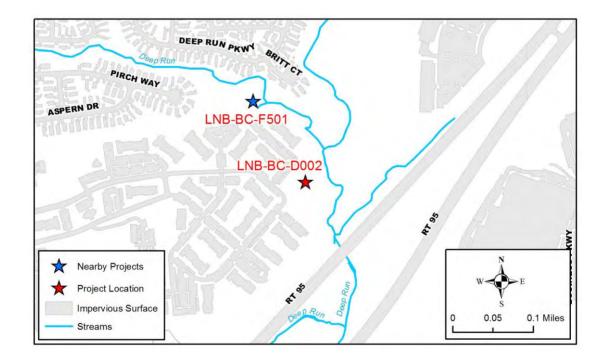
Site ID: LNB-BC-D002 Contractor: Straughan

This facility, built in 1987, is designed as a dry pond to provide storm water management associated with the Sherwood Crossing Subdivision. Most of the subdivision runoff is from parking areas and secondary roads which drain into a major storm drain system. This system discharges into the pond via a 21 in. BCCMP, a 27 in. BCCMP, and a 42 in. BCCMP pipe. There is a riser structure at the west side of the pond which discharges to a 54 in. RCP spillway then to a rip rap channel before flow enters Deep Run. The pond is providing limited water quality improvement. Erosion was noted at the pond outfall.

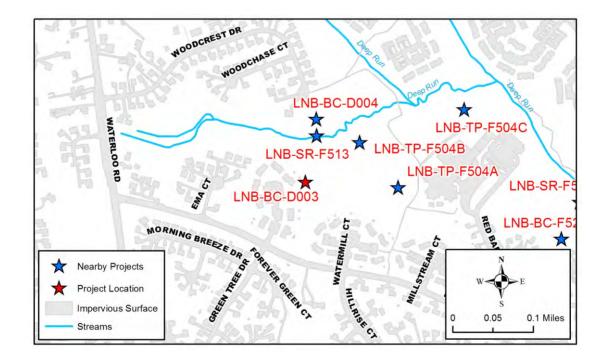
Site ID: LNB-BC-D003 Contractor: Straughan

The facility, built in 1985, is private and is owned by the homeowners association of the surrounding community. Drainage is collected from all main roads of the subdivision via two major stormdrain systems. Most of the runoff enters the facility to the south via a grass swale north of Mayfield Avenue; the remainder of the flow discharges into the dry pond via a CMP pipe west of the facility. The principal spillway consists of two CMP pipe outflows that discharge north into a nearby stream. This facility is not providing any water quality treatment. Dense vegetation and accumulated sediment were observed in the pond.

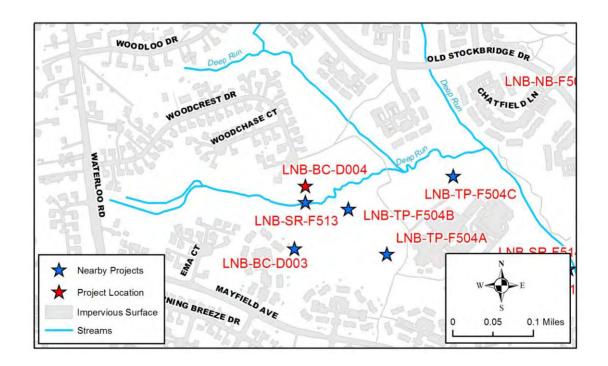
Site ID: LNB-BC-D004 Contractor: Straughan

This facility, built in 1991, is a dry detention facility with a forebay downstream of the main storm drainage system that provides management for almost the entire Woodbrook subdivision, including all of the roadways. Only a small area bypasses the forebay and enters the pond via a grass swale located along the western property line. The current forebay spillway requires repairs to the wire mesh and replacement of rock. Existing anti-seep collar and core trench was noted on as-builts.

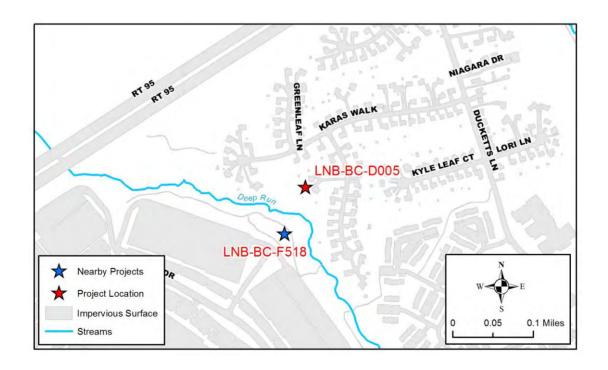
Site ID: LNB-BC-D005 Contractor: Straughan

This facility, built in 1989, is designed as a dry pond to provide stormwater management associated with the Melbourne subdivision development and the drainage area to the stream. The facility is owned by this homeowners association. Runoff is conveyed via two main stormdrain systems that discharge at two locations into the pond. Twin RCP cross culverts convey the stream across Kara's Walk into the facility. The existing concrete riser structure discharges directly into a stream. There appears to be a measure of intended water quality pretreatment shown on the as-built plans; however, clogging of the riser has created a permanent pool throughout the facility. Existing anti-seep collar and core trench were noted on as-builts.

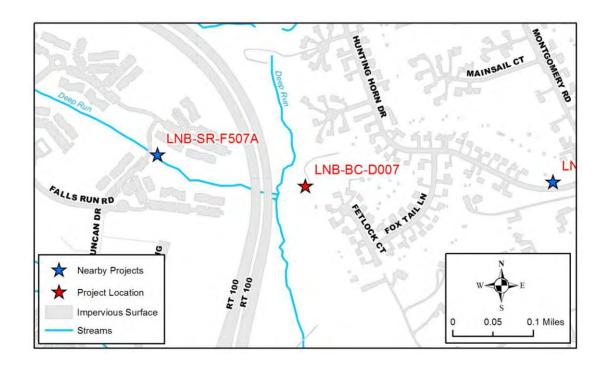
Site ID: LNB-BC-D007 Contractor: Straughan

This facility, built 1983, is designed as a dry pond to provide storm water management associated with the Hunt County Estates Subdivision. Most of the development runoff is from Hunting Horn Drive, which is collected into a major storm drain system and discharges into the pond, via a 27 in. RCP pipe. The pipe leads to a swale which then leads to the riser at west side of the pond. Plans for a future 15 in. pipe to outfall into the south side of the pond are depicted on the as-built drawings. A 36 in. BCCMP spillway then discharges to a riprap channel before entering a nearby stream. No water quality improvement is being provided by the pond. At the outfall and downstream of the outfall, erosion was observed. Siltation and standing water was observed at the inlet to the outfall.

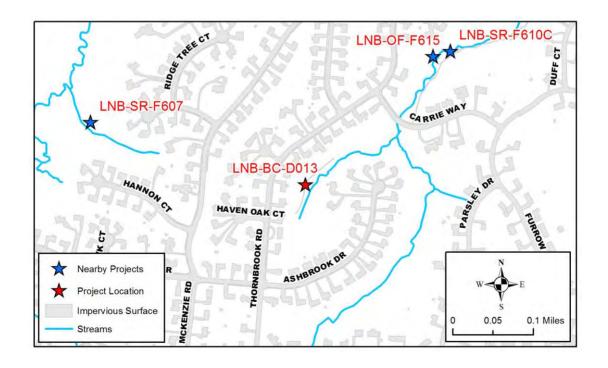
Site ID: LNB-BC-D013 Contractor: Straughan

This facility, built 1988, is noted as a water quality wet pond on the as-built drawings for the Mt. Hebron Subdivision development; however, photographs, field investigation, and the county's database indicate it is a dry pond. Most of the subdivision runoff is from the southern portion of Thornbrook Road, Haven Oak Court, and Sara Beth Court which drain into a major storm drain system. This system discharges into the pond via a 33 in. CMP pipe. The pond outfalls its high flow via a weir with a crest elevation of 402.1 ft. which discharges against the receiving stream flow. The pond outfalls its low flow via a 12 in. BCCMP spillway. The spillway is severely eroded with crumbling concrete and displaced riprap. The field photos do not depict the weir nor do they depict the plate with a 3 in. diameter hole welded to the face of the 12 in. BCCMP pipe as shown on the as-built drawings for the facility. The pond appears to provide very limited water quality benefit.

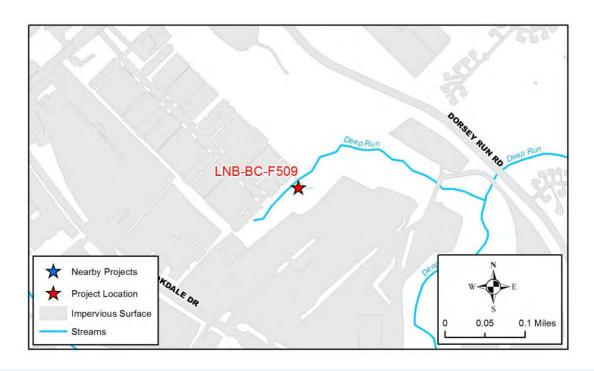
Site ID: LNB-BC-F509 Contractor: McCormick Taylor

The pond is located in the Baltimore Washington Commerce Park business park and receives runoff from the commercial buildings and parking lots. The majority of the property is impervious surface and there is one large, 42 in. CMP inflow with the bottom half of the pipe poured with concrete. A very large, eroded scour hole was observed at the inflow with over 1 ft. of ponded water. The pond grading continues southwest of the CMP inflow and there is significant seepage from this wooded area as well as seepage near the inflow scour pool. In the bottom of the pond, there is an eroded pilot channel with small stones leading to the low flow near the riser structure. The concrete riser appears in good condition, although there is some sediment and debris partially blocking the flow orifice. Some erosion is occurring on the upstream pond slope near the top of the southeastern side of the embankment and emergency spillway. The emergency spillway has what appears to be recent riprap placed at the downstream end. A sewer line was observed near the emergency spillway as well. Two gates provide access to the facility from the parking lot, but the access path form the gate on the southwestern side is filled with trees. The access from the gate on the northeastern side is at the embankment where the steep slopes are located. The outfall is stable although some moderate erosion is occurring in the downstream outfall channel. Per the plans (SDP-88-205) the open top concrete riser has several weirs and the 72 in. BCCMP barrel is in good condition with little corrosion.

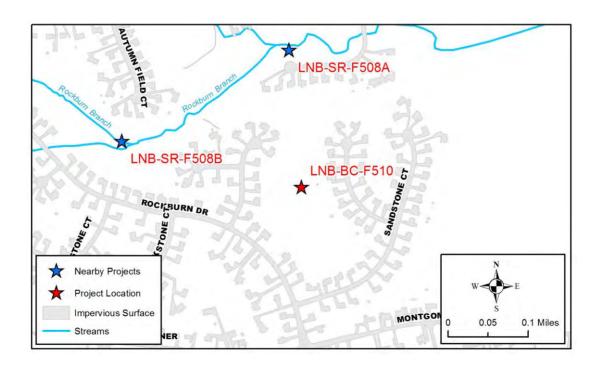
Site ID: LNB-BC-F510 Contractor: McCormick Taylor

The site is located in the Rockburn Township development between Briarstone Court and Rockburn Drive. The facility is completely surrounded by homes and currently receives runoff from two storm drain inflows, an 18 in. RCP from Sandstone Ct with an eroded inflow channel and a 24 in. CMP from Rockburn Dr with severe corrosion and trees growing at the pipe. The facility and inflows are located within an existing drainage and utility easement according to the original plans (F-88-273). Pond retrofit design plans (SDP-02-157) proposed improvements to include a new riser structure for extended detention resulting in increased storage and reduced discharges. The concrete riser structure is in good condition except there is less than 1 ft. of clearance between the bottom of the trash rack and the embankment. The embankment appears to be designed per Code 378 standards with an anti-seep collar, concrete cradle, and clay core. Underdrains were also installed throughout the pond bottom. The immediate outfall with riprap is stable; however, just downstream of the riprap, the channel is eroded and beginning to headcut into the riprap. Downstream, most of the channel has several feet of erosion occurring along the banks. Tree roots are exposed, and trees are falling over the channel.

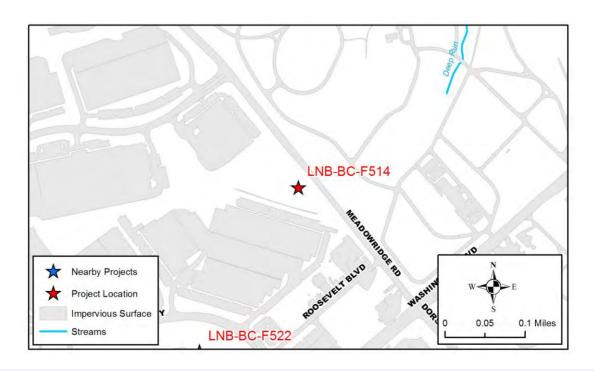
Site ID: LNB-BC-F514 Contractor: McCormick Taylor

The site is located within the Meadowridge Business Park along Meadowridge Road. Although this pond was designed as a dry pond field crews observed standing water in the pond and the water appeared to be several feet deep. Three storm drain inflows (two 48 in. RCP and one 27 in. RCP) were observed in the field along with an additional swale in the western corner that is likely the contribution of several storm drain outfalls along a small channel leading to the pond. Several PVC outfalls, assumed to be from building roofs, were also observed along the pond perimeter. Per several design plans (F-89-163, SDP-89-069, 98-075-p07), the development in the business park increased the storm drain inflows and pond impervious drainage area over several years. The BCCMP riser and 30 in. BCCMP spillway pipe are corroding. The 30 in. barrel has several holes along the sides and bottom and outfalls for a few feet before entering a corroding 24 in. CMP pipe that goes under Meadowridge Road. The 24 in. CMP also has holes from severe corrosion. An emergency spillway exists in the southeastern corner of the facility, but it is unclear where any overflow would easily continue to flow. The area appears to be a sump and likely this causes localized roadway flooding during larger storm events. No utilities were observed in the pond area, although water and sewer lines likely run along the bottom of the embankment and Meadowridge Road. Access is easy from Meadowridge Road, although getting around the entire pond may be difficult with some areas of steeper slopes and thick vegetation.
