# **STREAM CORRIDOR ASSESSMENT SURVEY OF THE LITTLE PATUXENT RIVER IN HOWARD COUNTY**

**WATERSHED RESTORATION DIVISION  
CHESAPEAKE AND COASTAL WATERSHED SERVICES  
MARYLAND DEPARTMENT OF NATURAL RESOURCES  
ANNAPOLIS, MARYLAND**

**STORM WATER MANAGEMENT DIVISION  
BUREAU OF WASTE MANAGEMENT  
HOWARD COUNTY DEPARTMENT OF PUBLIC WORKS  
COLUMBIA, MARYLAND**

September 2001

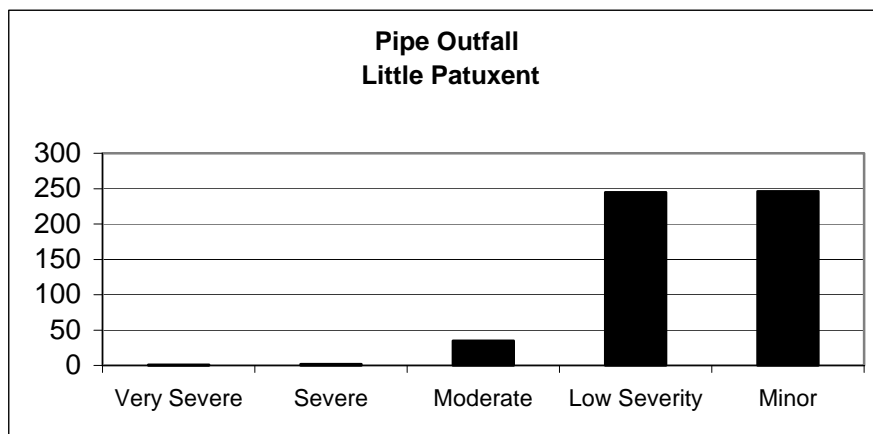
Sixty percent or 320 of the 529 outfall pipes observed during the survey were found to have some type of discharge coming out of them. Of these, only 38 were reported to have a discharge that had some coloration or smell associated with it (Appendix C). The remaining discharges were recorded as clear with no odor. The survey was done during the late fall and winter of 1999/2000. Snow was on the ground during part of the survey and snowmelt could account for the high percentage of discharging pipes.

Figure 4c shows the frequency of the severity rating given to pipe outfalls during the survey. As can be seen from the graph, the majority of the pipe outfalls were given either a very low or minor severity rating. Only one problem at Site LP110234 received a very severe rating. During the survey, field crews found an open manhole that was discharging sewage at a rapid rate at this site. This problem was reported to Howard County and was corrected immediately. Two other sites (Sites LP022308 and LP082342) received a severe rating and at both of these sites, a colored discharge and a sewage smell were reported. There were no estimates of the amount of fluid coming from the pipes. No immediate follow up actions were taken as part of this study to determine the source of the color or smell coming from any of the pipes. In some cases, coloration or smell from a storm drainpipe may be a sporadic occurrence. This is especially true in areas where there is no stormwater management system present.

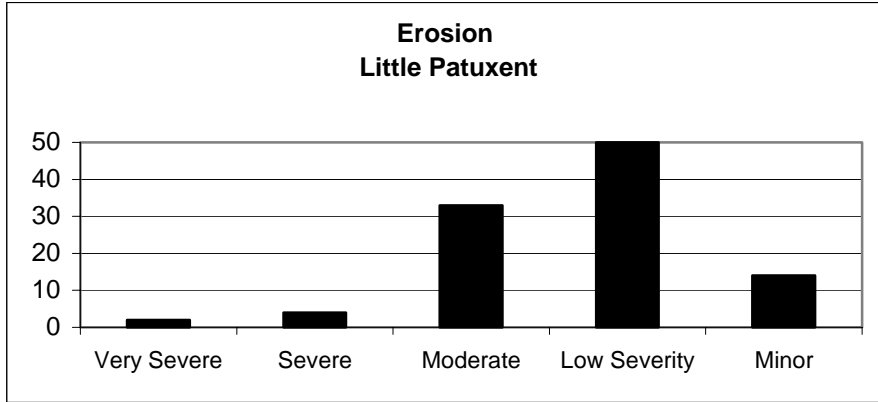
Unstable eroding streams are areas where the stream banks are almost vertical and the roots from the vegetation along the stream's banks are unable to hold the soil on the banks. Unstable eroding stream banks were reported at 103 sites during the survey (Figure 6a). The majority of the erosion sites showed moderate to minor erosion that extended over long distances. The lengths of stream segments that were recorded as having unstable banks varied from 6 feet in some areas, to other areas where up to 2 miles of stream was found to have an erosion problem (Appendix C). Overall, results indicate approximately 9.7 miles of unstable eroding banks in the Little Patuxent watershed. Figure 6b shows the frequency of the severity rating given to erosion sites. Only two sites received a very severe rating and five other sites were rated as severe.

Head cuts were also reported at several sites during the survey. Head cuts are areas where the streambed drops suddenly and indicate continuing readjustment of the stream channel. An example of an active head cut can be seen at Site LP039308.

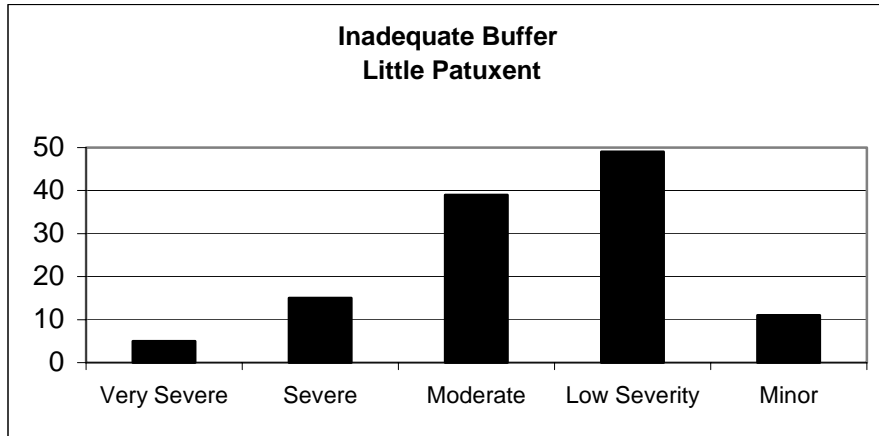
Figure 7b

While there is no single minimum standard for how wide a stream buffer should be in Maryland, for the purposes of this study a buffer is generally considered inadequate if it is less than 50 feet wide, measured from the edge of the stream. Inadequate buffers were reported at 119 sites during the survey as shown in Figure 7a. The field crew provided a rough estimate of the length of the inadequate stream buffer at all sites (Appendix C). Based on the data that was collected, there are approximately 97,265 feet (16.7 miles) of inadequate buffer in the Little Patuxent watershed. Field teams found inadequate buffers ranging in distance from 75 feet to 6,900 feet. This survey was done in a highly urbanized area, with mowed lawn reported as the dominant adjacent land use at inadequate buffer sites, accompanied by a small amount of agricultural land and parkland. While a large number of inadequate buffer sites were identified, most sites received a moderate to low severity rating (Figure 7b). This would indicate that most of the stream reaches with inadequate buffers were not very long or some trees were already present at many of the sites.

Survey results indicate that there are several possible locations on both public and private lands where forested buffers could be reestablished. Sites LP097230 and LP091120 received the highest severity rating possible and should be investigated to determine if establishing a forested buffer would be possible. In some locations, including Sites LP041304, LP042310, and LP128106, bike paths come close to the stream and there may be opportunities to plant trees between the bike path and the stream to allow for larger buffers in these areas. Another area that should be further investigated is site LP162204, which is above Centennial Lake. A vegetated stream buffer in this area could help reduce nutrient input to the lake. Centennial Lake was constructed in the early 1980's and algae growth, which could be caused by excess nutrients, is a problem in the lake. Based on the survey's initial results, a buffer planting has already been done at site LP128106 and site LP128105, inside of Altholton Park in October 2000.

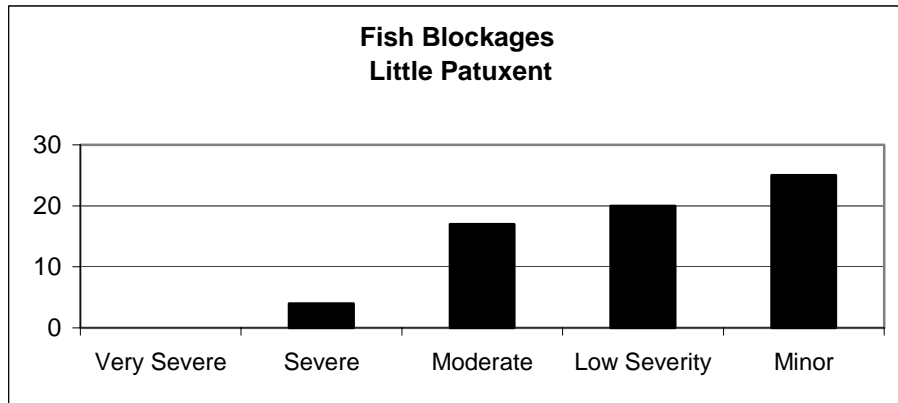
Sixty-seven fish migration barriers were reported during the survey. The locations of fish migration blockages are shown in Figure 8a. The blockages were due to a number of reasons including small dams (10), road crossings (17), pipe crossings (5), channelized stream sections (5), natural falls (8), ponds (7), and debris dams (11). Of the remaining fish blockages, gabion baskets and a weir were reported to cause one fish migration blockage each. Most of the sites were given moderate to minor severity ratings (Figure 8b). Overall, the mainstem of the Little Patuxent River is relatively barrier free. The only man made structures on the River's main stem are two small dams (Sites LP110121 and LP105106), which were in the upper portion of the watershed. Downstream of the area that was surveyed there is a dam at the Fort Meade Wastewater Treatment plant. This dam, however, does have a working fish ladder and the migration of Blueback herring and alewife through the ladder has been documented. Once these anadromous fish pass through the fish ladder at Fort Meade, there are no presently known blockages to their migration until they reach Savage Mill. Savage Mill is located at the fall line between the Coastal Plain and Piedmont physiographic provinces and there is a natural waterfall present at Site LP049501. The waterfall is composed of a series of greater than 1-foot water drops and it is presently believe that alewife and herring would have difficulty migrating upstream through this area. This site was given a minor ranking because it is a natural barrier.

Any strategy to remove fish migration barriers in the Little Patuxent River should first attempt to keep the mainstem of the River as barrier free as possible. In addition, barriers that isolate large sections of tributaries from the mainstem, such as Site LP121109, or barriers that isolate significant portions of the upper portion of a tributary, such as Site LP099247, should also be targeted.

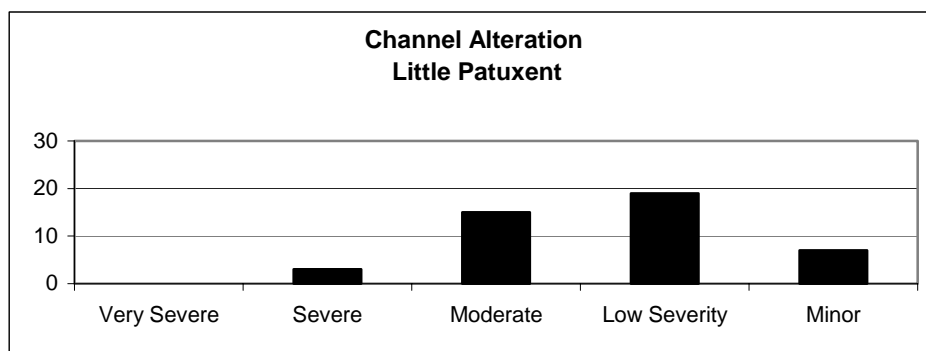
Results of this survey indicate that the stream has been recognizably altered in 45 areas and their locations are shown in Figure 9a. The total length of stream affected by channelization was estimated to be 14,262 feet or about 2.7 miles. There were no major stream systems reported in the survey as being extensively channelized and most of the sites were given a moderate to minor severity rating (Figure 9b). Most of the sites identified were also on small channels. Over half of the sites were channelized with concrete (25), while 9 were earthen channels that had been straightened, 8 were armored with rip-rap, 1 channel was lined with gabion baskets, and 2 were lined with wood. The correctability rating given for most of these sites were high because of the difficulty and expense of removing concrete. At one site, LP125301, it appears that the concrete channel is failing and the stream is beginning to flow underneath the concrete. Though this site received a low severity rating because of its short length, extensive gullying could occur beneath the concrete if it is not fixed.

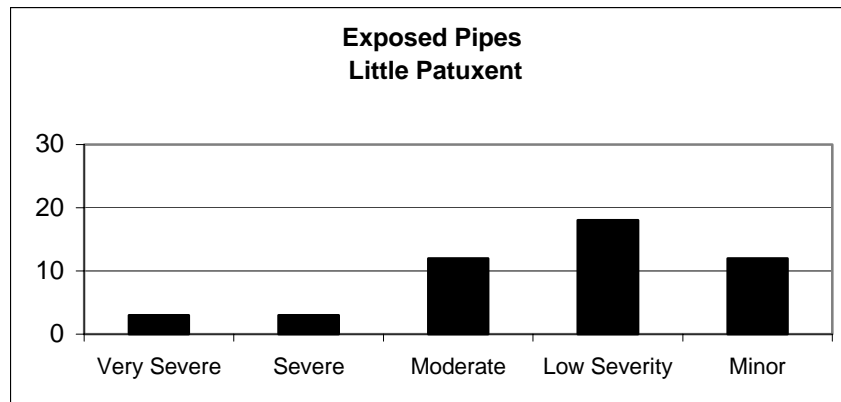
Figure 10a

Exposed pipes were reported at forty-six sites during the survey. Locations of these sites are shown in Figure 10a. Of those, thirteen were manhole stacks, twenty-three were places where pipelines crossing the bottom of the stream had been exposed, seven sites had pipes exposed along the edge of the stream channel, and pipes were located crossing above the stream at 3 sites. Field survey teams reported 2 sites as having very severe problems. Sites LP039303 and LP064305 had discharges with a sewage odor and should be investigated further.

No other discharges were reported during the survey and most sites were give a moderate to low severity rating (Figure 10b). All exposed pipe photos should be reviewed by public works officials and follow-up visits should be done based on their evaluations.

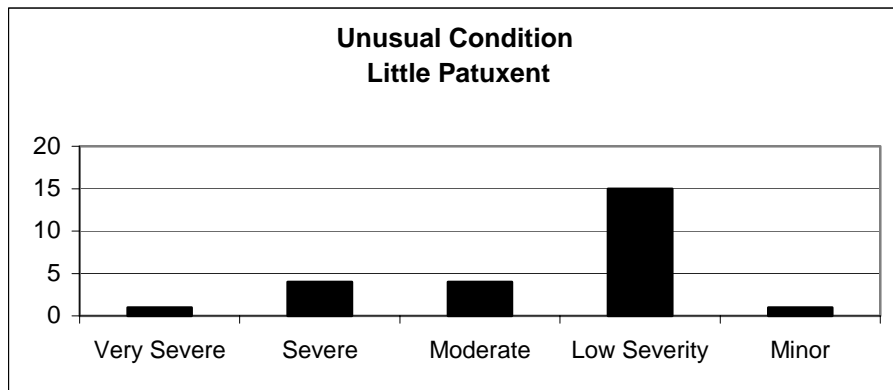
Figure 11b

The unusual condition/comment data sheets are used by survey teams to record the location of anything out of the ordinary seen during the survey or to provide some additional written comments on a specific problem. Twenty-five unusual condition sites were found during the Little Patuxent survey (Figure 11a) and two comment data sheets were filled out. Site LP110234, a manhole discharging sewage, was given the highest severity rating. Three other sites were reported to have a sewage odor, but were not associated with an exposed pipe or pipe outfall. The other problems frequently recorded were red flock and large amounts of algae. These were give lower severity ratings (Figure 11b).

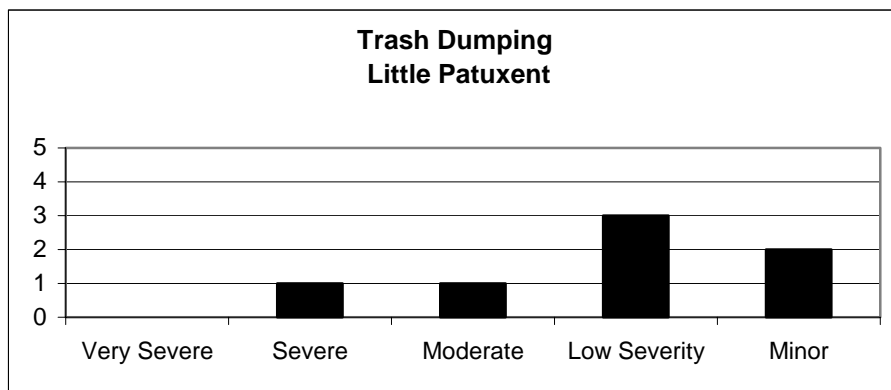
Figure 12b

The trash dumping data sheets are used to record the location of places where large amounts of trash has been dumped inside the stream corridor or to note places where trash tends to accumulate. The field survey crew found seven sites where there was excessive trash and their locations are shown in Figure 12a. Only one was recorded as severe, Site LP031320, which is a construction site. It was estimated to require 15 pick-up truckloads to remove all the trash from this site. Four sites were recorded as having yard waste, one had residential waste and one had industrial waste. These sites were given severity rating ranging from moderate to minor (Figure 12b).
