Historic Preservation and Mitigation Documentation
Identification of Salvageable Material
8049, 8055, 8059, and 8069 Main Street,
Ellicott City, Maryland

Prepared by: *EHT | Tracerics* for
Howard County Department of Public Works

Report Date: November 3, 2020

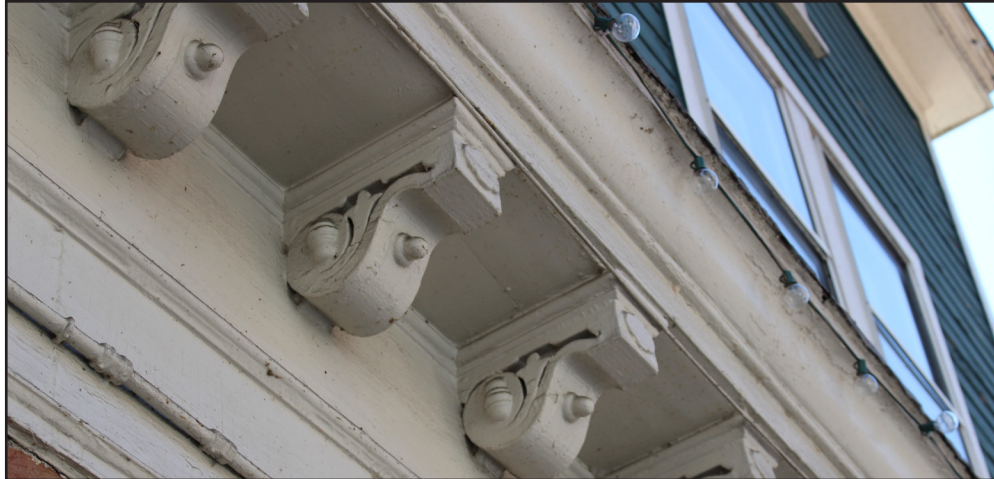
- Full cornice between the first and second floors on the north and east elevations (Figure 4)
- Iron railing and posts at second floor porch (Figure 5)
- Standing seam metal roof at rear of second floor (Figure 6)

Figure 4: Detail of cornice. Tracerics, 2020

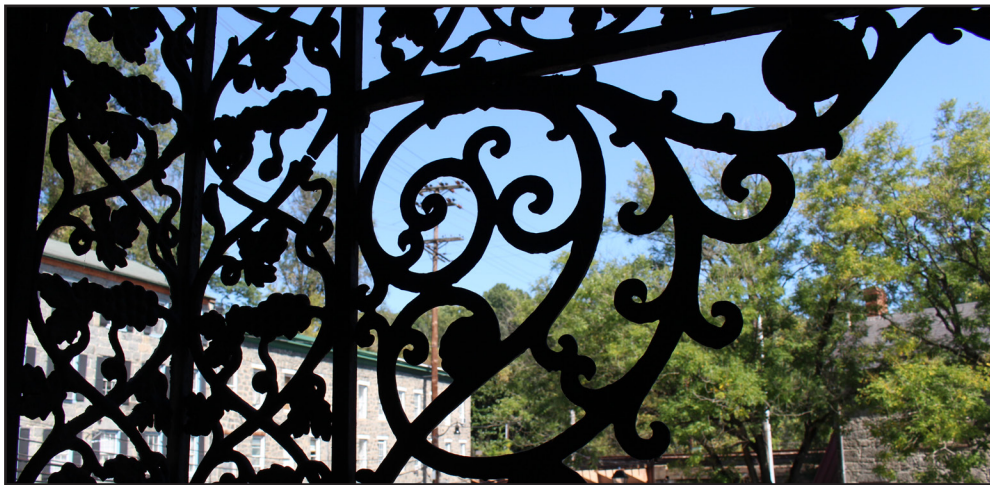
Figure 5: Detail of iron railing. Tracerics, 2020

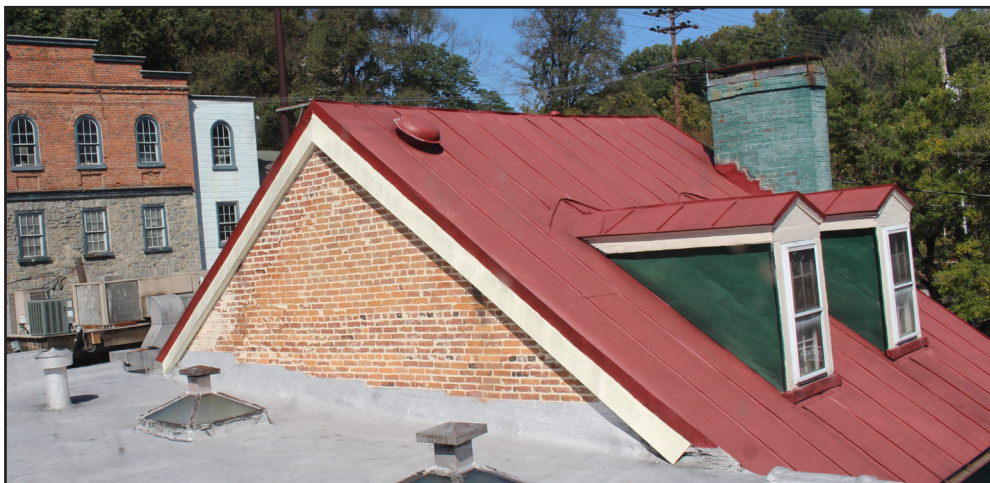
Figure 6: Standing seam metal roof. Tracerics, 2020

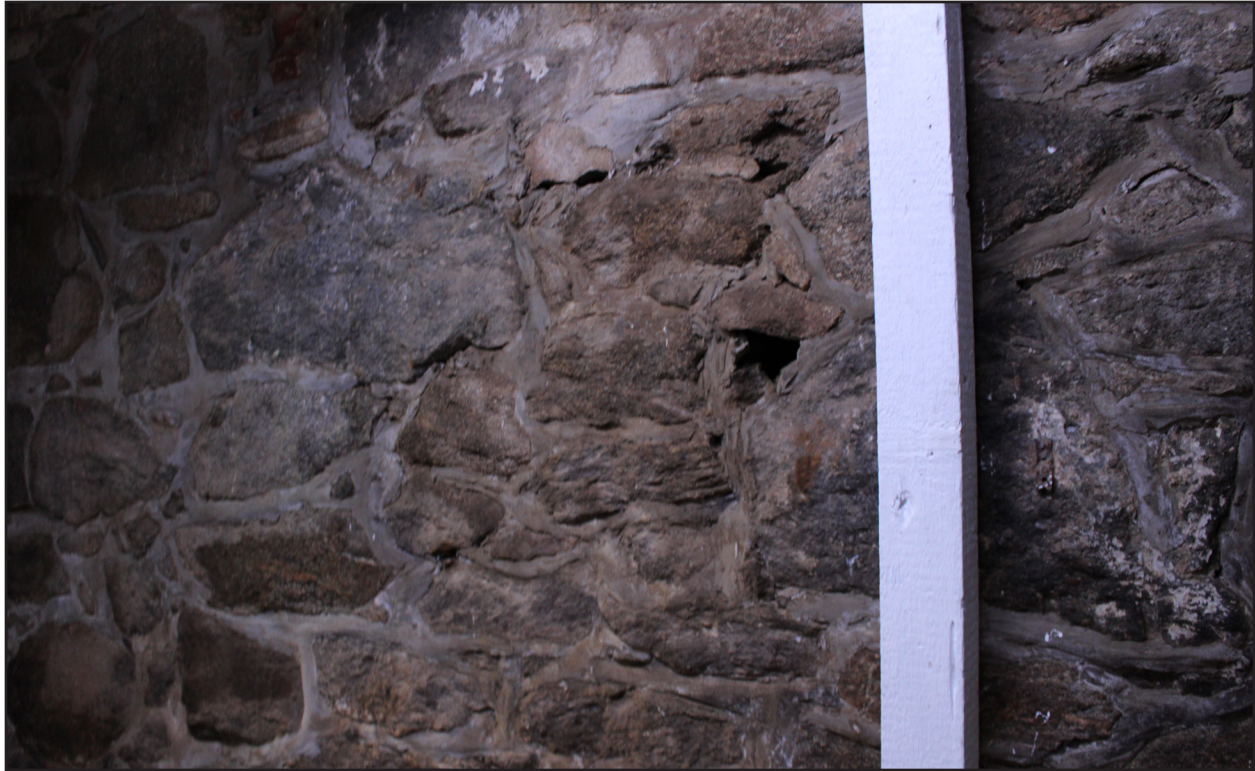
- Fieldstone at the basement foundation walls (Figure 7)
- Bricks of the two chimney stacks (Figure 8)
- Six historic wood windows at the attic level (Figure 9)
- Roof rafters and beams (Figure 10)

Figure 7: Fieldstone walls of the basement. Tracerics, 2020

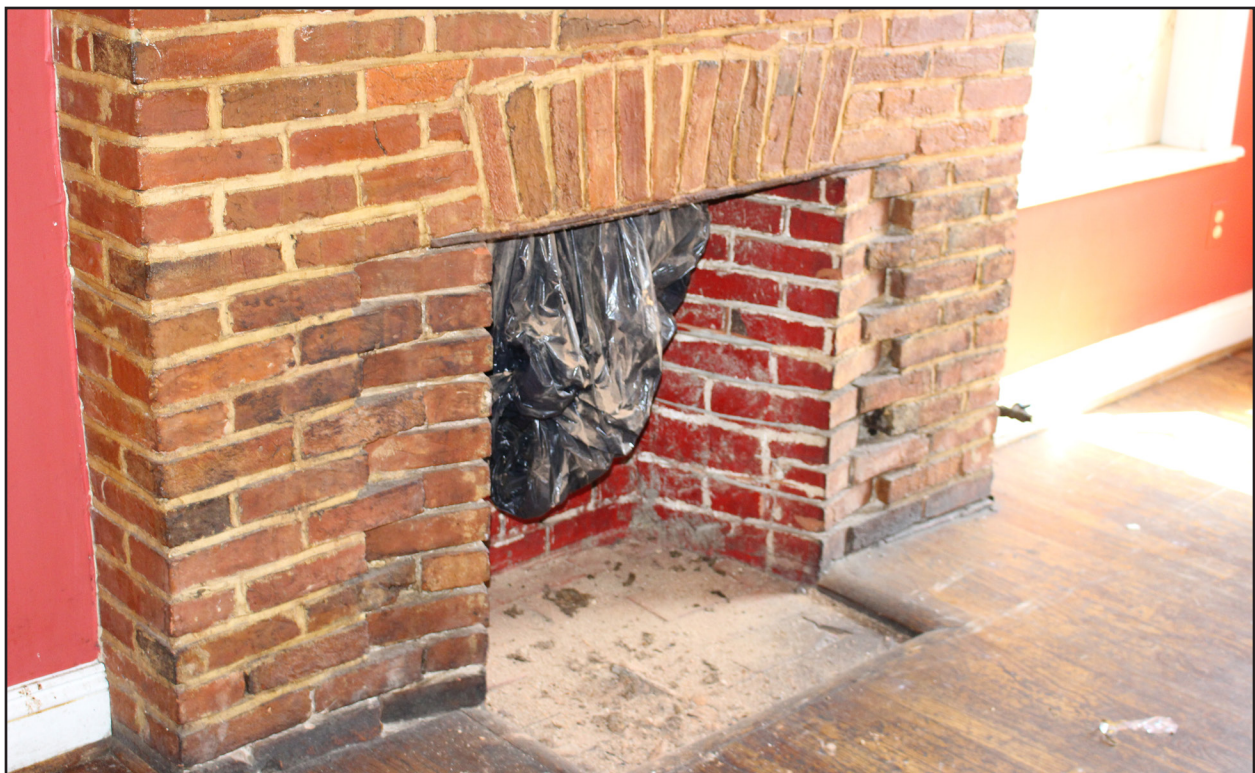
Figure 8: One of the two remaining chimney stacks in the building. Tracerics, 2020

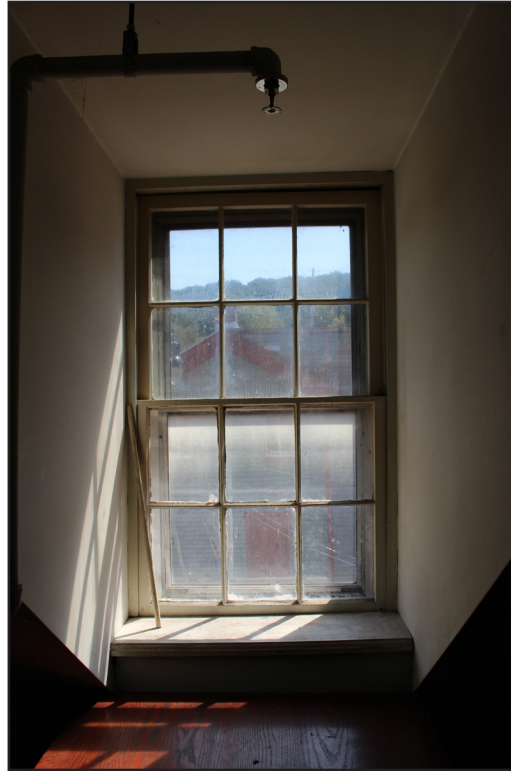
Figure 9: Six-over-six wood window in the attic. Tracerics, 2020

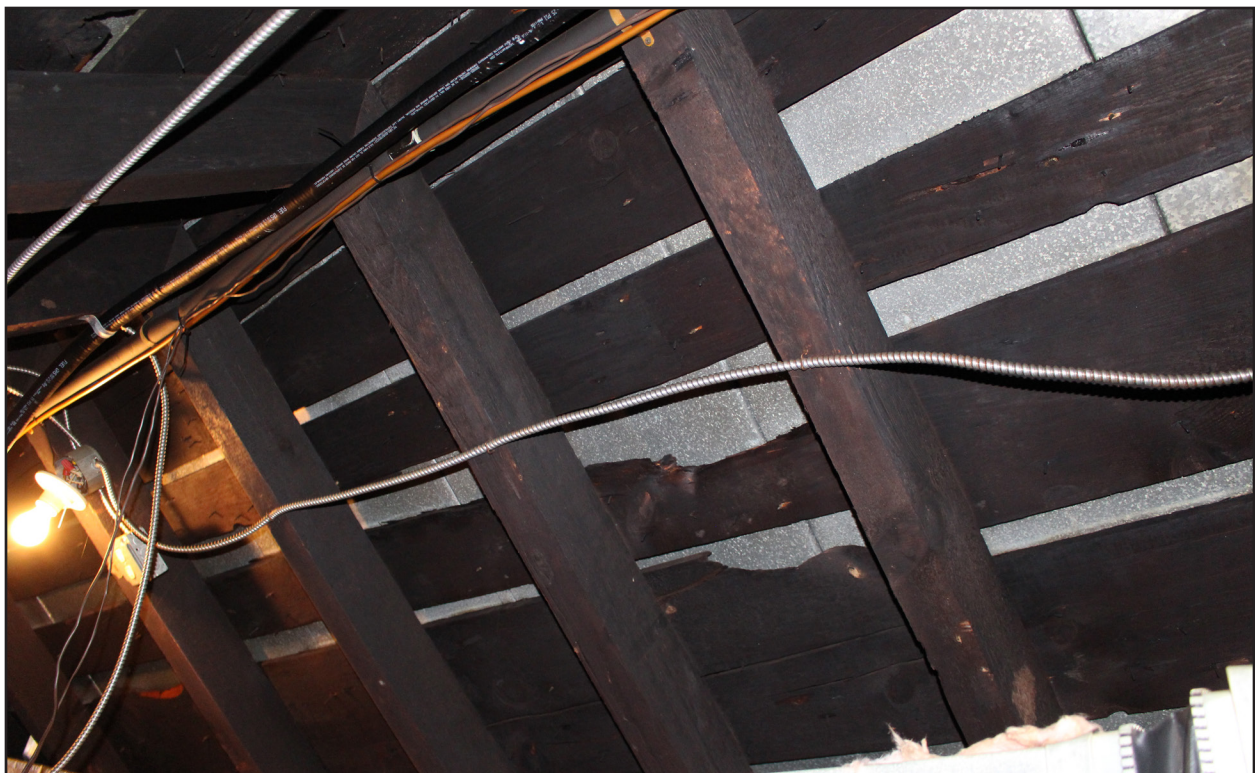
Figure 10: Wood roof rafters. Tracerics, 2020

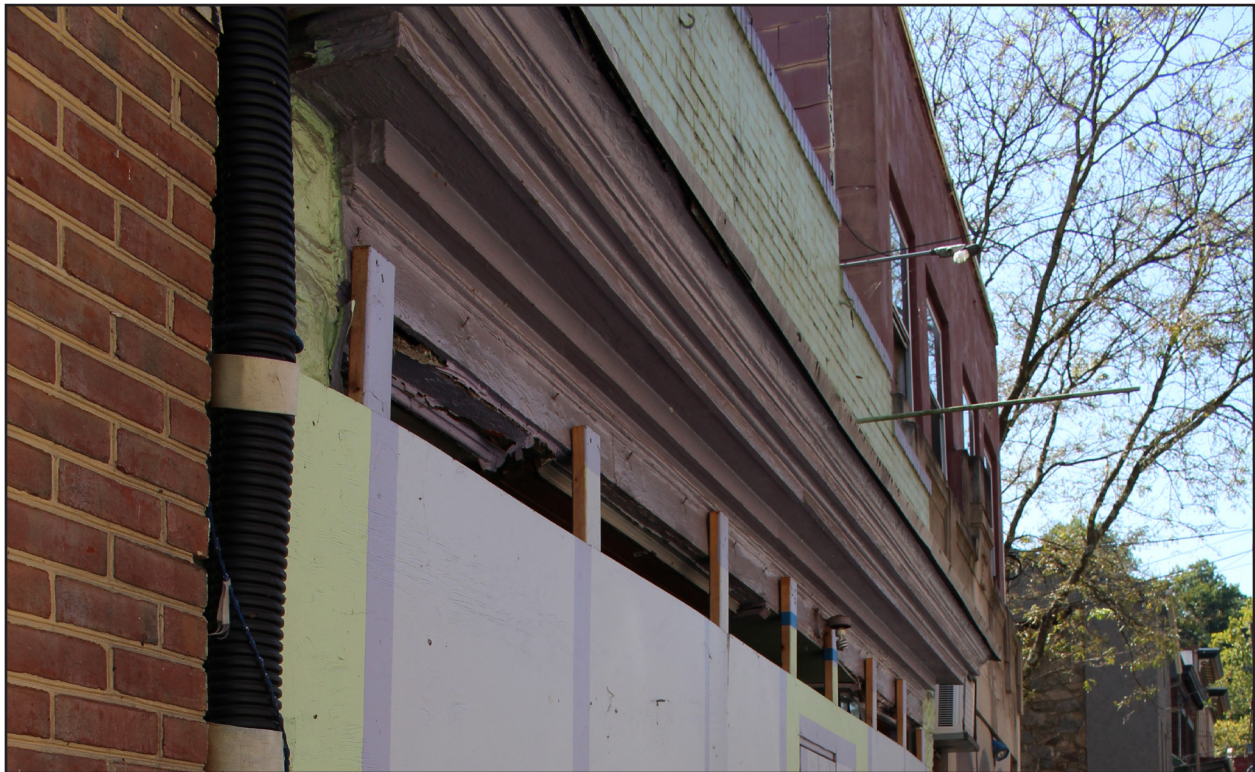
- Wood cornice on the facade (Figure 13)

Figure 13: Wood cornice. Tracerics, 2020

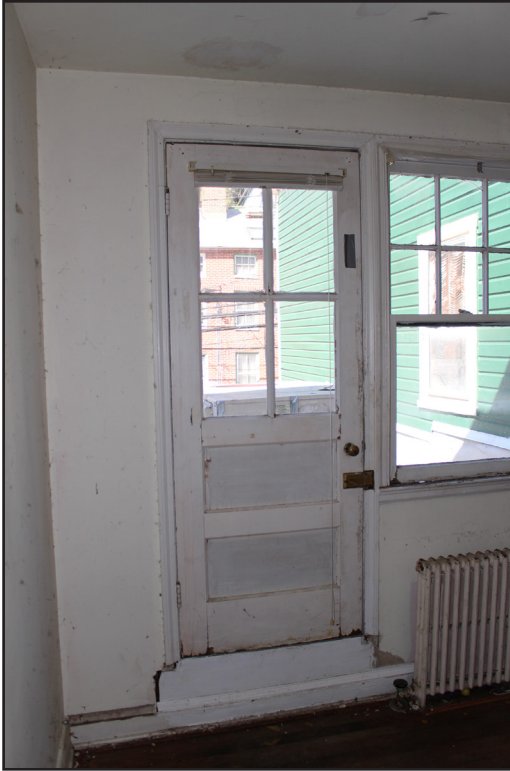
- Solid wood paneled doors at second floor (Figure 14)
- Remaining wood windows at the second floor (Figure 15)
- Steel skylight windows (Figure 15)
- Basement fieldstone walls (Figure 16)

Figure 14: Wood panel door. Tracerics, 2020

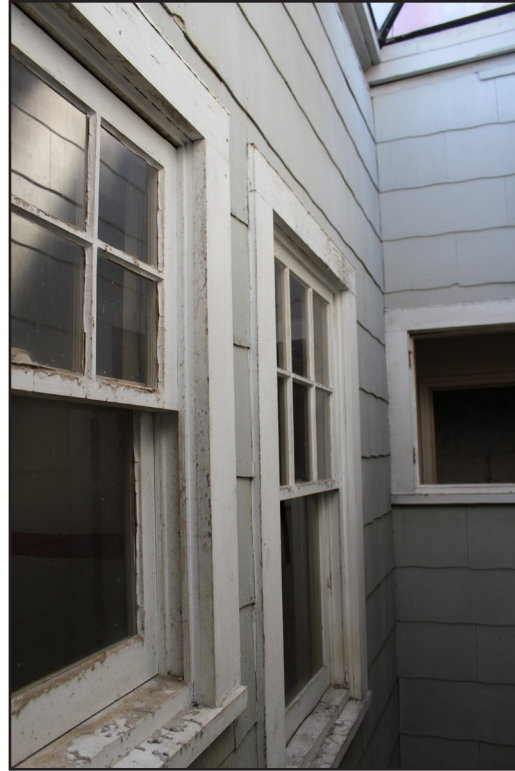
Figure 15: Wood windows and steel skylight. Tracerics, 2020

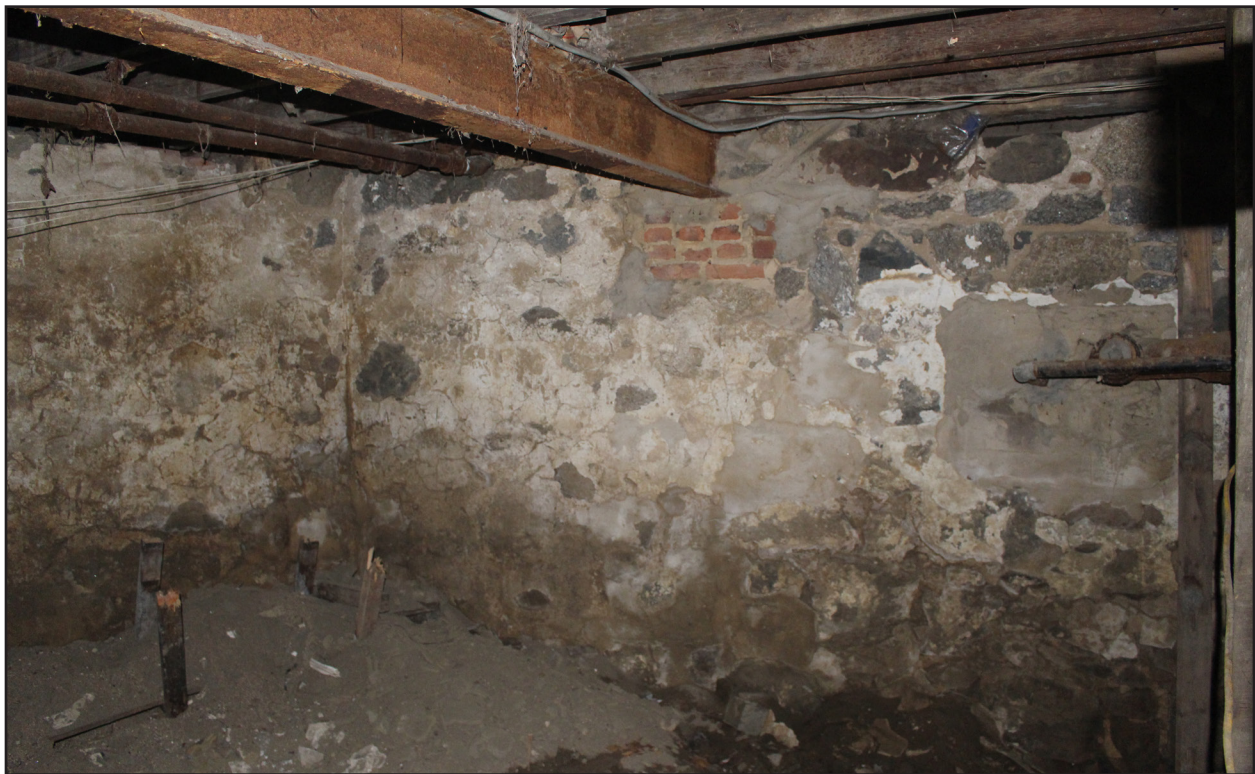
Figure 16: Fieldstone walls of the basement. Tracerics, 2020

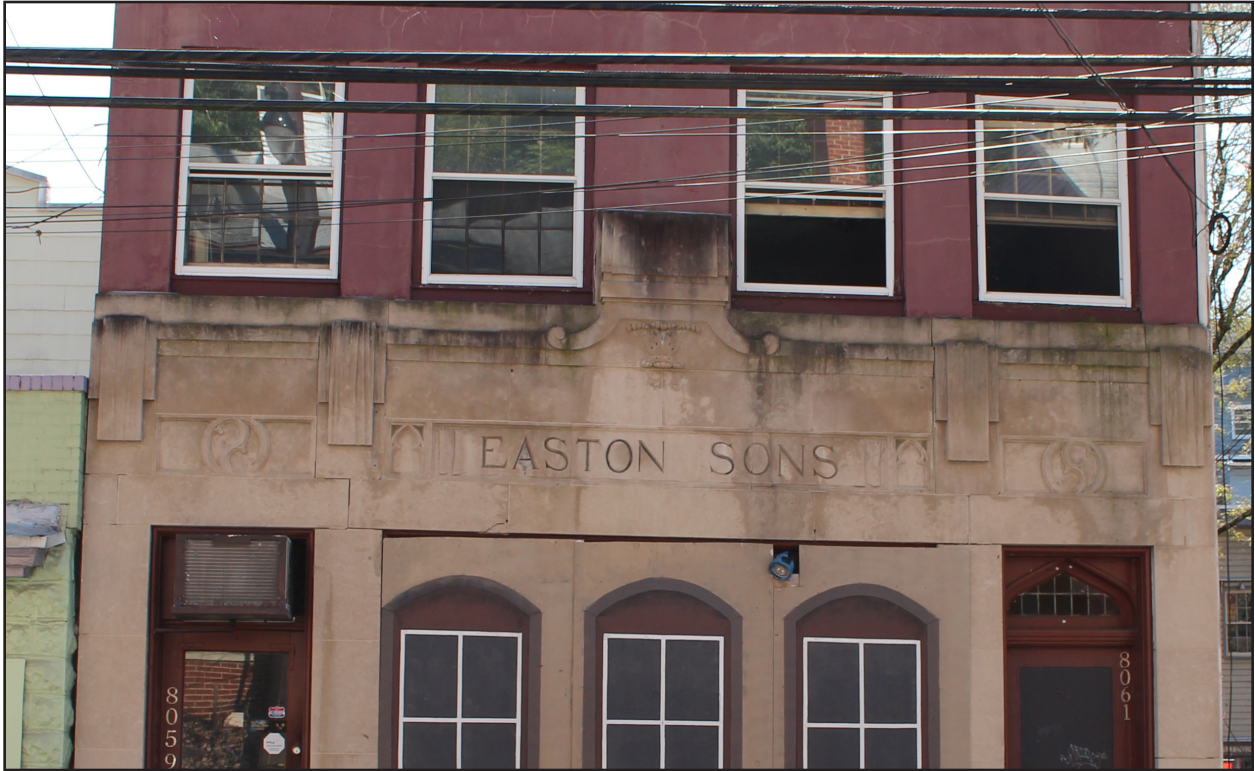
- Limestone veneer of first floor; especially the 'EASTON SONS' signage and decorative detailing between the first and second floor (Figure 20)
- Granite base and entrance step (Figure 21)
- Apartment entrance door surround and transom window (Figure 22)
- Main window surrounds at facade (Figure 23 and 24)

Figure 20: Limestone 'EASTON SONS' signage. Tracerics, 2020

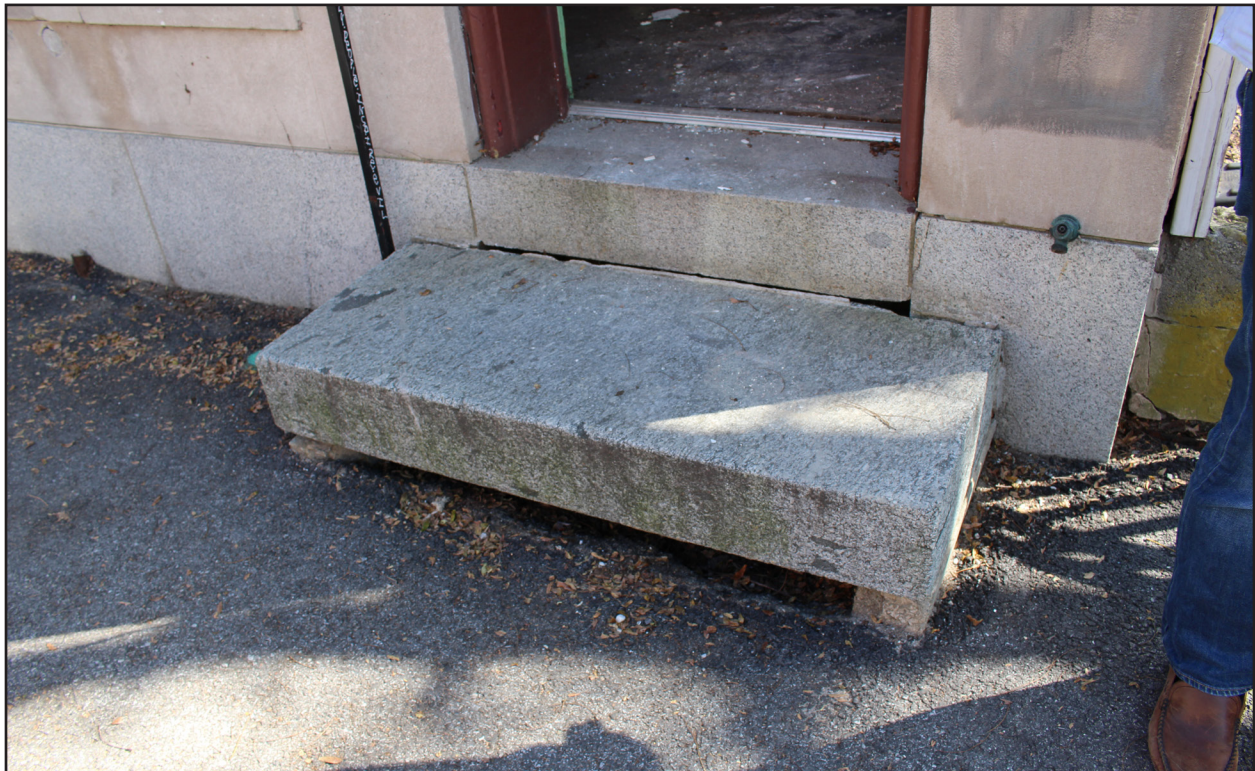
Figure 21: Granite base and entrance step. Tracerics, 2020

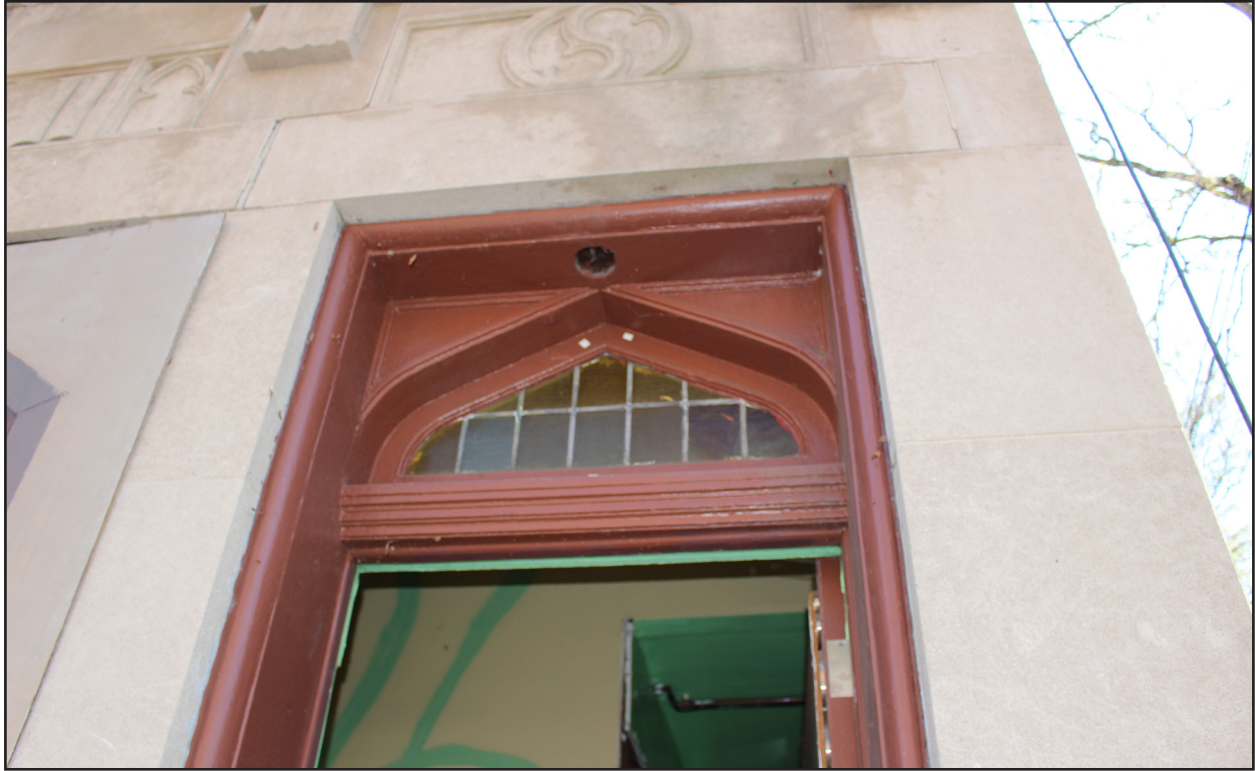
Figure 22: Historic transom. Tracerics, 2020

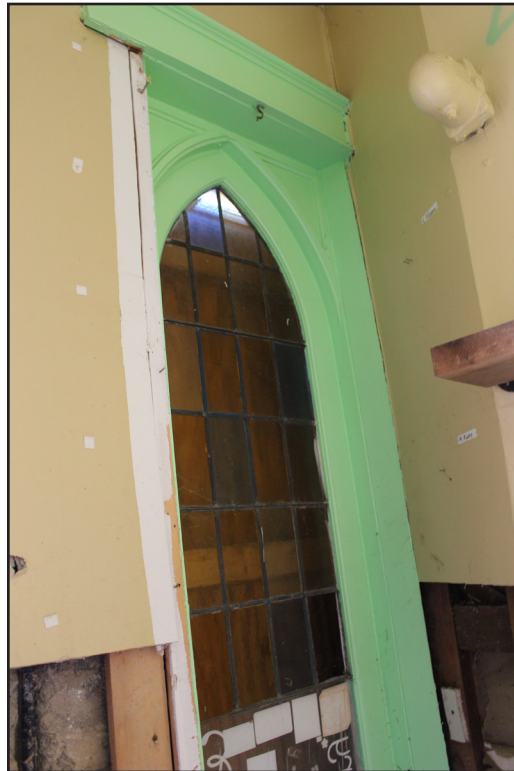
Figure 23: Remaining facade window and surround. Tracerics, 2020

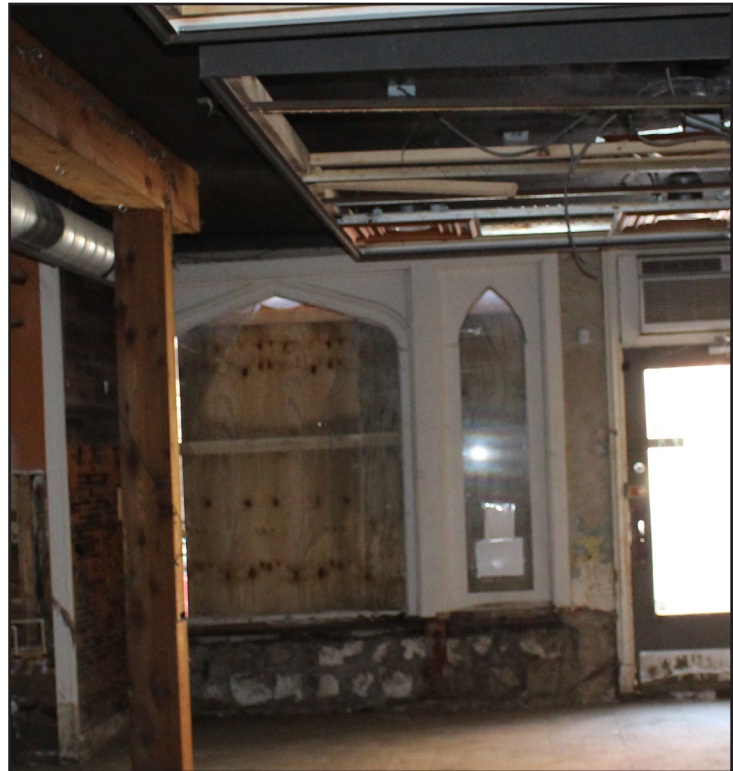
Figure 24: Facade window surrounds. Tracerics, 2020

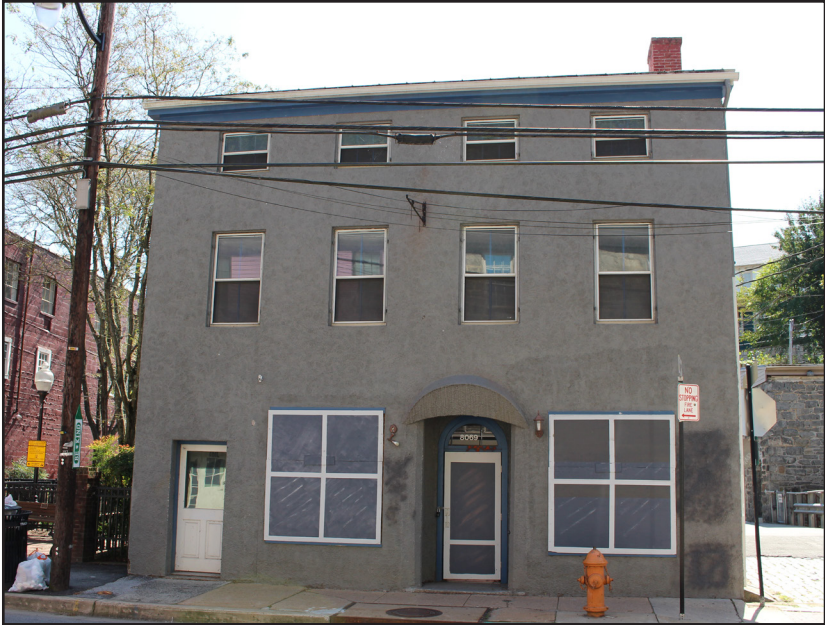
Figure 25: Facade 8069 Main Street. Tracerics, 2020

floors are currently vacant. The two storefront windows and main entrance of the facade were damaged by the 2018 flood and are currently boarded-up. The entrance features a wood surround with an arched transom light. The first floor of the building contains retail space and the upper

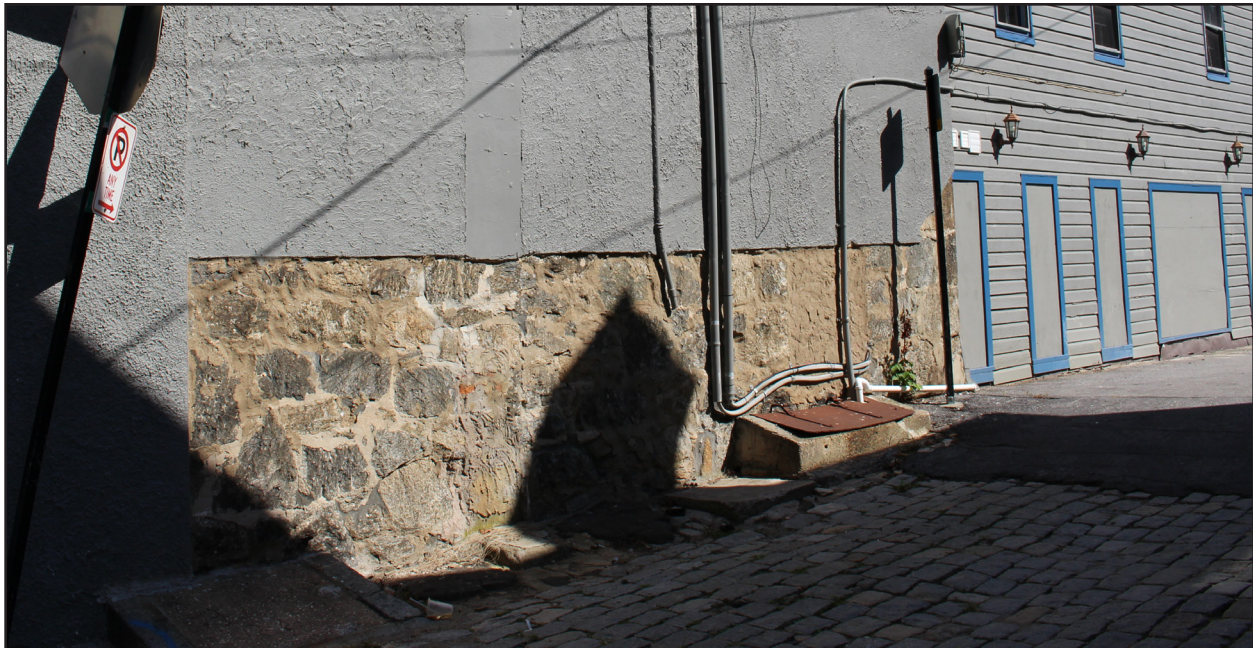
- Exterior fieldstone walls (see if additional stone is salvageable under the stucco) (Figure 27)

Figure 27: Fieldstone. Traceries, 2020

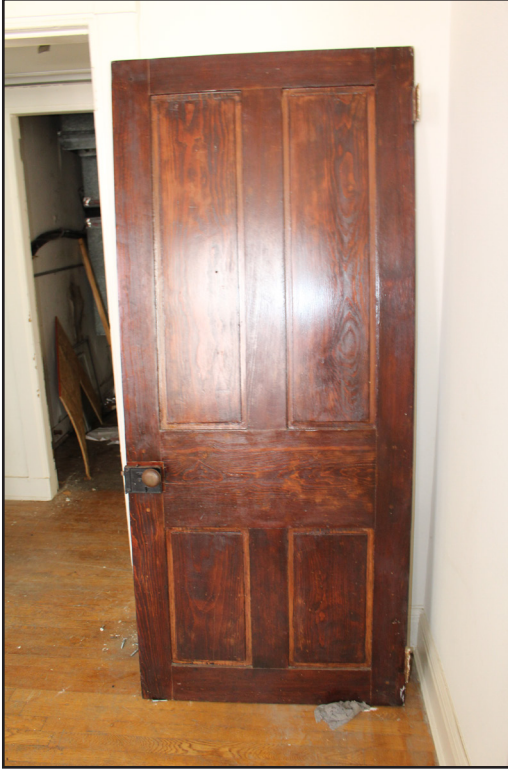
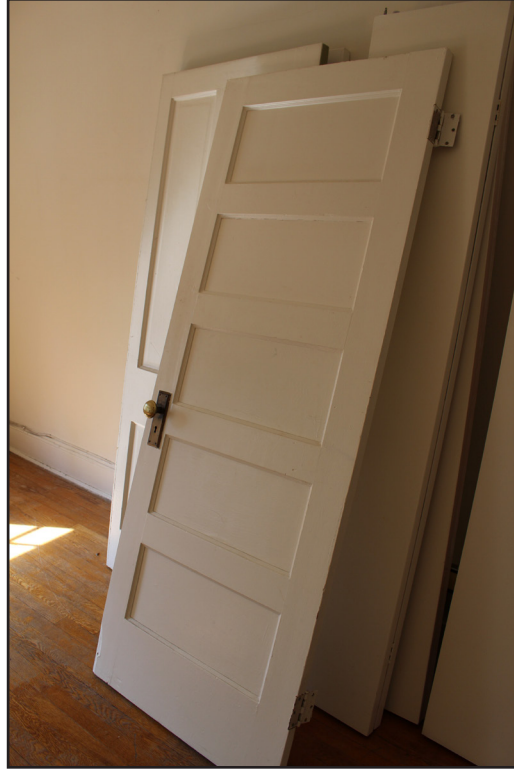
- Solid wood paneled doors at second floor (Figure 28)
- Remaining wood windows (Figure 29)
- Two fireplace surrounds (Figure 30)
- Wood balustrade (Figure 31)
- Stone wall at first floor, should it be determined to be historic (Figure 32)

Figure 28: (Left and Right) Some of the wood paneled doors. Tracerics, 2020

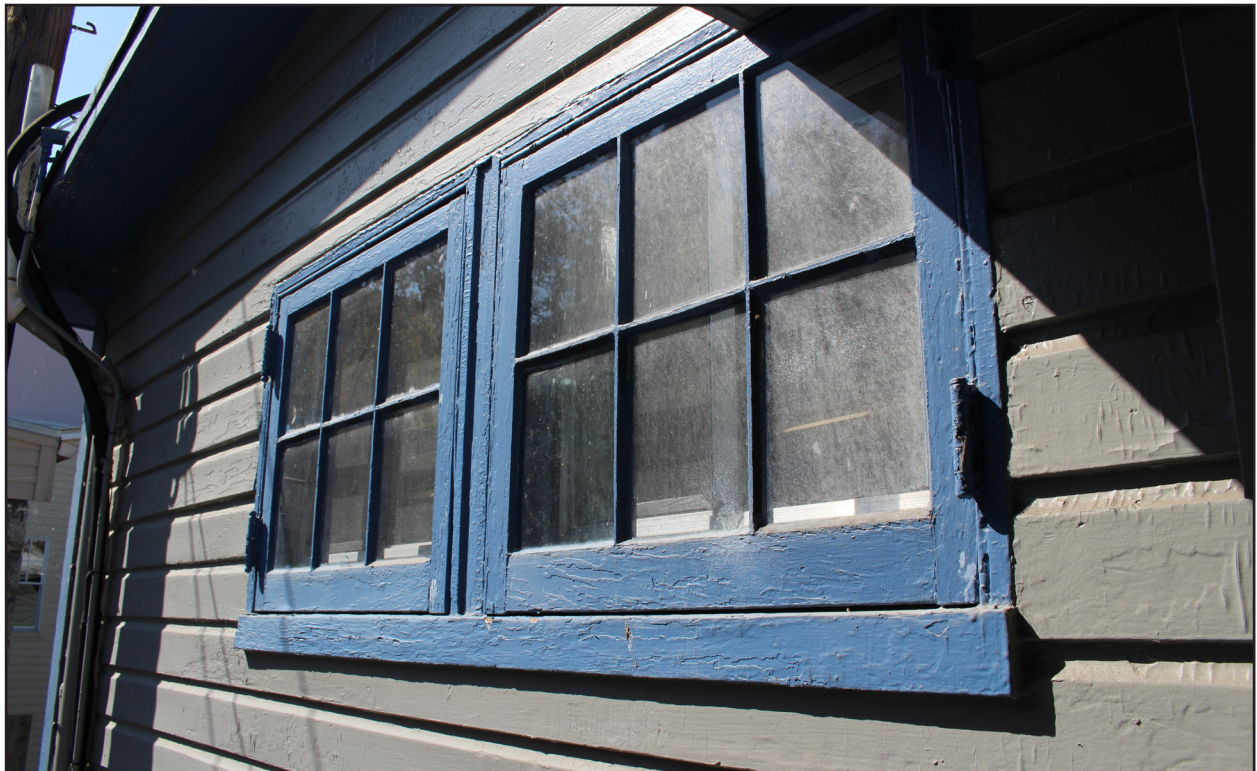
Figure 29: Wood windows. Tracerics, 2020

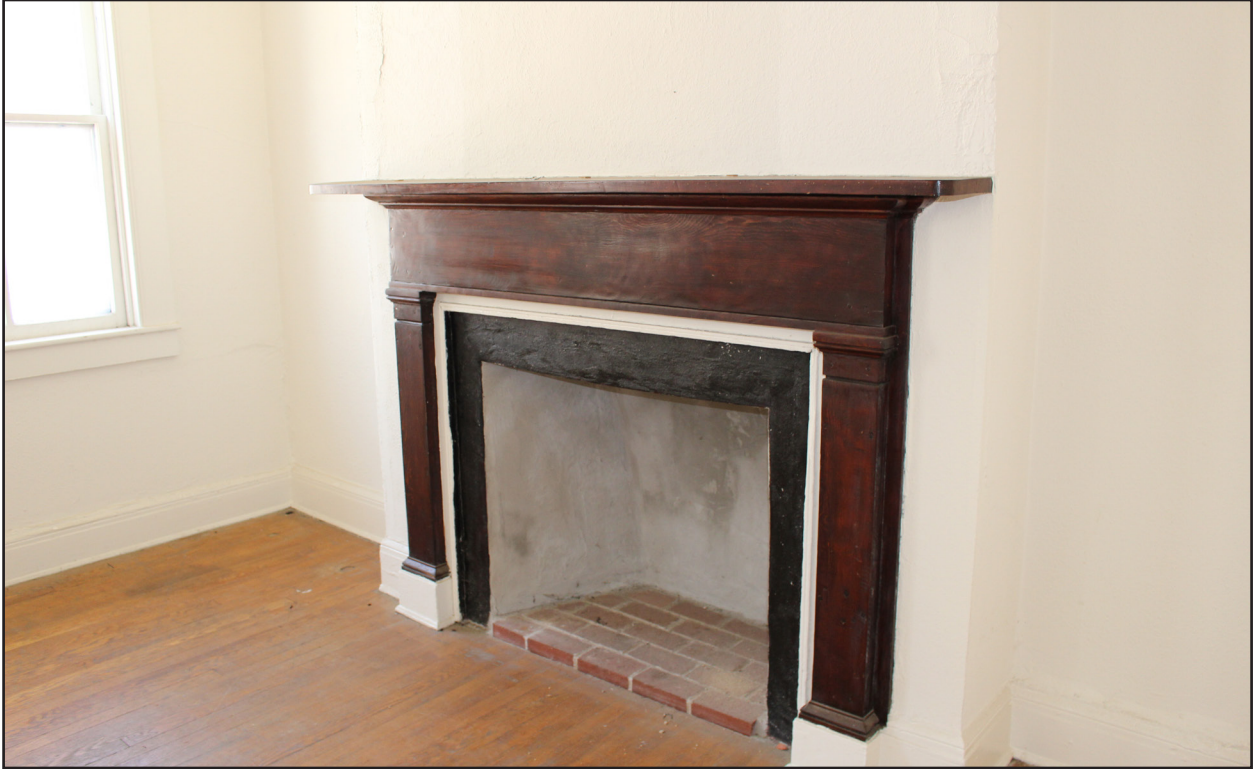
Figure 30: Fireplace. Traceries, 2020

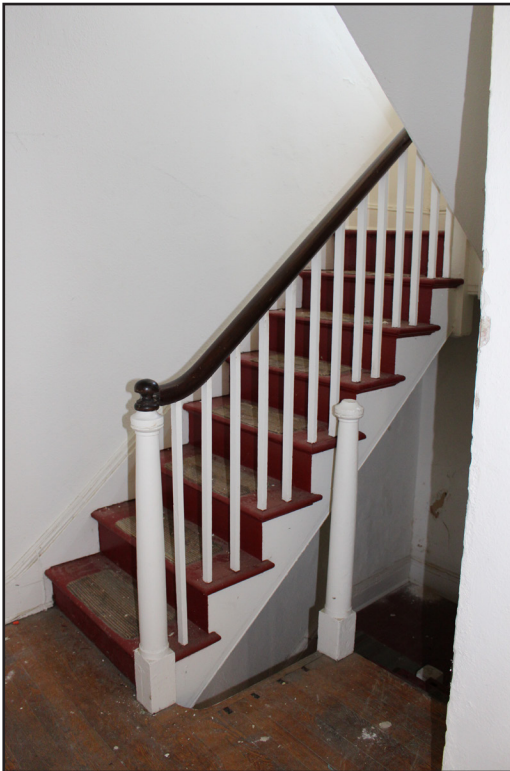
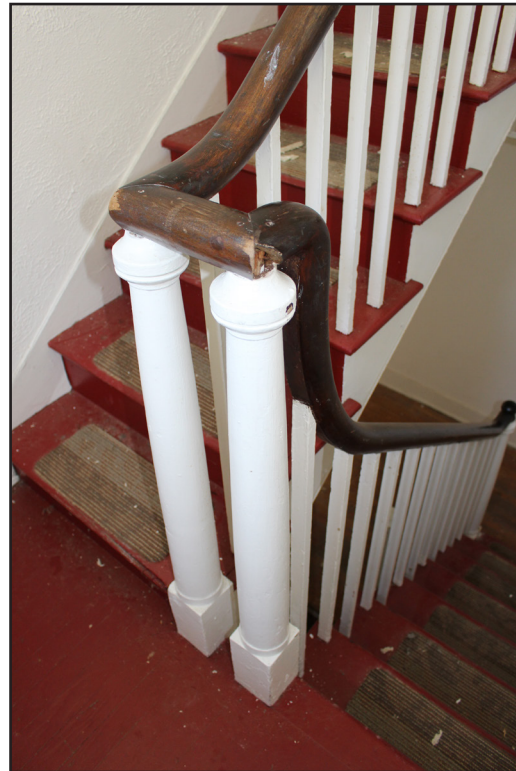
Figure 31: (Left and Right) Wood balustrade. Traceries, 2020

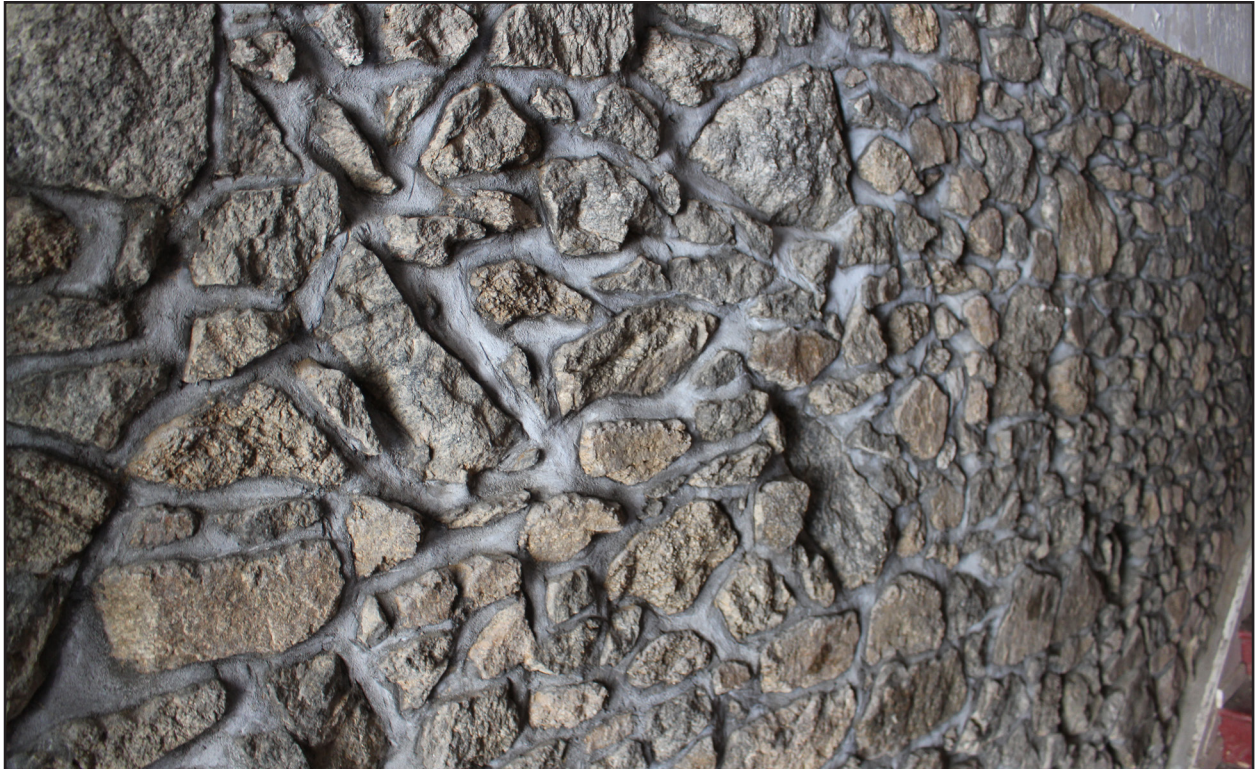
Figure 32: Stone wall. Traceries, 2020
