Best Management Practices for Symphony Stream and Lake Kittamaqundi Watersheds

Supplemental Document General Plan Amendment

September 2008

Associated with Columbia Town Center General Plan 2000 Amendment

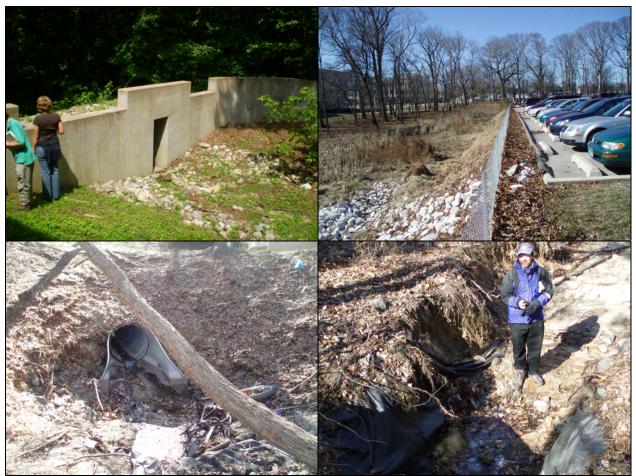
Figure 1-2: Stormwater infrastructure observed throughout the watershed, including: a dry pond that treats runoff from a townhome community (top left); a bioretention practice that treats runoff from a college parking lot (top right); an outfall that discharges unmanaged runoff from an apartment complex (bottom left); and channel erosion resulting from the outfall in the previous photo (bottom right).

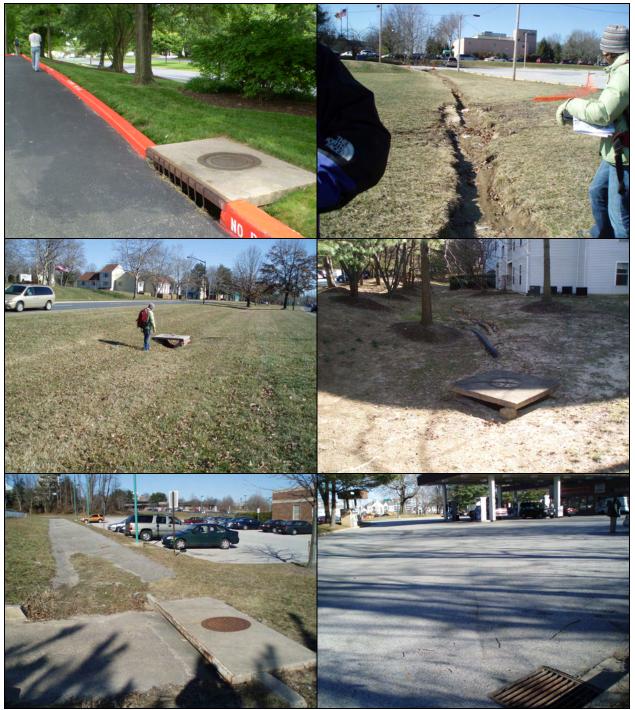
Figure 2-1: Retrofit opportunities include: creating a bioretention practice along the perimeter of a parking lot (top left); converting an eroding drainage channel into a bioswale (top right); installing a bioswale in a road median (middle left); installing a bioretention practice to treat rooftop runoff (middle right); converting a paved drainage channel into a bioswale (bottom left); and installing perimeter sand filter to treat runoff from a gas station (bottom right).

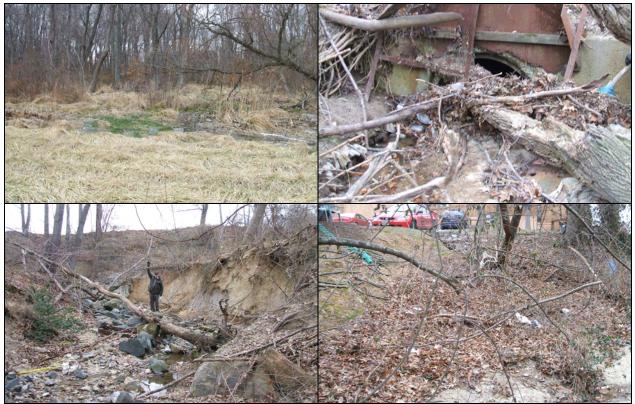
Throughout the watersheds the stream has been impacted by higher storm flows associated with urbanization. This has led to morphological changes within the stream channels; the streams have become disconnected from their floodplains, an undersized channel is causing high amounts of bank erosion, and culverts are perched on the downstream end, causing fish passage obstructions. Parts of the channels have been straightened. Much of the riparian buffer within the area assessed has become dominated by invasive species. Examples of typical impacts are displayed in Figure 2-1.

Figure 2-1: Examples of typical impacts observed along Symphony Stream: impacted buffer (top left); a blocked road culvert (top right); severe bank erosion (bottom left); and accumulated trash (bottom right).

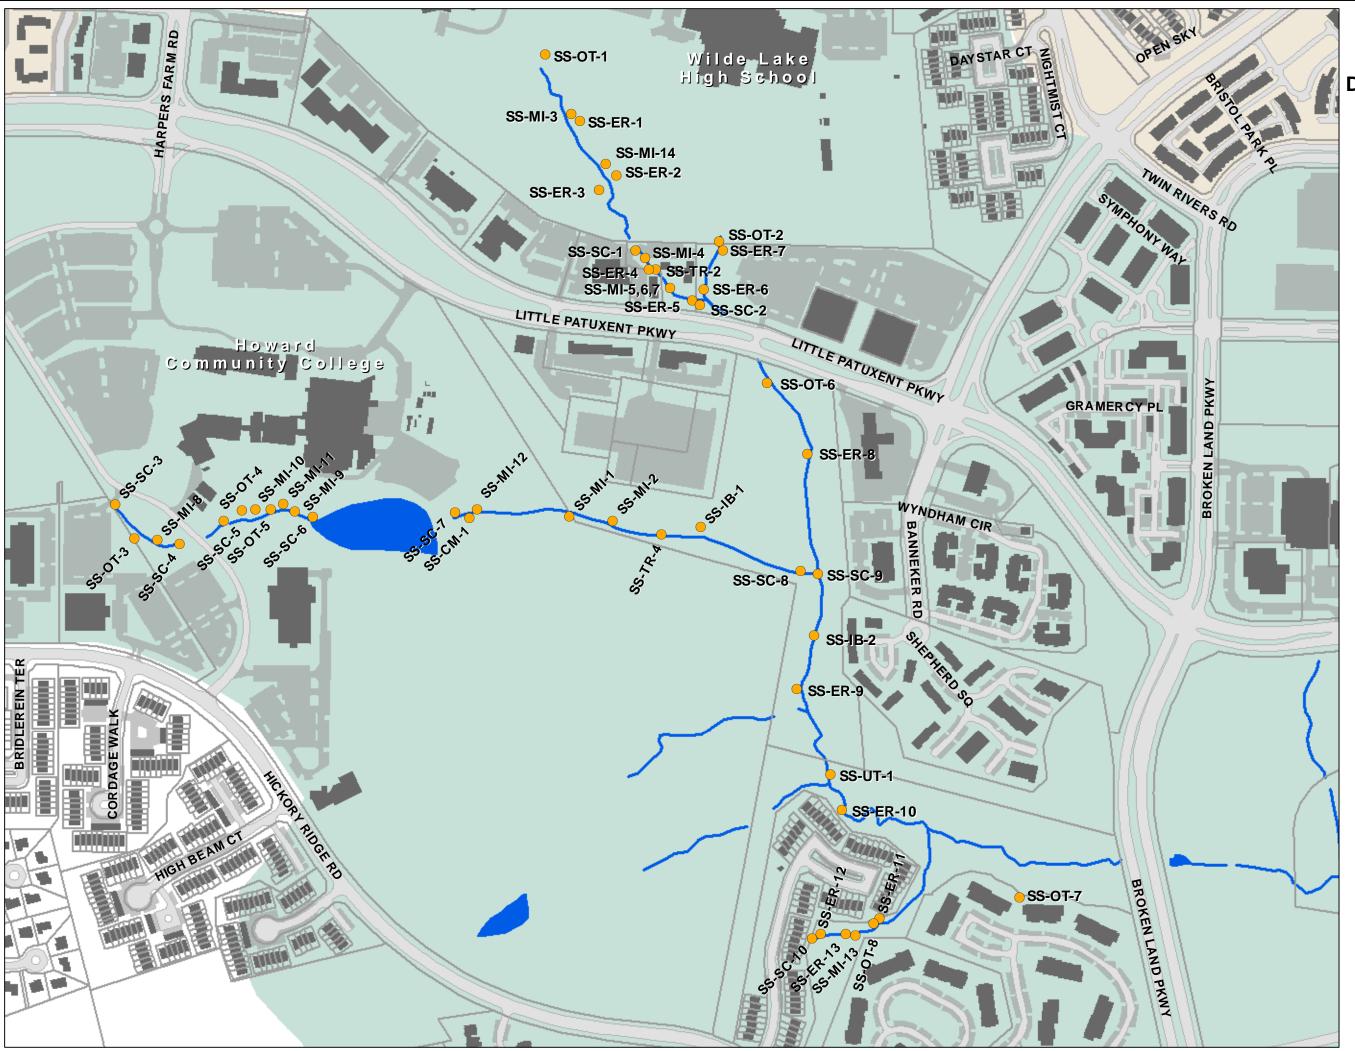
MAP 5: Impacts Identified During Stream Assessments in Symphony Stream Watershed

Field crews assessed approximately 2 miles of stream and identified 10 opportunities for riparian corridor restoration (see Maps 5 and 6 in Appendix A). These opportunities are on public and private land along Symphony Stream and the upstream end of the tributary stream to Lake Kittamaqundi. Specific types of restoration options identified include stream restoration, riparian buffer reforestation, floodplain reconnection, and bank stabilization. More information on these sites is provided in Section 3. Completed USA field forms are provided in Appendix D. Downstream sections of Symphony Stream and the tributary stream to Lake Kittamaqundi that are not identified as priorities for riparian corridor restoration still present opportunities for integrated vegetation management in the corridor and adjacent areas. More information is provided in Section 3.
