PATUXENT RIVER

BRIGHTON DAM, ROCKY GORGE DAM, AND PATUXENT RIVER UPPER WATERSHED ASSESSMENT

January 2017

KCI Technologies
936 Ridgebrook Rd
Sparks, MD 21152

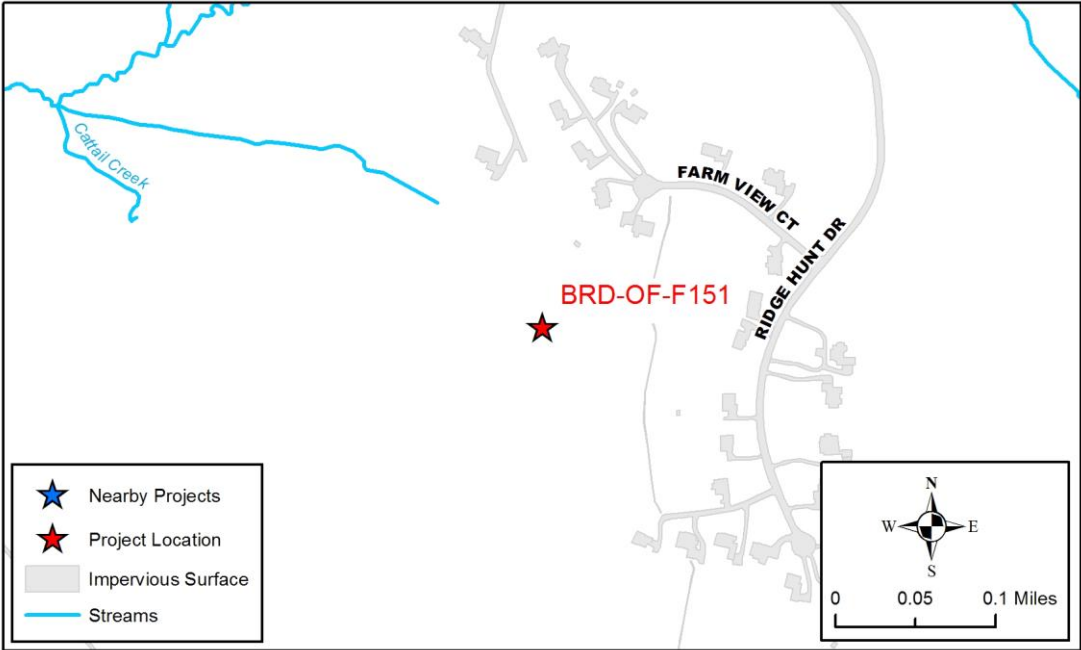
Currently, the outfall channel is eroded with 1-2 ft. exposed banks below the riprap apron. Additionally, a head cut was observed along the flow path. At the confluence with the receiving stream, signs of streambank erosion were noted. An extended detention pond discharges via a 30 in. RCP to a 20 ft. class II riprap apron. The riprap apron energy dissipation has not prevented channelization and erosion between the apron and stream convergence.

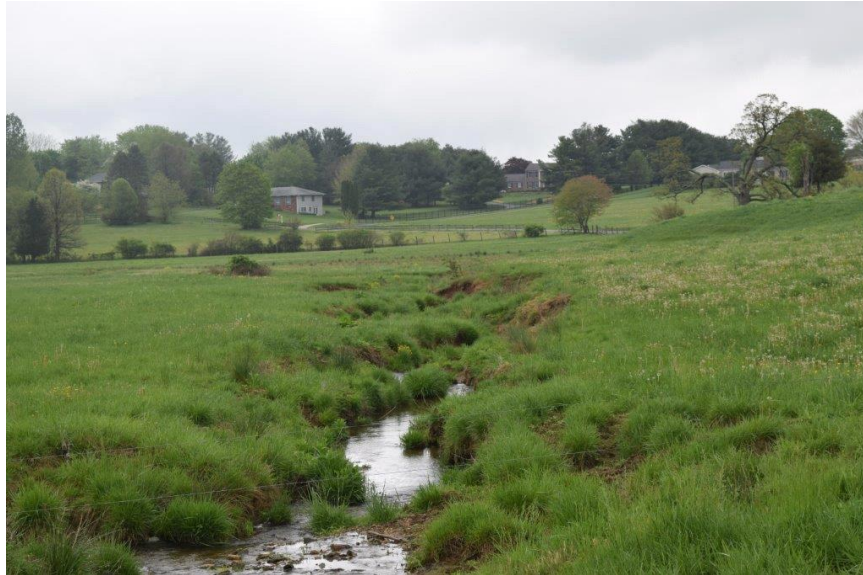
Typical stream conditions across eastern fields from culvert under AE Mullnix Rd. Bank erosion estimated to be 4 ft. or more in height at some locations.

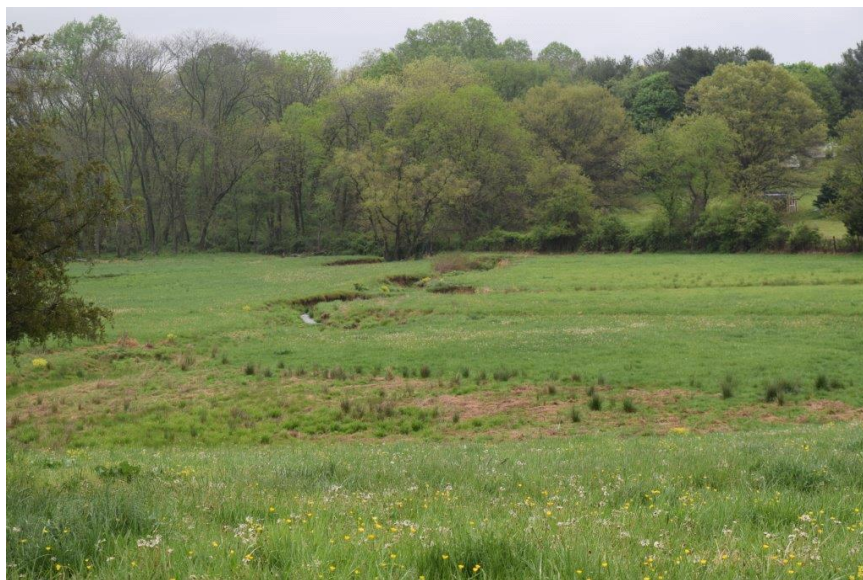
Tight meanders and high bank erosion at downstream extent of site.

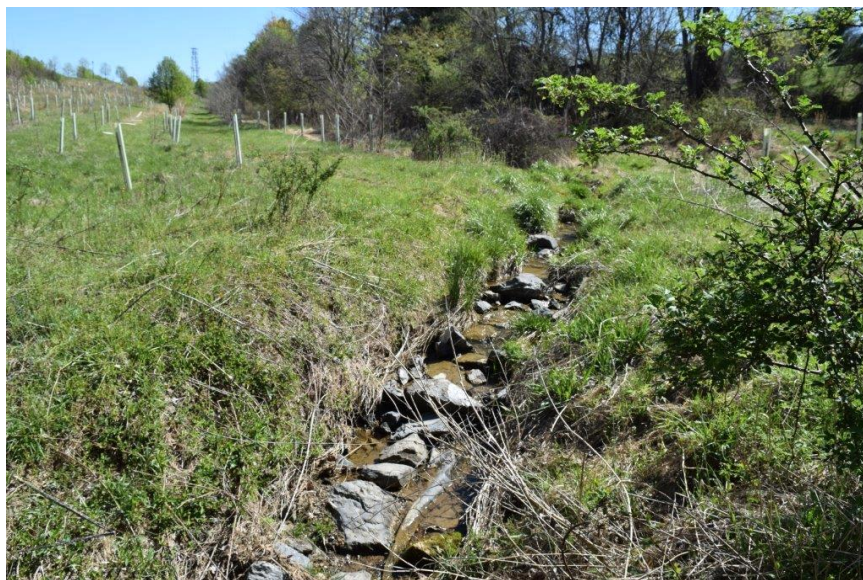
The upstream reach of this restoration site includes a channel that was previously riprapped; step pool conveyance is recommended in this area.

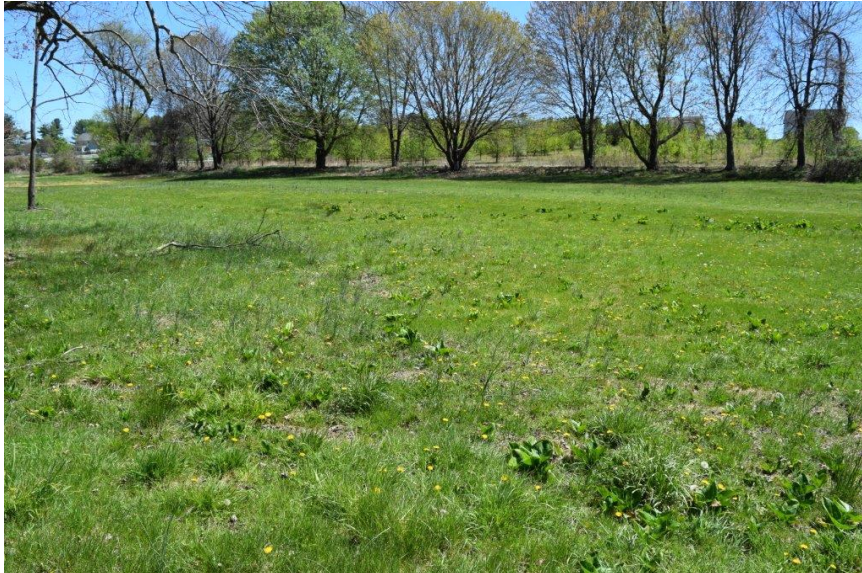
Typical condition of mowed area with skunk cabbage; much of the area had signs of a high water table.

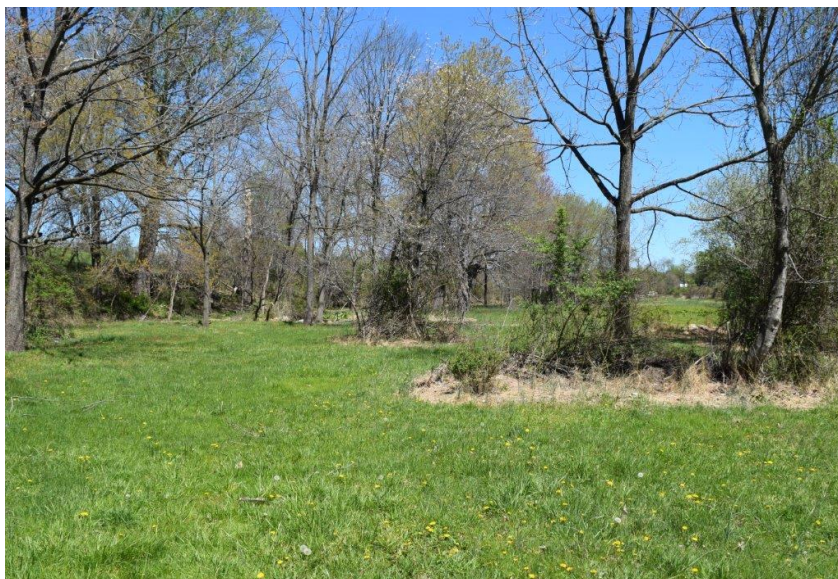
Isolated existing trees surrounded by patches of invasive plants.

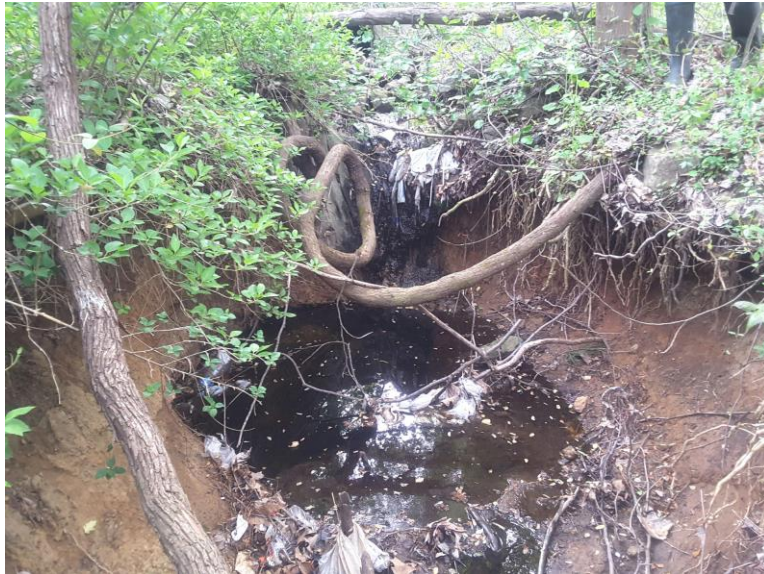
Photo facing upstream at the existing 5 ft. headcut caused from outfall PRU-OF-F306A.

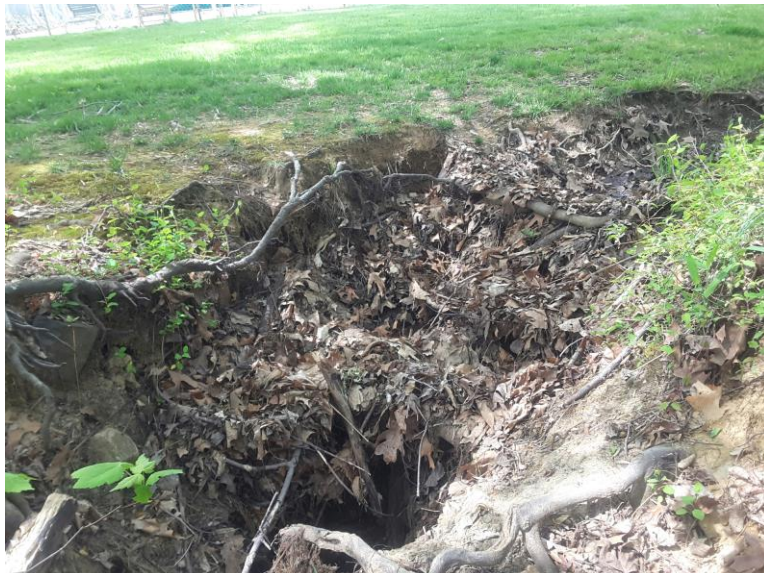
Photo facing upstream at the existing 3.5 ft. headcut caused from outfall PRU-OF-F306B.

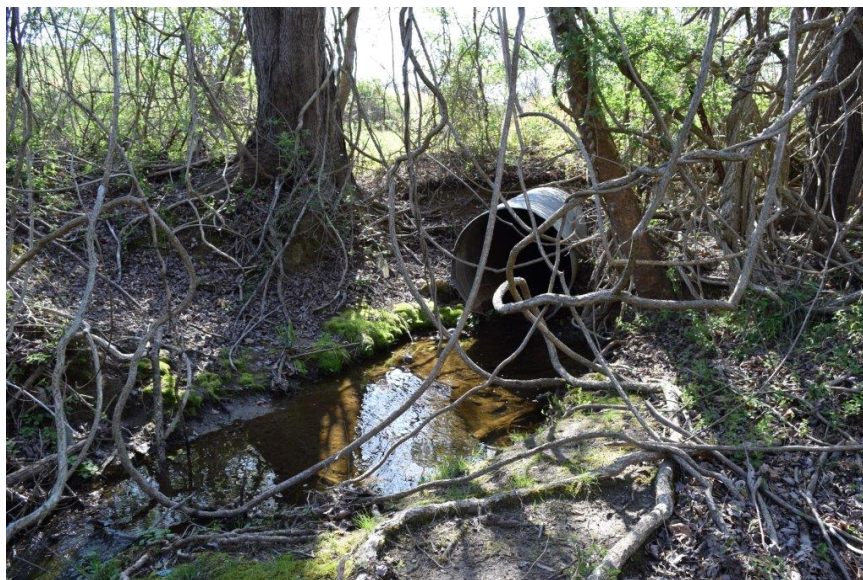
Stream exits piped reach in forested area just southeast of the agricultural pond; 2 to 3.5 ft. bank erosion was noted downstream.

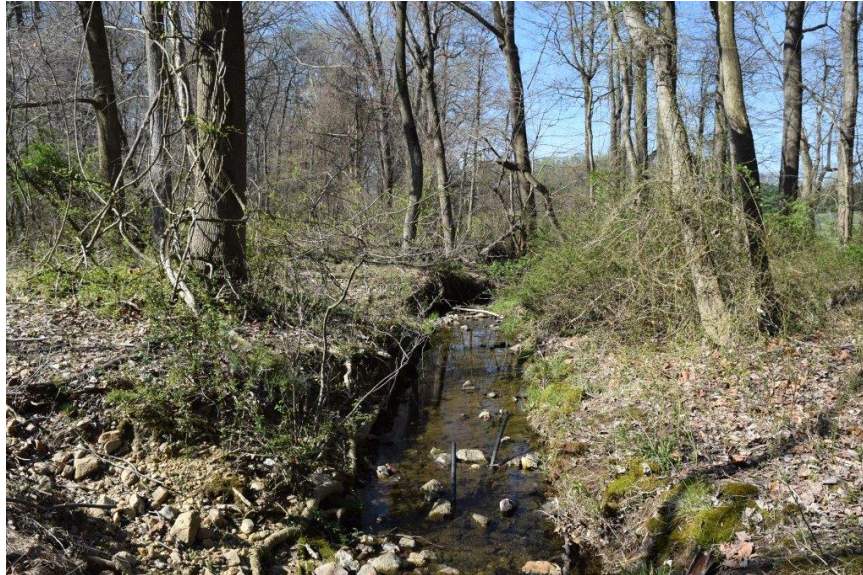
Typical conditions (construction debris, bank erosion, and wide, shallow flow) along both branches of the downstream portion.

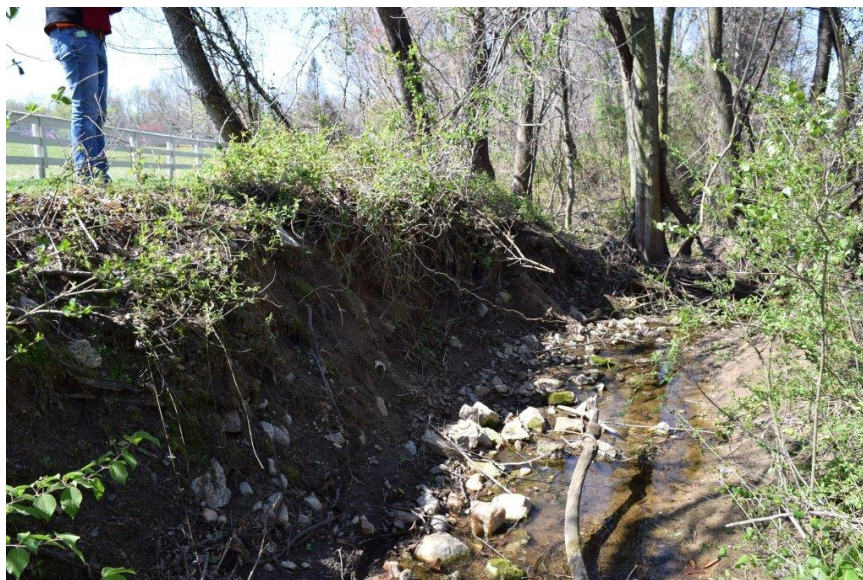
The portion of site upstream of Hall Shop Rd. is highly entrenched.

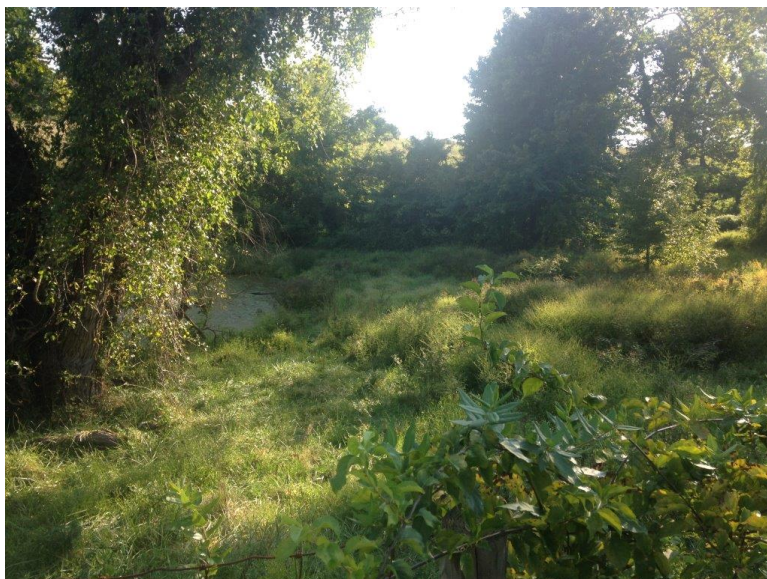
Agricultural pond in the eastern field, which will be filled in as part of stream restoration reach RGD-SR-F201A to allow for wetland planting.
