ELLICOTT CITY

8081, 8085, 8095, 8111, 8113 and 8125 Main Street, Ellicott City, Maryland

Historic Preservation and Mitigation Documentation

Howard County July 2021

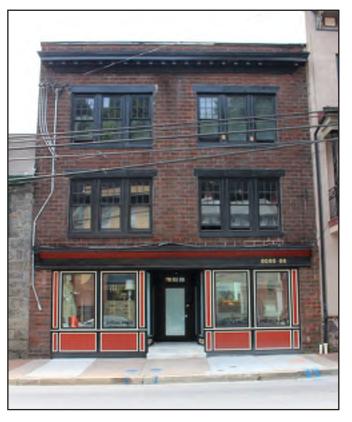
Figure 6: 8085 Main Street

Located on Parcel 51, 8085 Main Street (historically 109-110 Frederick Avenue, and 8085-8089 Main Street) is a commercial threestory, two bay masonry building that likely dates to the early twentieth-century. The building consists of a rectangular plan with a flat roof. The building's facade is a simple, symmetric design clad is dark red brick construction. The windows are double-hung arranged in a six-over-one configuration at the second and third stories. The storefront contains a central entry door flanked by fixed storefront windows, topped with a heavy cornice. The upper facade of the building is topped with a bracketed cornice.

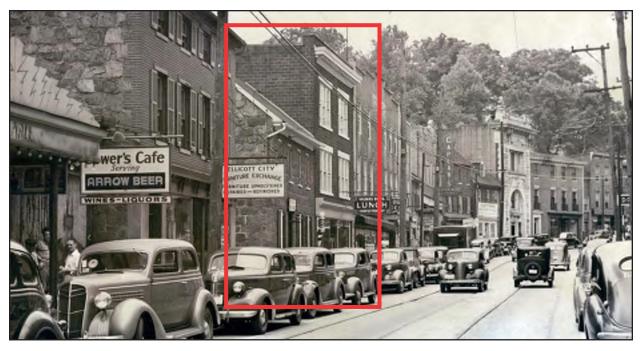
Figure 9: Detail of 8085 Main Street in 1939 (Baltimore Sun)

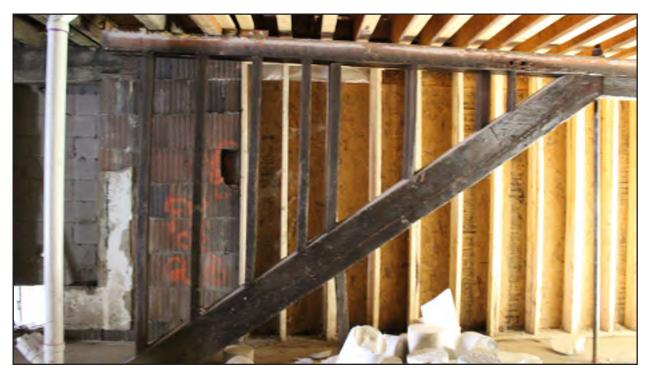
Note: The only remaining materials on the interior of this building are the stud walls, piping, heavy timber structural supports, and contemporary stairs.

Figure 11: One of the timber supports that span the interior of the building

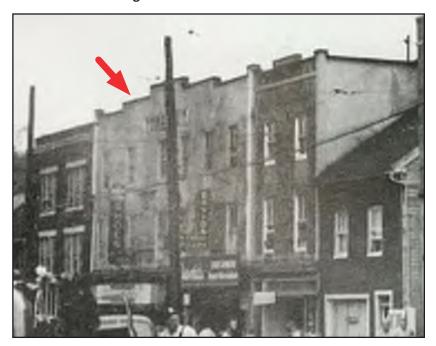
Figure 12: Detail of 8095 Main Street, circa 1950 (Enoch Pratt Free Library)

building today The has commanding presence along Main Street, standing threestories tall, and three-bays wide. According to an article published in the Baltimore Sun, the design of the new 12,000 square-foot building was based on a 1920s historic photograph found in the basement of a nearby property. Decorative iron railings define the balcony apartments and a thick cornice tops the building. Clad in large concrete block, the main facade echoes the architecture of the original building that was destroyed by the fire. One of the main goals of the project when the building was replaced was to make the building as fire and flood proof as possible. Almost the entire structure is constructed from non-combustible materials including concrete, steel, and plastic with exception of the stair rails, trim, and kitchen cabinets which are made of wood. The

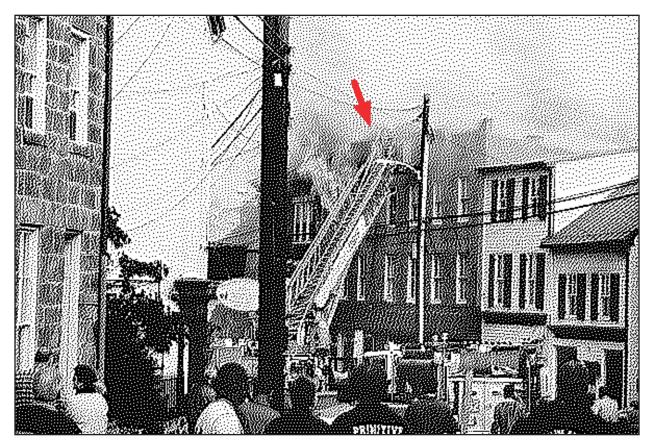
$\textbf{Figure 15:} \ Photograph \ of \ 8095 \ Main \ Street \ after \ fire \ in \ 1899. \ (Ellicott \ City, \ Then \ and \ Now)$

Located on Parcels 49 and 50, 8095 Main Street (historically 112-11 Frederick Avenue) was constructed in 2000. The present building replaces three buildings once collectively known as the "Rosenstock Building," which was constructed in the late nineteenth century. Sadly, the original buildings were destroyed by a devastating six-alarm fire on November 9, 1999.

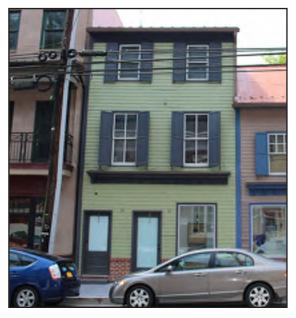
8111 Main Street (historically 113 Frederick Avenue, also 8109 Main Street) sits on a portion of Parcel 48. Today, 8111 Main Street stands three stories tall and spans two-bays wide. The building is clad in German siding and lap boards with a painted standing seam metal roof. Windows along the third story are arranged in a one-over-one pattern, and a two-over-two at the second floor with wood shutters. The main entrance is centrally located along the facade. A secondary entry door is positioned to the left of the main door. A fixed show window sits to the right of the main entry door.

Figure 17: Facade of 8111 Main Street

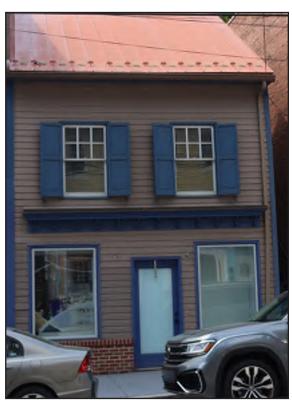
Occupying part of Parcel 48, 8113 Main Street (historically 114 Frederick Avenue). Like 8111 Main Street, the building appears on historic maps as early as 1860, but likely dates to the early nineteenth century when its neighbor, 8111 Main Street was built. The commercial building is rectangular in plan, and is two-stories in height, and two-bays wide topped with a gable roof. Modest in design, the main entrance is arranged with a central doorway flanked by fixed plate glass show windows. The two sash windows at the upper story are arranged in a six-over-one pattern with wooden shutters. A simple cornice separates the upper floor from the ground floor entryway.

Figure 19: Facade of 8113 Main Street

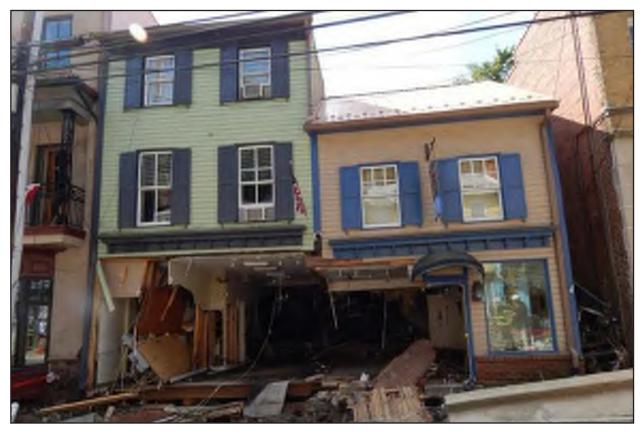
Figure 20: Photograph of 8109-8113 after the flood in 2016 (Ellicott City Patch)

After the flood of 2016, the buildings at 8111-8113 Main Street sustained extensive damage concentrated along the ground floor. From August 2016 through May 2017, structural engineers Keast & Hood led emergency efforts to stabilize the two buildings in order to prevent a total loss. The Wehlands and Johnsons sold the property to Howard County, who owns the property today under the management of the Department of Public Works. For the sustained extensive damage concentrated along the ground floor.

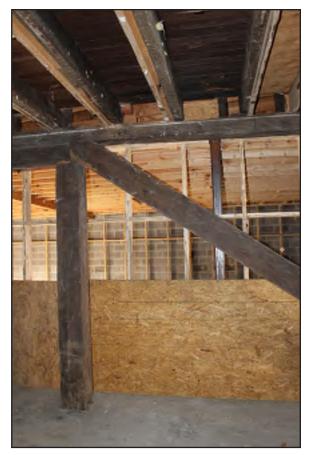
Note: The only remaining materials on the interior of this building are the stud walls, piping, heavy timber structural supports, and contemporary stairs.

Figure 22: Timber supports

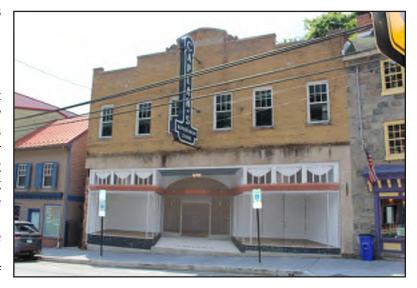
8125 Main Street sits on Parcel 45 and dates to the early twentieth century. The building is two stories in height and three-bays wide clad in yellow brick. The footprint of the building is irregular in shape, filling the angular lot that it sits on. The windows along the upper story are double-hung in a six-over-one pattern. The store entrance is recessed and accented by an arched entryway. Large store front windows frame the main doorway along Main Street. Two of the character defining features of the exterior include the large sign fixed on the facade of the building, and the shaped brick parapet topped with a cast-stone inscription displaying the name "Caplan's" at the top.

Figure 23: 8125 Main Street (EHT Traceries, Inc. 2021)

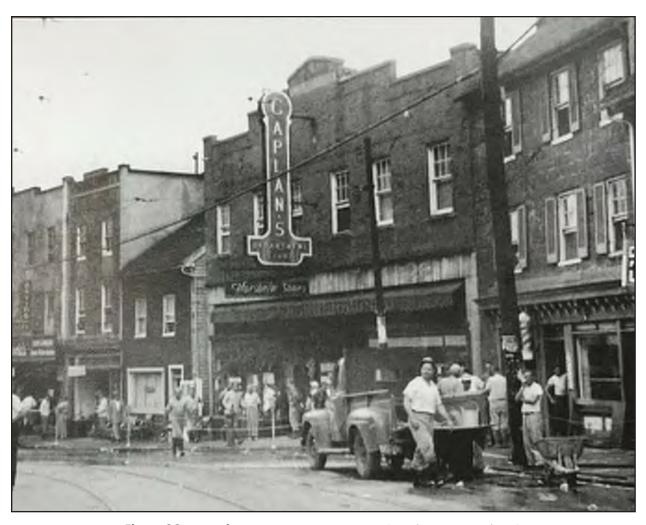
Figure 26: View of 8125 Main Street, circa 1950 (Enoch Pratt Free Library)

county requested the removal of the Caplan store sign that had been fixed to facade of the building since 1925. They county agreed to allow the sign to stay up as long as the words "department store" at the bottom were removed. It appears that Caplan won this argument as the sign is still extant on the facade of the building as it was originally installed.²⁰

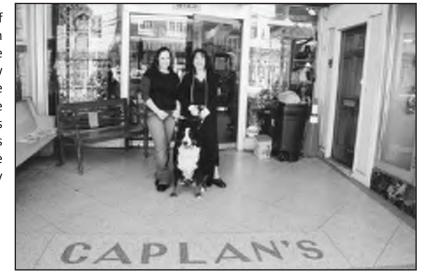
Figure 27: Photograph of entrance of 8125 Main Street, circa 2006 (Ellicott City, Then and Now)

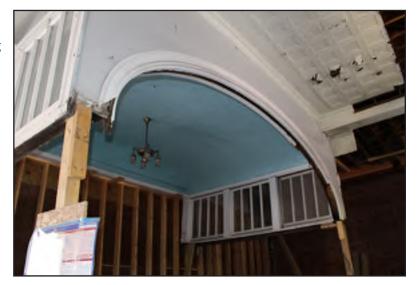
Figure 28: Pressed tin ceiling and remainder of storefront

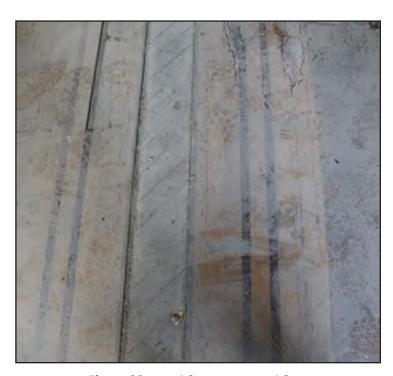
Figure 29: Wood flooring at second floor
