January - December 2014

CMOM Audit Report No. 4

Complaint and Settlement
Agreement between Howard
County, Maryland and the
Maryland Department of the
Environment CO-10-1116

October 2015

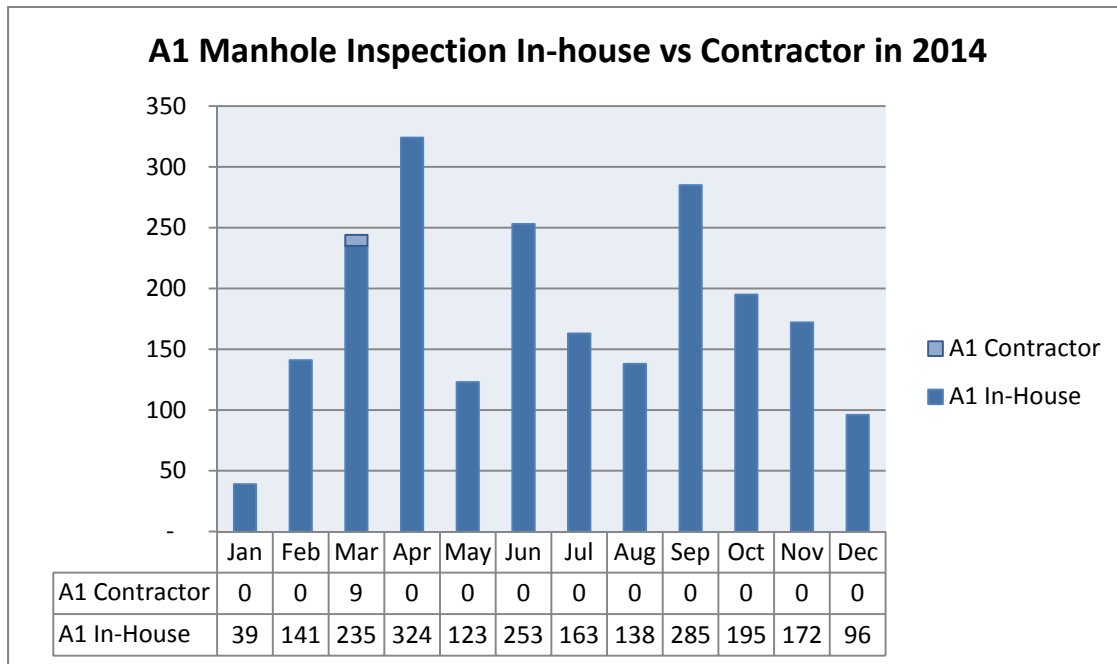
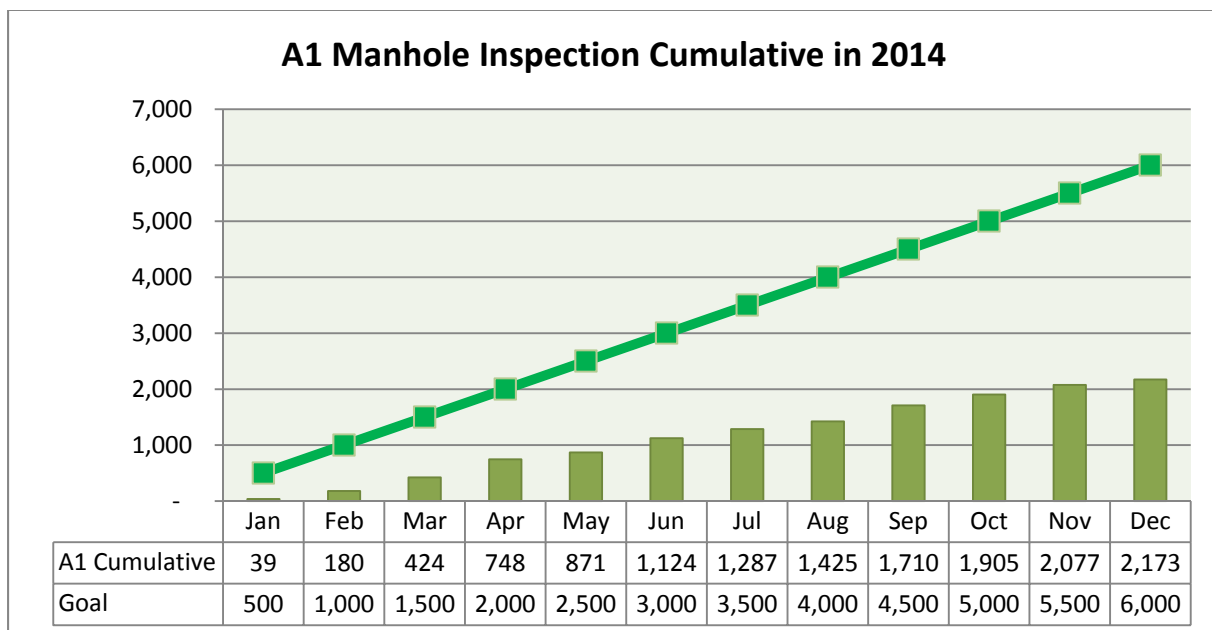
A1. Manhole Inspections:

- Inspect 6,000 manholes.
- Clean 195 miles of sewer mains.
- Perform routine CCTV inspection on approximately 48.75 miles (257,400 ft) of sewer collector mains.
- Enhance the efficiency of maintenance crews to achieve an average response time to routine sewer problems of one (1) hour or less.

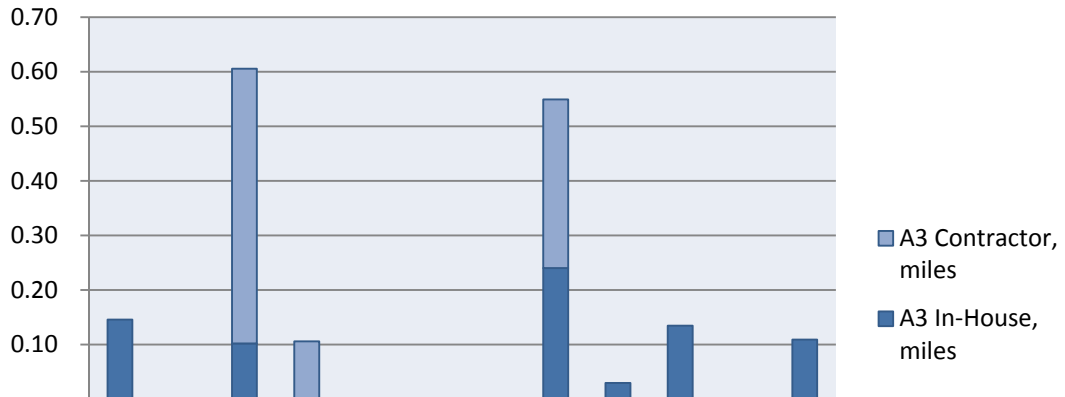
A3 Main CCTV In-house vs Contractor in 2014

Jan	Feb	Mar	Apr	May	Jun	Jul	Aug	Sep	Oct	Nov	Dec
A3 Contractor, miles	-	-	0.50	0.11	-	-	-	0.31	-	-	-	-
A3 In-House, miles	0.15	-	0.10	-	-	-	-	0.24	0.03	0.13	-	0.11

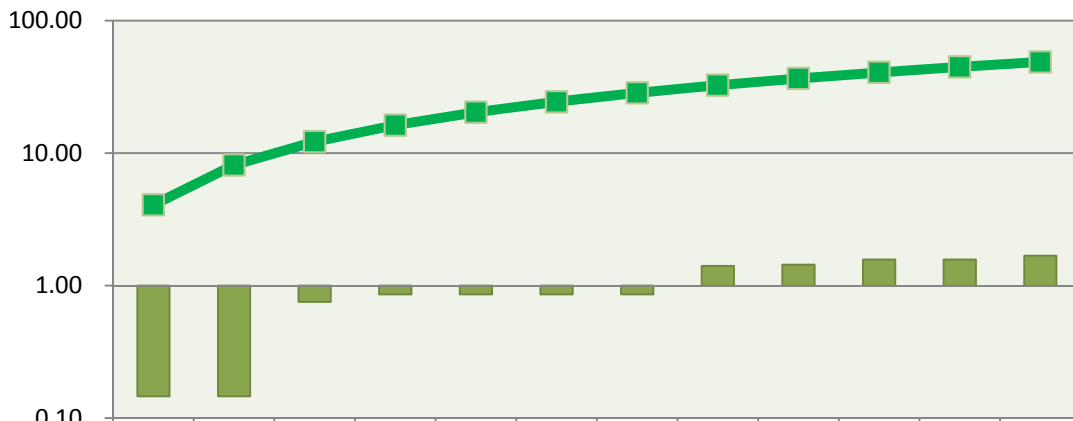
A3 Main CCTV Cumulative in 2014

Jan	Feb	Mar	Apr	May	Jun	Jul	Aug	Sep	Oct	Nov	Dec
A3 Cumulative	0.15	0.15	0.75	0.86	0.86	0.86	0.86	1.41	1.44	1.57	1.57	1.68
Goal	4.06	8.13	12.19	16.25	20.31	24.38	28.44	32.50	36.56	40.63	44.69	48.75

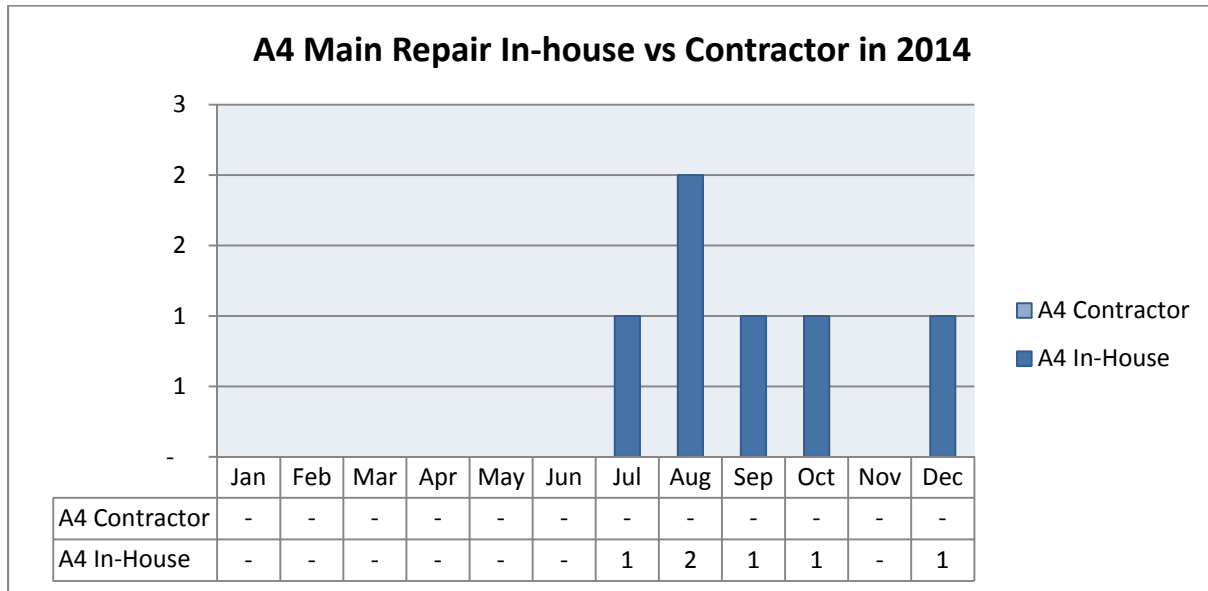
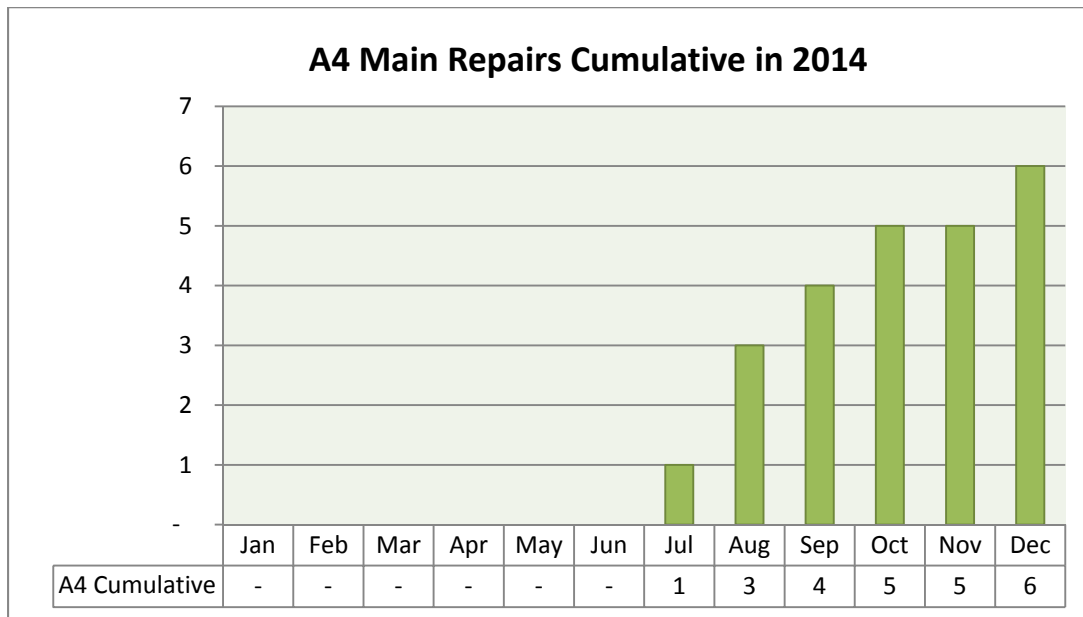
A4. Sewer Main Repairs

The County performed the sewer main repair/replacement on an As-Needed basis. Six (6) sewer mains were repaired by County's in-house staff in 2014, totaled 621 ft.

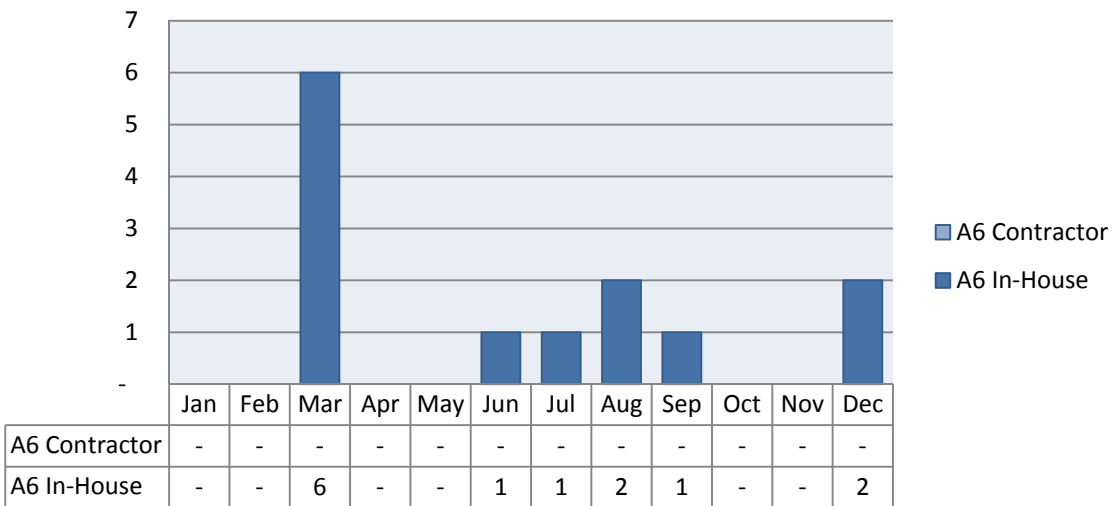
A6 Manhole Repairs In-house vs Contractor in 2014

The County performed the manhole repair/replacement on an As-Needed basis. Sanitary sewer manholes are repaired by County’s in-house staff and contractors. There were 13 manholes repaired in 2014 by the County’s in-house staff.

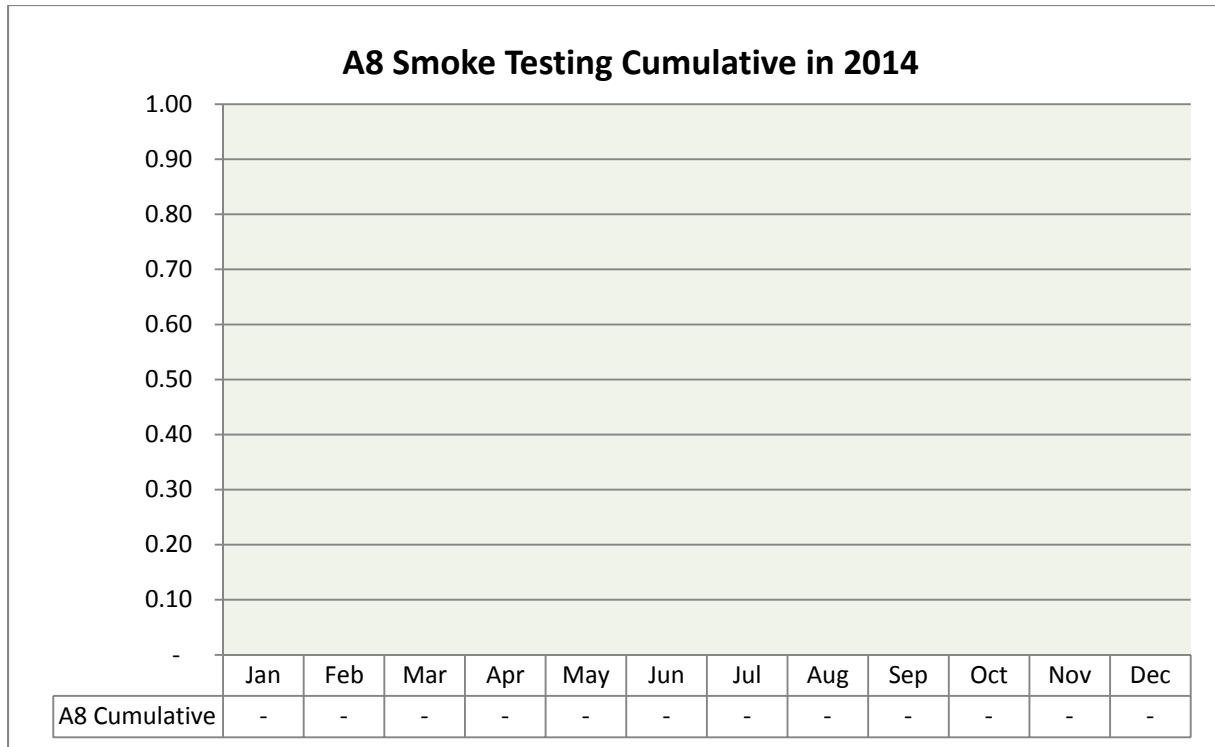
A8. Smoke Testing

In 2014, there was no smoke testing performed by in-house staff. The County has contracted George, Miles & Buhr (GMB) to provide engineering services with smoke testing the next Subsewershed. The intent of this project is to identify the specific locations where the system defects exist to reduce the quantity of extraneous inflow from entering the Little Patuxent Interceptor.

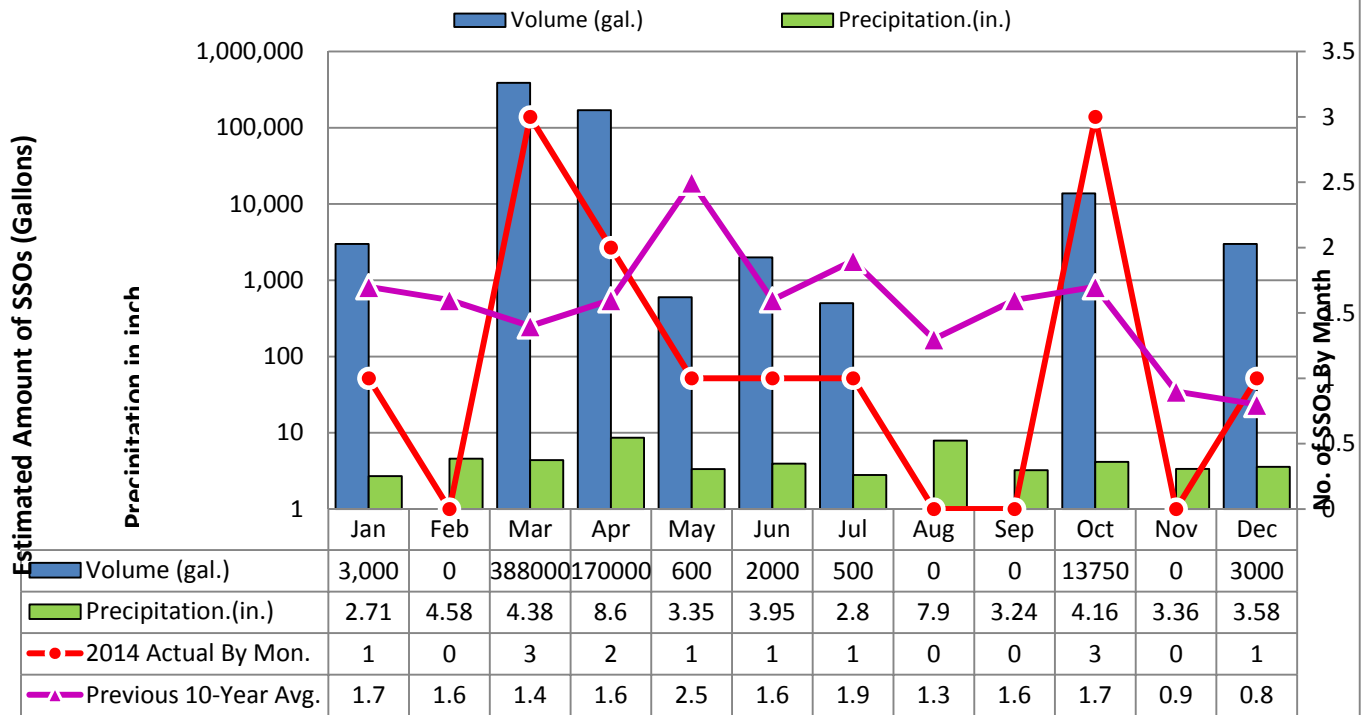
Howard County SSO vs Precipitation in 2014

The County’s SSO’s have been plotted by month in the above chart. As is shown in the chart, most months’ SSO occurrence numbers in 2014 were all below the previous 10-year average. There was no SSO occurred during February, August, September and November. You can also see the number of SSO occurrence in each month still correlates the amount of precipitation. The more it rained, the more SSO occurred.

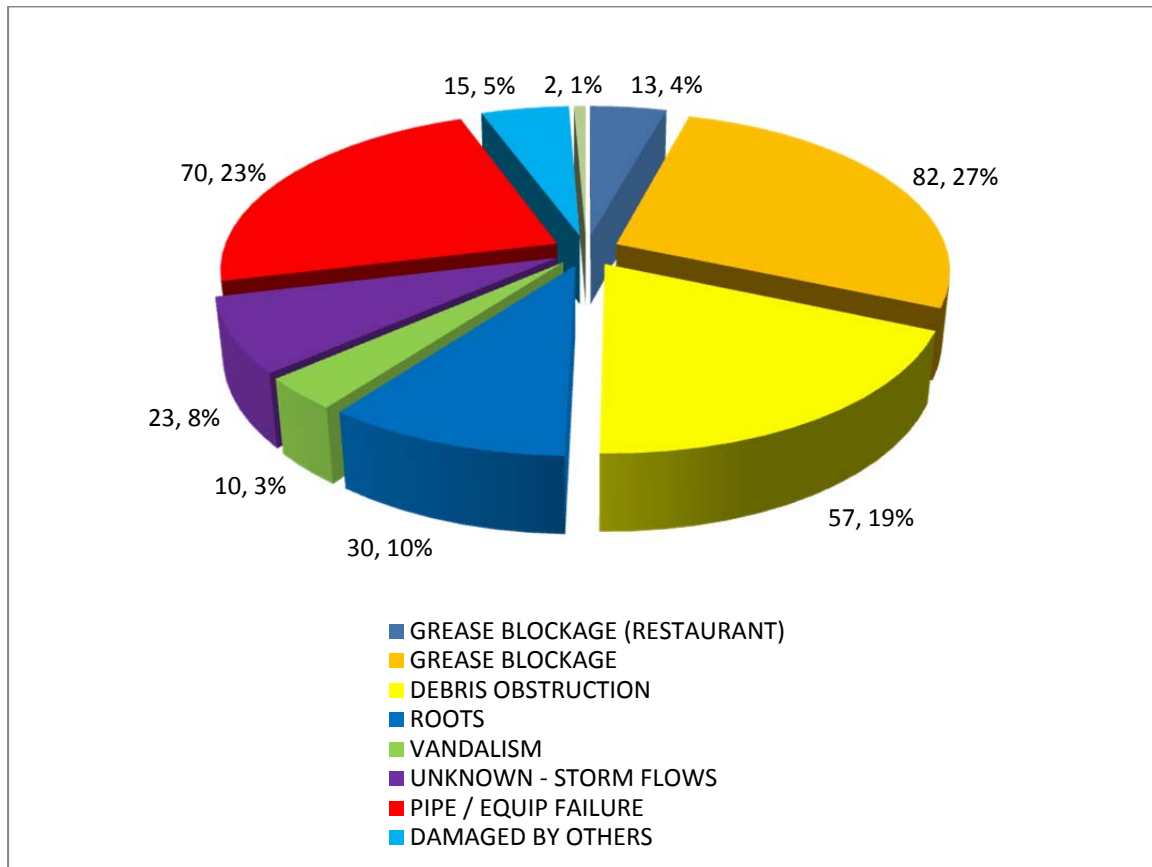
As is shown in the above chart, the top three (3) causes of overflows county-wide are: grease blockage (non FOG, 27%), pipe/equipment failure (23%), and debris obstruction (19%).

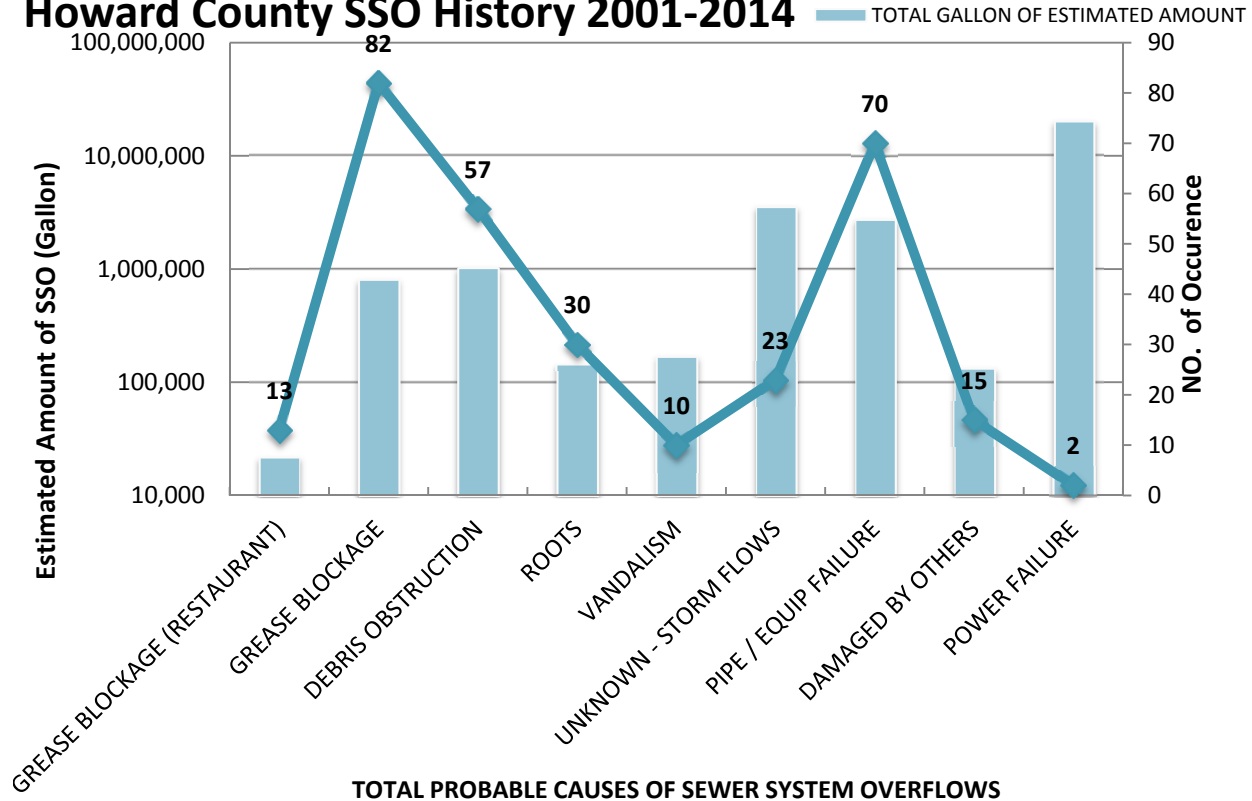
Howard County SSO History 2001-2014

While taking the estimated overflow amount into consideration, power failure, storms, pipe and equipment failures rank the highest of the total SSO volume contribution. This observation has not changed from 2012.

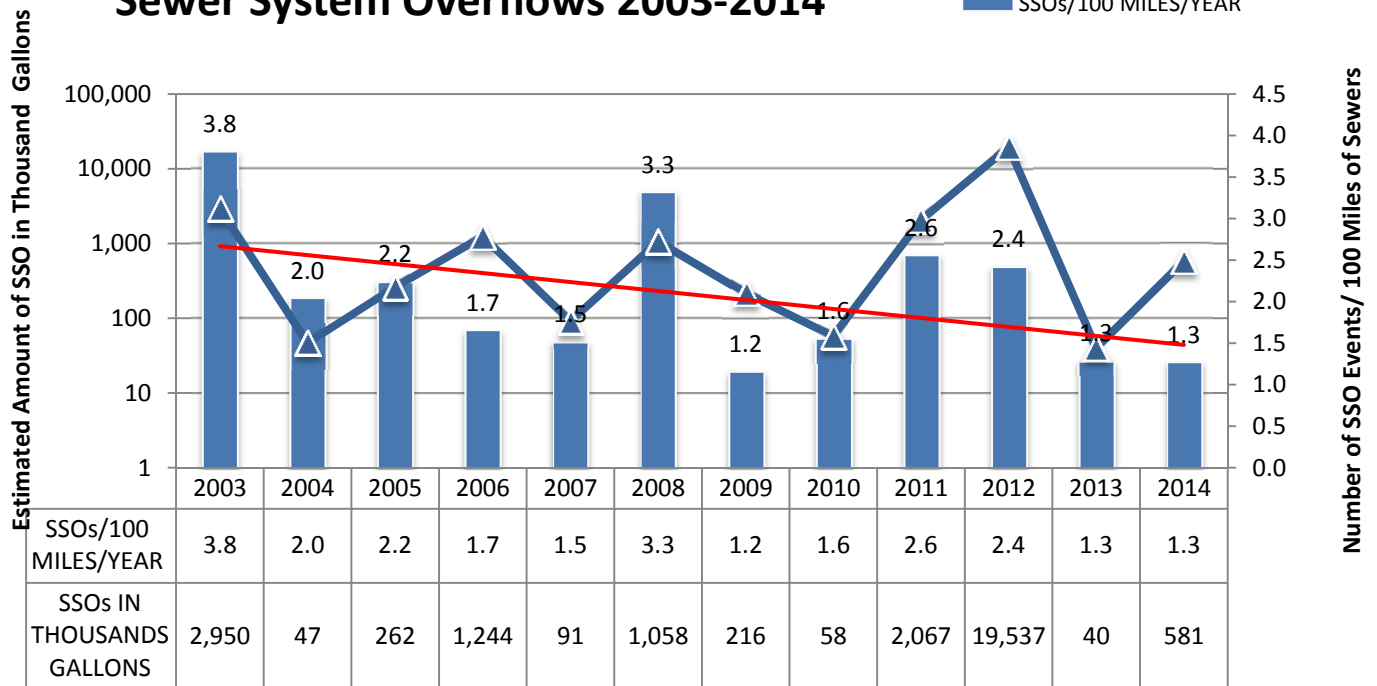
Sewer System Overflows 2003-2014

As is shown in the above chart, over the past 12 years from 2003 to 2014, the County has the SSOs/mile/year ranging from 1.2 to 3.8, while the national average posted by EPA in 2004 is 4.5. What's more, the County's overall trend of SSOs/mile/year is downward. The SSOs/mile/year for 2013 is 1.3, which is the second lowest number among the past 11 years.

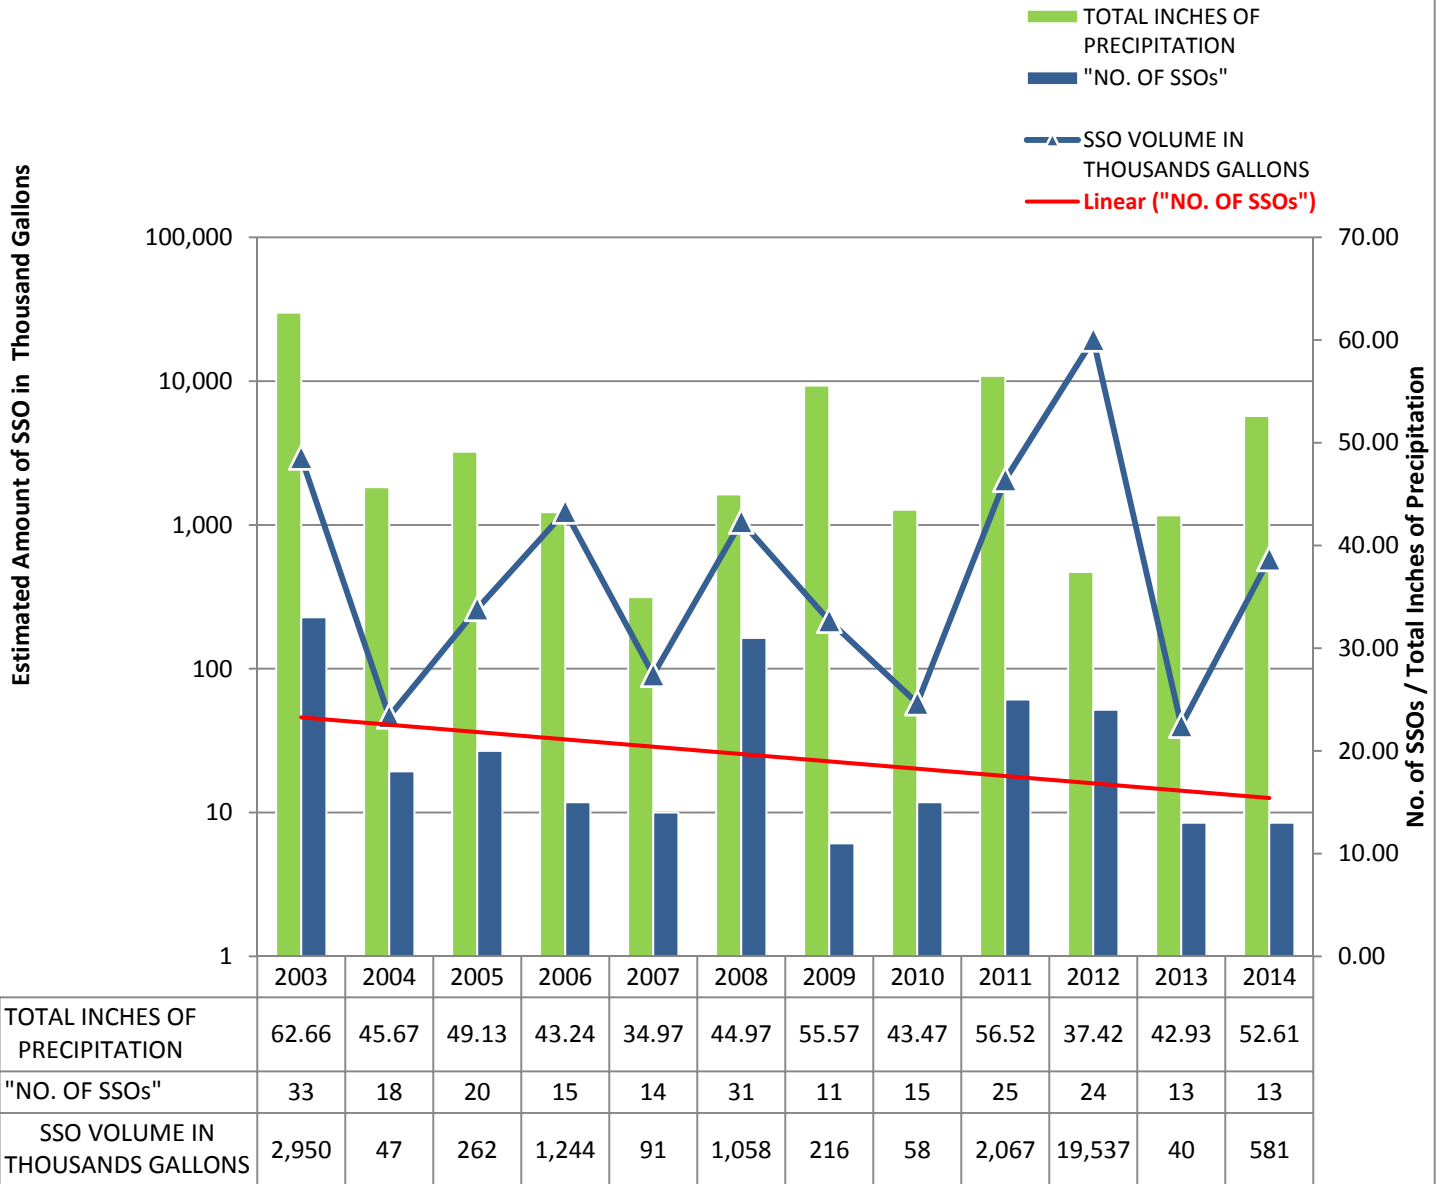
Sewer System Overflows vs Precipitation 2003-2013

To further investigate the correlation between numbers of SSO occurrence to the total amount, the 11 years' precipitation data is plotted in the below chart. The numbers of SSO occurrence over the years keep a downward trend, despite the fact that the total overflow amount in 2012 was severely affected by the by-pass incident that happened during Hurricane Sandy at LPWRP.

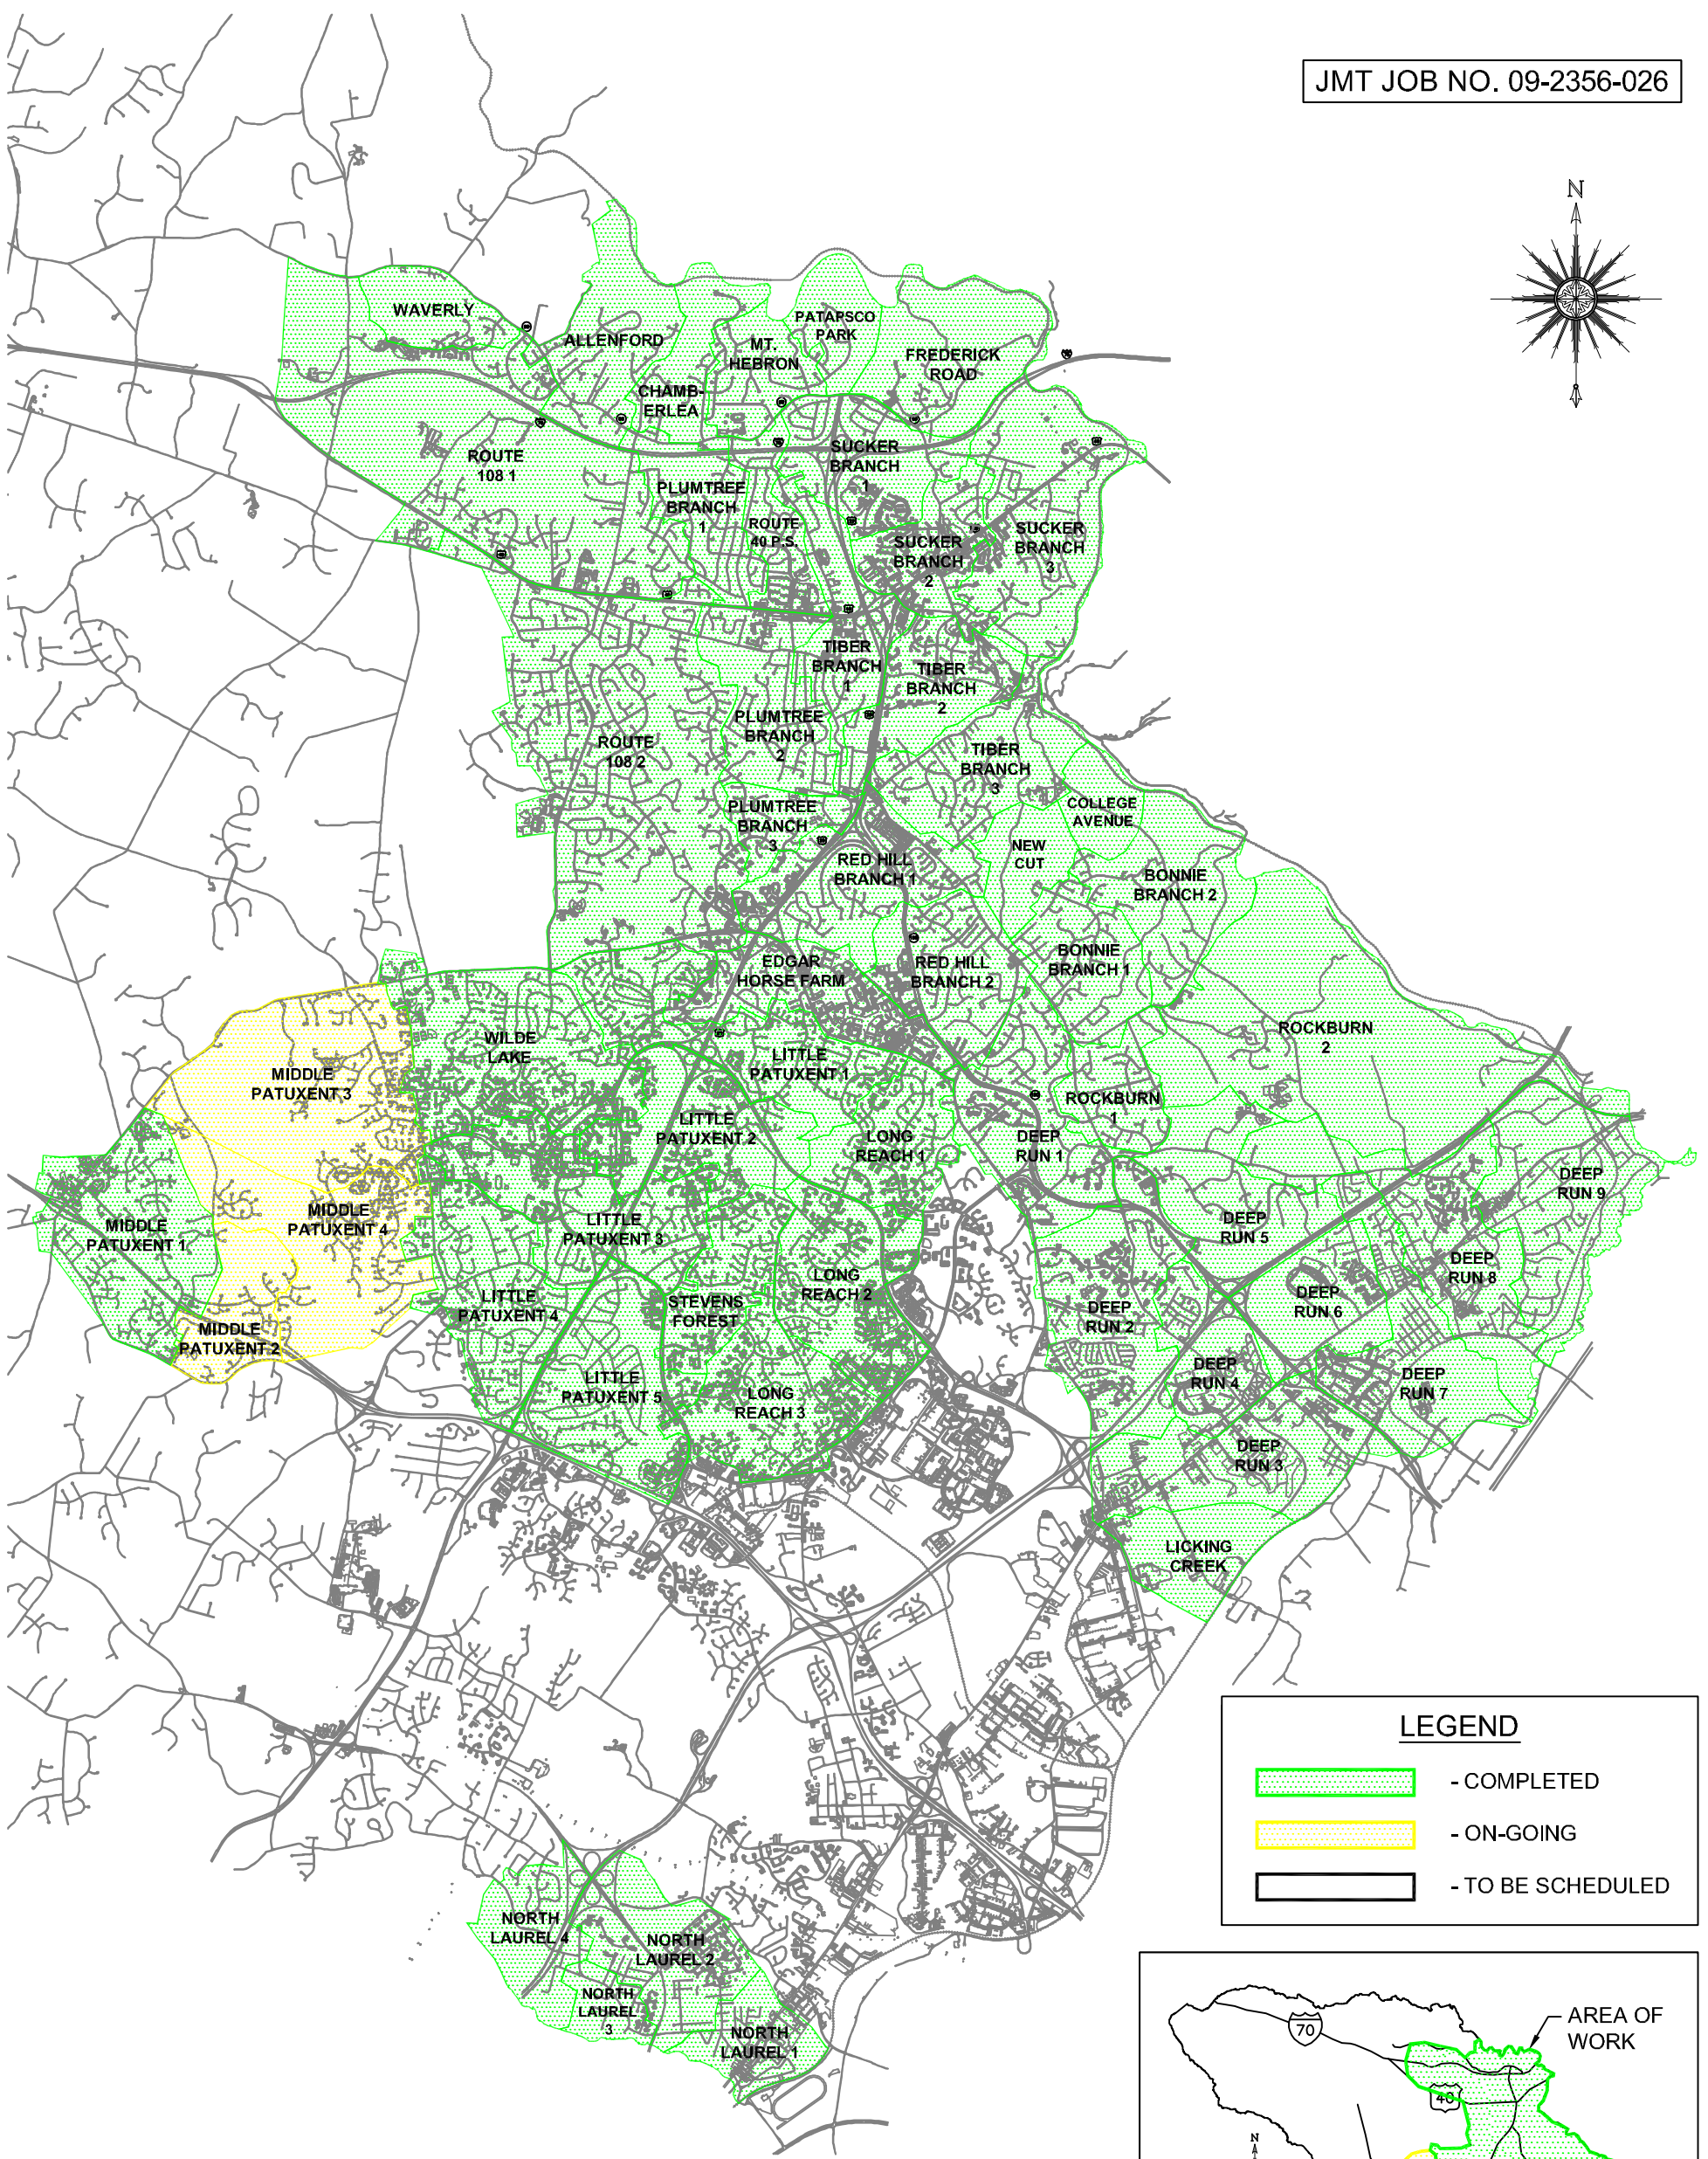
FIGURE D1

By the end of 2014, the County completed the cleaning for the following drainage basins: small pump stations above route 99, Tiber Branch, Sucker Branch, Route 40 pump station, Plumtree, Edger Horse Farm, Red Hill, Bonnie Branch, Rockburn, Deep Run, Licking Creek, Wilde Lake and part of Little Patuxent. The County completed the CCTV inspections for the problematic sewers notified by cleaner in the following drainage basins: small pump stations above route 99, Tiber and Sucker Branch, Route 40 pump station, and Plumtree. The drainage basins are illustrated in Appendix D.

CLEANING SCHEDULE

The collection system repair/replacement will still be conducted on an as-needed basis. The County has planned more CCTV and rehabilitation activities in 2014. The cleaning, CCTV and smoke testing activity progress in 2013 has been illustrated in Figure D1, D2 and D3 respectively in the Appendix D.
