CMOM Audit Report No. 2

Complaint and Settlement
Agreement between Howard
County, Maryland and the
Maryland Department of the
Environment CO-10-1116

June, 2013

**Complaint and Settlement Agreement between Howard County,
Maryland and the Maryland Department of the Environment
CO-10-1116**

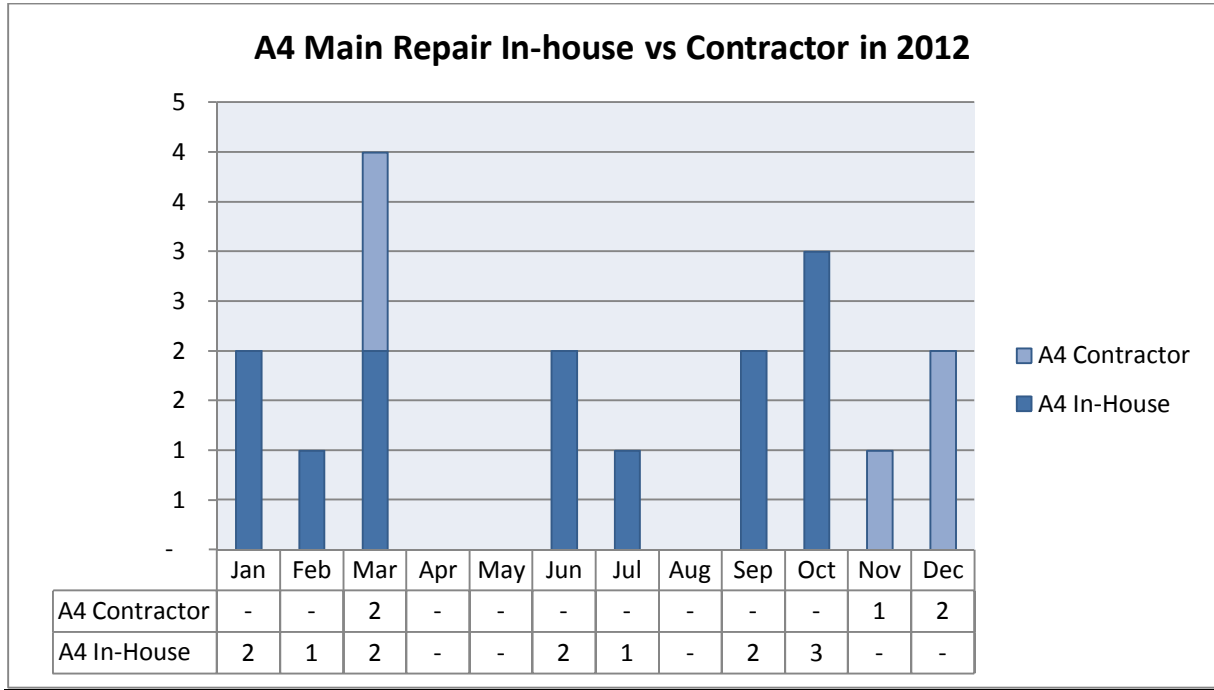
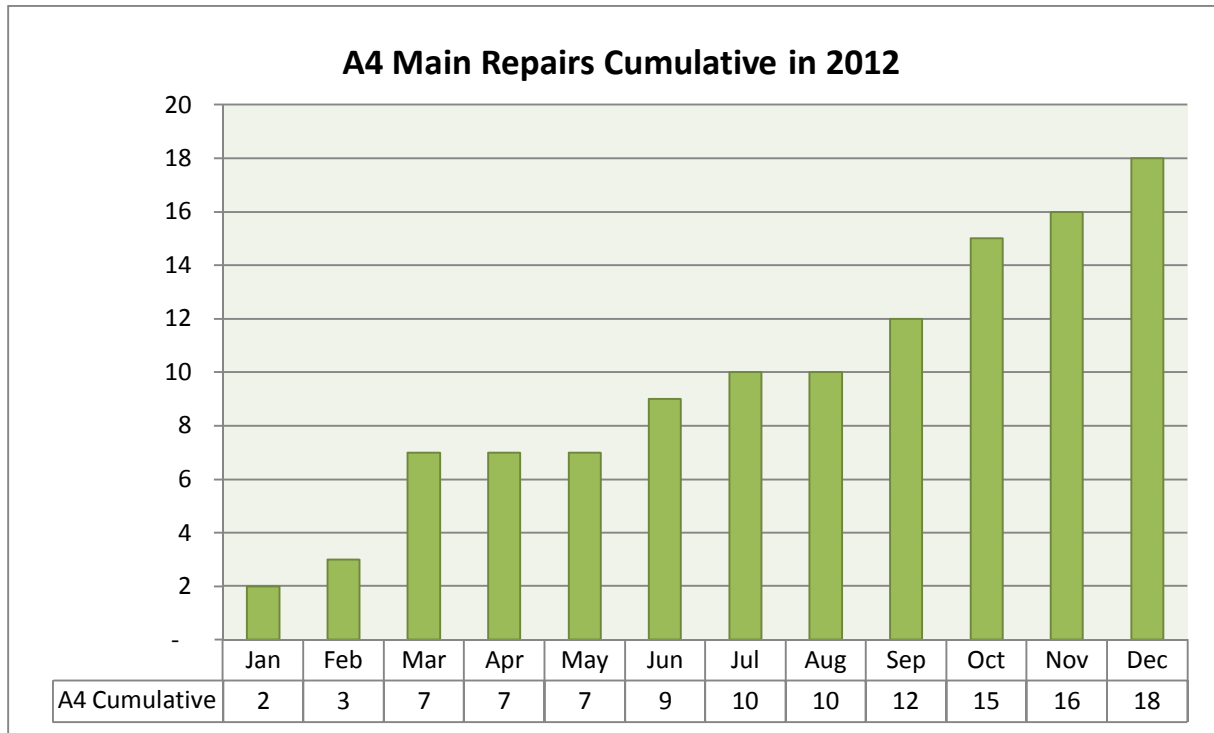
A4. Sewer Main Repairs

The County performed the sewer main repair/replacement on an As-Needed basis. 18 sewer mains were repaired by County's in-house staff in 2012, totaled 4,888 ft.

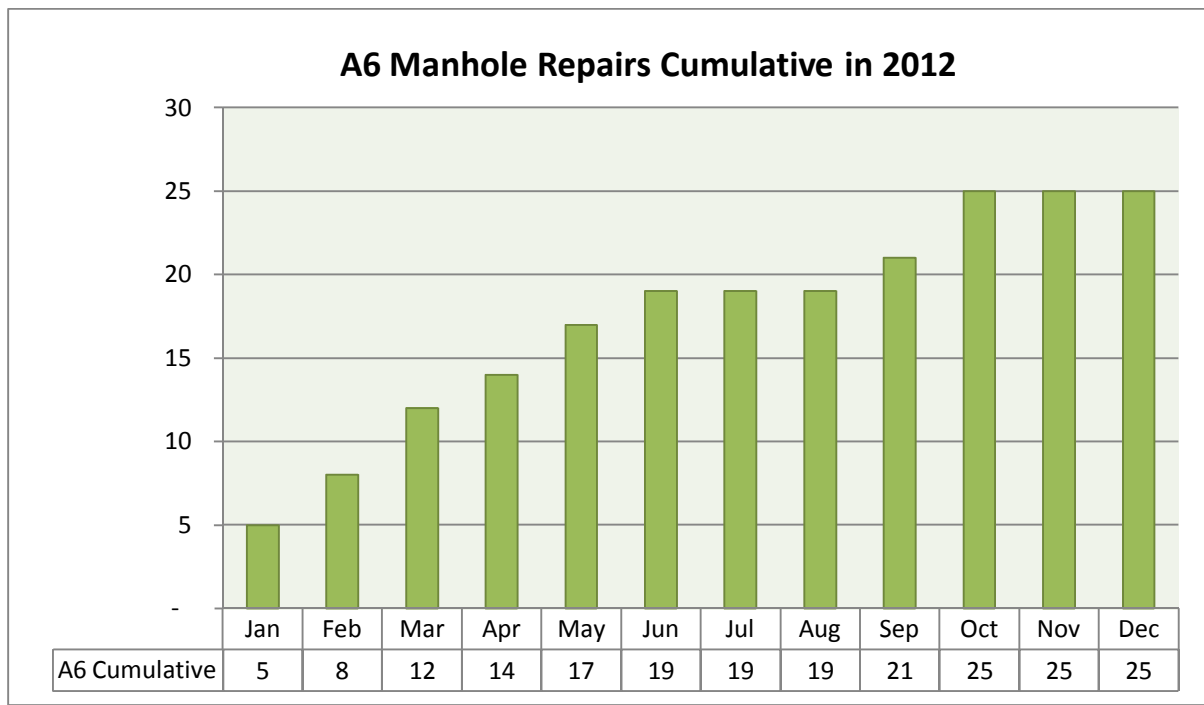
A6. Manhole Repairs

The County performed the manhole repair/replacement on an As-Needed basis. Sanitary sewer manholes are repaired by County’s in-house staff and contractors. There were 25 manholes repaired in 2012.

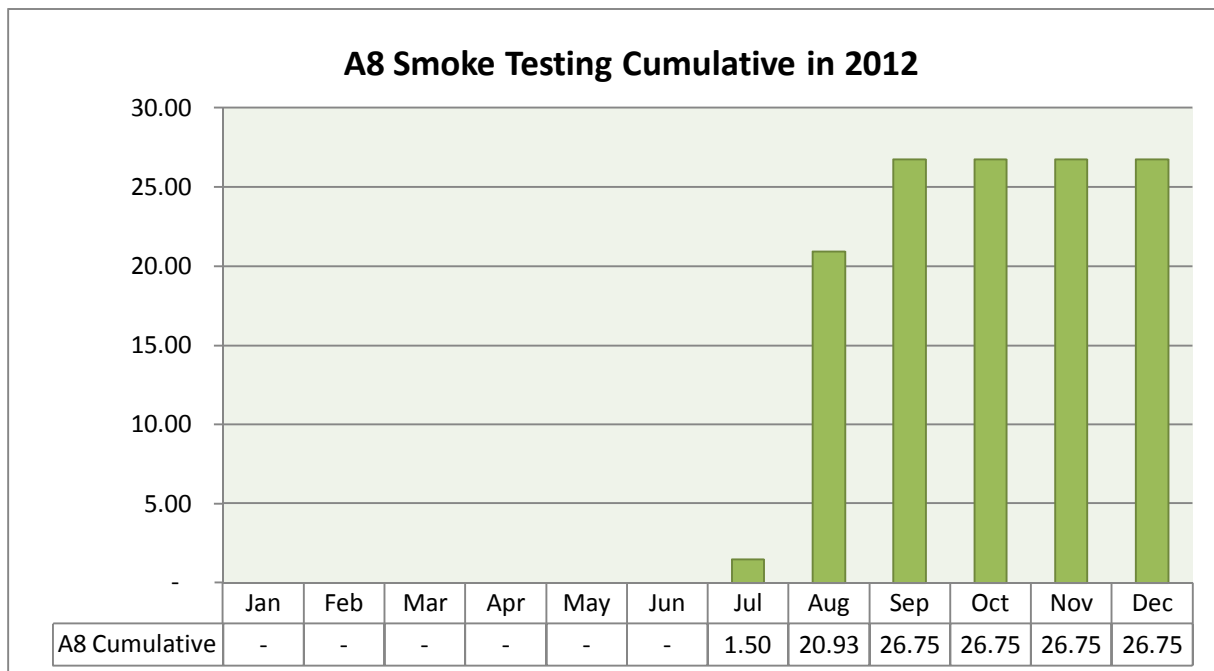
A8. Smoke Testing

In 2012, there was no smoke testing performed by in-house staff. The County has contracted George, Miles & Buhr (GMB) to provide engineering services with smoke testing the North Laurel Area. The intent of this project is to identify the specific locations where the system defects exist to reduce the quantity of extraneous inflow from entering the North Laurel Pump Station.

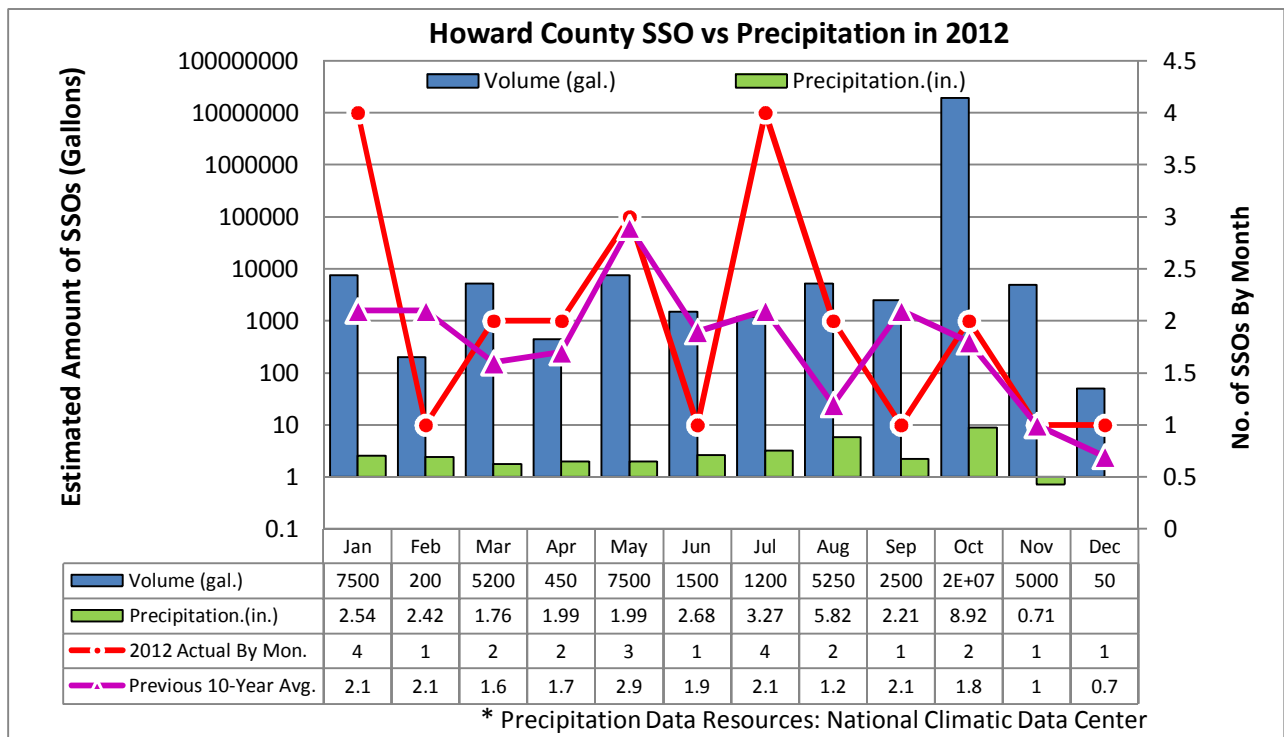
The County's SSO's have been plotted by month in the above chart. As is shown in the chart, October, when Hurricane Sandy took place, had the greatest amount of precipitation and overflow volume in 2012.

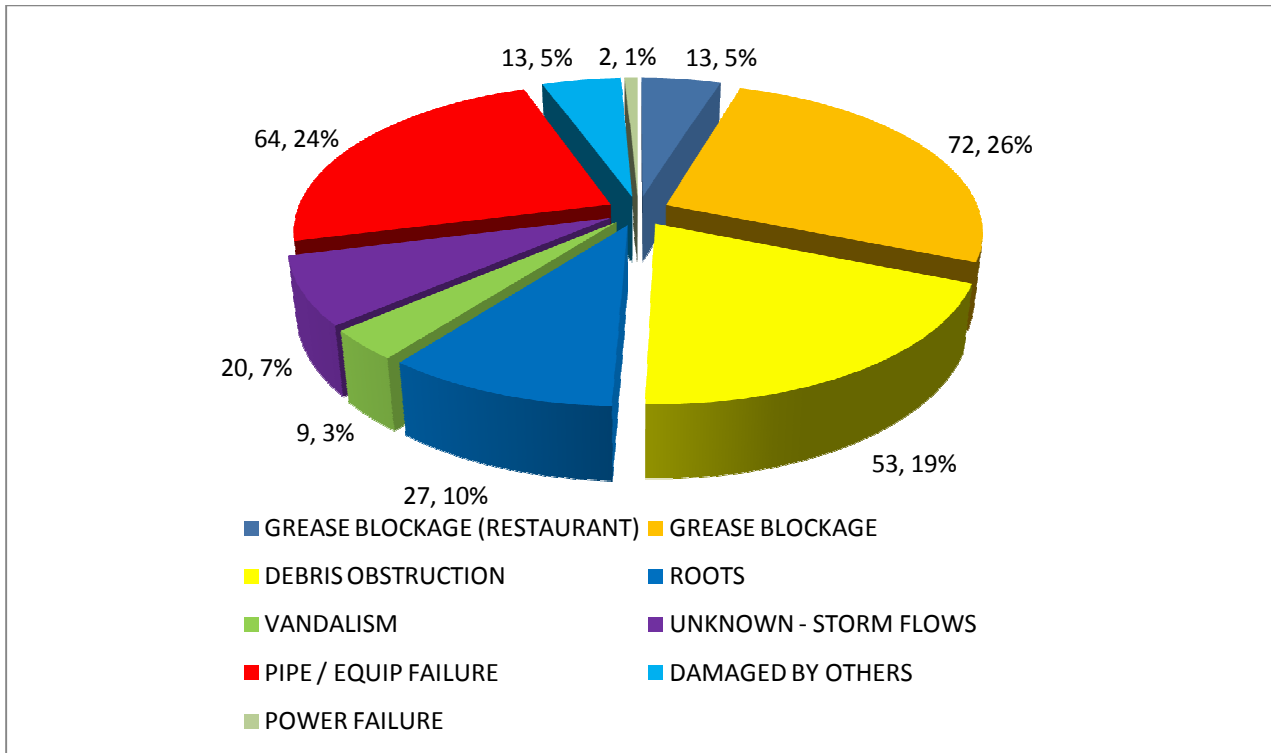
As is shown in the above chart, the top three (3) causes of overflows county-wide are: grease blockage, pipe/equipment failure, and debris obstruction. While taking the estimated overflow amount into consideration, power failure, storms, pipe and equipment failures rank the highest of the total SSO volume contribution.

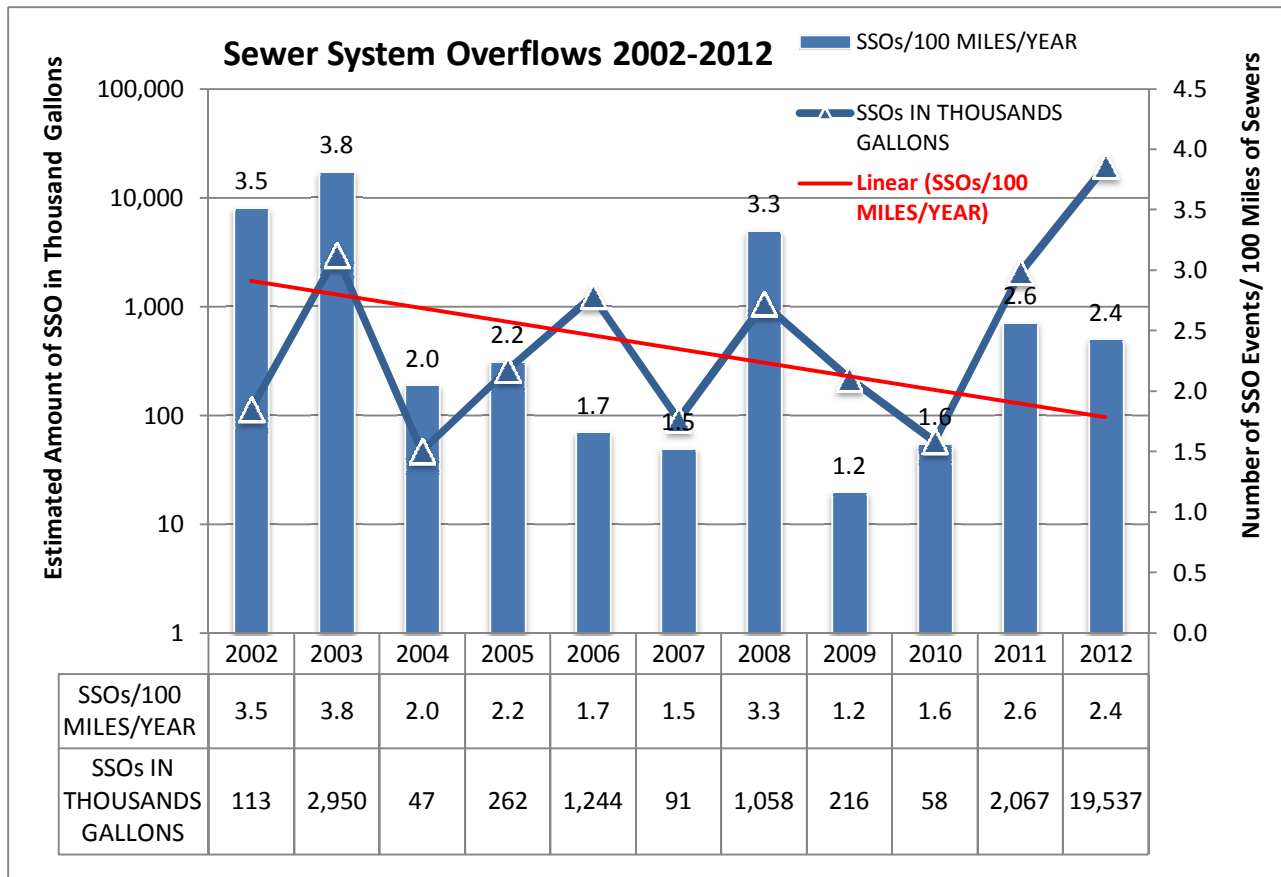
As is shown in the above chart, over the past 11 years from 2002 to 2012, the County has the SSOs/mile/year ranging from 1.2 to 3.8, while the national average posted by EPA in 2004 is 4.5. What's more, the County's overall trend of SSOs/mile/year is downward.

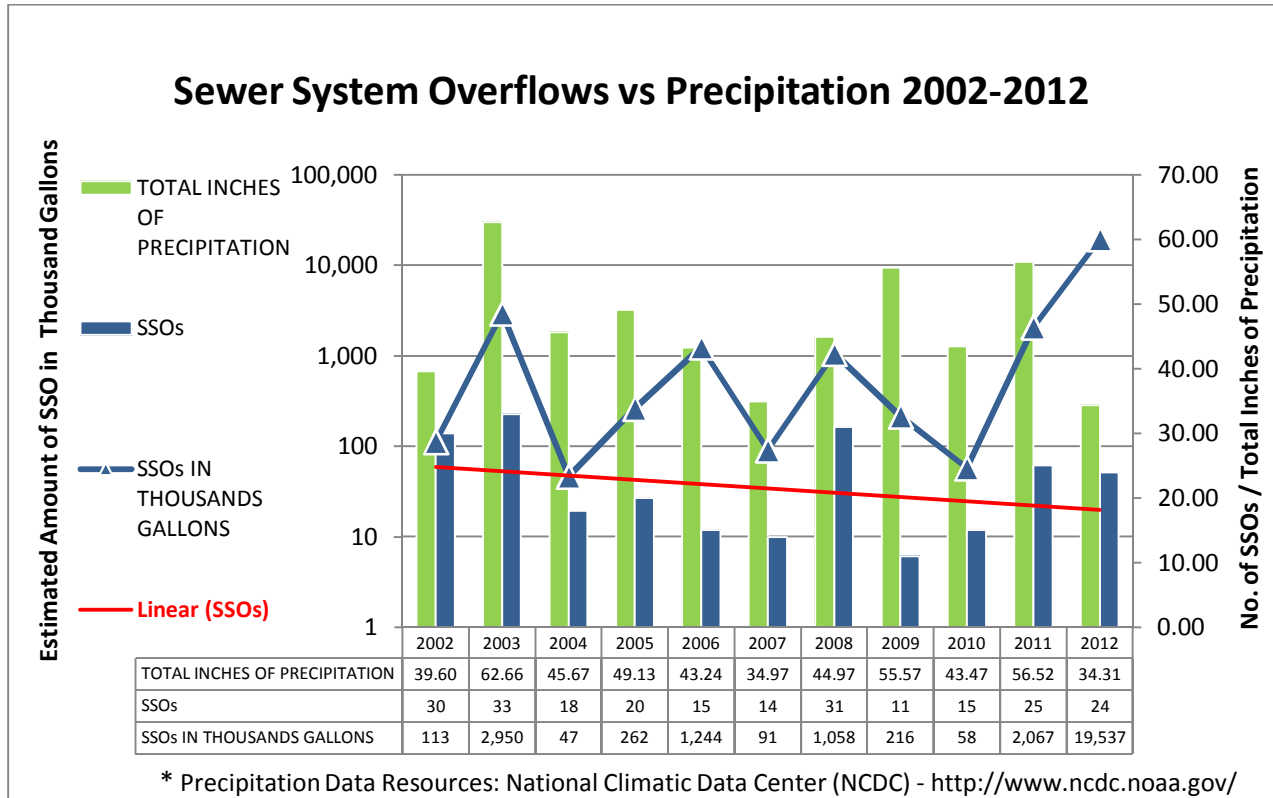
To further investigate the correlation between numbers of SSO occurrence to the total amount, the 11 years' precipitation data is plotted in the below chart. Although the

numbers of SSO occurrence over the years keep a downward trend, the total overflow amount is severely affected by the by-pass incident that happened during Hurricane Sandy at LPWRP.

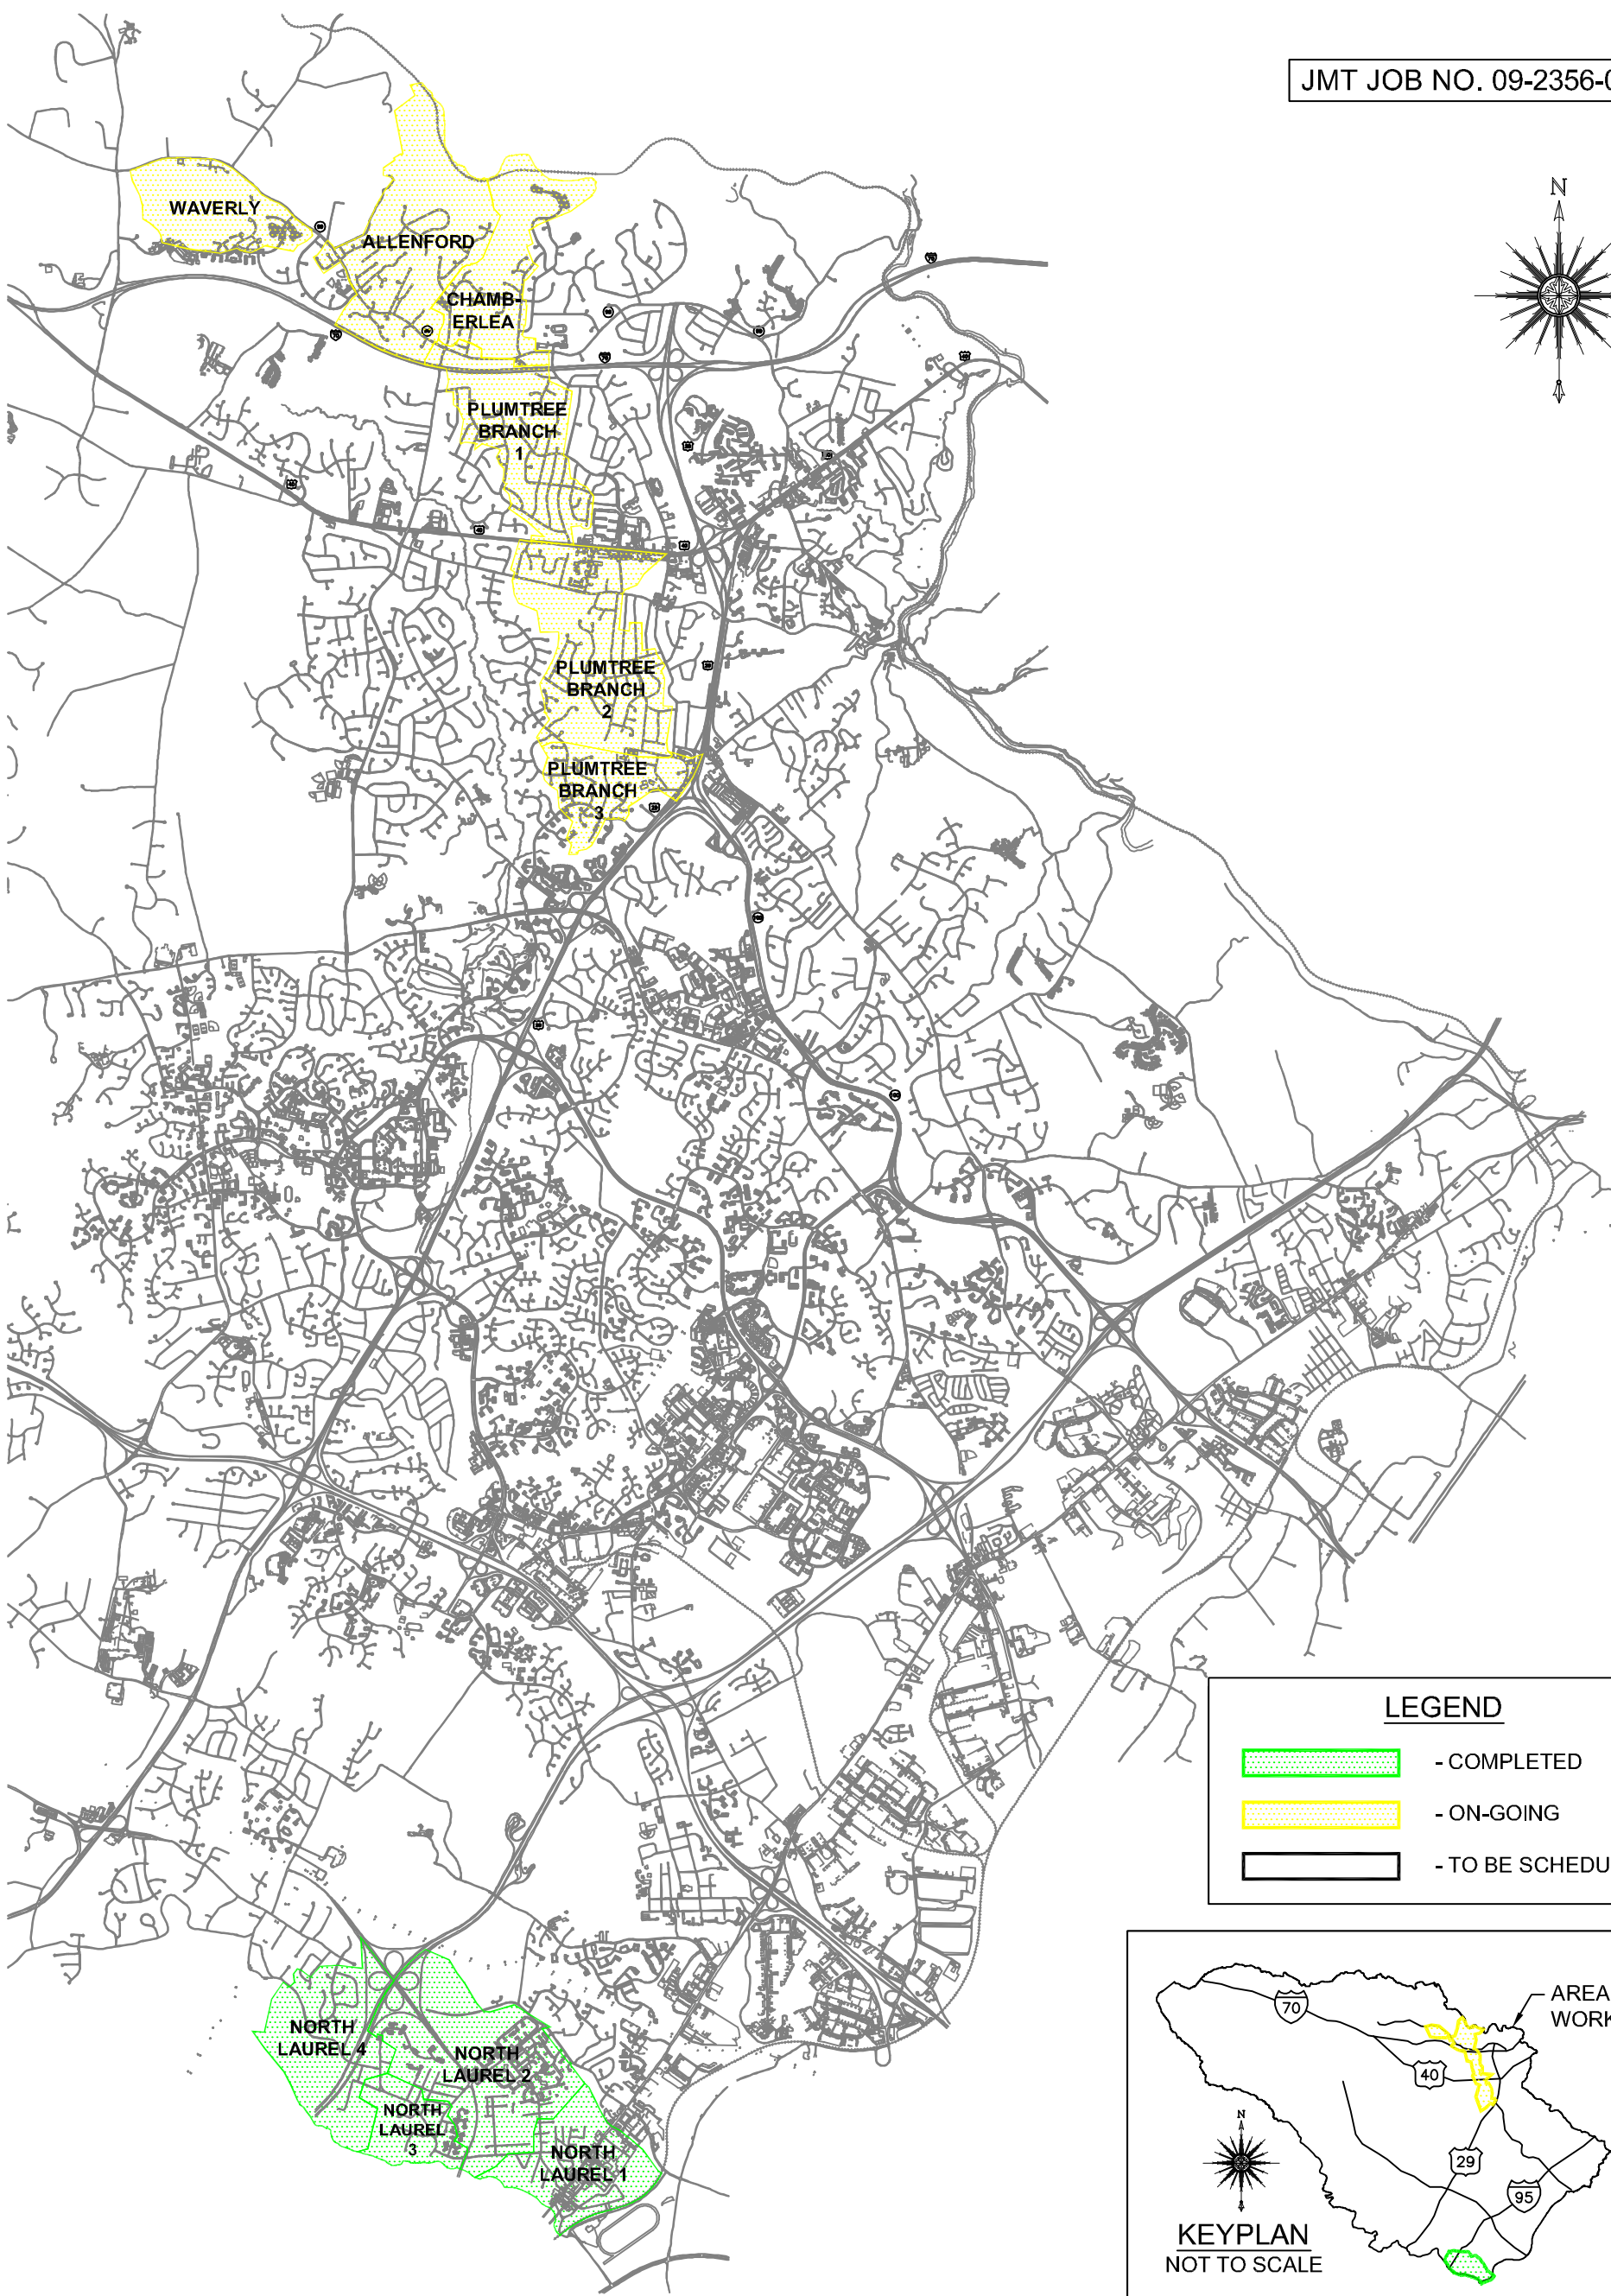
SMOKE TESTING SCHEDULE

The collection system repair/replacement will still be conducted on an as-needed basis. The County has planned more CCTV main inspections-A3, and smoke testing-A8 in 2013. The cleaning, CCTV and smoke testing activity progress has been illustrated in Figure A1, A2 and A3 respectively in the Appendix D.
