Howard County Biological Monitoring and Assessment

Little Patuxent - 2006

KCI Technologies, Inc.
December 2006

NPDES Permit No. 00-DP-3318 MD0068322

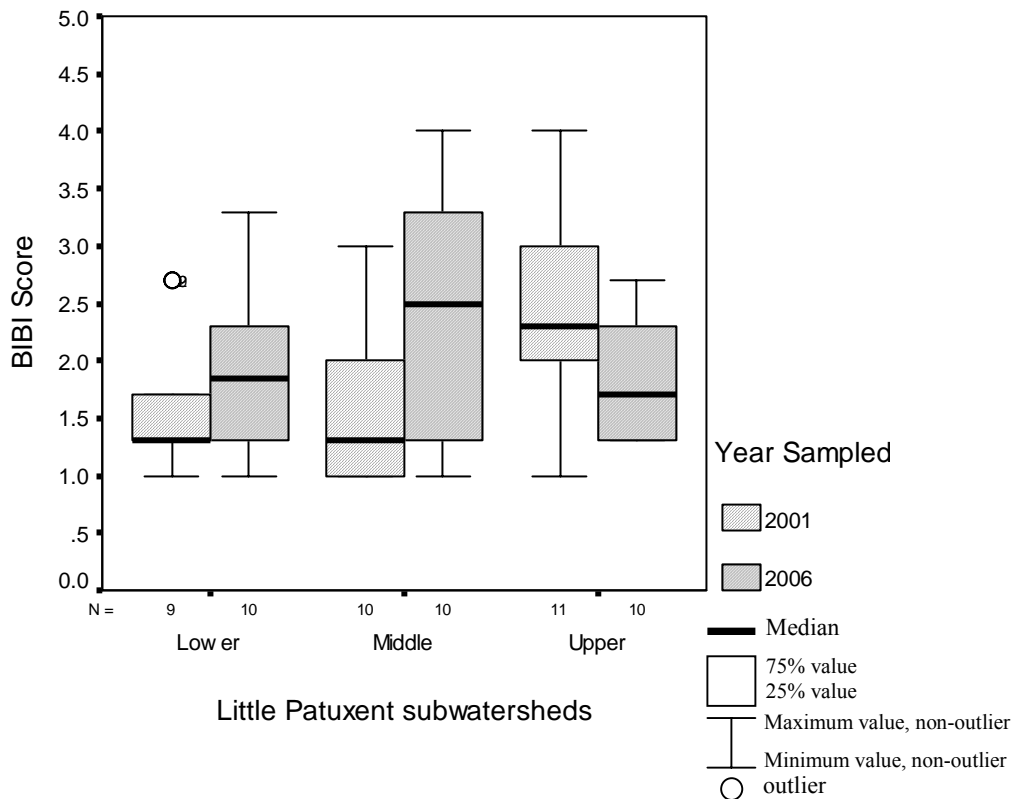
Figure 8 - Comparison of 2001 and 2006 BIBI scores in the Little Patuxent River subwatersheds

The data collected in 2006 indicate that conditions are similar to those reported in 2001. Table 11 and Figure 8 summarize the results for 2001 and 2006 BIBI data. In 2006, the Lower Little Patuxent PSU had an overall average BIBI of 1.9, with a rating of ‘Very Poor’. This represents an increase in the overall score for the Lower Little Patuxent, increasing from a 1.6. This did not change the narrative rating. There was also improvement seen in the mean score for the Middle Little Patuxent increasing to a 2.5, a ‘Poor’ rating, in 2006, from a score of 1.6, a ‘Very Poor’ rating, in 2001. However, the 2006 Middle Little Patuxent score is favorably affected by the four sites on the Clark and Carroll farms. The Upper Little Patuxent watershed was the only subwatershed for which there was a decrease in the mean BIBI score and rating, a 2.5 in 2001 (‘Poor’) to a 1.9 in 2006 (‘Very Poor’). Increases in the Lower Little Patuxent and Middle Little Patuxent contributed to an increase in the overall score and rating for the entire Little Patuxent watershed. The overall mean BIBI score changed from a ‘Very Poor’ rating (1.9) in 2001 to a ‘Poor’ rating (2.1) in 2006. This change in overall group means is not considered a statistically significant difference.

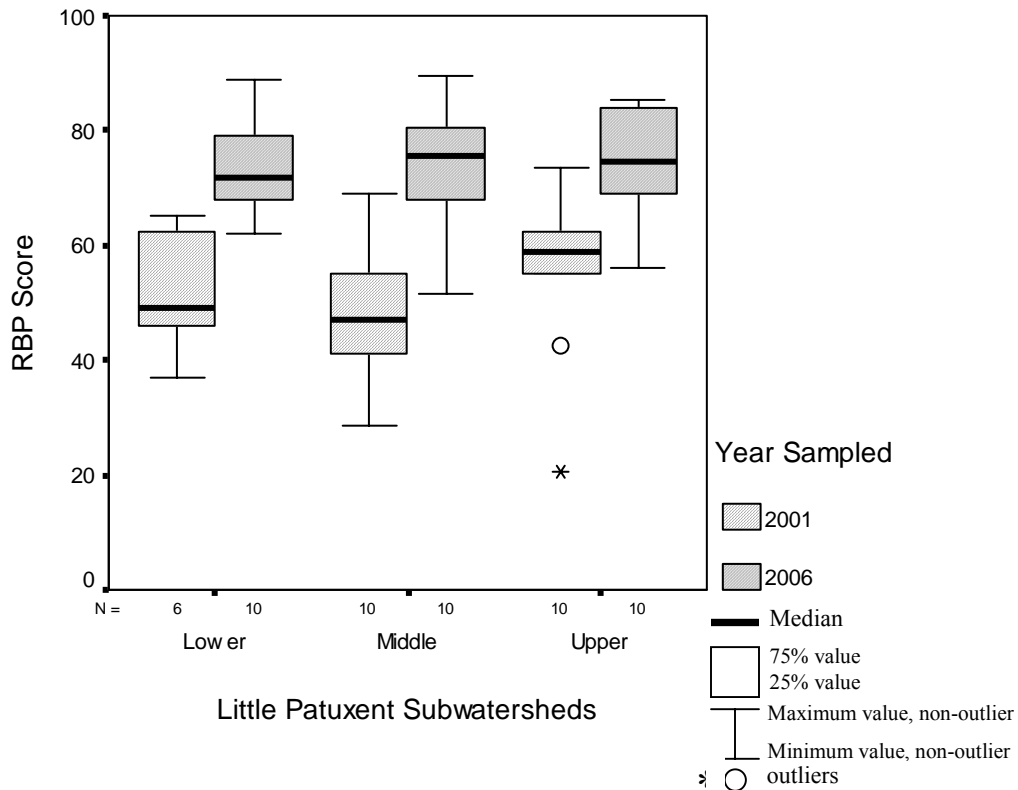
Figure 9 - Comparison of 2001 and 2006 RBP Physical Habitat Assessment scores in the Little Patuxent River subwatersheds

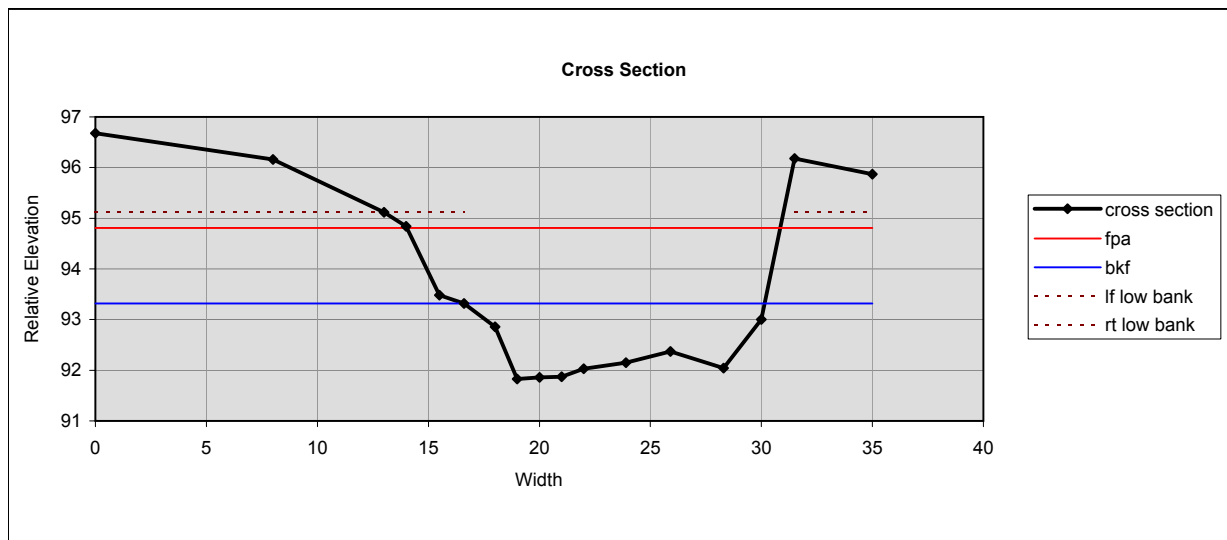
Bankfull Dimensions		Flood Dimensions		Bankfull Flow	
14.1	x-section area (ft.sq.)	17.0	Width flood prone area (ft)	3.2	velocity (ft/s)
13.6	width (ft)	1.3	entrenchment ratio	45.9	discharge rate (cfs)
1.0	mean depth (ft)	3.3	low bank height (ft)	0.57	channel slope (%)
1.5	max depth (ft)	2.2	low bank height ratio		
14.6	wetted perimeter (ft)				
1.0	hydraulic radius (ft)				
13.0	width-depth ratio				
		<u>Flow Resistance</u>		<u>Sinuosity</u>	<u>Channel Type</u>
		0.034	Manning's roughness	1.17	F4c

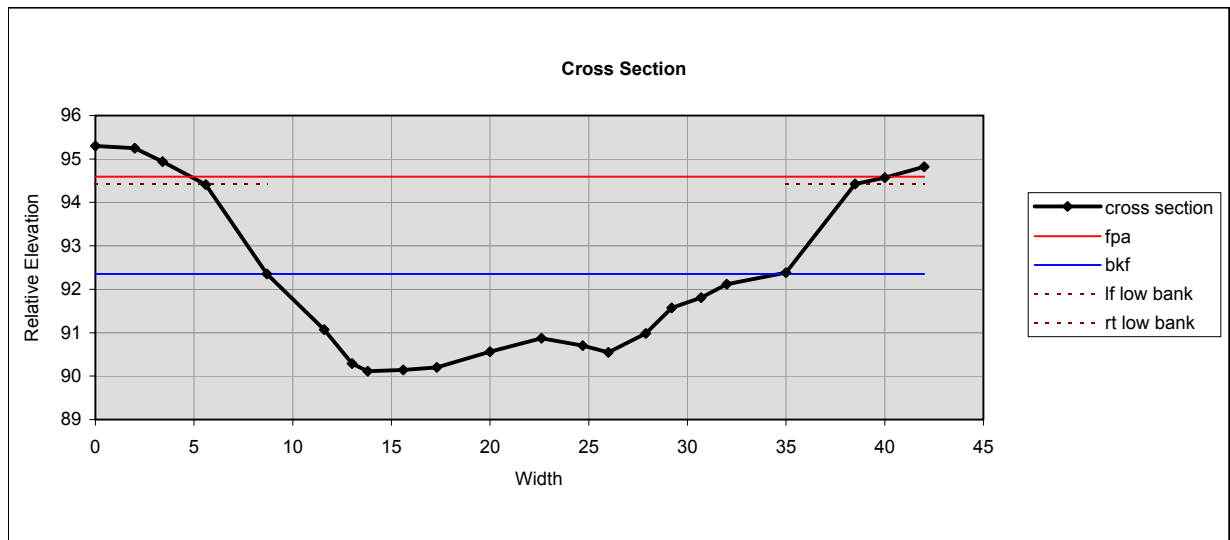
Bankfull Dimensions		Flood Dimensions		Bankfull Flow	
34.9	x-section area (ft.sq.)	100.0	Width flood prone area (ft)	4.7	velocity (ft/s)
26.0	width (ft)	3.9	entrenchment ratio	165.7	discharge rate (cfs)
1.3	mean depth (ft)	4.3	low bank height (ft)	0.3	channel slope (%)
2.2	max depth (ft)	1.9	low bank height ratio		
26.7	wetted perimeter (ft)				
1.3	hydraulic radius (ft)				
19.3	width-depth ratio				
		Flow Resistance		Sinuosity	Channel Type
		0.021	Manning's roughness	1.26	C5

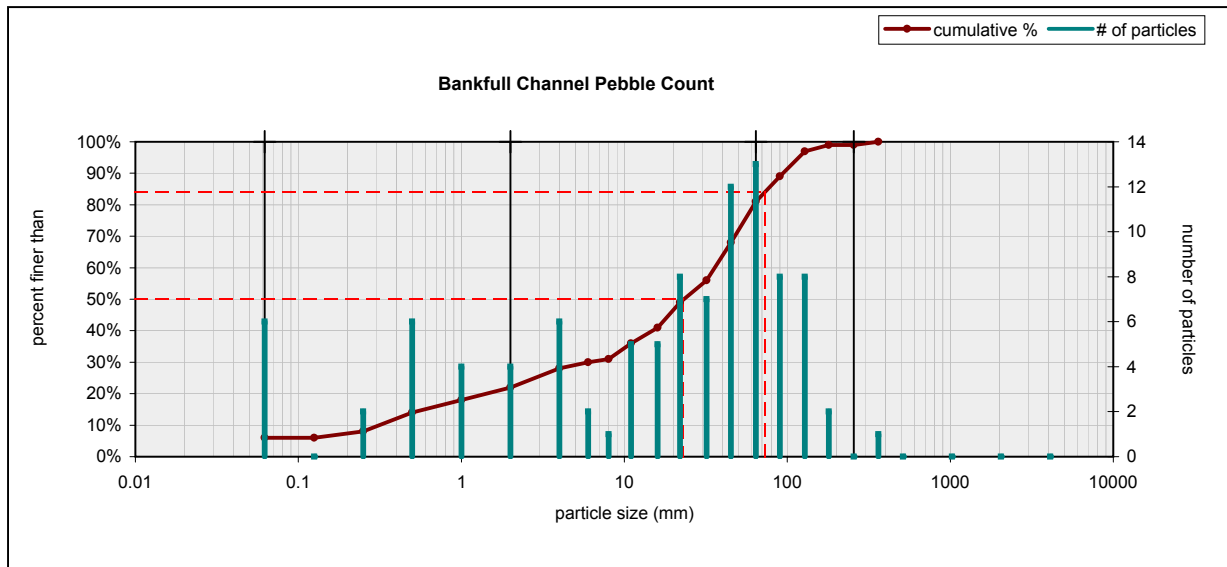
Size (mm)		Size Distribution		Type	
D16	0.71	mean	7.2	silt/clay	6%
D35	10	dispersion	17.8	sand	16%
D50	23	skewness	-0.4	gravel	59%
D65	41			cobble	18%
D84	73			boulder	1%
D95	120			bedrock	0%

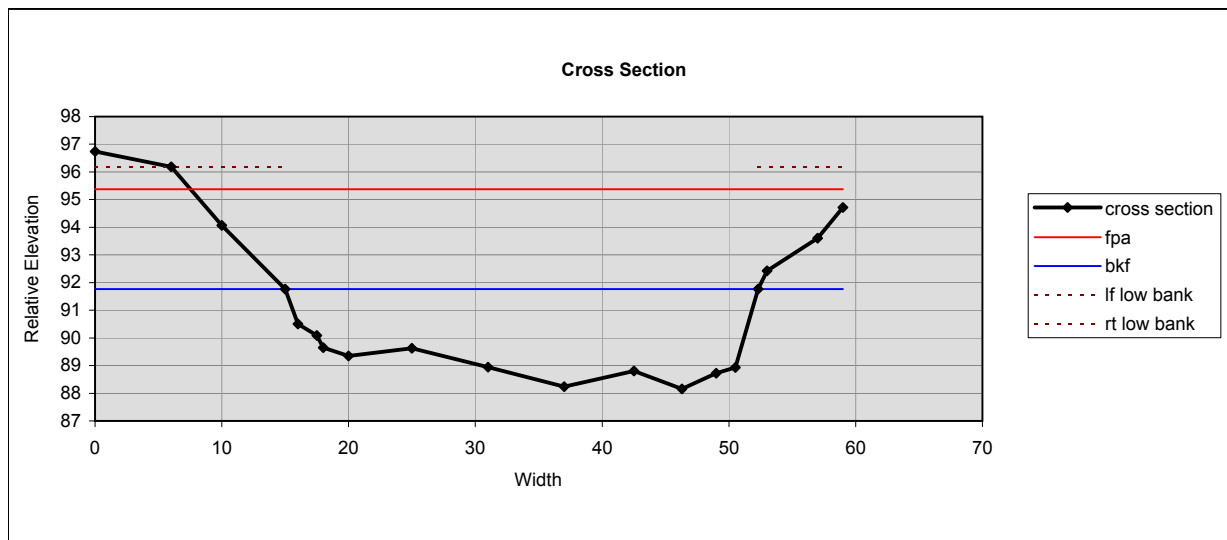
Bankfull Dimensions		Flood Dimensions		Bankfull Flow	
100.0	x-section area (ft.sq.)	42.9	Width flood prone area (ft)	5.8	velocity (ft/s)
37.3	width (ft)	1.2	entrenchment ratio	579.2	discharge rate (cfs)
2.7	mean depth (ft)	8.0	low bank height (ft)	0.38	channel slope (%)
3.6	max depth (ft)	2.2	low bank height ratio		
40.0	wetted perimeter (ft)				
2.5	hydraulic radius (ft)				
13.9	width-depth ratio				
		<u>Flow Resistance</u>		<u>Sinuosity</u>	<u>Channel Type</u>
		0.029	Manning's roughness	1.26	F4/5c

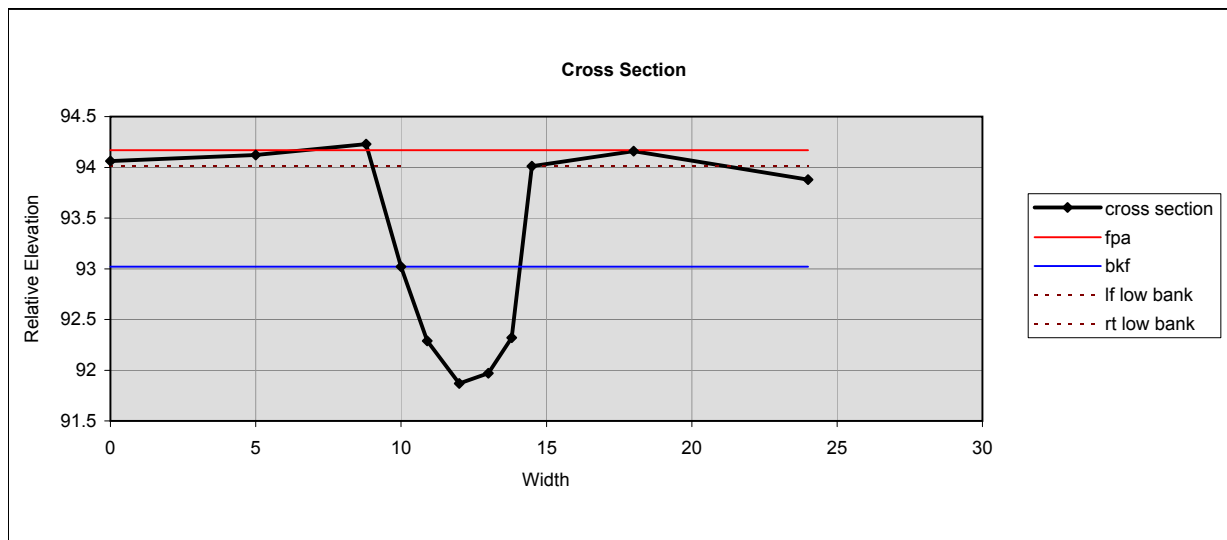
Bankfull Dimensions		Flood Dimensions		Bankfull Flow	
3.3	x-section area (ft.sq.)	52.5	Width flood prone area (ft)	4.9	velocity (ft/s)
4.1	width (ft)	12.8	entrenchment ratio	16.1	discharge rate (cfs)
0.8	mean depth (ft)	2.1	low bank height (ft)	3.10	channel slope (%)
1.1	max depth (ft)	1.9	low bank height ratio		
5.0	wetted perimeter (ft)				
0.7	hydraulic radius (ft)				
5.1	width-depth ratio				
		<u>Flow Resistance</u>		<u>Sinuosity</u>	<u>Channel Type</u>
		0.040	Manning's roughness	1.15	C4b
