# Little Patuxent River Watershed Assessment

Prepared for:  
Howard County,  
Department of Public Works,  
Stormwater Management Division

Prepared by:  
Versar, Inc.  
9200 Rumsey Rd, Suite 1  
Columbia, MD 21045

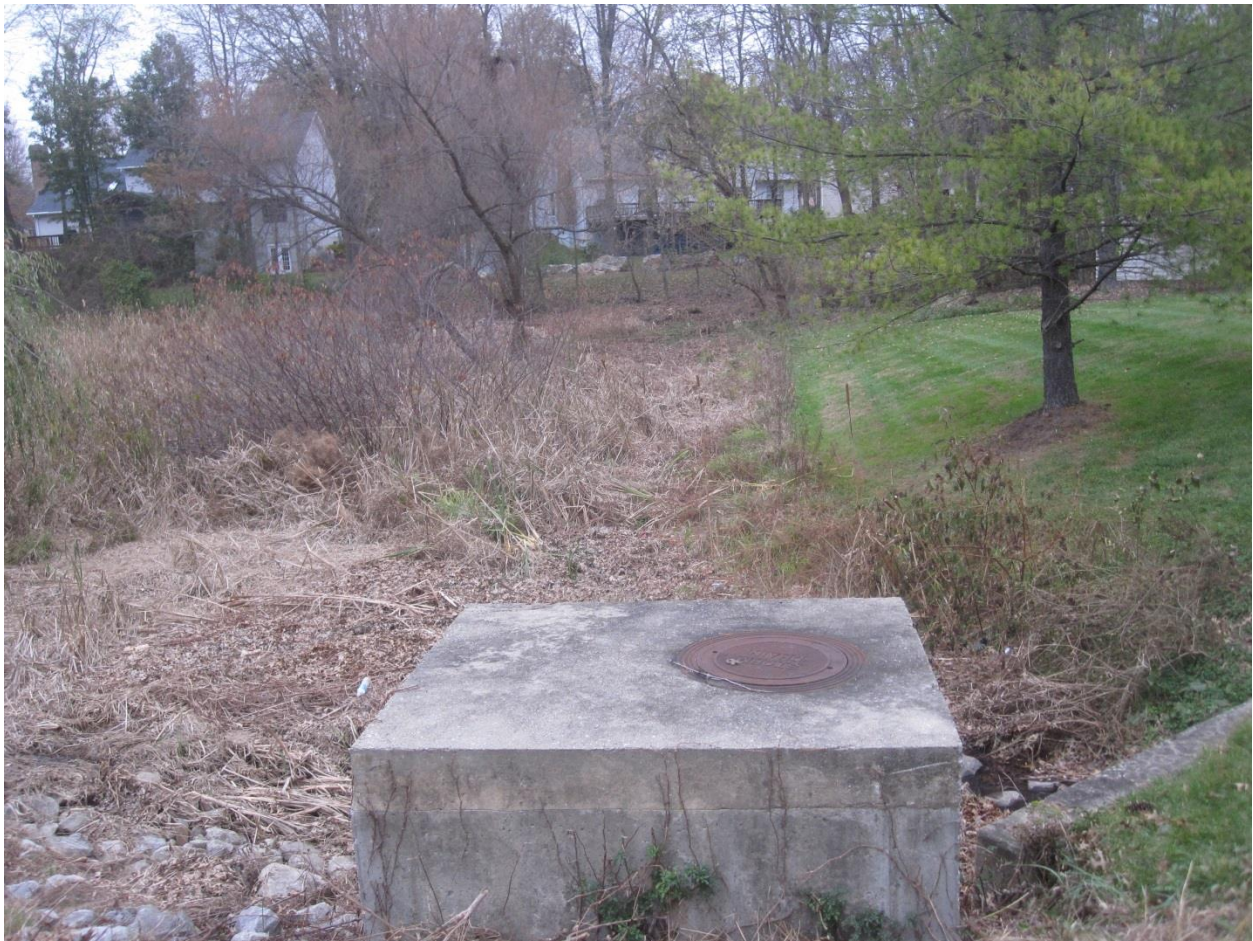
**Figure 2. SWM pond at dead end of Durham Road East, SLP-BC-D774**

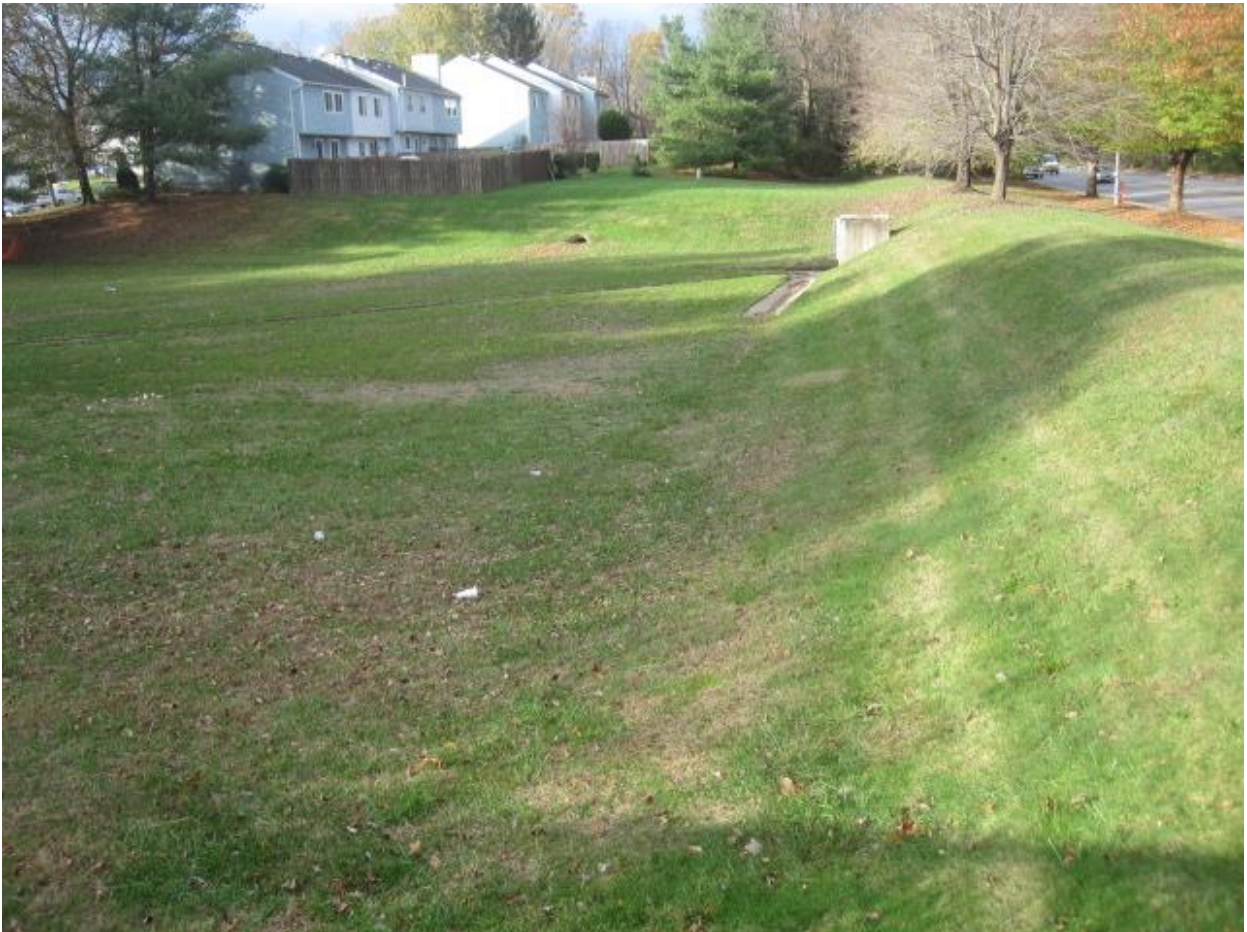
**Figure 2. SWM pond at 6047 Tree Swallow Court, SLP-BC-D780**

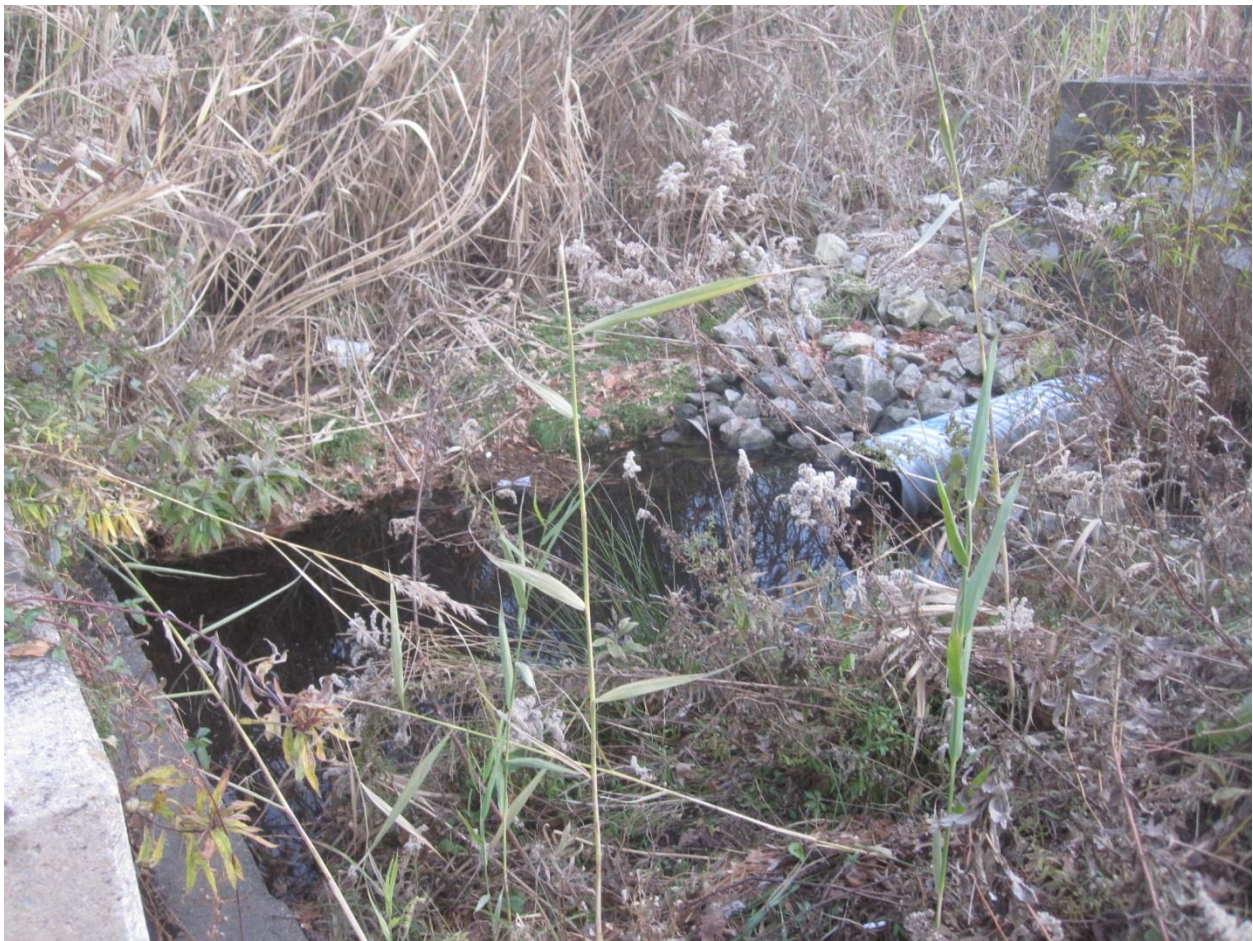
**Figure 2. SWM pond at 6480 Dobbin Road, Dobbin Road Commercial Business Center, short circuiting dewatering structure, SLP-BC-D792**

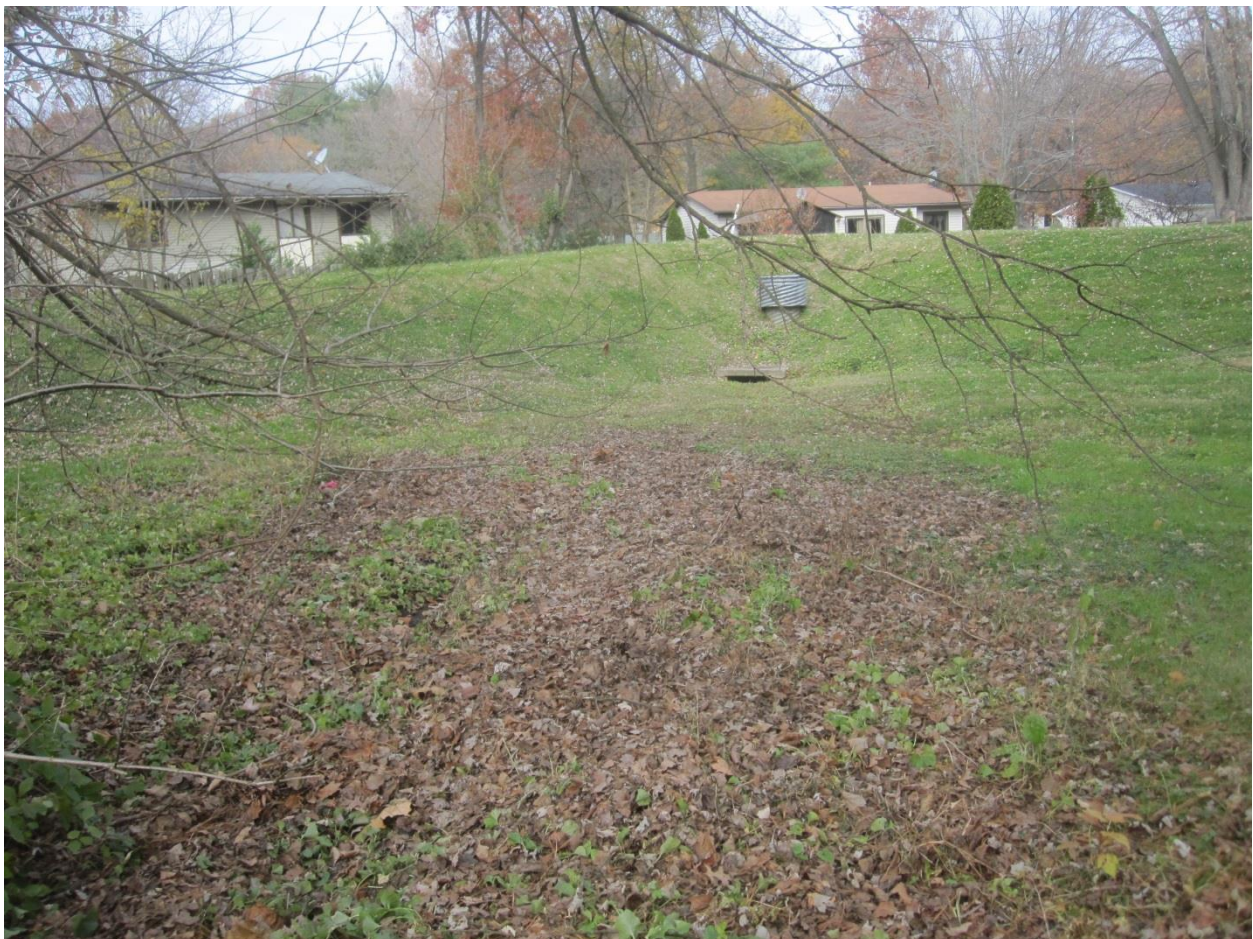
**Figure 2. SWM pond at 6527 Golden Coin Court, SLP-BC-D798**

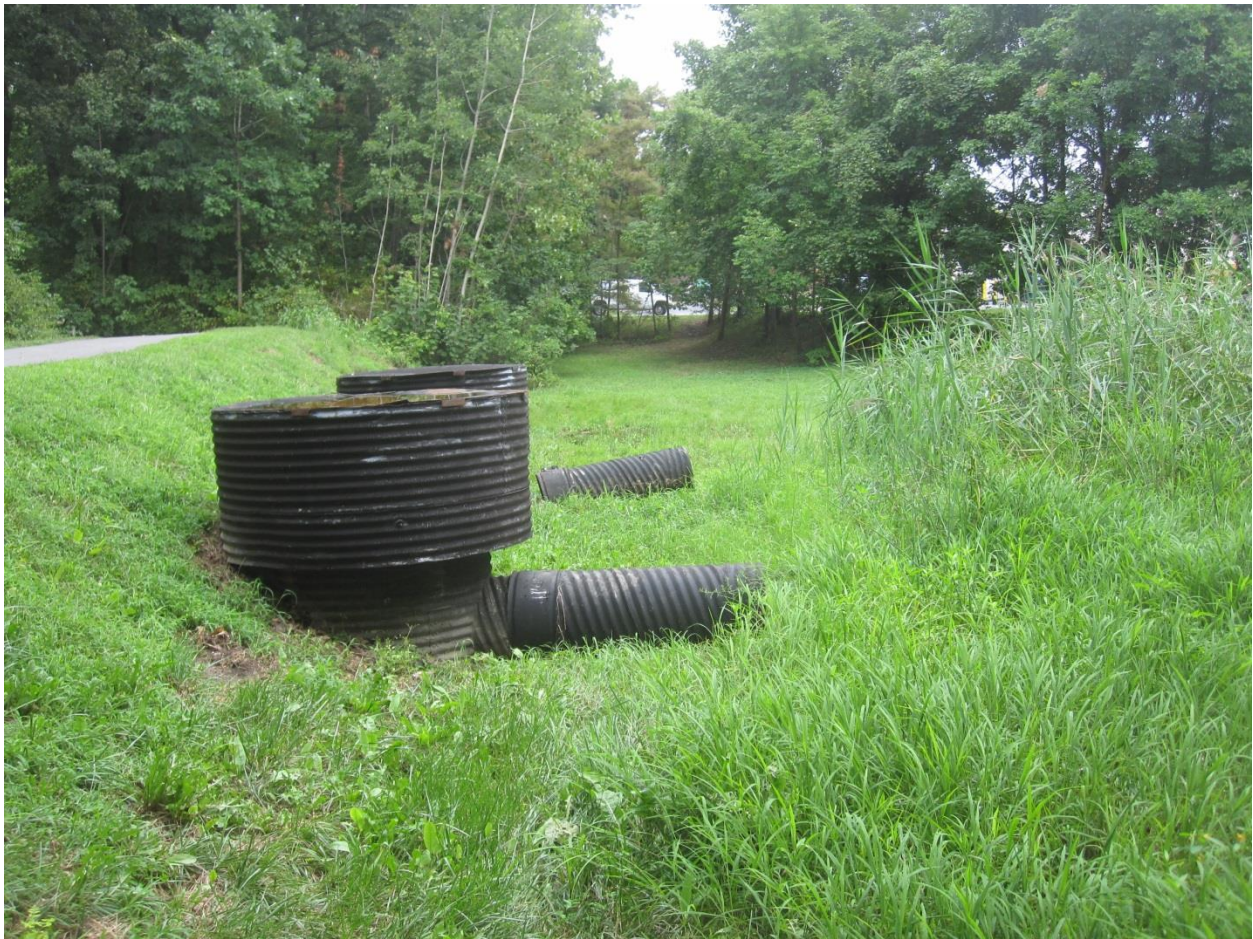
**Figure 2.** SWM pond at 8970 Old Annapolis Road, SLP-BC-D802

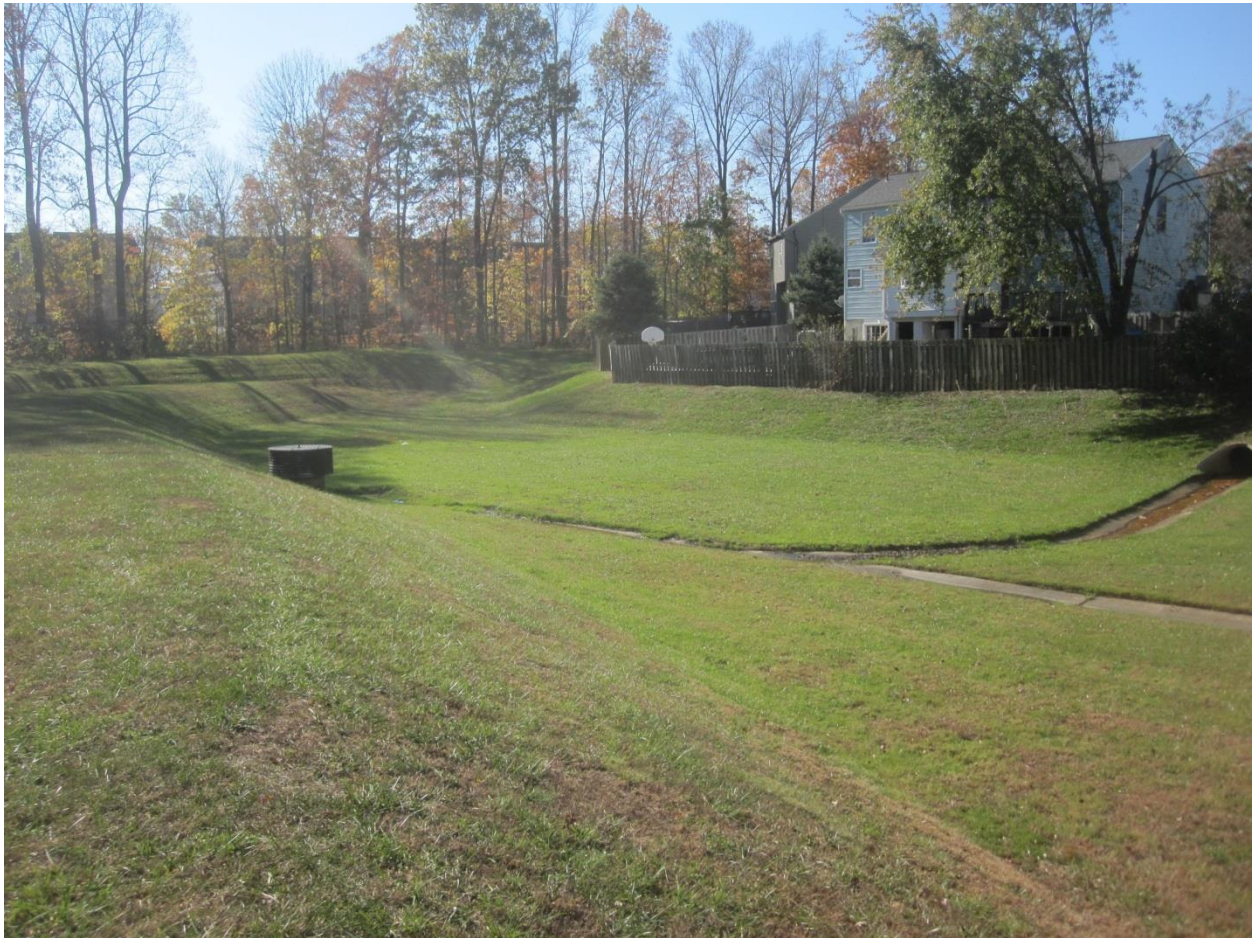
**Figure 2. SWM pond at 9518 Jaclyn Court, access via Fens Hollow Court, SMP-BC-D332**

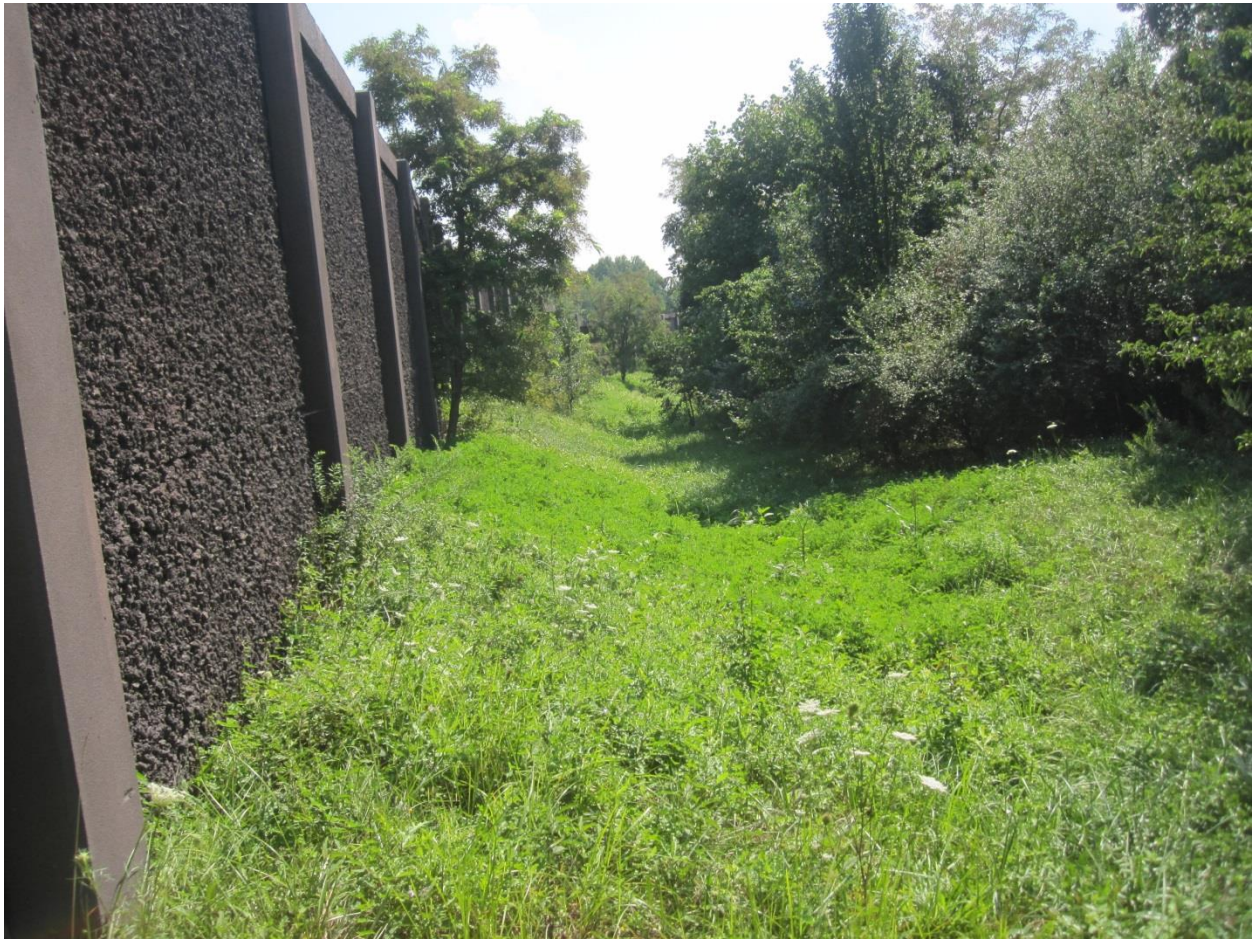
**Figure 2. SWM pond at Crest Drive and Route 216, SMP-BC-D333**
