Middle Patuxent River Watershed Assessment

Prepared for:
Howard County,
Department of Public Works,
Stormwater Management Division

Prepared by:
Versar, Inc.
9200 Rumsey Rd., Suite 1
Columbia, MD, 21045

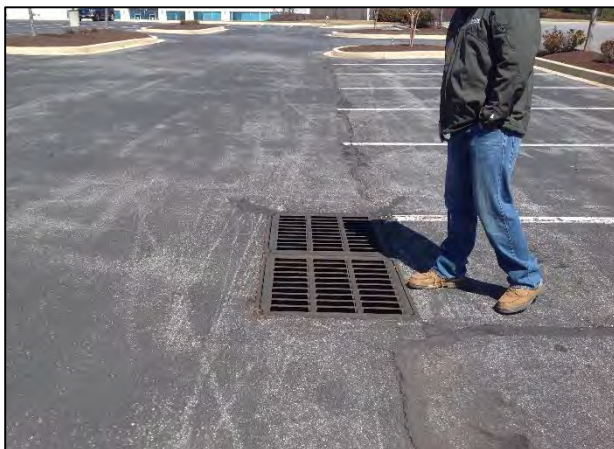
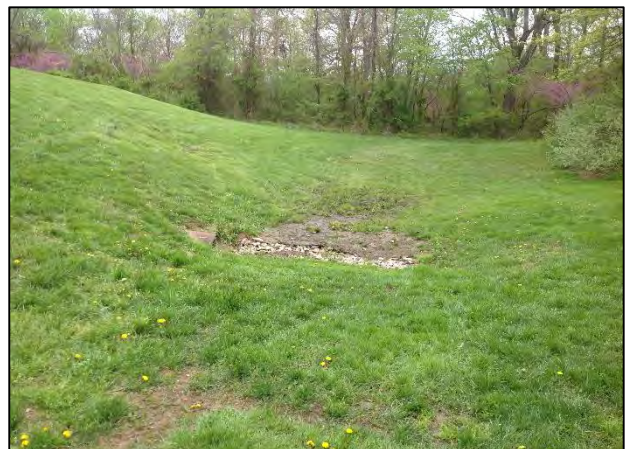
Figure 4-3. Typical untreated impervious surface (left) and a potential location for a new BMP facility (right) observed during New BMP Assessments

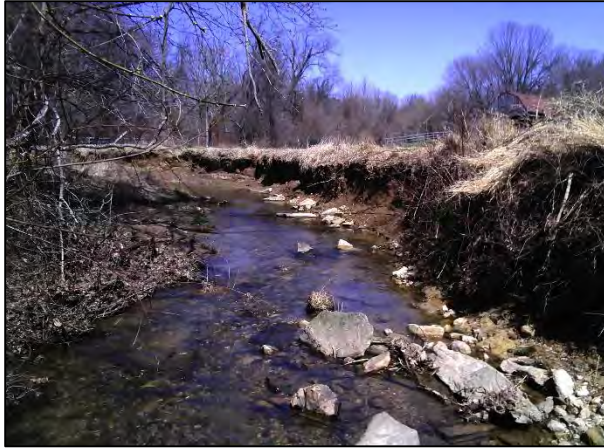
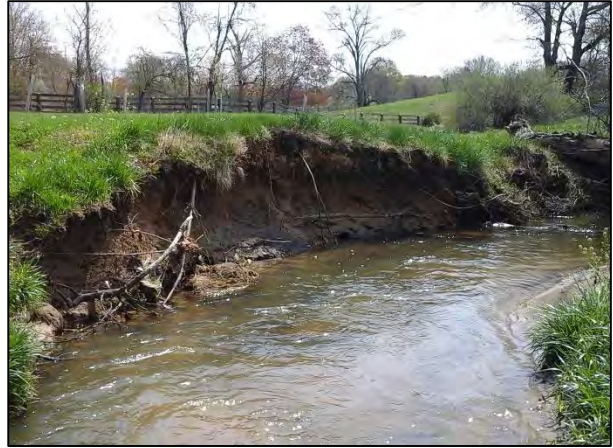
Figure 4-4. Typical degraded stream channels observed during Stream Restoration Assessments

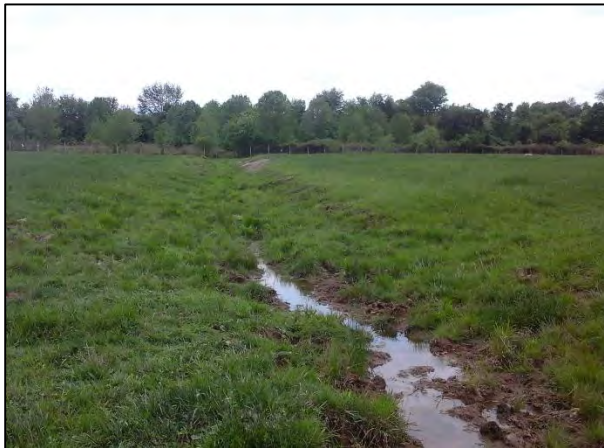
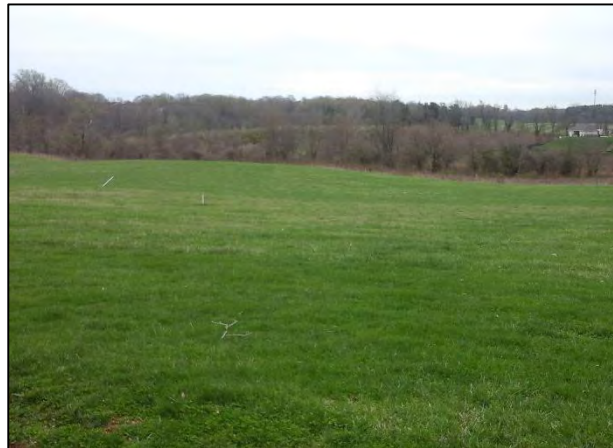
Figure 4-5. Typical tree planting opportunities found along stream corridors (left) and adjacent to existing forest (right)

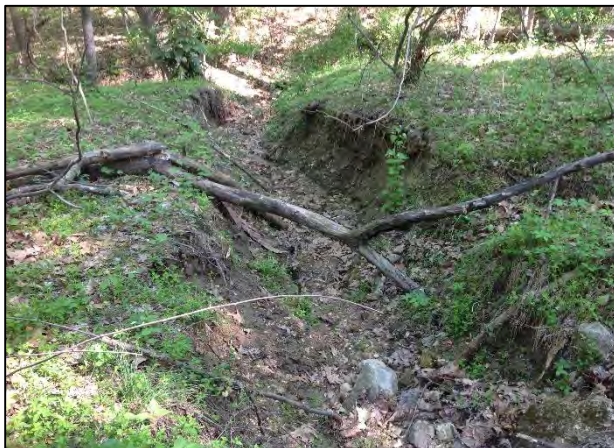
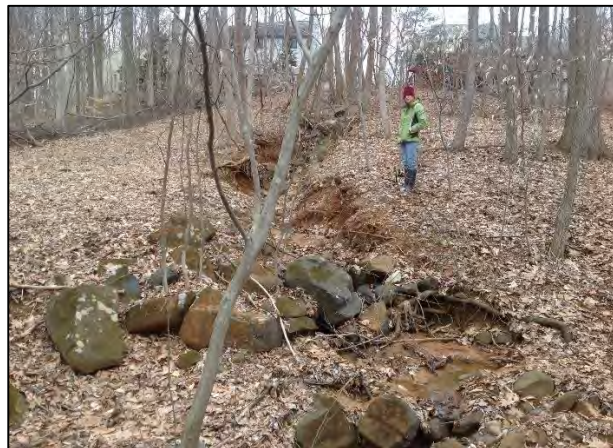
Figure 4-6. Typical degraded outfall channels observed during Outfall Stabilization Assessments

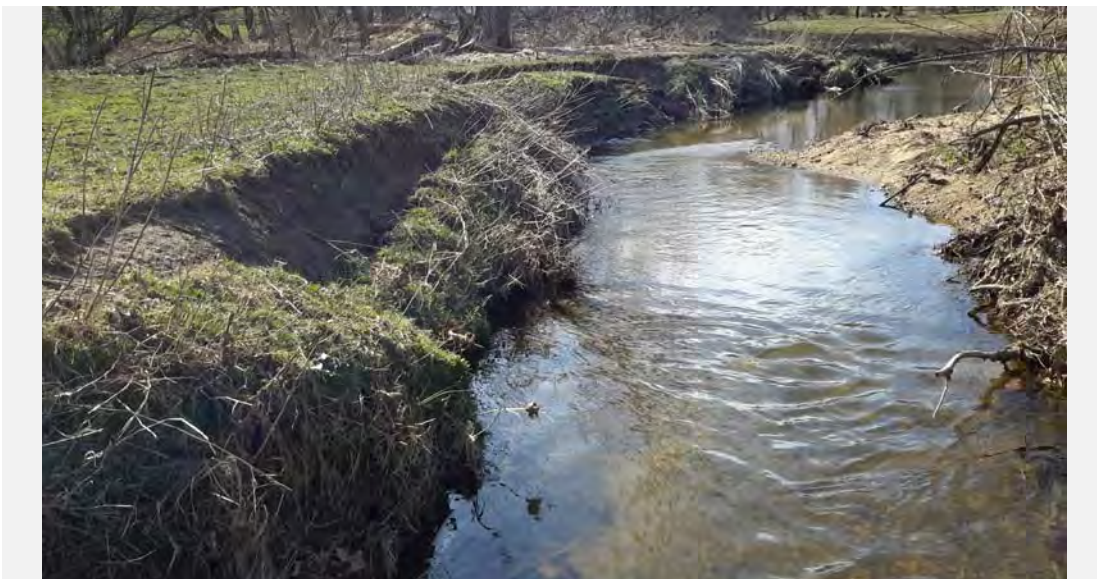
Facing upstream at a recent bank failure. Poor vegetative protection and heavy grazing up to the stream bank is also evident.

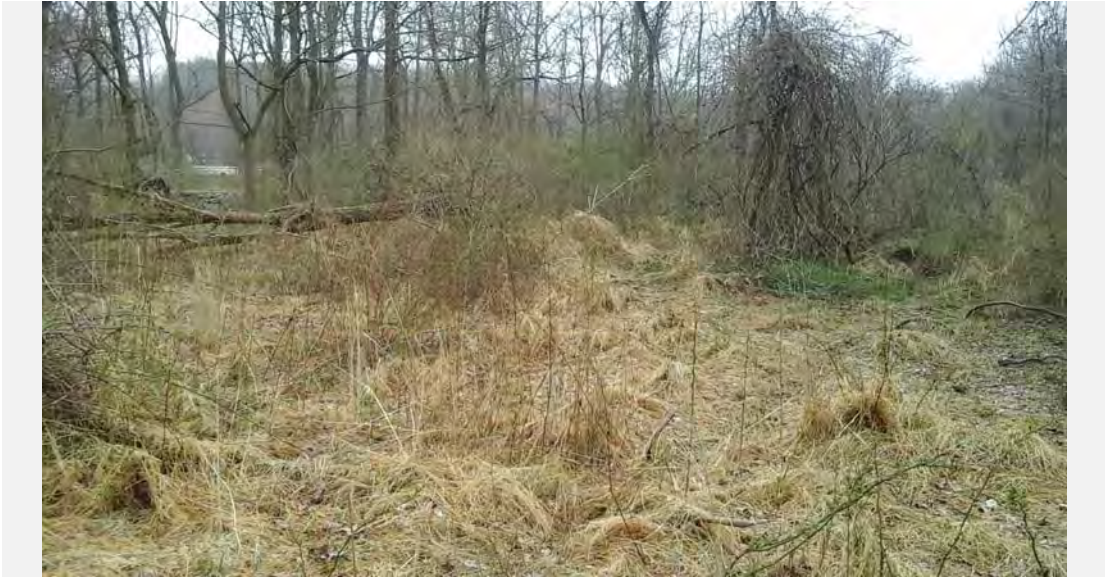
Proposed tree planting site NMP-TP-F104 facing southwest at inadequate riparian buffer.

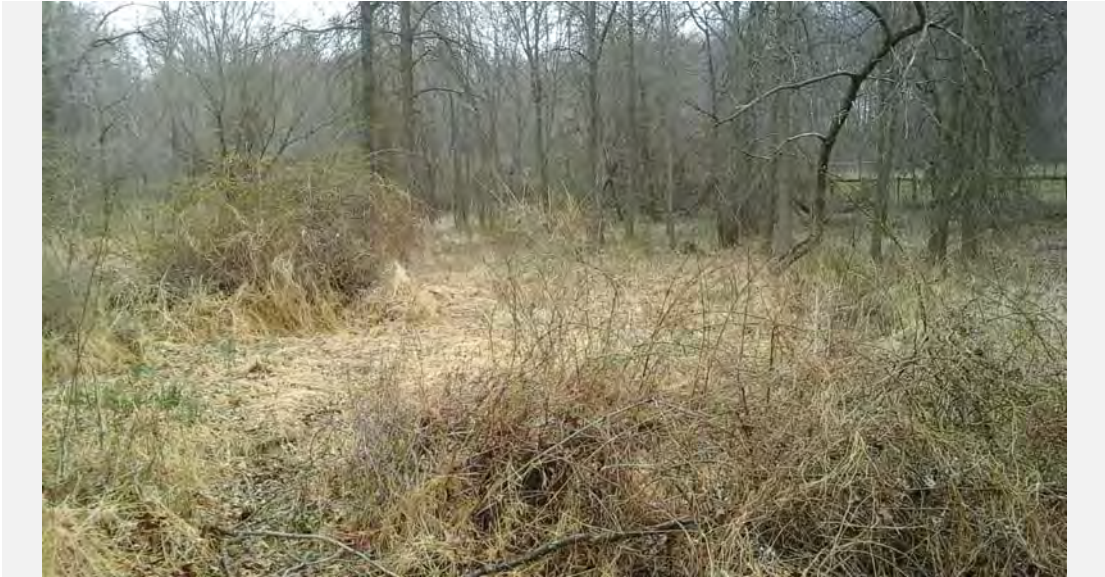
Proposed tree planting site NMP-TP-F104 facing northeast at inadequate riparian buffer.

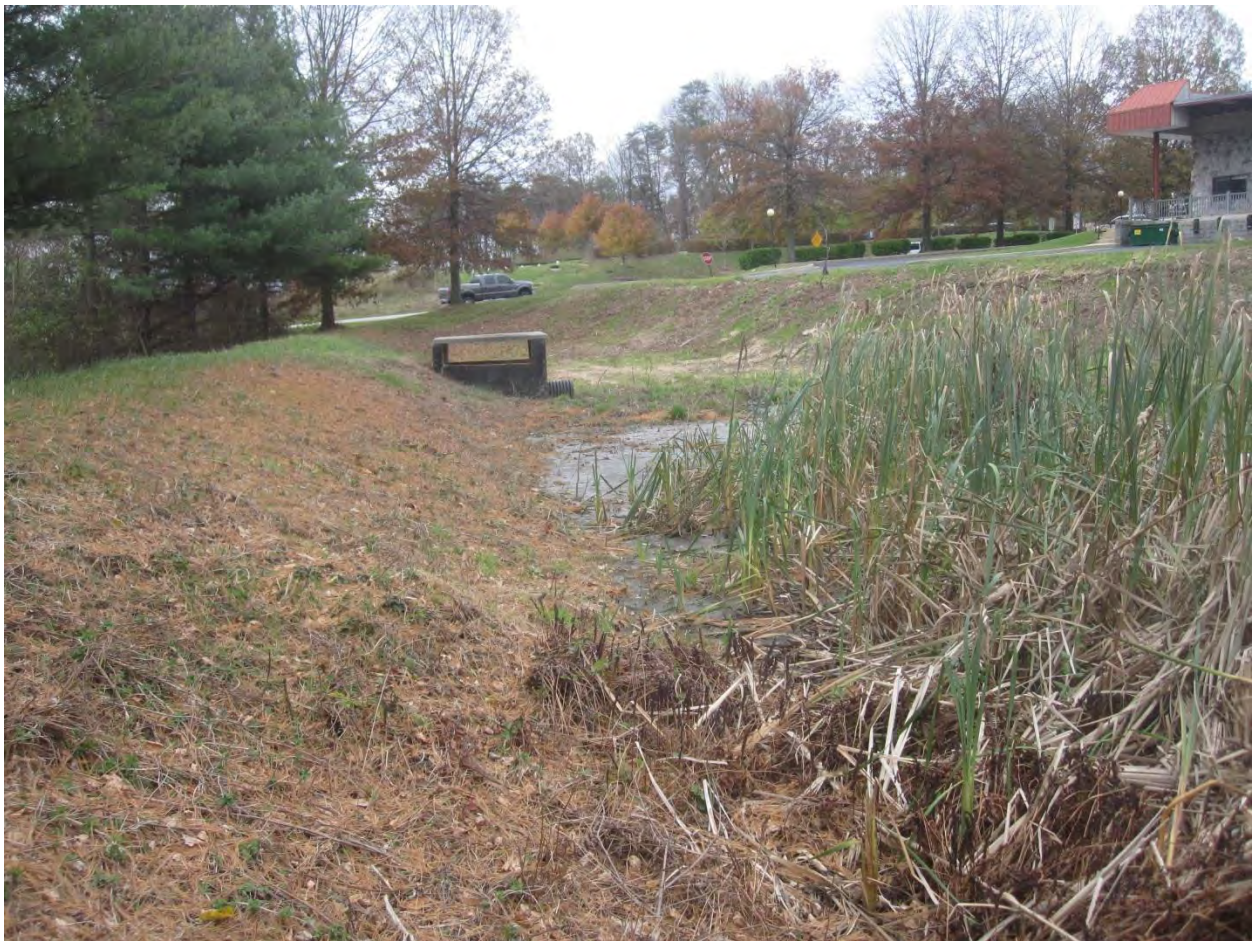
Figure 2. SWM pond at 3800 Ten Oaks Road, NMP-BC-D113

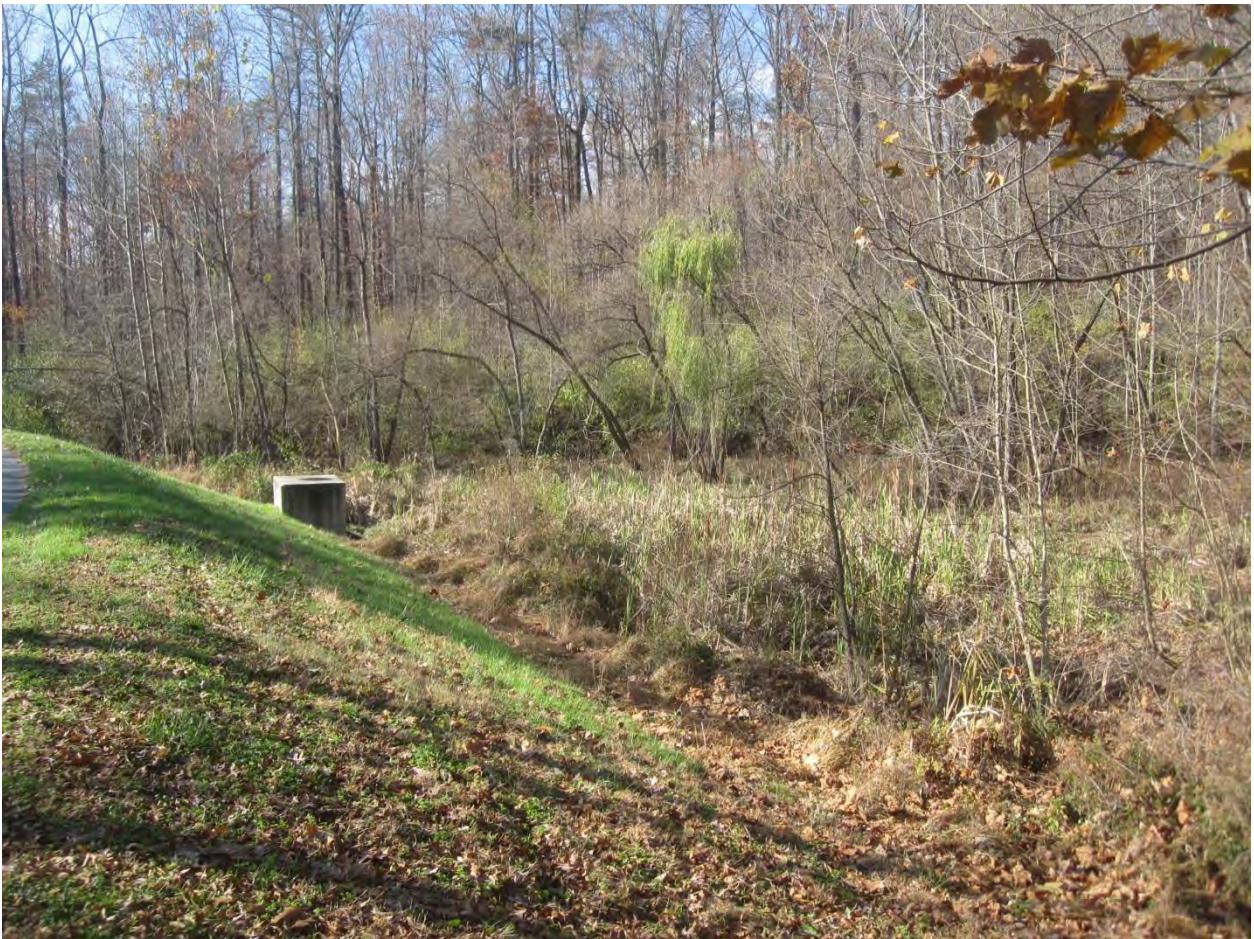
Figure 2. SWM pond at power line R-O-W and 9023 Moving Water Lane, SMP-BC-D330
