SECTION 4 CENTENNIAL AND WILDE LAKE IMPLEMENTATION PLAN RECOMMENDATIONS

4.1 CENTENNIAL LAKE SUBWATERSHED PLAN RECOMMENDATIONS

4.2 WILDE LAKE SUBWATERSHED PLAN RECOMMENDATIONS

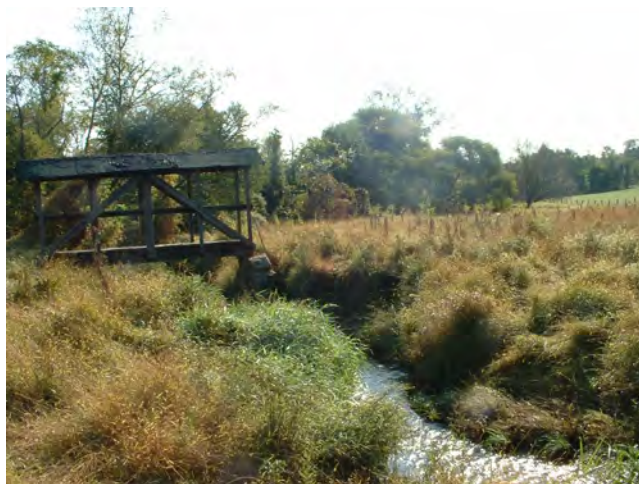
Figure 4.2 Site for forested wetland complex.

Two primary recommendations are being made for this site. The first is to recouple the stream with its floodplain in locations where there is considerable incision and streambank erosion. This could be accomplished by raising the invert of the stream or by decreasing the elevation of the existing floodplain. Decreasing the elevation of the stream would more closely represent the historical condition of the floodplain but would require the use of the excavated material on site or selling it for use as topsoil, as hauling costs would be prohibitive. The second

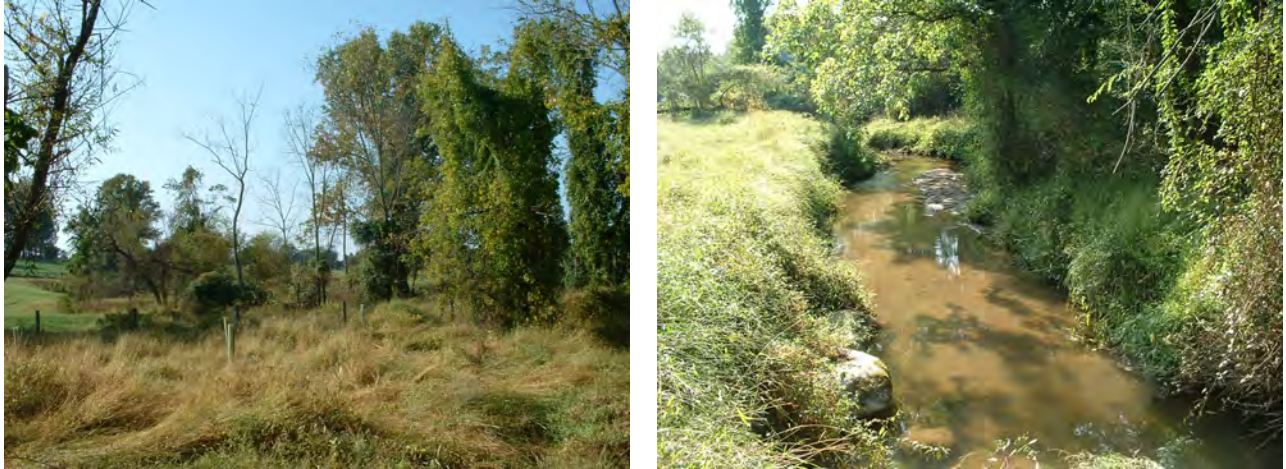
Note the dominance of invasive grasses and lack of recruitment of trees on the left, and the sediment deposition in the picture on the right where invasive species also hide an eroding stream bank.

Figure 4.3 Examples of invasive species.

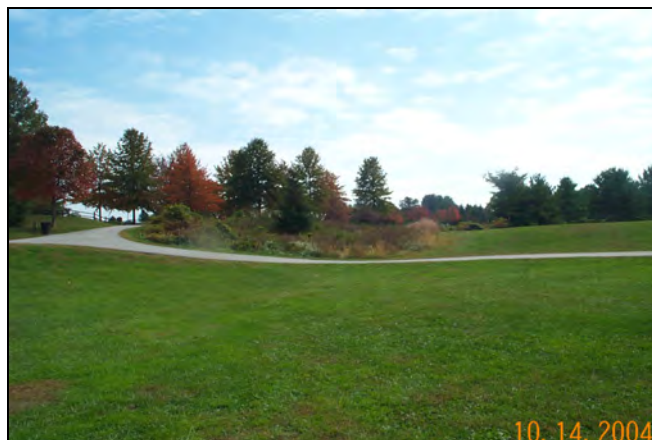
Figure 4.6 Centennial Park.

The site consists of two locations approximately 150 feet apart. Site A is a low-lying spot between the existing paved walking path and the waterfowl exclusion fencing. During the field visit the ground was saturated and evidence of erosion and attempts at erosion control were observed. Further investigation of the topography revealed that stormwater flows through the vegetated area above the paved path before entering a shallow, naturally formed depression. The stormwater flows overland through the depression to a storm drain inlet. The inlet then flows to an outfall directly to Centennial Lake.

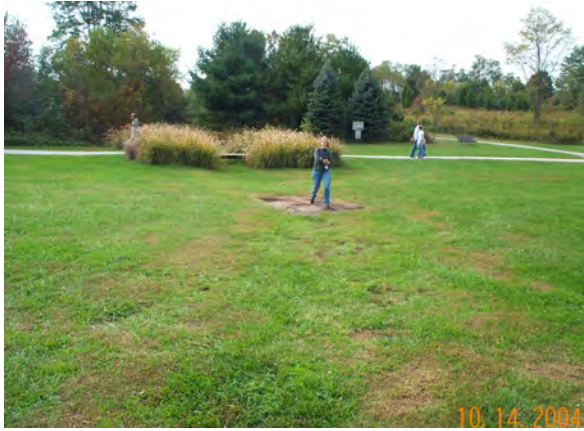
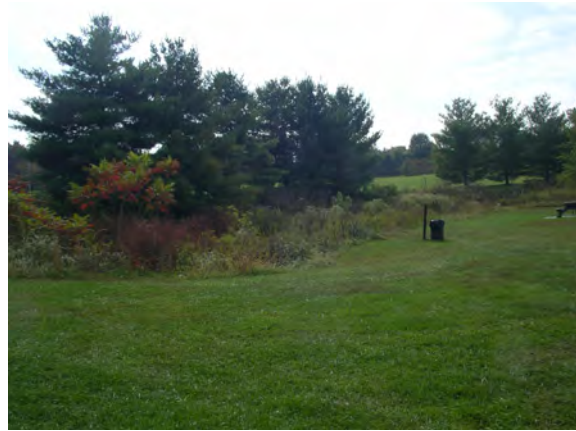
Site A

Site B

Figure 4.7 Sites A and B.

The proposed concept involves creating bioinfiltration cells at Sites A and B (Figure 4.7). The bioinfiltration cells at both sites will be designed to provide water quality treatment to reduce the nutrient and sediment load directly discharged to the lake.

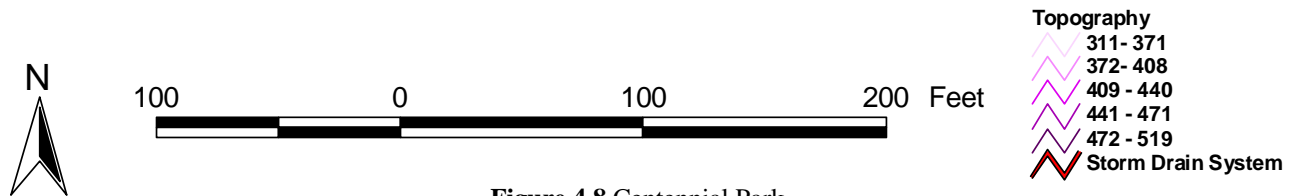
CL-2 Centennial Park

Figure 4.8 Centennial Park.

Figure 4.8 is a map showing how the recommended features would work in Centennial Park.

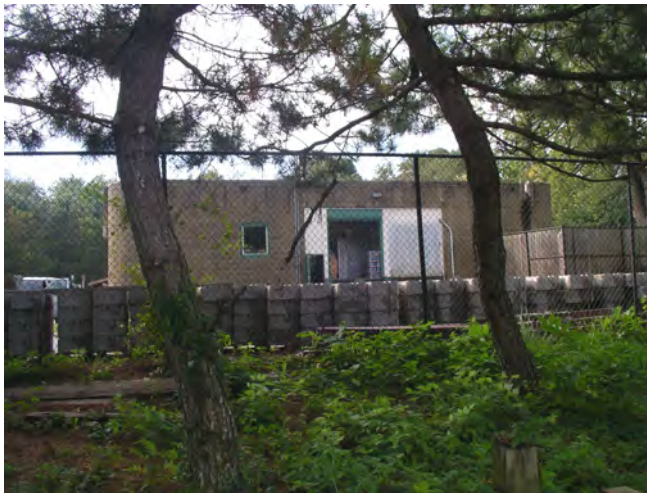
Figure 4.10 Maintenance facility.

The park maintenance facility consists of a central maintenance building and several smaller storage sheds. There is a large asphalt area and rooftop that drains untreated off the site via sheet flow primarily to the northwest corner of the site. From there the site runoff flows overland and enters a swale leading down to the lake. An uncovered fueling station was observed with petroleum sheen apparent and some additional staining. The eastern perimeter of the site contains a row of unlabeled, uncovered storage drums.

The proposed concept involves providing a perimeter sand filter or bioretention cell at the surface drainage outlet point along the edge of the maintenance yard (Figure 4.10). Other site design elements include provision of an overhead canopy to cover the fueling area and covered storage for all drums and containers stored on-site. The development of a pollution prevention plan for this site is also recommended.

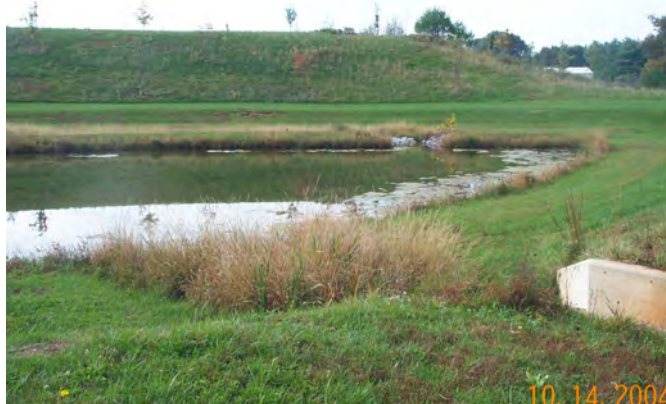
Figure 4.12 Stormwater pond at the Homewood School.

An existing stormwater pond treats runoff from the Homewood School site (Figure 4.12). Currently, runoff from much of the ARL bypasses this facility in a concrete-lined trapezoidal channel. In particular, the maintenance area of the school drains to this conveyance channel and appears to receive no or limited (some oil and grit separators may exist) stormwater treatment. In addition to the concrete conveyance channel, there is also a pipe bypass that receives higher flows at the beginning of the conveyance. The outfall of this piped bypass was not seen in the field; however, it is believed to discharge somewhere downstream of the existing wet pond.

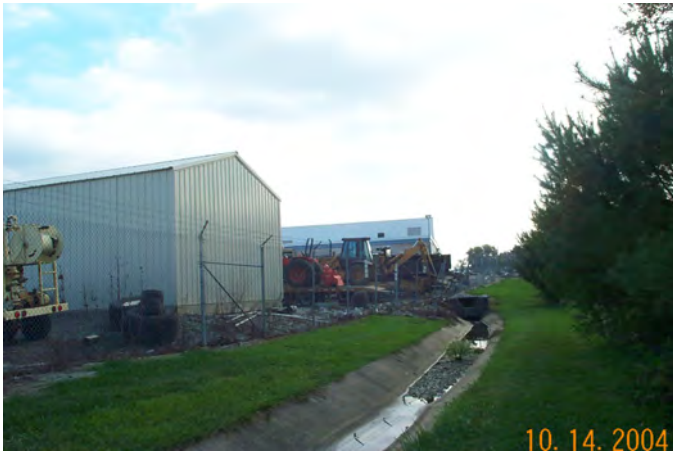
Figure 4.13 Typical plan and section view of dry swale.

- Provide plunge pool at existing splitter box for pretreatment prior to discharge to new dry swale.
- Replace concrete channel with dry swale (Figures 4.13, 4.14, and 4.15). Swale slope to be ~1%, which will require check dams using timber or concrete weir walls.
- Maximum flow depth allowed—18 inches.
- Filter media 2.5 feet deep with perforated underdrain to be used for water quality treatment.
- Bottom widths ~ 6 feet, with slide slopes of 3H:1V.
- Underdrain to daylight downstream of pond outfall using rock-lined level spreader/apron.
- See retrofit concept sheet for typical details.

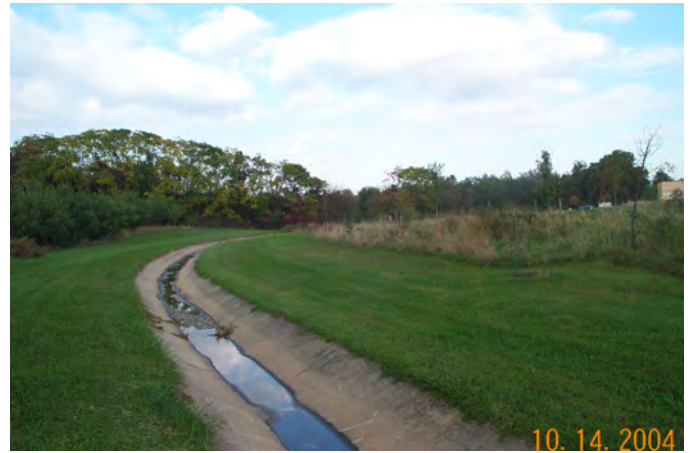
Figure 4.14 Existing concrete channel looking down channel.

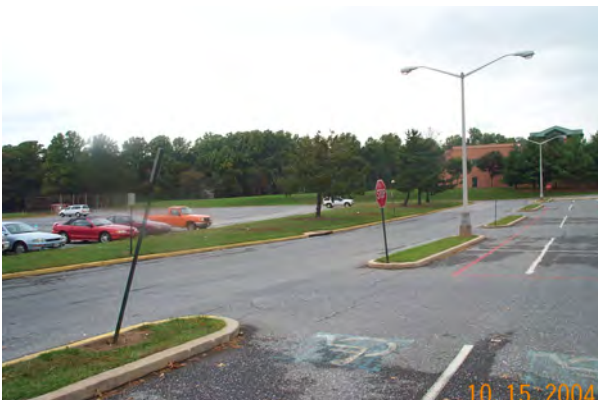
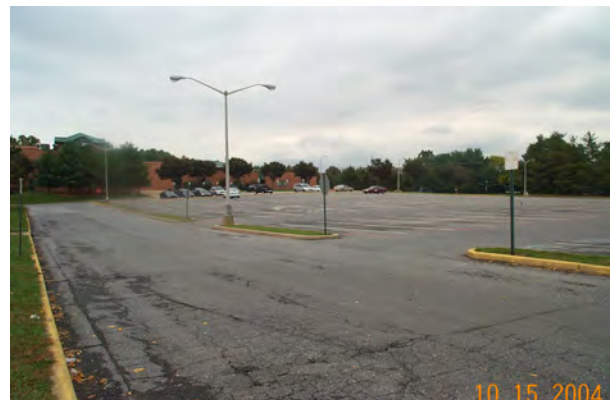
Figure 4.17 Views of Centennial High School parking lot and proposed area for bioretention.

Figures 4.17 through 4.22 illustrate current condition of school parking lot and representative photographs and schematics of bioretention features being proposed for this site.

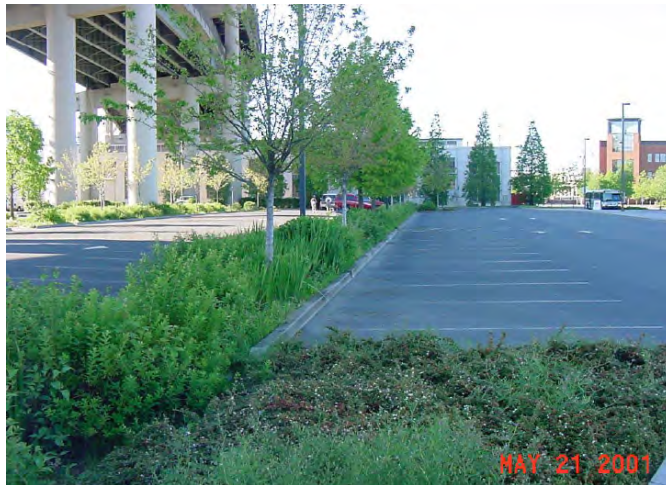
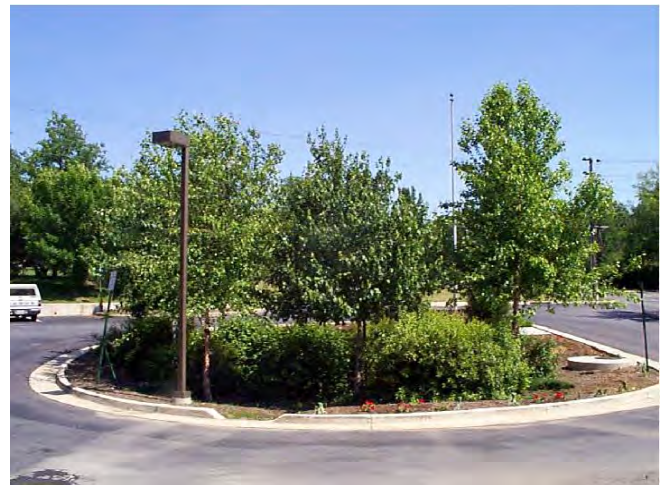
Figure 4.20 Examples of bioretention in parking lots with curb cuts and mixtures of tree and shrub plantings.

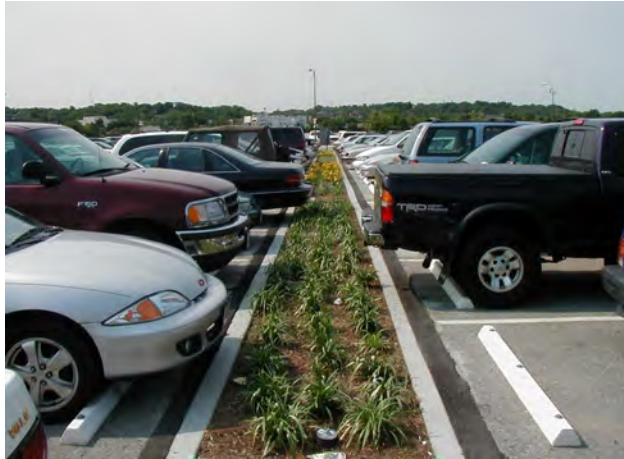
Figure 4.21 Typical linear bioretention strip proposed for area adjacent to tennis courts.

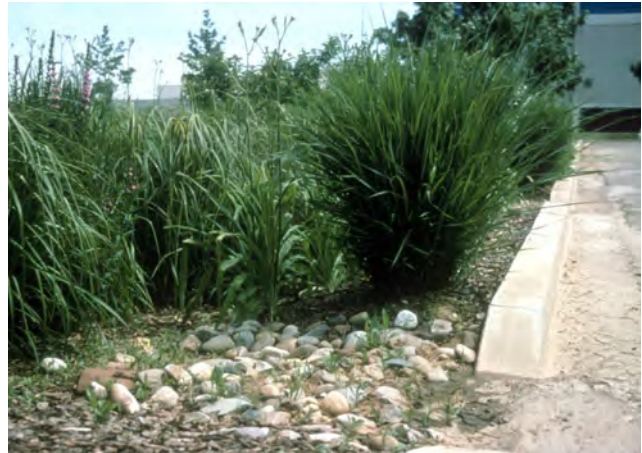
Figure 4.22 Typical inlet with rock-lined entrance to provide energy dissipation and pretreatment.

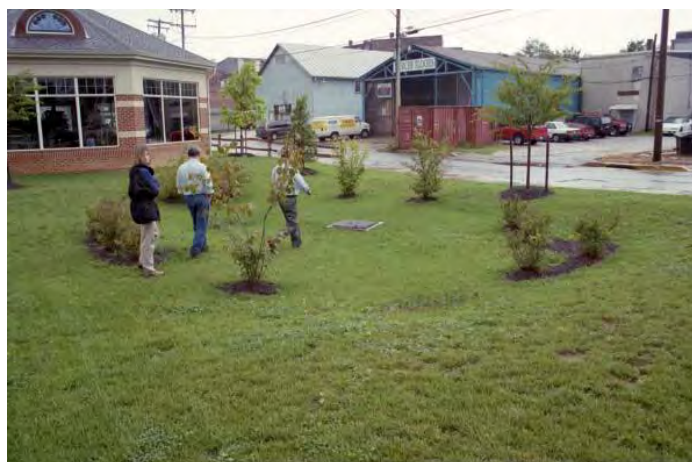
Figure 4.24 Low maintenance application of a biofilter project (Carroll County, MD).

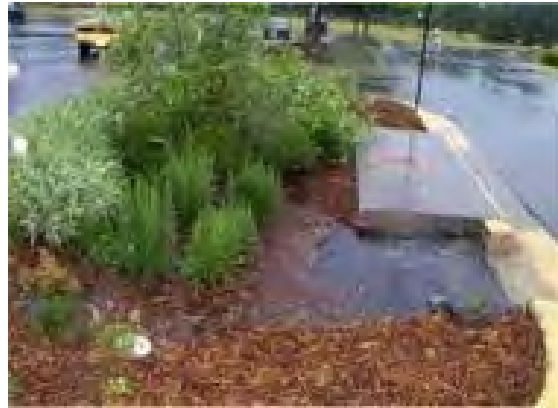
Figure 4.27 Raingarden. Similar application though proposed facility would be larger (LID Center, 2005).

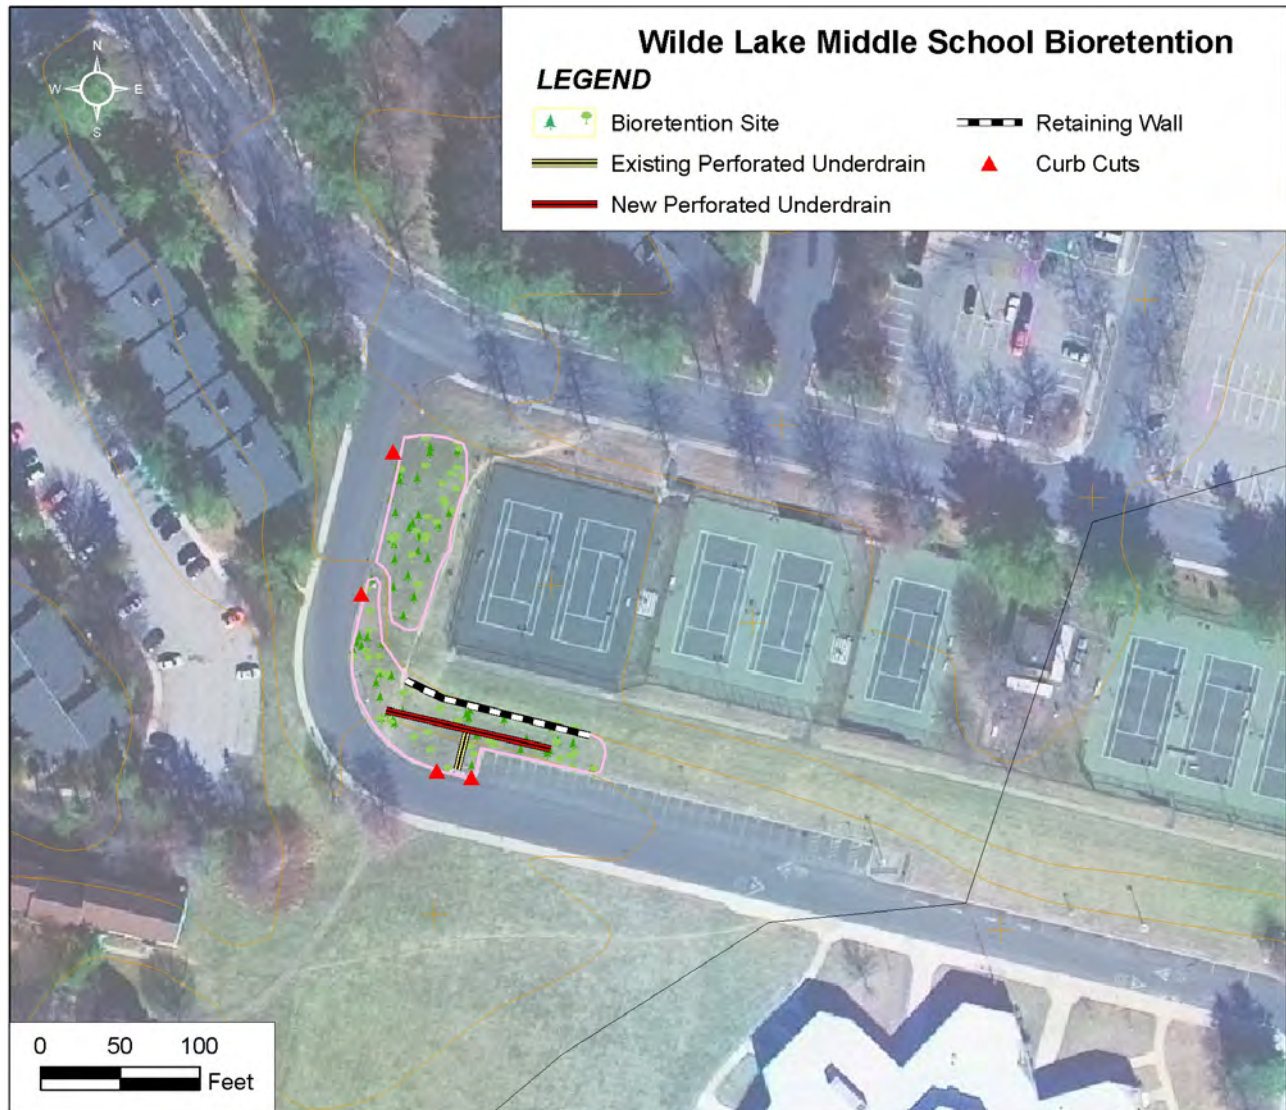
Figure 4.29 Sketch of WL-01 concept on aerial photo.

Figures 4.28 and 4.29 show examples of the restoration concepts.

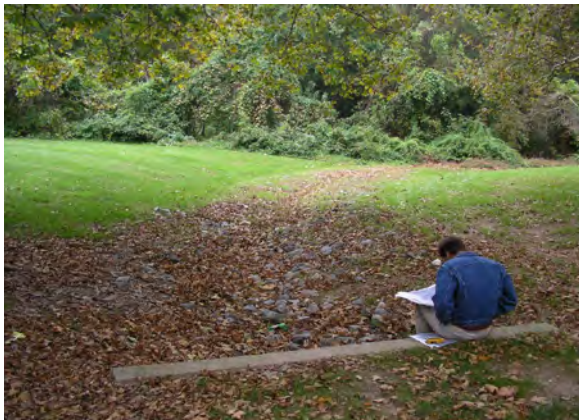
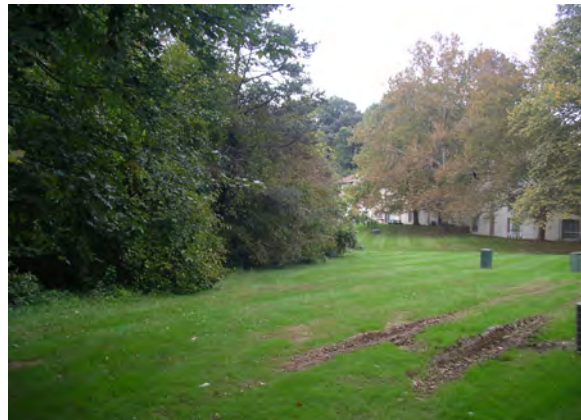
Figure 4.31 Left photo shows 18-inch RCP outfall adjacent to apartments that has been recently lined with riprap to reduce erosion. Right photo shows managed turf area adjacent to the conveyance channel.

(Figure 4.30). Two 18-inch RCP outfalls exist, both showing signs of impacts from significant uncontrolled flows. The easternmost outfall is actively eroding and has recently been repaired by placement of riprap. The receiving channel is incised and a source of significant sediment loads downstream. Some woody riparian growth is present immediately adjacent to the channel. The channel is located within CA’s park area and has a sanitary line running roughly parallel on the north side.

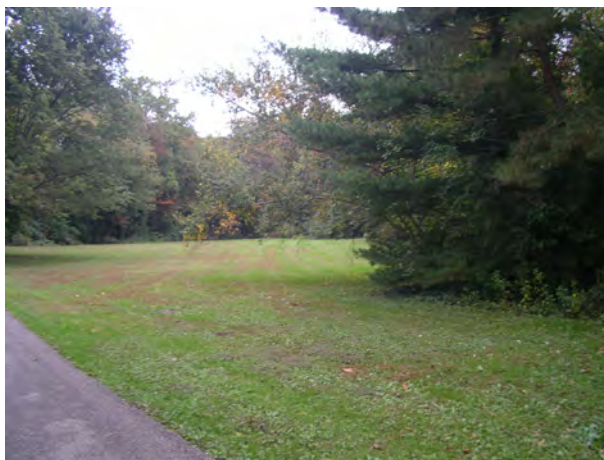
Figure 4.32 North side of conveyance channel that contains sewer ROW.

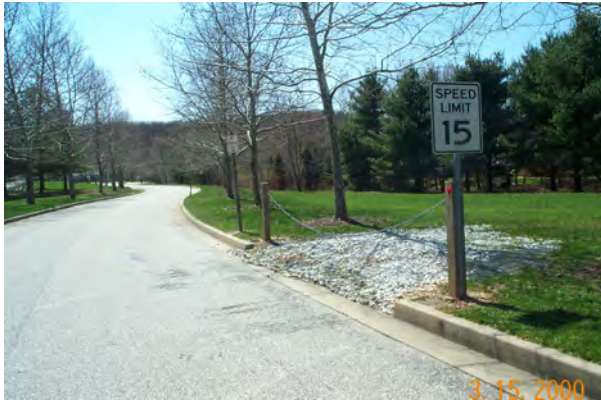
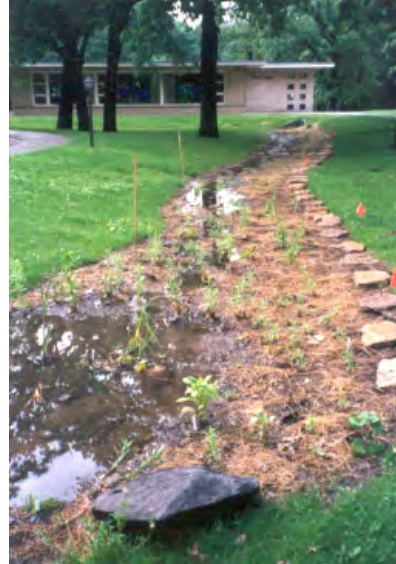
Figure 4.35 Proposed rain garden location and example.

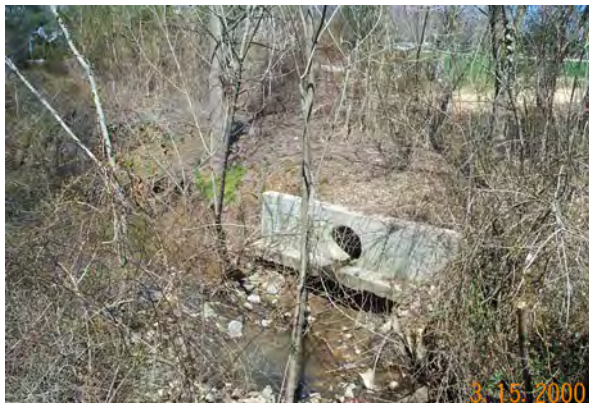
Figure 4.36 Eroding outfall from parking area/road.

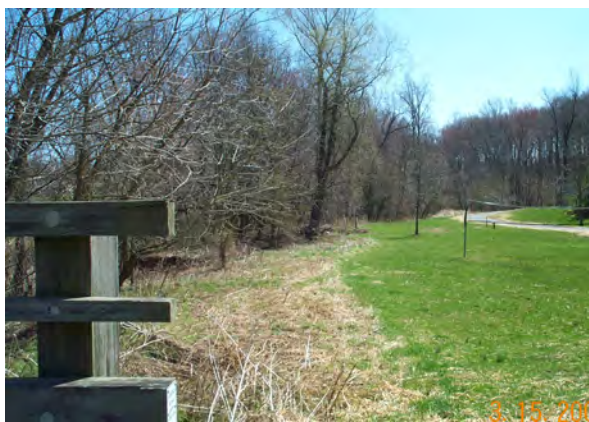
Figure 4.37 Proposed floodplain reconnection.

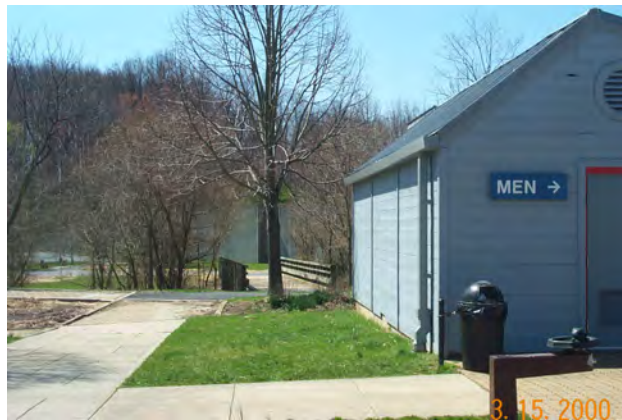
Figure 4.40 Proposed rain barrel/rain garden.

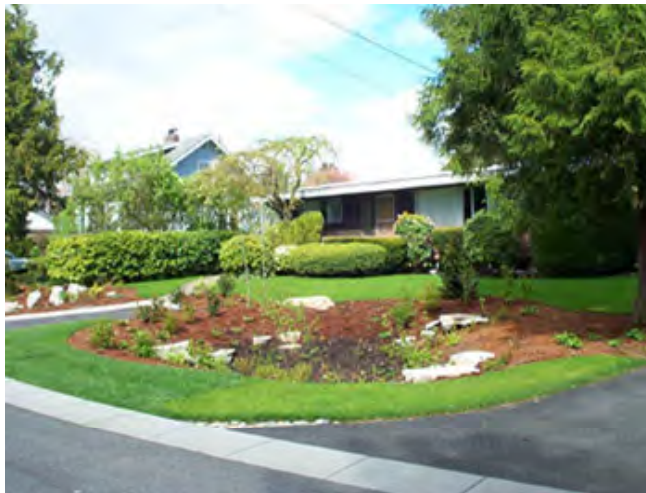
Figure 4.42 Example streetscape stormwater filtration (Seattle, WA).

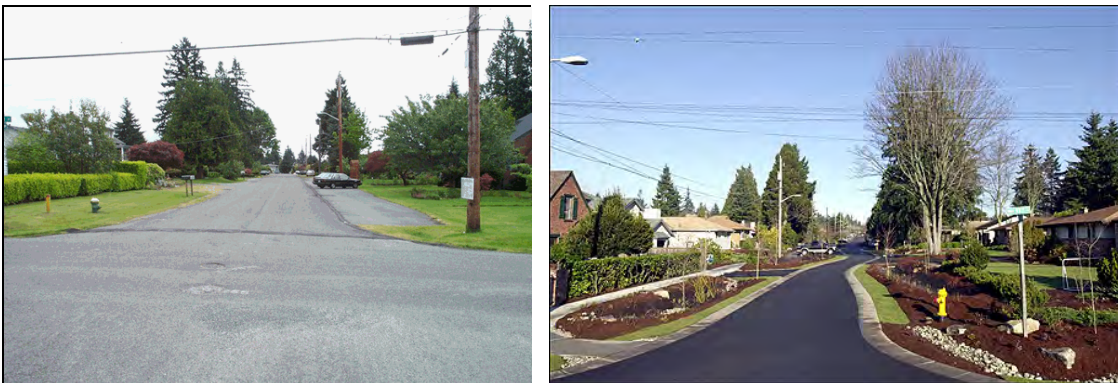
Figure 4.43 Seastreets in Seattle before and after construction (SPU, 2004).

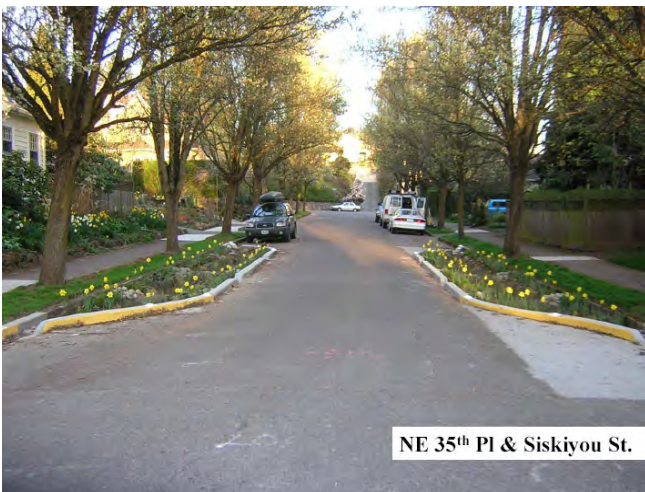
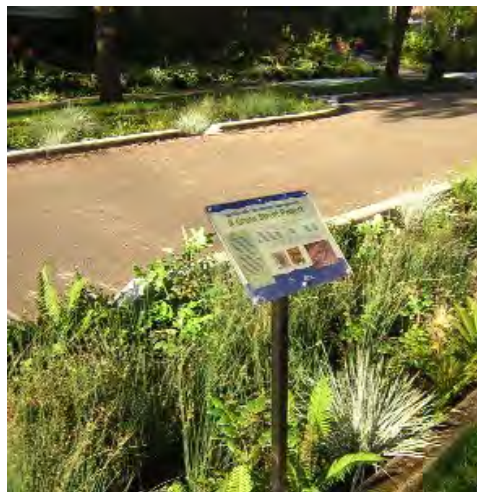
Figure 4.45 Streetscaping bioretention project and signage within the existing roadway (Portland BES, 2005).

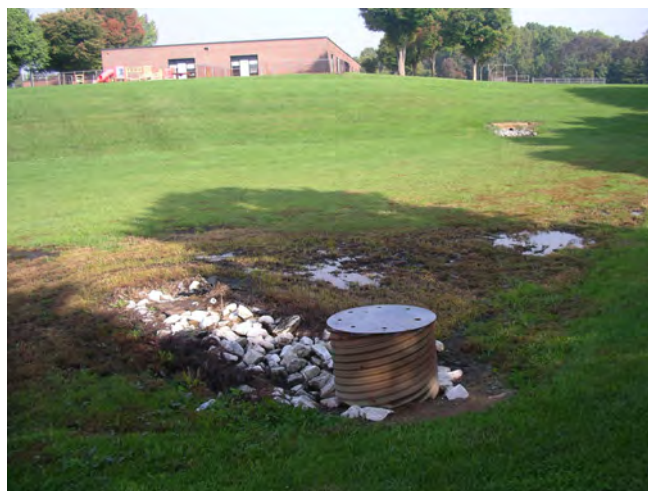
Figure 4.46 Harpers Choice Middle School dry pond.

An existing dry pond (Figure 4.46) provides limited stormwater management function at this school site. The existing practice suffers from eroding conditions at the two inflow points as well as a riser structure. Standing water is commonly found during wetter periods of the year (i.e., spring and fall). Runoff is primarily from the parking lot, the road, and some rooftops. Outflow from facility ties into the existing storm drain infrastructure.

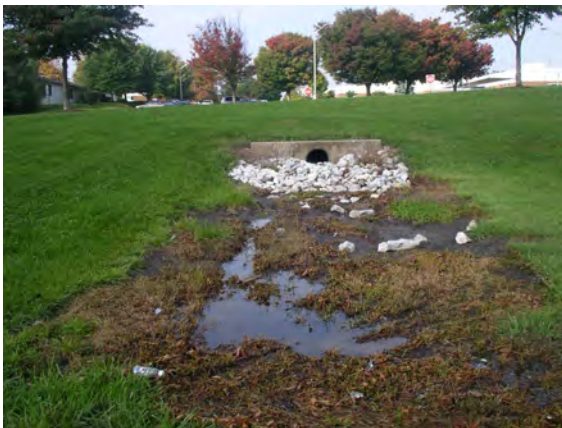
Figure 4.47 Existing inflow to dry pond.

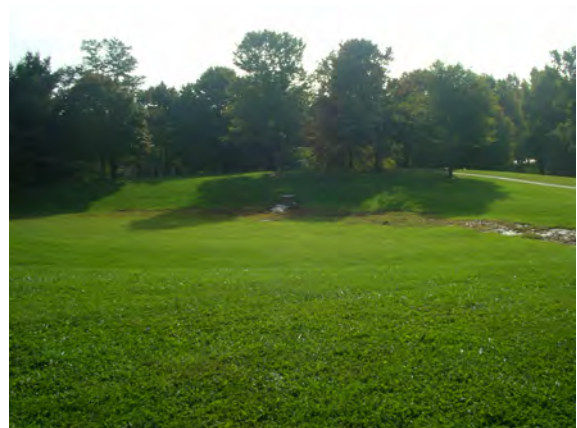
Figure 4.48 View of riser from opposite embankment.

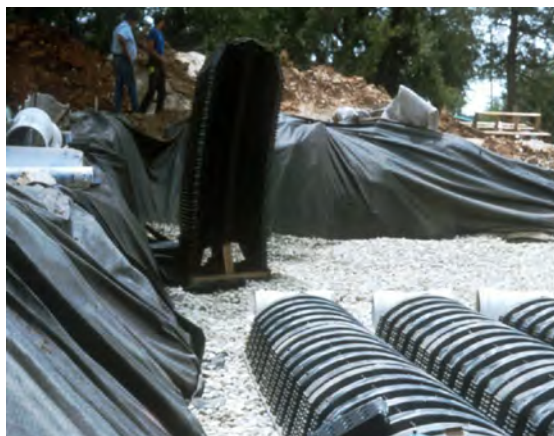
Figure 4.49 Typical perforated plastic half pipe used for recharge.

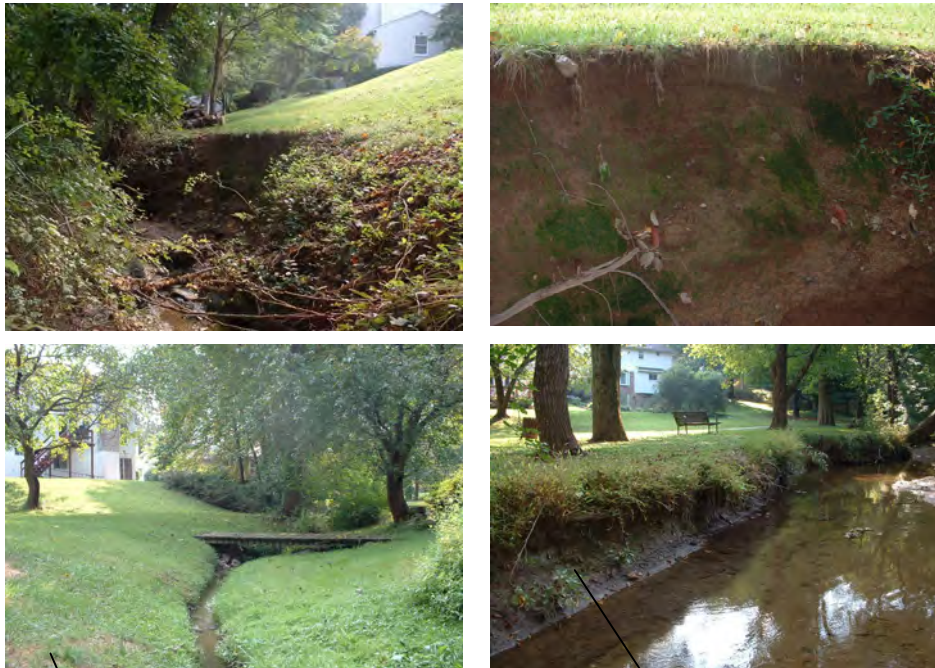
Figure 4.51 Typical inadequate buffer and streambank repair areas.

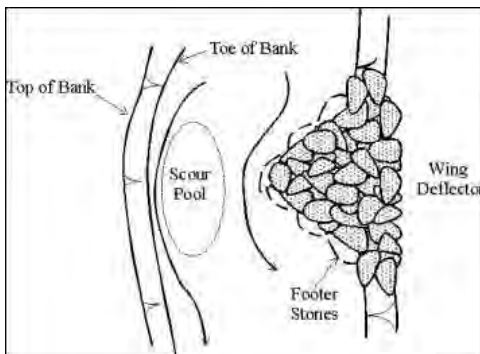
Figure 4.54 Examples of deflectors and grade control where more structural bank protection is needed.

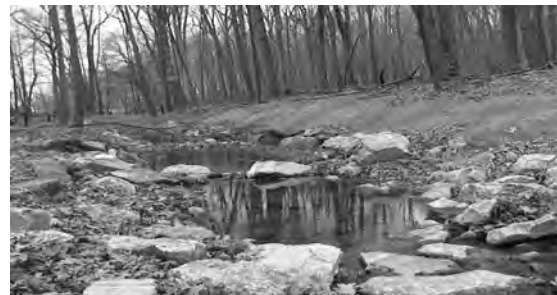
Streambank shaping and grade control

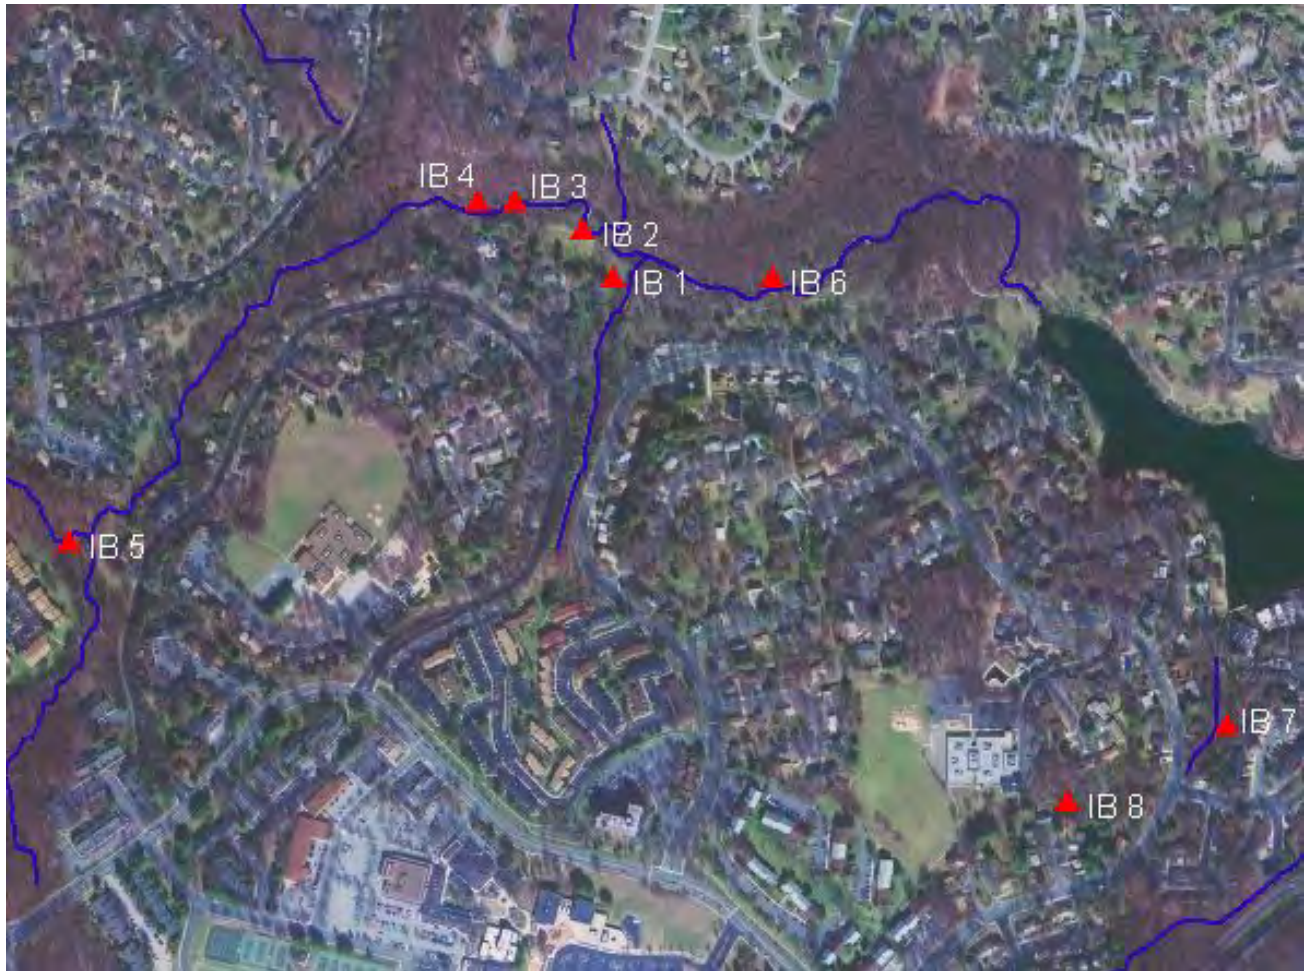
Figure 4.55 Location of impacted buffer sites 1-8.

Figure 4.55 shows the location of impacted buffer sites 1-8.
