# Columbia Town Center Merriweather & Crescent Environmental Enhancements Study

Supplemental Document  
General Plan Amendment

Prepared by  
Biohabitats, Inc.  
2081 Clipper Park Road  
Baltimore, MD 21211

Prepared for  
General Growth Properties  
10275 Little Patuxent Parkway  
Columbia, MD 21044

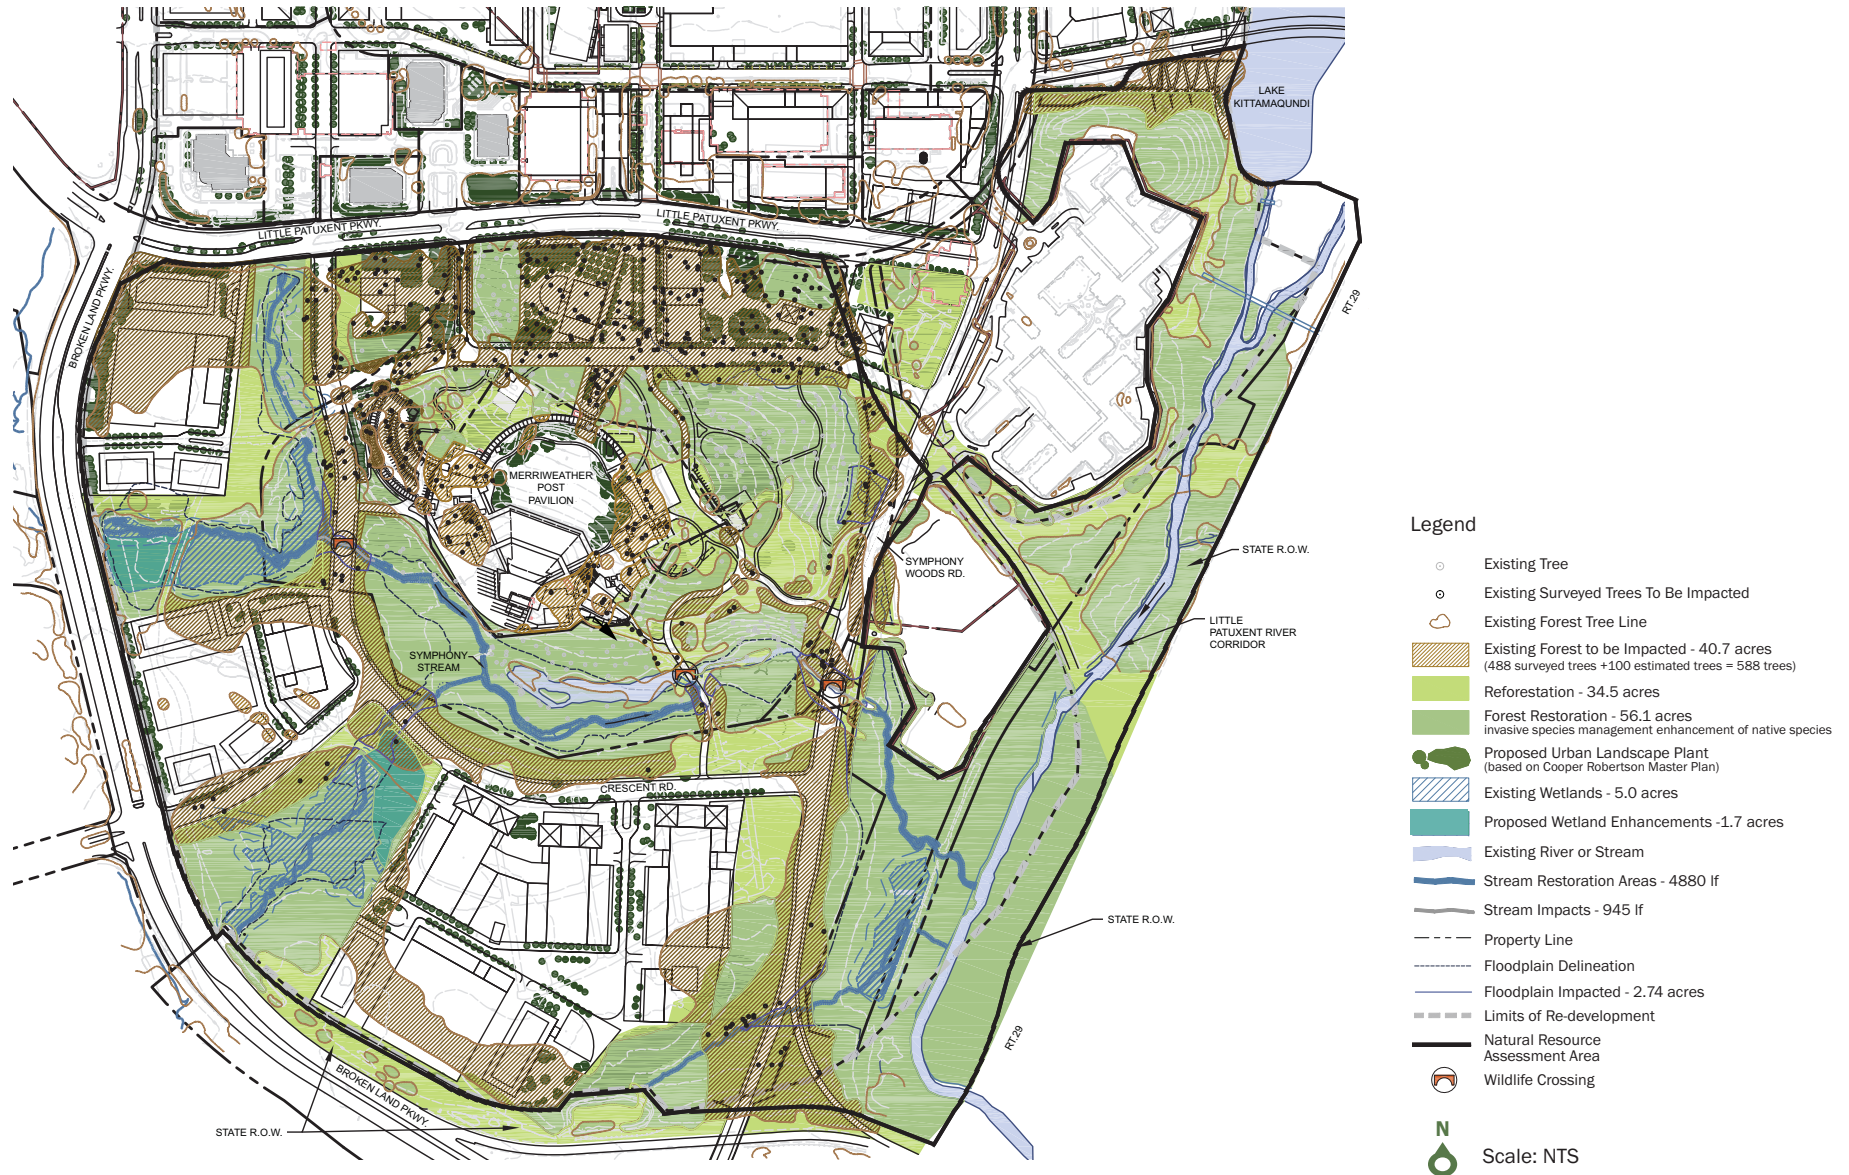
Figure 1. Environmental impacts & enhancements map for the Columbia Town Center Redevelopment.

At the end of the day, the ecological restoration and enhancement activities slated for Columbia Town Center (see Figure 1) will create or improve approximately 4,880 linear

feet of stream, 6.7 acres of non-tidal freshwater wetlands, and 90 acres of forest.

Biohabitats assessed the estimated impacts of Columbia Town Center Redevelopment activities to existing natural resources within the NRA area. The goal of these assessments was to identify and quantify the amount of potential impact to streams, wetlands, forest, and individual trees. Impact areas were identified by overlaying the conceptual development design on top of an existing natural resource map. Any areas of existing forest, wetland and stream that were within potential areas of building and/or grading were considered to be impacted (Figure 1 Environmental Impacts & Enhancements Map).

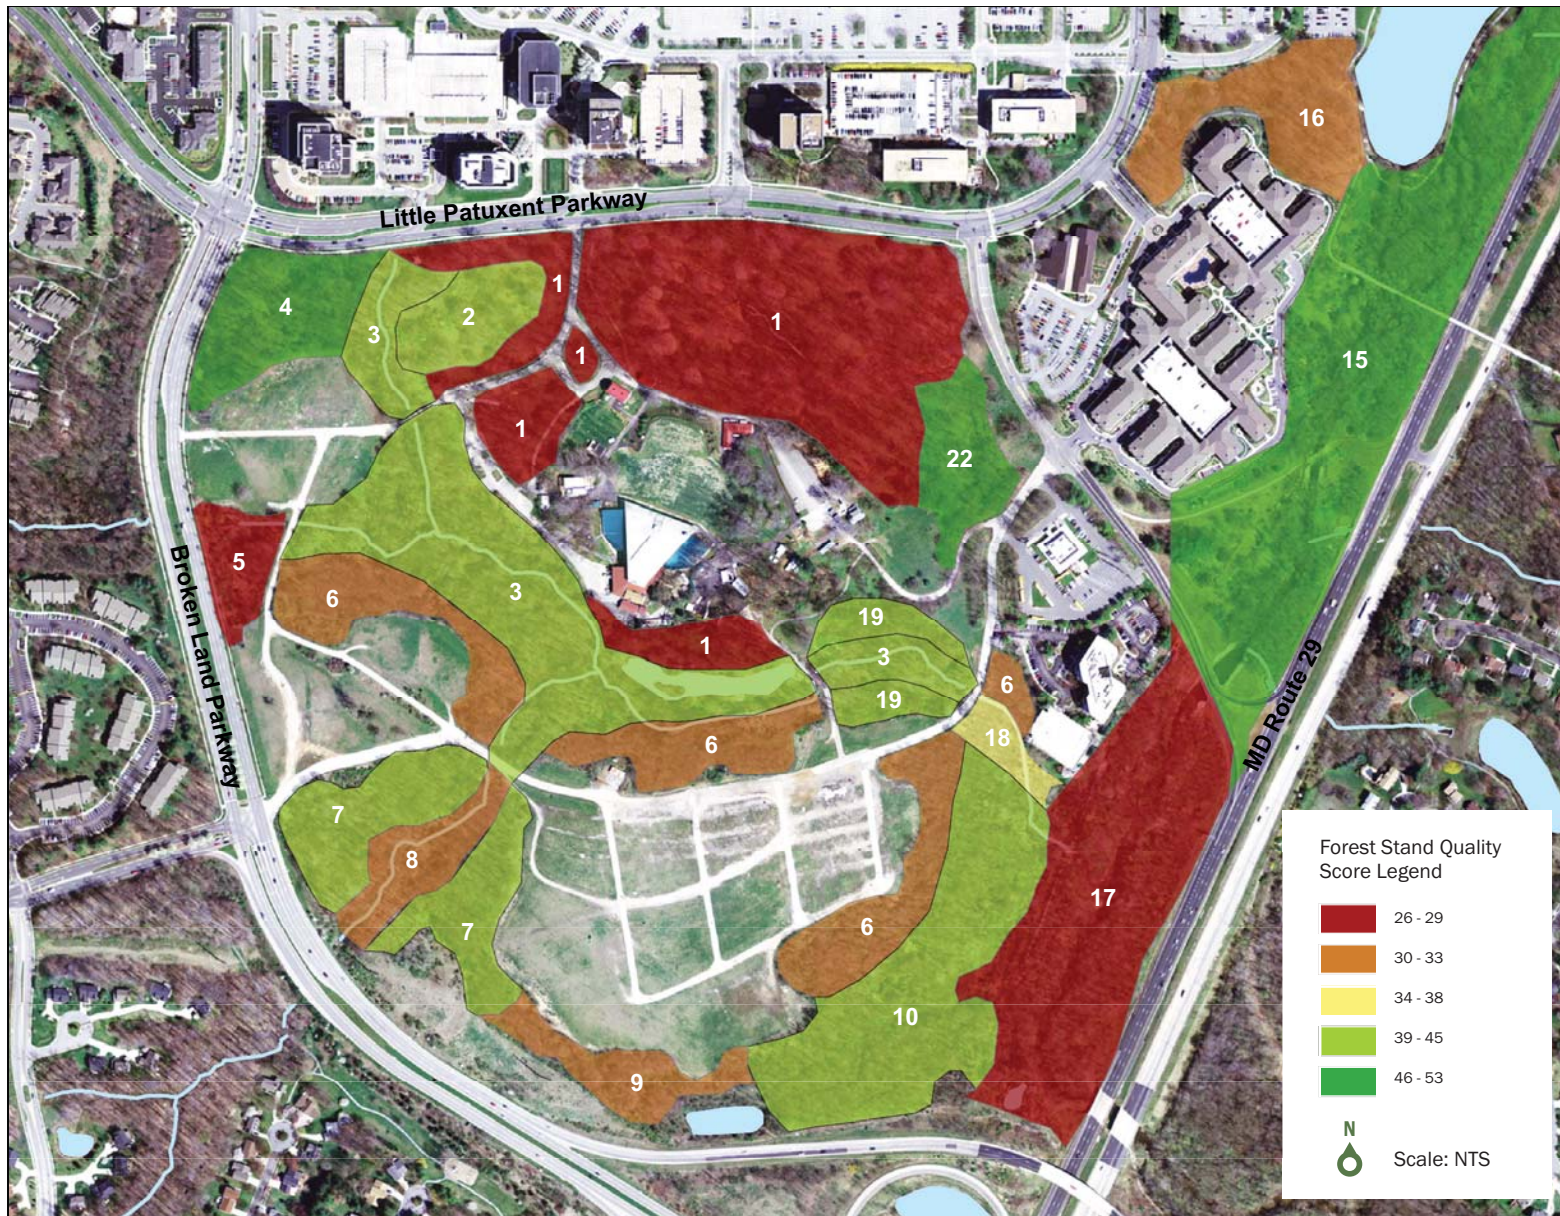
Figure 3. Map of assessed forest communities within the redevelopment area showing associated condition ranking. (White numbers refer to forest types in Appendix A.)

Biohabitats assessed approximately 106 acres of forest community within the 150 acre NRA area. The extent of the assessment is shown in Figure 3. Each of the forest stands was characterized with regards to species composition and size/age. These stands were then evaluated for their condition or ability to provide ecological value.

A set of parameters were developed for scoring the relative quality of the forest condition as it relates to the functional ability to provide ecosystem services. These parameters were given a range of values from 1 to 5 (5 being the highest value or most beneficial) for positive attributes (ie. Number of species, number of strata, and proximity to critical areas). Negative attributes (ie. Presence of invasives and disease) were assigned negative values ranging from -1 to -5 (-5 being worst condition). Using a data dictionary developed in Trimble Pathfinder software, data was collected for each stand using a Trimble GeoExplorer XM Global Positioning System (GPS) handheld datalogger. The cumulative scores of these parameters were calculated therefore ranking each stand with the highest score representing the best quality forest(Figure 3).

# APPENDIX A: FOREST TYPE CHARACTERIZATION (see figure 3)

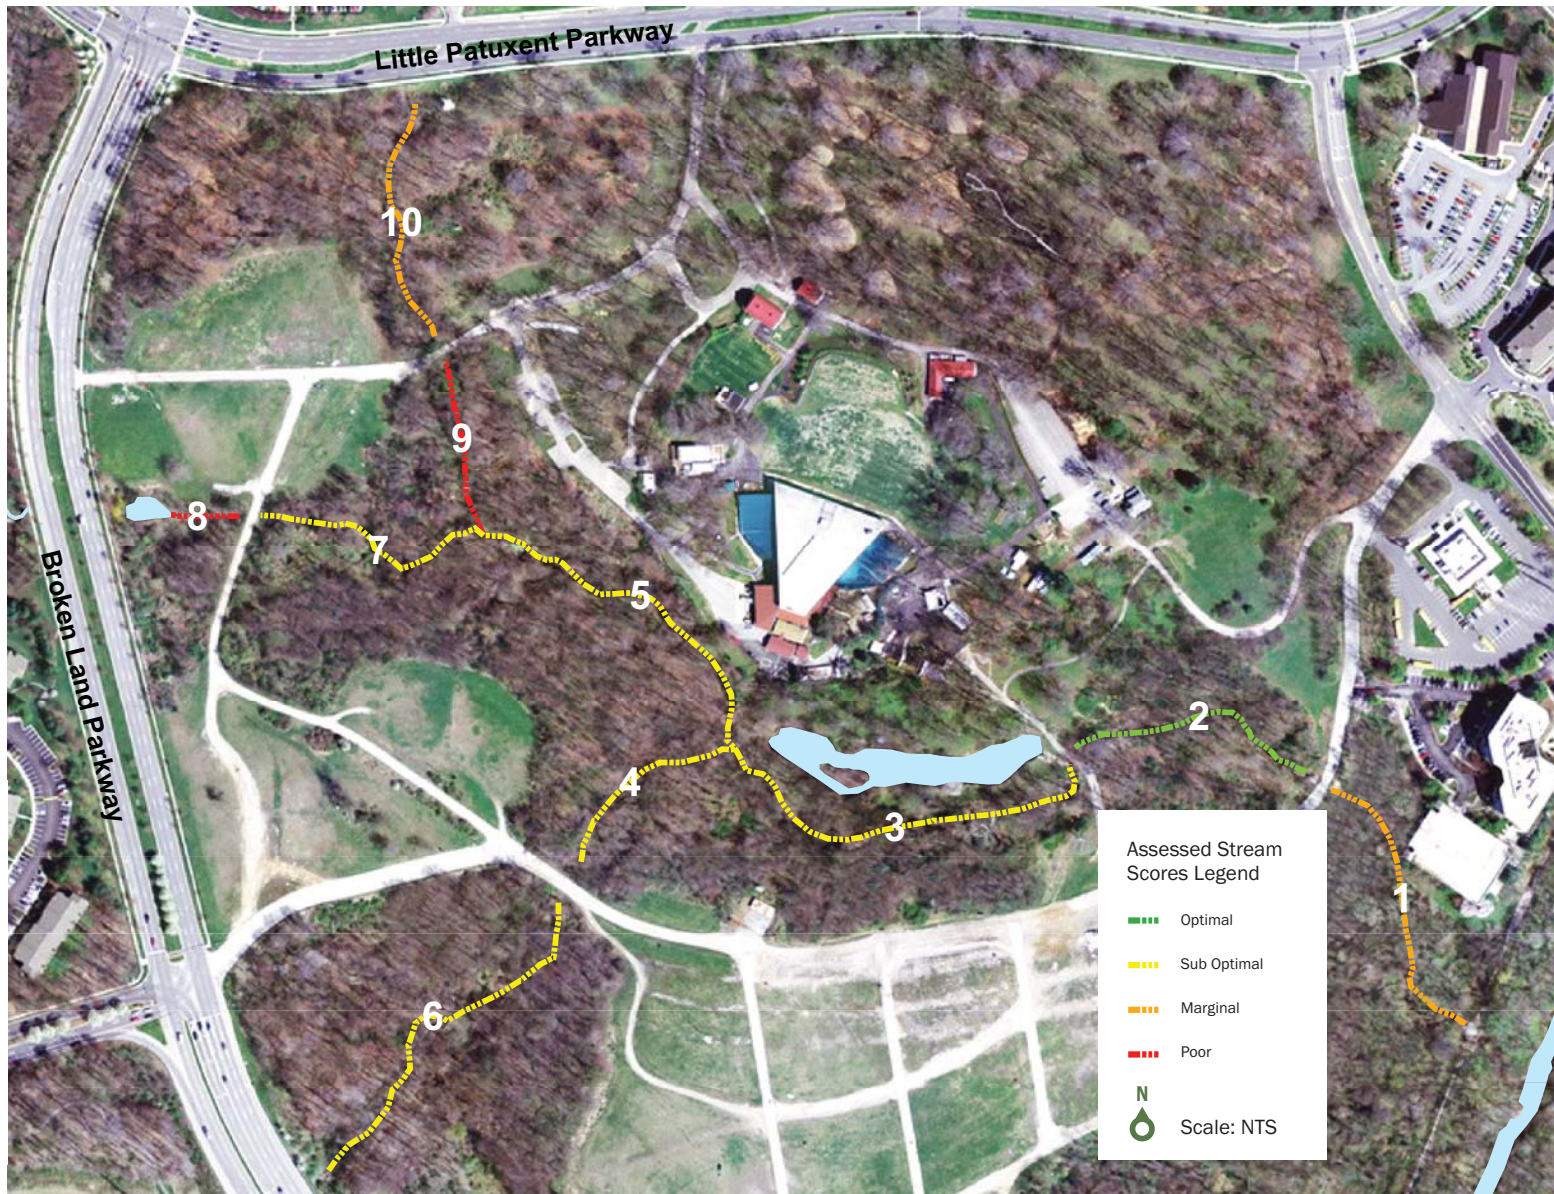
Figure 5. Map of assessed stream reaches within the Merriweather & Crescent area showing stream Habitat Condition rating.

A visual-based stream habitat assessment was performed on over 5000 linear feet of perennial stream in the Merriweather & Crescent areas of the NRA area (Figure 5). Assessments were conducted using the Habitat Assessment Field Data Sheets for low gradient streams from the “Rapid Bioassessment Protocols for Use in Streams and Wadeable Rivers” produced by the U.S. Environmental Protection Agency (Barbour et. al, 1999). All perennial streams within the site were divided into survey reaches with breaks at road crossings and tributary confluences. Each entire survey reach was then evaluated for ten parameters and given a numerical rating from 1-10 based on criteria provided in the data sheets.

Reference conditions were used to scale the assessment to the “best attainable” situation. An average score of 157 was achieved after surveying three selected reference reaches and this was determined to be the “best attainable” score. A ratio between the score for the reference reach and the survey reaches was calculated and each survey reach was classified (Optimal, Sub-Optimal, Marginal, Poor) relative to the reference conditions (Table 4).
