Rocky Gorge Dam and Patuxent River Upper Watershed Assessment

COMMUNITY MEETING NO. 1

June 21, 2016

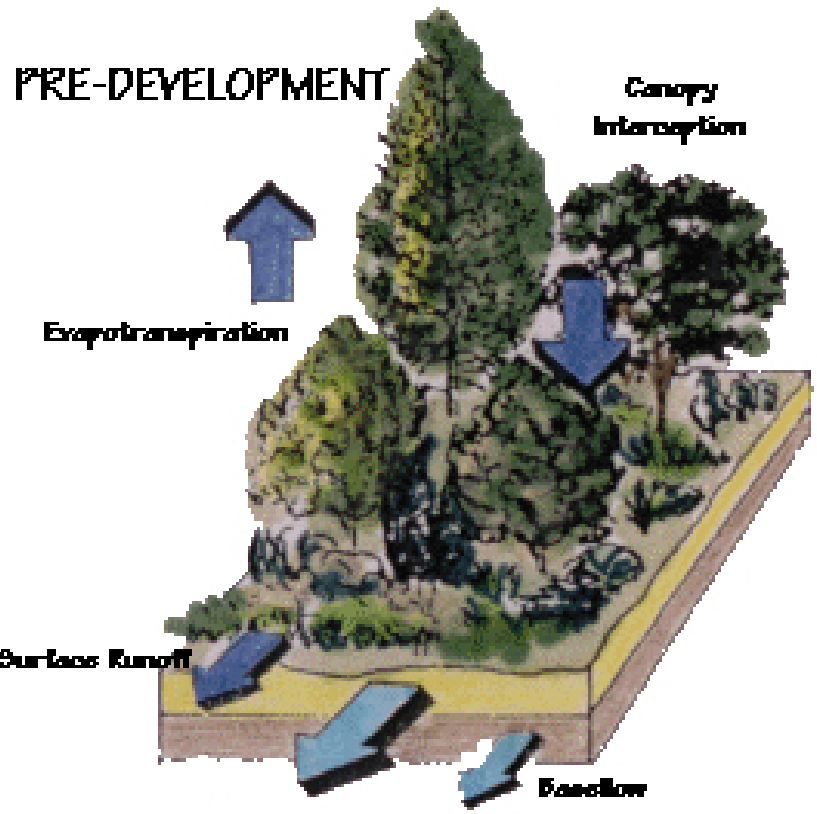
PRE-DEVELOPMENT

WATER BALANCE

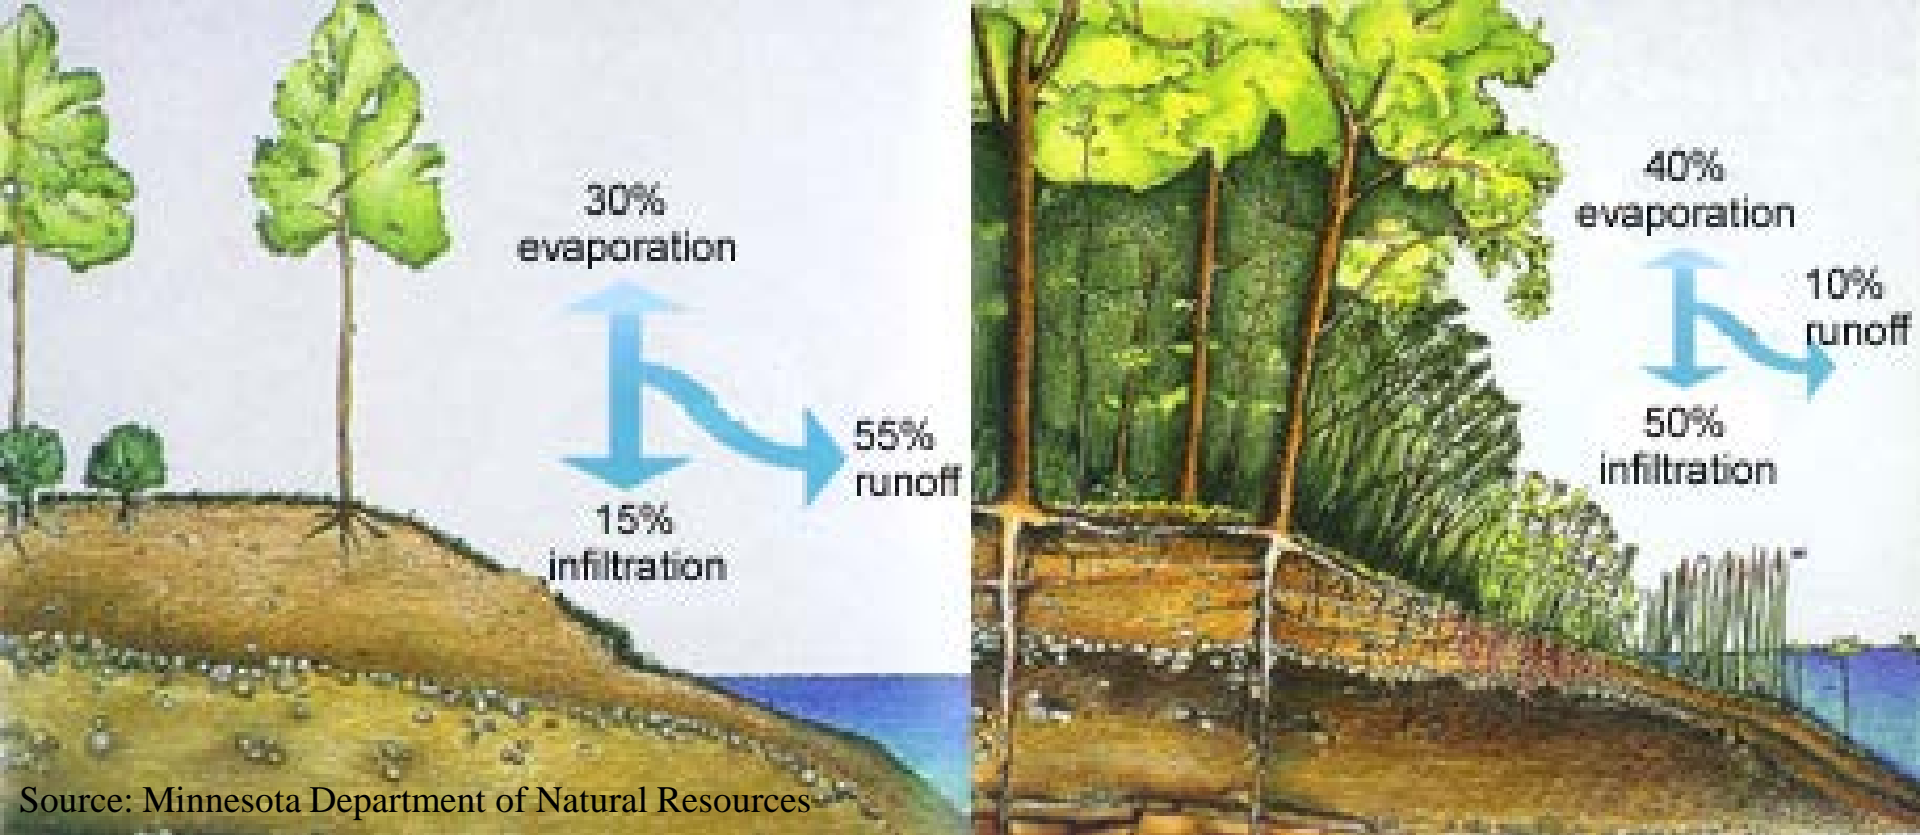
Water quickly runs off a shoreline cleared of natural vegetation, washing nutrients and pesticides into the water. A natural shoreline holds rainfall, which soaks into the soil; less water, soil and chemicals run into the lake or river. Shoreline and aquatic plants anchor shoreline areas, helping to protect them from erosion due to runoff and waves (Source:MN DNR)

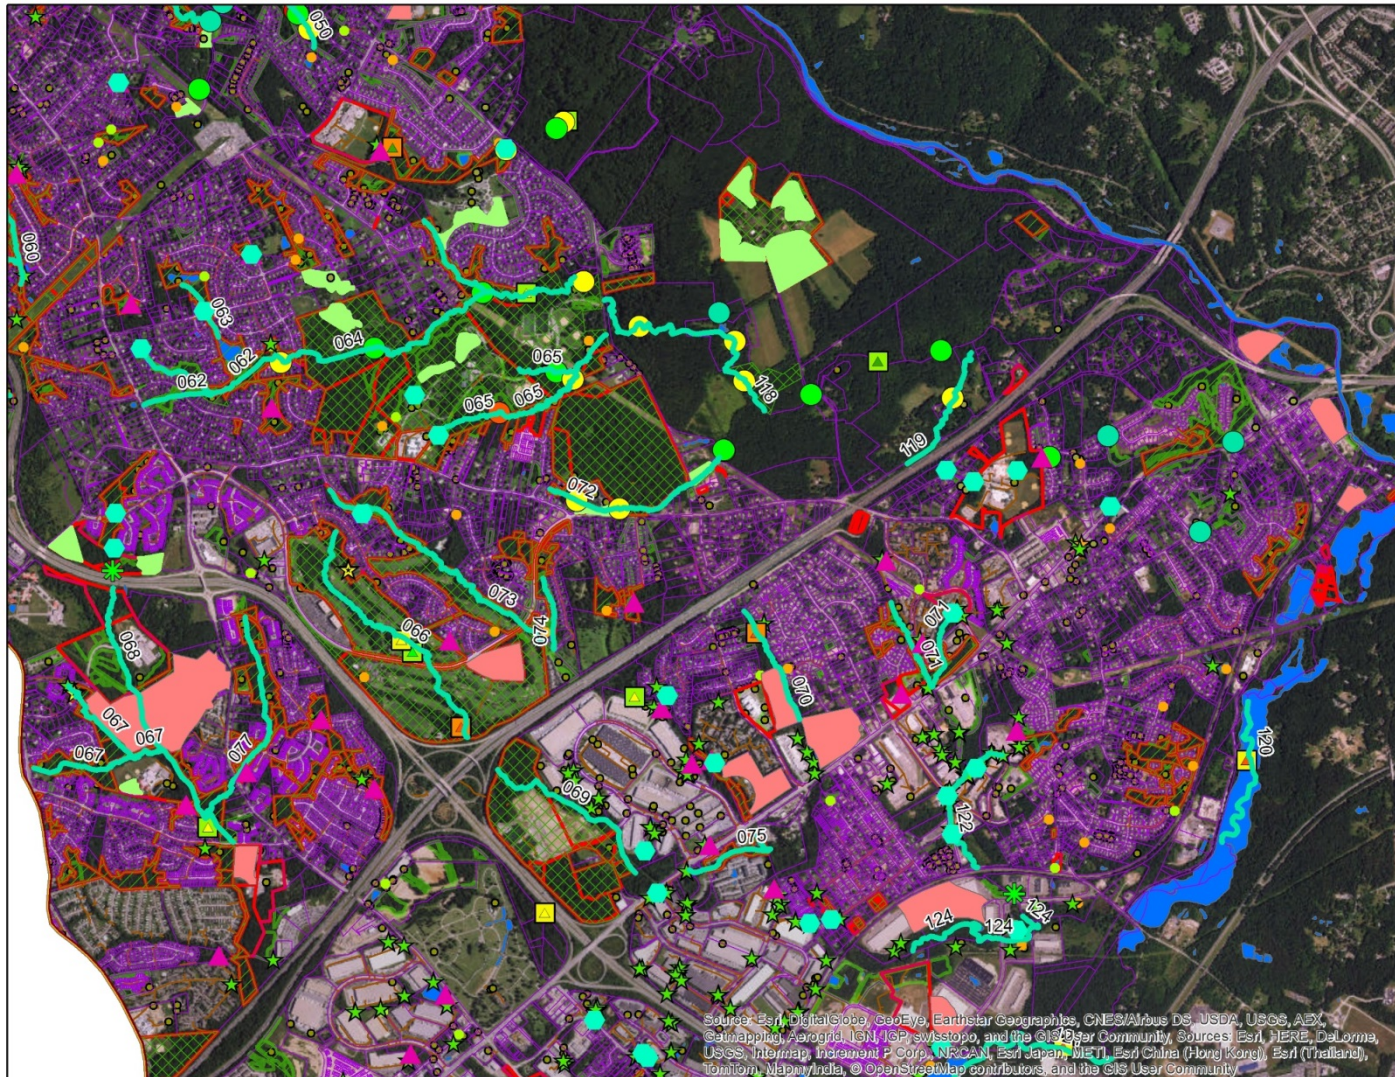
Sample composite GIS map used for final office review

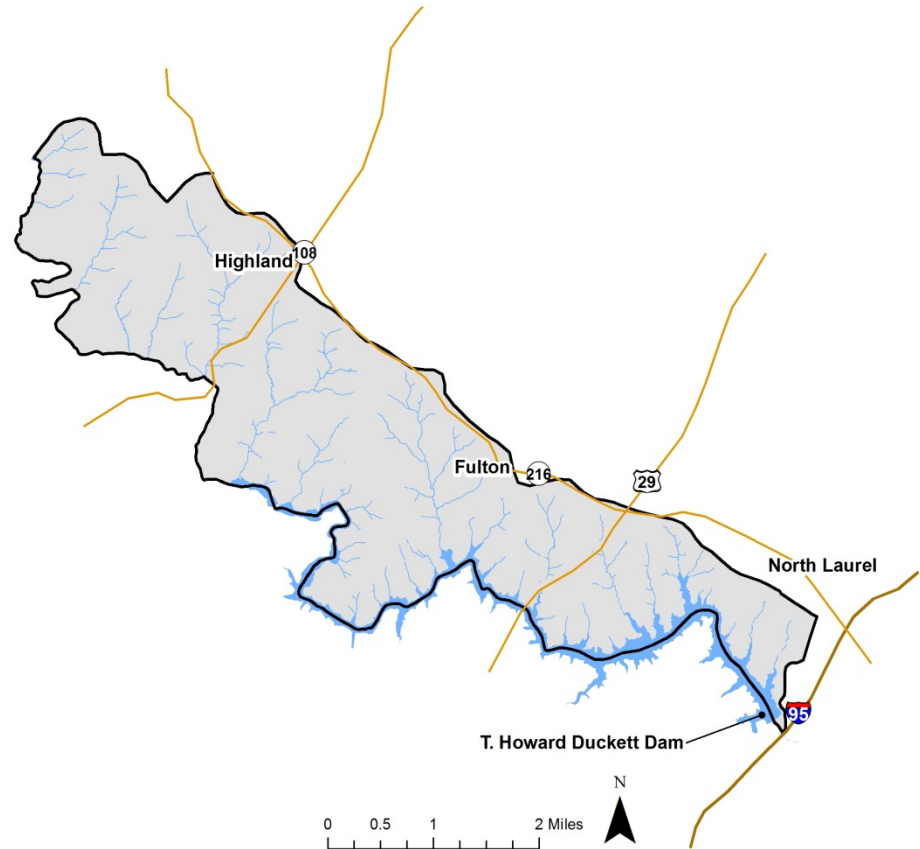
Rocky Gorge Dam Watershed

- 12.5 square miles
- 8,006 acres
- 585 total impervious acres
- 531 County impervious area
- 2,729 wooded acres
- 150 stormwater BMPs treating 160 acres of impervious surface

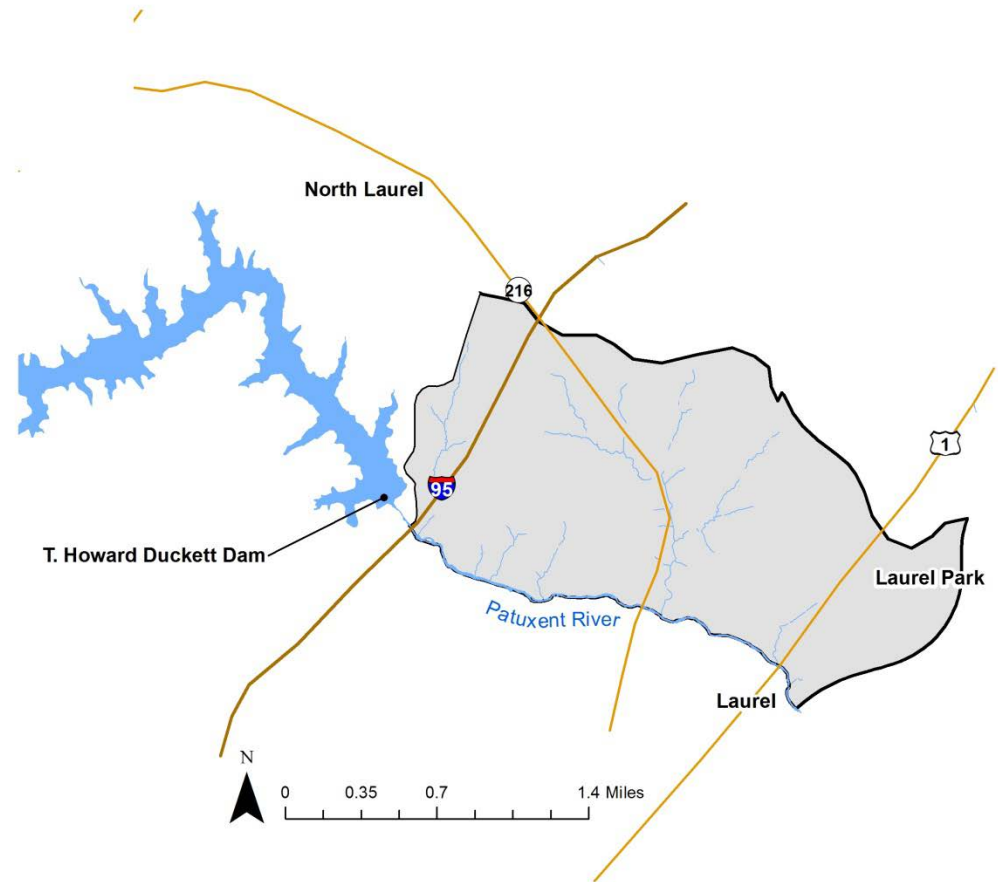
Patuxent River Upper Watershed

- 2.7 square miles
- 1,725 acres
- 439 total impervious acres
- 381 County impervious acres
- 478 wooded acres
- 134 stormwater BMPs treating 153 acres of impervious surface

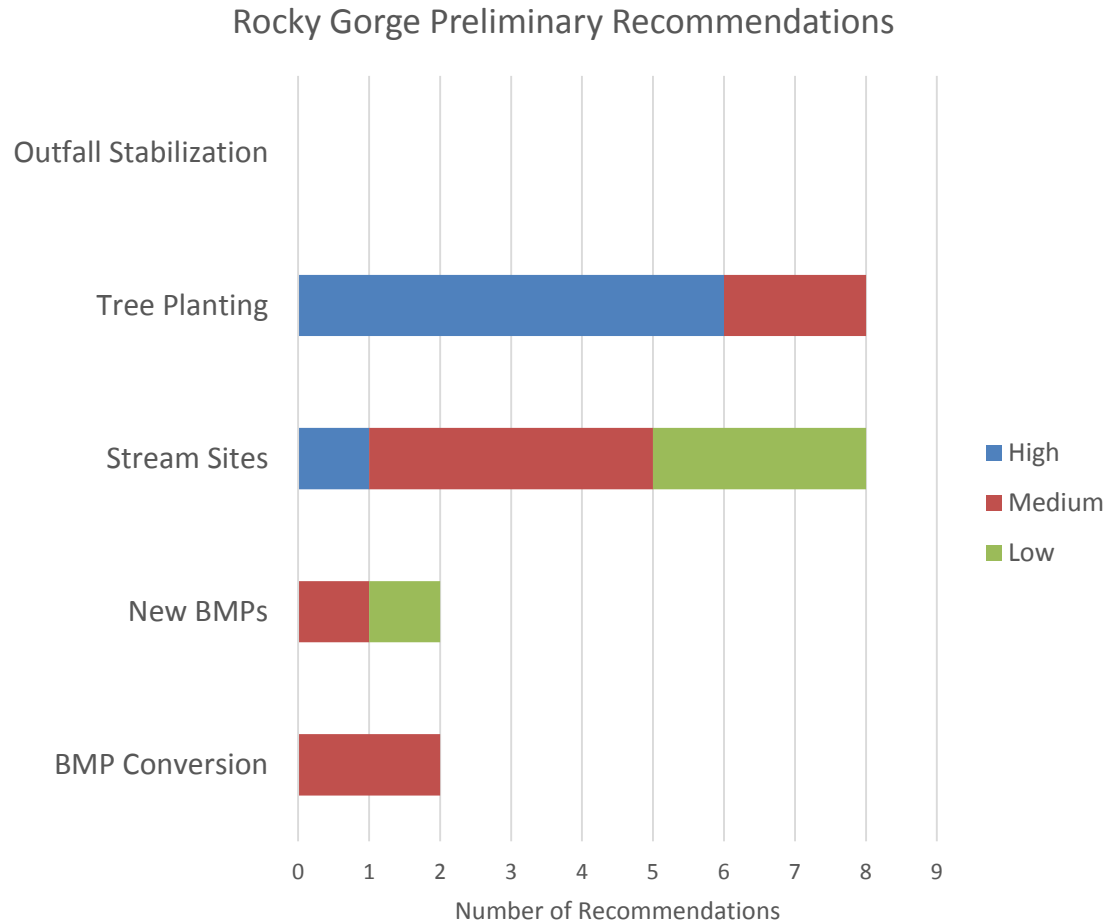
Assessment Recommendations – Rocky Gorge

High Priority Sites:

- 0 Outfall stabilizations
- 6 Tree planting sites
- 1 Stream sites
- 0 New BMP sites
- 0 BMP conversions

Medium Priority Sites:

- 0 Outfall stabilizations
- 2 Tree planting sites
- 4 Stream sites
- 1 New BMP sites
- 2 BMP conversions

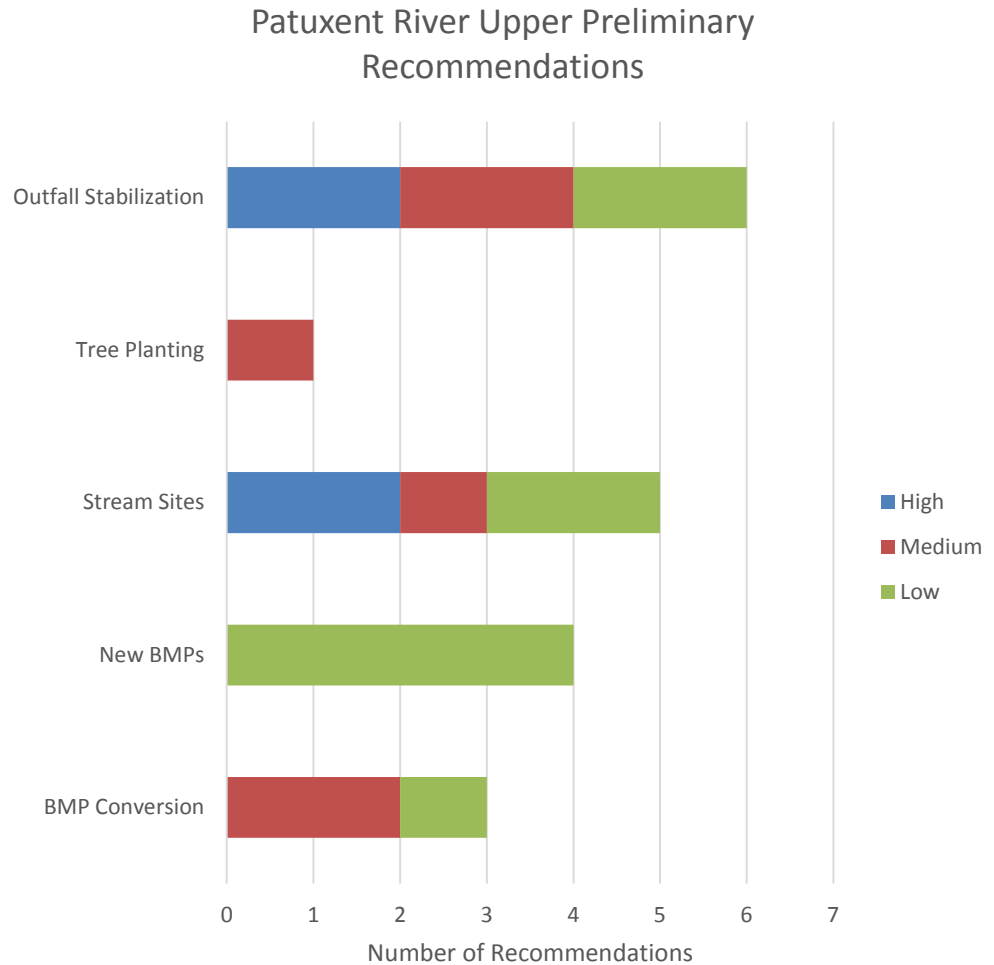
Assessment Recommendations – Patuxent River Upper

High Priority Sites:

- 2 Outfall stabilizations
- 0 Tree planting sites
- 2 Stream sites
- 0 New BMP sites
- 0 BMP conversions

Medium Priority Sites:

- 2 Outfall stabilizations
- 1 Tree planting sites
- 1 Stream site
- 0 New BMP sites
- 2 BMP conversions

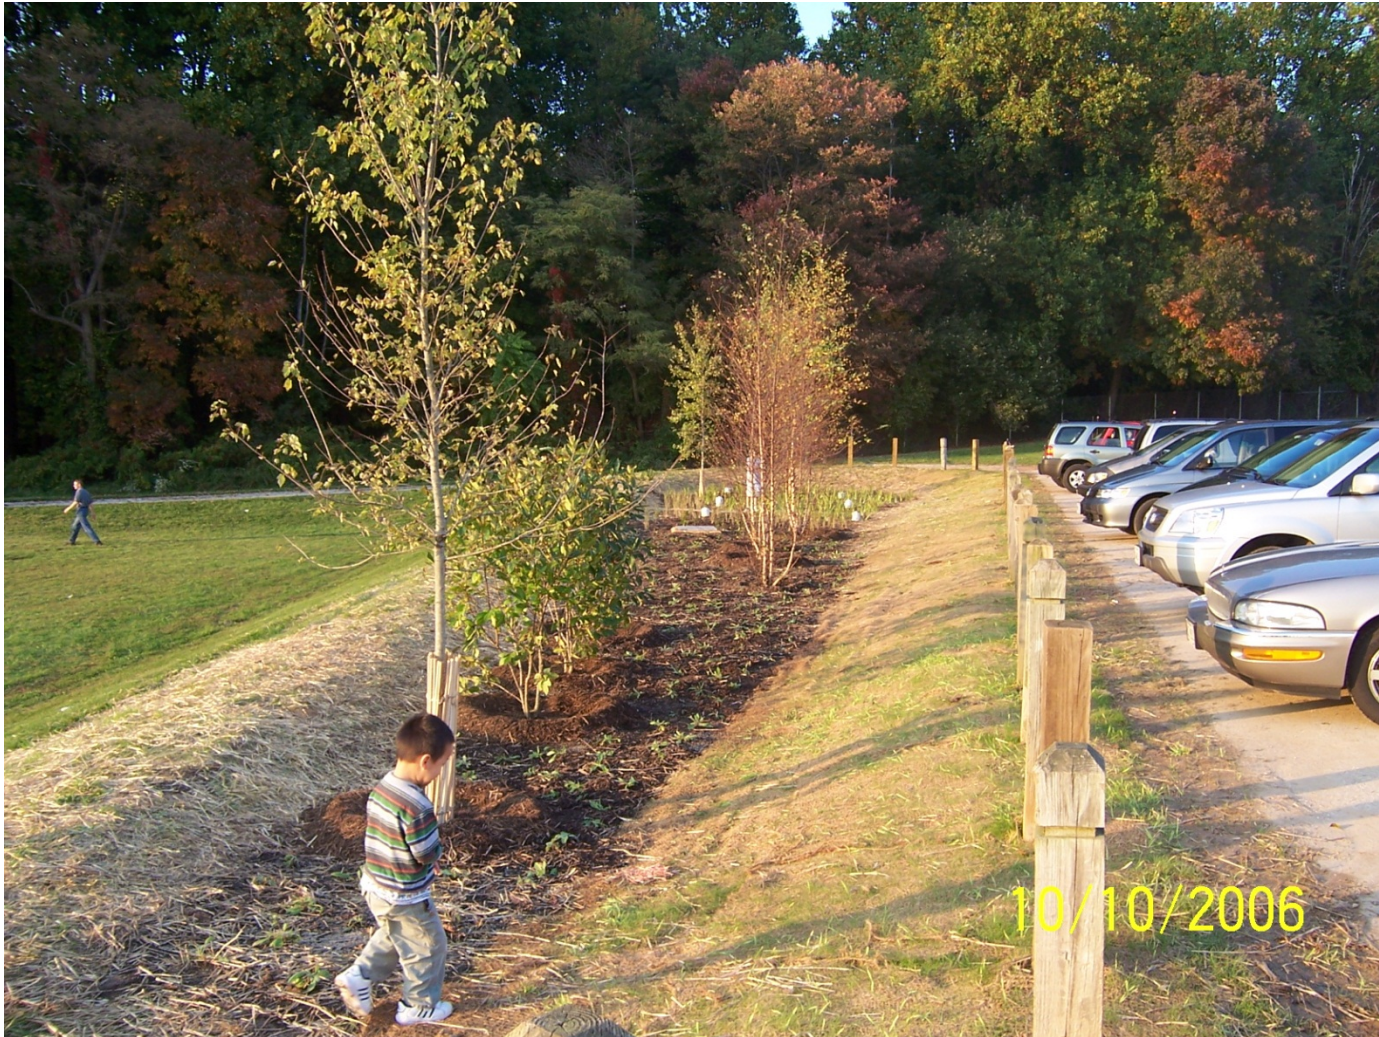
Bioretention Facility

BIORETENTION FILTER
