Patuxent River Watershed Assessment

COMMUNITY MEETING NO. 2

January 23, 2017

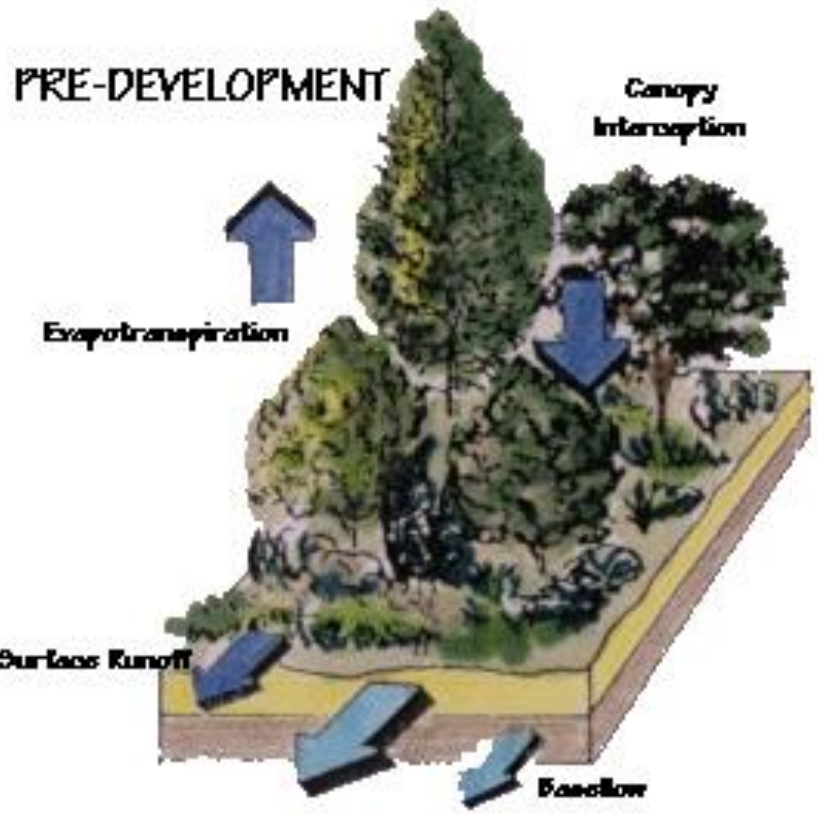
PRE-DEVELOPMENT

WATER BALANCE

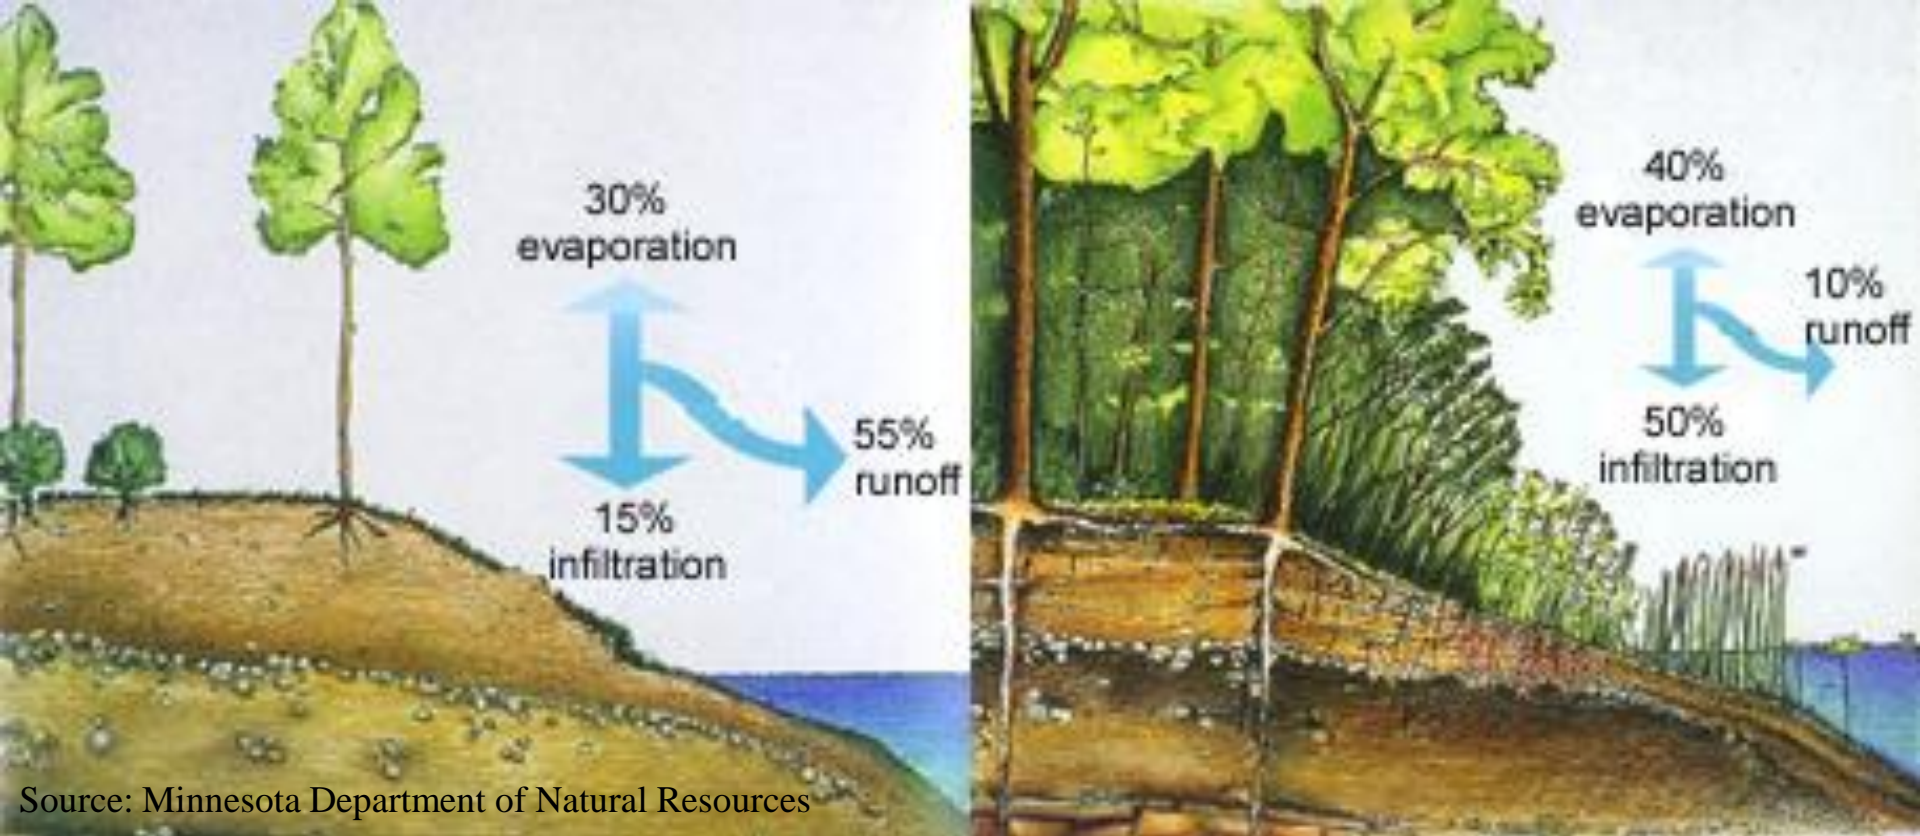
Water quickly runs off a shoreline cleared of natural vegetation, washing nutrients and pesticides into the water. A natural shoreline holds rainfall, which soaks into the soil; less water, soil and chemicals run into the lake or river. Shoreline and aquatic plants anchor shoreline areas, helping to protect them from erosion due to runoff and waves (Source:MN DNR)

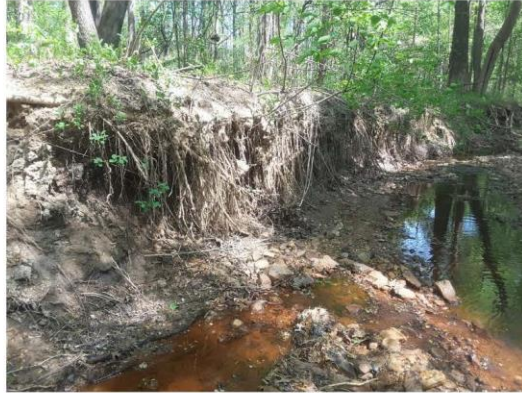
Photo facing downstream assessing the left bank and depicts a typical stream bank within the downstream limits of the assessed stream.

The site is located within Howard County property and is classified as Howard County Open Space in Laurel, MD. The stream is located within a medium density residential area; however, the riparian zone is forested with Maryland 216 adjacent to the left and residential homes adjacent to the right (while looking downstream). The existing mainstem channel has persistent erosion throughout its extent, with alternating stream bank erosion between the left and right banks; however, the severity varies depending on location. The assessed stream has a small tributary that joins it about half way throughout its extents. This tributary is a pipe outfall channel from Maryland 216 and it was not assessed; however, the tributary was observed at its confluence with the assessed stream and was later revisited during the concept phase. The tributary is a 360 ft. long incised channel currently disconnected with its floodplain and exhibits an eroded bank height between 4 ft. and 5 ft. along both the left and right bank. Upstream of this tributary, alternating left and right bank erosion occurs at an average eroded bank height between 2 ft. and 3 ft.; however, this erosion is spotty and is healing over throughout the upstream extents. A sewer line crossing is also observed directly upstream of the tributary. The sewer line is not exposed, but the sewer line protection has been shifted and could possibly expose the pipe over time. Directly downstream of this tributary, the mainstem exhibits some of the worst erosion throughout the stream channel. The mainstem is widening and is disconnected from its floodplain directly downstream of the tributary for approximately 125 lf. at an average height of 5 ft. along the left bank. The mainstem then enters tight meanders creating high eroded banks. Downstream of these tight meanders, the mainstem bank erosion becomes less severe, with more spotty areas of erosion that are in the process of healing. The most downstream limits of the mainstem become very sinuous and steep with bank erosion shifting from the left and right banks with the average eroded bank heights between 2 ft. and 3 ft. Moderate sediment deposition throughout the channel is evident based on recent bank failure which is creating alternating bars along the toe of the banks. Riparian vegetative zone for both the upstream and downstream limits of the stream are optimal, with human activities (homes and roads) being more of an impact in the upstream limits. Shading along the existing channel is optimal (80%).

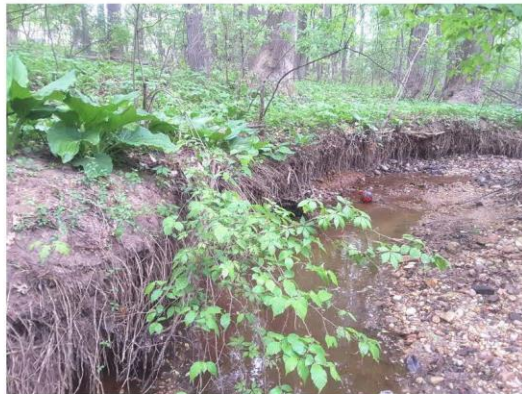
Photo facing upstream assessing the right bank and depicts a typical stream bank within the upstream limits of the assessed stream.

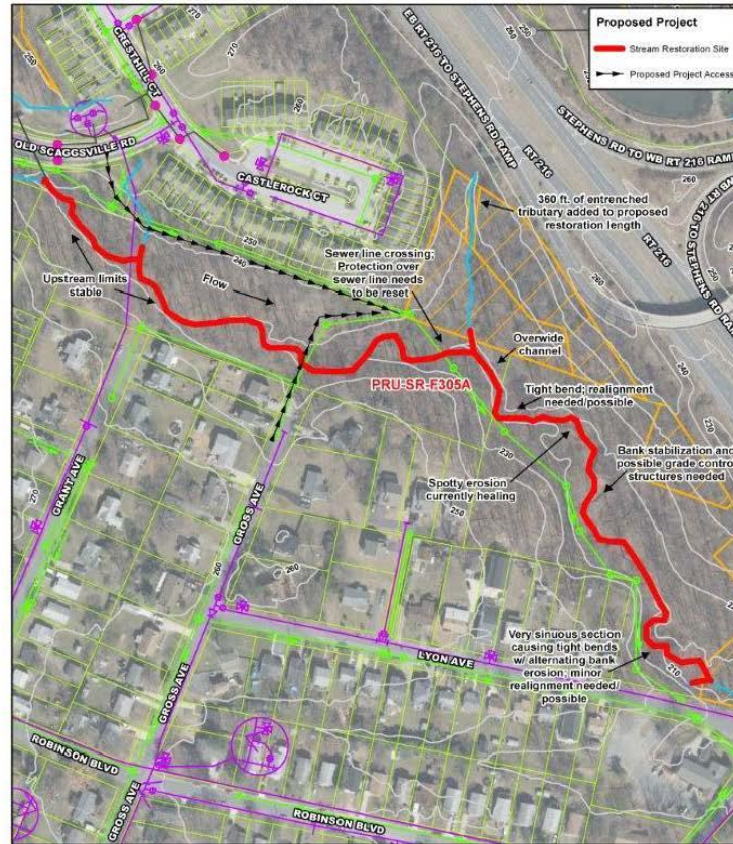
Plan-View Design Drawing - PRU-SR-F305A

The objective for this project is to reduce bank erosion and improve instream habitat for aquatic organisms. This project proposes the restoration of 1,650 lf. of stream channel which encompasses 1,290 lf. of the mainstem and 360 lf. of a tributary/outfall channel that was added during the concept reconnaissance. Because the tributary is currently entrenched with 4 ft. to 5 ft. eroding banks, the channel should be reconnected to its floodplain through stream restoration as well as safely convey into the mainstem to prevent further downstream erosion. Upstream of the tributary is a sewer crossing that is not currently exposed, but the existing sewer protection needs to be stabilized. This area also provides a logical tie-in point for the proposed restoration. Directly downstream of the sewer crossing and the tributary is a section of stream that is currently overwide and needs to be restored. Opportunities for the restoration of this reach include: 1.) raising the invert of the stream to provide better access to the existing broad floodplain, or 2.) create a nested channel with a shallow hyporheic bench within the overwidened channel while grading back the eroded banks to a stable angle, which will better align the channel cross section within the urban channel's flow regime. Moving downstream from this overwide section, the mainstem alignment should be realigned to reduce bank erosion occurring along the tight bends. Minor bank stabilization throughout the downstream limits of the mainstem and possible grade control structures could increase stability of the mainstem. Adding woody debris, cobble riffles, pools, and other nature-like habitat structures will reinforce the stream bed and banks, improve the flow diversity and structural complexity of the stream bed, and uplift the instream habitat throughout the mainstem. The proposed channel restoration work would occur predominately on the existing channel alignment; however, some minor realignment may be necessary at the tight meander bends at the downstream limits of the mainstem. This channel restoration has the potential to reduce sediment supply, improve habitat and provide opportunities for nutrient uptake.

Access to the stream poses an issue due to steep side slopes and surrounding private properties, but the site can be accessed from the sewer line easements along Old Scaggsville Road or Gross Ave. A water line crosses the stream at the upstream limits of the stream, while a sewer line runs adjacent to the stream and crosses the stream at several locations. Moderate impact to trees and wetlands could be an issue during construction due to the close proximity of these natural resources to the stream itself. The tributary is located with a forest conservation easement.
