**HOWARD COUNTY
BIOLOGICAL MONITORING
AND ASSESSMENT
UPPER LITTLE PATUXENT,
MIDDLE LITTLE PATUXENT, AND
LOWER LITTLE PATUXENT
WATERSHEDS 2013**

NPDES Permit Number 00-DP-3318 MD0068322

December 15, 2013

Versar, Inc.
9200 Rumsey Road, Suite 100
Columbia, MD 21045

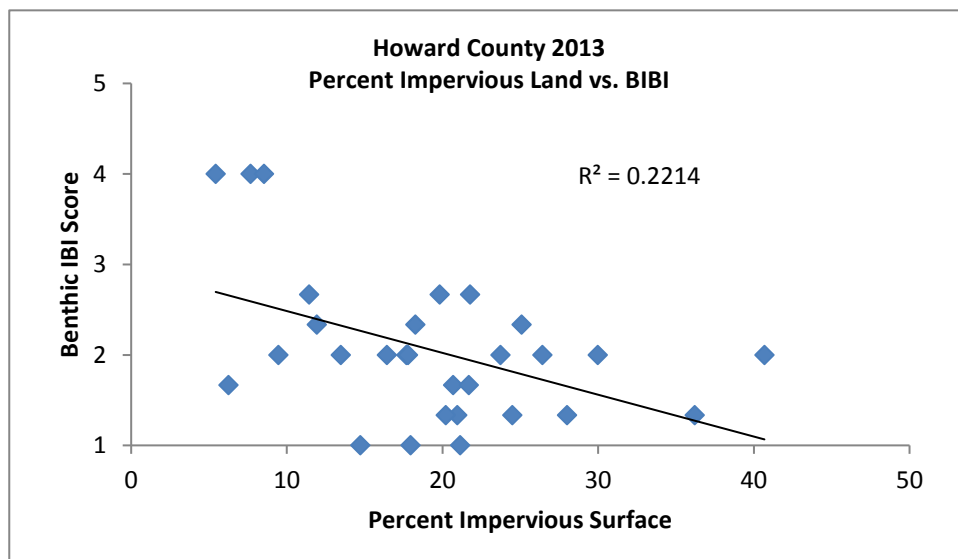
Figure 4-1. Regression relationships between the Benthic Index of Biotic Integrity (BIBI) and impervious surface in upstream catchments during 2013 Howard County Biological Monitoring

The relationship of BIBI scores to impervious surface in the catchments upstream of the sample site was significant (Figure 4-1; $R^2 = 0.2214$, $p = 0.009$). Generally, as impervious surface increased, the BIBI scores decreased. Although there were only three sites sampled in 2013 that received a BIBI score greater than 3.00, those three sites were all in catchments with less than 10% impervious surface, consistent with the notion that overall biological condition is likely being affected by the amount of development (i.e., imperviousness) in the watershed.

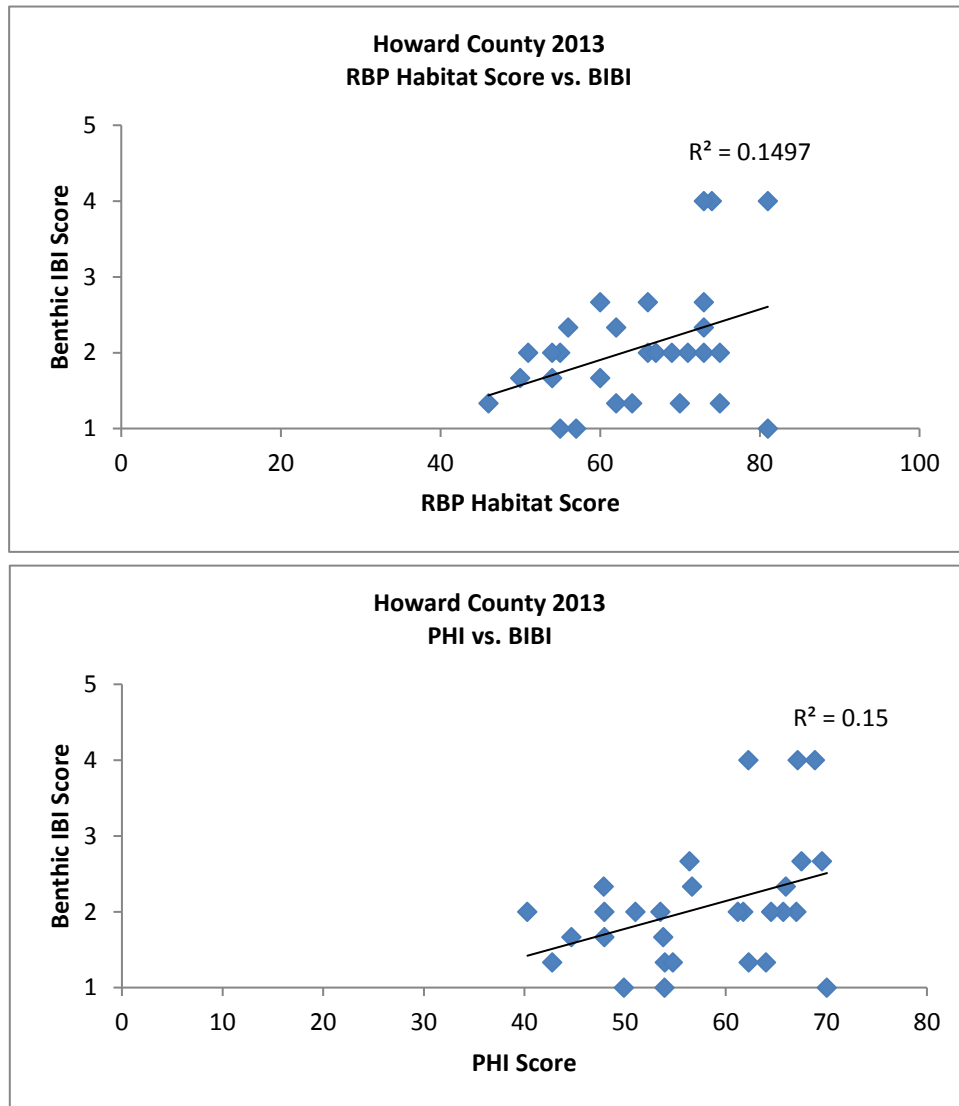
Figure 4-2. Regression relationships between the Benthic Index of Biotic Integrity (BIBI) and both RBP Habitat Assessment Score and Physical Habitat Indicator (PHI) for sites sampled in the 2013 Howard County Biological Monitoring.

Although not very strong, there are significant positive relationships between the BIBI and both the RBP habitat assessment score and the PHI score ($R^2 = 0.15$, $p = 0.04$, for both parameters). As the habitat scores increase, so does the BIBI (see Figure 4-2). This suggests that physical habitat conditions directly affect the biological condition of a stream.

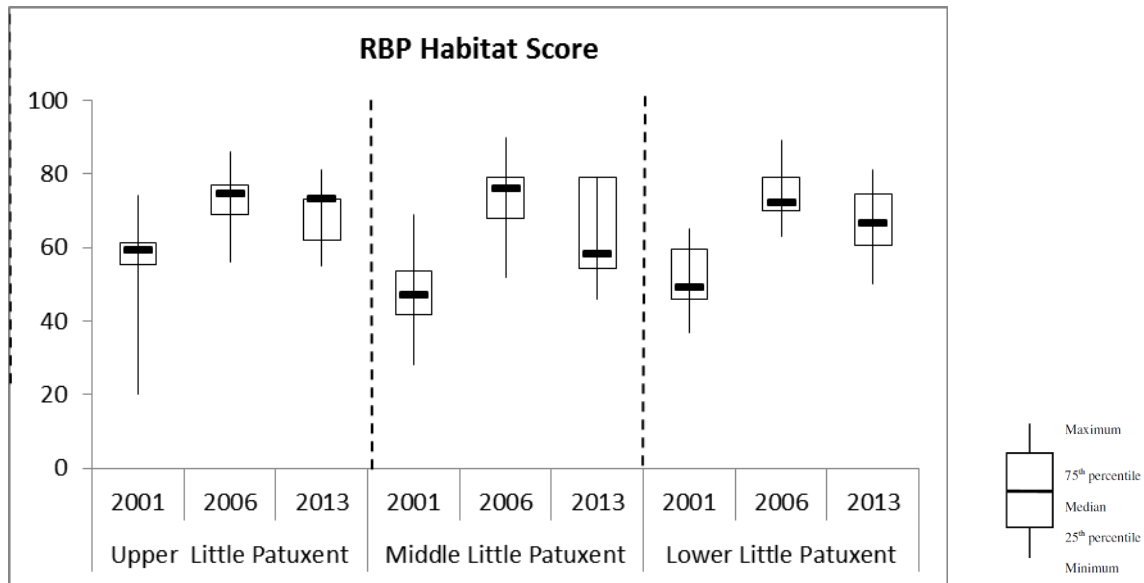
Figure 4-4. Comparison of 2001, 2006, and 2013 RBP assessment scores

RBP Physical Habitat Assessment – Table 4-3 summarizes the 2001, 2006, and 2013 RBP comparability scores, and Figure 4-4 is a box plot illustrating RBP comparability scores. Results of the Round 1 (2001) assessment indicate that the Upper Patuxent River subwatershed rated “Non-Supporting” (RBP score of 54.8 ± 14.5). Round 2 (2006) and Round 3 (2013) assessments indicate that the physical habitat condition in this subwatershed increased to “Partially Supporting” (RBP scores of 73.8 ± 9.6 and 68.2 ± 8.7 , respectively). For this subwatershed, Round 2 and Round 3 habitat assessment scores were not significantly different from each other, but the Round 1 score was significantly less than both Round 1 and Round 2.
