**HOWARD COUNTY
BIOLOGICAL MONITORING
AND ASSESSMENT
UPPER MIDDLE PATUXENT,
MIDDLE MIDDLE PATUXENT,
AND LOWER MIDDLE PATUXENT
WATERSHEDS 2014**

NPDES Permit Number 00-DP-3318 MD0068322

Versar, Inc.
9200 Rumsey Road, Suite 100
Columbia, MD 21045

December 30, 2014

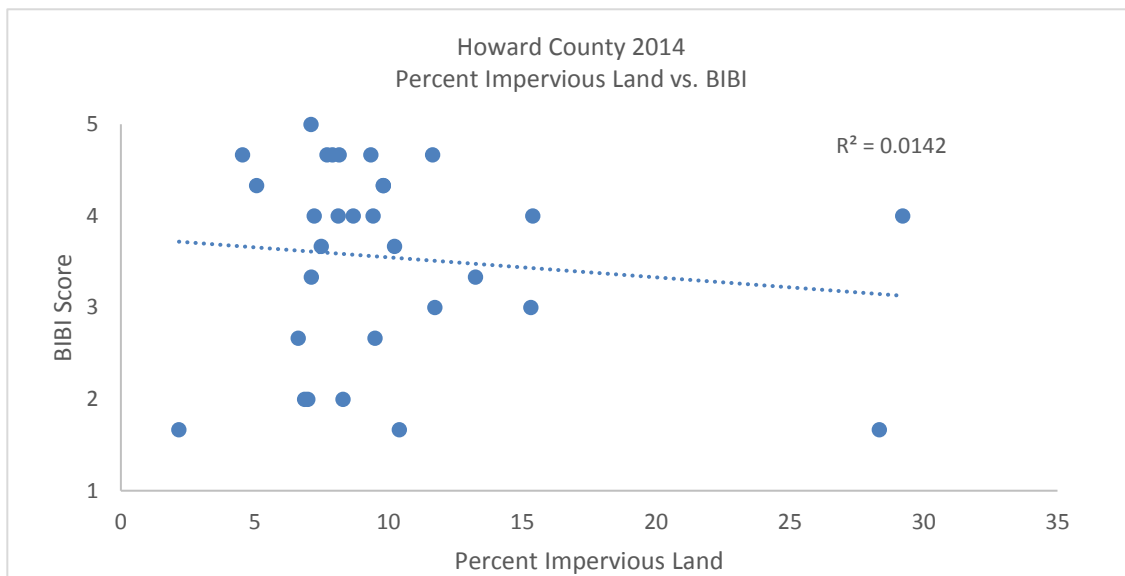
The relationship of BIBI scores to impervious surface in the catchments upstream of the sample site was not significant (Figure 4-1; $R^2 = 0.01$, $p = 0.53$), primarily due to the relatively small range of impervious values in catchments sampled in 2014. Generally, as impervious surface increased, the BIBI scores decreased. Although not significant, these results are consistent with the notion that overall biological condition is likely being affected by the amount of development (i.e., imperviousness) in the watershed.

Figure 4-1. Regression relationships between the Benthic Index of Biotic Integrity (BIBI) and impervious surface in upstream catchments during 2014 Howard County Biological Monitoring

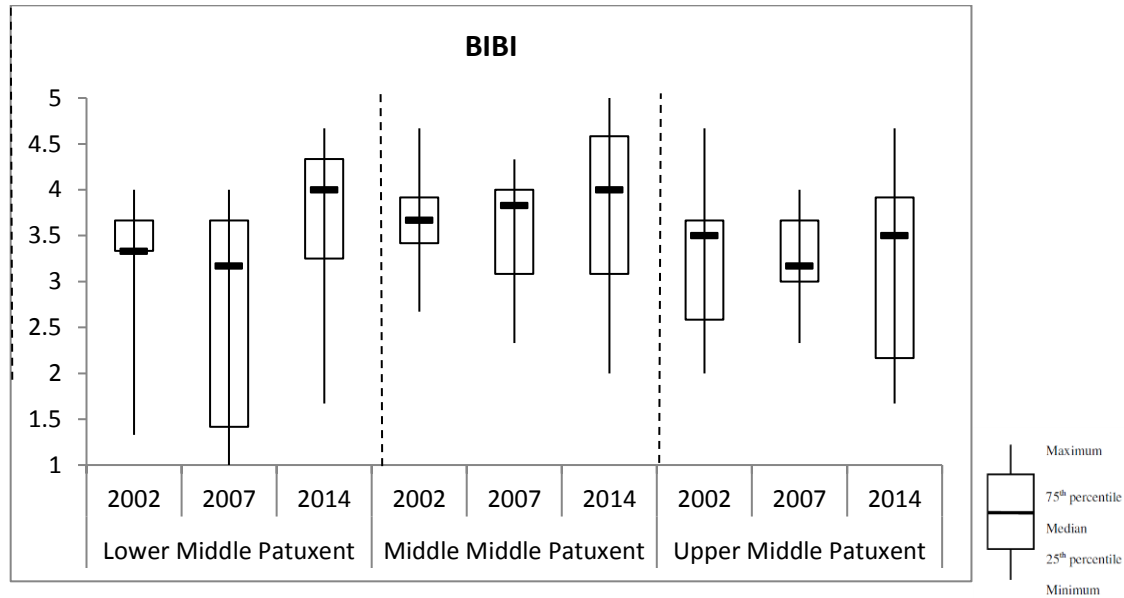
Figure 4-3. Comparison of 2002, 2007, and 2014 BIBI scores

In the Upper Middle Patuxent and Middle Middle Patuxent subwatersheds, the assessments in all three Rounds indicated that the subwatersheds were in “Fair” biological condition overall, according to the updated BIBI scores. The ANOVA test for differences amongst the years showed that the biological condition in all three Rounds were not significantly different from each other in either subwatershed.

In the Lower Middle Patuxent subwatershed, the Round 1 and Round 3 biological condition were “Fair” overall, but condition decreased slightly in Round 2 to “Poor”. Although in different narrative categories, the ANOVA test show that the biological condition was not significantly different in Round 2 than in Rounds 1 and 3.
