US 1 Safety Evaluation on Bicyclists and Pedestrian Safety

Final Report | 7

Executive Summary

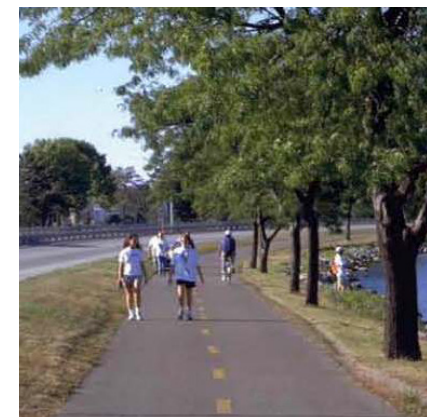
Example of a Shared Use Path from Bike Howard- Bicycle Facilities Visual Glossary page 35

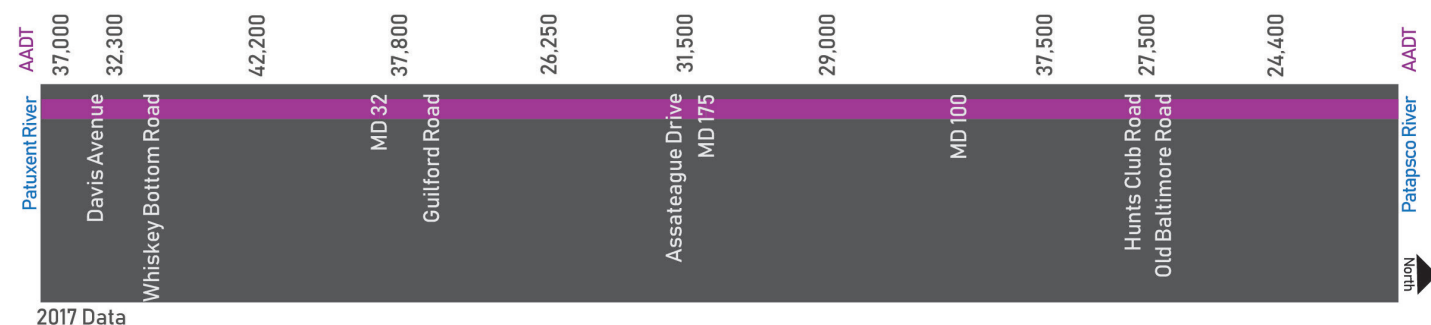
Average Annual Daily Traffic & Truck Percentages

The average annual daily traffic (AADT) along US 1 ranges between 18,000 and 42,000 with a corridor-wide average of 29,000. Segments of higher AADT occur to the south of MD 32 and to the north of MD 100. Truck percentages range between 6% and 12% with the highest truck percentage occurring in Jessup. Due to the industrial land uses along the corridor, truck percentages are higher than what is typical of state-maintained arterial roadways. Data sourced from MDOT SHA (<http://www.roads.maryland.gov/Index.aspx?PageId=792>).

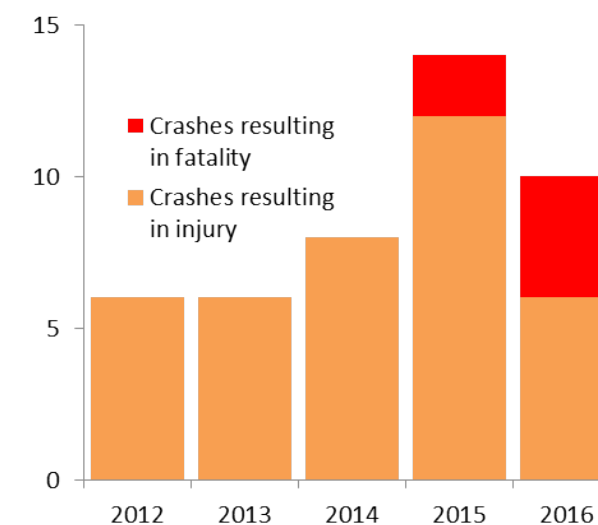
Between 2012 and 2016, a total of fifty-four pedestrian related crashes occurred along US 1, six of which resulted in seven pedestrian fatalities. The majority of pedestrian crash locations along the corridor occurred 1) in the North Laurel area between Prince George’s County line and Whiskey Bottom Road, 2) in Jessup within a half mile of MD 175, and 3) in Elkridge near Montgomery Road. The growth in annual pedestrian related crashes that resulted in an injury or a fatality is shown in Chart 1. The maps on the following pages show the location of pedestrian related crashes that occurred within the four focus areas (reference the Field Evaluation section for an explanation on the focus areas). Detailed crash information and maps are available in **Appendix F**.

Chart 1. Annual Pedestrian Crashes on US 1
This graphic does not include 10 Property Damage Only crashes

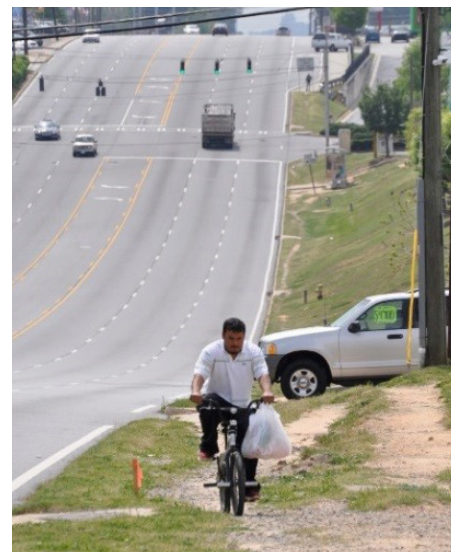
Street View of Route 13, Georgia

Buford Highway, also known as State Route 13, is a six lane undivided highway with an AADT between 20,000 to 45,000. The road has a posted speed limit between 35 to 45 MPH. The study segment is six miles in length. Identified key issues include lack of sidewalks, lack of bicycle facilities, numerous uncontrolled access points such as driveways and entrances, limited pedestrian crossings, and high vehicle operating speeds. The corridor serves a mix of commercial and residential land uses, It is served by a bus route with high volume stops (up to 400 daily boardings and alighting). With the high number of pedestrians using the bus system and a crash rate that is two to three times higher than the statewide average for similar highways, the corridor has experienced a recent increase in the number of pedestrian and bicycle fatalities. In response, Buford Highway became the focal point of a 2016 grant to create a master plan to address connectivity, affordable housing, and pedestrian safety.

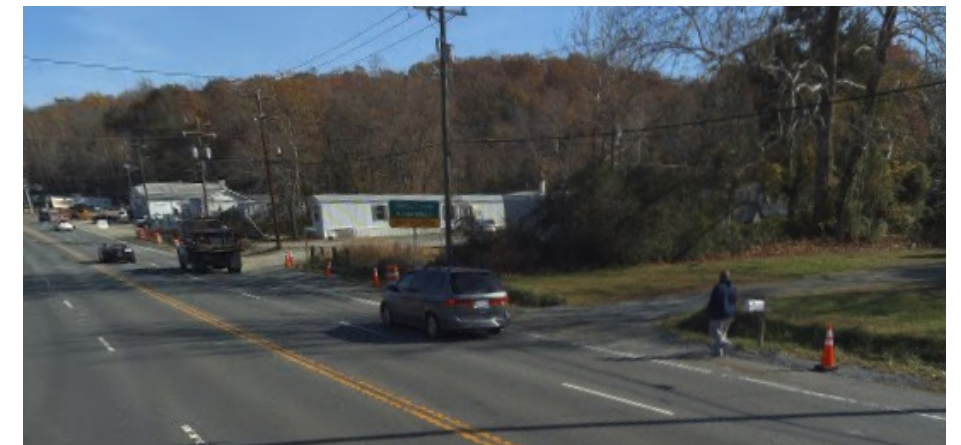
Street View of US 1 in Stafford, VA

US 1 in Stafford County and the City of Fredericksburg, Virginia is primarily a four lane undivided roadway, with an AADT between 20,000 to 40,000, posted speed limits varying between 35 and 50 MPH, and local bus service along the ten miles evaluated in the 2008 Route 1 Multimodal Corridor Study. Key issues include significant development pressure and growth, over-capacity intersections and traffic congestion, lack of sidewalks, lack of bicycle facilities, numerous uncontrolled access points, inaccessible bus stops, over-capacity park and ride lots, limited pedestrian crossings, and high vehicle operating speeds. Additionally, the corridor serves as a detour route for I-95 when incidents or weekday and seasonal traffic volumes causes delays on I-95.

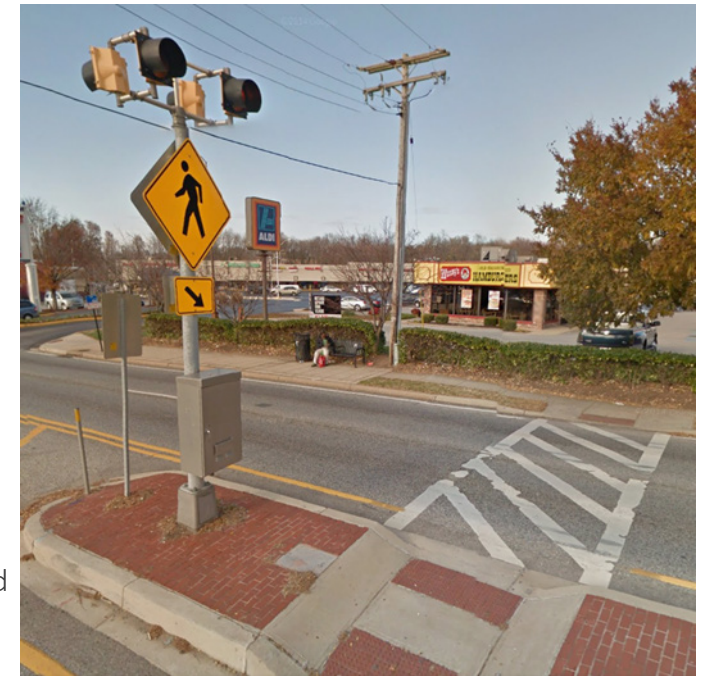
Median Pedestrian Refuge Implemented on MD 26

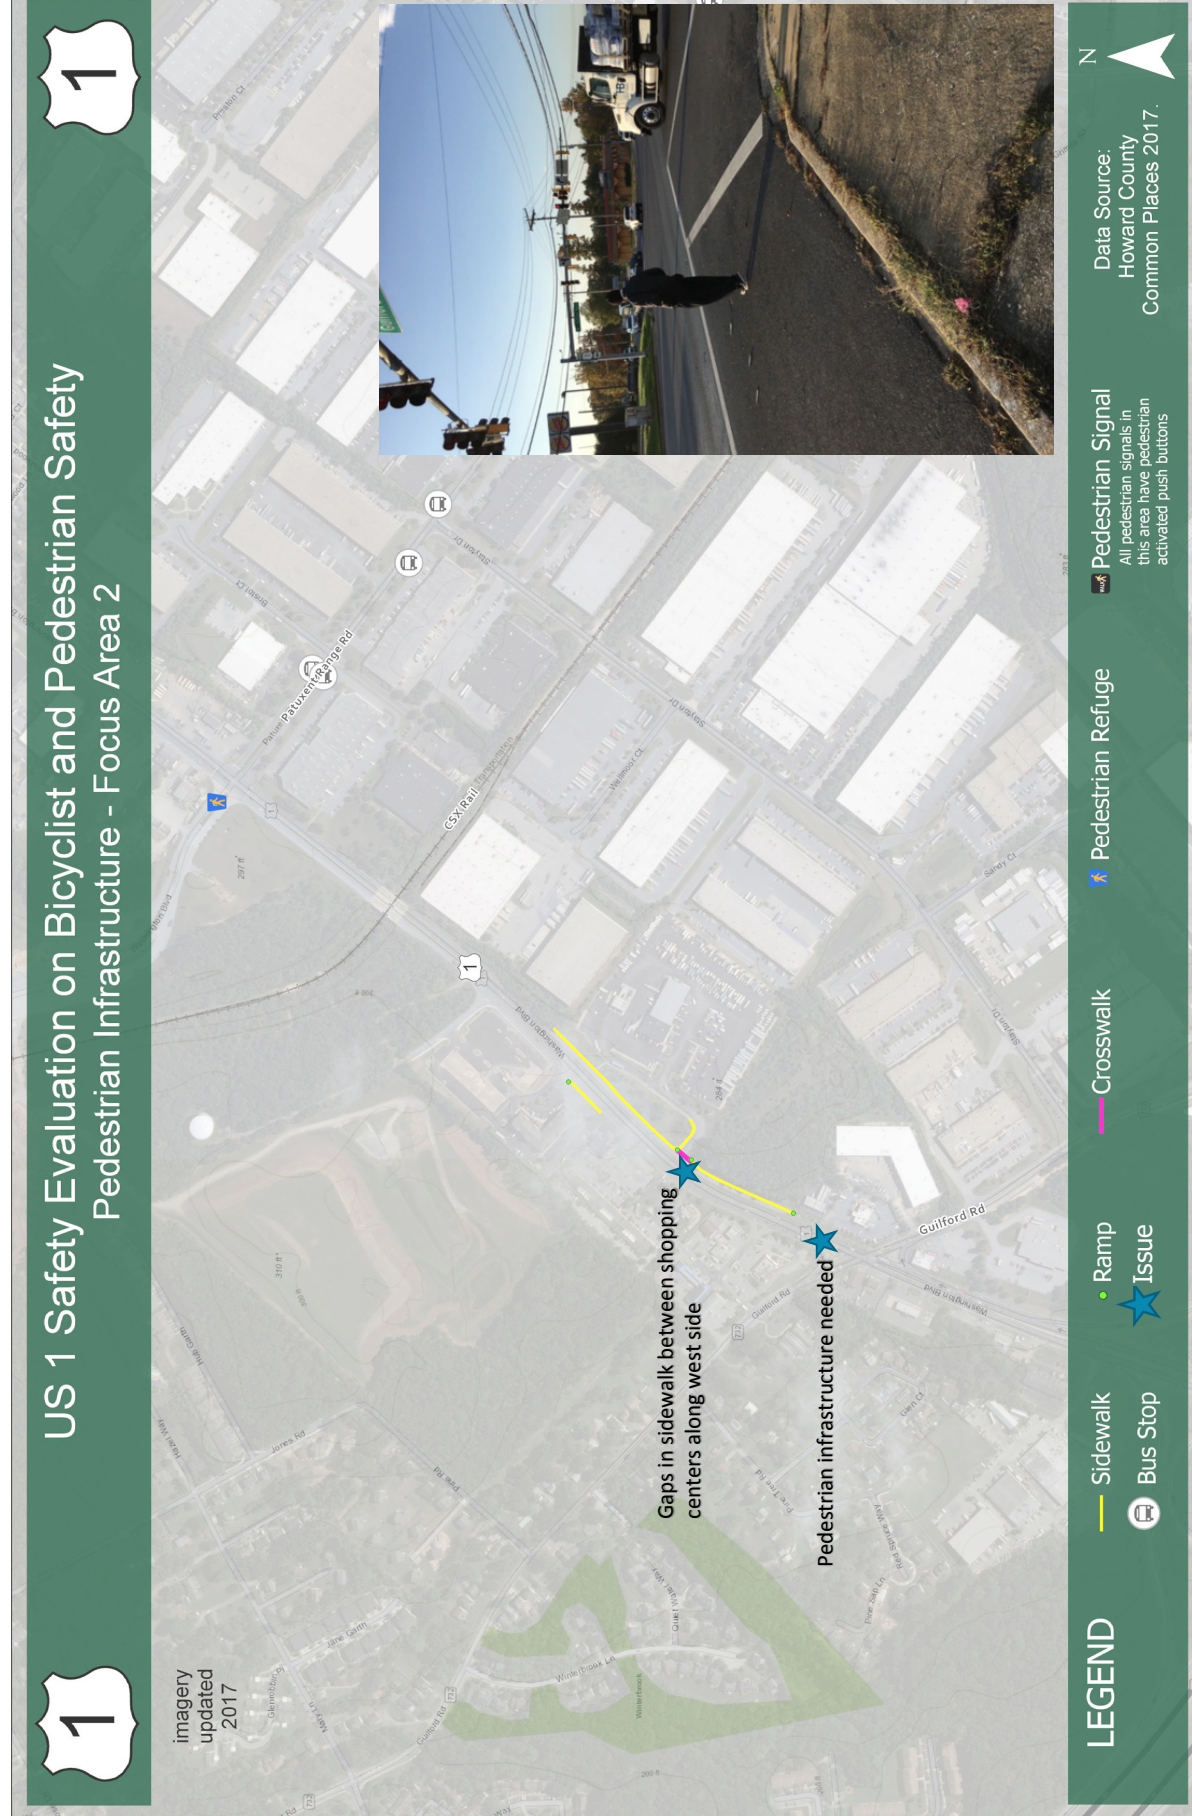
Map 7. Area 2 Field Observations and Issues

- » Noted absence of pedestrian infrastructure (crosswalk, ADA ramps, and pedestrian signals) at Guilford Road.
- » The intersection at Guilford Road had two pedestrian related crashes in the past five years including one fatality; several pedestrians were observed crossing during the field visit and were hesitant or unable to follow the traffic signal indications to find a safe time to cross.
- » There are sidewalk gaps along the west side of US 1 north of Guilford Road; filling these gaps would provide connectivity between the adjacent shopping centers.

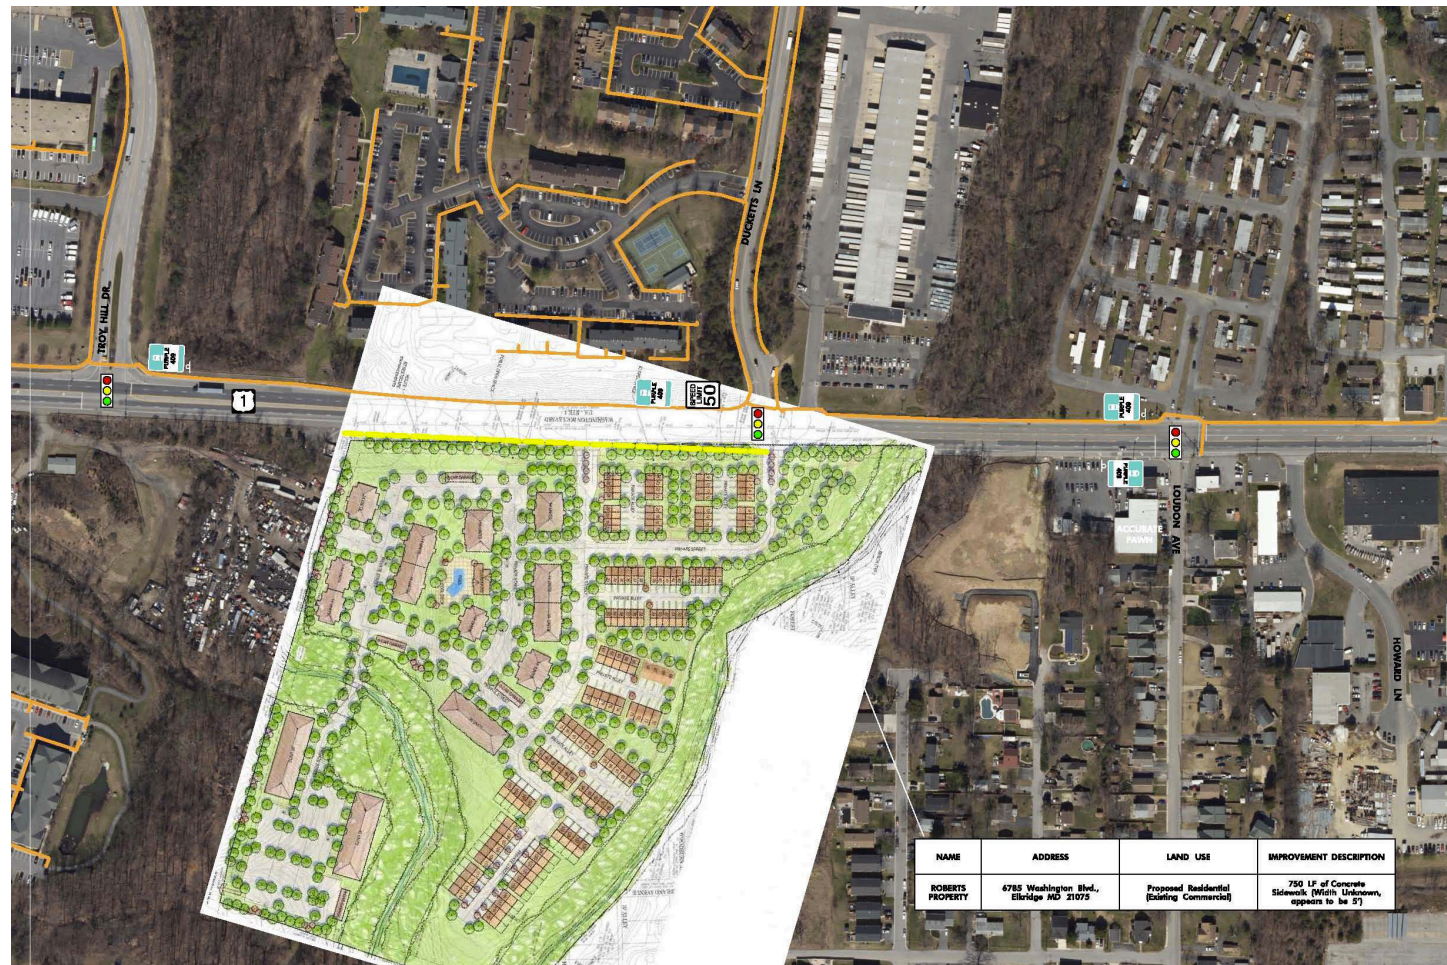
Example of Planned Improvement Drawings- Site Plan for Roberts Property 6785 Washington Blvd

There are fifteen pipeline projects along US 1, including five in each of the following areas: Laurel, Jessup, and Elkridge. Sidewalk or shared use path construction account for a majority of the improvements. One project is the installation of a new traffic signal at US 1 and Kit Kat Road in Jessup. Four of the development and capital projects include sidewalk construction along intersecting roadways such as Whiskey Bottom Road, Kitkat Road, and Montevideo Road. The developments and projects will add approximately 4,380 linear feet of new shared used path and 4,090 linear feet of new sidewalk along the corridor. This equates to a 20% increase in pedestrian or bicycle friendly infrastructure along US 1.

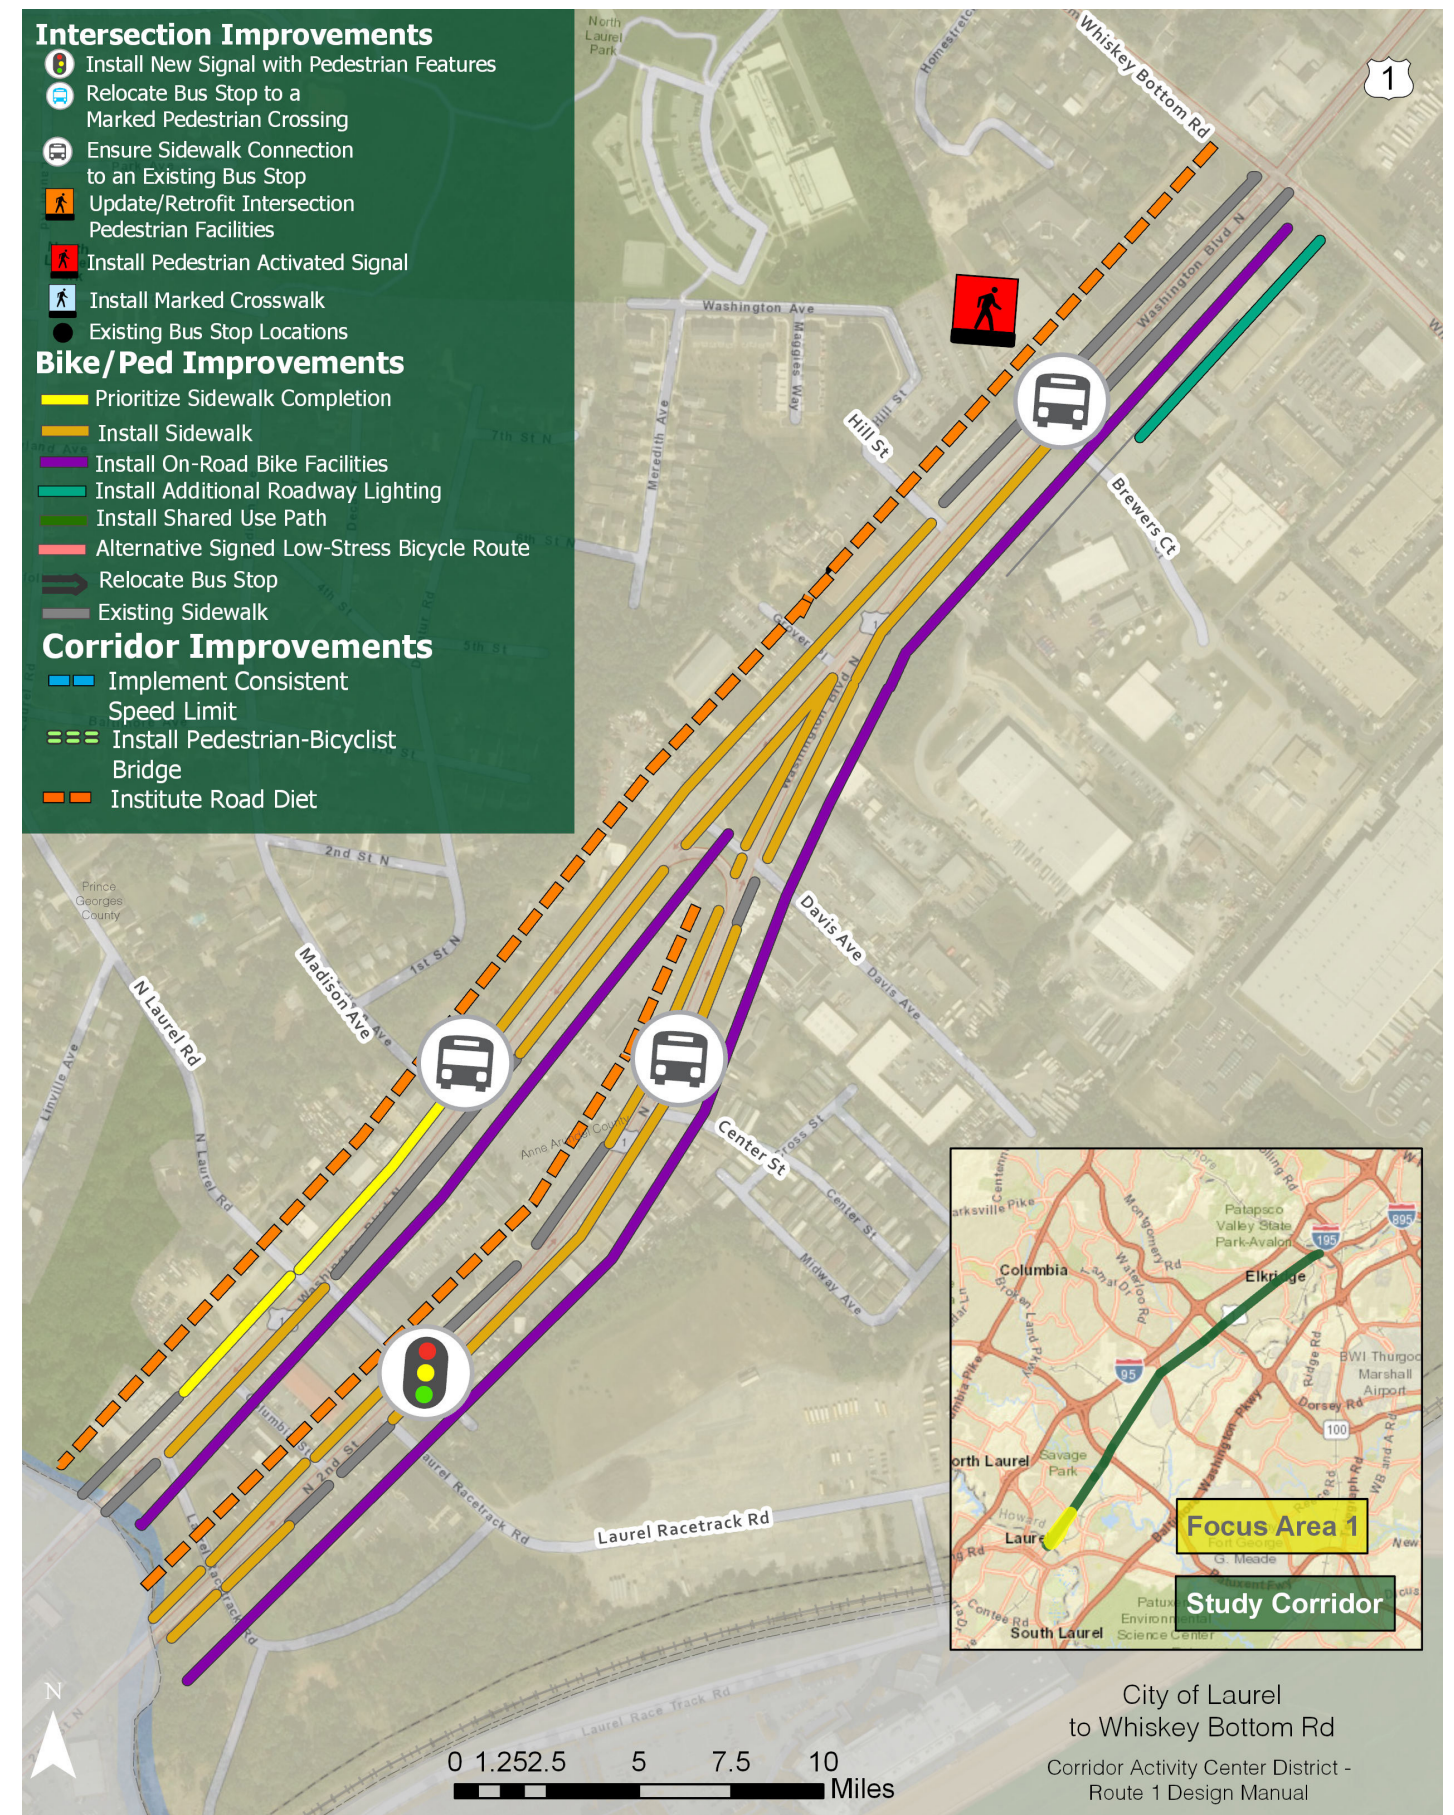
Map 10. Area 1 Recommendations: The City of Laurel/ Howard County line to Whiskey Bottom Road

- » A **road diet** is recommended along northbound and southbound US 1 from the Laurel Park Entrance Road to Davis Avenue to allow for repurposing of existing roadway space for other modes. A road diet of US 1 from the Prince George’s County Line to Whiskey Bottom Road was previously evaluated for traffic operations in 2014 by MDOT SHA Office of Highway Development and was found to provide acceptable traffic performance. This recommendation expands on the concept by proposing a higher quality bike facility. Specifically, the outside lane in each direction, which currently operates as an auxiliary lane for right turns into and out of properties along US 1, is recommended to be repurposed as **buffered one-way bike lanes**. The proposed bike facility will provide a five foot northbound and five foot southbound bike lane each buffered by a five foot hatched area. The existing properties and side streets along this segment of US 1 are low traffic generators but it is recommended to reduce the speed limit to 30 MPH in this segment to further enhance traffic safety. Such an operational change is consistent with this segment’s designation in the Route 1 Manual as a corridor activity center district.

- » While sidewalks are recommended for all curbside in segments currently lacking, a **priority new sidewalk completion** segment is recommended between Columbia Street and Madison Avenue (1,000 feet) to support observed pedestrian activity.

- » The roadway segment between Hill Street and Whiskey Bottom Road (1,250 feet) does not have marked or controlled pedestrian crossings. Field observations showed pedestrian activity in this segment. The danger of crossing the six lane roadway is compounded by the dark conditions at night due to limited ambient lighting from adjacent businesses and limited roadway lighting. A **pedestrian-activated traffic signal and a marked crosswalk** is recommended at Brewer’s Court to provide a controlled crossing along this segment. Additional **roadway lighting** is also recommended along the segment between Brewers Court and Whiskey Bottom Road to improve pedestrian visibility.

- » To decrease the distances between pedestrian controlled crossings, this report carries forward the planned **new traffic signal** at US 1 northbound and North Laurel Road.

- » To improve access to bus stops, this report recommends constructing new **sidewalk connections to three bus stops**.

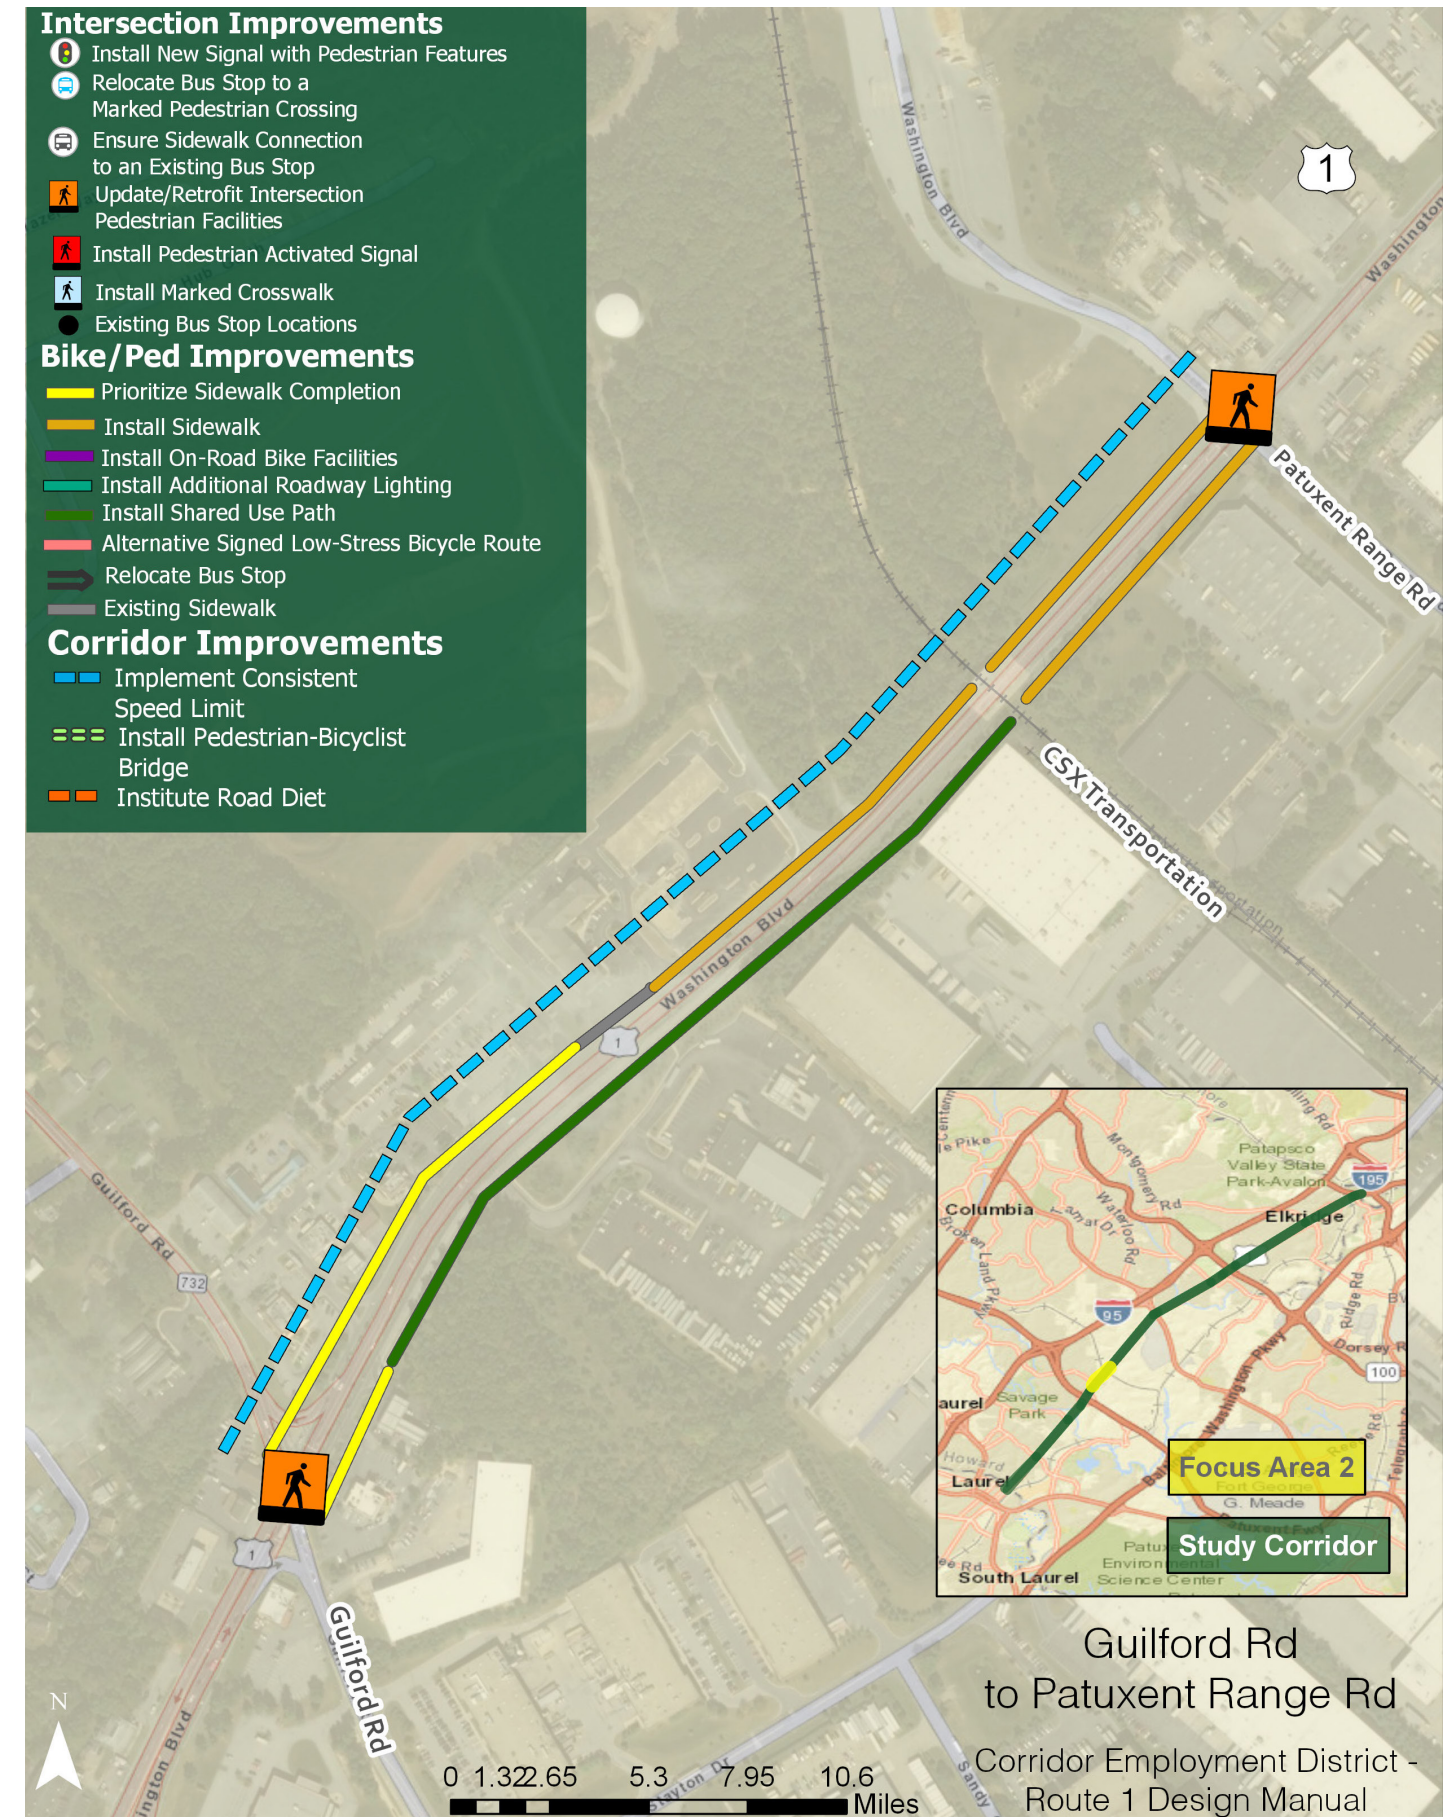
- » To provide for bicycle facilities in this focus segment, this report recommends establishing a **shared use path** along the east side of US 1. This recommendation may include the construction of a new path and/or widening of the existing sidewalk. Such a facility would connect the county proposed bike lane along Guilford Road to the shared use path proposed in the County's Bicycle Master Plan along the CSX railway corridor west of US 1 and south of Patuxent Range Road.

- » While sidewalks are recommended for all segments currently lacking sidewalks, a **priority sidewalk completion segment** is recommended along the west side of US 1 from Guilford Road traveling north along the Columbia Junction center connecting to the existing sidewalk in front of the Extended Stay America hotel (600 feet), as well as along the eastern side of US 1 between Guilford Road and the existing sidewalk 230 feet north of the intersection. This would complete the sidewalk network in this area and provide a pedestrian path between Guilford Road and the destinations in the Columbia Junction shopping center.

- » To safely accommodate the observed pedestrian activity at the intersections of US 1 with Guilford Road and Patuxent Range Road, this report recommends **upgrading these intersections for pedestrian crossing facilities including pedestrian signals, curb ramps, and marked crosswalks**. Pedestrian activity was observed walking to and from the surrounding commercial land uses.

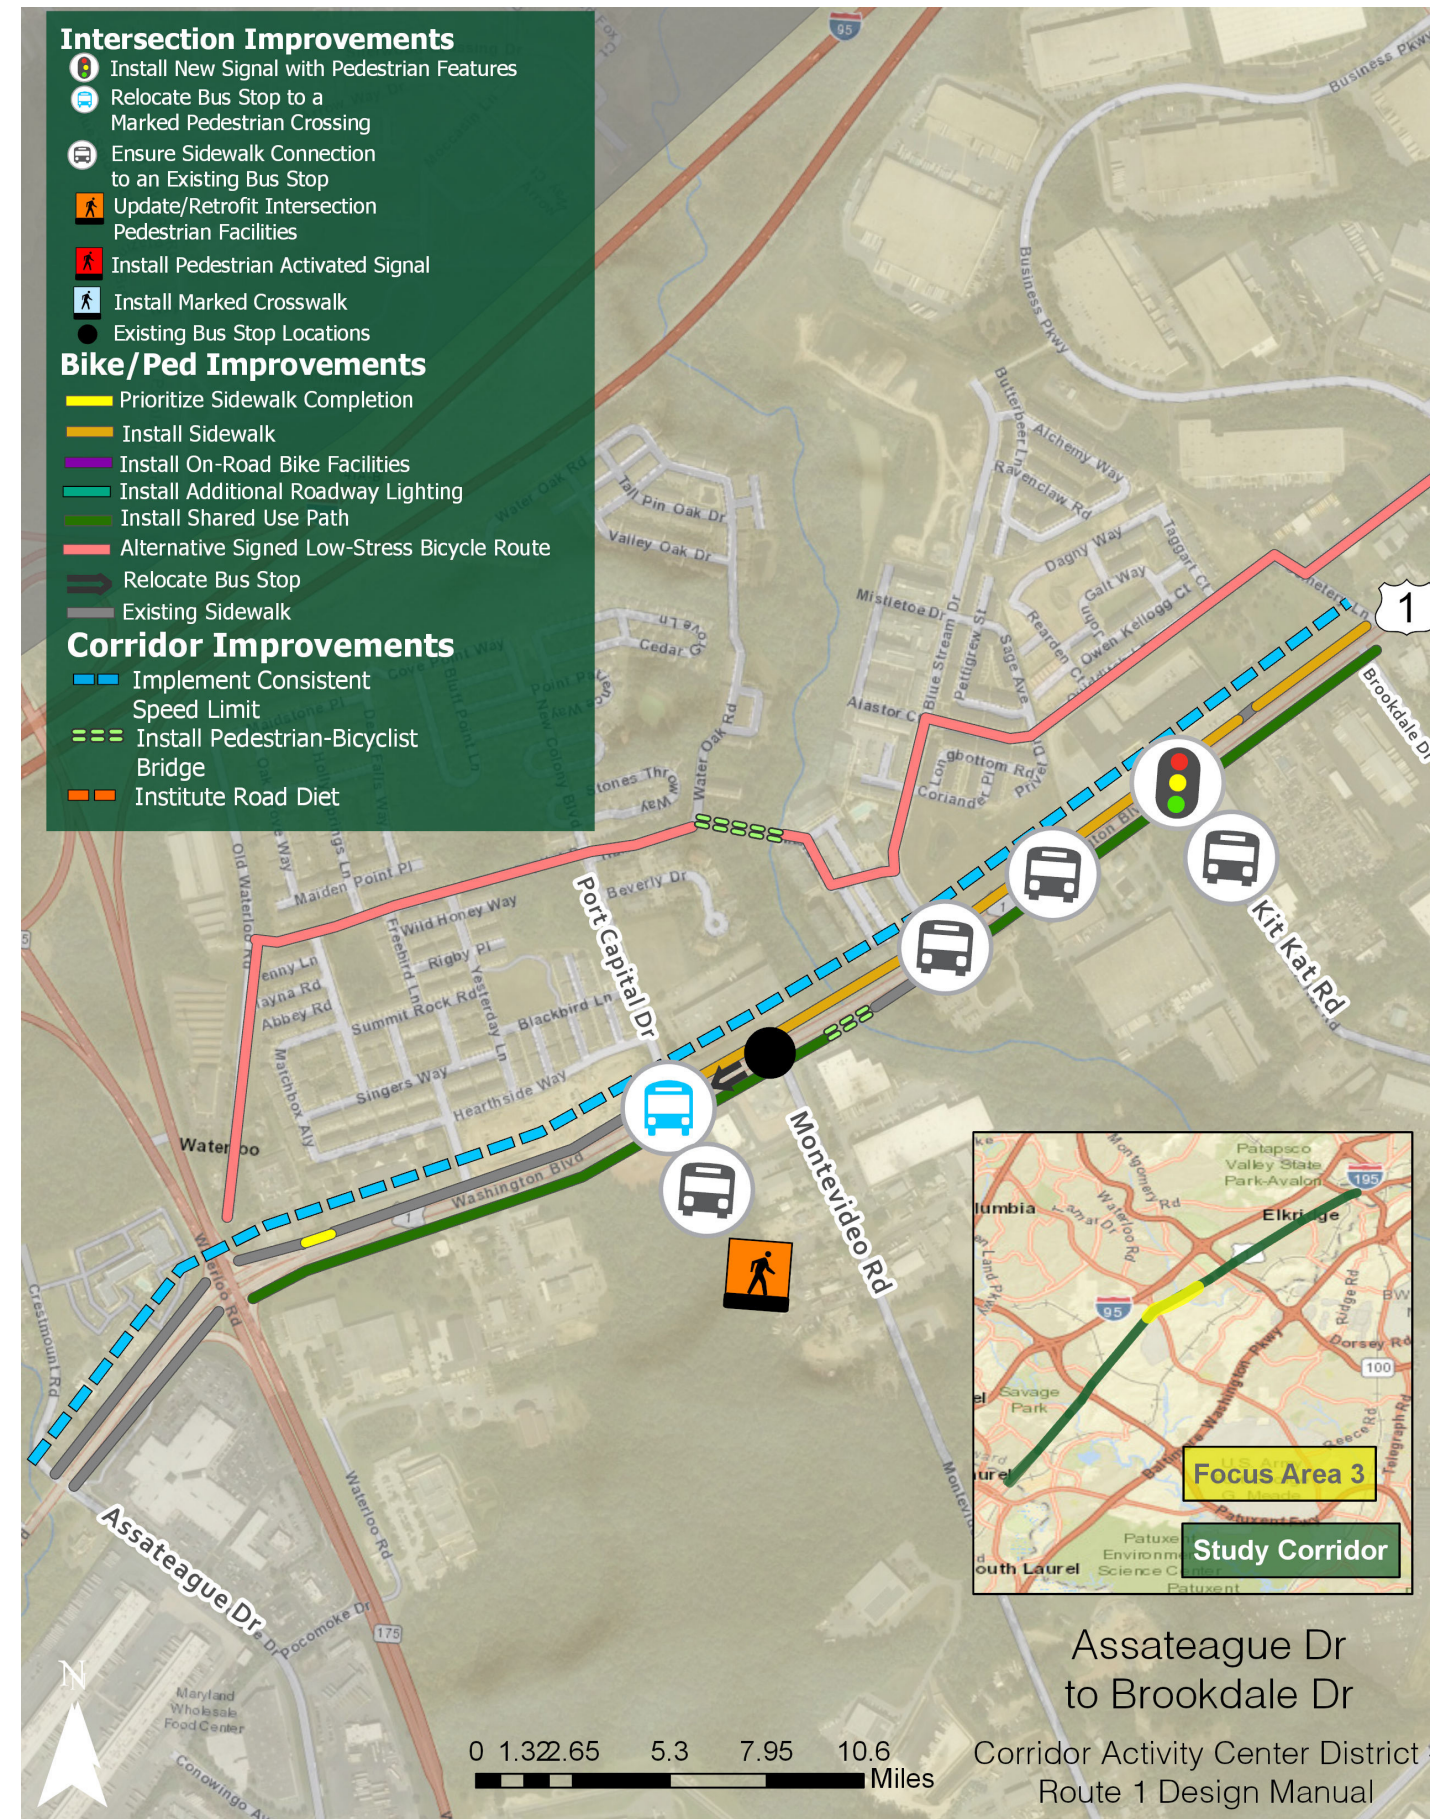
Map 12. Area 3 Recommendations: Assateague Drive to Brookdale Drive

- » To provide for bicycle facilities along this segment, this report recommends installing a **shared use path** between MD 175 and Brookdale Drive. Alternatively or additionally a **low-stress signed bike route** could be developed between Old Waterloo Road and Meadowridge Road along parallel local County streets including Port Capitol Drive, Blue Stream Drive, Quidditch Lane, and Roosevelt Boulevard with the construction of a **new pedestrian bridge** over Deep Run.

- » While sidewalks are recommended for all segments currently lacking, a **priority sidewalk completion segment** is recommended to fill in the 130 foot gap between existing sidewalk segments just north of MD 175. Pedestrian demand is evident by the well-worn path.

- » It is recommended to provide a **sidewalk connection to four bus stops** along the corridor. This may include either a mainline sidewalk path parallel to US 1, or a perpendicular branch connection to the bus stops in areas where the existing sidewalk is set back from the curb.

- » To improve access to bus stops, **relocating the existing bus stop** at Montevideo Road to the proposed signal at Port Capitol where the bus stop will align with the proposed controlled crossing is recommended.

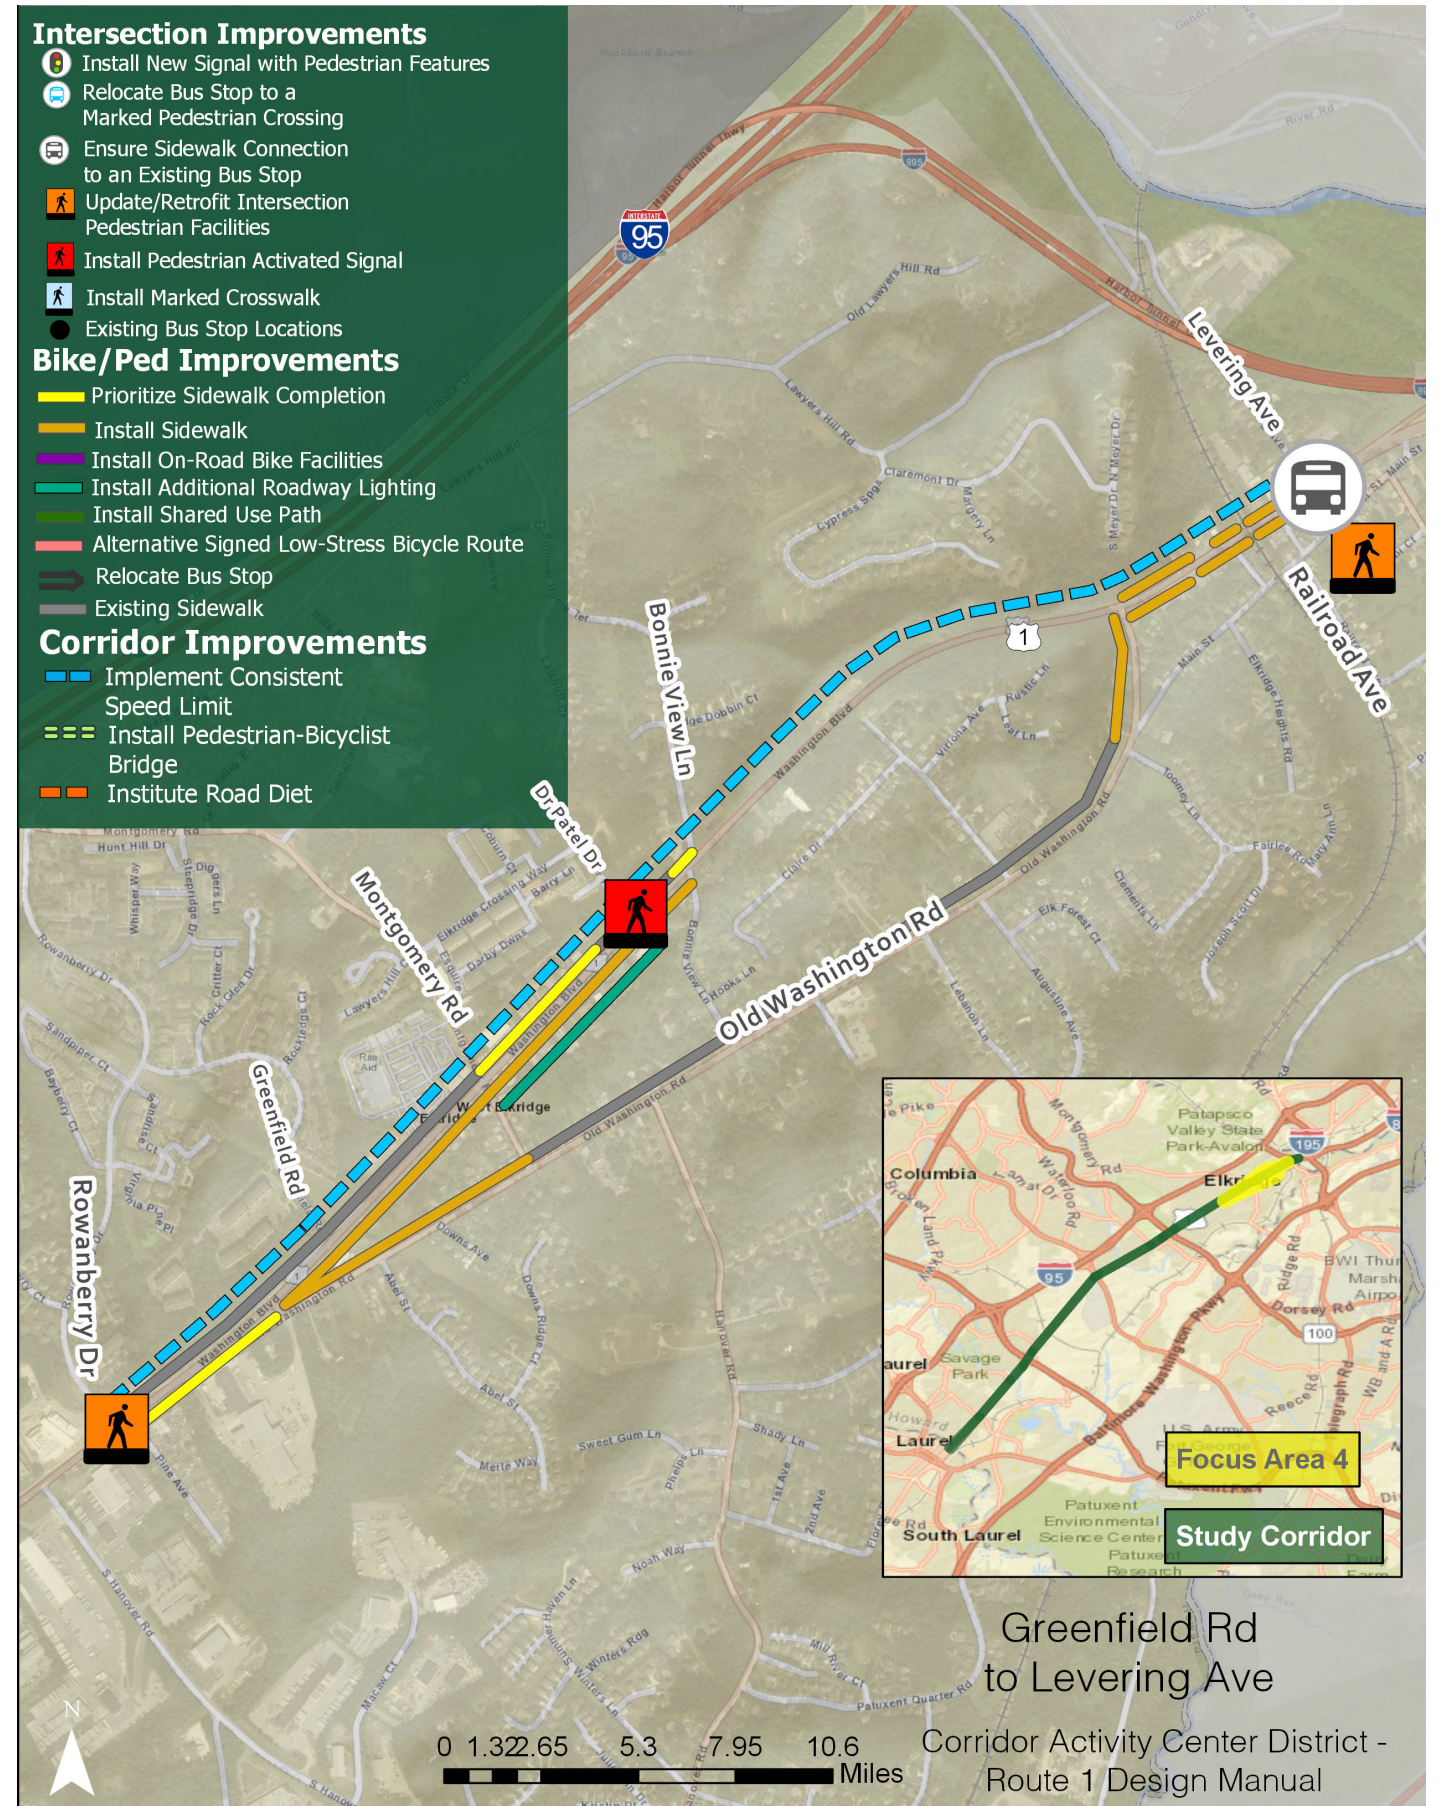
- » While sidewalks are recommended for all segments currently lacking, a **priority sidewalk completion segment** is recommended 1) between Rowanberry Drive and Old Washington Road (430 feet) to provide a connection to the library, 2) between Montgomery Road connecting to the existing sidewalk at Doctor Patel Drive (650 feet), and 3) for the 150 gap from the existing sidewalk north of Doctor Patel Drive to Bonnie View Lane. This completes the sidewalk network in key pedestrian generator land use areas including from residential areas to food or shopping destinations.

- » The roadway segment between Montgomery Road and Bonnie View Lane (1,750 feet) does not have marked or controlled pedestrian crossing despite the pedestrian generating adjacent land uses of overnight lodging and food establishments. Field observations and crash reports showed pedestrian activity in this segment. The hazard of crossing the five lane roadway is compounded by the dark conditions at night due to limited ambient lighting from adjacent businesses and limited roadway lighting. A **pedestrian activated traffic signal and a marked crosswalk** is recommended at Doctor Patel Drive to provide for a controlled pedestrian crossing along this segment. To increase pedestrian visibility, additional **roadway lighting** is recommended between Montgomery Road and Doctor Patel Drive.

- » To provide for a controlled pedestrian crossing in the small commercial segment in northern Elkridge, **upgrading the existing traffic signal** at US 1 and Levering Avenue with pedestrian infrastructure including ADA compliant curb ramps and marked crosswalks is recommended.

- » To complete the pedestrian connection to the library, **upgrading the existing traffic signal** at US 1 and Rowanberry Drive with pedestrian infrastructure including pedestrian signals, ADA compliant curb ramps, and marked crosswalks is recommended.

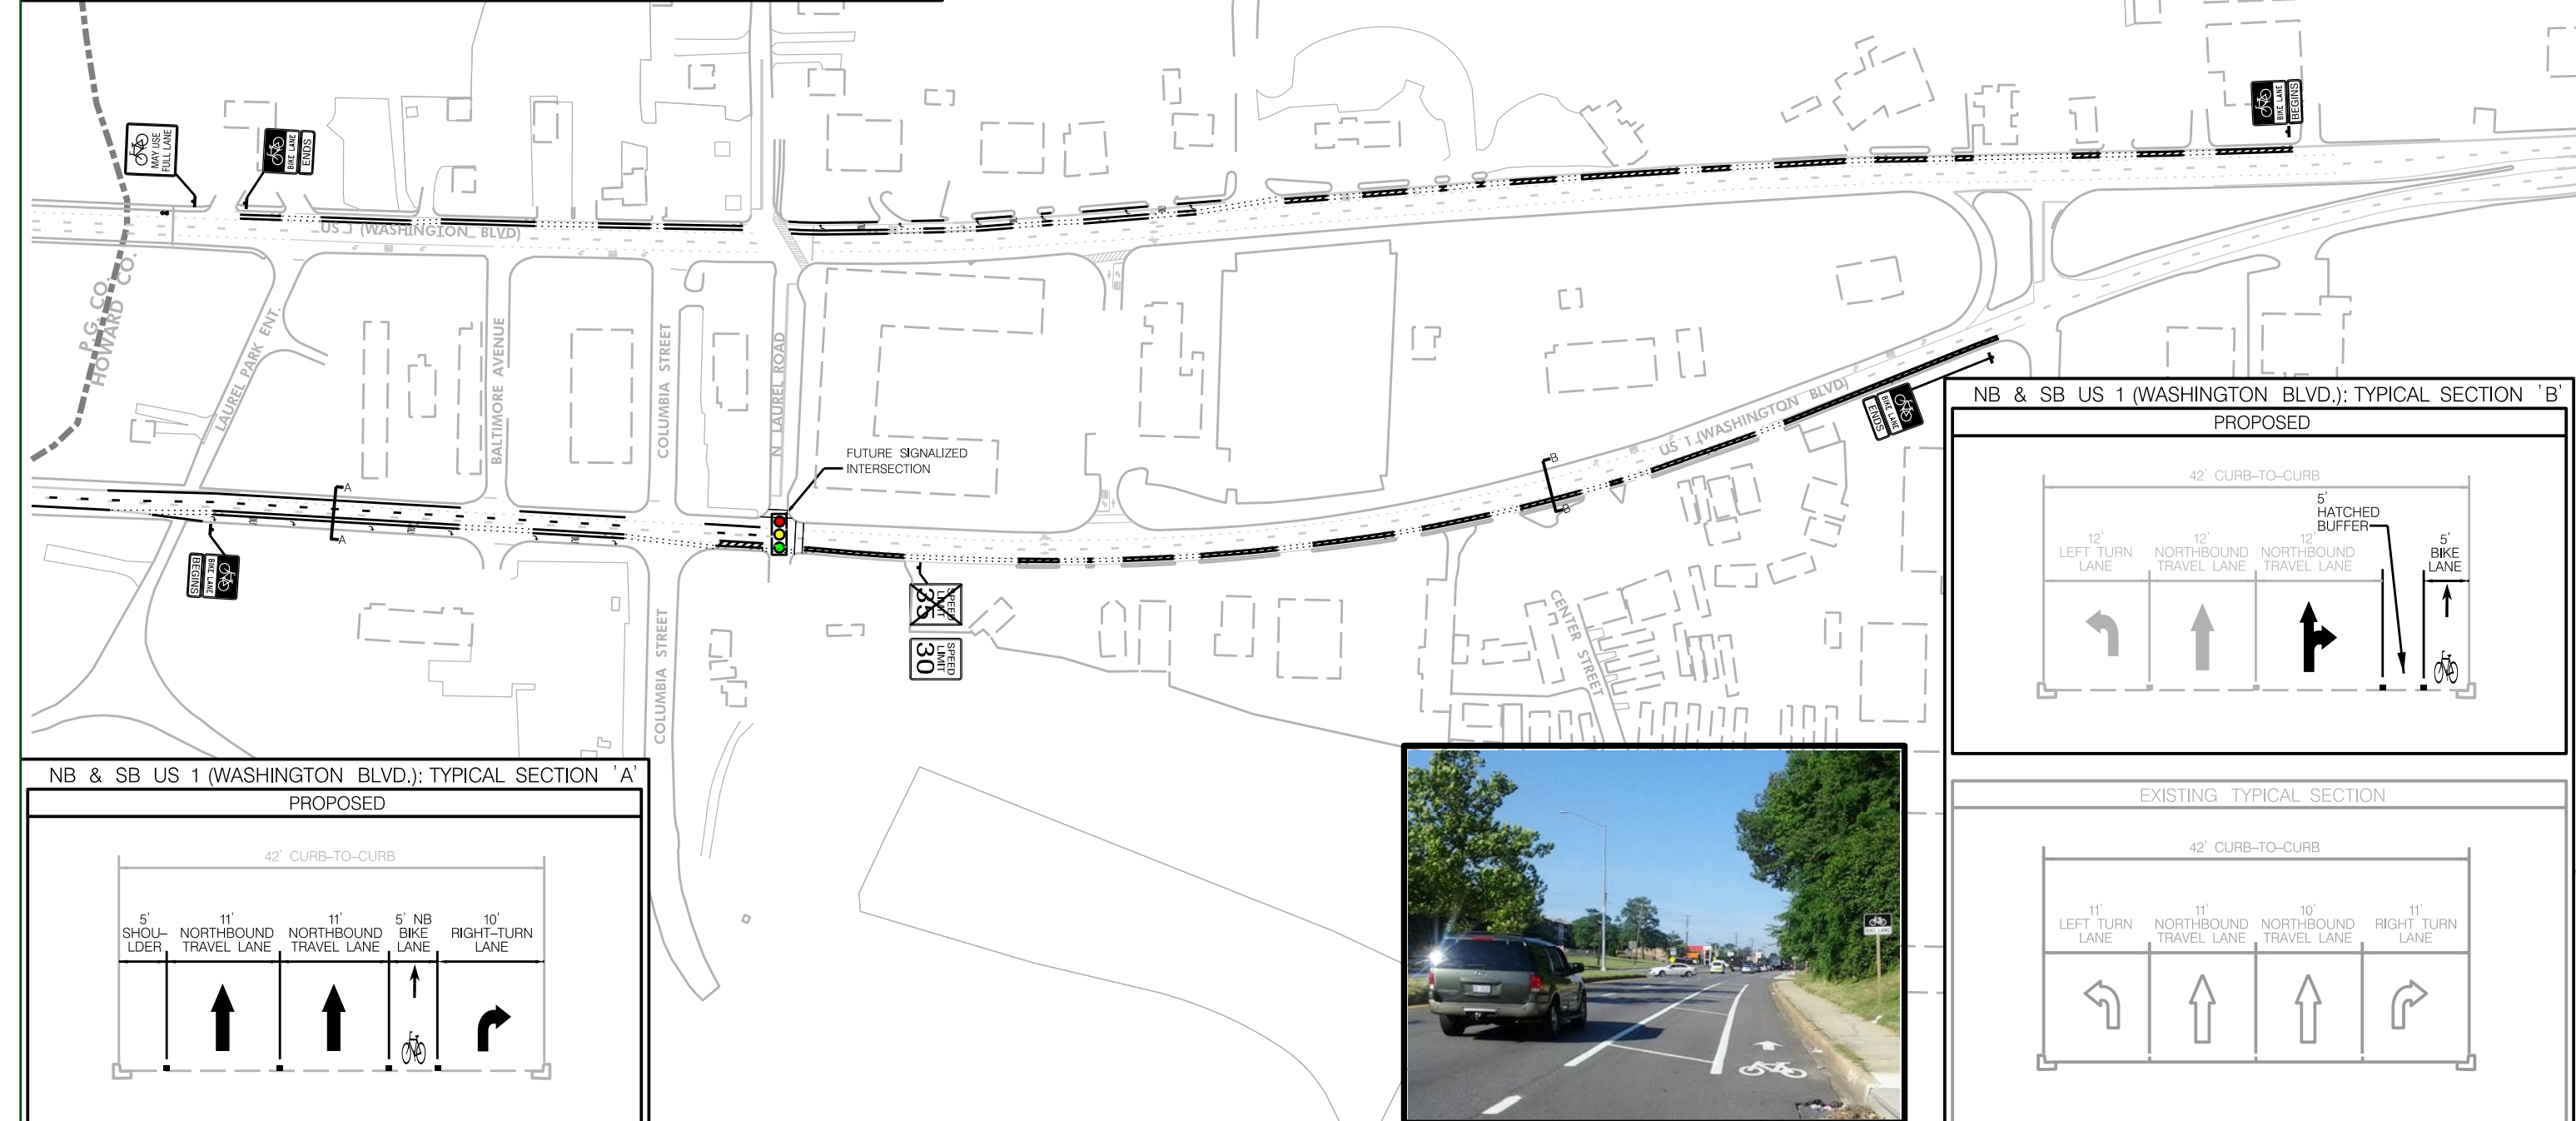
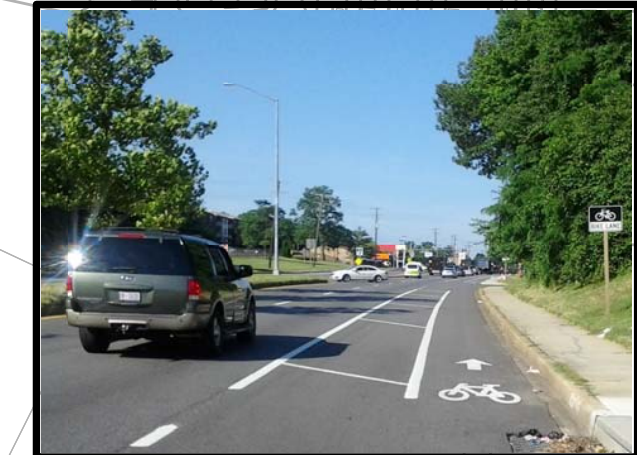
Although a detailed traffic operations analysis has not been conducted to assess the resulting impacts of repurposing a travel lane, an assessment of the average daily traffic, low traffic generating land uses, side street volumes, and 35 MPH speed limit in this segment significant traffic operations or safety impacts are not anticipated.

Concept 1. Lane Repurposing to provide for a bicycle facility
