US 1 Safety Evaluation on Bicyclists and Pedestrian Safety

Final Report | 7

Executive Summary

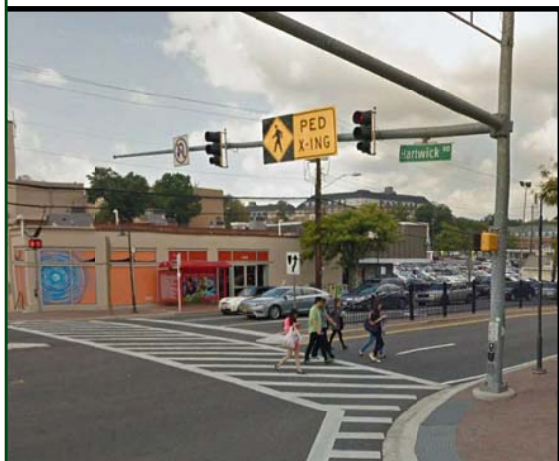
Concept 2. Pedestrian crossing north of Brewer's Court
