Maryland Department of Natural Resources  
Watershed Services  
Technical and Planning Services  
April 2005

# **DEEP RUN AND PATAPSCO RIVER STREAM CORRIDOR ASSESSMENT SURVEY In Howard County**

PREPARED BY  
Robin Pellicano and Kenneth T. Yetman

WATERSHED SERVICES  
TECHNICAL AND PLANNING SERVICES  
MARYLAND DEPARTMENT OF NATURAL RESOURCES  
ANNAPOLIS, MARYLAND

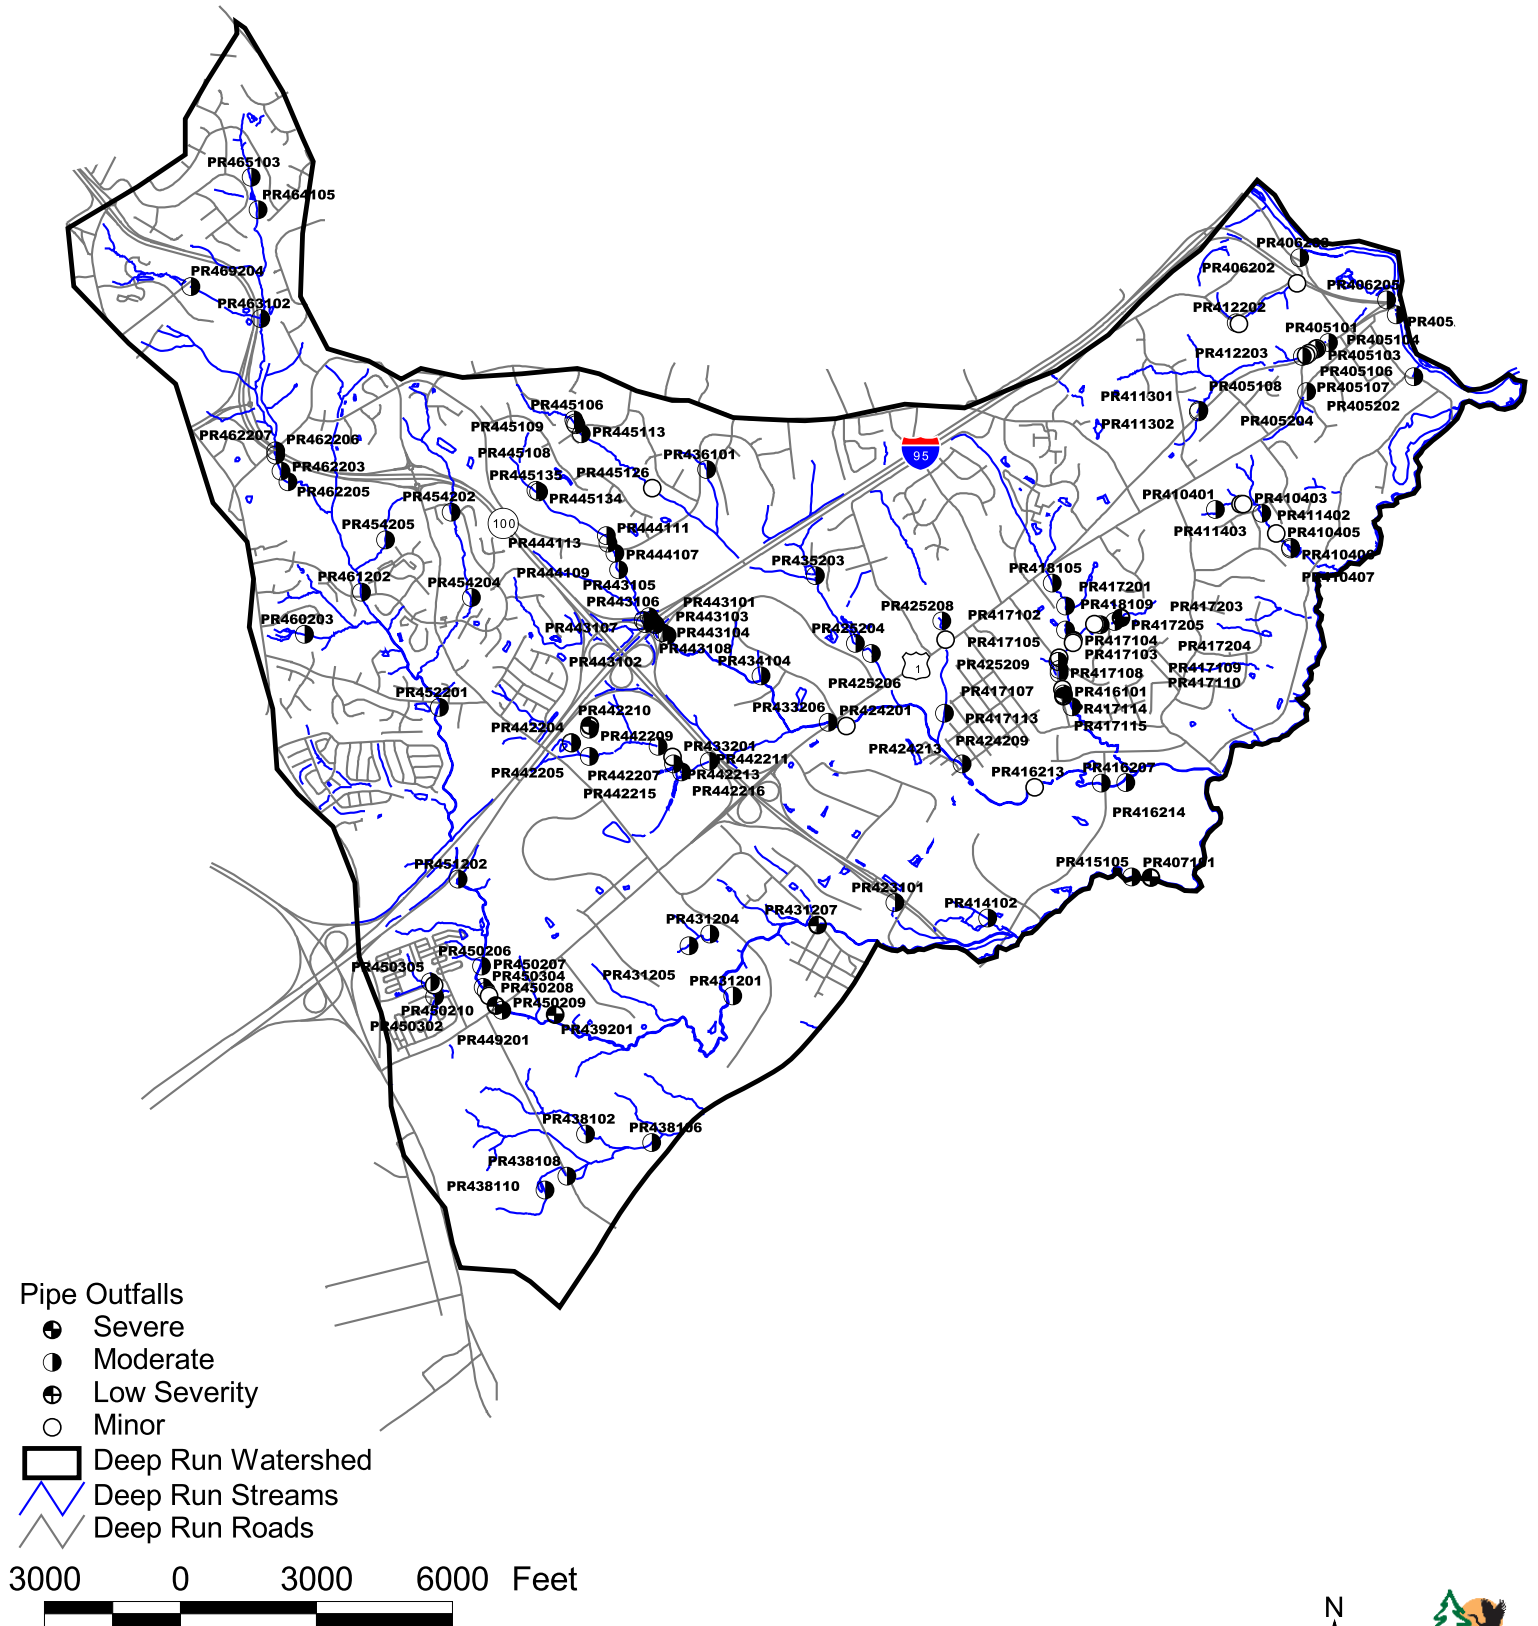
Figure 4b: Map showing the location of the Pipe Outfalls in Deep Run

Pipe outfalls include any pipes or small, constructed channels that discharge into the stream through the stream corridor. Pipe outfalls are considered a potential environmental problem in the survey because they can carry uncontrolled runoff and pollutants such as oil, heavy metals and nutrients to a stream system. The survey crew identified a total of 123 pipe outfalls (Figure 4a). The locations of pipe outfalls are shown in Figures 4b-c.

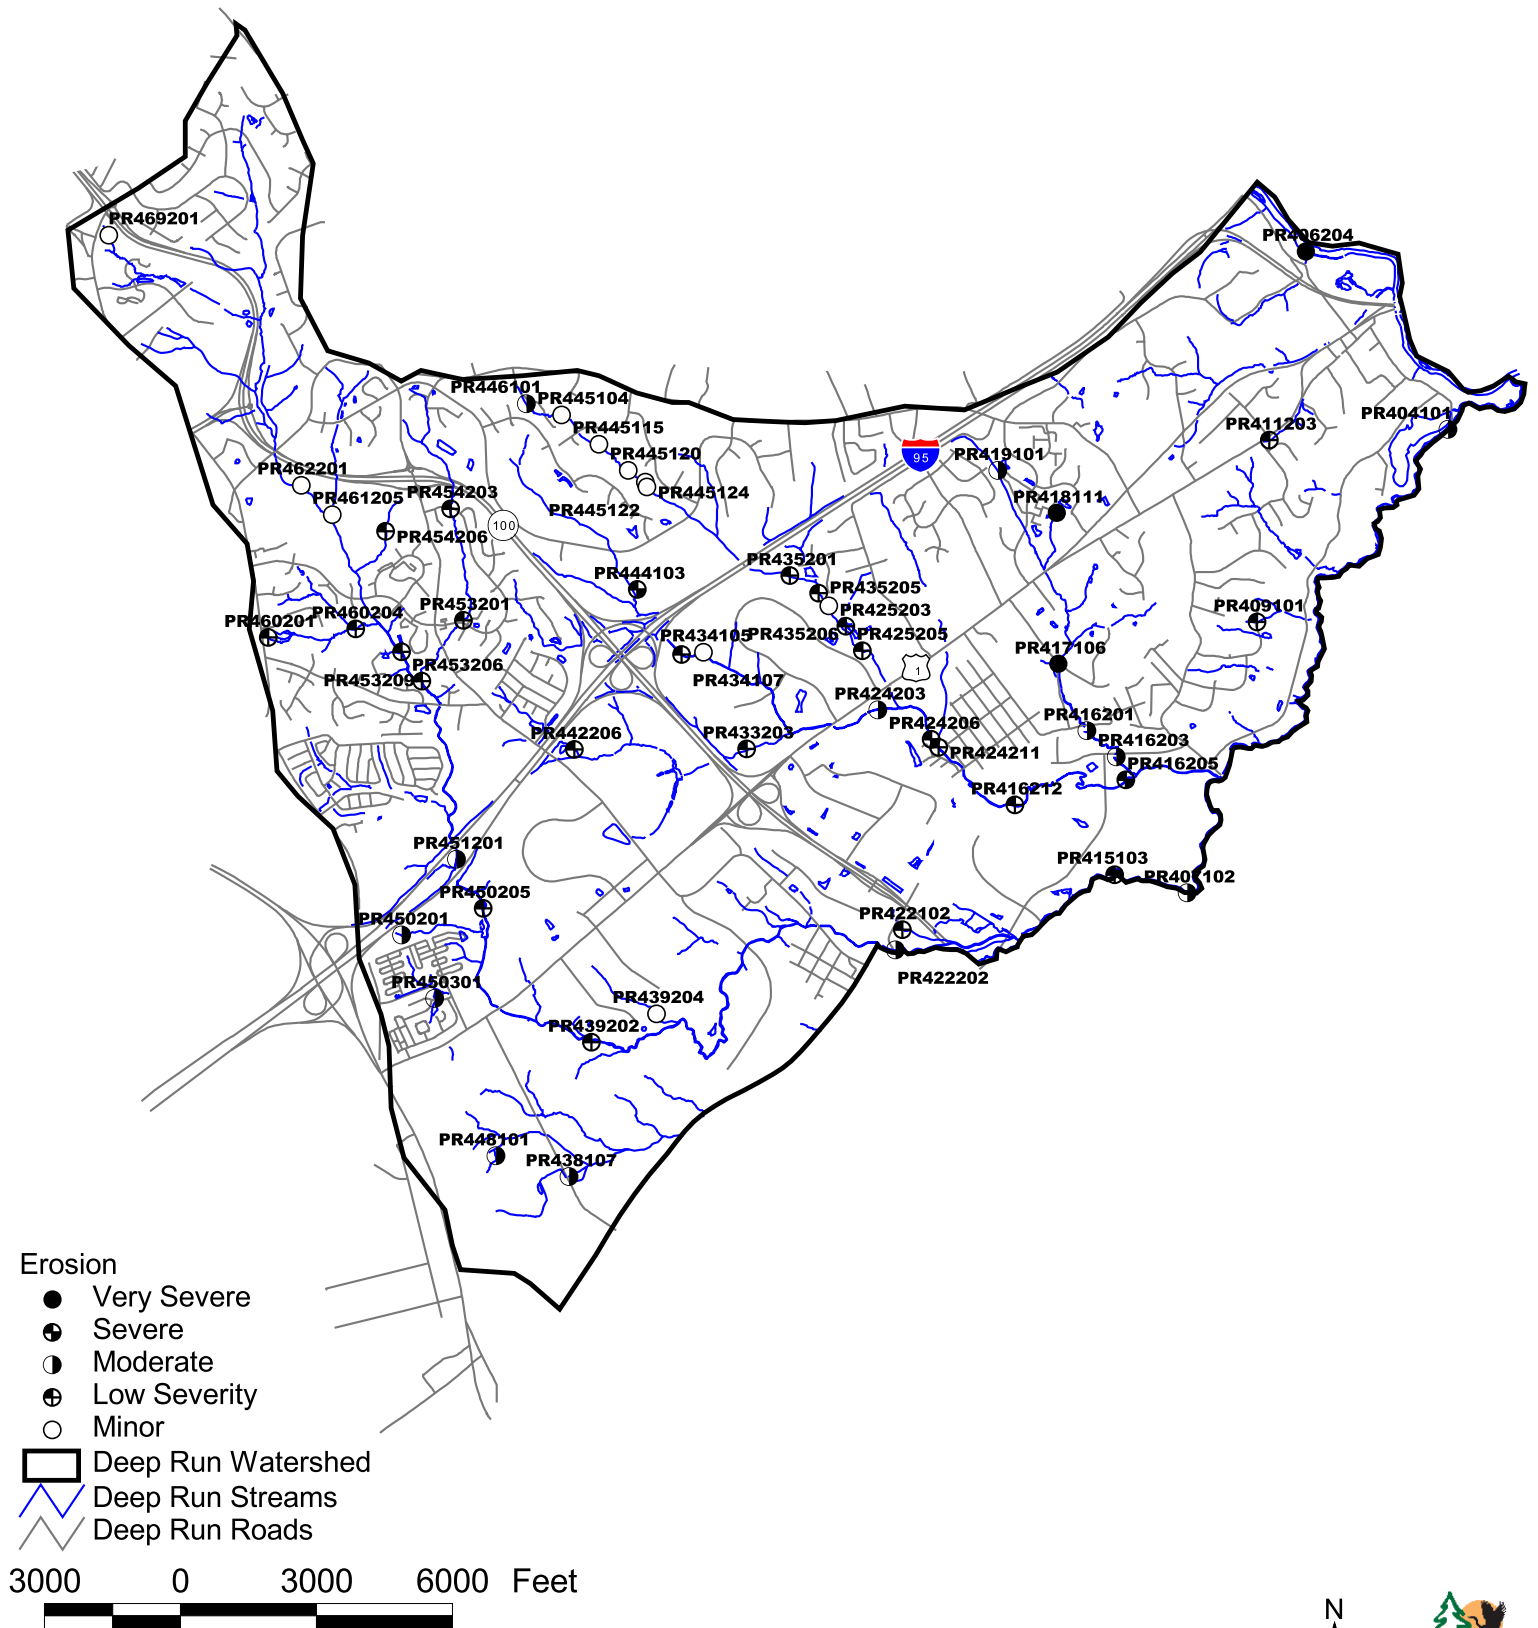
Figure 5b: Map showing the location of the Erosion Sites in Deep Run

This survey found 56 unstable eroding banks sites with a total length of approximately 4.7 miles of stream (Appendix B). Figure 5a shows the frequency of the severity rating given to erosion sites. Within this watershed, there were three very severe erosion sites (PR406204, PR417106, PR418111) and two severe sites (PR416205, PR444103). The majority of erosion sites were minor- to moderate-in severity. The lengths of stream segments with unstable banks varied from 20 feet to 3,300 feet of stream (Appendix B).

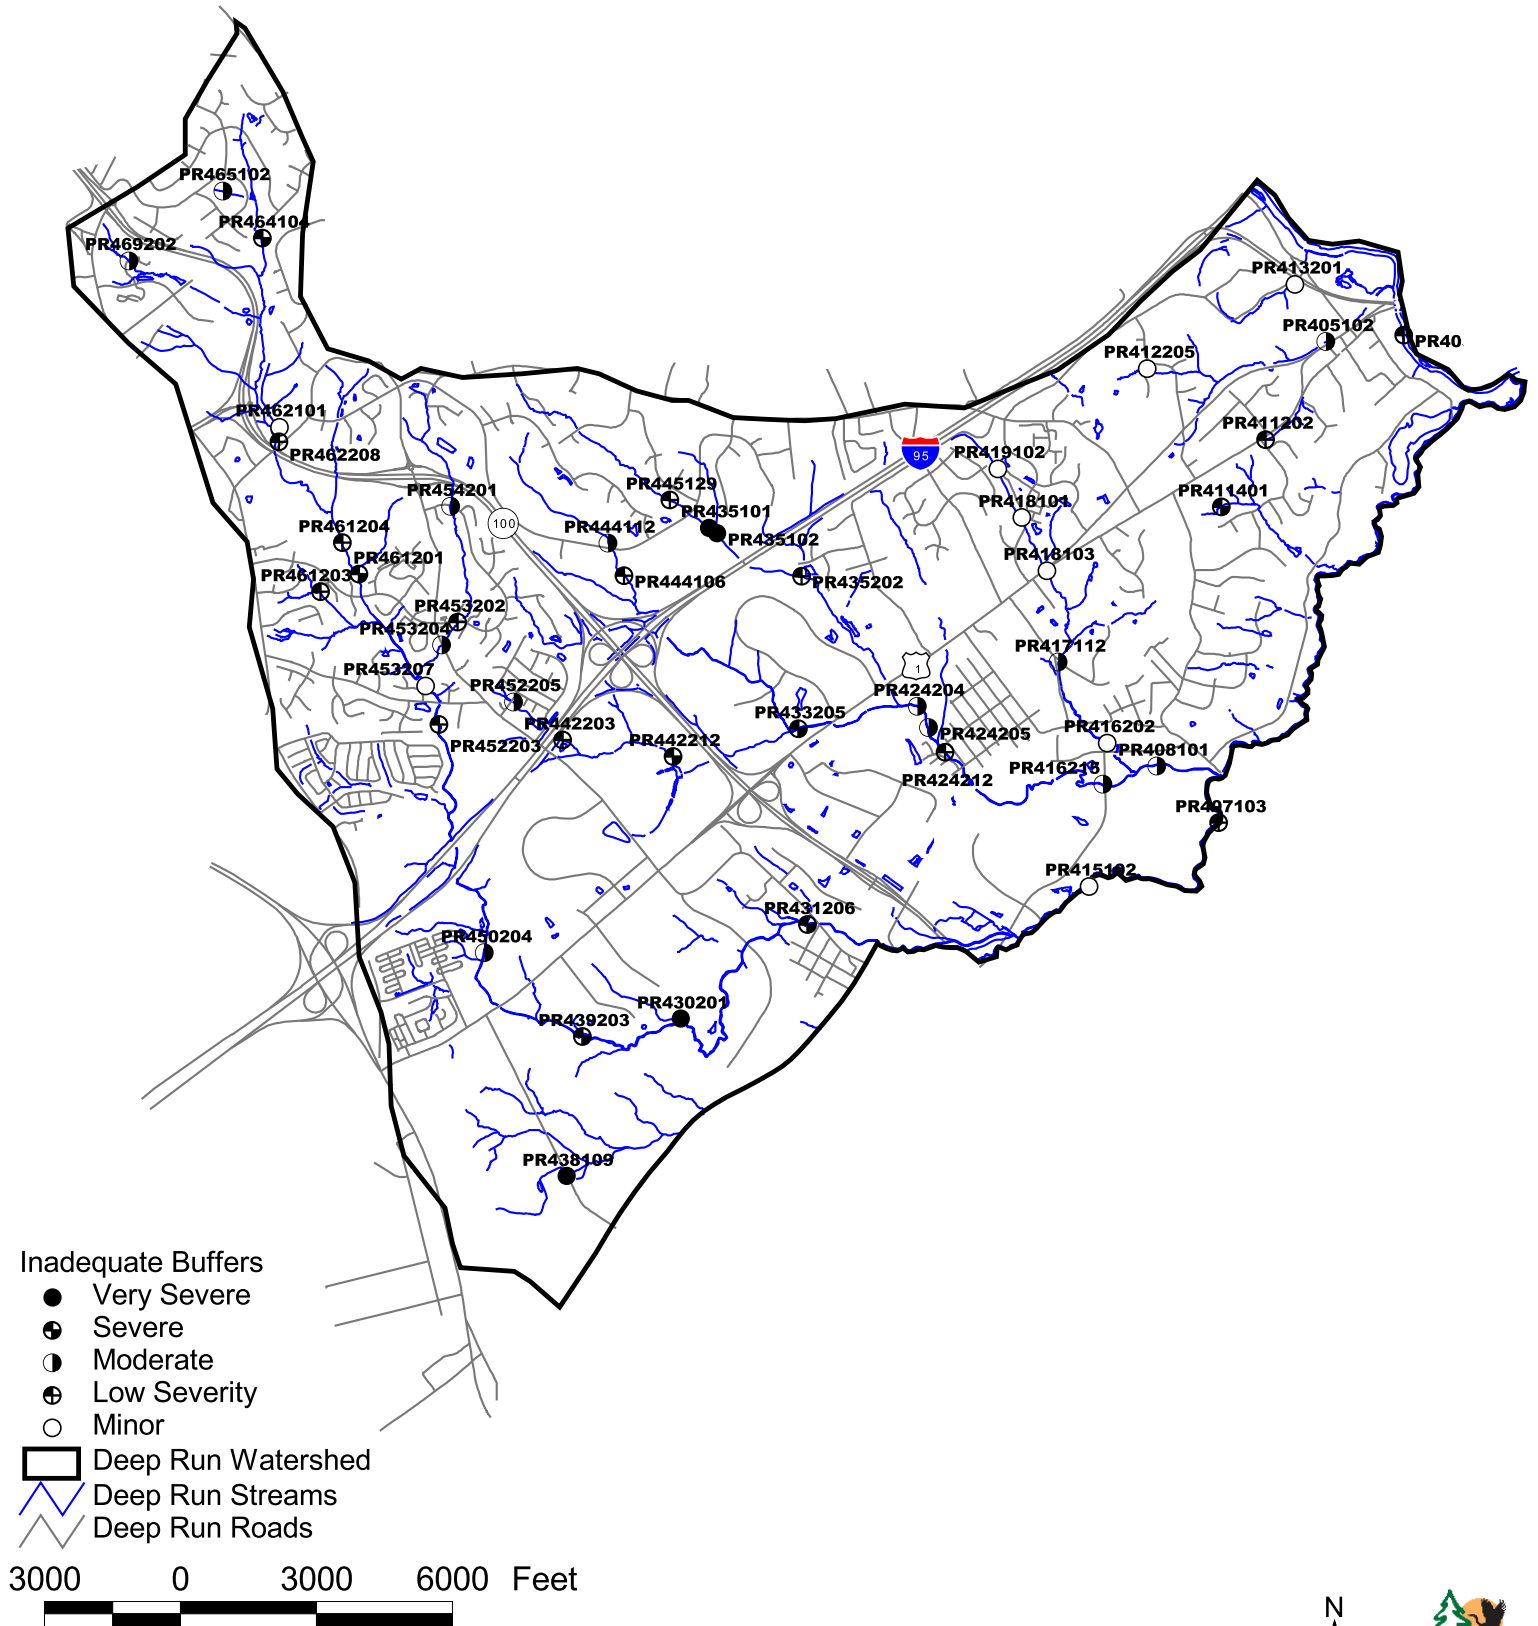
Figure 6b: Map showing the location of the Inadequate Buffers in Deep Run

While there is no single minimum standard for how wide a stream buffer should be in Maryland, for the purposes of this study a buffer is considered inadequate if it is less than 50 feet wide, measured from the edge of the stream. The survey crew identified 48 inadequate buffers sites (Figures 6b-c), and provided an estimate of the length of the inadequate stream buffer at all sites (Appendix B). Based on the collected data, there are approximately 45,600 feet (8.6 miles) of inadequate buffers.

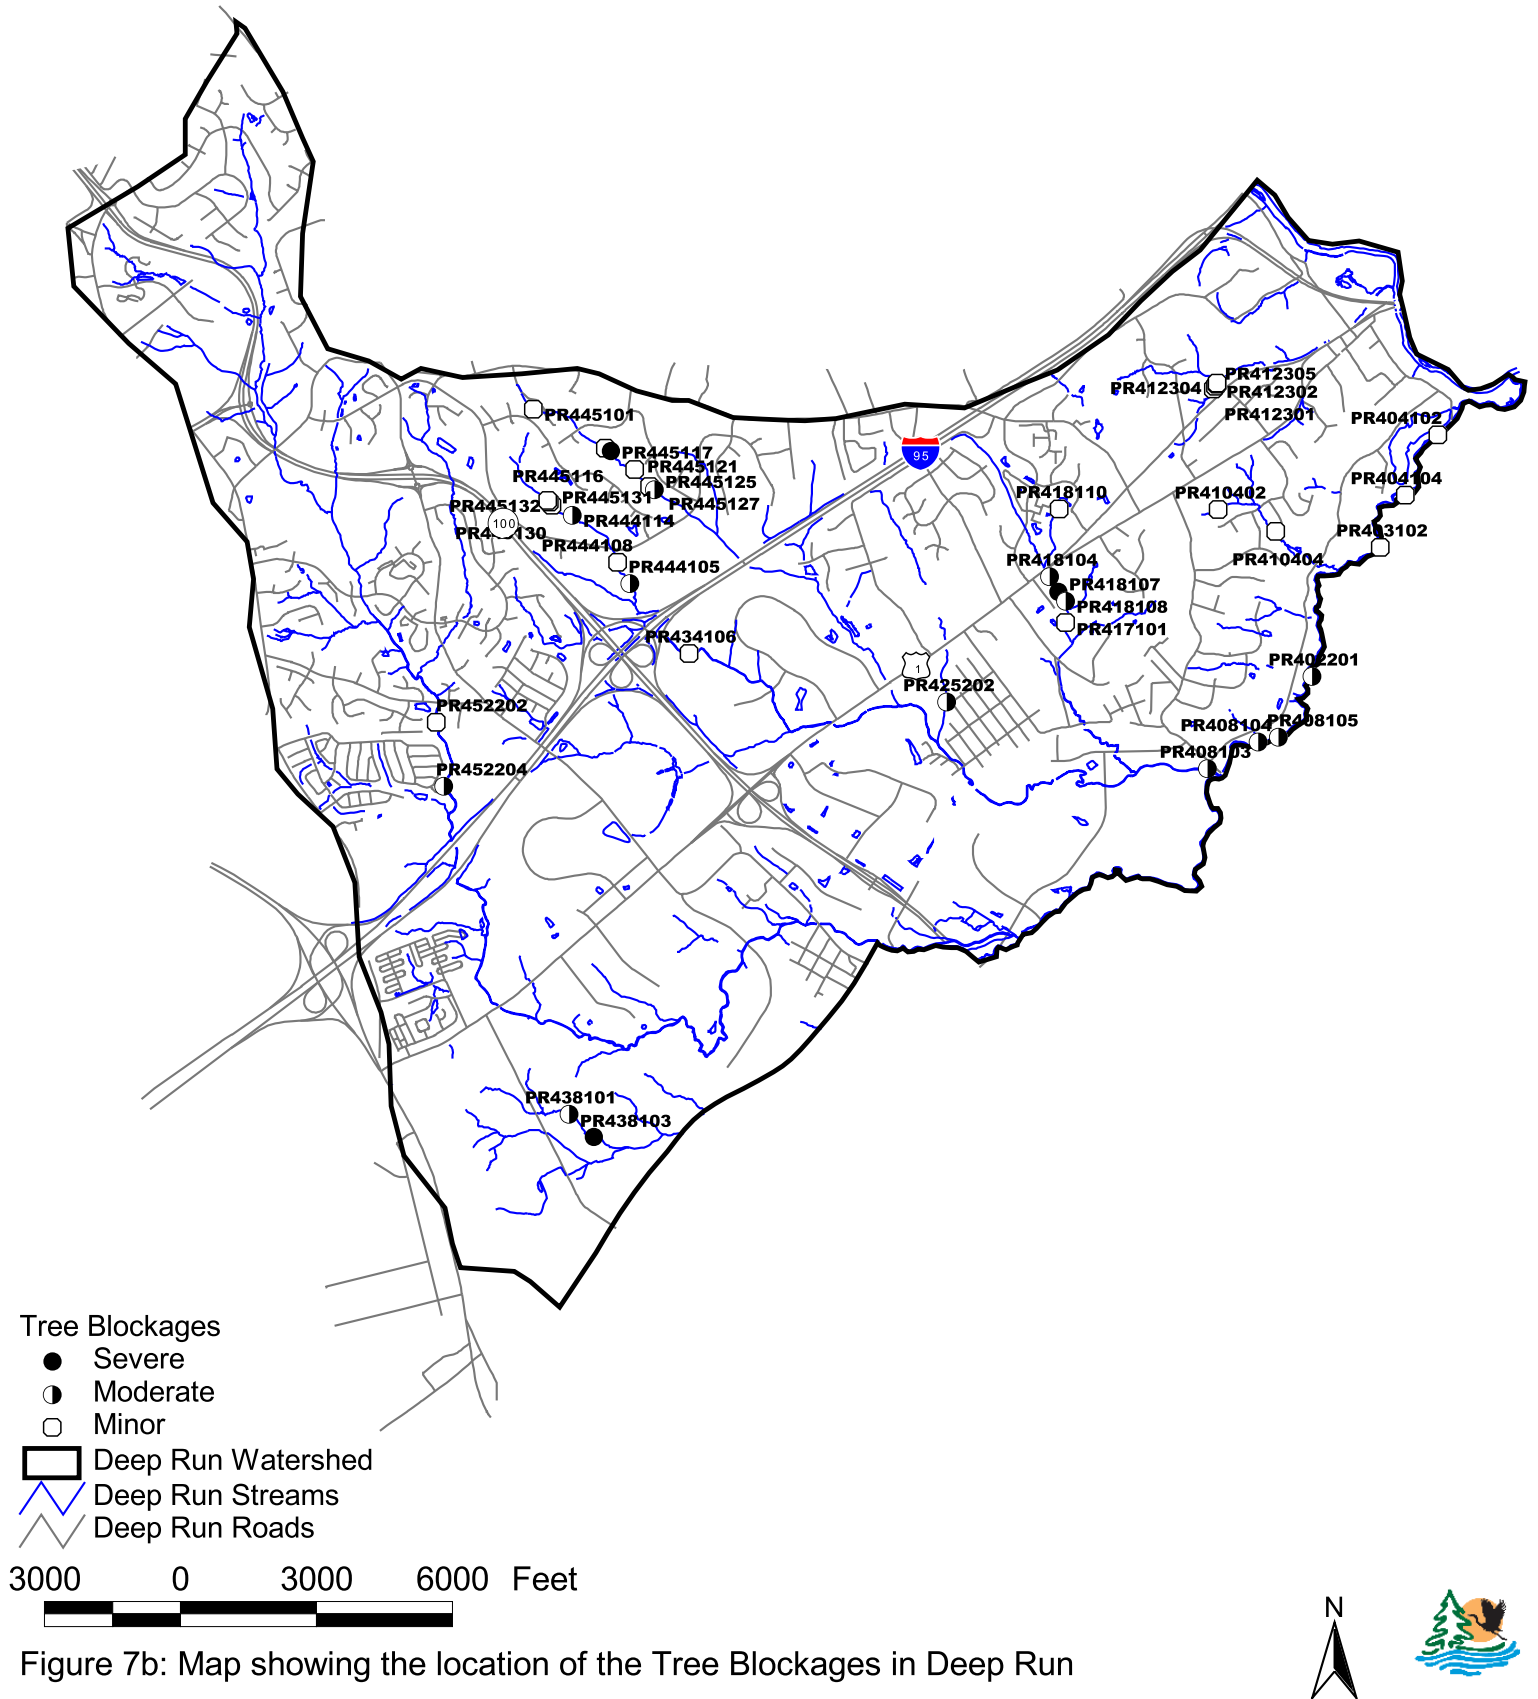
# Tree Blockages

The survey crew recorded 36 tree blockage sites. The locations of tree blockages are shown in Figure 7b. There are 12 sites with a severity rating of “moderate” and 21 sites rated as “minor.” Twenty of the recorded blockages have had some impact on the stream bank or bed and are collecting some amount of debris (32 sites).

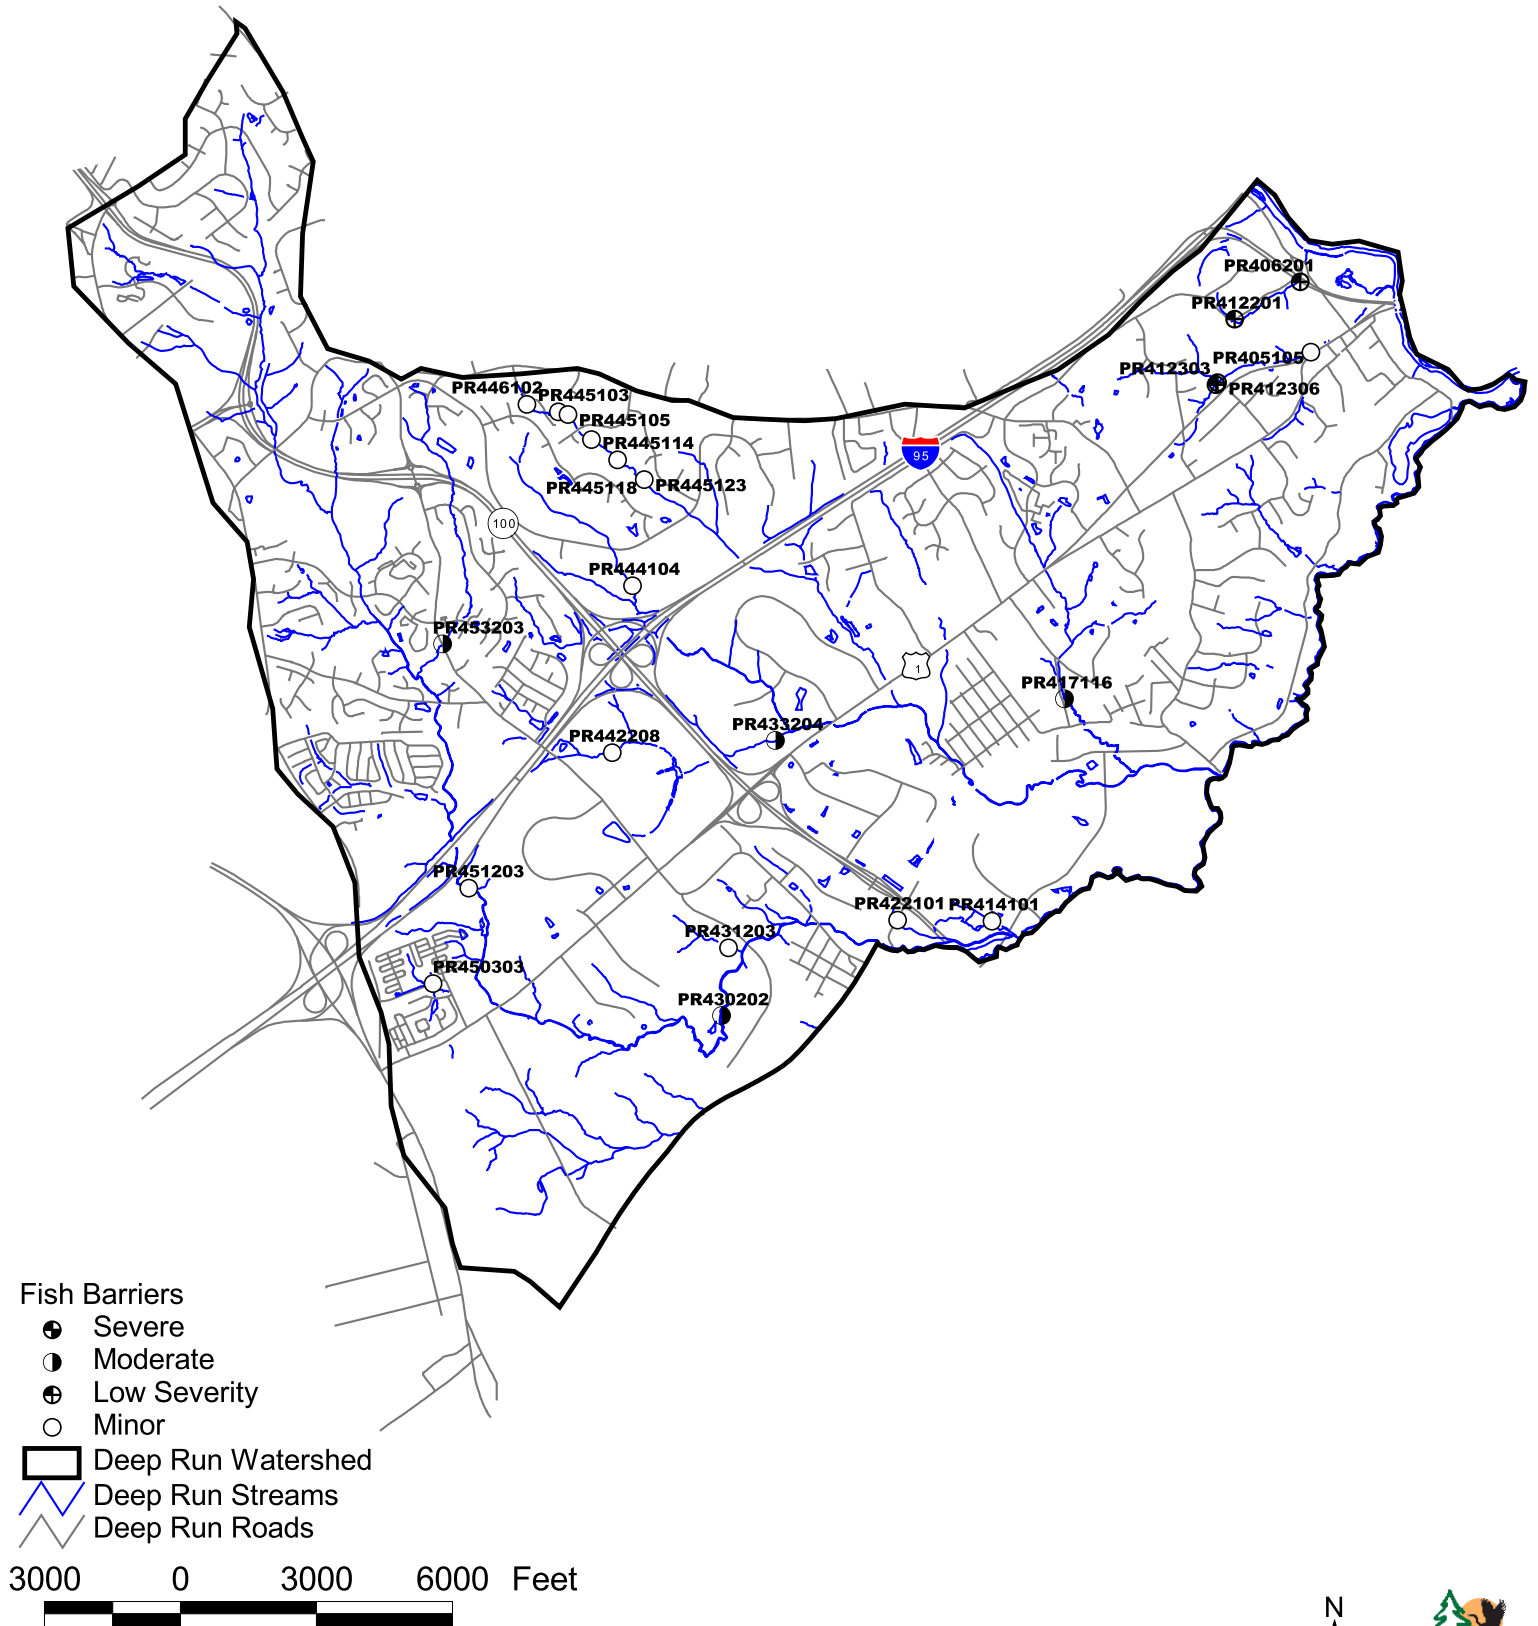
Figure 8b: Map showing the location of the Fish Barriers in Deep Run

The Patapsco SCA survey observed 23 fish migration barriers. The locations of fish blockages are shown in Figure 8b-c. The fish barriers are due to natural falls (5), road crossings (7), channelized stream sections (2), debris dams (5), Beaver dams (1), pipe crossings (1), and constructed dams (2). The majority of fish migration barriers are moderate to minor in severity, with one severe site recorded (Figure 8a). This site (PR317101) was located on the main stem approximately 600 feet below Route 40.

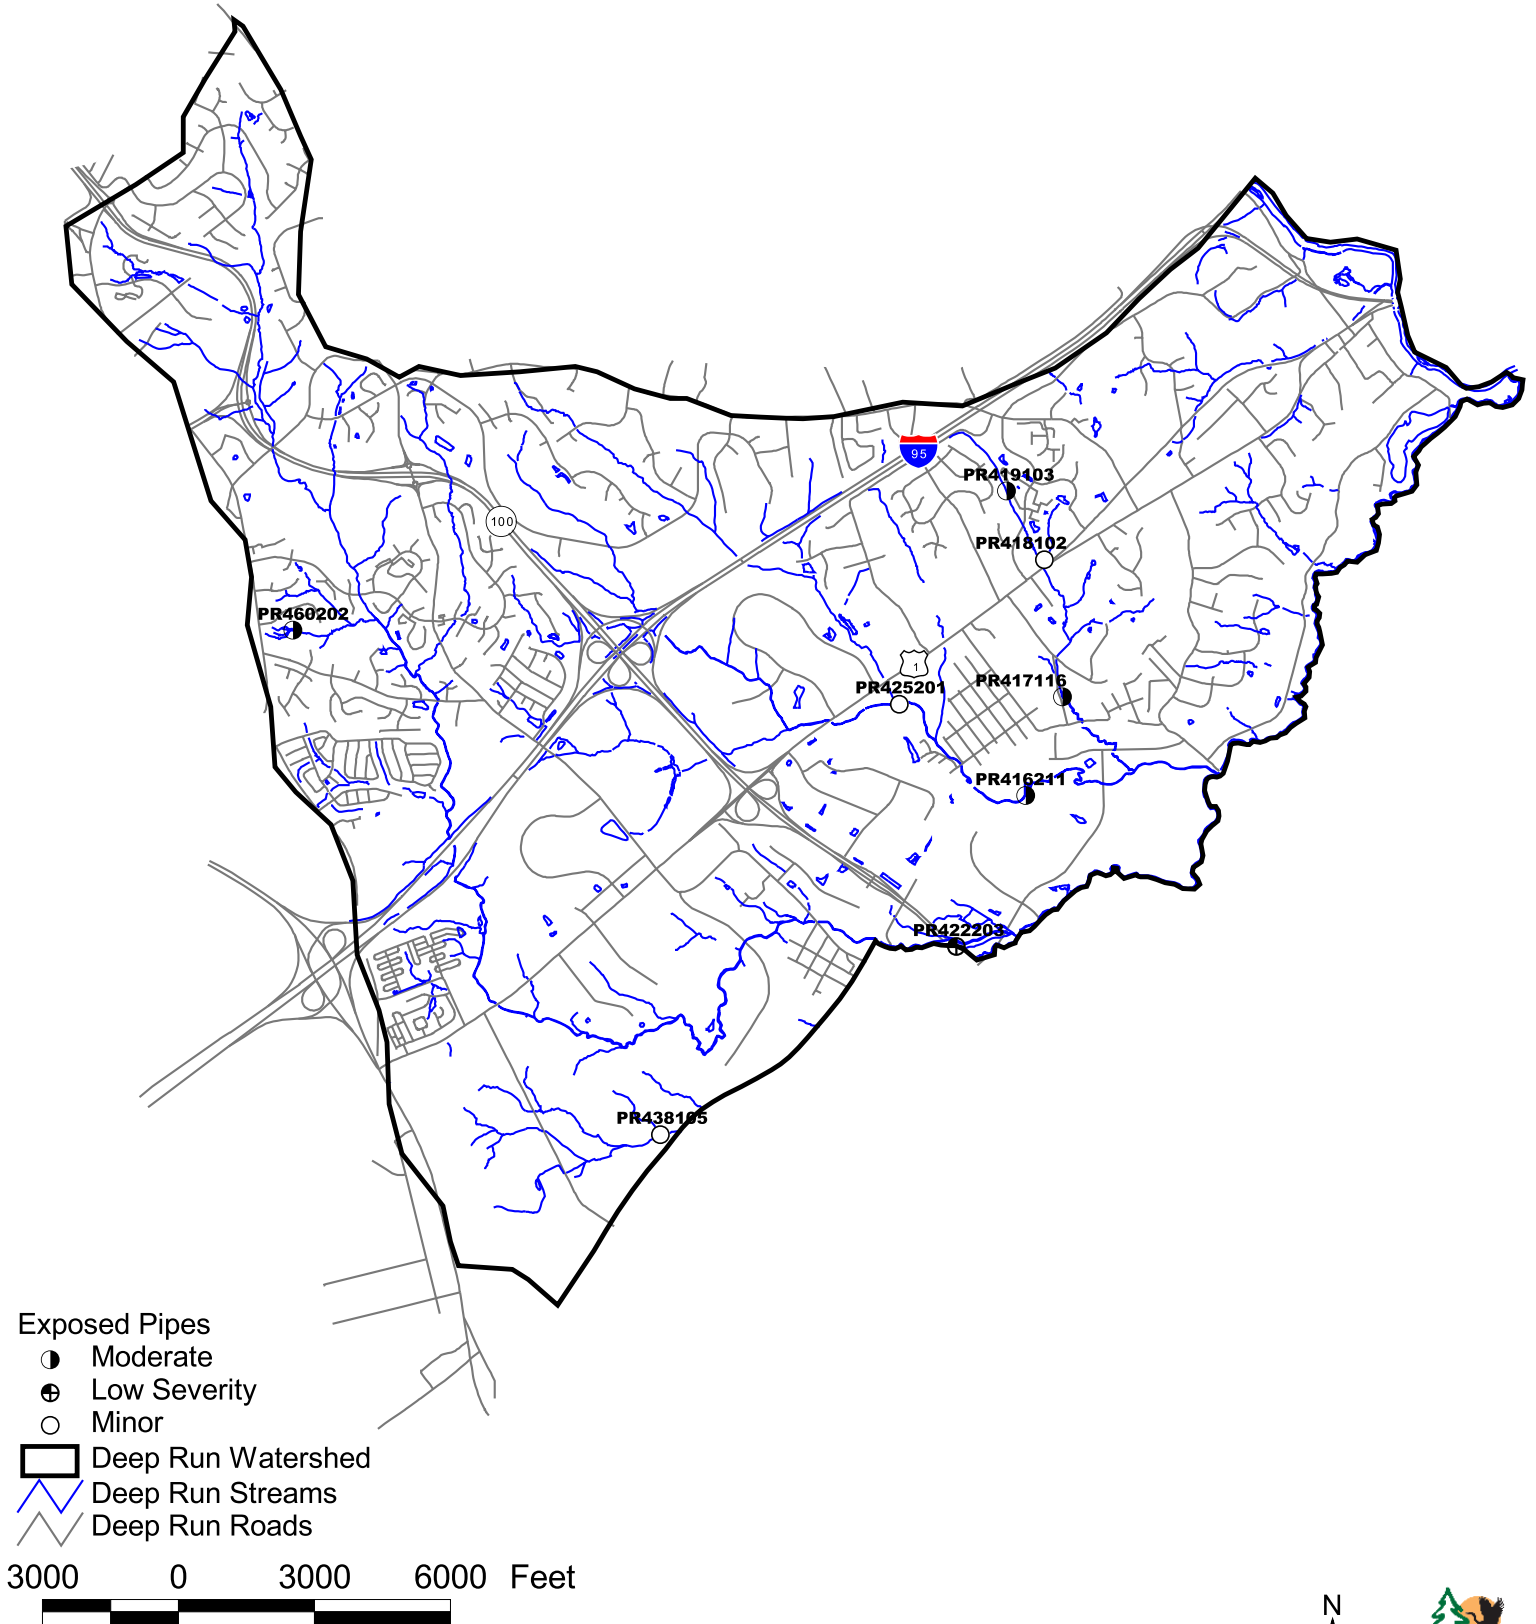
Figure 9b: Map showing the location of the Exposed Pipes in Deep Run

Field crews observed nine exposed pipes during the survey, all moderate to minor in severity (Figure 9a). Locations of these sites are shown in Figures 9a-b. Four pipes were recorded as being sewage. The remaining exposed pipes are recorded as unknown in purpose.

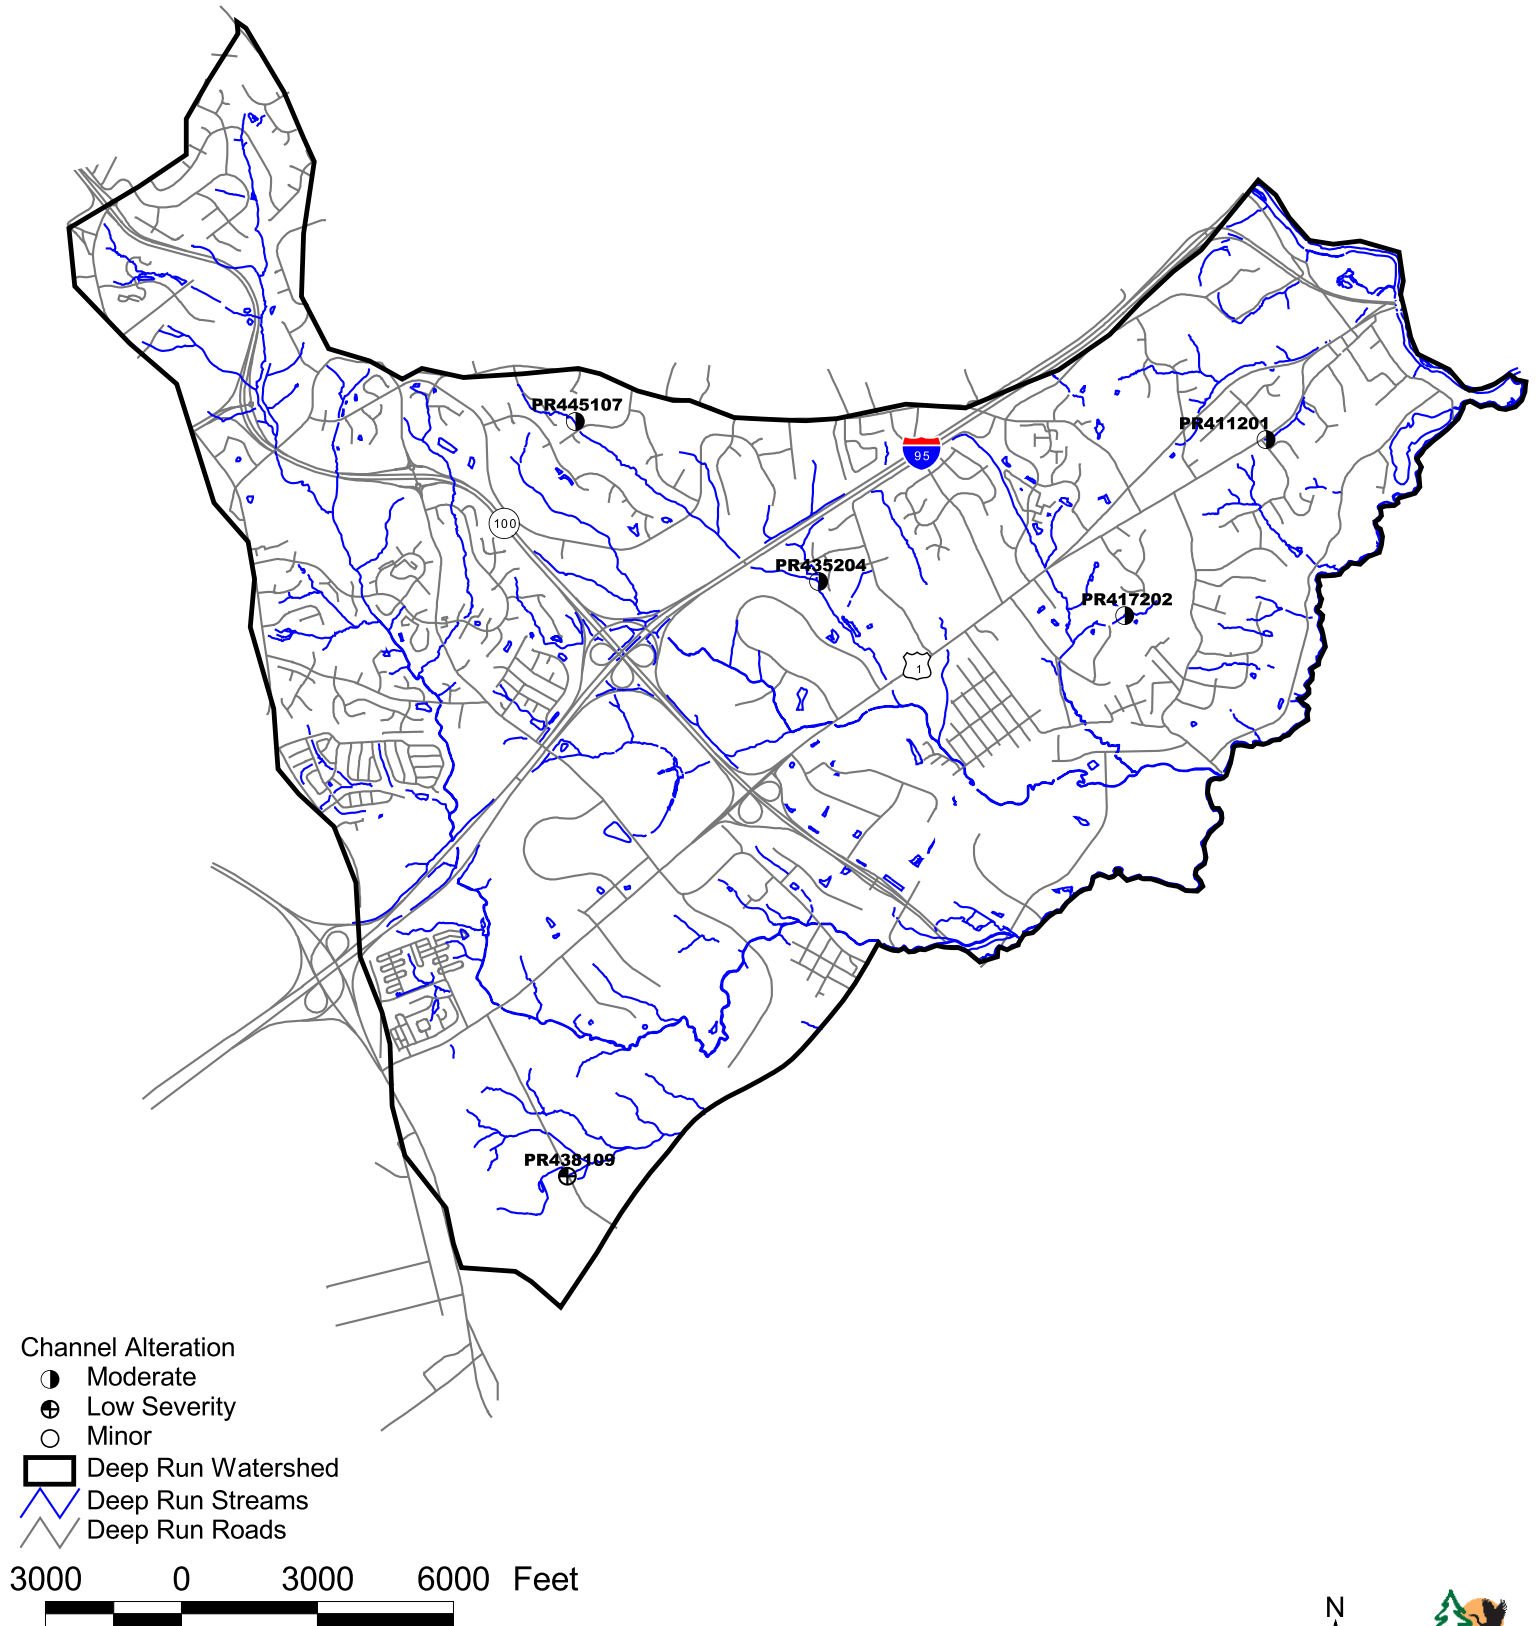
Figure 10b: Map showing the location of the Channel Alterations in Deep Run

Results of this survey show recognizably altered stream channels at seven sites. The severity and location of channel alterations are shown in Figure 10b-c. The total length of stream affected by channelization is estimated to be 2,580 feet (0.48 miles).

The channel alteration in this watershed is most often over a short stretch and constructed of a variety of materials, from concrete to earth channels. All of sites are rated as moderate to minor in severity (Figure 10a). These channel alterations are a made of earth channels, gabion baskets, rip-rap, and concrete.

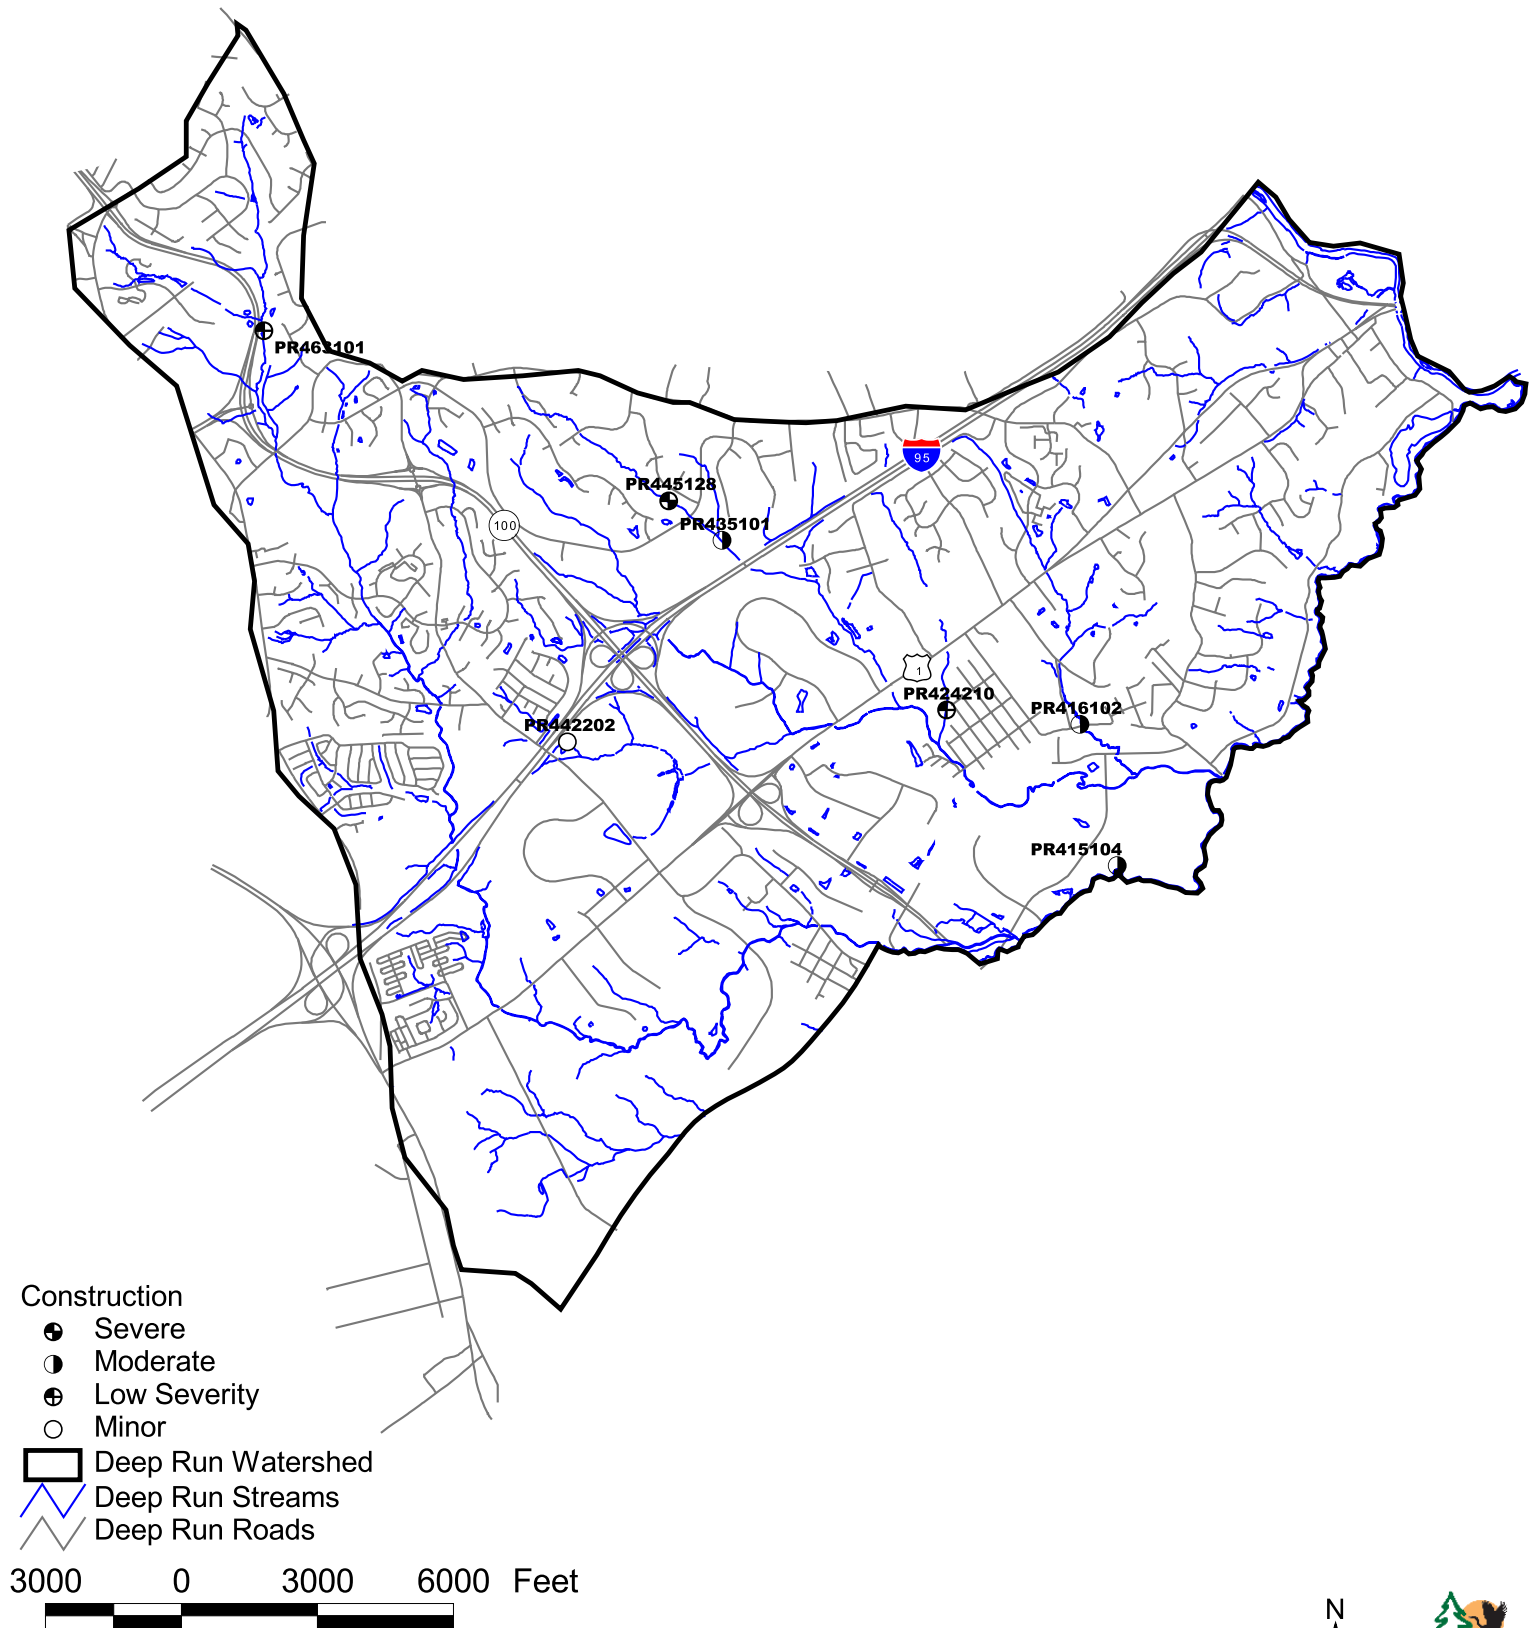
Figure 11b: Map showing the location of the Construction Sites in Deep Run

Seven construction sites affected a nearby stream during the time of the survey. Types of construction included: residential construction (2), a golf course (1), road crossings (2), industrial construction (1) and an unknown (1). All but one site was rated as moderate to minor in severity (Figure 11a).
