Maryland Department of Natural Resources  
Watershed Services  
Technical and Planning Services  
April 2005

# **DEEP RUN AND PATAPSCO RIVER STREAM CORRIDOR ASSESSMENT SURVEY In Howard County**

PREPARED BY  
Robin Pellicano and Kenneth T. Yetman

WATERSHED SERVICES  
TECHNICAL AND PLANNING SERVICES  
MARYLAND DEPARTMENT OF NATURAL RESOURCES  
ANNAPOLIS, MARYLAND

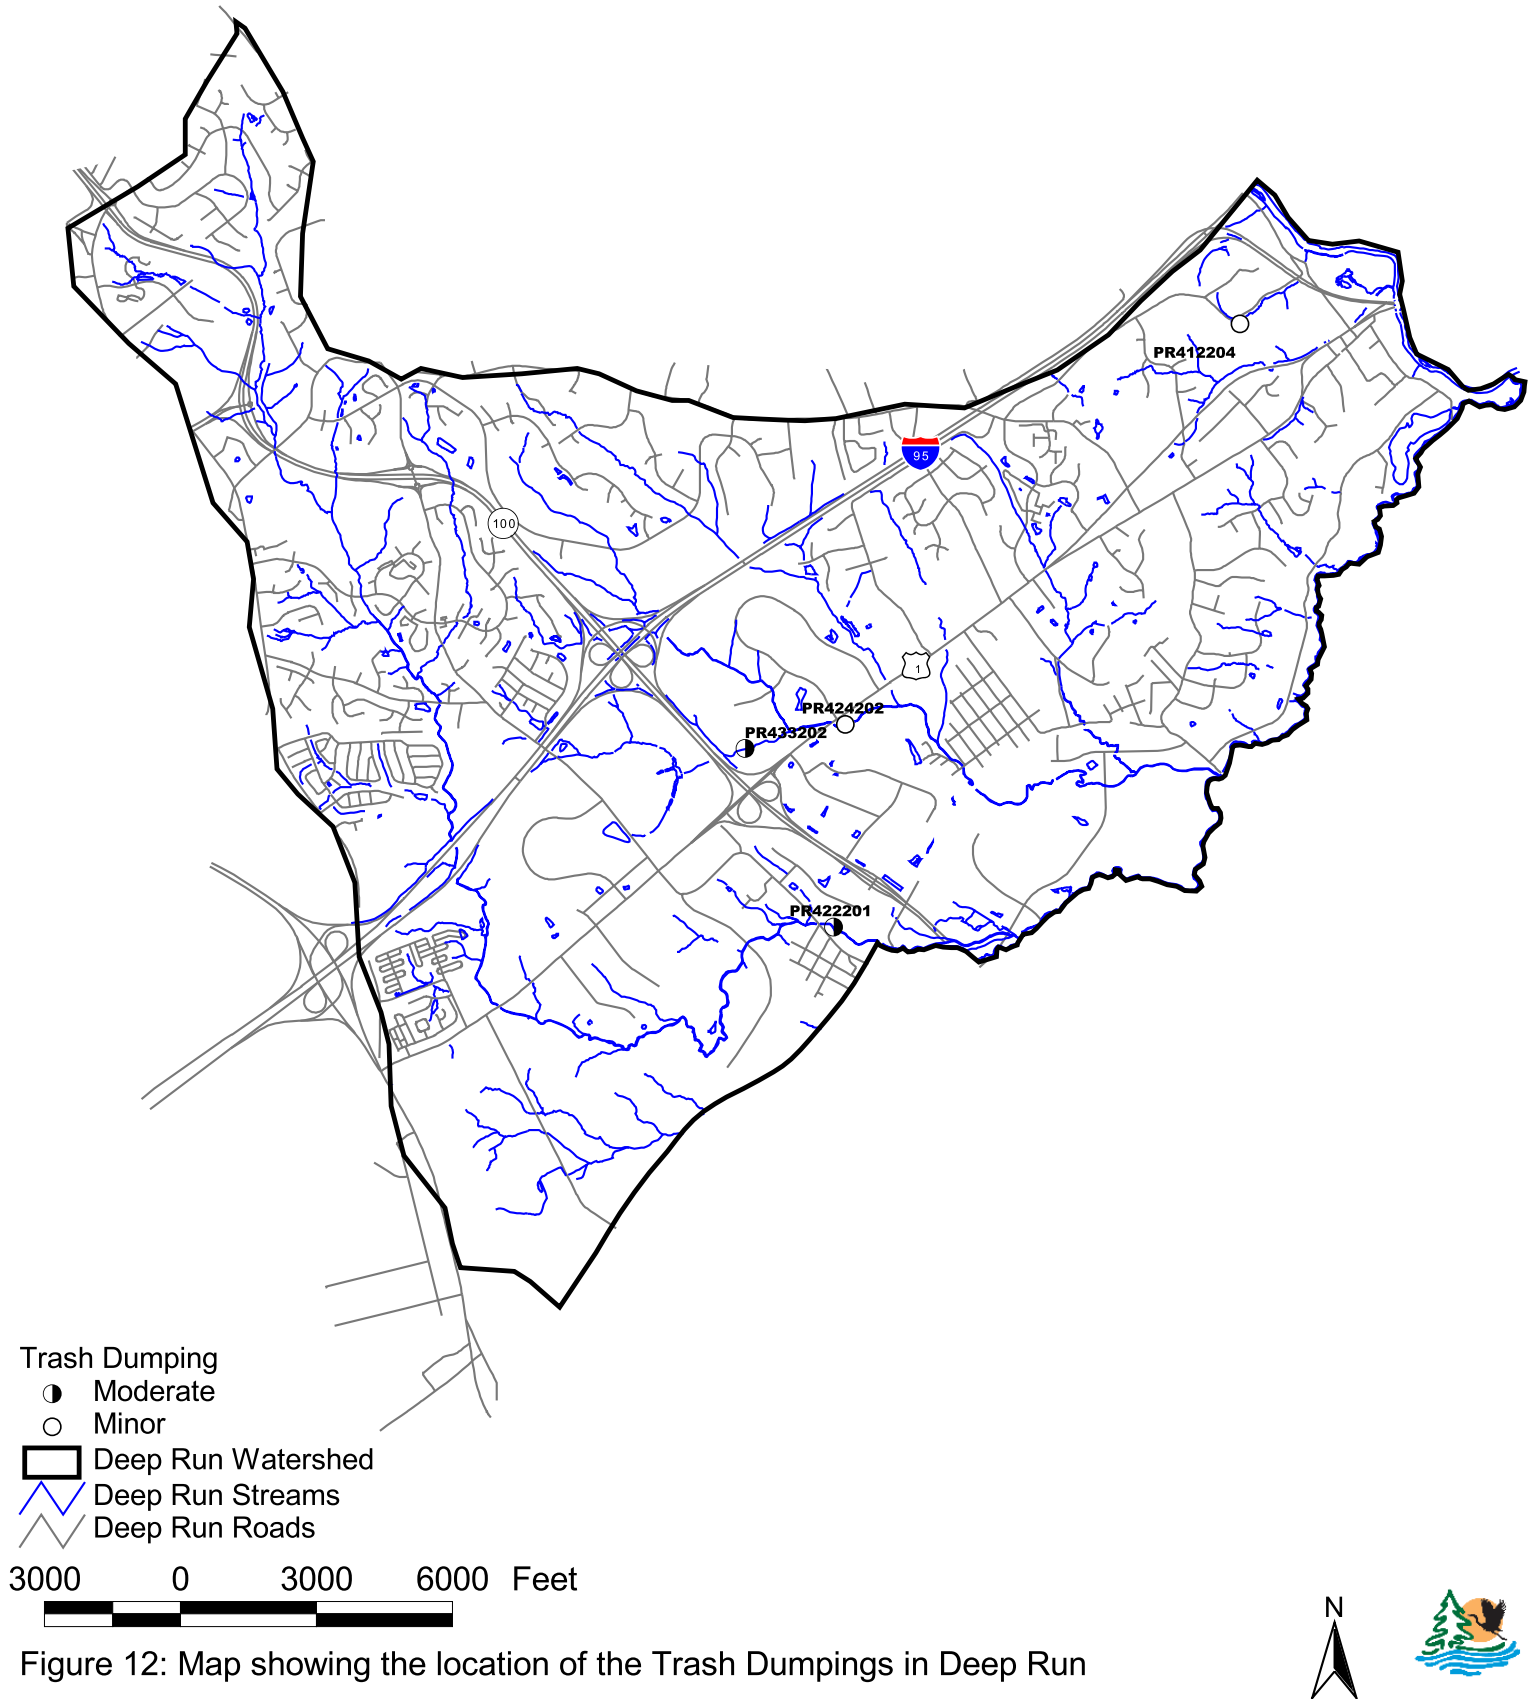
Figure 12: Map showing the location of the Trash Dumpings in Deep Run

Trash dumping sites are places where large amounts of trash are inside the stream corridor, either as a site of deliberate dumping or as a place where trash tends to accumulate (often a result of storm drainage). The field survey crew found four trash dumping sites; locations are listed in Figure 12.

The types of trash sites present during the survey were all residential waste. All the sites were moderate to minor. Three of the four sites could be considered for volunteer clean-up projects within the county (Appendix B).

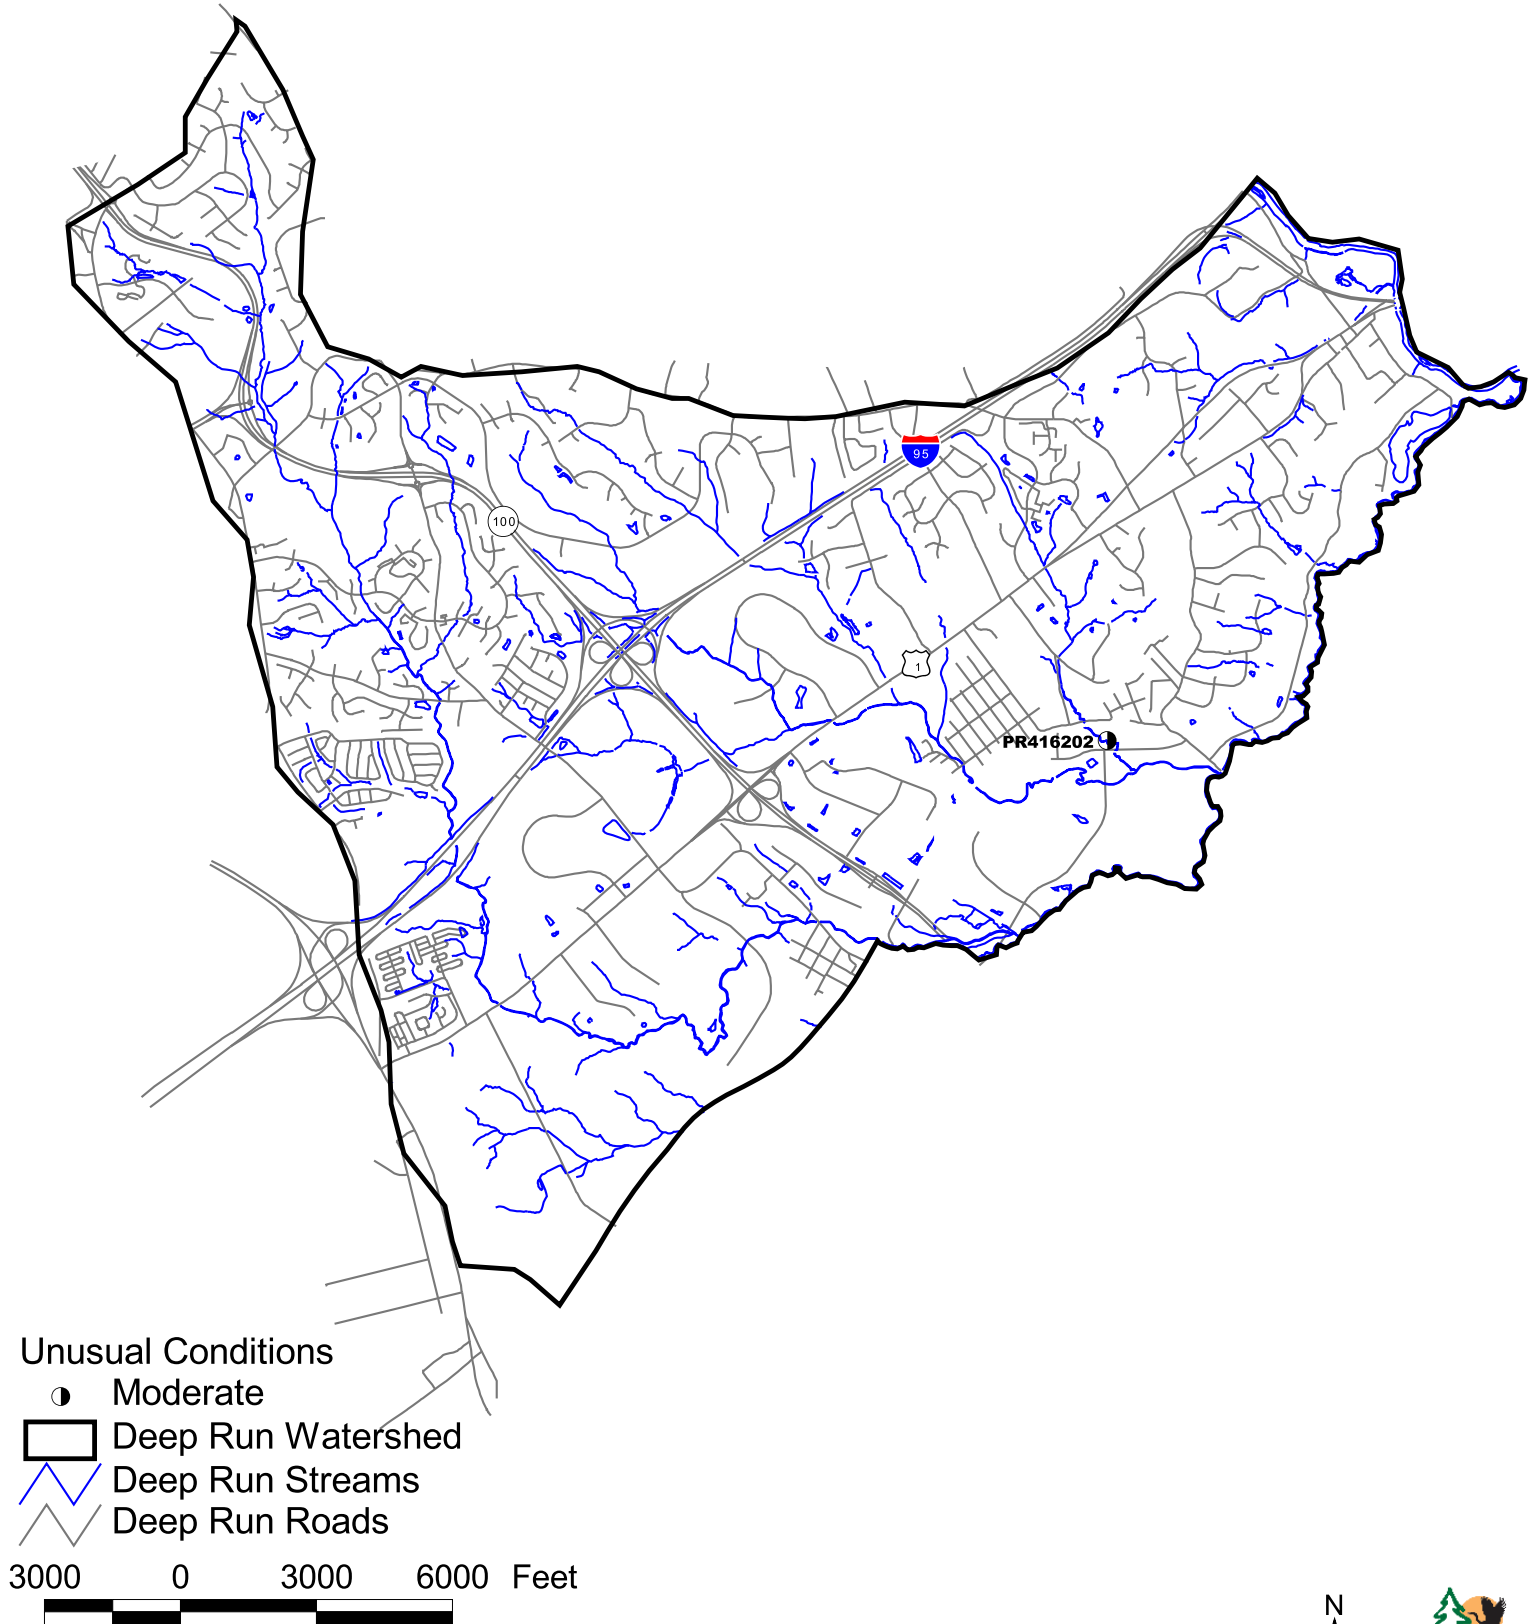
Figure 13: Map showing the location of the Unusual Conditions in Deep Run

Survey teams record unusual conditions or comments to note the location of anything out of the ordinary observed during the survey or to provide additional written comments on a specific problem site. The survey crew identified one unusual condition site during the survey (Figure 13). It was moderate in severity. There were concrete road barriers in stream. They could have been placed for bank protection but they are now located in the middle of the stream.

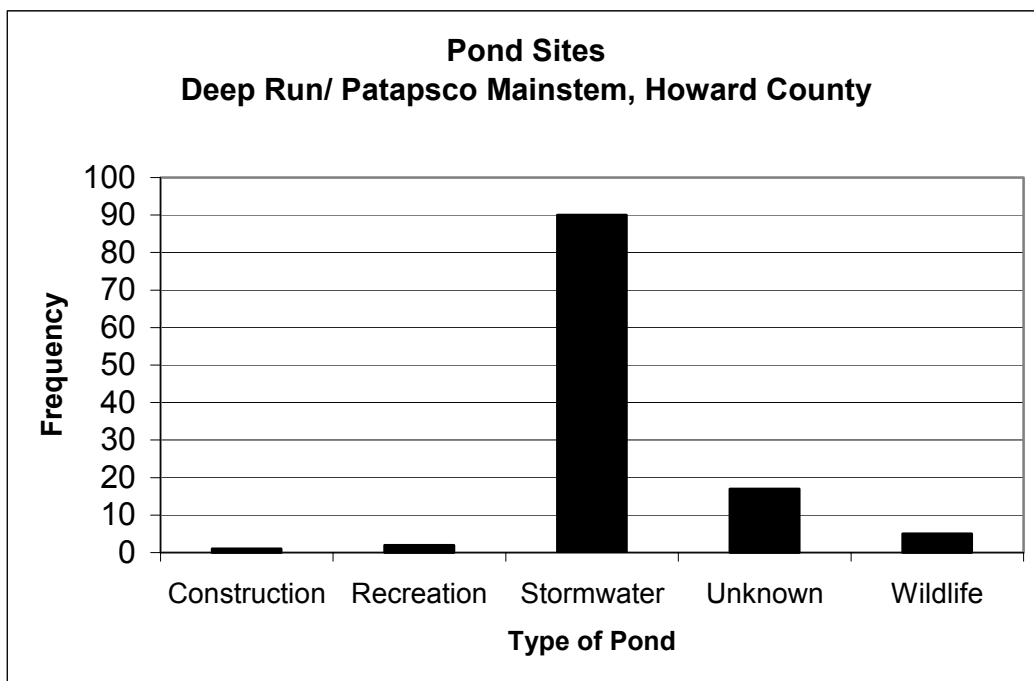
One hundred and fifteen pond sites are recorded from this survey, and their locations are shown in Figures 14b. The majority of the watershed's ponds (90) are stormwater ponds (Figure 14a). Of these, seven are recorded as not maintained or abandoned (Appendix B).

**Figure 14a. Histogram showing the number of pond types given to pond sites during the Patapsco SCA survey in Howard County**

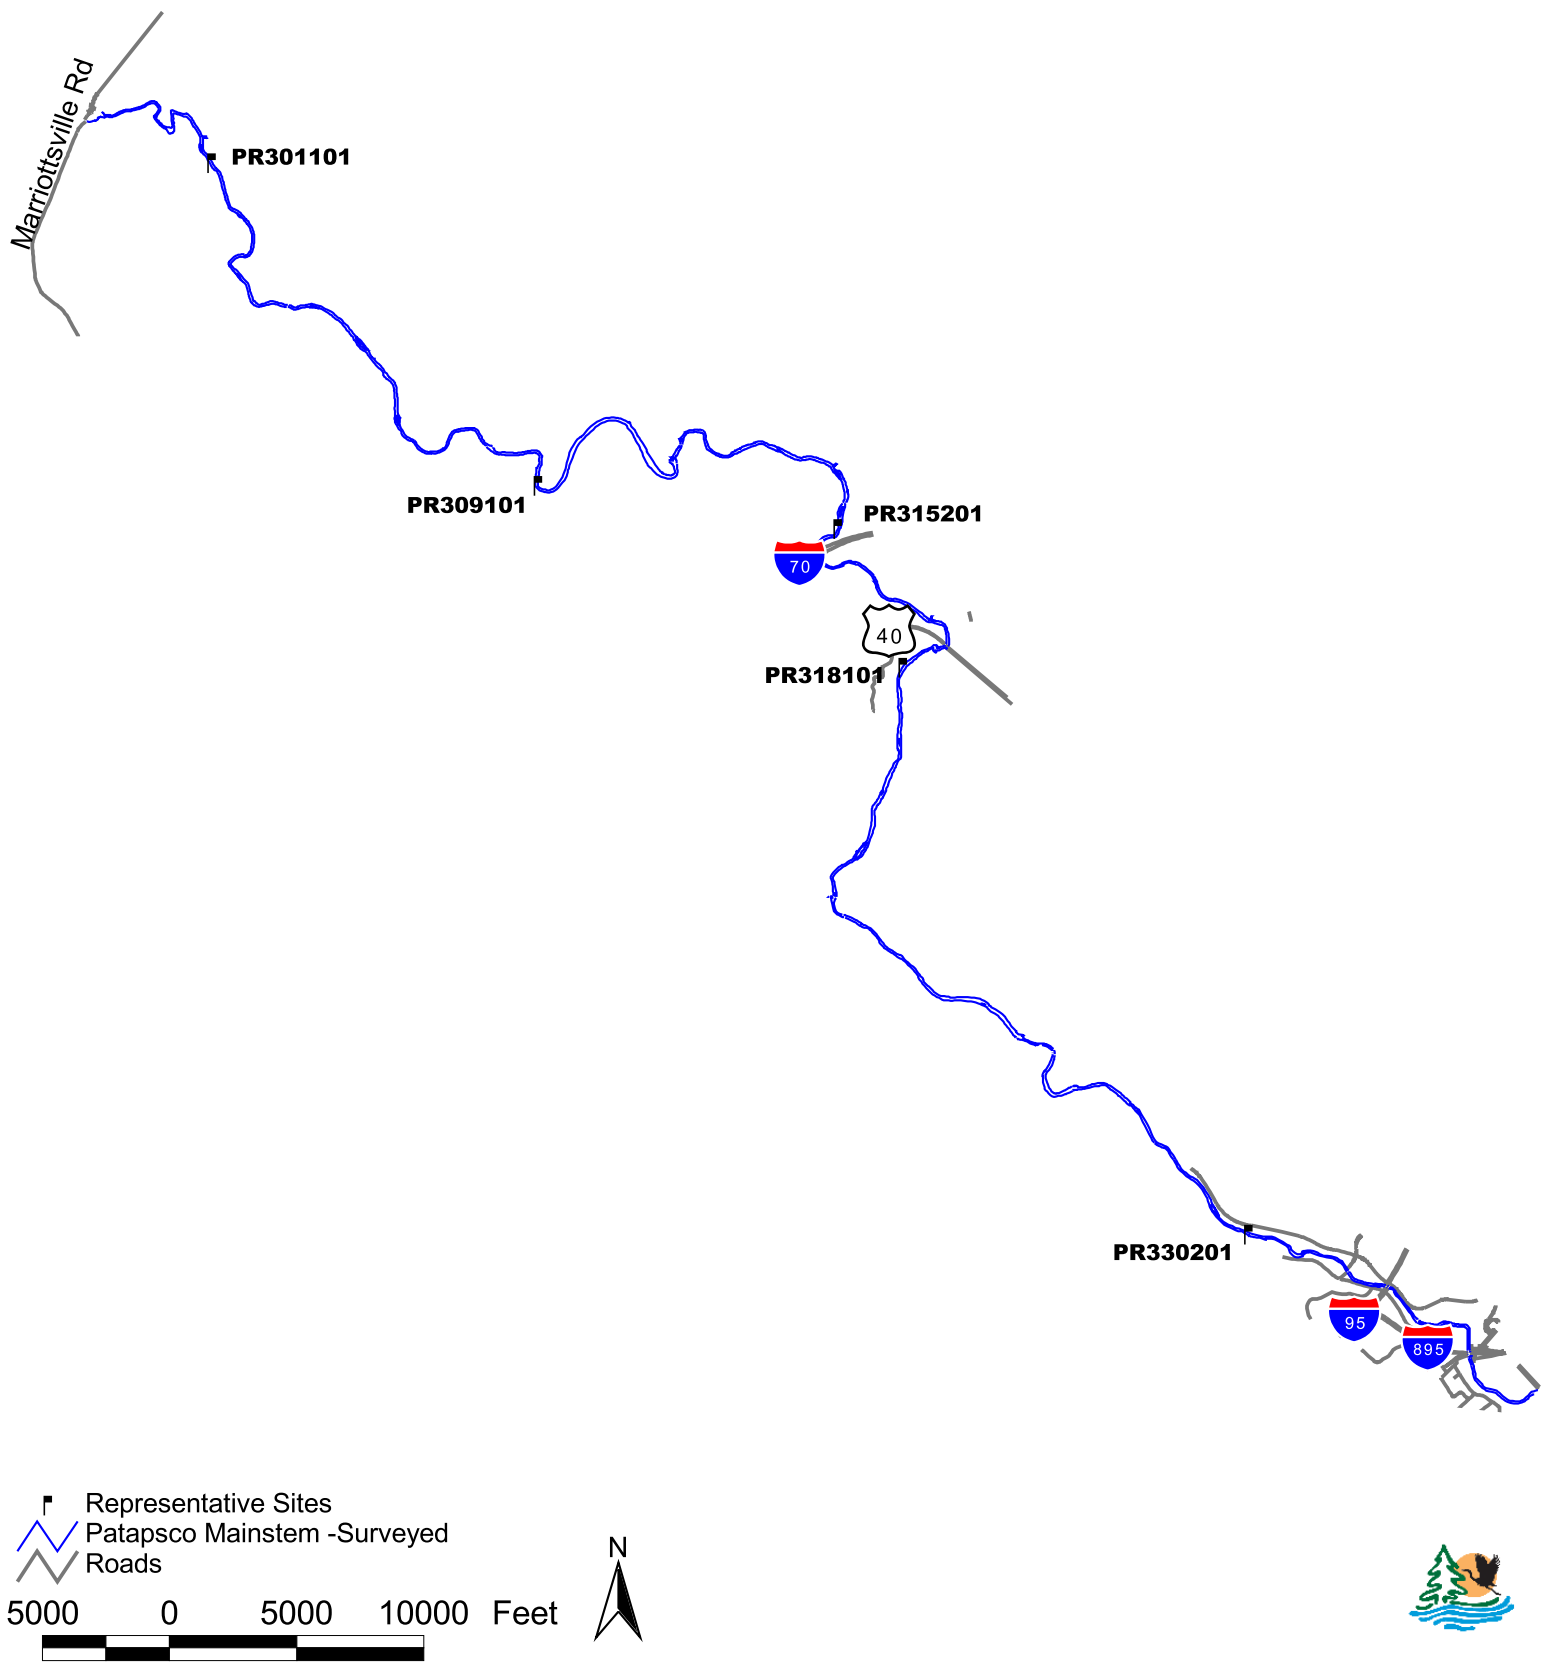
Figure 15c: Map showing the location of the Representative Sites on the surveyed Patapsco Mainstem

In the main stem of the Lower North Branch of the Patapsco the macroinvertebrate substrata was mostly optimal. The shelter for fish was optimal. Channel alteration was rated to be optimal. Sediment Deposition was rated as suboptimal. There are several areas where bars have formed. The bank condition was found to be mostly stable along the main stem and it was found to be mostly adequately buffered.
