## **SECTION 3 STUDY METHODS AND ASSESSMENT RESULTS**

This section details the results of the fieldwork associated with the Centennial and Wilde Lake Restoration Plans, which includes the Unified Stream Assessment (USA), Unified Subwatershed and Site Reconnaissance (USSR), subwatershed retrofitting, and lake shoreline assessments. Detail includes the areas assessed, a summary of data findings, and associated mapping.

### **3.1 STREAM ASSESSMENT**

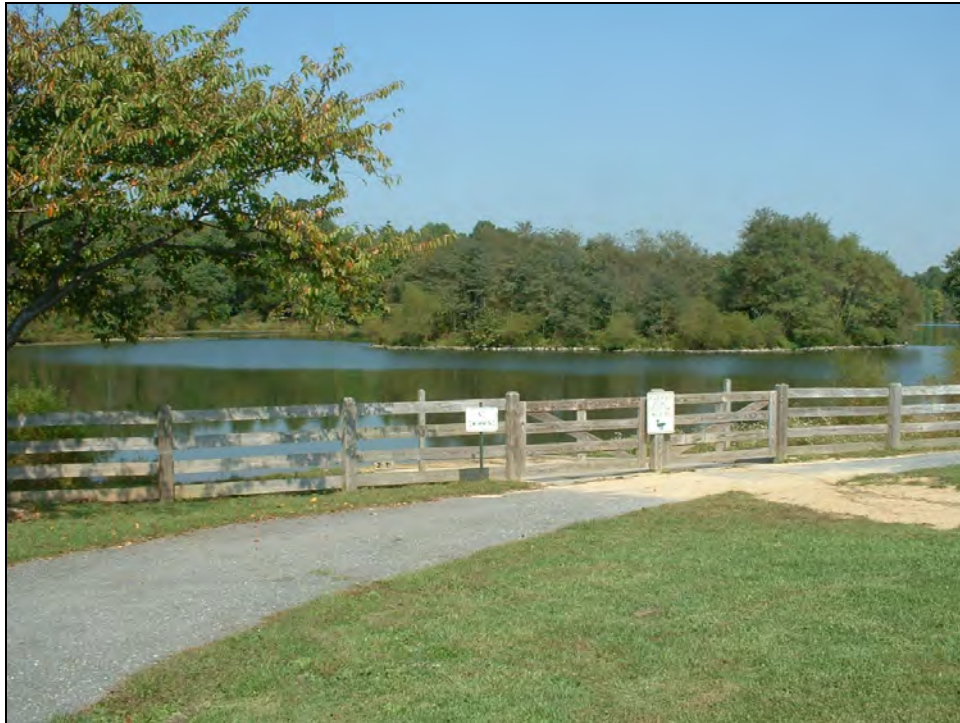
The presence of large numbers of waterfowl can negatively affect both the lake water quality and the quality of the shoreline buffer, as many waterfowl trample and feed on the shoreline vegetation. Waterfowl droppings on the shoreline are washed directly into the lake, contributing to the excessive nutrient loading. The County has made numerous efforts to encourage waterfowl to migrate elsewhere or to exclude them from certain areas of the park. Fencing, such as that shown in Figure 3.20, has been relatively successful in excluding waterfowl from portions of the shoreline buffer. The remaining exception to this is the large hill tract adjacent to the boat ramp areas (parallel to outfall #2) on the south side of the lake that is managed in turf grass and contains extensive evidence of goose fecal matter.

**Figure 3.20** Goose exclusion fencing.
