# Tiber-Hudson & Plumtree Branch Stream Corridor Assessment 2012

Tiber-Hudson and Plumtree Branch Stream Corridor Assessment

S&S Planning and Design, LLC.

12/12/2012

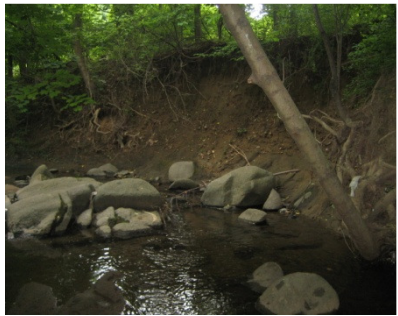
**Point # 1048**  
**Location:** -76.815140 39.270648  
Description: Erosion site. High bank, outside meander.

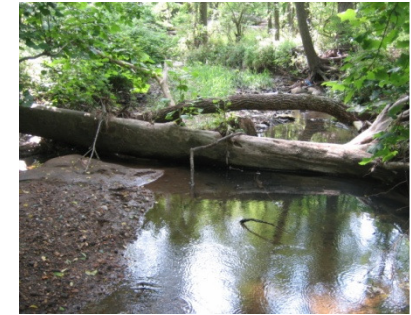
**Point # 1045**  
**Location:** -76.813976 39.270581  
Description: Debris blockage. Fallen sycamore across channel.

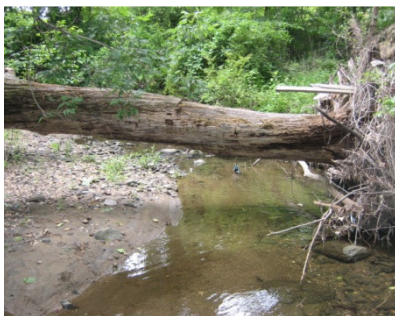
**Point # 1047**  
**Location:** -76.814724 39.270583  
Description: Debris blockage. Tree across channel. Tree is ~24" DBH and ~ 2' above water surface.

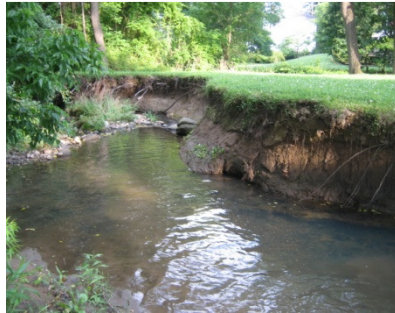
**Point # 1063**  
**Location: -76.820501 39.272305**  
Description: Erosion site. Mowed lawn up to top of bank.

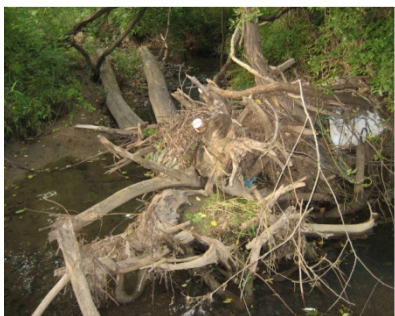
**Point # 1062**  
**Location: -76.820210 39.272175**  
Description: Debris blockage. Twin bole root wad in middle of channel.

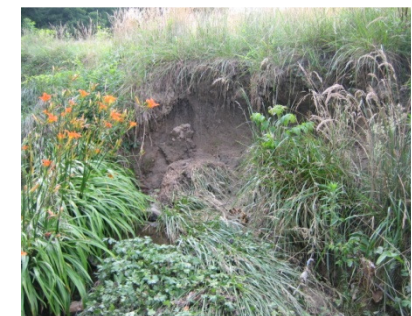
**Point # 1060**  
**Location: -76.819545 39.271980**  
Description: Erosion site. Lack of vegetation.

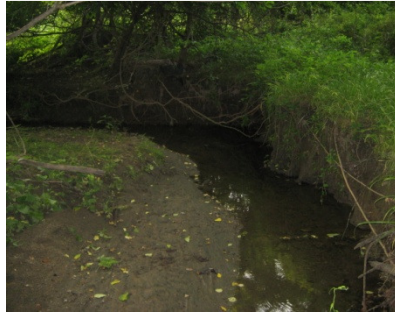
**Point # 1074**  
**Location:** -76.821125 39.272177  
Description: Erosion site. Outside meander.

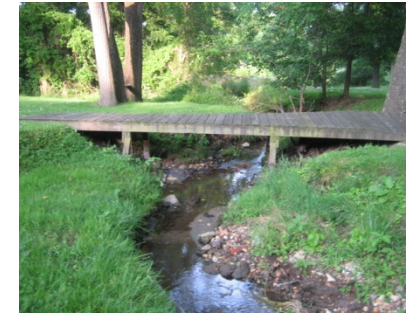
**Point # 1071**  
**Location:** -76.820460 39.272208  
Description: Road crossing. Foot bridge on small tributary.

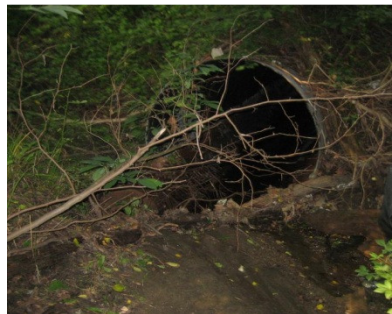
**Point # 1073**  
**Location:** -76.820834 39.272047  
Description: Debris blockage. Debris and sediment built up at inlet.

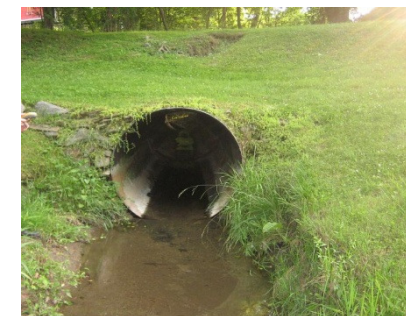
**Point # 1072**  
**Location:** -76.820626 39.272273  
Description: Road crossing. Pipe culvert.

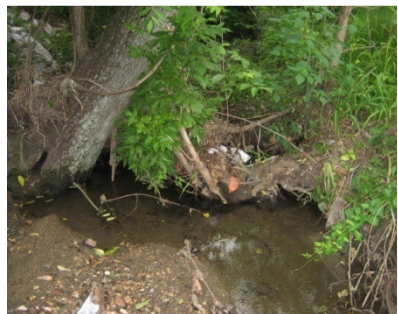
**Point # 1077**  
**Location: -76.821750 39.271887**  
Description: Debris blockage. Leaning tree and root ball blocking channel.

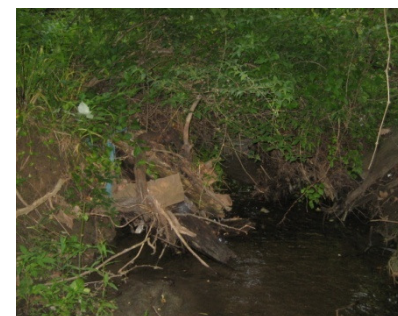
**Point # 1075**  
**Location -76.821333 39.272209**  
Description: Debris blockage. Various debris in channel.

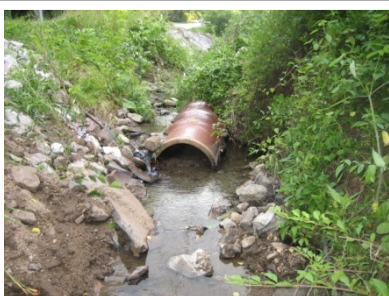
**Point # 1078**  
**Location: -76.822124 39.271855**  
Description: Old pipe in channel.

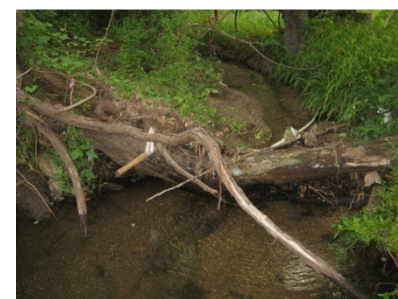
**Point # 1076**  
**Location: -76.821417 39.272015**  
Description: Debris blockage. Tree across channel, backing up sediment.

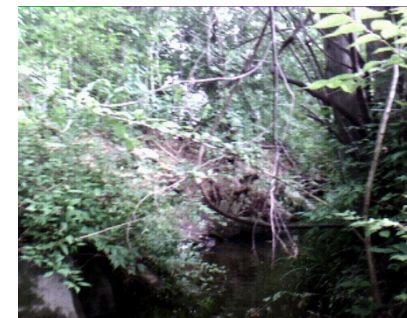
**Point # 104**  
**Location** -76.840632 39.279754  
Description: Bank height transition point. 4-6 ft banks to 8 ft banks.

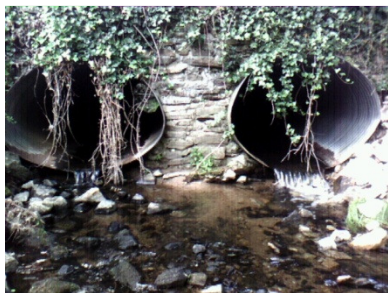
**Point # 102**  
**Location:** -76.840877 39.279324  
Description: Road crossing. Stacked stone headwall, ~8 feet above culvert inlet.

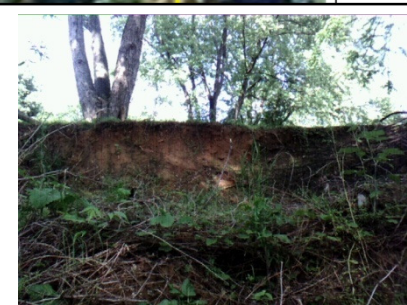
**Point # 103**  
**Location:** -76.840812 39.279274  
Description: Erosion site. Appears to have taken out a split rail fence.

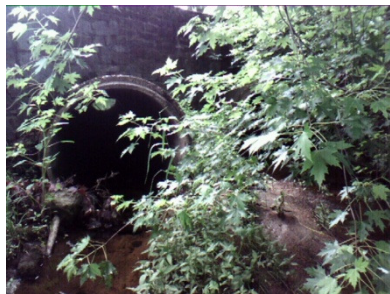
**Point # 111**  
**Location: -76.841346 39.280958**  
Description: Minor debris in right cell, excessive point bar formation with heavy vegetation immediately upstream of inlets of both cells. Stacked stone headwalls, ~8' above invert.

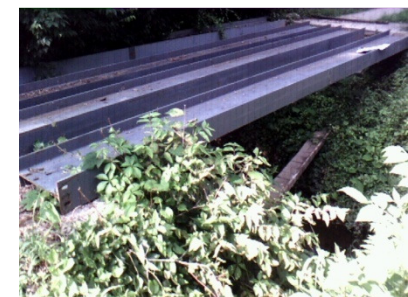
**Point # 109**  
**Location: -76.841102 39.280692**  
Description: Road crossing. Destroyed bridge, just abutments and beams left. 19'W x 102"L.

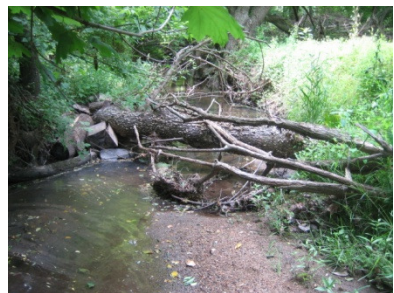
**Point # 115**  
**Location -76.840667 39.278438**  
Description: Potential debris blockage.
