Assessing the Rockburn Branch Subwatershed of the Lower Patapsco River for Restoration Opportunities

Prepared for:
Howard County, Maryland
Department of Public Works
Bureau of Environmental Services
NPDES Watershed Management Program

Prepared by:
JoAnna Lessard and Sam Stribling, Tt

January 23, 2006
Final Draft

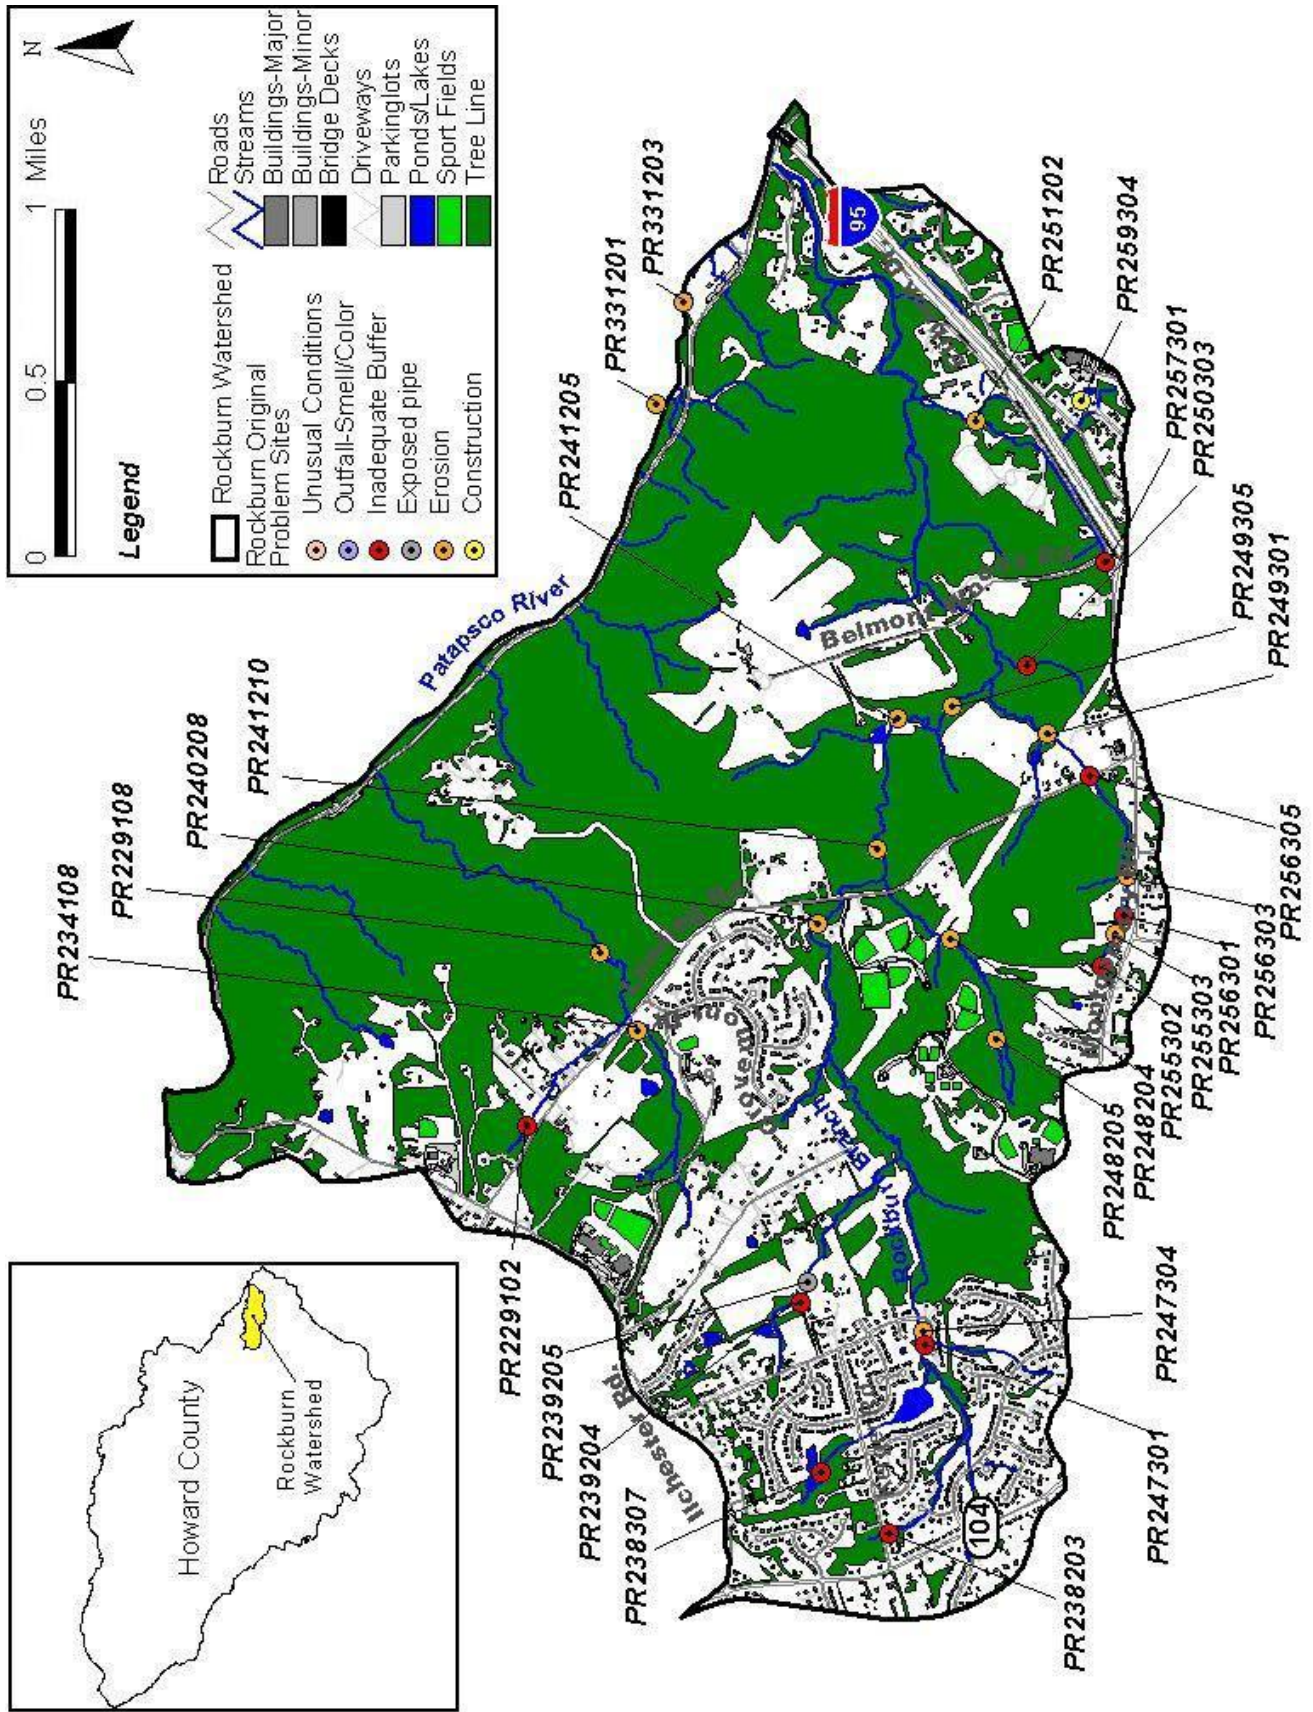
Figure 2. Rockburn Branch Subwatershed problem site locations and types from the SCA

Priority Problem Type	Number of Sites
Erosion	15
Inadequate buffer	10
Exposed Pipe	1
Construction Site	1
