PATUXENT RIVER

BRIGHTON DAM, ROCKY GORGE DAM, AND PATUXENT RIVER UPPER WATERSHED ASSESSMENT

January 2017

KCI Technologies
936 Ridgebrook Rd
Sparks, MD 21152

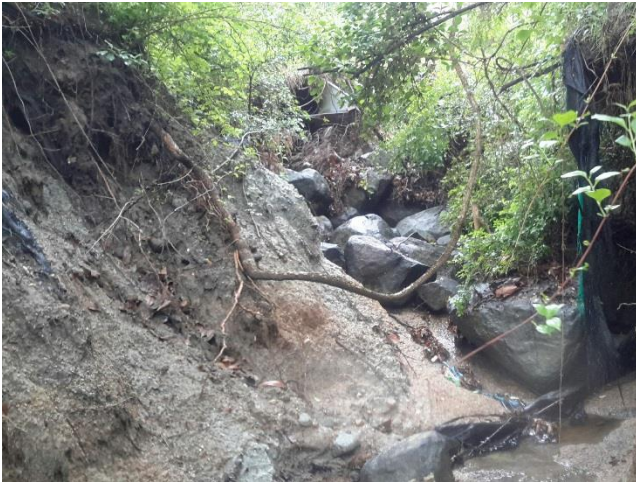
The majority of outfall stabilization assessments were located in the Patuxent River Upper watershed due to its higher density of impervious surfaces and stormwater infrastructure. Outfall sizes ranged from 12 to 36 inches. Photos of typical outfalls assessed are presented in Figure 18.

Figure 18. Typical outfall stabilization recommendation sites

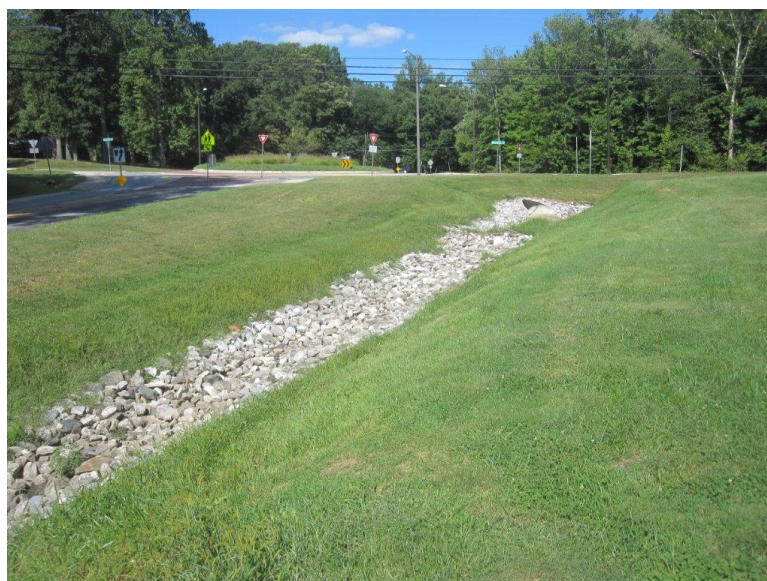
Receiving riprap ditch.

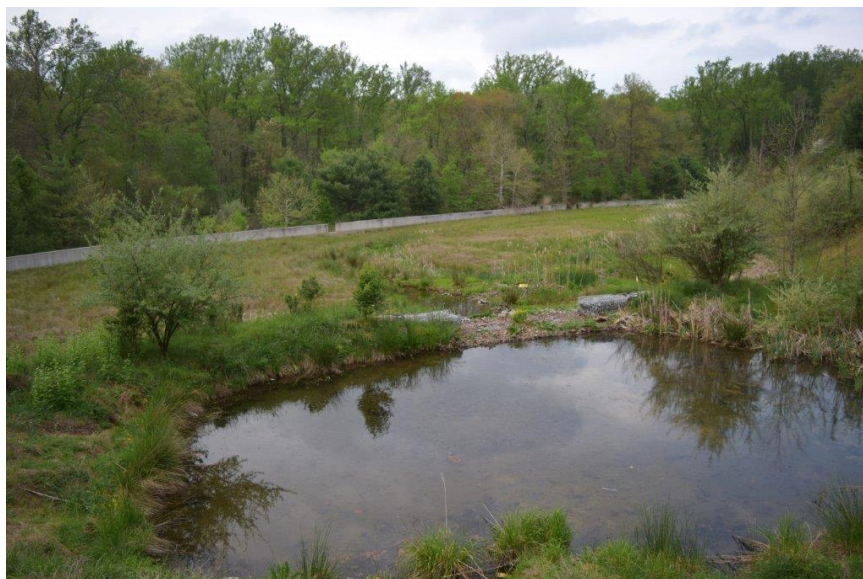
Pond view from forebay bank.

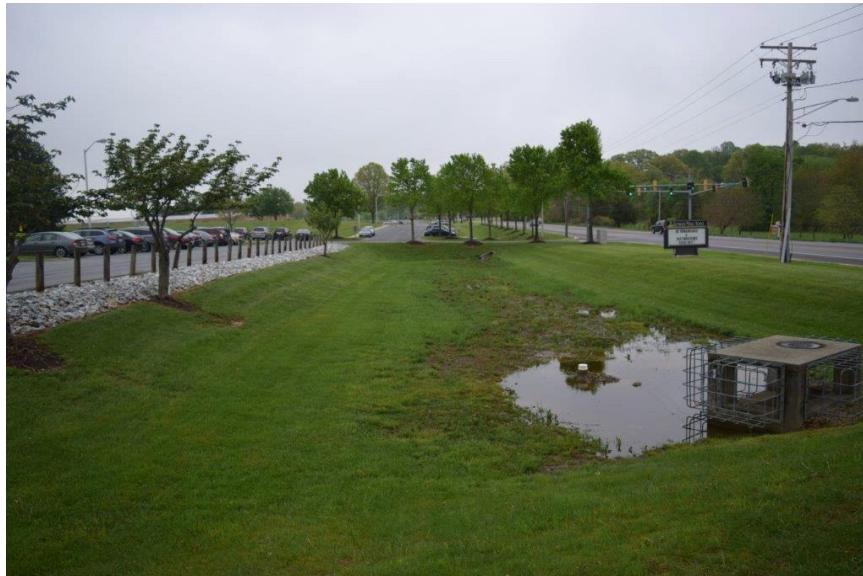
Overall pond view from south berm.

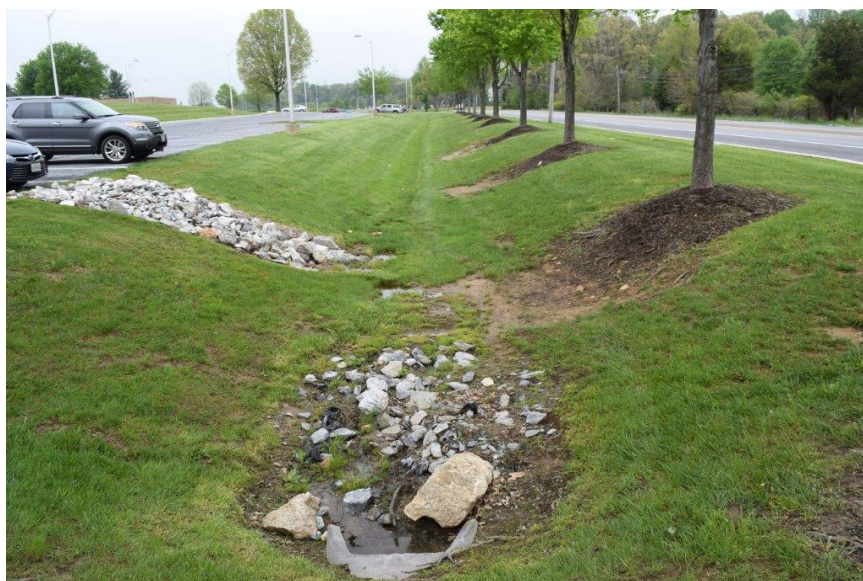
Upstream ditch discharging to pond.

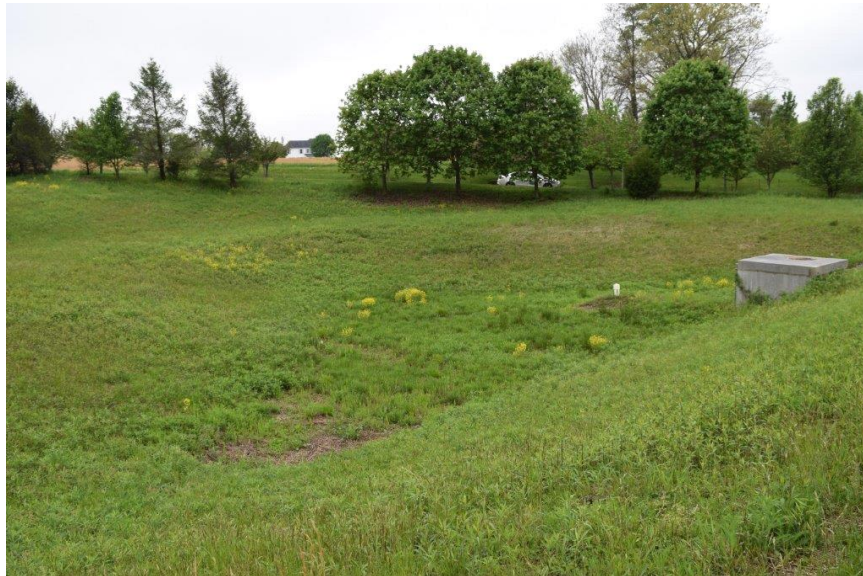
Pond view from emergency spillway.

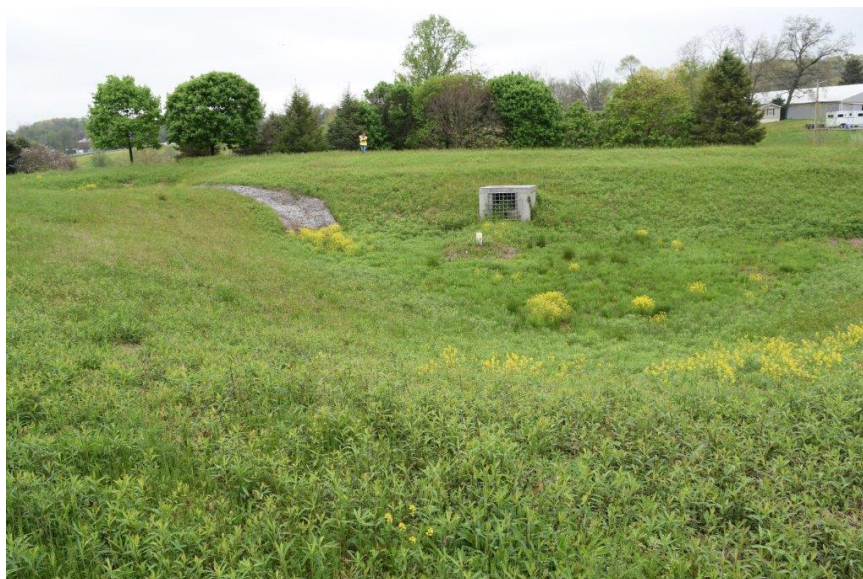
Overall pond view from south.

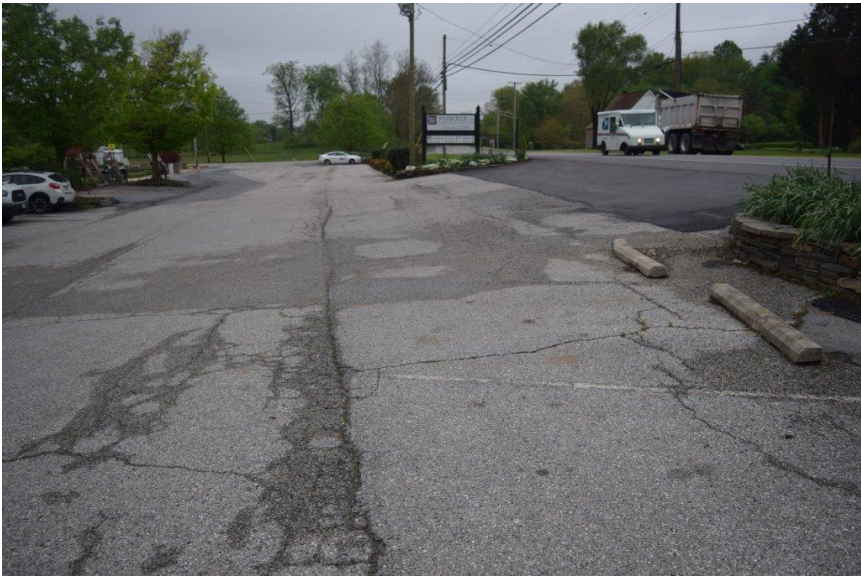
Existing site conditions looking south with Route 97 on the right.

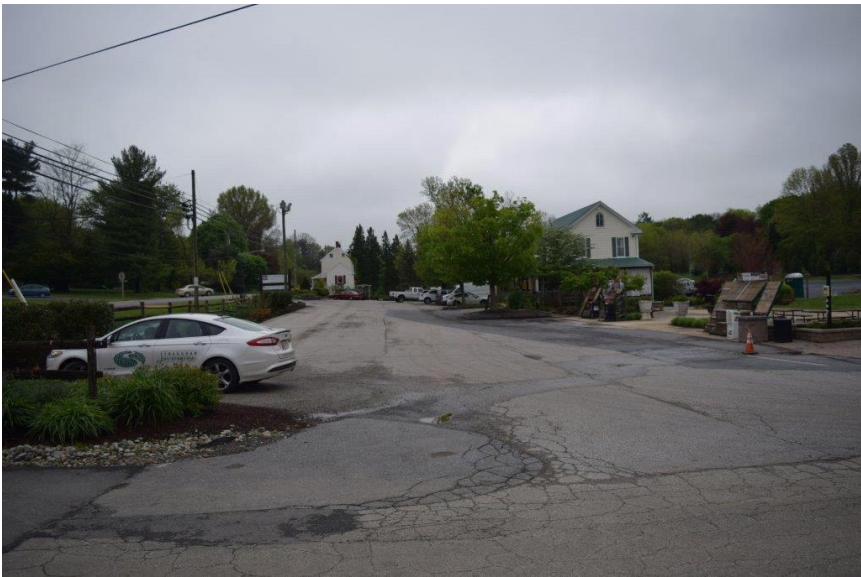
Existing site conditions looking north with Route 97 on the left.

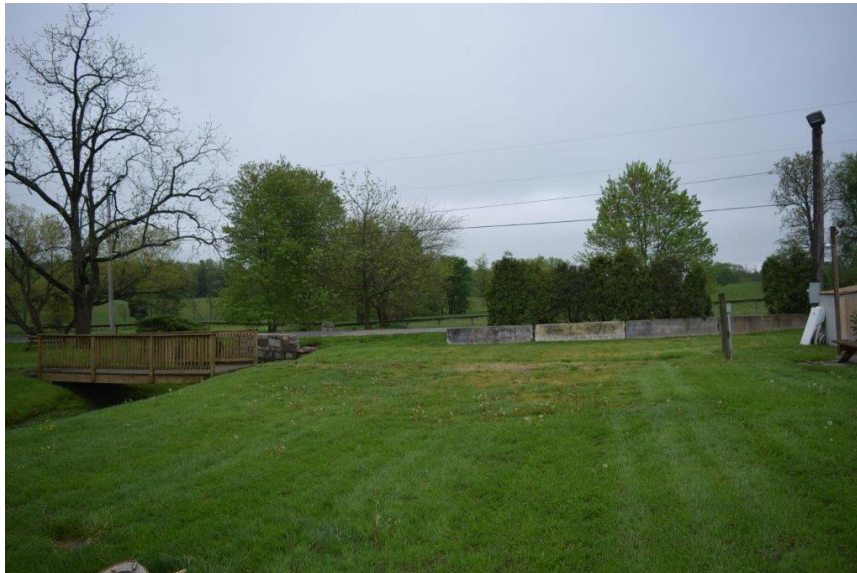
Grassed area between parking lot and stream.

The proposed rain garden location will be placed on the grassed area between the concrete pad and stream. The 0.12 ac. drainage area consists of 62% impervious area collecting runoff from the upslope parking lot. The available surface area allows greater than 1.0-in. rainfall depth treatment. Direct discharge to the stream and soil infiltration designates no storm drain piping required. There may be an opportunity to partner with the landscaping company to complete the construction of this project on the property. If completed together then overall F102 site mobilization and design work cost is decreased.

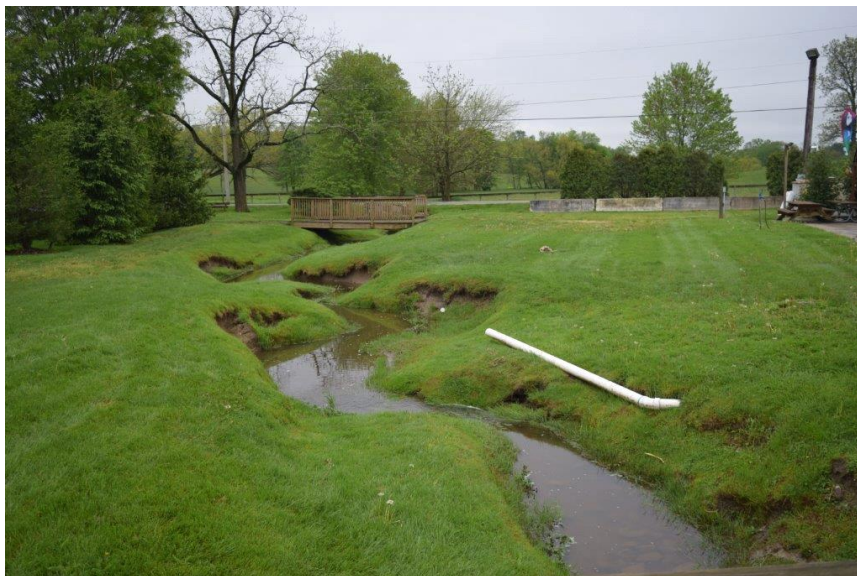
Downstream view of receiving stream.

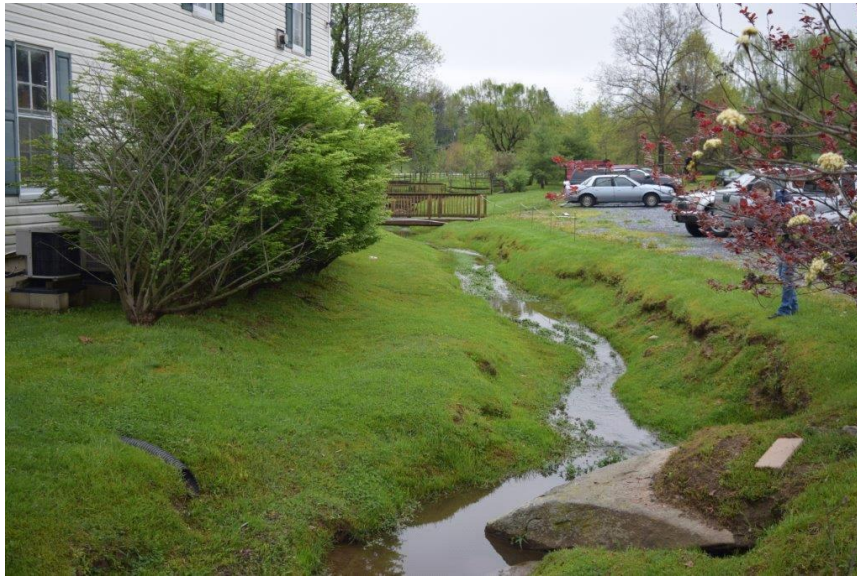
Upstream view of receiving stream with footprint beyond bridge on right bank of stream.

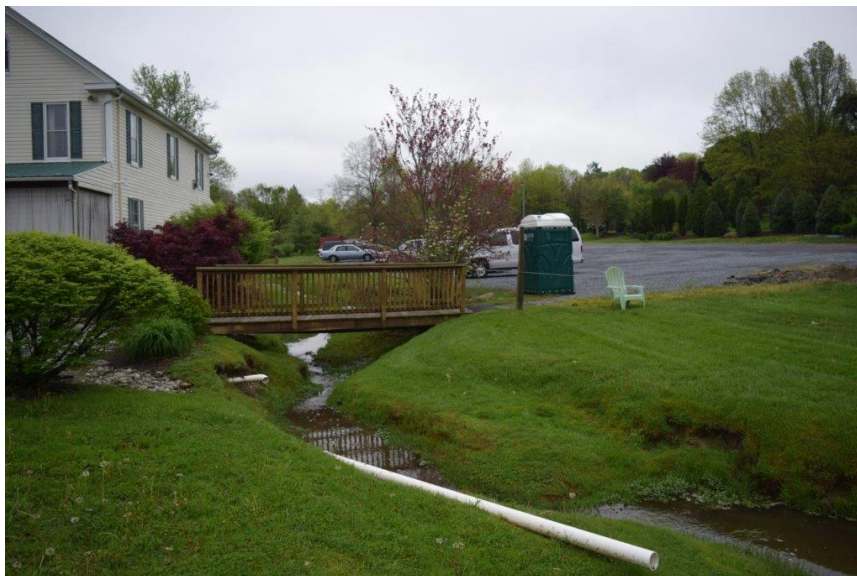
Footprint area, looking north, between gravel lot and stream beyond wooden bridge.

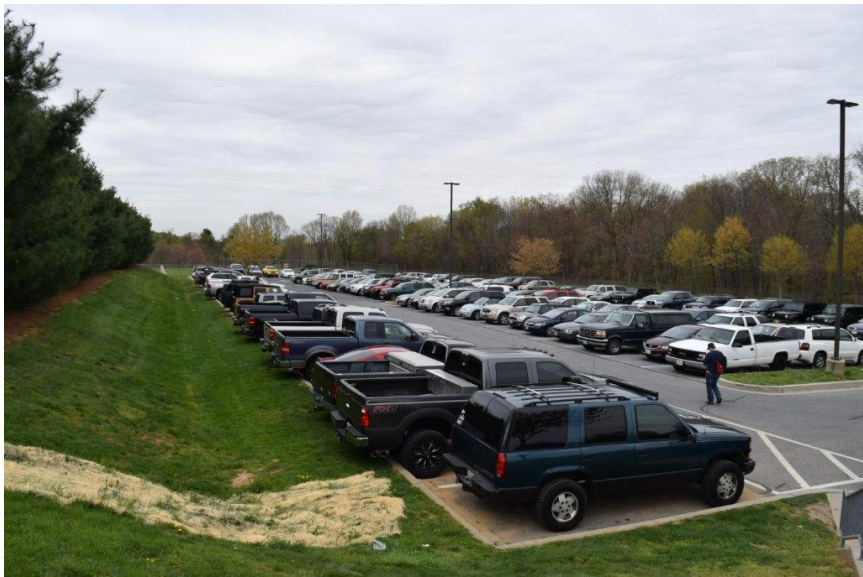
Parking lot draining to existing BMP concept footprint located in back corner of lot.

The proposed infiltration trench location collects parking lot runoff. Curb cuts and existing storm drainage removal or relocation are required to direct flow to the proposed facility. The 0.76 ac. drainage area consists of 57% impervious area collecting upslope pervious and paved lot runoff. Given available surface area, greater than 1.0-in. rainfall depth is treated. The bioretention discharges are piped under the down gradient road and to the adjacent stream. A soil boring and testing will be needed to ensure minimum infiltration requirements. Additionally, the existing BMP should be analyzed for water quality volume treatment and overall need for new BMP addition.

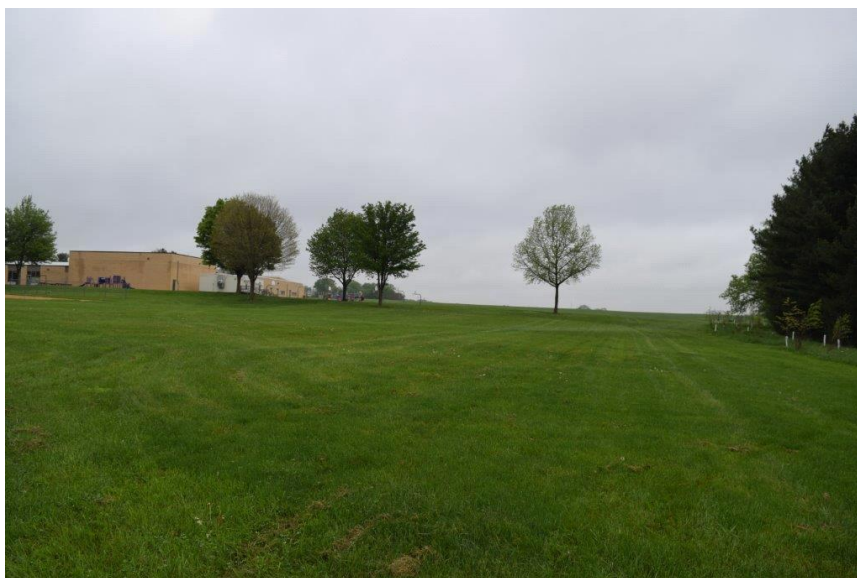
Upslope view of footprint site from existing concrete channel.

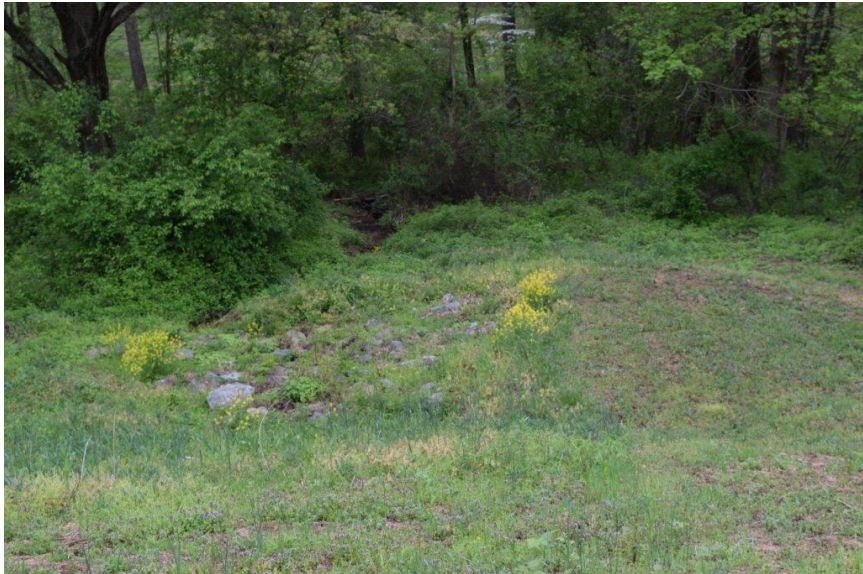
Currently, the outfall channel is eroded with 1-2 ft. exposed banks below the riprap apron. Additionally, a head cut was observed along the flow path. At the confluence with the receiving stream, signs of streambank erosion were noted. An extended detention pond discharges via a 30 in. RCP to a 20 ft. class II riprap apron. The riprap apron energy dissipation has not prevented channelization and erosion between the apron and stream convergence.

Downstream view of outfall channel from BMP berm.

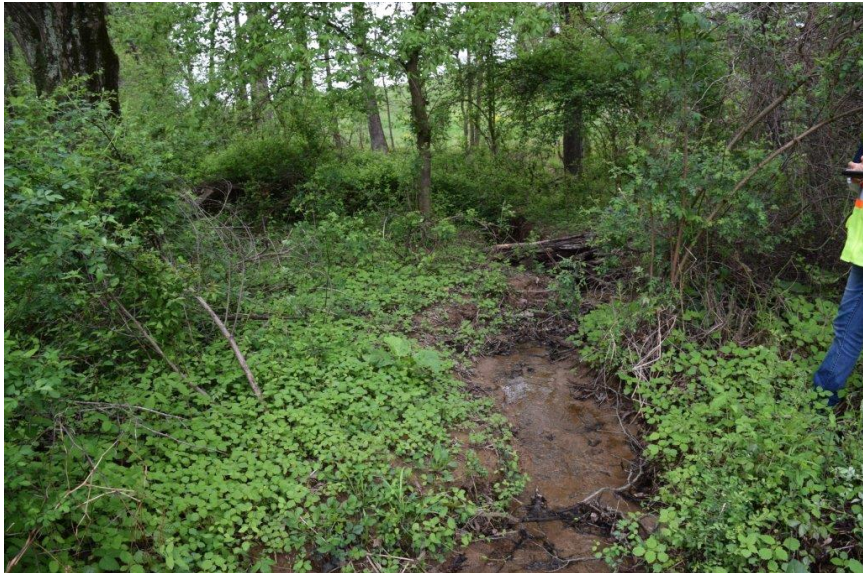
Outfall channel below riprap apron.

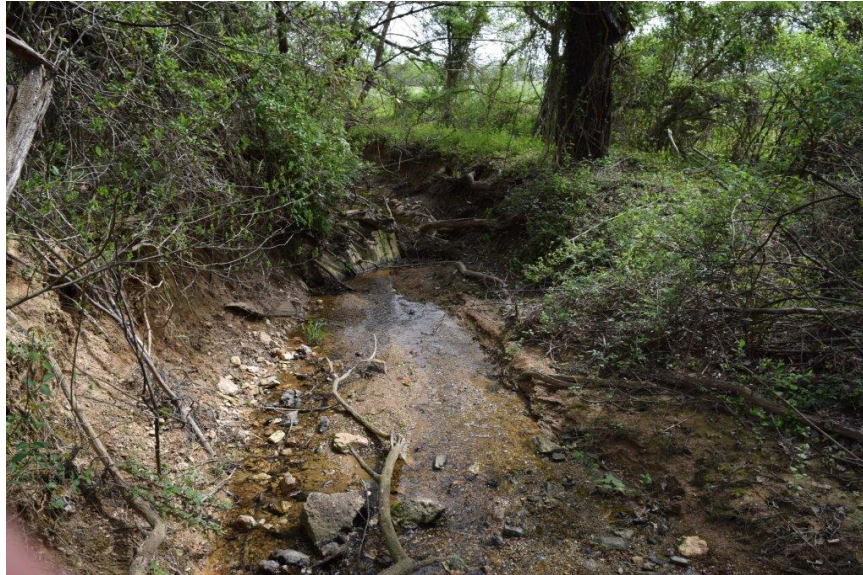
Bank erosion and accumulation of trees and brush looking downstream along school property.

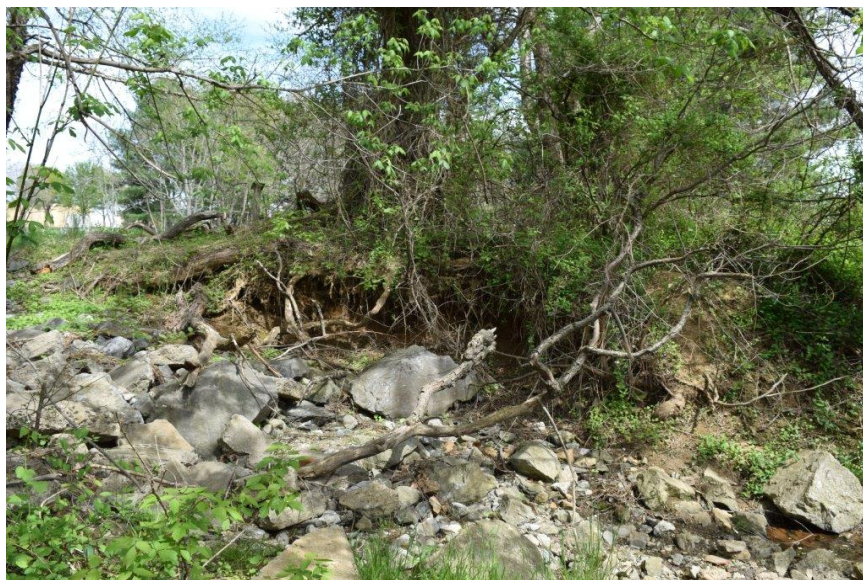
Active headcut requiring stabilization from end of concrete drainage channel (just out of photo to the left) to confluence with stream (bottom right).

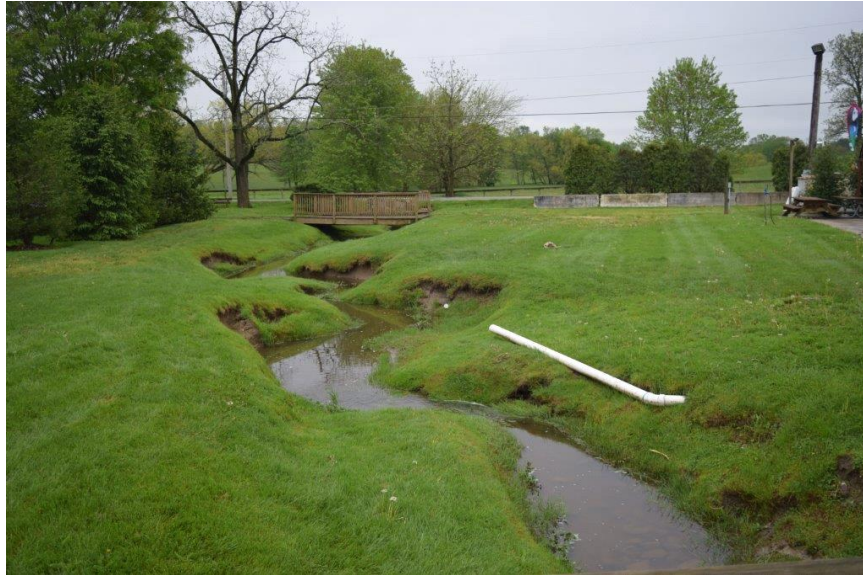
Along the northern property, tight meander bends with eroding and sloughing banks. Several pipes discharge roof runoff along the stream banks.

The objective for this project site is to stabilize the banks and improve in-stream habitat for aquatic organisms. At the upstream landscaping company, this would be accomplished by grading banks back to a stable angle, installing in-stream structures, and creating a more natural sinuosity pattern. The riparian area should be landscaped with native vegetation selected to provide stability but also continue to allow the landscaping company to use the area as an outdoor showcase area. The condition of the pond should be assessed more thoroughly and steps taken to ensure water does not become stagnant and anoxic in any portion. There may be an opportunity to fill a portion of the pond to create a wetland habitat. A number of new BMPs are also recommended on this site (BRD-NB-F102). There may be an opportunity to partner with the landscaping company to complete the construction of these projects on their property. It is highly recommended to limit mowing and allow natural wetland vegetation to establish on both banks along portion of stream upstream of the project site. Building downspouts should also be changed so that they do not discharge directly into the stream—they could be directed to the recommended rain garden, or the landowner could use rain barrels or another rooftop disconnection strategy. Given the condition of the culvert headwalls, it may be advisable to have it replaced prior to completing a restoration project to avoid future impacts to the project. In the downstream portion, banks should be graded back to a stable angle wherever possible in areas of significant erosion to reconnect the stream to the floodplain; however, impacts to specimen trees should be minimized. Where necessary, spot structural measures could be implemented to provide bank stabilization. Given the steep slopes and grass-only cover above the left bank, reduction of erosion could be realized by planting a significant riparian buffer of native vegetation to slow the overland flow. The addition of woody debris, cobble riffles, pools, and other habitat structures will reinforce the streambed and banks and improve the flow diversity and structural complexity of the stream bed, improving the instream habitat. Access is easy. Preferred access would be from the private drive between the properties, but this may require approval of the other property owner.

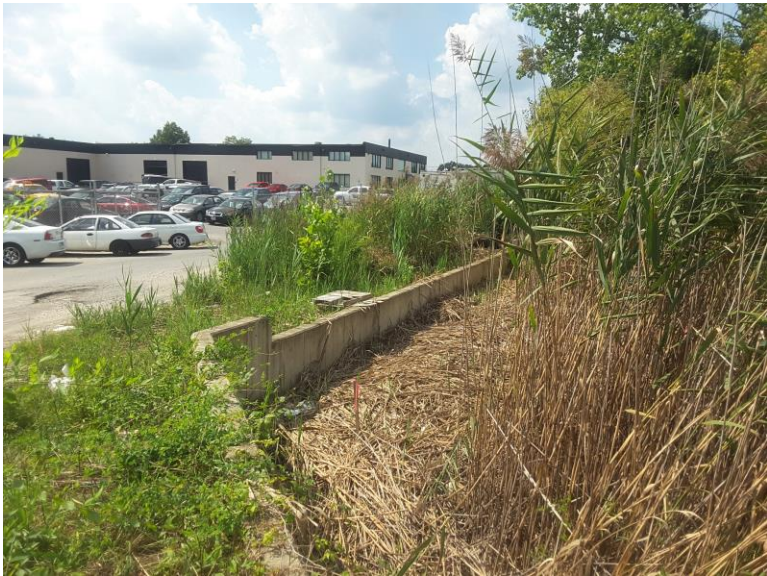
Existing pond weir and concrete embankment

The existing dry pond could be converted to a retention pond (wet pond) by excavating to original ground by removing the existing 2 ft. phragmites mat. The existing outfall structure, a headwall and 12 in. RCCP, would need to be replaced with a riser structure and new outfall barrel. The existing sediment forebay would need to be excavated and the surrounding berm and gabion weir rebuilt.

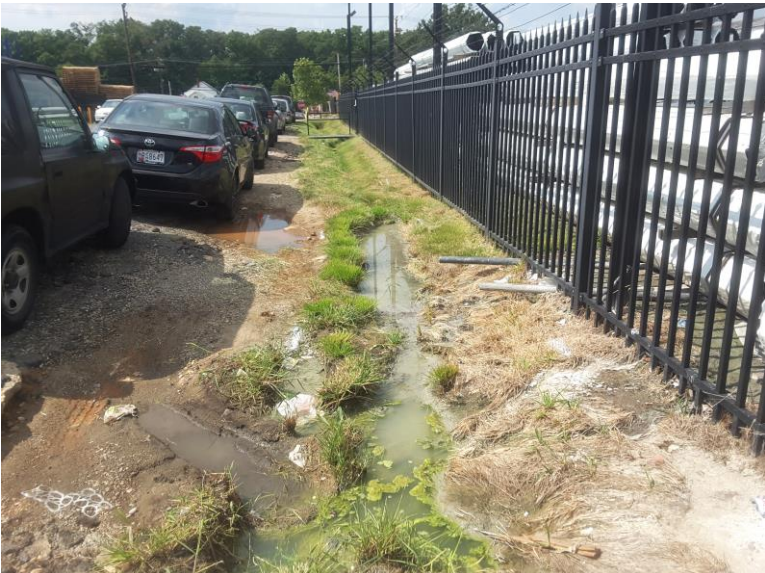
Overview of existing swale showing examples of drainage issues

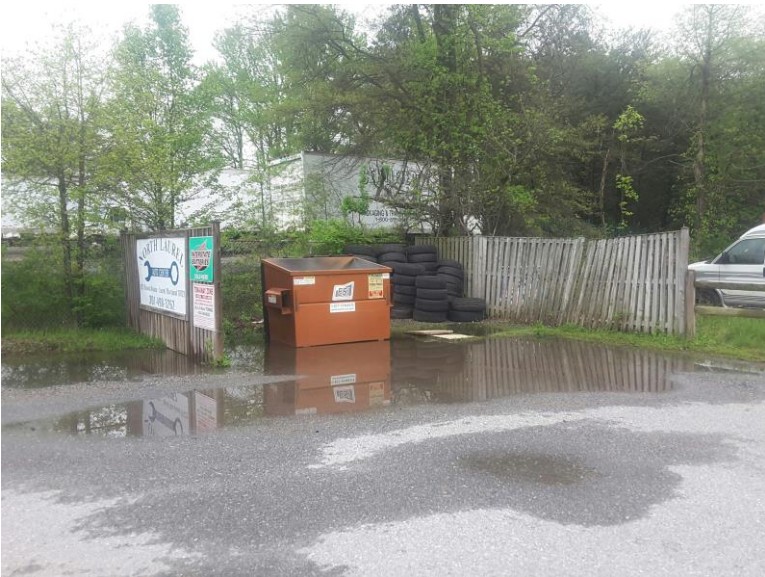
Potential micro-bioretenion site with ponding evident

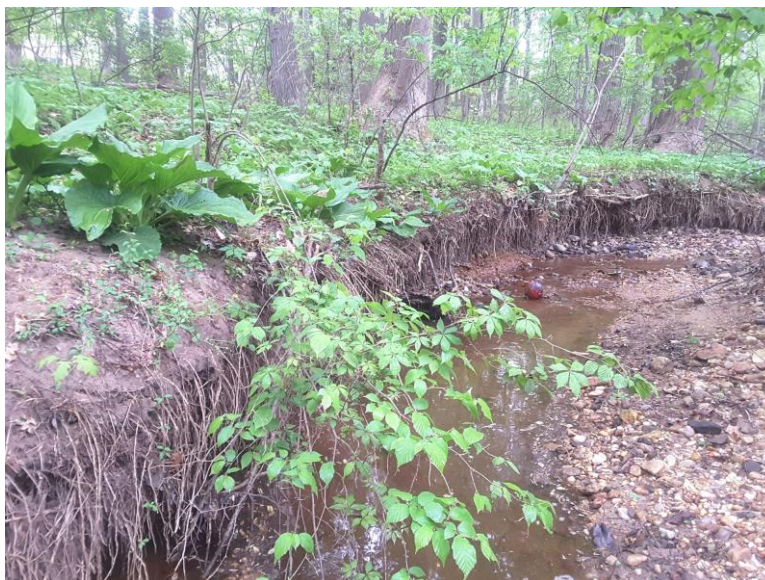
Photo facing upstream assessing the right bank and depicts a typical stream bank within the upstream limits of the assessed stream.

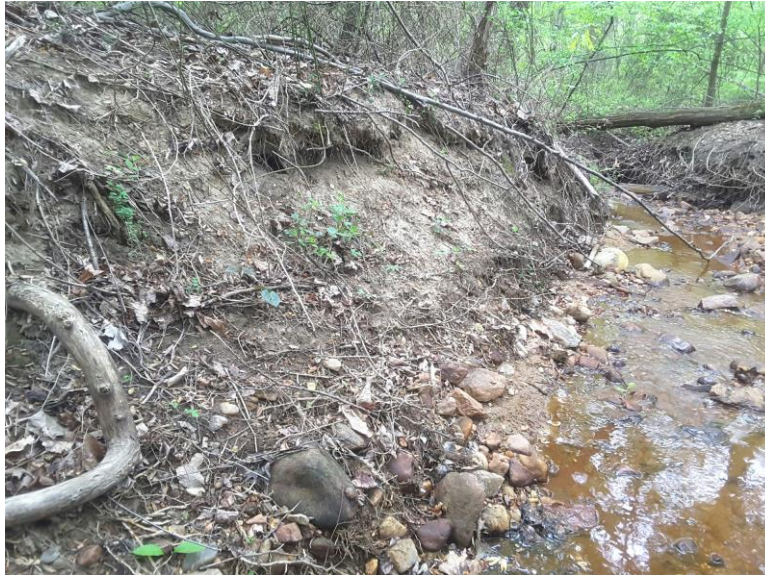
Photo facing downstream of bank erosion along the right bank.

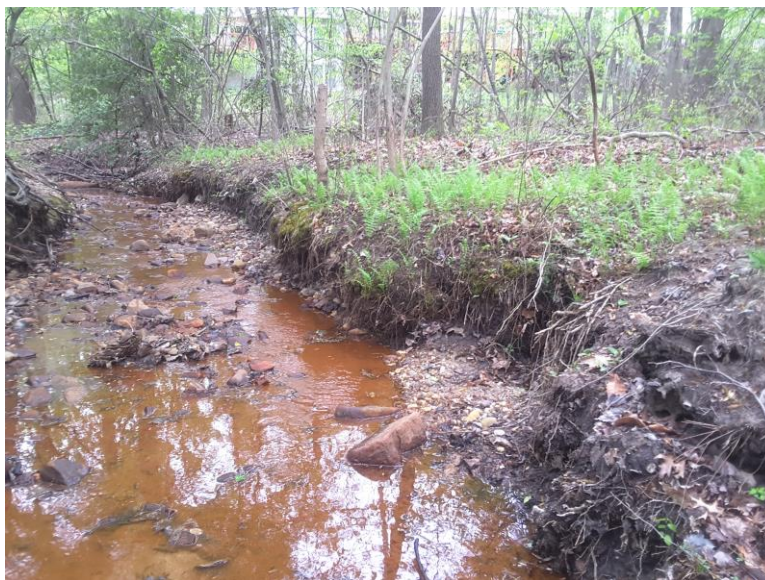
Photo facing downstream of minor bank erosion along the left bank. Forest and vegetative protection helping stabilize the bank.

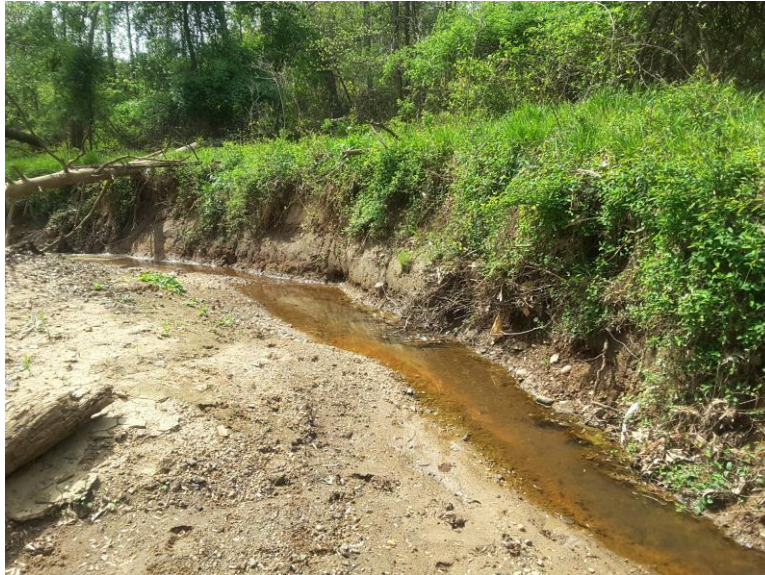
Photo facing upstream showing raw left bank around tight meandering bend.

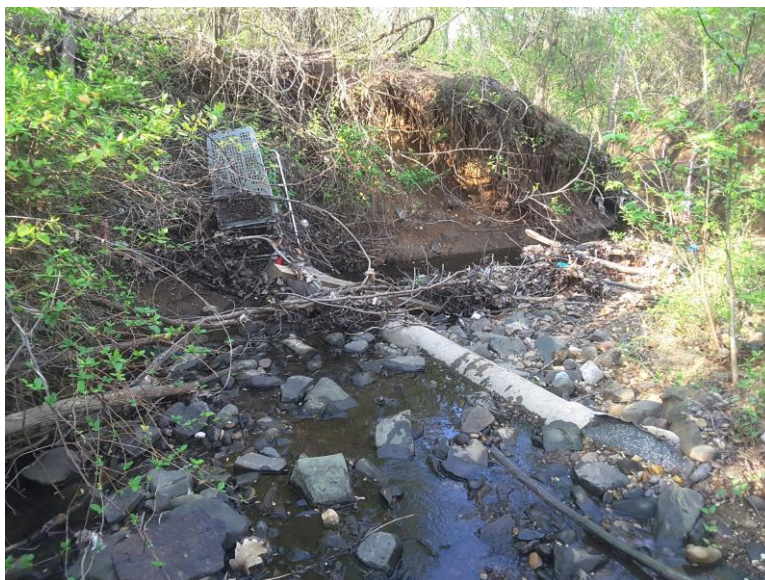
Photo facing downstream showing high left bank at tight meandering bend. Photo shows exposed sewer line and trash in-stream.

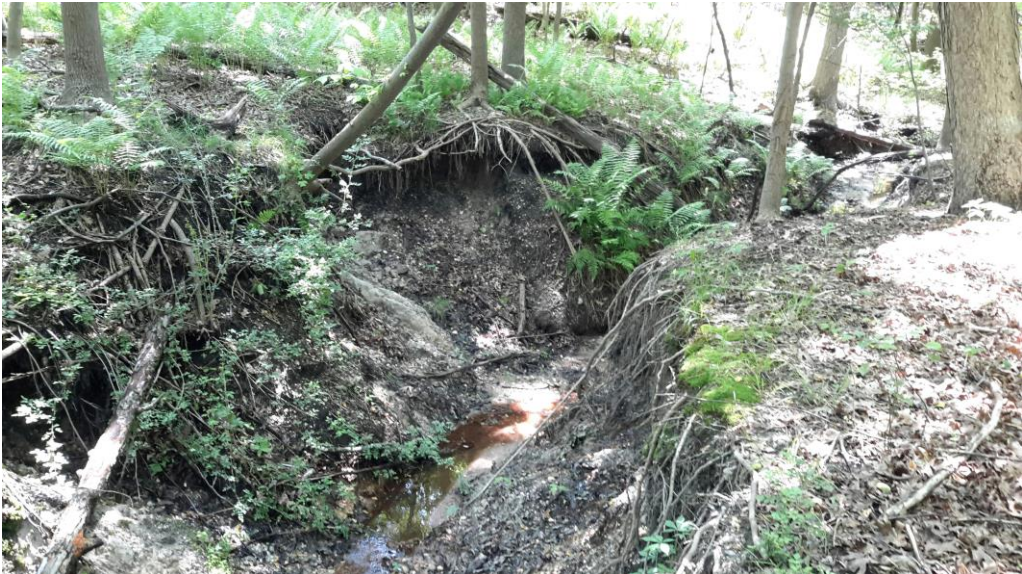
Facing downstream at typical left bank erosion

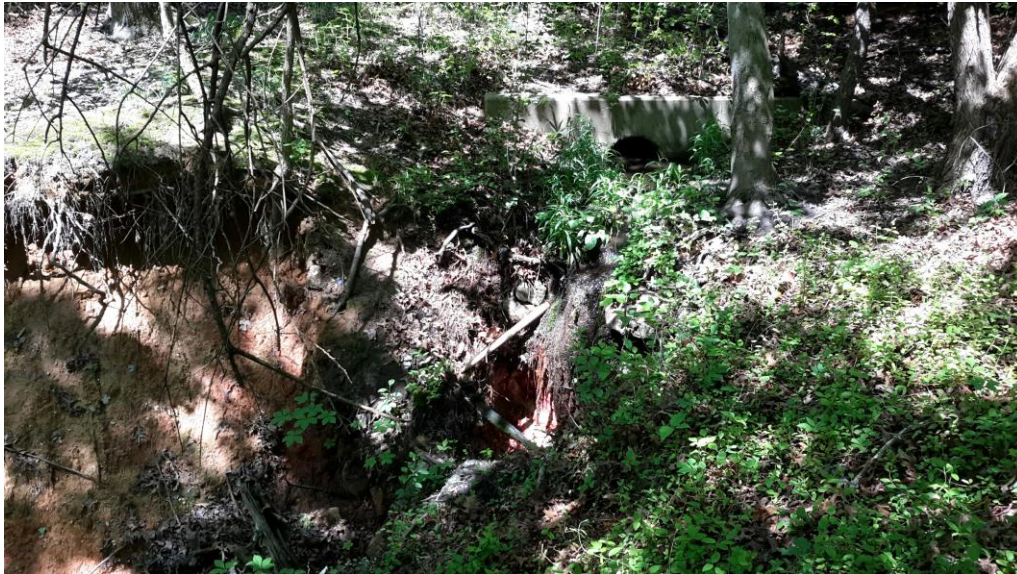
The proposed outfall stabilization is a severely eroded channel originating from a storm drain pipe with no stormwater management treatment. The channel erosion starts immediately downstream of the outfall and extends the entire length of the outfall channel of approximately 230 ft. downstream until it meets an unnamed tributary to the Patapsco River. The channel has approximately 10 ft. high banks and a 15 ft. wide channel. Site access is moderately easy from the adjacent apartment complex parking lot off Livery Ln.

View of headcut at outfall pipe.

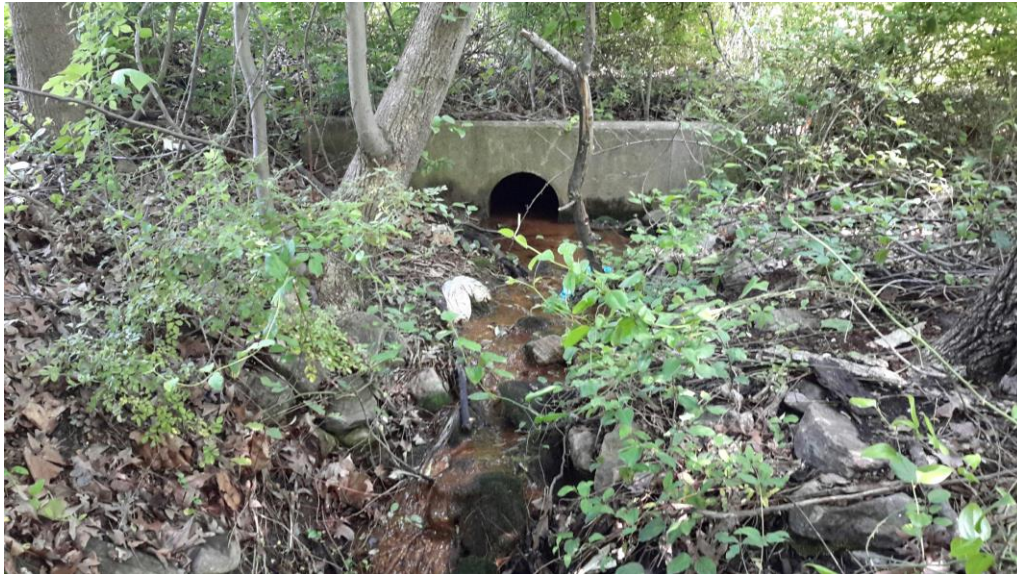
The proposed outfall stabilization is a severely eroded channel originating from a storm drain pipe with no stormwater management treatment. The channel erosion starts immediately downstream of the outfall and extends the entire length of the outfall channel of approximately 275 ft. downstream until it meets an unnamed tributary to the Patapsco River. The channel has approximately 10 ft. high banks and a 8 ft. wide channel. Site access is moderately easy from the adjacent apartment complex parking lot off Livery Lane.

View of headcut at outfall pipe.

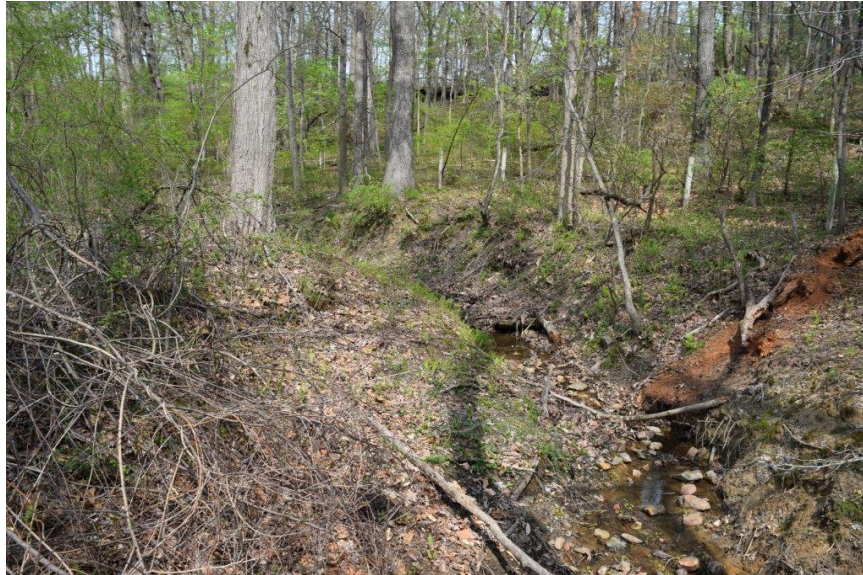
Bank erosion and exposed bed material near the downstream end of the project reach.

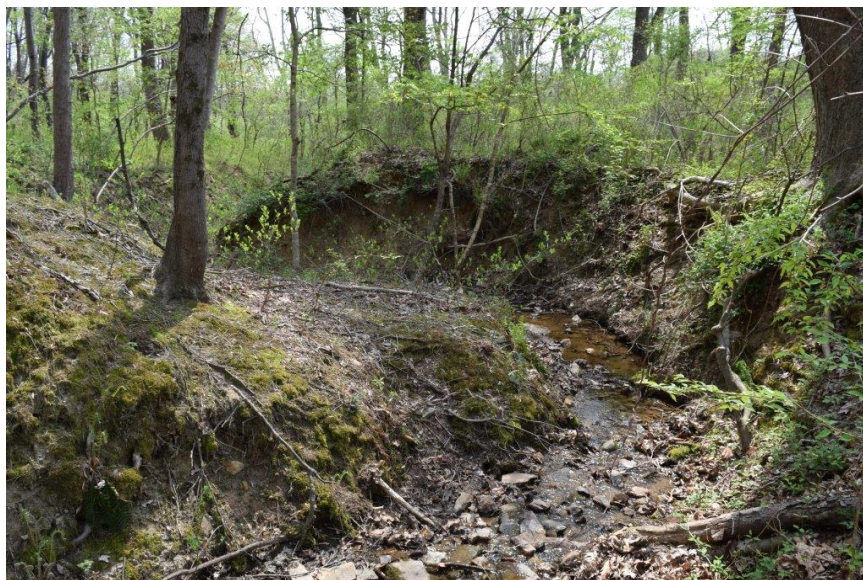
Severe bank erosion on the outside of a meander bend in the highly sinuous portion near the middle of the project reach.

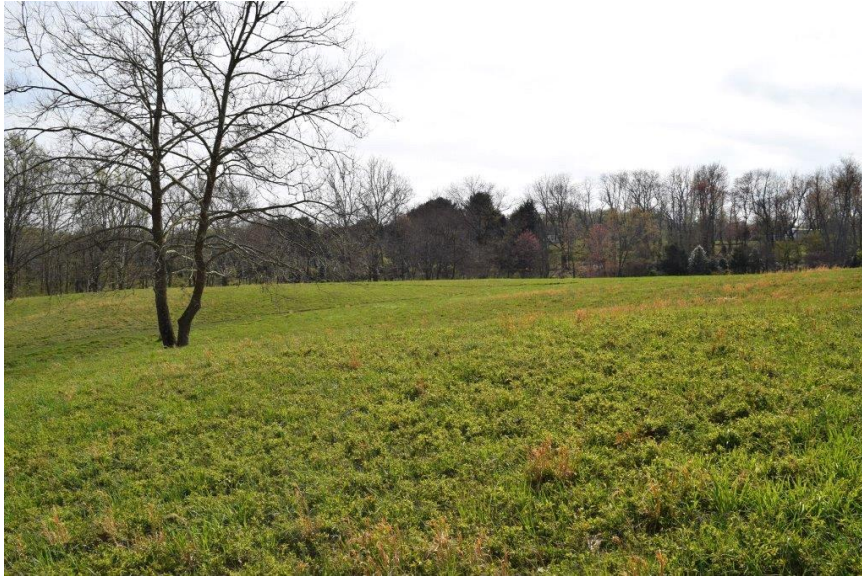
The western half of the proposed planting area; current vegetative cover is primarily grass with a few trees.

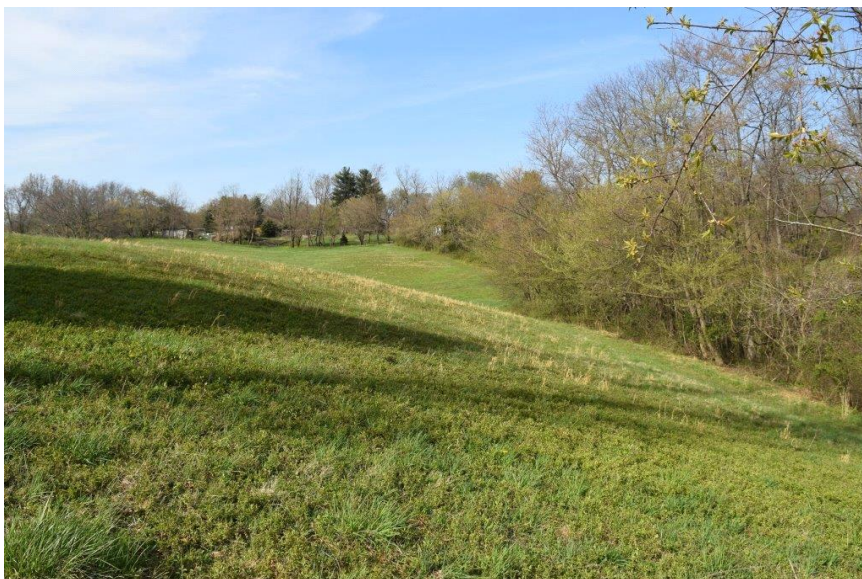
View towards the eastern back half of the proposed planting area. Photo shows the higher slopes present in some areas and the existing forest edge to the right of the picture.

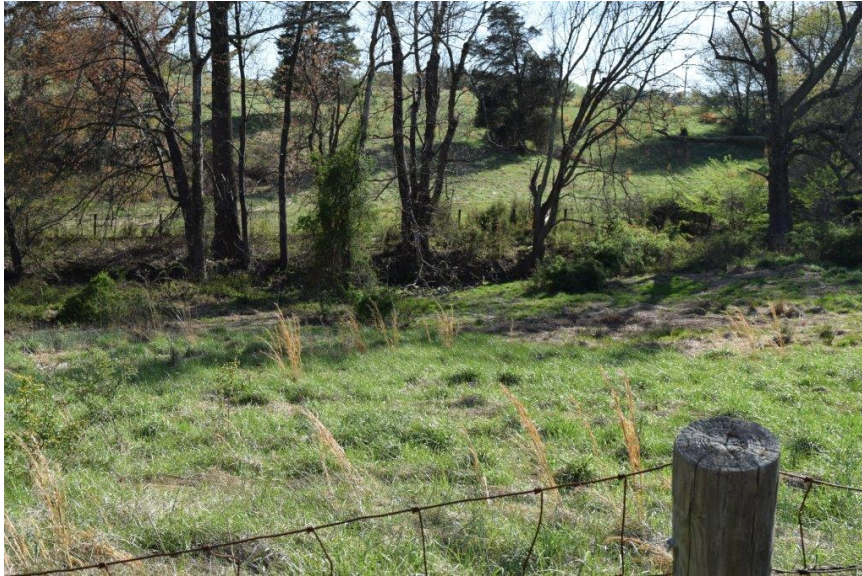
Typical conditions within the western field.
