Historic Preservation and Mitigation Documentation
Identification of Salvageable Material
8049, 8055, 8059, and 8069 Main Street,
Ellicott City, Maryland

Prepared by: *EHT | Tracerics* for
Howard County Department of Public Works

Report Date: November 3, 2020

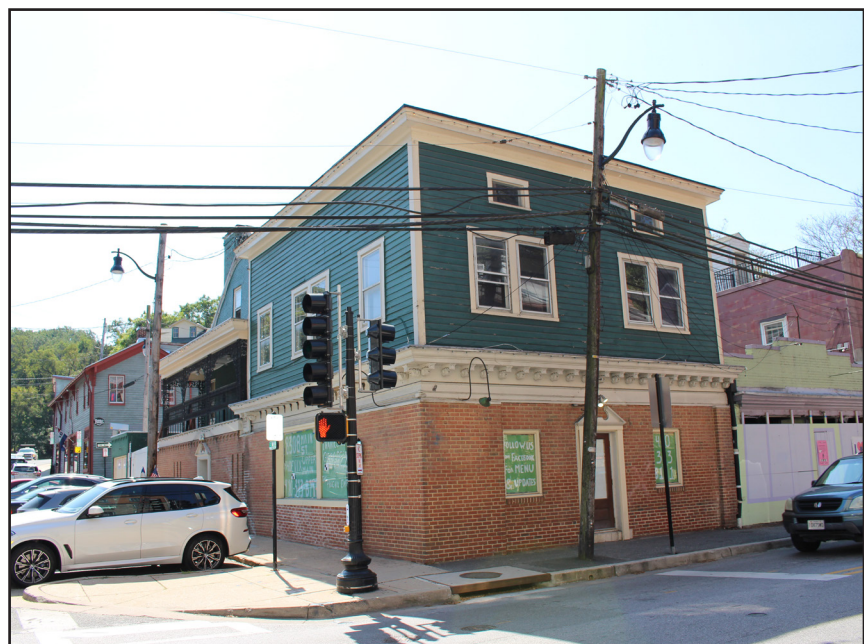
Located on Parcel 57, at the southwest corner of Main Street and Maryland Avenue, are two attached buildings. To the north, and fronting on Main Street, is a two-story frame commercial building. The original first story is faced in brick veneer and contains plate-glass store front windows on its north and east elevations. The primary entrance is located on Main Street and features a Colonial Revival-style wooden surround with a broken pediment. The first story terminates in a heavy molded wood cornice with scrolled modillions. Above this cornice is a frame, flat-roofed second-story clad in wood siding and pierced by one-over-one, double-hung, vinyl-sash replacement windows.

Figure 1: 8049 Main Street. Tracerics, 2020

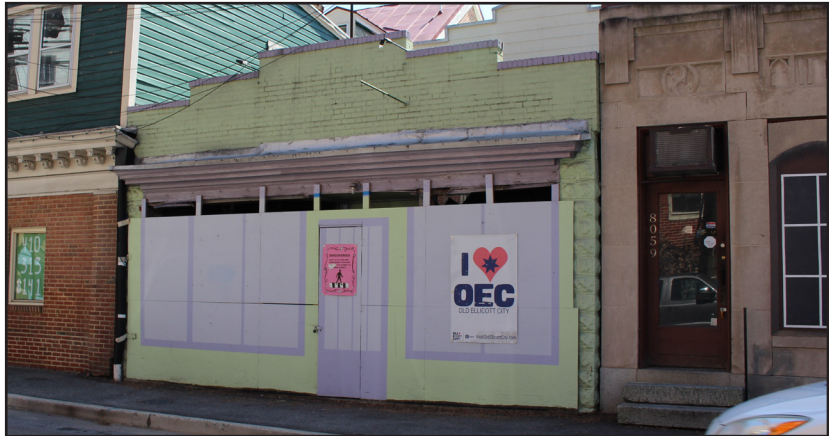
Occupying Parcel 56 is a frame commercial building that was constructed c. 1925, possibly incorporating parts of an earlier nineteenth-century building. The north half of the building is one-story in height and historically functioned as a store. The rear section is two stories and contains a garage on the first story and two apartments on the second. Both sections are covered by flat roofs. The facade faces Main Street, and its character-defining exterior features include a shaped brick parapet topped with brick coping and a molded wood cornice. The building's storefront was damaged during the 2018 flood and is currently boarded-up. A second, siding-clad parapet rises at the junction of the first and second stories.

Figure 11: Facade 8055 Main Street. Tracerics, 2020

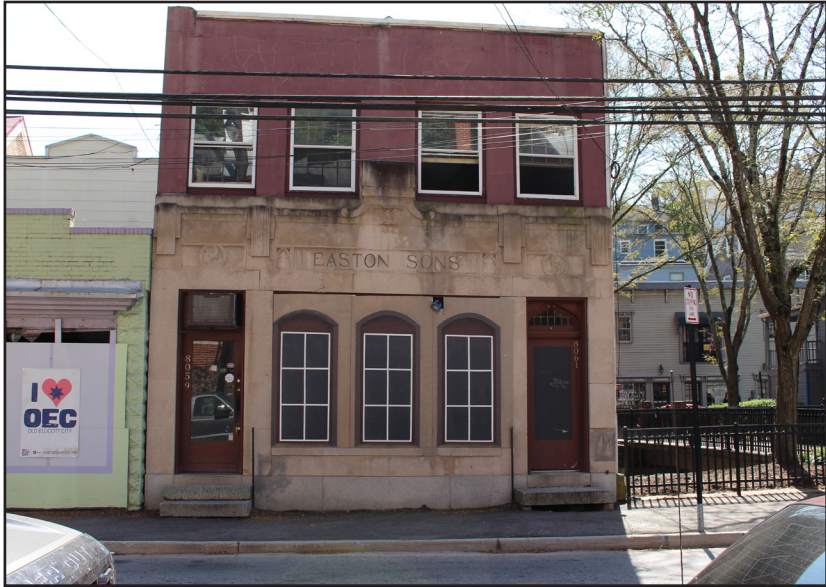
Located on Parcel 55, this commercial building is of masonry construction and ranges from two to four stories in height. The first floor of the front portion of the building historically housed commercial uses. Two apartments are located on the second floor and a single apartment is on the third. A small service space that once housed a dumb waiter is located in the fourth floor, at the rear of the building. The defining feature of the building is the limestone front that extends across the first story of the four-bay facade. The first-story storefront originally incorporated three Gothic arched windows, the openings of which are now boarded-up. Two entrances with Gothic arched transoms flank the central storefront. The second story of the facade is finished in stucco and contains four eight-over-eight, double-hung, wood-sash windows. Metal casement and awning-sash windows pierce the side and rear elevations.

Figure 17: 8059 Main Street. Traceries, 2020
