CMOM Audit Report No. 3

Complaint and Settlement Agreement between Howard County, Maryland and the Maryland Department of the Environment CO-10-1116

Complaint and Settlement Agreement between Howard County, Maryland and the Maryland Department of the Environment CO-10-1116 This Self-Audit Report is a requirement of "Paragraph C, CMOM Audit" of the Complaint and Settlement Agreement. One year after the commencement of implementation of the approved CMOM Program, and annually thereafter until termination of this Agreement, the County shall conduct a performance assessment audit to evaluate the CMOM Program and submit a report to MDE certifying and describing:

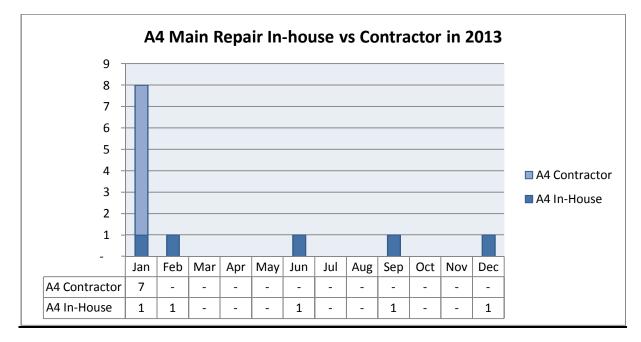
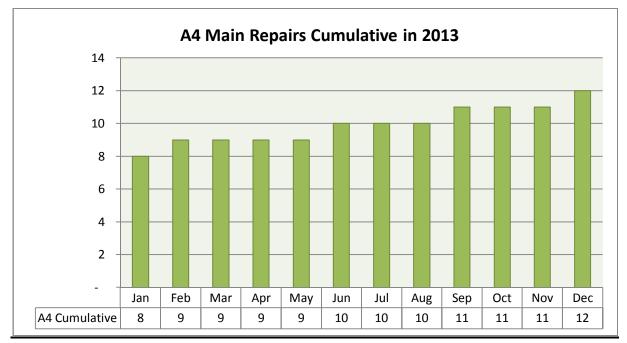
A4. Sewer Main Repairs

The County performed the sewer main repair/replacement on an As-Needed basis. Five (5) sewer mains were repaired by County's in-house staff in 2013, totaled 1,554 ft. Seven (7) sewer mains were repaired by County's on-call contractor VPS, totaled 3,210 ft. Additionally, there's 5,805 ft of CIPP performed at Murray Hills Subdivision.

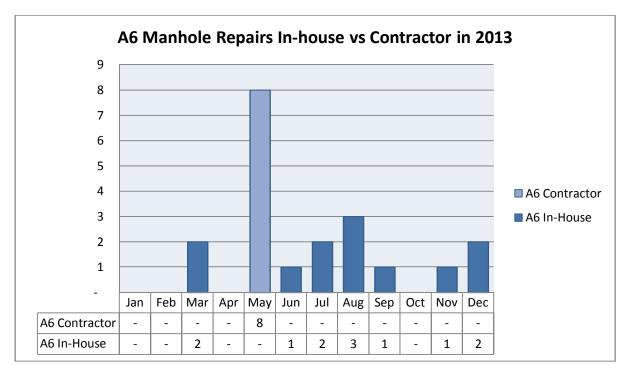
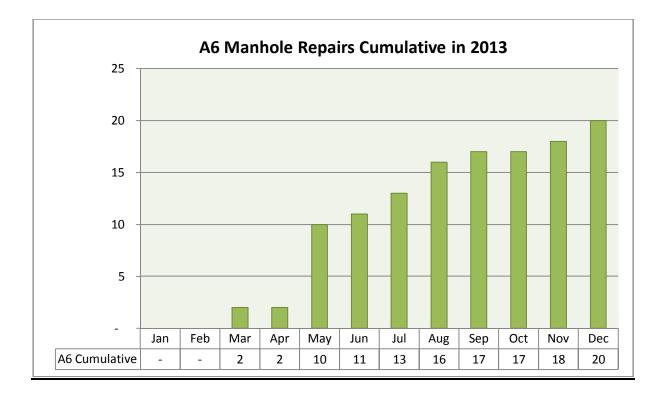
A6. Manhole Repairs

The County performed the manhole repair/replacement on an As-Needed basis. Sanitary sewer manholes are repaired by County's in-house staff and contractors. There were 20 manholes repaired in 2013, 8 by the on-call contractor and 12 by the County's in-house staff.

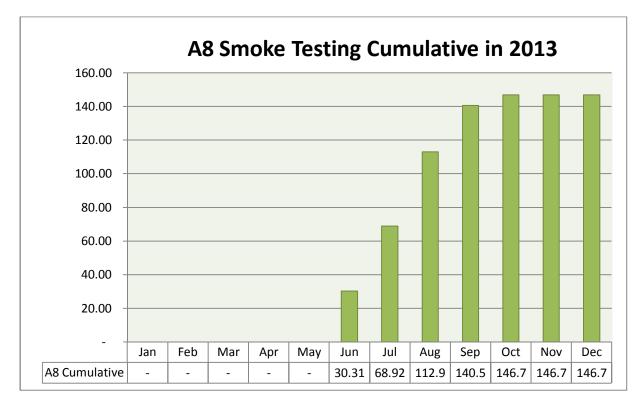
A8. Smoke Testing

In 2013, there was no smoke testing performed by in-house staff. The County has contracted George, Miles & Buhr (GMB) to provide engineering services with smoke

testing the Route 108 Subsewershed. The intent of this project is to identify the specific locations where the system defects exist to reduce the quantity of extraneous inflow from entering the Little Patuxent Interceptor.

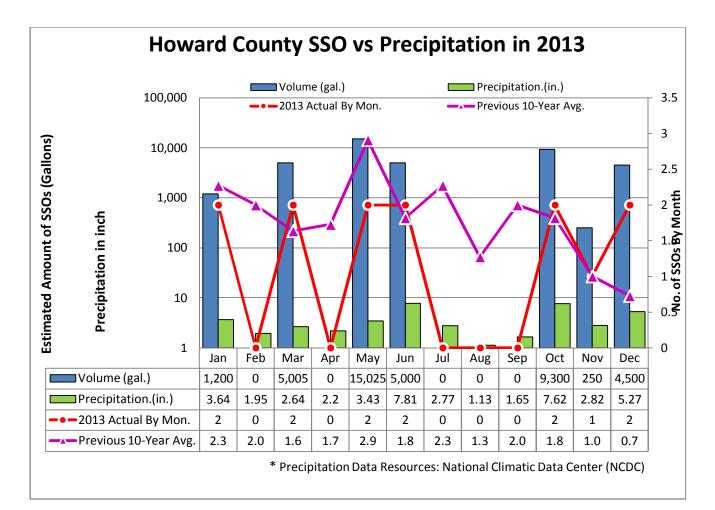
The County's SSO's have been plotted by month in the above chart. As is shown in the chart, most months' SSO occurrence numbers in 2013 were all below the previous 10-year average. There was no SSO occurred during February, April, and July through September. You can also see the number of SSO occurrence in each month still correlates the amount of precipitation. The more it rained, the more SSO occurred.

Same as 2011 and 2012, Howard County maintains a far below national average for the number of sewer overflow occurrence. The national average for SSO is 4.5 per 100 miles of sewer, based on a 2004 EPA report to Congress. The County's average is 1.3 per 100 miles of sewer.

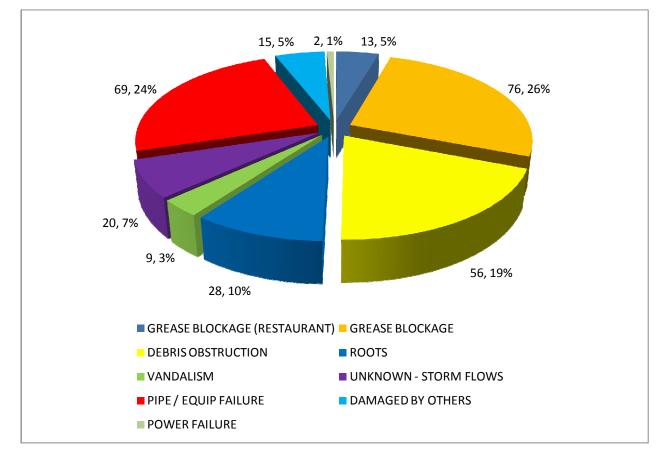
As is shown in the above chart, the top three (3) causes of overflows county-wise are: grease blockage (non FOG, 26%), pipe/equipment failure (24%), and debris obstruction (19%).

To take a further step into the long-term investigation, the County researches the causes and numbers of SSO occurrence from 2001 to 2013.

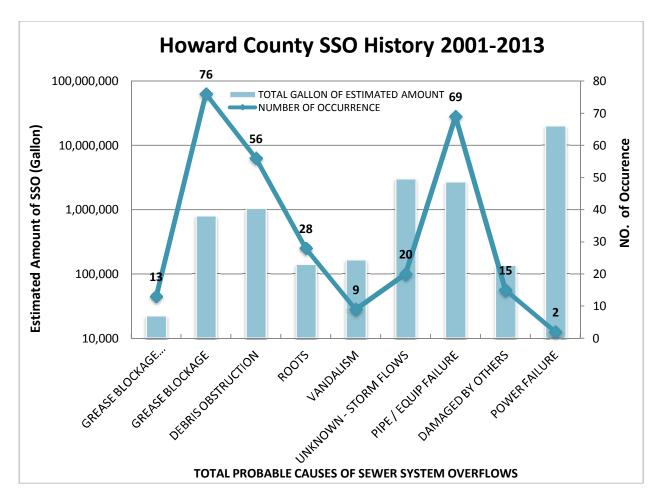
While taking the estimated overflow amount into consideration, power failure, storms, pipe and equipment failures rank the highest of the total SSO volume contribution. This observation has not changed from 2012.

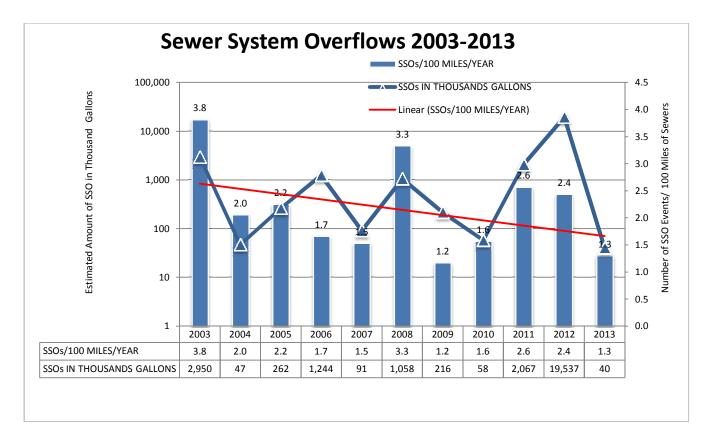
As is shown in the above chart, over the past 11 years from 2003 to 2013, the County has the SSOs/mile/year ranging from 1.2 to 3.8, while the national average posted by EPA in 2004 is 4.5. What's more, the County's overall trend of SSOs/mile/year is downward. The SSOs/mile/year for 2013 is 1.3, which is the second lowest number among the past 11 years.

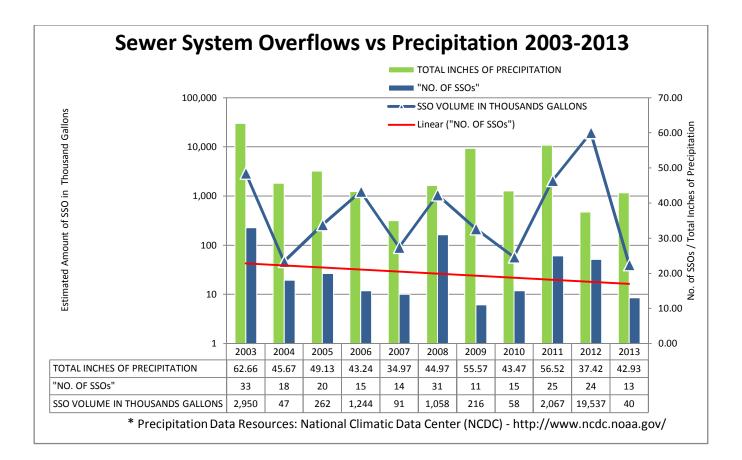
To further investigate the correlation between numbers of SSO occurrence to the total amount, the 11 years' precipitation data is plotted in the below chart. The numbers of SSO occurrence over the years keep a downward trend, despite the fact that the total overflow amount in 2012 was severely affected by the by-pass incident that happened during Hurricane Sandy at LPWRP.
