CMOM Audit Report No. 1

Complaint and Settlement Agreement between Howard County, Maryland and the Maryland Department of the Environment CO-10-1116

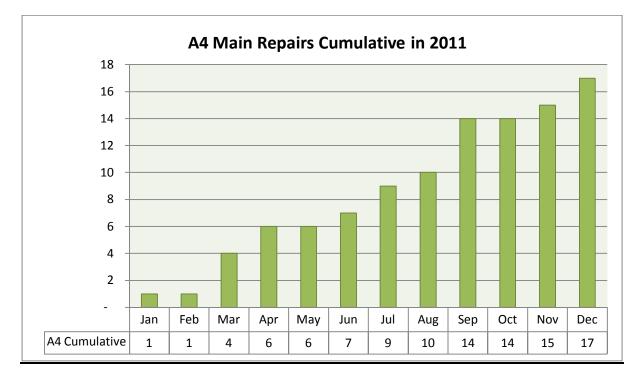
A4. Sewer Main Repairs

The County performed the sewer main repair/replacement on an As-Needed basis. 17 sewer mains were repaired by County's in-house staff in 2011, totaled 3,400 ft.

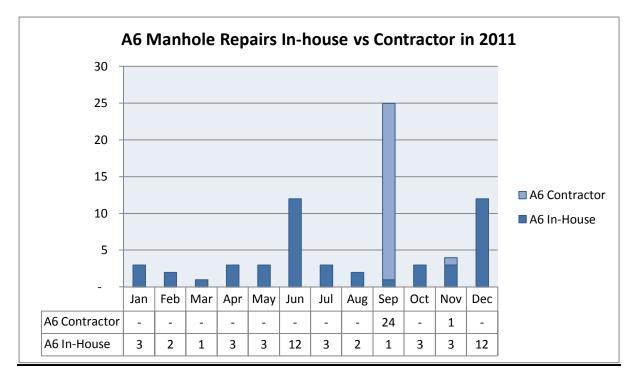
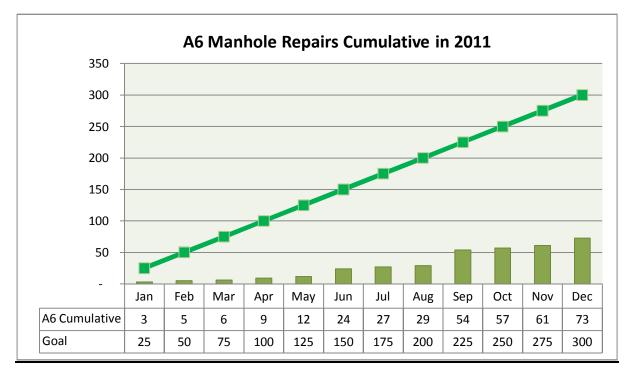
A6. Manhole Repairs

The County performed the manhole repair/replacement on an As-Needed basis. Sanitary sewer manholes are repaired by County's in-house staff and contractors. There were 73 manholes repaired in 2011, including the 24 manholes identified as problematic in the Little Patuxent Interceptor SSES report.

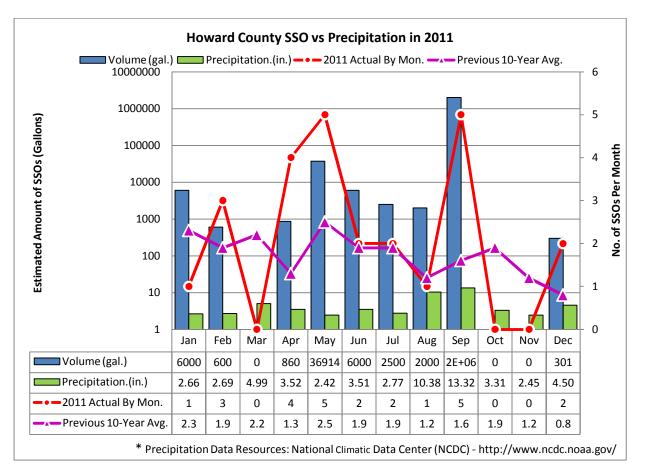
The County's numbers of SSO occurrence have been plotted by month in the above chart. As is shown in the chart, September, when Hurricane Irene and Tropical Storm Lee occurred, has the greatest amount of precipitation, numbers of SSO occurrence and volume in 2011.

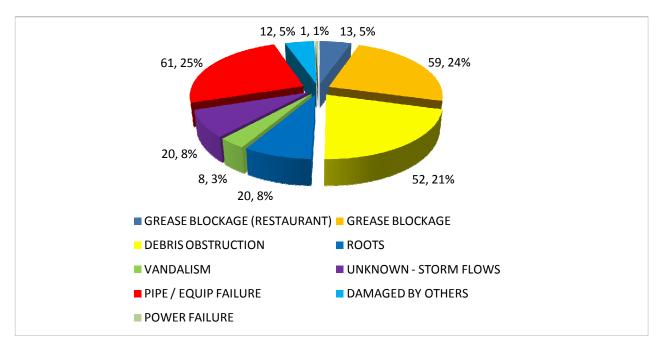
As is shown in the above chart, the top 3 causes of overflows county-wise are: pipe/equipment failure, grease blockage and debris obstruction.

Taking the estimated overflow amount into consideration, storms, pipe and equipment failures rank the highest of the total SSO volume contribution.

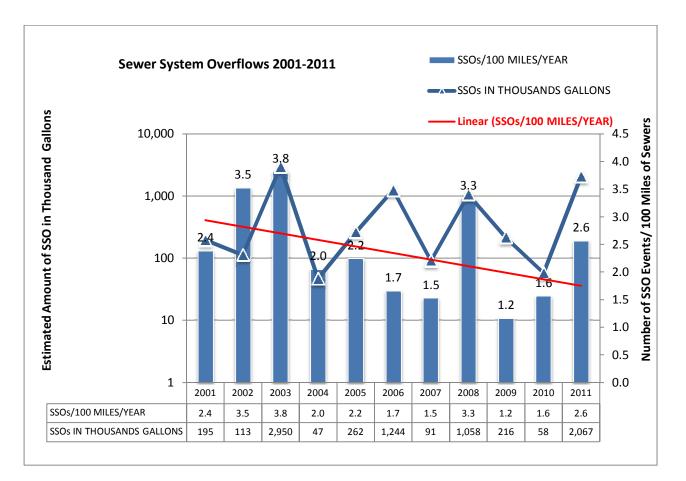
As is shown in the above chart, over the past 11 years from 2001 to 2011, the County has the SSOs/mile/year ranging from 1.2 to 3.8, while the national average posted by EPA in 2004 is 4.5. What's more, the County's overall trend of SSOs/mile/year is downward. Over the past 11 years, the County's total volume of SSO's ranges from 47,000 to 2,950,000 gallons.

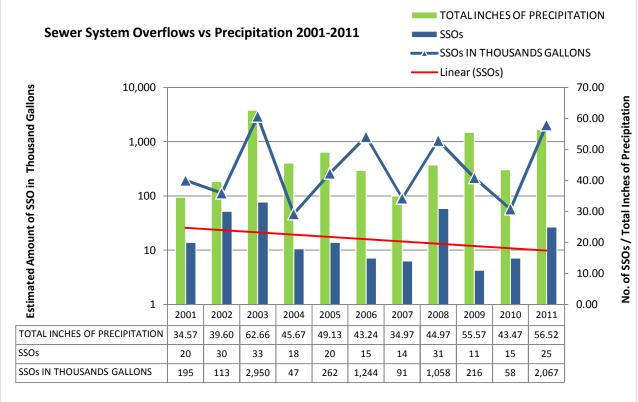
To further investigate the correlation between numbers of SSO occurrence to the total amount, the 11 years' precipitation data is plotted in the below chart. Although the numbers of SSO occurrence over the years keep a downward trend, the total overflow amount not only affected by the numbers of SSO occurrence, but also the total precipitation of the year.

* Precipitation Data Resources: National Climatic Data Center (NCDC) - http://www.ncdc.noaa.gov/
