# Tiber-Hudson & Plumtree Branch Stream Corridor Assessment 2012

Tiber-Hudson and Plumtree Branch Stream Corridor Assessment

S&S Planning and Design, LLC.

12/12/2012

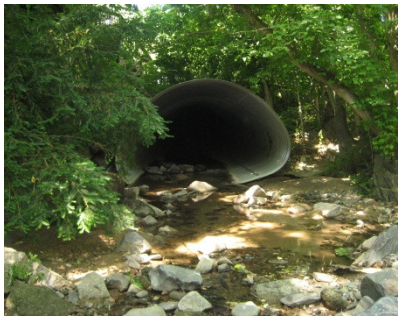
**Point # 1016**

Description: Downstream end of large culvert.

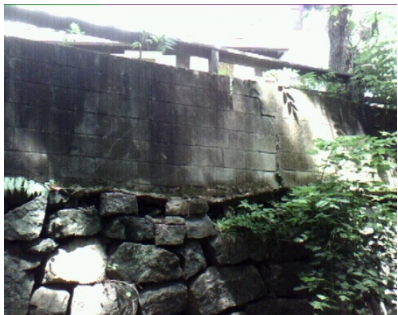
**Point # 1015**

Description: Failing cinderblock wall.

Site 4 is identified as Point No. 1015 within the SCA and is located adjacent to a parking lot for an apartment complex. It consists of a failing cinder block wall built on a stacked stone wall. The stacked stone wall is not mortared or grouted and it failing in locations as well. Where the stacked stone wall has completely failed, the block wall is ‘hanging’ without any base or support and the bottom of the wall is visible. In the event of a complete wall collapse, a portion of the parking lot above and adjacent to the wall would be compromised as well. This wall should be further evaluated for repair and/or replacement.

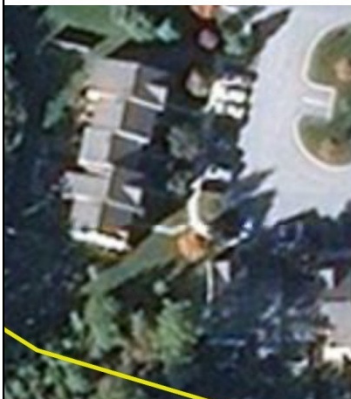
**Point # 1052**  
**Location: -76.817761 39.270135**  
Description: Road crossing. Bridge, box culvert.

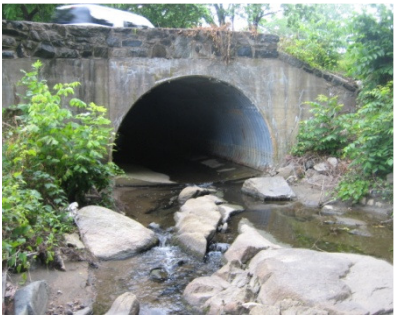
**Point # 1050**  
**Location: -76.816556 39.270004**  
Description: Road crossing. Pipe culvert, arch. 12'W x 8'H.

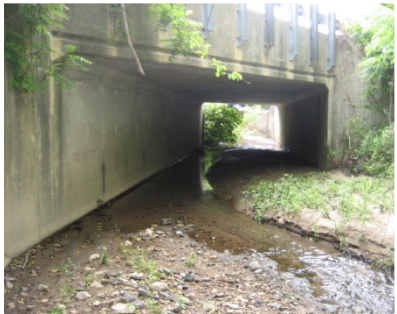
**Point # 1051**  
**Location: -76.817680 39.269650**  
Description: Road crossing. Bridge.

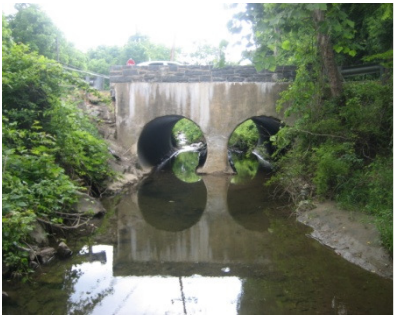
**Point # 1049**  
**Location: -76.815640 39.270099**  
Description: Road crossing. Pipe culvert.

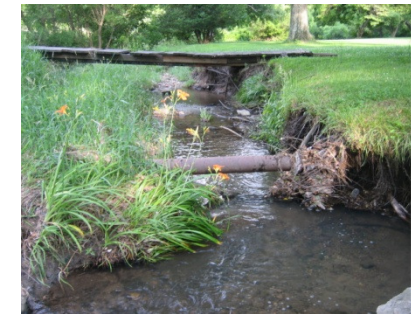
**Point # 1061**  
**Location: -76.820003 39.272013**  
Description: Erosion site. Lack of vegetation, mowed lawn up to top of bank.

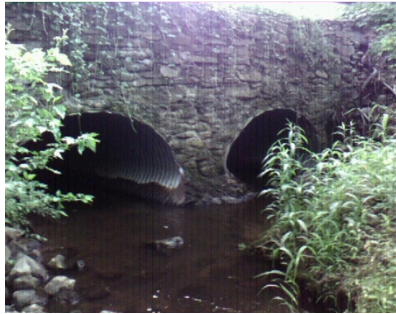
**Point # 101**  
**Location:** -76.840812 39.279565  
Description: Road crossing. Stacked stone headwall, ~8 feet above culvert inlet.

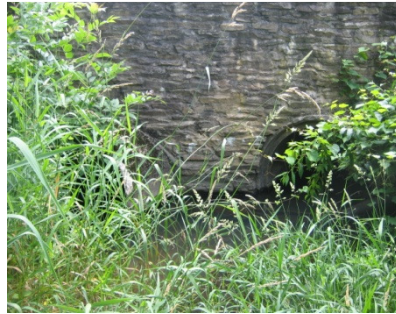
**Point # 112**  
**Location: -76.841476 39.281097**  
Description: See Point # 111.

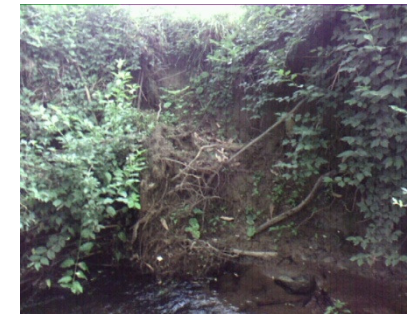
**Point # 110**  
**Location -76.841248 39.280920**  
Description: Erosion site. No vegetation or roots on bank.

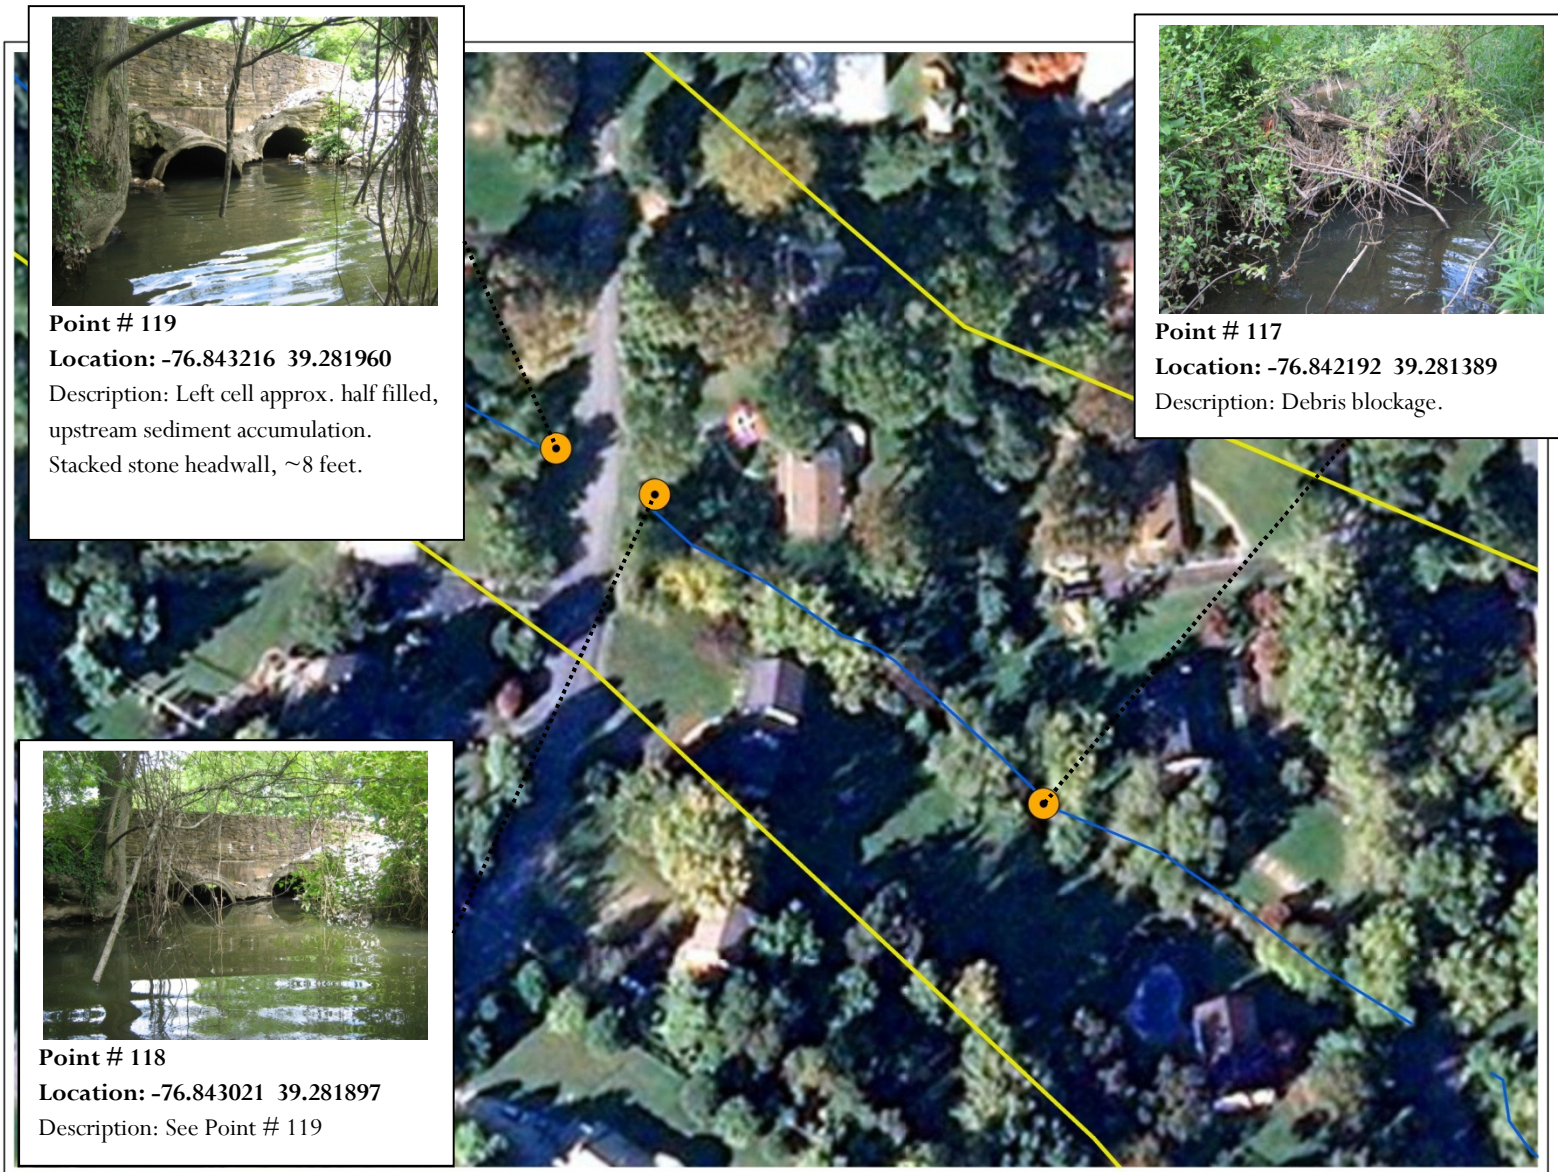
**Point # 116**  
**Location: -76.840603 39.278223**  
Description: Road crossing. Some debris at inlet.

Any debris accumulation at the culvert inlet can exacerbate flooding conditions by limiting the flow conveyance through the culvert, resulting in the crossing being overtopped with flood waters more quickly. As such, a debris maintenance and management plan could be implemented that could minimize the amount of debris within the stream channel. However, during any significant storm event within an unstable channel with eroding streambanks, additional debris can be introduced to the stream as banks fail and any woody vegetation along those banks gets caught in the flood flow. The implementation of effectiveness of such a plan is limited by the degree of cooperation among the stakeholders involved. Stream channels
