# **PATAPSCO RIVER**

## **SOUTH BRANCH AND LOWER NORTH BRANCH**

## **WATERSHED ASSESSMENT**

## January 2017

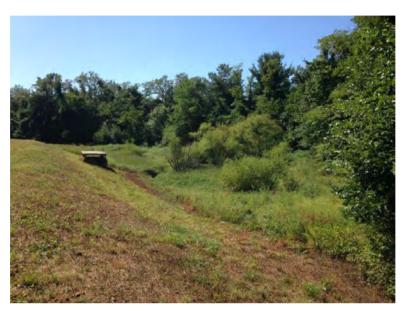
Site ID: LNB-BC-D002 Contractor: Straughan

Pond view from berm.

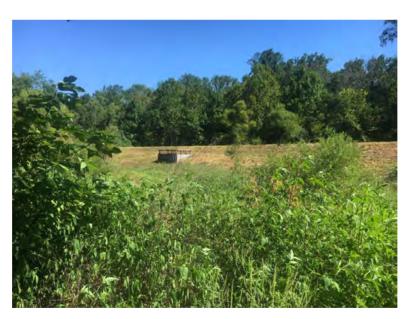
This facility, built in 1987, is designed as a dry pond to provide storm water management associated with the Sherwood Crossing Subdivision. Most of the subdivision runoff is from parking areas and secondary roads which drain into a major storm drain system. This system discharges into the pond via a 21 in. BCCMP, a 27 in. BCCMP, and a 42 in. BCCMP pipe. There is a riser structure at the west side of the pond which discharges to a 54 in. RCP spillway then to a rip rap channel before flow enters Deep Run. The pond is providing limited water quality improvement. Erosion was noted at the pond outfall.

Riser structure.

Expansion of the facility and conversion to an extended detention shallow wetland is proposed to improve water quality performance. This retrofit will require replacement of the existing riser structure. A shallow wetland was chosen because the drainage area should be sufficient to support a wetland, there is adequate head, and retaining existing vegetation was desirable. Shallow wetlands have high community acceptance, provide high habitat quality, are relatively easy to maintain, and are usually not a safety concern. Outfall stabilization is recommended to prevent further outfall undercutting. Ensure compliance with MD Pond Code 378.

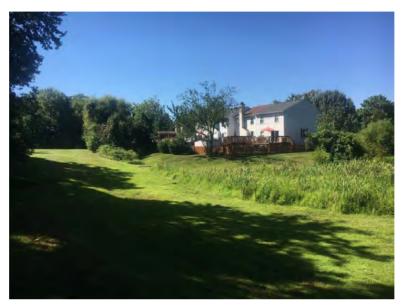
Pond view from downstream berm.

The proposed retrofit concept is to convert existing dry pond into a Micropool extended detention facility with a forebay and a Micropool. A principal spillway including a new riser structure is proposed to replace the existing dual CMP pipe outfall. An extended detention pond with micropool was chosen because the drainage area to the facility is greater than 10 ac. and the available dry storage capacity that can be reallocated to meet the current regulations to the maximum extent practicable. Ensure compliance with current MD Pond Code 378.

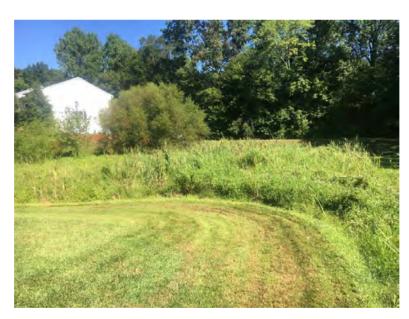
Pond view from upstream.

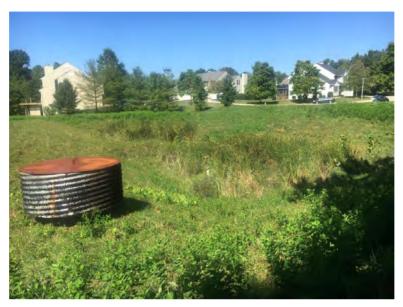
This facility, built in 1991, is a dry detention facility with a forebay downstream of the main storm drainage system that provides management for almost the entire Woodbrook subdivision, including all of the roadways. Only a small area bypasses the forebay and enters the pond via a grass swale located along the western property line. The current forebay spillway requires repairs to the wire mesh and replacement of rock. Existing anti-seep collar and core trench was noted on as-builts.

Pond view from berm.

The proposed retrofit is to excavate to increase capacity to provide for the water quality volume. The capacity of the existing forebay within the pond basin will also be increased and the riser structure will be replaced to provide the necessary storage volume and safely pass the higher storm events. An extended detention pond with micropool was chosen because the drainage area is sufficient if an anti-clogging device is installed and the available dry storage capacity can be reallocated to meet the current regulations to the maximum extent practicable. Repair to current forebay spillway components is recommended. Ensure compliance with current MD Pond Code 378.

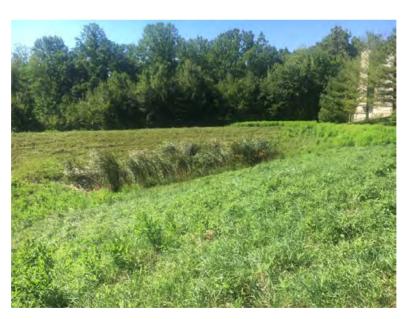
Pond forebay from upslope bank.

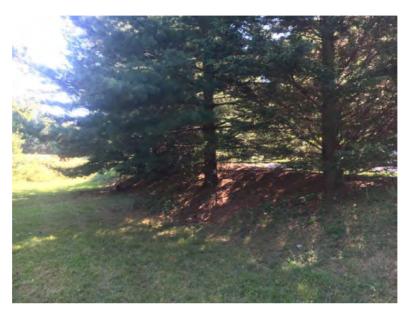
The facility, built 1984, is in public ownership. Drainage is collected from Hunting Horn Drive and Montgomery Road via a stormdrain system that is designed to flow into the dry pond through an inlet and 21 in. RCP. A concrete structure with an internal weir and low flow orifice within the downstream stormdrain system restricts flows draining to the downstream 18 in. RCP under Montgomery Road. The downstream storm drain system ultimately discharges into a stream that connects to Rockburn Branch.

Downstream view of earthen berm.

The proposed retrofit concept is to improve water quality performance by converting the existing dry pond to a "micropool" extended detention pond. The forebay, pilot channel, and micropool (3 to 4 ft. deep) will be designed to retain adjacent vegetation to the maximum extent possible. The pond bottom is to be excavated to increase capacity and the existing outfall structure modified to store the required management volumes. The existing inlet to the south of the pond is to be replaced with a splitter structure to allow runoff to be diverted during low flow events. A more detailed analysis may show that this design could provide channel protection. A detailed hydraulic gradient analysis of this downstream storm drain is necessary to determine the effects on peak discharge capacity and on water surface elevations in the pond. Soil borings may be required to determine water table elevation.

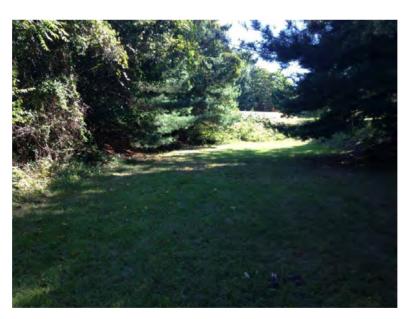
Upstream view of pond.

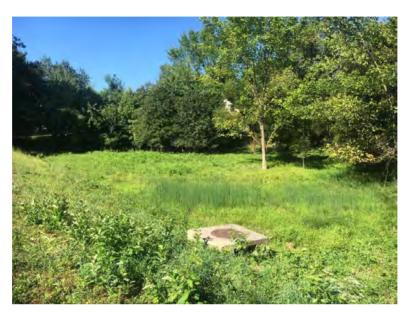
The facility, built 1984, is in public ownership. Drainage is collected from Mitzy Lane via a stormdrain system that discharges into a riprap apron at the northwest side of the pond. The dry pond outfalls through a riser structure ultimately flowing to a nearby open field.

Overall pond view from berm.

The proposed retrofit concept is to improve water quality performance by converting the existing dry pond to a "micropool" extended detention pond. The forebay, pilot channel, and micropool (4 ft. deep) will be designed to retain adjacent vegetation to the maximum extent possible. A manhole and pipe is to be connected to the existing 18 in. RCP stormdrain pipe at the northwest end of the pond. The existing pond bottom is to be excavated to provide a flatter slope for the pilot channel. The existing outfall structure is in excellent condition and is to be modified to store the required management volumes. A more detailed analysis may show that this design could provide channel protection while satisfying freeboard requirements. An extended detention pond with micropool was chosen because the drainage area is greater than 10 ac., and since space is limited a micropool ED requires a relatively small footprint. Ensure compliance with current MD Pond Code 378.

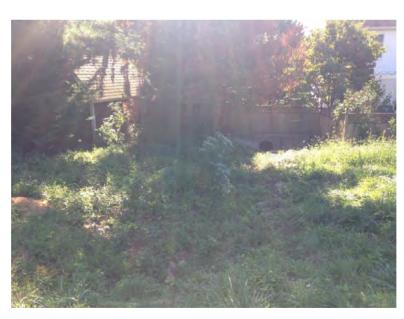
Downstream view to receiving storm drain pipe.

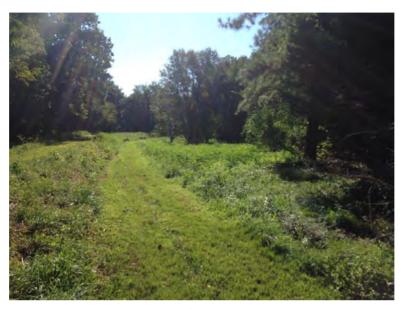
The facility, built 1984, is in public ownership according to County GIS property data. Drainage is collected from East Glen Road and discharged into a small drainage swale located between two residences. Eventually, stormwater runoff is conveyed to a dry stormwater management pond and ultimately discharged into the county drainage system.

Pond view from access path.

This project will convert a dry stormwater detention pond into an infiltration basin with a forebay. The concept requires the removal of 3.5 ft. of existing soil and the installation of underground perforated pipes. The excavated soils will be replaced with 1 ft. of crushed stone, 15 in. of sand with 3 in. of topsoil. The proposed basin will have an elevation approximately 1 ft. lower than the existing pond. To provide pre-treatment, the existing drainage ditch will be upgraded with the installation of synthetic erosion control blankets and construction of a dry forebay with a concrete level spreader. The infiltration basin is sized to provide water quality (WQv) for the greater than 1-in. storm event. Given the available pond bed surface, only a portion will need to be converted to infiltration media. Recharge volume (to the aquifer) is provided within a stone-filled reservoir directly below the basin. A new overflow structure and discharge pipe will be constructed to provide flow for the underground pipes. Since the elevation of the outfall is lower than the existing conditions, the discharge pipe needs to be extended farther from the pond and may require an easement for construction. An infiltration basin was chosen because the drainage area is under the maximum threshold, there is adequate head, and there is recharge availability. Infiltration basins are relatively moderately easy to maintain and are not a safety concern. A geotechnical investigation is required to confirm infiltration rates. If the geotechnical analysis shows inadequate infiltration rates, then a secondary option, such as micropool extended detention pond or retention pond, should be considered. Ensure compliance with current MD Pond Code 378.

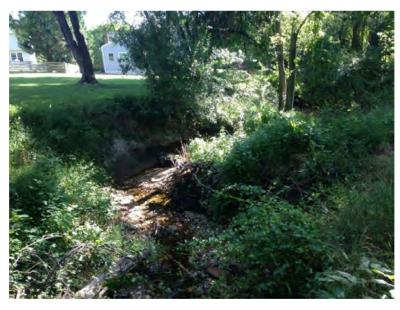
Outfall into stream.

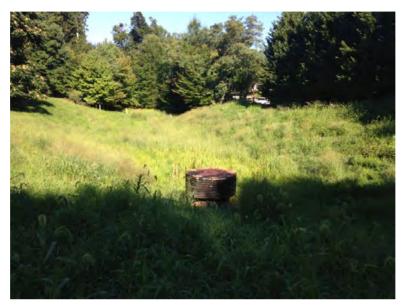
This existing dry pond, built 1992, is labeled SWM #1 on the as-built plan and is adjacent to Kesting Court cul-desac. The pond receives runoff from two separate storm drain systems that discharge to the west through two 24 in. pipes. The low orifice of the riser is currently clogged and causing standing water. The pond outfalls via a 36 in. spillway to an unstable ditch that runs through residential backyards to a nearby public storm drain system.

Pond view from riser side berm.

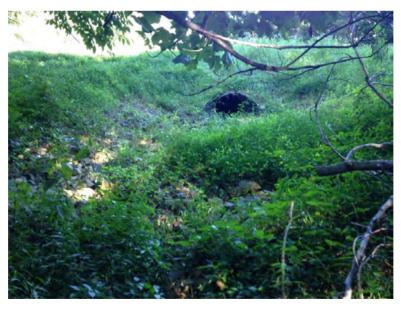
Upstream view of outfall channel.

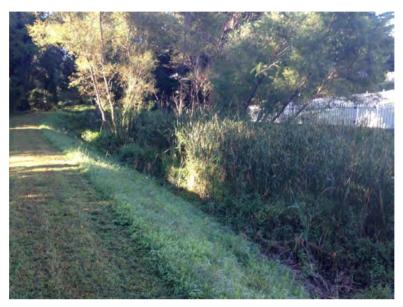
This facility, built 1988, is noted as a water quality wet pond on the as-built drawings for the Mt. Hebron Subdivision development; however, photographs, field investigation, and the county's database indicate it is a dry pond. Most of the subdivision runoff is from the southern portion of Thornbrook Road, Haven Oak Court, and Sara Beth Court which drain into a major storm drain system. This system discharges into the pond via a 33 in. CMP pipe. The pond outfalls its high flow via a weir with a crest elevation of 402.1 ft. which discharges against the receiving stream flow. The pond outfalls its low flow via a 12 in. BCCMP spillway. The spillway is severely eroded with crumbling concrete and displaced riprap. The field photos do not depict the weir nor do they depict the plate with a 3 in. diameter hole welded to the face of the 12 in. BCCMP pipe as shown on the as-built drawings for the facility. The pond appears to provide very limited water quality benefit.

Pond view upstream from streamside berm.

The concept retrofit design is to replace the dry pond with a wet extended detention pond. Either full water quality treatment or a pretreatment forebay will not be provided due to limited available space. The ponding will require excavation for the water quality volume storage. The low-flow orifice invert will have to be raised. A wet extended detention pond was chosen because the drainage area to the facility is greater than 10 ac. and the available dry storage capacity that can be reallocated to meet the current regulations to the maximum extent practicable. The estimate also includes embankment repair at an outfall at the upstream end of the pond that is not shown on the as-builts. Ensure compliance with current MD Pond Code 378.

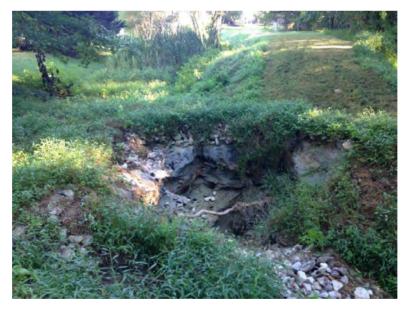
Outfall channel looking upstream to SWM facility. Spillway erosion noted.

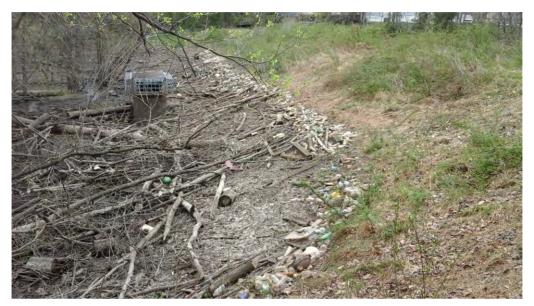
The site consists of a residential neighborhood and the pond appears to be online with a channel running through the facility. Currently, the 169.65 ac. drainage area includes the bordering neighborhoods along with portions of Old Waterloo Road and commercial and residential buildings west of Old Waterloo Road. Discharge enters the facility from the stream from the west/northwest and a storm drain outfall from the west/southwest. The stream channel has a large number of storm drain outfall points from the residential neighborhoods both south and north of the channel. The existing pond has a severe amount of sediment (estimated 2+ ft.) and is swamp-like with standing water and trees in the pond bottom. A significant amount of trash was observed on the pond perimeter and at the embankment. Per the original design plans F-80-162, a 30 in. low flow RCP pipe with an end section is to convey the stream baseflow. As observed in the field, the pipe and end section are almost buried in sediment. The sediment has built up around the end section resulting in a depression for the constant flow to leave the facility. The large concrete riser structure with weirs on all sides appears to be in good condition along with the twin 30 in. RCP principal spillway pipes. An emergency spillway to the north has riprap stabilization with vegetation growing. A large scour hole is present at the outfall and moderate erosion is occurring in the stream banks downstream. No utilities were observed in the field, but per the plans and County data, a sewer line runs along the north edge of the existing pond.

Looking north along the embankment toward the riser structure.

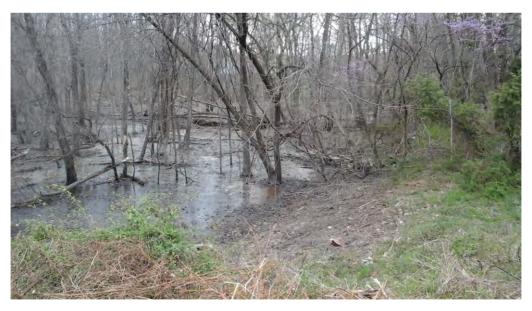
Looking west toward the pond area from the emergency spillway/embankment.

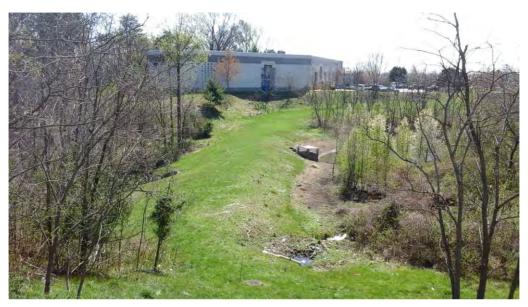
The site is a commercial business park with large warehouses, loading docks, and parking lots. Currently, flows enter the pond from three storm drain inflows. Two of the inflows enter into a forebay in the southwestern corner of the pond and the other storm drain inflow outfalls into an elevated and vegetated area; the inflows in the forebay are partially submerged. The forebay and primary pond area have some silt and sediment deposition and are wet with about 1 ft. or more of standing water. The low flow riprap shown in the design plans (F-96-136) was not visible, but there was a steady flow observed through the orifice plate in the riser. Some erosion is occurring in the pond bottom from the third inflow. The riser is in good condition, but there is not 1 ft. of clearance between the trash rack and the embankment. Per the design plans, the riser has weirs on all four sides and a 48 in. RCP principal spillway. The outfall is stable with riprap, but downstream prior to the stream confluence, a pilot channel is actively eroding and small headcuts are forming. Steep slopes surround a majority of the pond and a sewer line runs along the western side of the facility. Access would likely be from the eastern side of the facility.

Looking southeast toward the embankment and riser structure from the building parking lot.

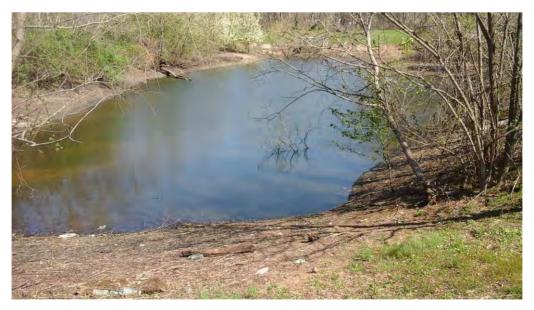
Looking northeast toward the pond area and riser structure from the slope along Troy Hill Drive.

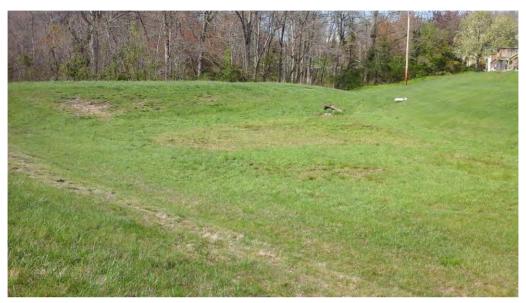
Looking west toward the pond area, embankment, and outfall end section structure.

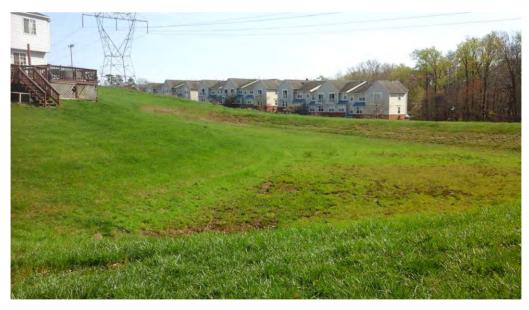
Looking southeast toward the pond area, inflow swale, and embankment from the outfall end section.

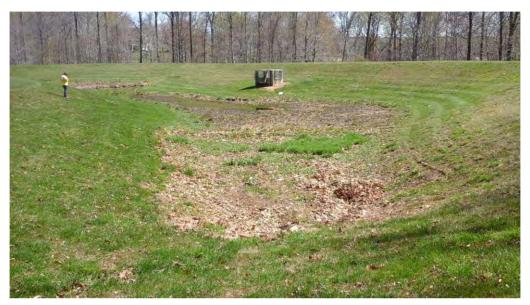
Looking north from the south inflow toward the pond area, riser, and embankment.

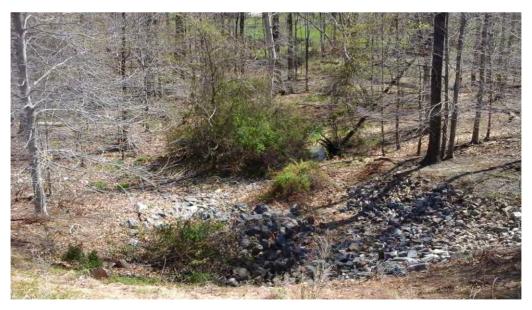
Looking east at the pond outfall from the embankment.

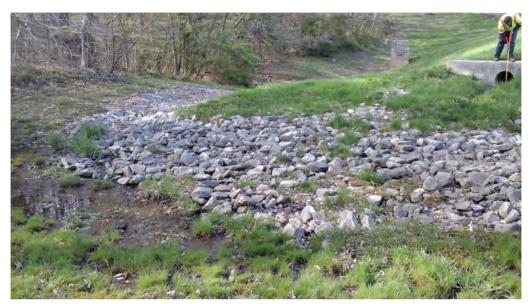
Looking north from the forebay at the inflow, gabion channel, and riser structure.

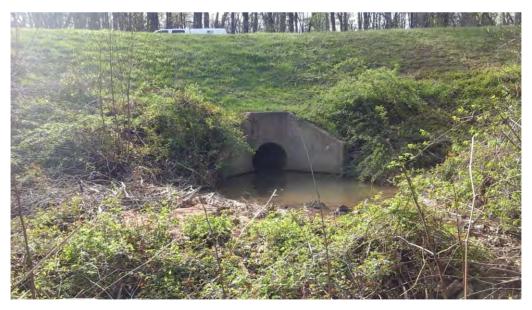
Looking west toward the outfall from the area where erosion and headcuts begin.

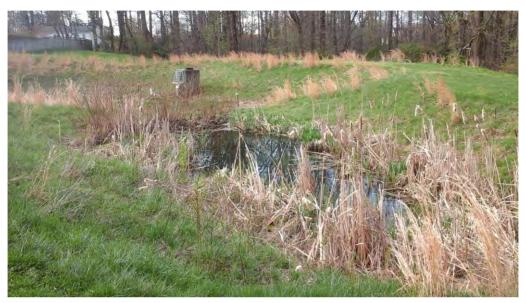
Looking southeast toward the inflow forebay, riser structure, and embankment.

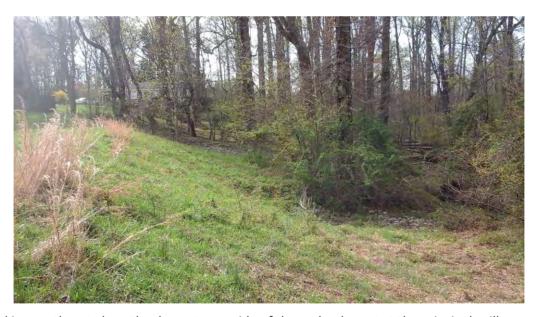
Looking southeast along the downstream side of the embankment at the principal spillway outfall (near riprap) and emergency spillway outfall (far riprap).

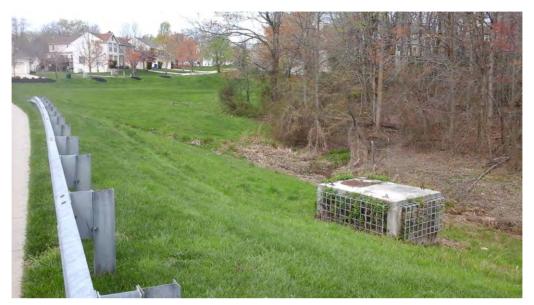
Looking northwest at the riser, western inflow, and a portion of the wooded pond bottom.

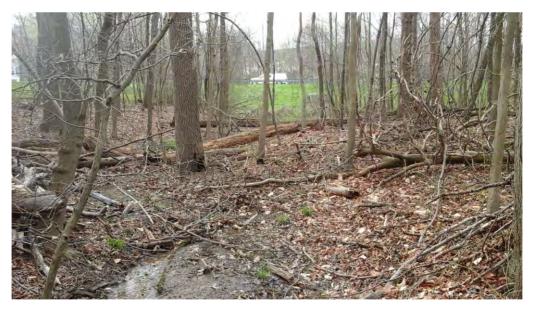
Looking south toward the riser and embankment (Greenmount Drive) from inside the facility bottom.

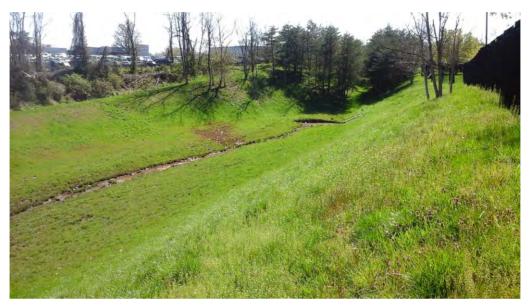
Looking southwest toward the pond inflow from the embankment near the parking lot.

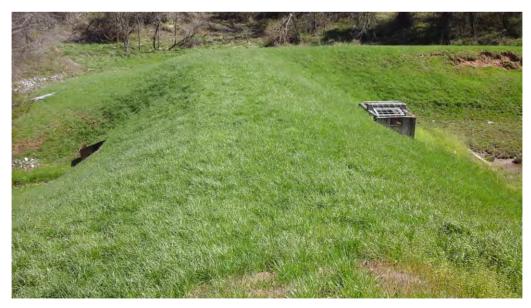
Looking southeast along the embankment toward the riser structure and outfall from the top of the embankment near the parking lot and access gate.

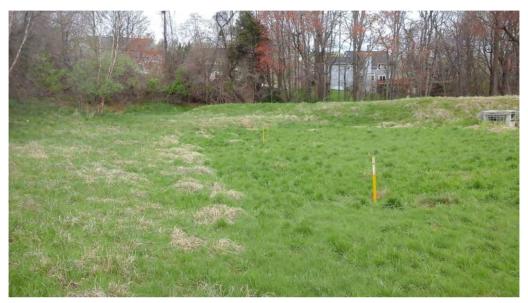
Looking north toward the emergency spillway (left), embankment, and riser structure.

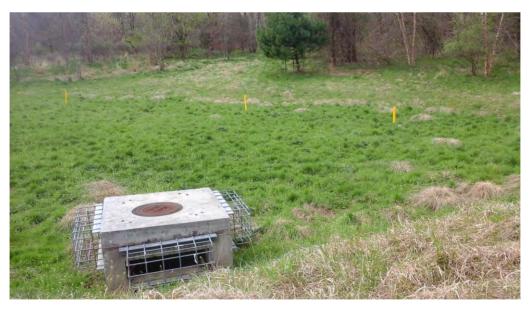
Looking south toward the riser, upland area of the pond, and riser structure from the embankment.

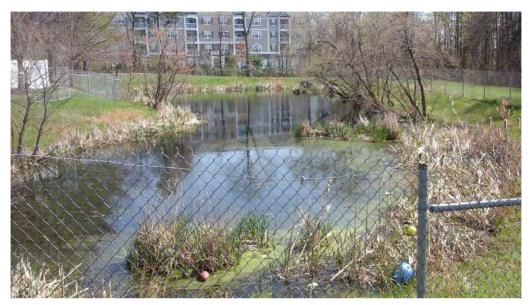
Looking southeast toward the riser structure from the area just uphill of the inflows.

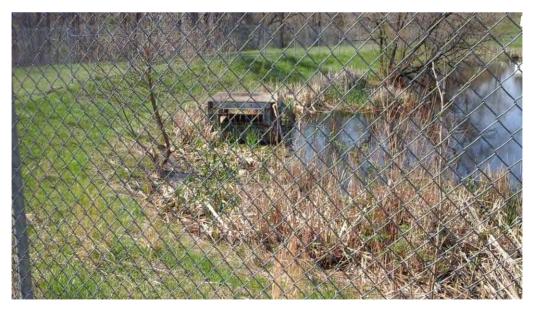
Looking west toward the riser structure and embankment.

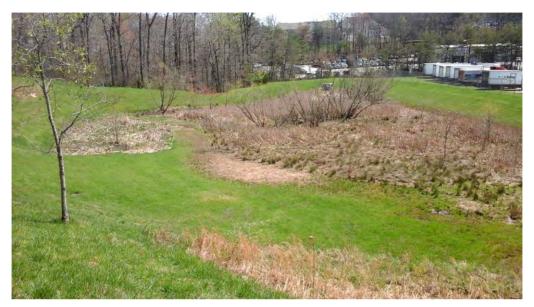
Looking south toward the pond with the inflow, forebay, riser structure, and embankment included in the photo.

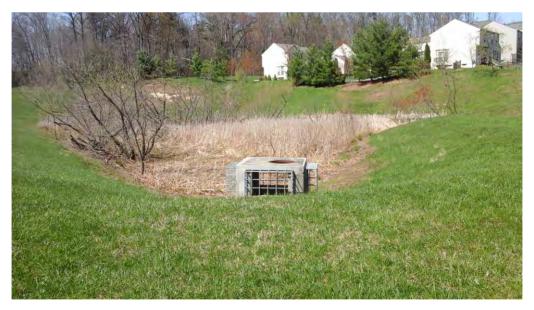
Looking north toward the riser and pond area from the embankment with areas of erosion and the access in the distance.

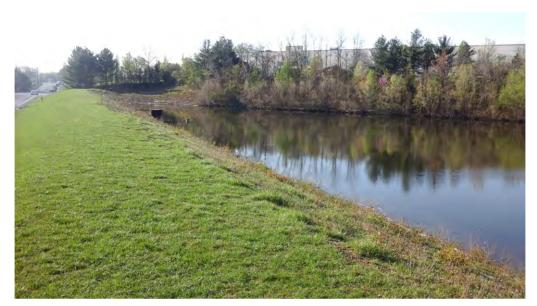
Looking southeast along the embankment toward the riser structure and emergency spillway.

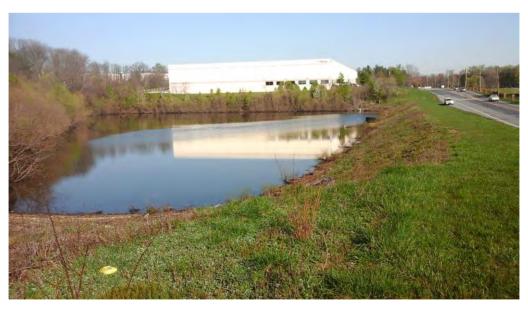
Looking northwest along the embankment toward the riser structure.

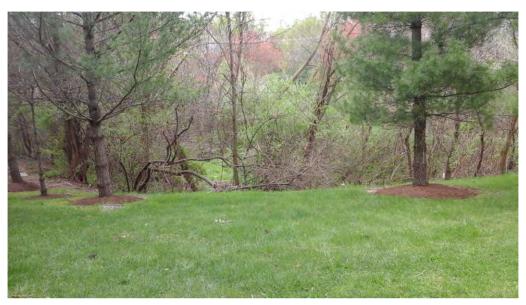
Looking south toward the pond and the area of the storm drain inflow.

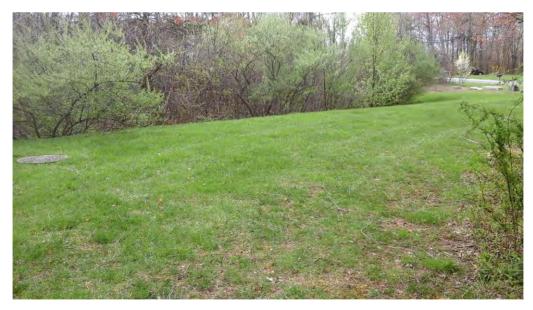
Site ID: LNB-BC-F515 Contractor: McCormick Taylor

Looking south toward the pond and Meadowridge Road from the embankment near the outlet structure manhole.

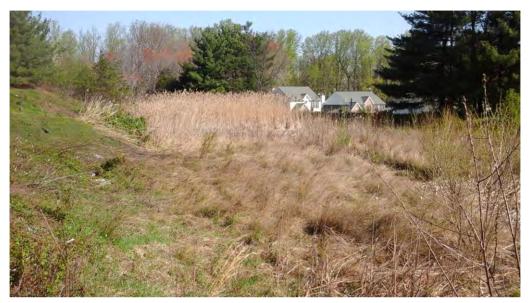
Looking north toward the area of phragmites at the inflows from the upland area of the pond.

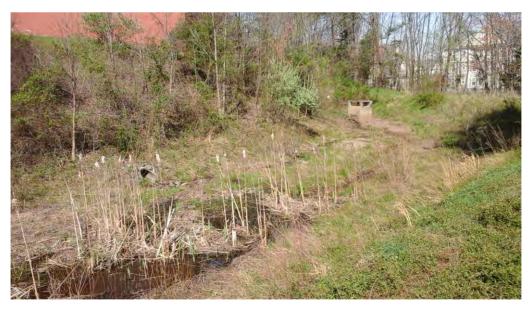
Looking north toward the riser structure and embankment.

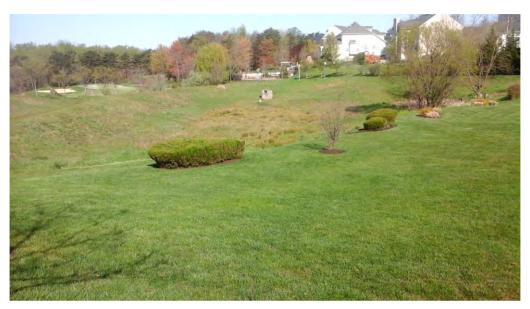
Looking northwest toward the pond from the access path with the inflows and forebay to the right, riser in the center, and embankment on the left.

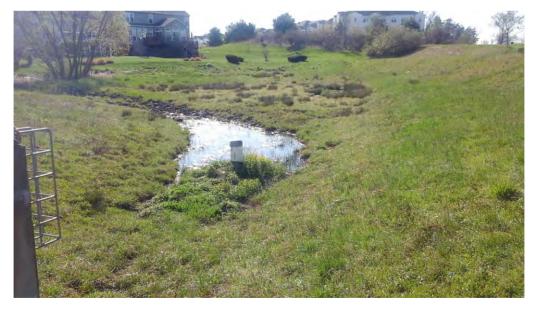
Looking southeast toward the access path, pond area, and low flow standpipe from the riser structure.

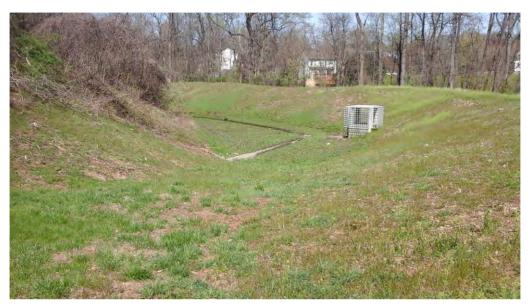
Looking northwest from the access path toward the pond area, concrete inflow channels, riser structure, and embankment.

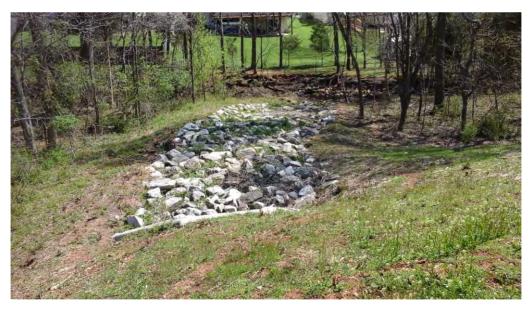
Looking east at the outfall gabion weir channel from the embankment.

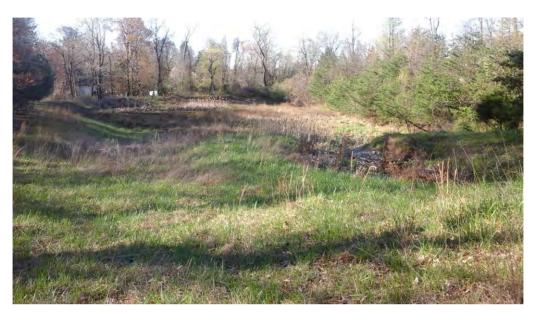
Looking south toward the pond with the inflow and forebay on the right and embankment and weir structure on the left.

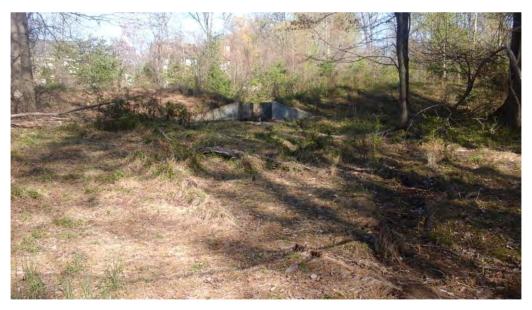
Looking west toward the weir structure from the downstream side.

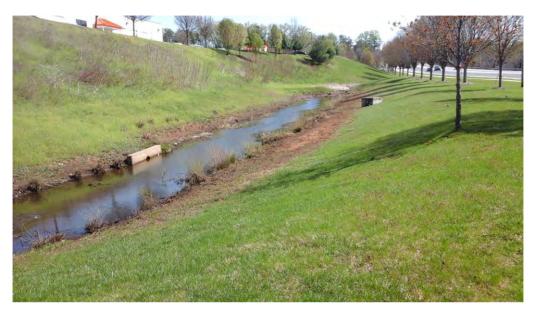
Looking northeast toward the facility showing one of the inflows and one of the riser structures.

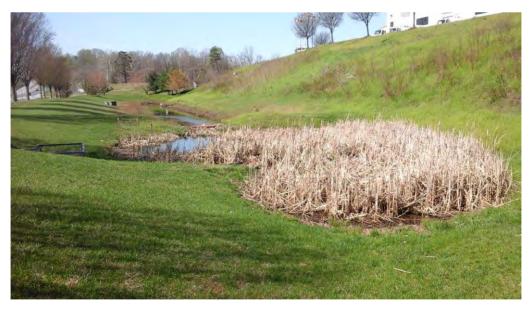
Looking southwest toward the facility showing a second inflow and riser structure.

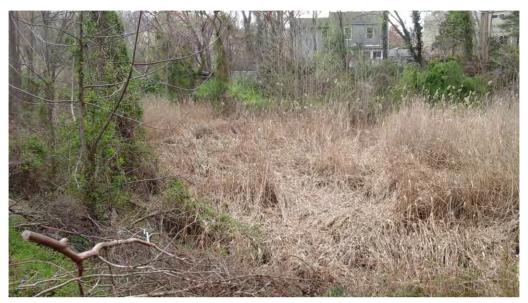
Looking west toward the pond area and Well Water Way from the embankment.

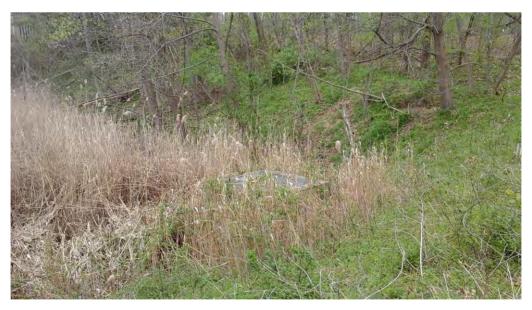
Looking northwest at the riser structure from the embankment.

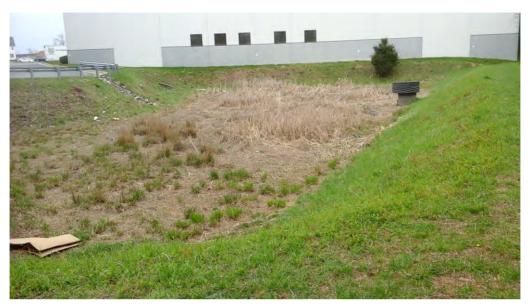
Looking west toward the facility with the two inflows on the left and the riser and embankment on the right.

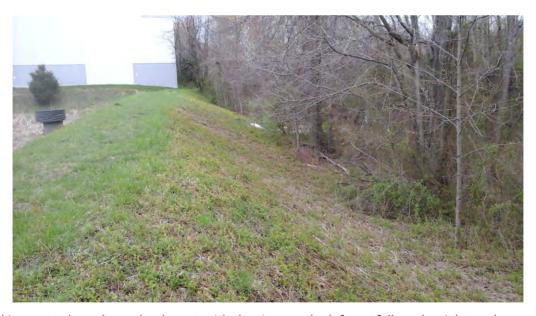
Looking west along the embankment with the riser on the left, outfall on the right, and emergency spillway in the distance.

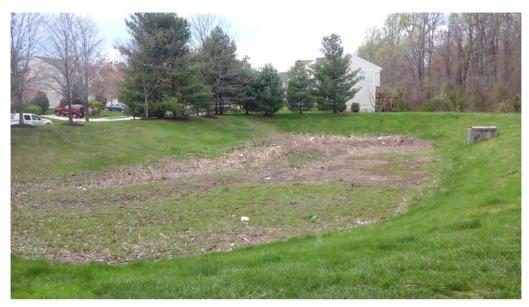
Looking northwest at the pond area with the inflows and forebay on the left and riser structure and embankment on the right.

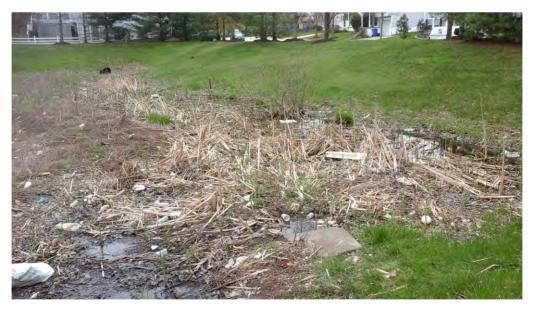
Looking southeast at the forebay from the inflow on the western side of the pond.

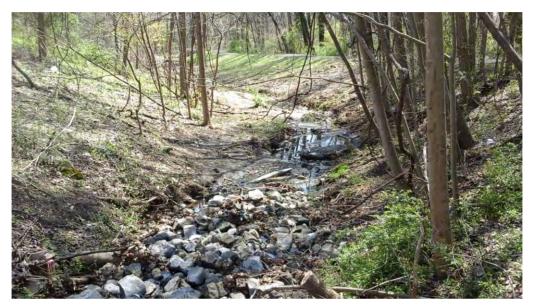
Looking southeast toward the pond from the inflow in the northwest corner of the pond.

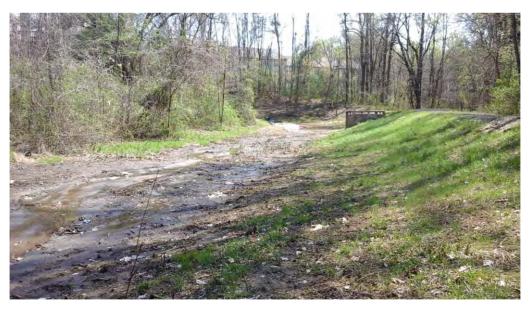
Looking southeast toward the riser structure from the center of the pond.

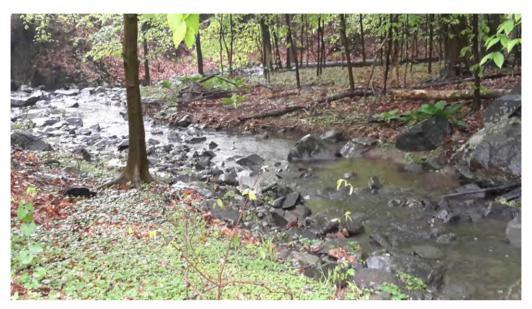
The existing BMP is a dry pond which is not functioning as designed. Water bypasses the riser structure and drains through the embankment. The outfall channel has about 5 lf. of eroded banks but there is no erosion along the stream channel downstream of the outfall. The pond bottom is over vegetated.

Outfall channel looking northeast.

The dry pond can be converted to a wet pond by removing the riser structure and barrel pipe. The embankment will be reconstructed and the pond regraded to address potential embankment failure. However, the project would be confined to a small area which may cause complications in the design phase and ultimately would not provide much water treatment. If the pond is not chosen to be converted, the embankment and riser structure should be repaired.

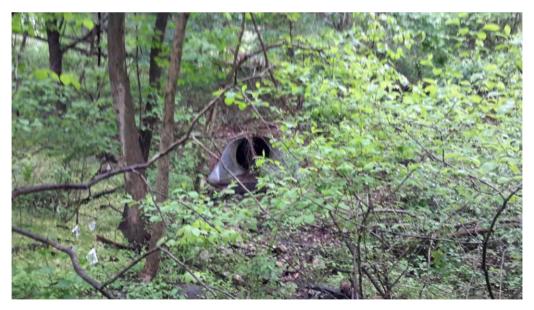
Pond inflow looking south.

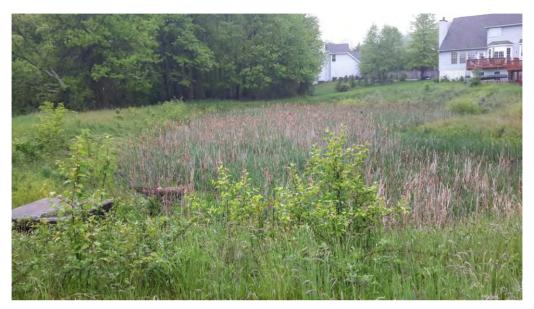
The existing BMP is a dry pond in good condition. At the time of assessment, the pond had standing water and flow through the low flow orifice. The low flow orifice has been buried and partially clogged, causing water to pond at the surface and the invasion of cattails. The riser structure was in good condition. There was no erosion noted at the site.

Overview of pond facing northwest.

Since this site is large and suitable for a wetland type environment, the site is proposed to be converted to a shallow wetland. The wetland will be graded to include a forebay micropool, high marsh and low marsh zones, a deep pool near the riser, and a low flow channel. The riser will be modified to provide ponding depth. Overgrown vegetation and trees will be removed and replaced with wetland vegetation.

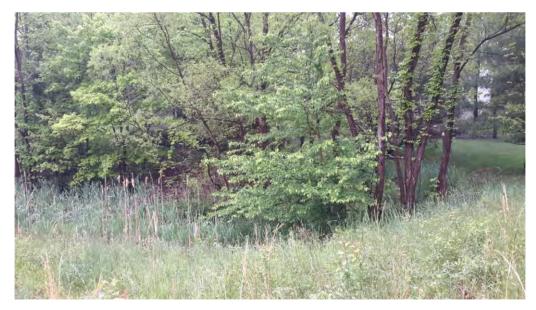
View of existing forebay.

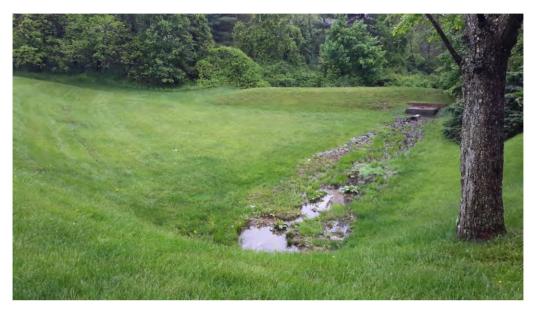
The existing site is a dry pond with a straight rip rap conveyance channel in good condition. The existing riser is functioning well but the inflow and outflow metal structures are corroded and need repair. No erosion was found at the site.

Existing pond overview looking east.

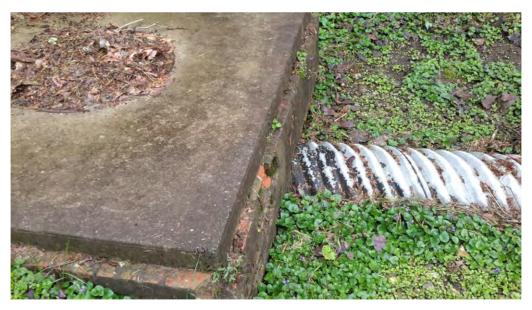
Existing riser structure and inlet.

The conversion of this site to an infiltration basin is proposed. A stilling basin is proposed near the inflow of the pond and the main basin near the riser structure. The existing riser structure will be replaced to address corrosion issues. An investigation of the existing soils will be required to determine infiltration capability, but at the time of assessment, the pond was relatively dry even after several days of rain.

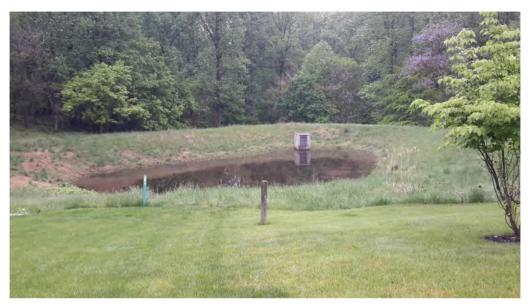
This BMP was designed as a extended detention dry pond. The riser structure is in good condition. However, the low flow orifice is partially clogged, causing water to pond. The inlet pipe may be buried or below the water surface. There is 10 ft. of minor erosion at the outfall and 20 ft. of minor stream channel erosion downstream of the outfall.

Overview of pond looking east.

The facility is proposed to be converted to a wet pond to treat stormwater. A forebay is proposed at the inflow and the riser will be modified to increase storage volume. The pond may need excavation to increase pond depth without flooding nearby properties. This site has easy access and is in good condition. Therefore, this BMP is a good candidate for conversion for water quality credit.

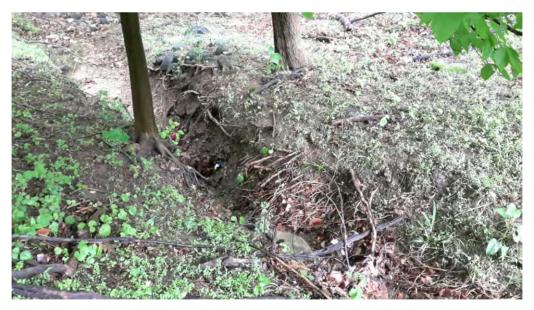
Channel erosion downstream of outfall.

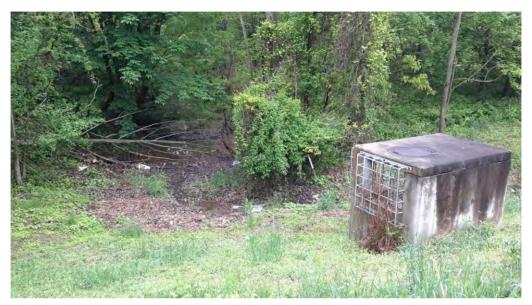
The existing pond is in line with the stream and is very narrow. The pond is functioning and the structure is in good condition. There was no erosion found at or downstream of the outfall. Minor maintenance is needed.

Overall view of pond with riser looking west.

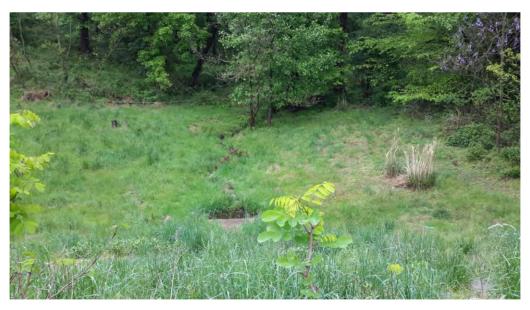
Outfall channel on east side of Chews Vineyard looking east.

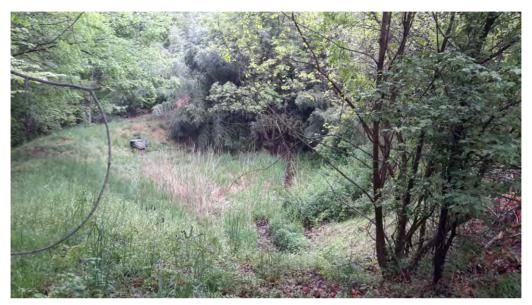
Existing pond and riser structure looking north.

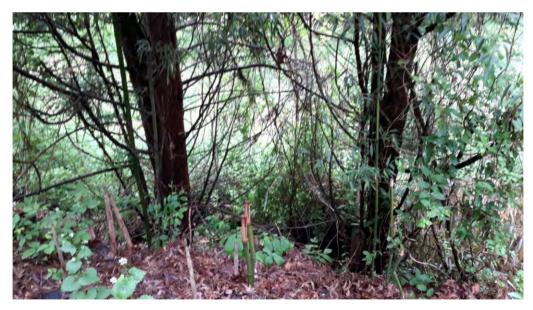
Limited information on existing pond condition. Adjacent property owner made a complaint about trees and bamboo on the southeast side of the pond encroaching into the adjacent southern property. There is 50 ft. of minor erosion at outfall and 200 ft. of moderate stream channel erosion downstream of the outfall. The pond needs maintenance for invasive species.

Trees and invasive vegetation growing into nearby residential property looking south.

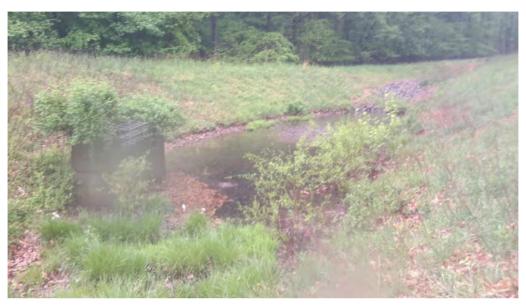
The existing pond and riser structure are in good condition and functioning as a dry pond with a little bit of ponding water due to recent storms. No erosion was noted at the outfall but 50 ft. of minor stream channel erosion downstream of the outfall was noted.

Overview of pond and riser structure looking southeast.

Due to limited surface area, this pond is proposed to be converted to a wet pond or infiltration basin depending on infiltration capability of the soils. The riser structure will be modified to increase water storage.

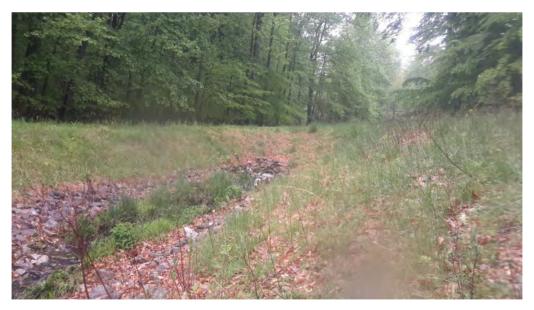
Inflow pipe to pond looking south.

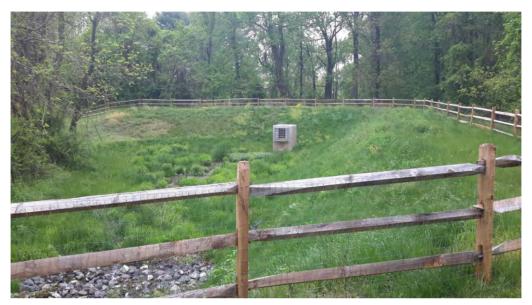
The existing pond is in good condition and the riser structure is new. The inflow and outfall structures are also in good condition. No erosion was noted at the site.

Overview of pond looking east.

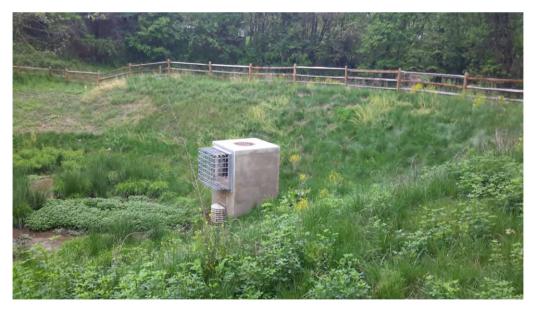
Pond riser structure looking north.

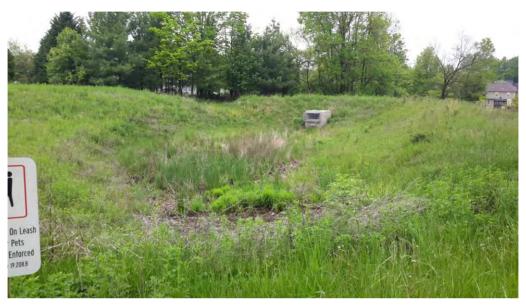
The existing dry pond is in good condition. The structures are new and functioning well. There was no erosion at the site.

Overview of pond looking south.

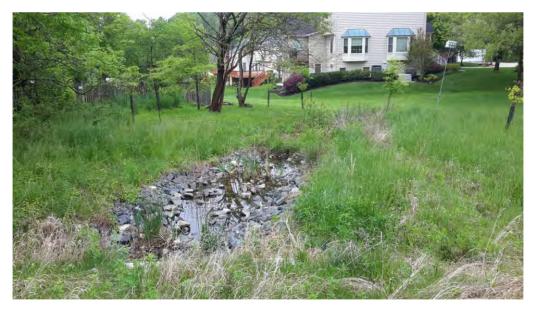
Pond outfall looking north.

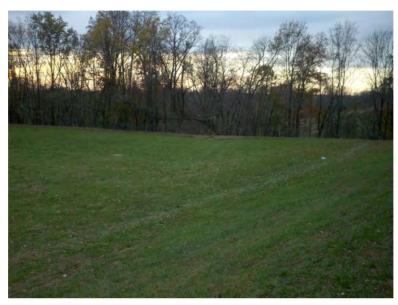
Looking south toward the area of the proposed underground sand filter.

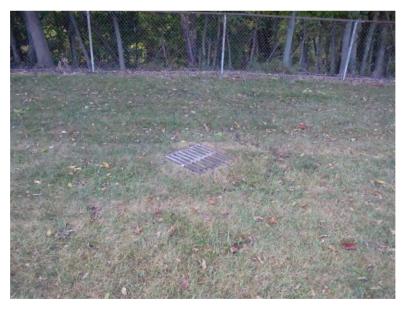
Looking northwest toward the existing inlet.

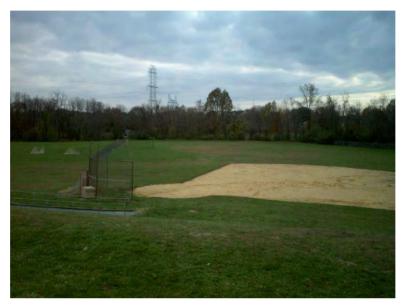
Looking west toward the area of the proposed underground sand filter.

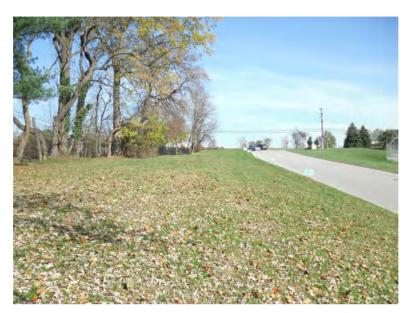
Looking north along the school entrance driveway toward the area of the proposed bioswale.

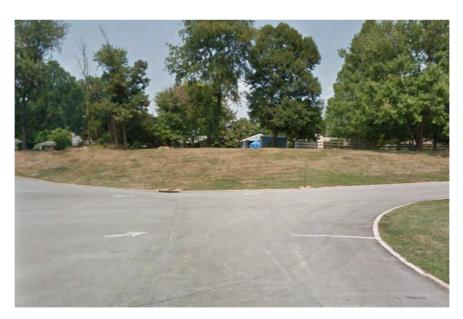
Looking west toward the downstream inlet the bioswale underdrain should tie into.

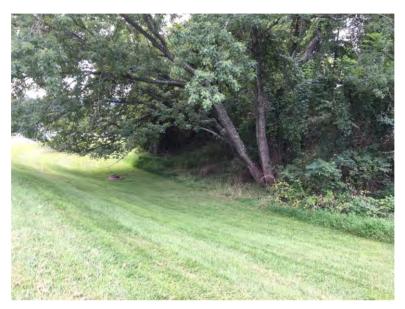
Existing grass area for proposed bioretention

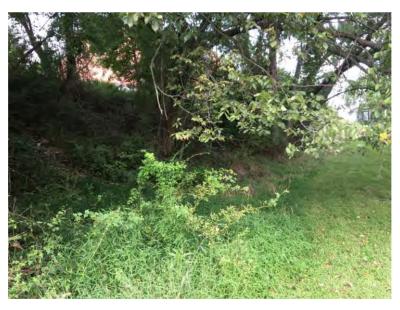
This is a concept from the Tiber-Hudson Subwatershed Restoration Action Plan- site RRI\_8. There is an existing grass area on the east side of the parking lot receiving water from buildings, parking lots, and driveways of the County office complex. The slopes of the area between the parking lot and the grass area are steep. There is an existing stormdrain manhole and inlet near this site that can be used for proposed facility underdrain connection.

Steep slope area between the parking lot and grass area

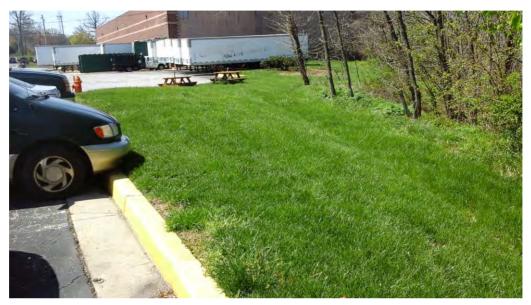
Looking west toward the upstream area of the existing swale.

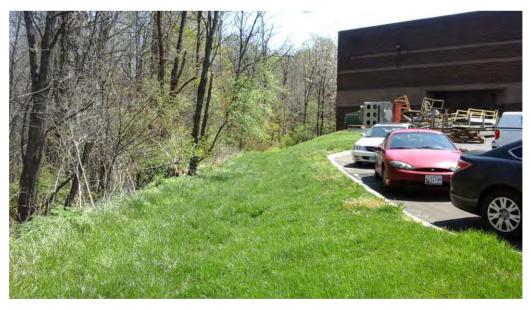
Looking east toward the downstream area of the existing swale.

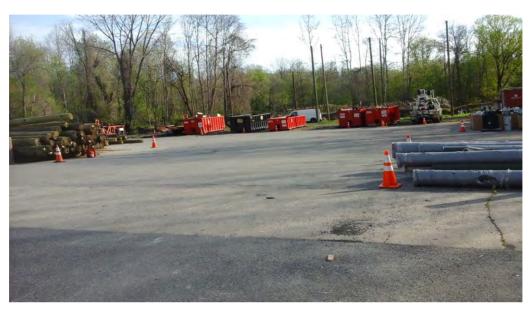
Looking northeast toward the back of the property from the parking lot (LNB-NB-502A).

LNB-NB-F502A - An infiltration trench is proposed along the northeastern edge of the property. An infiltration test should be completed to determine if the soil has sufficient drainage and the water table will need to be verified to ensure a 5ft vertical separation between the facility bottom and the water table. These parameters may result in this facility being unfeasible. For this concept, a 141 lf. level spreader is assumed for the pretreatment of 635 cf. at 3 ft. wide and 1.5 ft. deep. Following the level spreader, a 20 ft. grass buffer is proposed, and finally a 51 ft. wide by 42 ft. long infiltration trench area. The infiltration trench is assumed to be 8 ft. deep with 40% porosity, providing 6,854 cf. of treatment, 88% of the WQv for the drainage area.

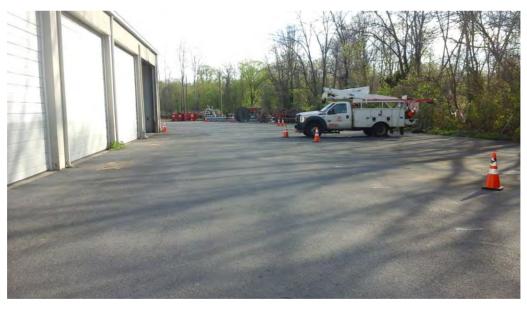
Looking northeast toward the area of the proposed facility (LNB-NB-502B).

LNB-NB-F502B - An underground sand filter (USF) is recommended along the eastern edge of the parking lot in an existing low area. Along with the proposed facility, the addition of curb and gutter is proposed along the perimeter of the parking lot with new storm drain inlets to divert runoff into the facility. The USF would provide 1,080 cf. of pretreatment in a sedimentation chamber with a surface area of approximately 216 sf.. The sand filter area would be 1,044 sf. With 2 ft. of media for treatment. An additional 3 ft. of temporary ponding over the facility area (1,044 sf.) is also considered to treat 100% of the WQv (3,967 cf.). The total size of the USF would be approximately 36 ft. wide and 40 ft. long (interior dimensions). This area includes the three chambers for sedimentation, treatment, and overflow as typical per the MDE stormwater design manual. A storm drain outfall would need to be added to provide an outfall for the facility near the wetland to the east of the parking lot.

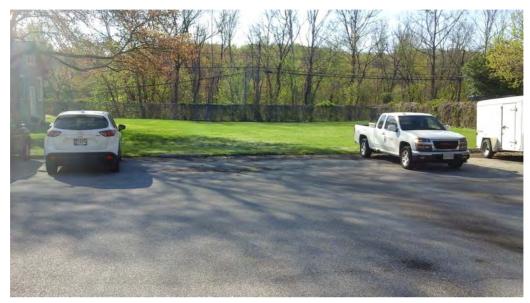
Looking southeast toward the open space where the facility is proposed (LNB-NB-503A).

LNB-NB-F503A - An infiltration trench is proposed in the existing grass space in the southern area of the property. Due to the flat grade, there is no opportunity for an outfall, so an infiltration trench is proposed that would allow flow to enter the treatment area and overflow runoff to continue down gradient. An infiltration test should be completed to determine if the soil has sufficient drainage and the water table will need verified to ensure a 5 ft. vertical separation between the facility bottom and the water table. These parameters may result in this facility being unfeasible. For this concept, two inflows from two different locations in the parking lot along with new curb and gutter are assumed and a riprap swale is proposed from each to provide pretreatment. Together, the swales provide 770 cf. of storage in 1 ft. of depth. Beyond each riprap pretreatment swale, a small grass channel will be designed to ensure runoff reaches the infiltration trench area and provide a 20 ft. grass buffer. The infiltration trench is assumed to be 8 ft. deep with 40% porosity, providing 3,072 cf. of treatment (100%) of the WQv for the drainage area in a 32 ft. by 30 ft. footprint.

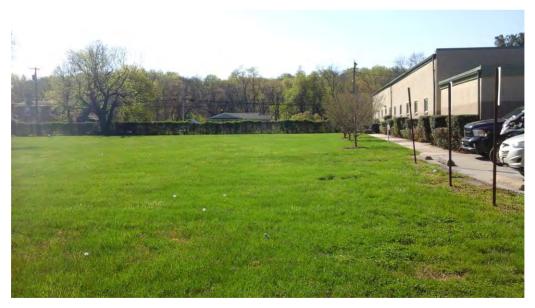
Looking southeast toward the building, roof drains, and grass open space for the proposed facility (LNB-NB-503B).

LNB-NB-F503B - An infiltration trench is proposed in the existing grass space in the eastern area of the property. An infiltration test should be completed to determine if the soil has sufficient drainage due to the type 'D' soils at this location and the water table will need verified to ensure a 5 ft. vertical separation between the facility bottom and the water table. These parameters may result in this facility being unfeasible. For this concept, a riprap level spreader is proposed along the building sidewalk to provide pretreatment from the roof drains. The riprap provides 230 cf. of storage in 1 ft. of depth. A grass buffer of 20 ft. is provided beyond the level spreader. The infiltration trench is assumed to be 4 ft. deep with 40% porosity, providing 960 cf. of treatment (100%) of the WQv for the drainage area in a 6 ft. by 100 ft. footprint.

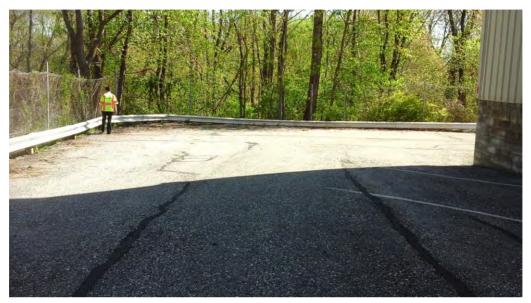
Looking east toward the northern corner of the property at the proposed facility location.

An underground sand filter (USF) is recommended in the northern corner of the parking lot. The roof drains are proposed to be connected using PVC pipe and routed to a flow splitter along with a proposed trench drain along the driveway on the northwestern side of the building. The flow splitter will divert the WQv storm to the USF and the remaining runoff will bypass the facility and outfall into the wooded area to the east. This new outfall will reduce the erosive flows at the existing outfall structure in the eastern corner of the property. The USF would provide 945 cf. of pretreatment in a sedimentation chamber with a surface area of approximately 158 sf. The sand filter area would be 788 sf. with 2 ft. of media for treatment. An additional 4 ft. of temporary ponding over the facility area (788 sf.) is also considered to treat 100% of the WQv (3,780 cf.). The total size of the USF would be approximately 15 ft. wide and 68 ft. long (interior dimensions). This area includes the three chambers for sedimentation, treatment, and overflow as typical per the MDE stormwater design manual. If impacts are too significant with the close proximity to the building, the drainage area could be reduced by diverting a portion of the roof drains and/or eliminating the trench drain and a smaller facility could be proposed. A storm drain outfall would need to be added to provide an outfall for the facility near the wetland to the east of the parking lot. Access to the site is from the property parking lot.
