# **PATAPSCO RIVER**

## **SOUTH BRANCH AND LOWER NORTH BRANCH**

## **WATERSHED ASSESSMENT**

## January 2017

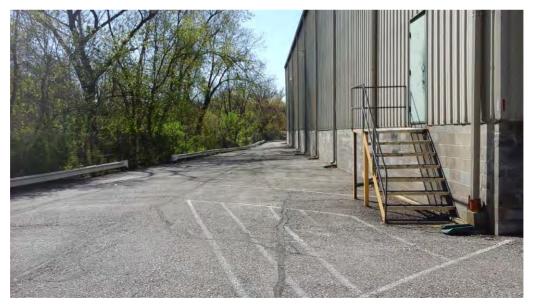
Looking south along the back of the building at the roof drains that will be connected and directed into the proposed facility.

An underground sand filter (USF) is recommended in the northern corner of the parking lot. The roof drains are proposed to be connected using PVC pipe and routed to a flow splitter along with a proposed trench drain along the driveway on the northwestern side of the building. The flow splitter will divert the WQv storm to the USF and the remaining runoff will bypass the facility and outfall into the wooded area to the east. This new outfall will reduce the erosive flows at the existing outfall structure in the eastern corner of the property. The USF would provide 945 cf. of pretreatment in a sedimentation chamber with a surface area of approximately 158 sf. The sand filter area would be 788 sf. with 2 ft. of media for treatment. An additional 4 ft. of temporary ponding over the facility area (788 sf.) is also considered to treat 100% of the WQv (3,780 cf.). The total size of the USF would be approximately 15 ft. wide and 68 ft. long (interior dimensions). This area includes the three chambers for sedimentation, treatment, and overflow as typical per the MDE stormwater design manual. If impacts are too significant with the close proximity to the building, the drainage area could be reduced by diverting a portion of the roof drains and/or eliminating the trench drain and a smaller facility could be proposed. A storm drain outfall would need to be added to provide an outfall for the facility near the wetland to the east of the parking lot. Access to the site is from the property parking lot.

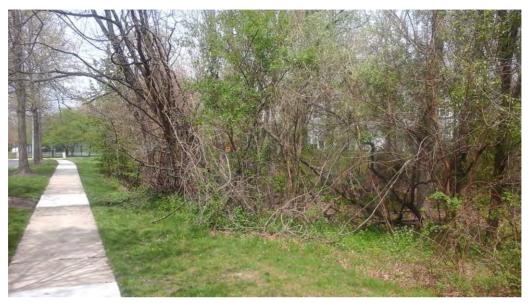
Looking northwest along Old Stockbridge Drive toward the area of the existing wetland.

The existing forested wetland sump is proposed to be used for water quality treatment and quantity storage. Redirecting storm drain from the adjacent parking lot to outfall into this area will increase the drainage area to 3.11 ac. with 1.08 ac. impervious area, resulting in a required WQv of 4,094 cf. If the forested wetland is not graded and only the outlet control structure is replaced, the total WQv is provided in the bottom 2 ft. of the existing sump (elev 304.00 ft. to 306.00 ft.). If instead the area is graded to the maximum extent possible from elevation 308.00 ft. to a facility bottom of 303.00 ft. with 3:1 side slopes, approximately 6,281 cf. of storage is provided in a 1 ft. permanent pool between elevation 303.00 ft. and 304.00 ft. Two forebays, each 1 ft. deep, provide a total of 651 cf. of pretreatment. Above the graded permanent pool, an additional 43,000 cf. is provided in 4 ft. of storage for extended detention. The existing k-inlet would be replaced for a new concrete outlet structure to provide sufficient storage and freeboard without increasing the discharges downstream.

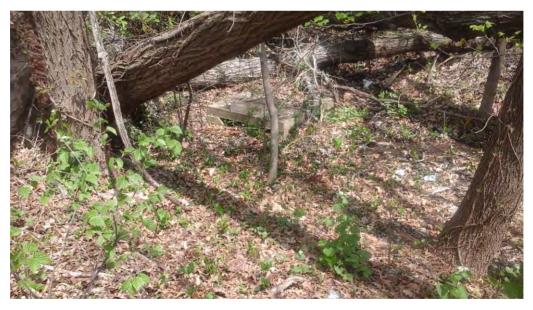
Looking north at the existing k-inlet within the wetland.

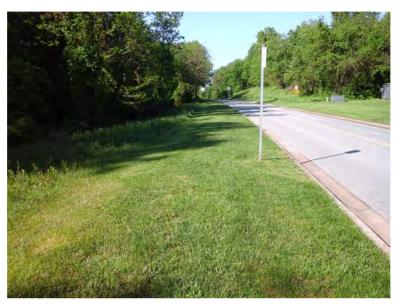
LNB-NB-F607d: This site is located in the grass area on the south side of the park driveway. The driveway is crowned in the center, and water drains towards the road curb and gutter and is collected by an existing inlet downstream of this site. The grass area is approximately 15 ft. wide and consists of well maintained grass. LNB-NB-F607f: This site is located at the grass area north of the circle driveway at the end of the park. There are two existing curb cuts directing flow into the grass area. Water is draining back towards the forested area north of the site. The grass area downstream of two existing curb cuts will be used to create riprap outfalls. The area has sediment in the grass and the ground was wet during the field visit.

Existing grass area for proposed swale, LNB-NB-F607d

LNB-NB-F607d: The dimensions of existing inlet are unknown and may affect the connection to the proposed bioswale underdrain. There is a utility box close to the inlet and it should not be impacted during construction. LNB-NB-F607f: The soil needs to be investigated to see if it is feasible for bioretention. Due to the heavy sediment observed during the site visit, the bioretention will be proposed with pretreatment to avoid clogging at the main bioretention basin. No utilities are anticipated to impact at this site.

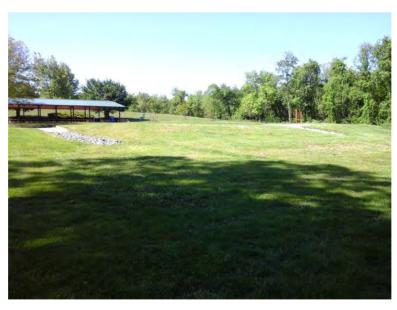
Existing grass area for proposed bioretention, LNB-NB-F607f

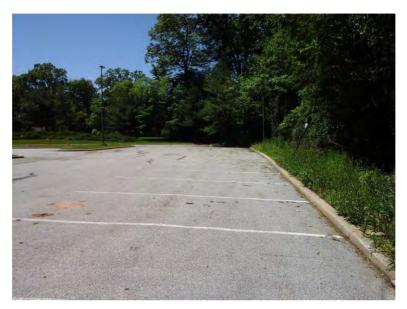
Parking space along the back of the parking lot that can be removed for bioretention

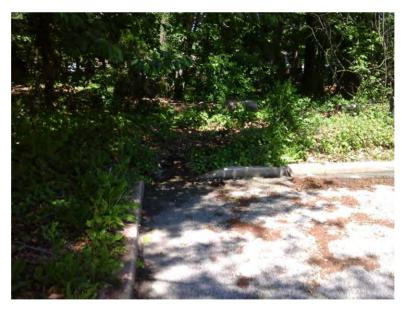
This site is located at the Elkridge Elementary School parking lot near the school entrance. The parking lot appears to be rarely used and is in fair condition. Runoff flows toward the north/back end of the parking lot and outfalls through two existing curb cuts in the corners of the parking lot. The outfall behind the parking lot is an eroded channel. There is dense vegetation, steep slopes, and eroded channels which should be investigated further.

Dense vegetation behind the parking lot

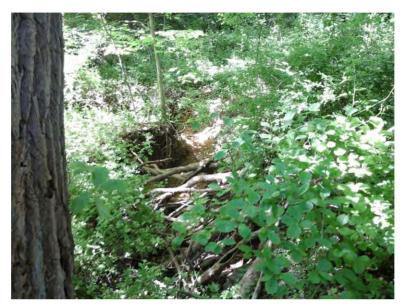
Overall drainage structures are in good condition. Significant sand/gravel from the baseball fields travels through the storm drain and is present at the outfalls.LNB-NB-F609a: The existing outfall channel is receiving water from upstream driveway and open space. It has erosion and headcuts issues.LNB-NB-F609b: This site is a large open space by the side of the park driveway.LNB-NB-F609c: This site is a riprap channel receiving water from the baseball field by the side of the driveway. An existing inlet and culvert is on the downstream end of this site.

Eroded channel at site LNB-NB-F609a

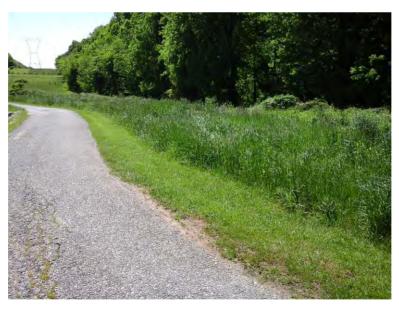
Open area for proposed bioretention, LNB-NB-F609b

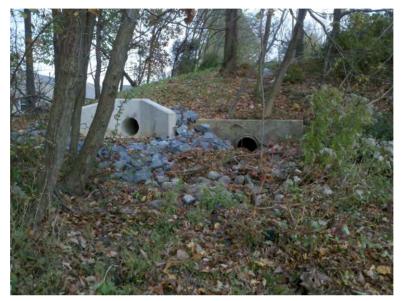
The stormwater outfall site is located adjacent to the Worthington Elementary School parking lot on the north side. The entire project site falls within Howard County Board of Education property. The site contains at least three drainage systems with three separate outfall pipes. Two of the drainage networks for the school outfall into a grouted riprap channel that extends approximately 500 ft. downstream (northwest) and has a significant grade change as it continues onto the New Cut Landfill. The 1.75 ac. drainage area is 94% impervious.

Facing upstream toward stormwater outfalls and headwalls.

A step pool storm conveyance structure (SPSC) is proposed to replace the 500 ft. of grouted riprap channel. The goal of this structure is to improve infiltration and reduce erosive velocities through modification of the channel profile and underlying filter material in constructed pools. For concept design purposes, a sequence of 27 boulder step-pools is proposed, with pool dimensions of 12.5 x 10 x 1.5 ft., riffle drops of 2.0 ft., and a filter depth of 2 ft. With these assumptions, 3,375 cf. of storage (59.1% WQv) is provided in the pools and 1,200 cf. (21% WQv) is provided in the void space sand filter. The site should be considered medium priority due to limited erosion offset by high impervious acres treated. Access is proposed from the school parking lot.

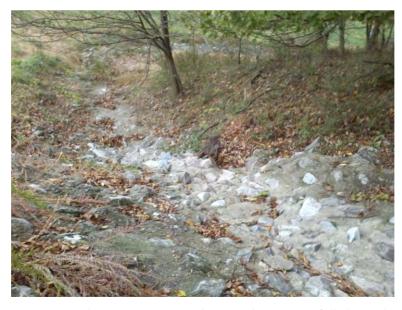
Facing downstream toward grouted riprap outfall channel.

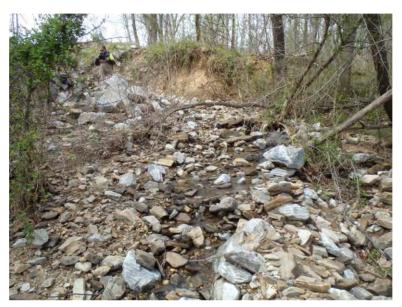
The stormwater pond outfall site is located in a commercial development and provides drainage to Deep Run. Debris is blocking the outfall pipe, which is estimated to be a round 36 in. concrete pipe with no headwall or endsection. The stormwater pond data shows an 8.73 ac. drainage area with 51% impervious, including commercial drainage and the stormwater pond itself. The Deep Run confluence is 110 ft. downstream (east) from the outfall and includes some areas of severe erosion. Bank heights range from 4 to 10 ft. and the pipe is approximately 10 ft. above the stream bed.

Facing upstream in outfall channel toward left bank erosion.

A step pool storm conveyance structure (SPSC) is proposed for 104 ft. of the outfall channel. The goal of this structure is to improve infiltration and reduce erosive velocities through modification of the channel profile and underlying of filter material in constructed pools. For concept design purposes, a sequence of 7 boulder steppools is proposed, with pool dimensions of 10 x 12 x 1.5 ft., riffle drops of 1.7 ft., and a filter depth of 2 ft. With these assumptions, 840 cf. of storage (5.2% WQv) is provided in the pools and 374 cf. (2.3% WQv) is provided in the void space of the sand filter. If combined with the Deep Run stream restoration site (LNB-SR-F506), this project should be considered high priority due to outfall instability and erosion. Access is proposed from Coca Cola Drive east across the downstream edge of the pond embankment. It will likely require the closure of a lane.

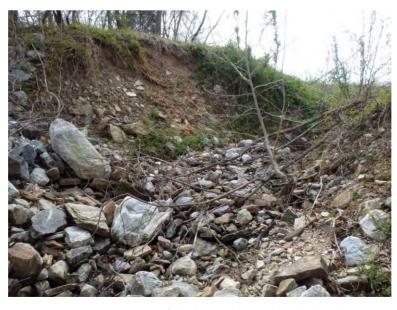
Facing upstream in outfall channel toward right bank erosion.

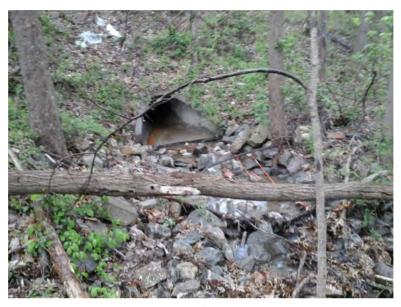
The stormwater outfall site is located south of a commercial development in a forested plot and provides drainage to Deep Run. The outfall is a 24 in. round concrete pipe with endsection. The Deep Run confluence is approximately 130 ft. downstream (south) from the outfall and moderate erosion extends for 10 ft., with bank heights ranging from 1 to 2 ft. If the existing riprap further destabilizes, the channel degradation could migrate upstream toward the outfall. At the downstream extent of the outfall, the channel dissipates into the floodplain with no direct channel connection to Deep Run observed.

Facing upstream in outfall channel toward pipe.

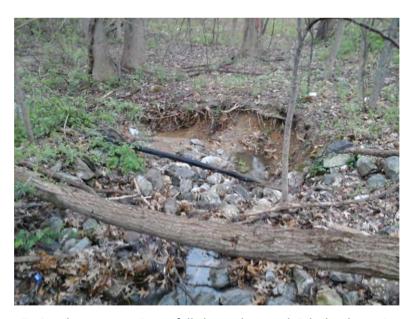
Facing downstream in outfall channel toward right bank erosion.

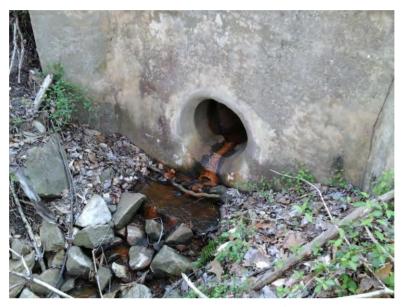
The stormwater outfall site is located on commercial property, adjacent to residential property and provides drainage to an unnamed tributary to Deep Run. The outfall is an 18 in. round concrete pipe with headwall. The unnamed tributary confluence is 70 ft. downstream (north) from the outfall and severe erosion extends for 60 ft. Both the outfall and stream channel are deeply incised and actively eroding. The 3.37 ac. drainage area is 89% impervious.

Facing upstream toward outfall.

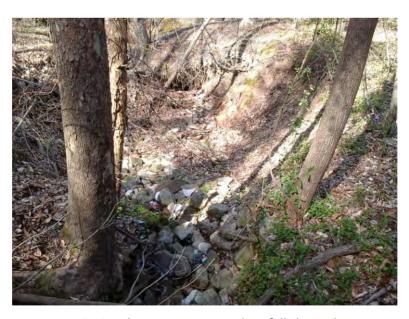
Facing downstream toward outfall channel.

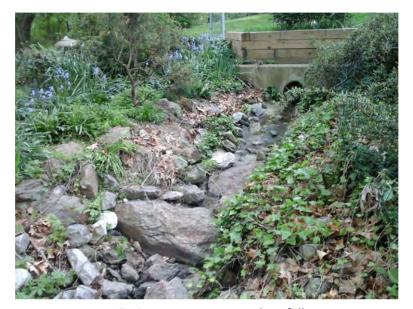
The stormwater outfall site is located on County and residential property and provides drainage to Deep Run. The outfall is a 15 in. round concrete pipe with headwall. The confluence with Deep Run is 88 ft. downstream (northeast) from the outfall and minor to moderate erosion extends for approximately 50 ft. The site already has riprap stabilization at the outfall; however there is bank erosion downstream of the slope. The 4.5 ac. Drainage area is 44% impervious.

Facing upstream toward outfall.

A step pool storm conveyance structure (SPSC) is proposed for approximately 88 ft. of the outfall channel. The goal of this structure is to improve infiltration and reduce erosive velocities through modification of the channel profile and underlying with filter material in constructed pools. For concept design purposes, a sequence of 5 boulder step-pools is proposed, with pool dimensions of 12 x 15 x 1.5 ft., riffle drops of 2.0 ft., and a filter depth of 2 ft. With these assumptions, 900 cf. of storage (12.2% WQv) is provided in the pools and 475 cf. (6.5% WQv) is provided in the void space of the sand filter. This project should be considered low priority due to minimal erosion. A stream stabilization project (LNB-SR-F514A) and BMP conversion project (LNB-BC-F521) are within close proximity to the site. It is recommended that these projects be implemented concurrently to improve efficiency, reduce costs and maximize TMDL credit. Access is proposed through county property from Mayfield Avenue.

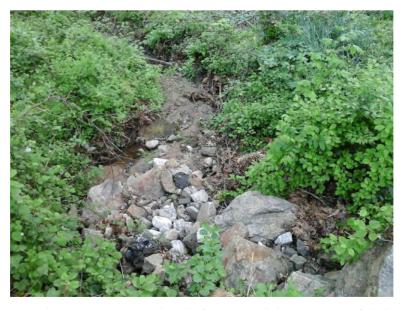
Facing downstream toward end of riprap stabilization in outfall channel.

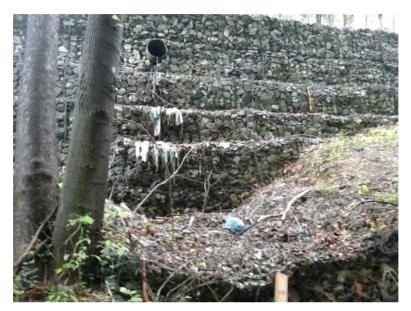
The stormwater outfall site is located on County and residential property and provides drainage to an unnamed tributary to Deep Run. The outfall is an 18 in. corrugated metal pipe without headwall or endsection perched in gabion baskets approximately 11 ft. above the ground. The gabion baskets extend 40 lf. from the end section of the pipe to earthen channel that contains riprap. Moderate erosion and destabilization of the riprap extends for approximately 46 ft. downstream (southwest) to the confluence with the unnamed tributary.

Facing upstream toward outfall and gabion.

Outfall stabilization is proposed for 46 ft. of the earthen channel. The goal of this project is to reduce erosive forces on channel bed and banks and stabilize the outfall pipe. This project should be considered medium priority due to moderate erosion and constraints. It is recommended that outfall stabilizations for LNB-OF-F557 and LNB-OF-F558 only be performed if LNB-SR-F552A is selected for stream restoration construction due to costs, limited crediting, and access issues. Access is proposed through steeply sloped private property.

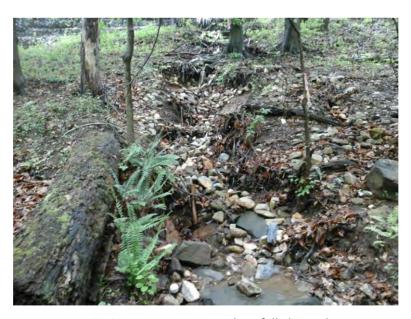
Facing upstream toward outfall channel.

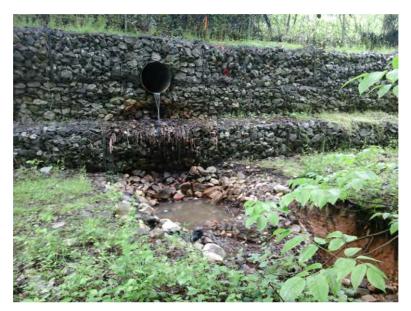
The stormwater outfall site is located on County and residential property and provides drainage to an unnamed tributary to Deep Run. The outfall is a 24 in. corrugated metal pipe without headwall or endsection perched in gabion baskets approximately 8 ft. above the ground. The gabion baskets extend 5 lf. from the endsection of the pipe to earthen channel that contians riprap. Severe erosion and destabilization of riprap extends approximately 38 ft. downstream (southwest) to the confluence with the unnamed tributary.

Facing upstream toward outfall and gabion.

Outfall stabilization is proposed for 38 ft. of the earthen channel. The goal of this project is to reduce erosive forces on channel bed and banks and stabilize the outfall pipe. This project should be considered medium priority due to severe erosion, offset by constraints. It is recommended that outfall stabilizations for LNB-OF-F558 and LNB-OF-F557 only be performed if LNB-SR-F552A is selected for stream restoration construction due to costs, limited crediting, and access issues. Access is proposed through steeply sloped private property.

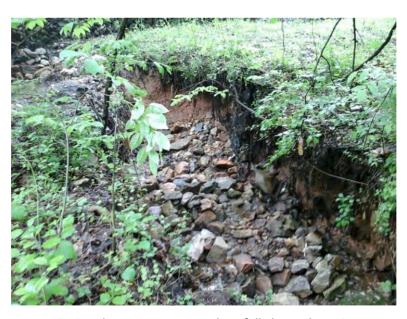
Facing downstream toward outfall channel erosion.

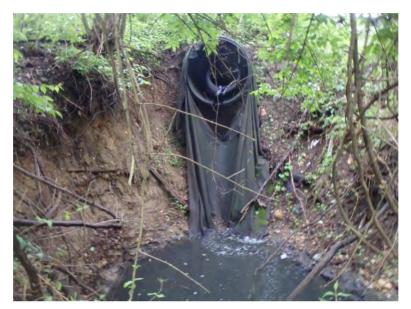
LNB-OF-F561 is a stormwater outfall that is located adjacent to US 1 (Washington Boulevard) and drains to LNB-SR-F517. Land use surrounding the project site is primarily forest and residential. The project site itself on situated on land owned by Howard County. The outfall stabilization site extends approximately 30 lf. downstream (northwest). The outfall pipe is a 36 in. corrugated plastic pipe that lacks an apron or headwall. The outfall pipe is associated with an 8 ft. drop in elevation from the edge of the pipe to the stream bed. The stream bed directly below the apron is severely eroded, as evidenced by entrenched channel banks and exposed geotextiles at the outfall pipe. Continued channel erosion could threaten the stability of an existing manhole and the existing roadway (US 1).

From channel facing upstream toward outfall.

The proposed project would include approximately 29 lf. of outfall stabilization using a drop structure. This outfall stabilization project would be more recommended to coincide with construction of the adjacent stream restoration project (LNB-SR-F517). Ease of access to the project is moderate due to abutting major roadway and impacts to existing trees. Access to the site is proposed off of US 1. It is likely that a lane closure would be required for access purposes.

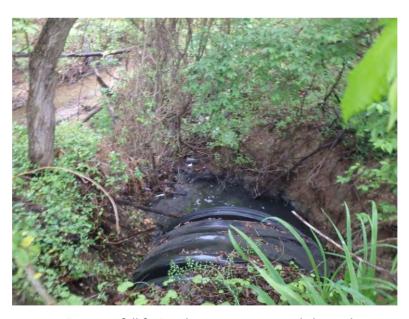
From outfall facing downstream toward channel.

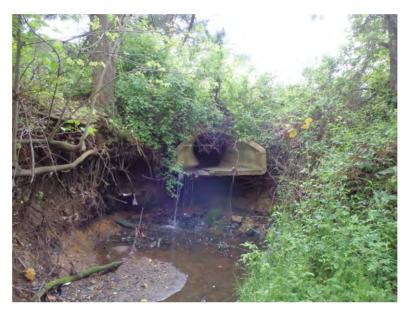
The stormwater outfall site is located on residential property and provides drainage to an unnamed tributary to Deep Run. The outfall is a severely undercut 24 in. round concrete pipe with a disconnected endsection. The confluence with Deep Run is 17 ft. downstream (east) from the outfall and severe erosion extends for the entire length of the outfall channel.

Facing upstream toward destabilized outfall.

Endsection repair, vertical realignment of the outfall channel, and riprap stabilization is proposed for the 17 ft. stabilization project. The goal of this project is to reduce erosive forces on channel bed and banks and stabilize the outfall pipe. This project should be considered high priority due to severe erosion and outfall instability. Access is proposed from Capitol Mobile property. This outfall stabilization project could be implemented concurrently with a stream resotration (LNB-SR-F516) to improve efficiency and reduce costs.

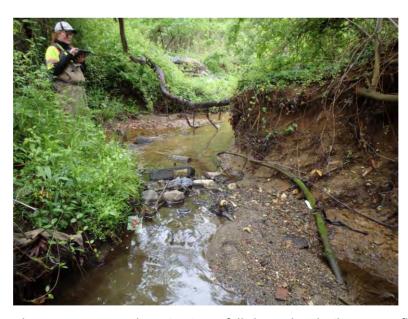
Facing downstream toward erosion in outfall channel and tributary confluence.

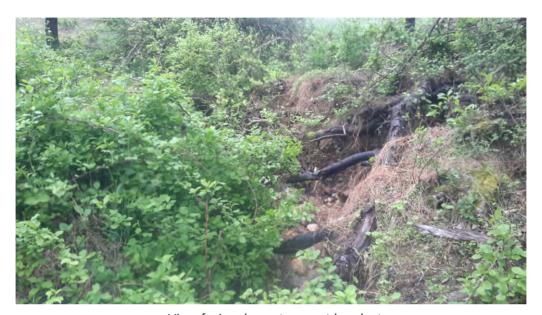
The proposed outfall stabilization begins at a pond emergency spillway and flows west for approximately 43 ft. until it meets an unnamed tributary to the Patapsco River. The outfall is approximately 10 ft. higher than the stream channel bed, resulting in several headcuts to form. The outfall is adjacent to multiple residential neighborhoods so access is easy through open fields. The adjacent stream bank on the west side of the pond is severely eroded and if not repaired could erode into the pond basin.

View facing downstream at headcut.

The proposed stabilization BMP is a Step Pool Storm Conveyance system (SPSC) with 2 cascades, 1 pool, and 1 riffle. The SPSC will be 8 ft. wide and span the full 43 ft. of erosion starting from the outfall. The eroded pond bank will also be repaired to prevent facility faliure. Since this outfall is downstream of a wet pond, the water quality treatment provided is in addition to what the wet pond provides. However, since the channel is eroded 10 ft. vertically, cascading structures may be necessary which do not provide water quality credit.

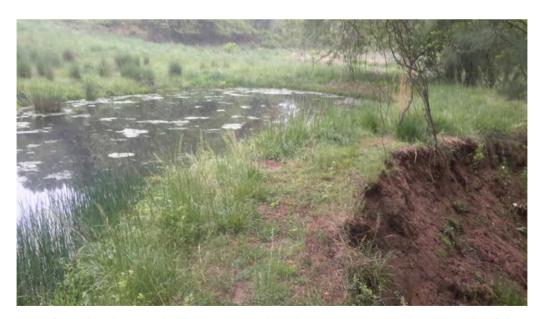
View of pond and severe bank erosion on the adjacent stream on the west side of the pond.

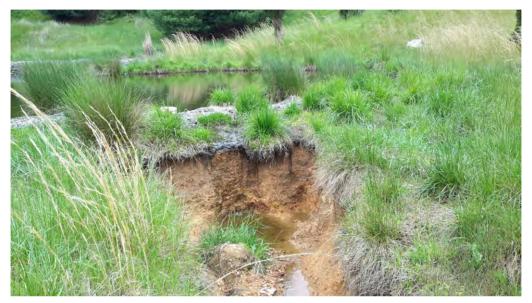
The proposed outfall stabilization is an eroded outfall channel of a stormwater management pond east of Stonehouse Drive. The channel begins at a gabion basket weir of the stormwater management pond and drains to an unnamed tributary to the Patapsco River. An approximate 4 ft. headcut has formed immediately downstream of the gabion weir. The first 30 ft. of the outfall channel has approximately 4 ft. high banks and severe erosion, the following 170 ft. of the channel has approximately 3 ft. high banks and moderate erosion. The outfall is adjacent to a fairly open field near residential properties. The lower portion of the channel is forested.

View facing upstream at headcut below gabion weir.

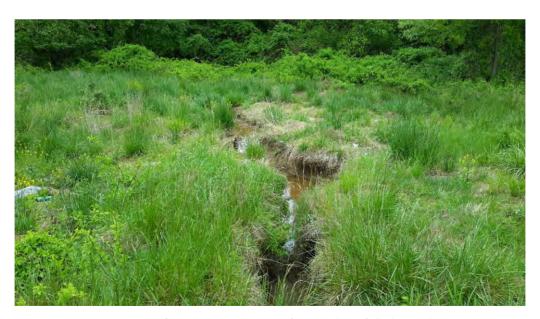
View facing downstream of eroded outfall channel.

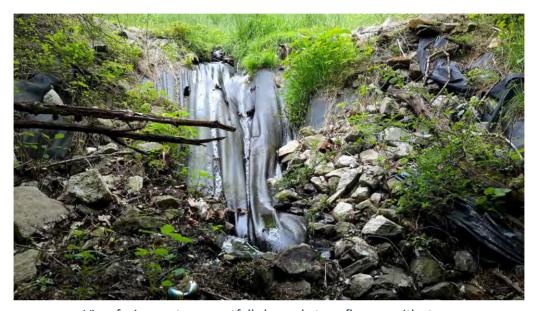
The proposed outfall stabilization is an eroded outfall channel of a stormwater management pond east of Thornbrook Road. The channel begins at the minorly corroded 24 in. corrugated metal pipe of the stormwater management pond and drains to an unnamed tributary to the Patapsco River. The outfall channel is very steep and the rip rap stabilization has washed out and exposed the underlying geotextile fabric. Approximately 43 ft. of the channel is in need of stabilization.

View facing upstream outfall channel at confluence with stream.

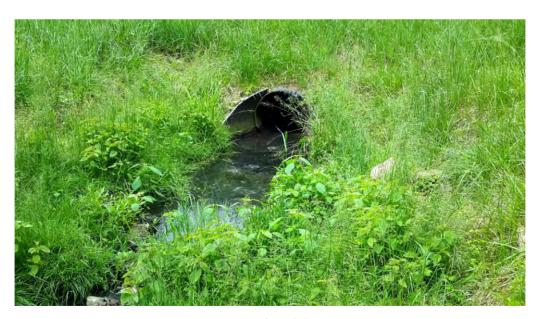
View of outfall pipe.

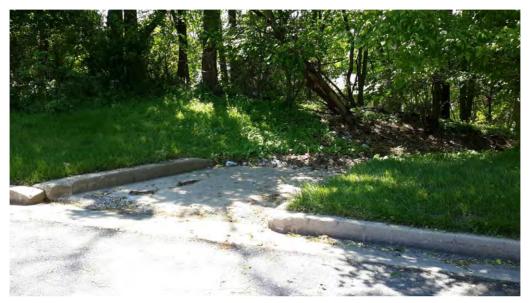
The proposed outfall stabilization is a drainage channel originating from a parking lot curb cut in the Howard County courthouse parking lot in Ellicott City off Court House Drive. The channel is approximately 250 ft. long and has approximately 5 ft. high banks with highly erodible soils. The channel originates at the parking lot curb cut and drains down a steep slope to Hudson Branch. The site is adjacent to an active parking lot and has high public education and demonstration potential.

View of curb cut in parking lot at top of eroded channel.

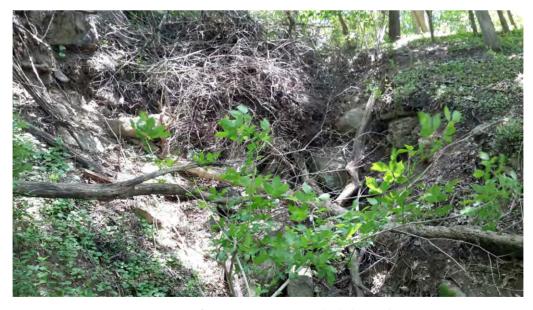
View facing upstream eroded channel.

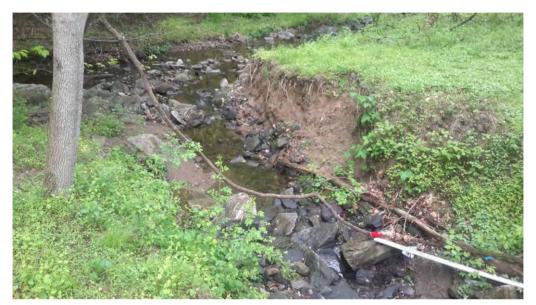
The proposed outfall stabilization is a severely eroded channel originating from a 36 in. concrete storm drain pipe with no stormwater management treatment. The channel erosion starts 50 ft. downstream of the outfall and extends approximately 217 ft. downstream until it meets Sucker Branch. Site access is easy from the adjacent parking lot off Normandy Woods Drive.

View facing downstream in eroded outfall channel.

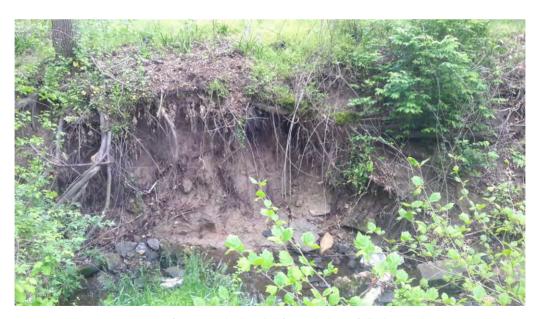
View facing right bank of eroded outfall channel.

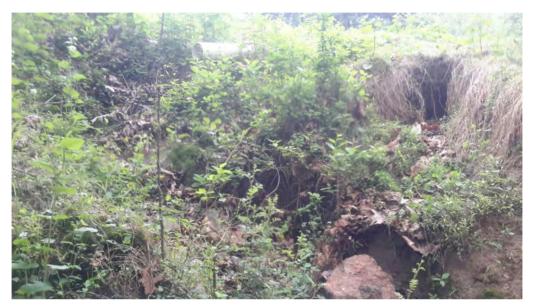
The proposed outfall stabilization project includes two assessment and recommendation sites, LNB-OF-F644 and LNB-SR-F613C PO001. The project includes three eroded channels that drain to an unnamed tributary to the Patapsco River. The eroded channel to the west originates from a storm drain pipe with no stormwater management, and is eroded for approximately 55 ft. The center channel originates from a 24 in. plastic pipe outfall from the adjacent stormwater management pond and is eroded for approximately 90 ft. The channel to the east originates from the emergency spillway of the stormwater management facility and is eroded for its entire length, approximately 65 ft. The surrounding area is relatively open and impact to the surrounding trees would be minimal

View facing upstream of outfall pipe of center channel.

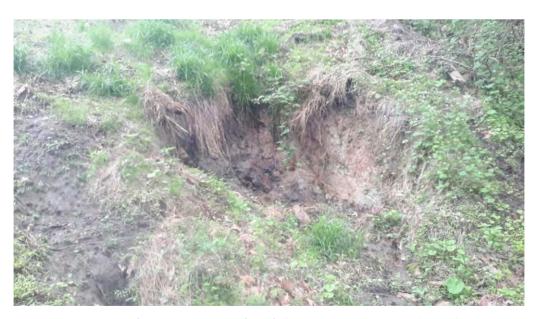
View facing upstream of outfall erosion on western channel.

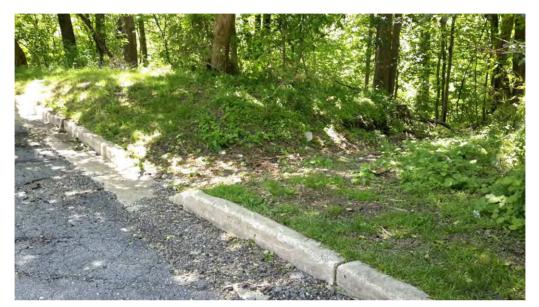
The proposed outfall stabilization is a drainage channel originating from a parking lot curb cut in the Howard County courthouse parking lot in Ellicott City off Court House Drive. The channel is approximately 166 ft. long and has approximately 7 ft. high banks with highly erodible soils. The channel originates at the parking lot curb cut and drains down a steep slope to Hudson Branch. The site is adjacent to an active parking lot and has high public education and demonstration potential.

View of curb cut in parking lot at top of eroded channel.

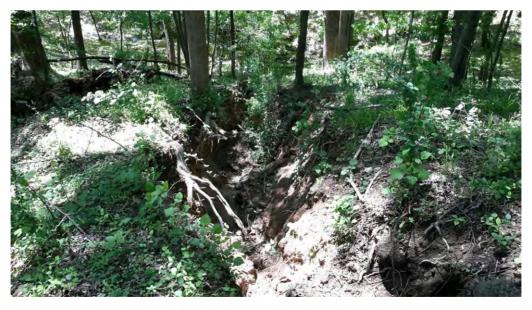
View facing downstream of eroded channel.

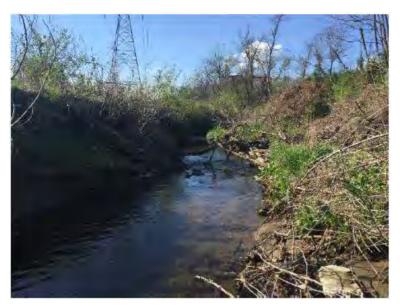
From Century Tiber Branch and Sucker Branch Interceptor Improvement Project, March 2016 - "This concept reach originates at an outfall under Columbia Pike (US-29) and encompasses approximately 2,000 lf. of the Tiber Branch downstream to Frederick Road. Additionally, a tributary originating at an outfall located further south along US-29 is also included as part of this concept reach. The portion of Tiber Branch within the concept reach primarily flows parallel along the BGE right-of-way. Under the existing conditions, the channel valley and drainage network has been significantly altered, leaving the channel pinned against the west hillslope and the existing sanitary sewer line. The channel has become deeply entrenched with 5 to 8 ft. banks in the upper extents before flowing behind several residential properties containing little to no riparian buffer, leading to significant bank erosion. In addition, several utilities have become exposed from both bed and bank erosion throughout the reach. A cross culvert maintained as part of the BGE right-of-way is currently perched 3 to 4 ft. above the invert of the tributary. This is likely the result of a head cut that has migrated up the tributary from the mainstem. In summary, this reach is considered to be significantly degraded, showing signs of both active bed and bank erosion with little to no regular floodplain access and multiple exposed utilities."

Looking downstream along Tiber Branch at typical conditions within Concept A reach (photo courtesy of Century Eng.)

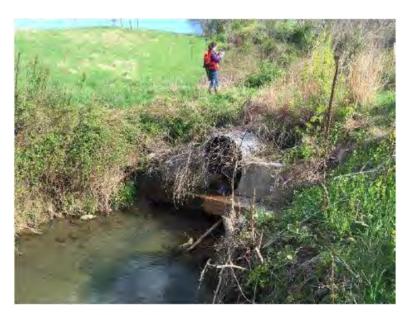
Looking upstream at perched culvert where tributary enters the concept reach (photo courtesy of Century Eng.)

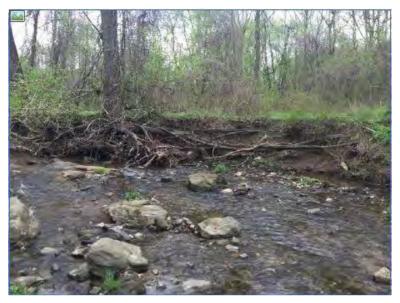
From Century Tiber Branch and Sucker Branch Interceptor Improvement Project, March 2016 - "This reach begins approximately 600 lf. downstream of Rogers Avenue along Sucker Branch and continues to flow south approximately 450 lf. before entering a culvert under Baltimore National Pike (MD 40). This concept reach also includes two tributaries that originate at stormwater outfalls along both the left and right banks, totaling 400 lf. While the left bank within this reach appears to have been previously stabilized with MDSHA Class II riprap to protect the existing sanitary sewer line, the right bank continues to exhibit signs of lateral migration. The formation of several midchannel bars within this vicinity indicates that the culverts are likely incapable of freely passing large storm events, thus resulting in backwater conditions and sediment depositions just upstream. Both of the tributaries show signs of active down-cutting, as headcuts continue to migrate up from mainstem to the perched outfalls. Specifically, Tributary 2 located along the right bank floodplain has begun to drain the adjacent wetland system and will likely continue to reduce the available hydrology for this system."

View of typical conditions along Sucker Branch within the concept reach (photo courtesy of Century Eng.)

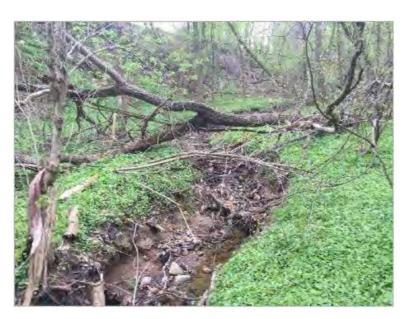
View looking upstream within Tributary 2 (photo courtesy of Century Eng.)

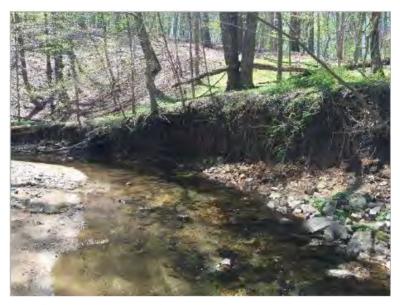
From Century Tiber Branch and Sucker Branch Interceptor Improvement Project, March 2016 - "The Concept E reach is located adjacent to Park Drive where an unnamed tributary flows into Sucker Branch. This approximately 415 lf. reach is located along Sucker Branch within a compressed meander bend. Here, a large steep point bar has formed as a result of the planform geometry within the valley, forcing flows into the right bank and creating a raw vertical 5 to 6 ft. bank along the outside of the meander bend. Within this meander bend, an unnamed tributary to Sucker Branch enters along the right bank, cascading 4 to 5 ft. to the channel invert of the mainstem. While grade within the tributary is currently being held by existing tree roots, there is a likely potential that a headcut will begin to develop, leading to considerable bed and bank erosion."

View of Sucker Branch facing downstream from tributary confluence (photo courtesy of Century Eng.)

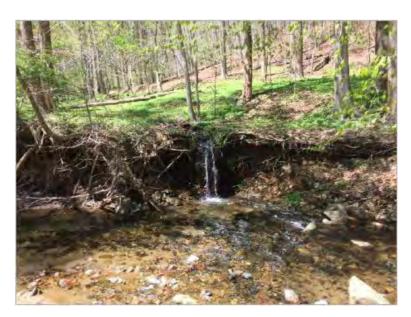
View of tributary perched on right bank of Sucker Branch (photo courtesy of Century Eng.)

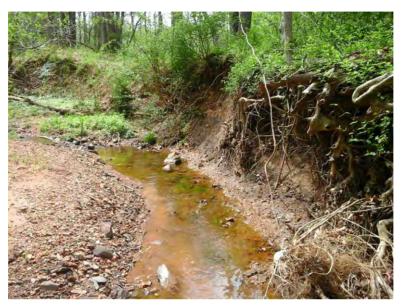
The site is located on forested agriculture and church property. The downstream extent of the site begins at the confluence with Rockburn Branch and the upstream extent ends as the stream enters an entirely forested floodplain condition. The majority of the channel is experiencing moderate to severe bank erosion. The eroding portions of the channel exhibit nearly vertical banks with heights of 3 to 7 ft., low root density and surface protection, and a primary material of silt. An old concrete culvert is causing a stream blockage and fish passage issue. The site appears to have been historically straightened. In-stream habitat is lacking, with high amounts of fine sediment and embeddedness in the system, inadequate diversity and cover, and low bank stability. Bed substrate is primarily gravel, sand, and silt. Riparian buffer is severely lacking on the right bank due to adjacent property mowing.

Erosion at the downstream extent of the site.

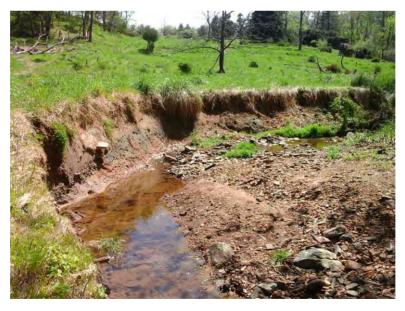
Typical erosion and lack of right bank riparian buffer.

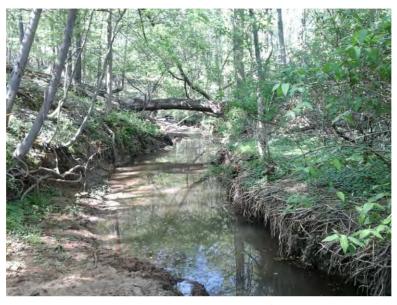
Low to moderate erosion, poor in-stream habitat, and forested banks typical of this site.

The proposed project consists of 1,247 lf. of the tributary to Rockburn Branch. The project goal is to increase instream habitat, floodplain connectivity, and decrease erosion through the creation of stable channel dimensions and spot treatments of bed and bank erosion. The addition of terraced bench features and in-channel woody debris will increase floodplain deposition of fine sediment, improve in-stream cover, aid in diversification of stream features, reduce risk of erosion, and increase uplift potential. Removal of broken concrete and stabilization of the driveway crossing is recommended. Access is proposed through private property from Elibank Drive. Two proposed stream restoration projects upstream and downstream of this site can be implemented concurrently to reduce costs and increase efficiency.

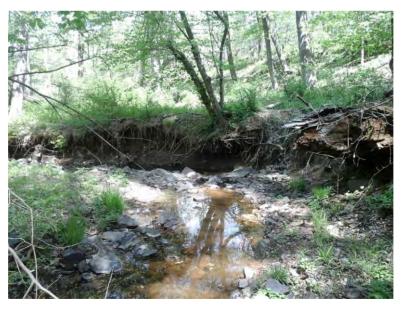
Moderate erosion at the downstream extent of the site.

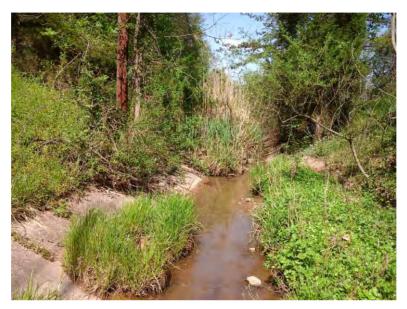
Concrete channelization with wetland vegetation.

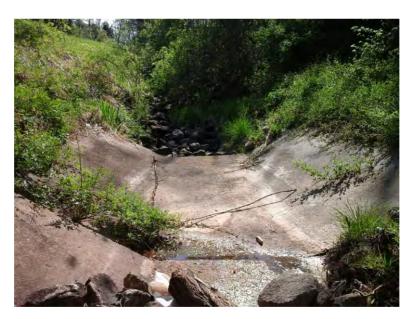
Concrete and riprap channelization at downstream extent of site.

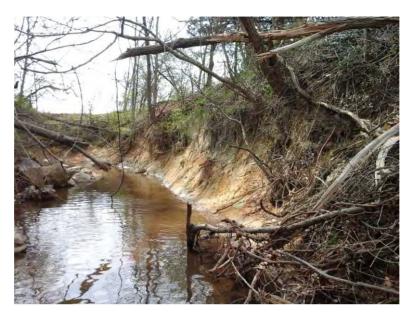
Typical erosion threatening private road.

The proposed project consists of 1,541 lf. of Deep Run. The project goal is to decrease erosion and protect existing infrastructure through bank stabilization treatments. Due to extensive constraints and poor water quality, instream habitat is not expected to significantly improve. Removal of asphalt stabilization and outfall end sections is recommended. Access is proposed from South Hanover Road and Loudon Avenue through private commercial and State Highway property.

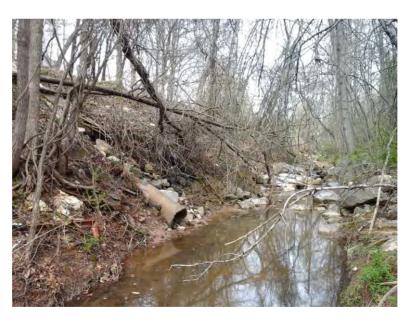
Riprap stabilization and disconnected outfall end section.

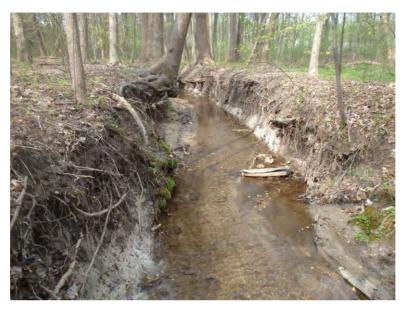
Typical erosion throughout project site.

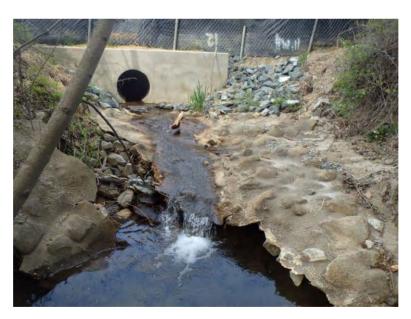
Montevideo Road undercut concrete apron.

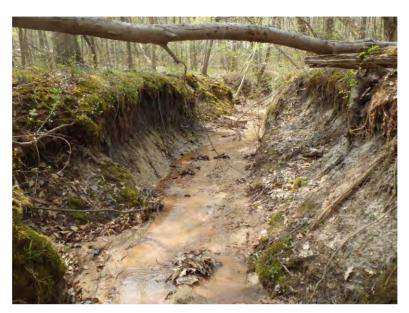
Typical erosion on both banks.

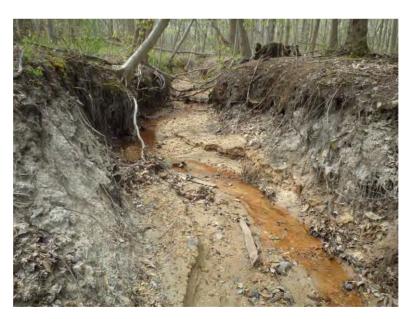
Typical erosion on both banks.

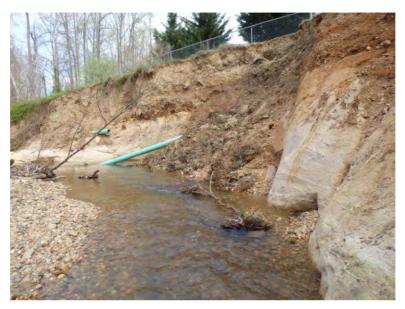
Reach one erosion threatening stormwater pond embankment.

The proposed project consists of 2,865 lf. of Deep Run. The project goal is to enhance in-stream habitat, increase floodplain connectivity, decrease erosion, and protect existing infrastructure through creation of stable channel dimensions and bank stabilization treatments. The addition of terraced bench features and in-channel woody debris will increase floodplain deposition, aid in diversification of stream features, reduce risk of erosion, and increase uplift potential. In reach one, shifting of the channel away from the stormwater pond embankment is recommended. In reach two, restoration opportunity is limited by sewer stabilization. Access is proposed from Coca Cola Drive west along the sewer access road and east across the downstream edge of the pond embankment. It will likely require the closure of a lane.

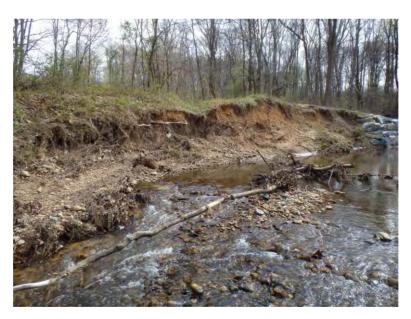
Typical erosion in reach two, upstream and downstream of recent bank stabilization.

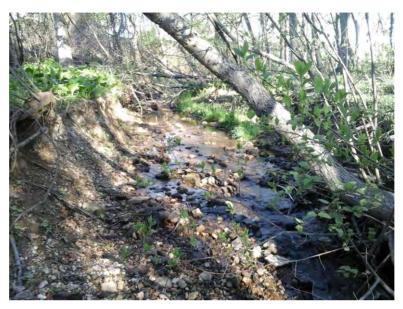
Right bank erosion and adjacent wetland.

The proposed project consists of 1,065 lf. of the tributary to Deep Run. The project goal is to increase in-stream habitat, floodplain connectivity, and decrease erosion through the creation of stable channel dimensions, restoration of natural channel sinuosity, and bank stabilization treatments. The addition of terraced bench features and in-channel woody debris will increase floodplain deposition of fine sediment, improve in-stream cover, aid in diversification of stream features, reduce risk of erosion, and increase uplift potential. Removal of the debris jam is recommended. Access is proposed through private residential property.

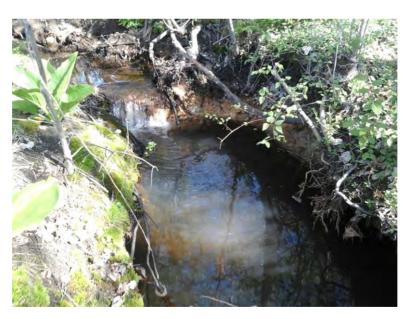
Headcut at upstream extent of site.

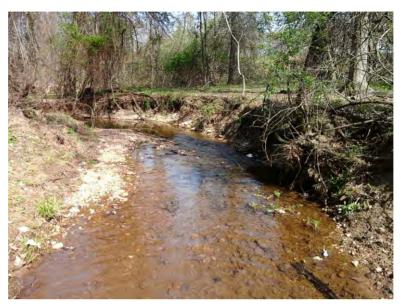
Moderate bank erosion.

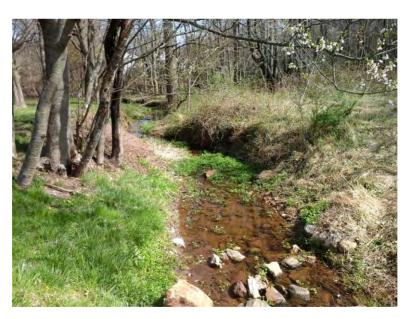
Typical erosion pattern at the site.

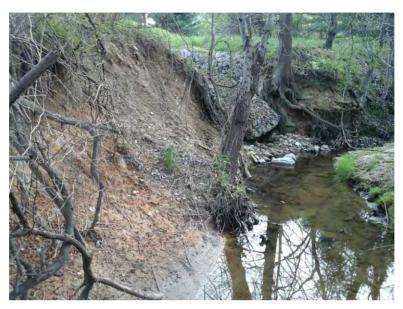
Severe bank erosion and gabion slumping.

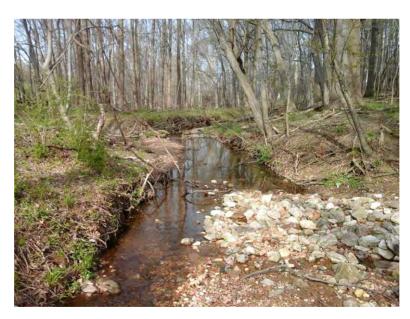
Typical erosion pattern at the site.

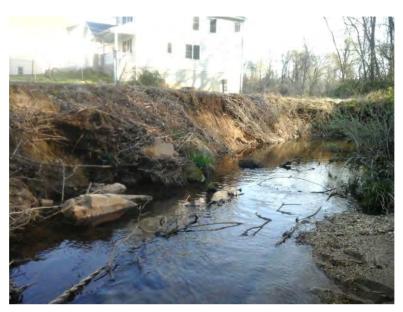
Typical erosion and lack of left bank riparian buffer near residential property.

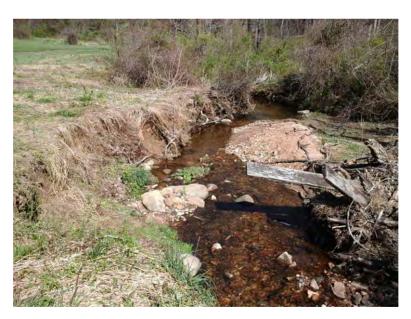
Typical erosion and lack of left bank riparian buffer within county park property.

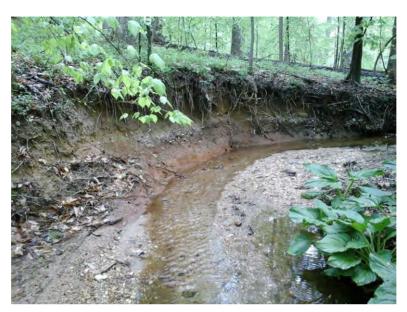
Erosion at the southern extent of the site.

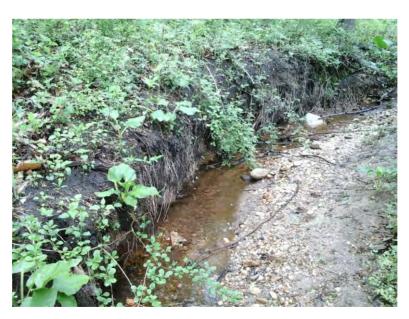
Typical minor erosion in northern reach.

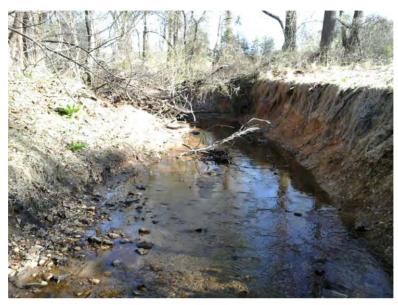
Typical erosion along the downstream extent.

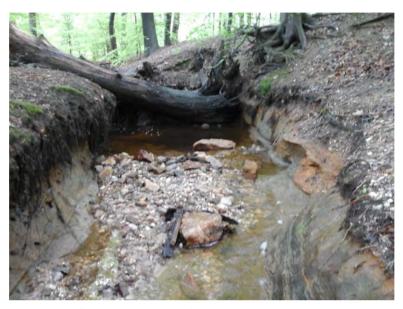
Looking upstream from tributary confluence at headcut and active bank erosion.

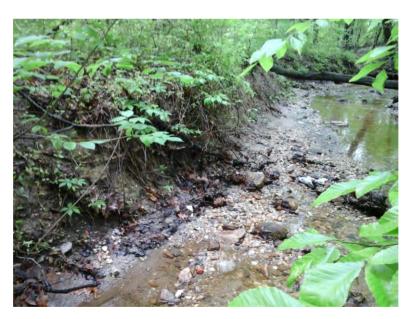
Typical erosion within mainstem.

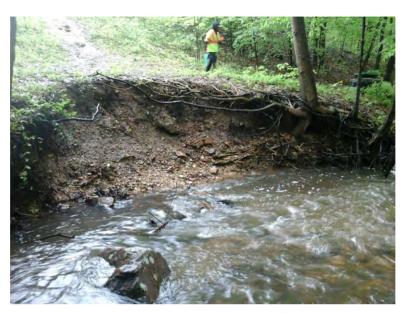
Erosion which may threaten sewer if untreated.

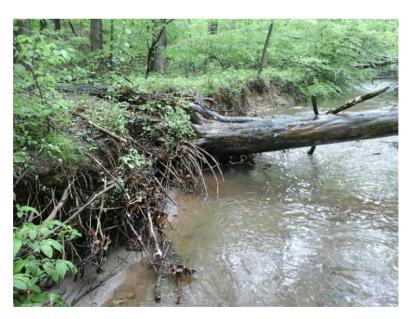
Typical erosion along downstream extent.

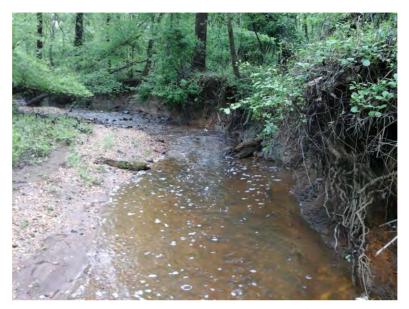
Typical erosion at upstream extent of site.

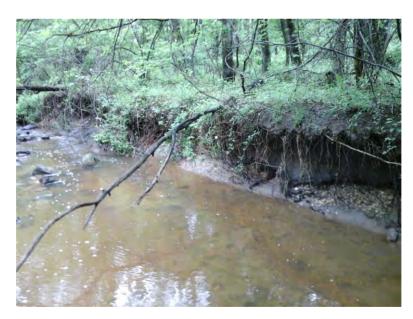
Typical erosion at upstream extent of site.

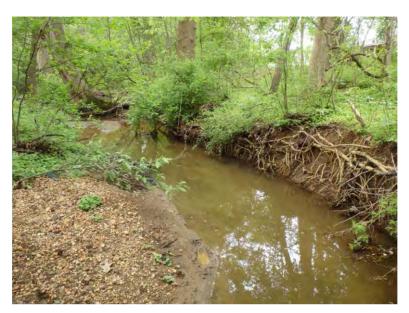
Typical erosion at the downstream extent.

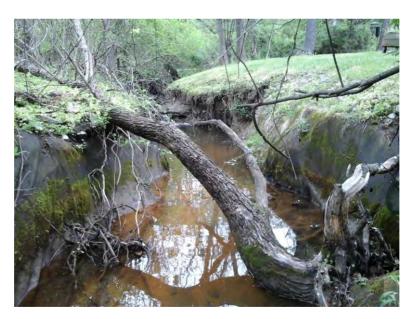
Downcutting threatening sewer crossing and private property.

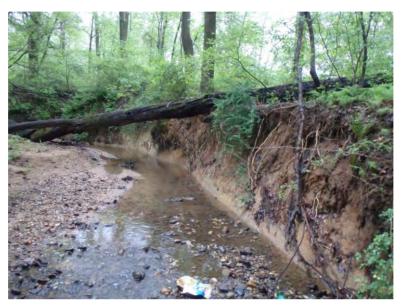
Erosion in east reach.

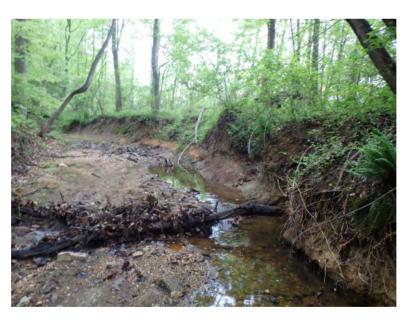
Erosion in west reach.

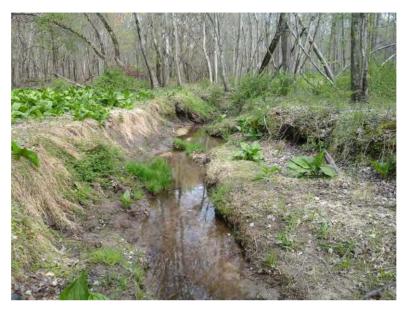
Erosion and adjacent wetland in the downstream reach.

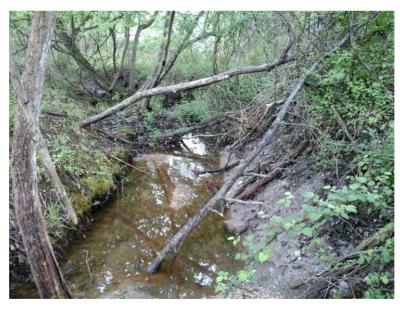
Incision and erosion in the upstream reach.

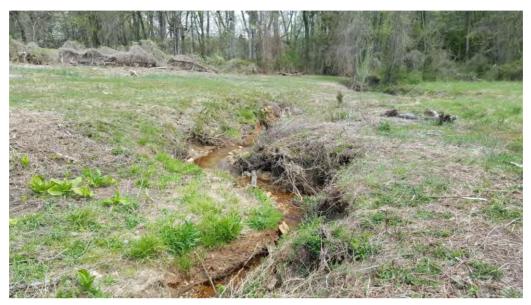
Typical pattern of erosion in site.

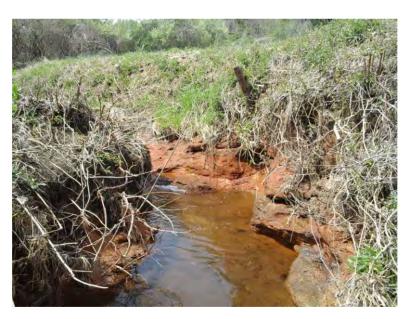
Erosion with bedrock protection.

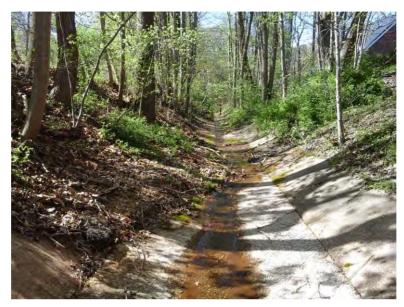
Concrete channel at downstream extent.

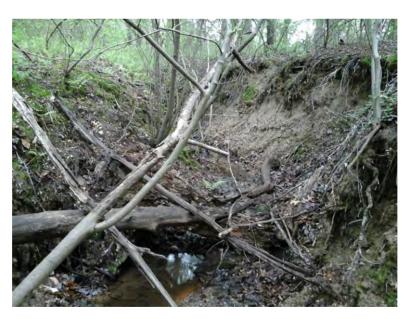
Incision and erosion in upstream reach.

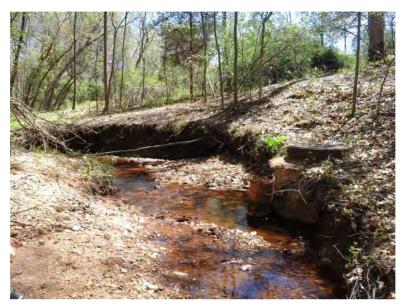
Threatened manhole in southern reach.

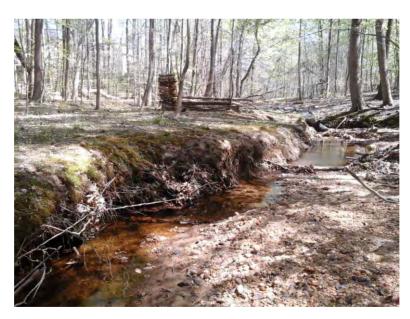
Typical erosion in northern reach.

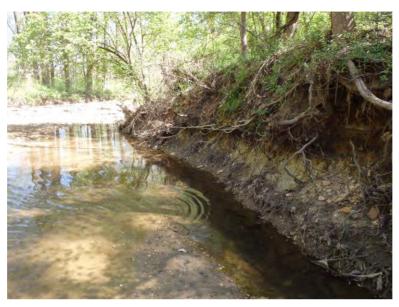
Moderate bank erosion.

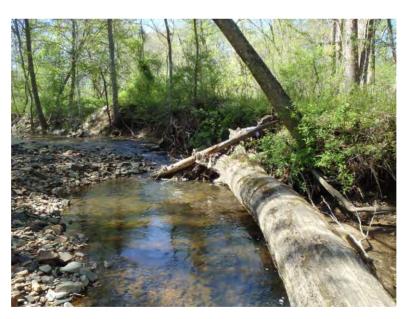
Typical pattern of erosion at site.

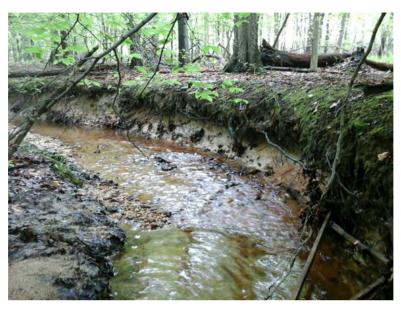
Typical erosion in upstream extent.

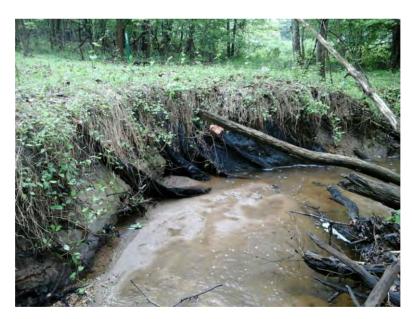
Typical erosion in downstream extent.

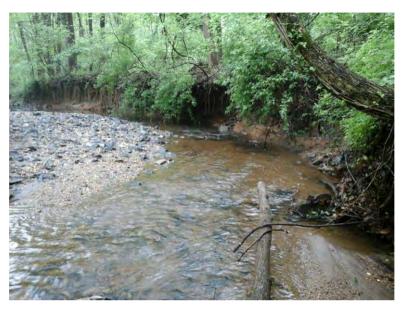
Typical erosion pattern at site.

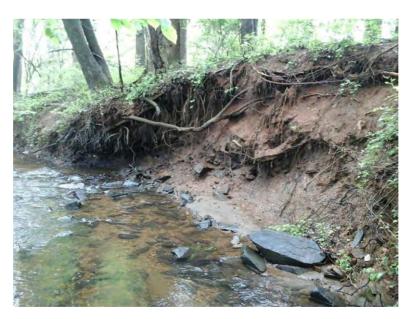
Active severe bank erosion.

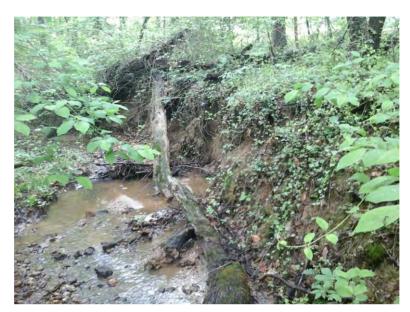
Looking upstream from downstream extent toward typical bank erosion.

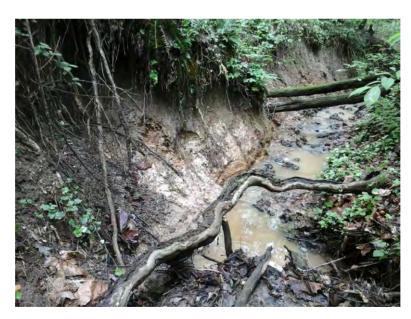
Erosion and headcutting at the upstream extent of the site.

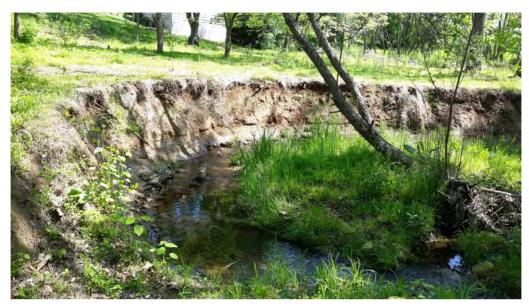
Typical eroding banks, facing left bank

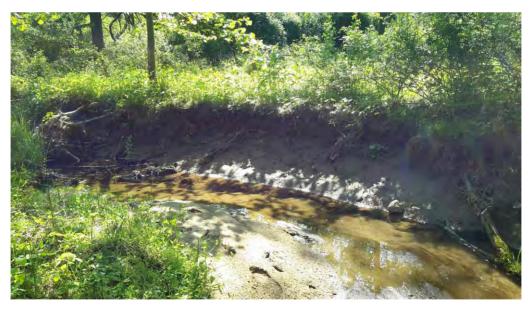
Typical eroding banks, facing right bank
