# **PATAPSCO RIVER**

## **SOUTH BRANCH AND LOWER NORTH BRANCH**

## **WATERSHED ASSESSMENT**

## January 2017

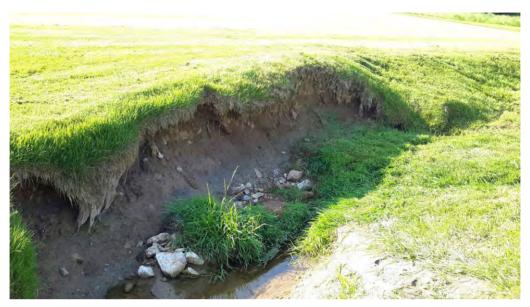
Typical stream erosion along the site

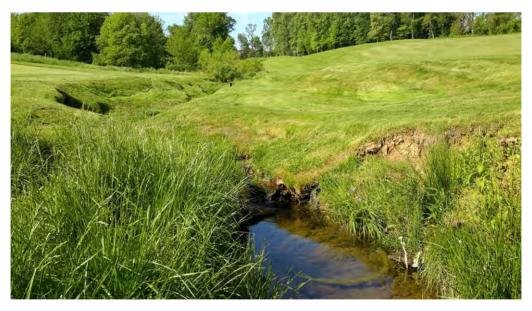
Mowing to edge of stream at golf course throughout site

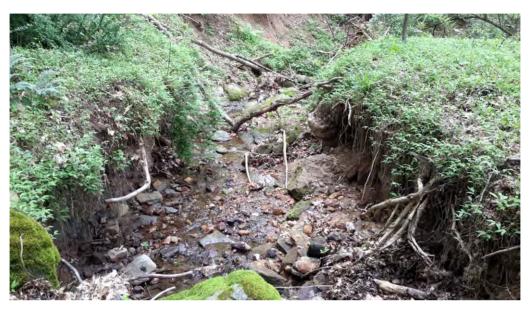
Facing downstream showing typical erosion in the site

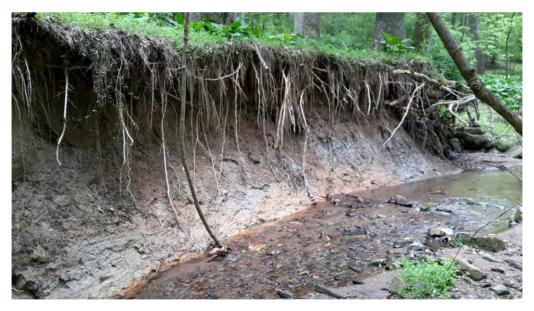
Typical stream bank erosion on the right bank

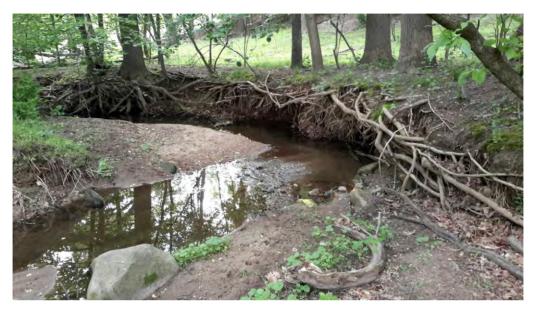
Typical stream bank erosion on the right bank

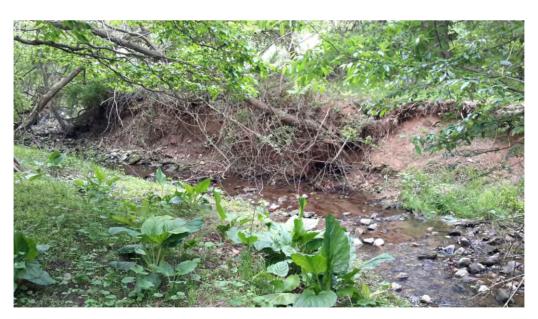
Typical stream bank erosion on the left bank

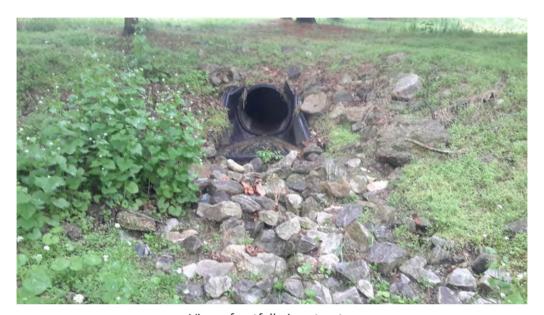
The existing site is a severely eroded channel originating from a HDPE stormdrain pipe with no stormwater management behind a residential property. The channel erosion starts immediately downstream of the outfall and extends approximately 100 ft. Site access is easy from the adjacent properties off Millers Way Drive.

View of outfall pipe structure.

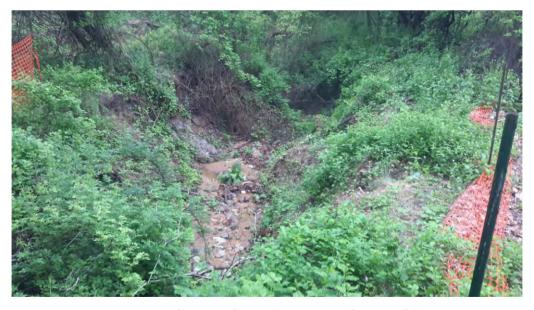
View of erosion facing downstream from outfall.

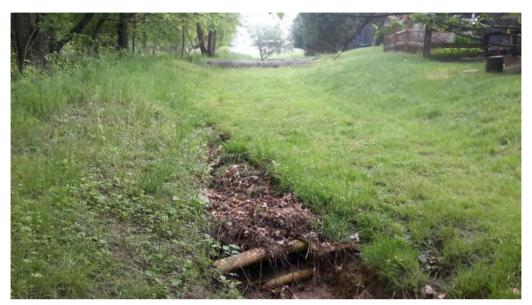
The proposed outfall stabilization is a stormwater pond outfall channel that drains to an unnamed tributary to the Patapsco River. The channel erosion begins approximately 30 ft. downstream from a gabion basket weir of the pond. The first 20 ft. of erosion is minor downcutting of the channel. The channel then splits into two, each with 5 ft. headcuts to meet the stream elevation. Total length of erosion is approximately 60 ft.

View facing upstream at top of eroded portion of outfall channel.

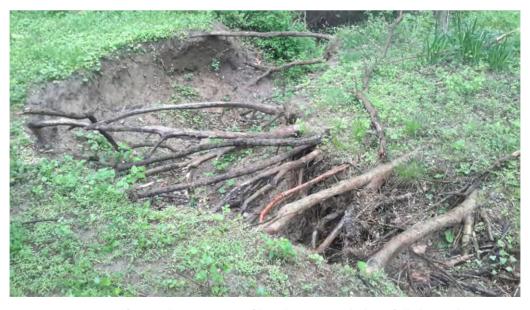
View facing downstream of headcut in eroded outfall channel.

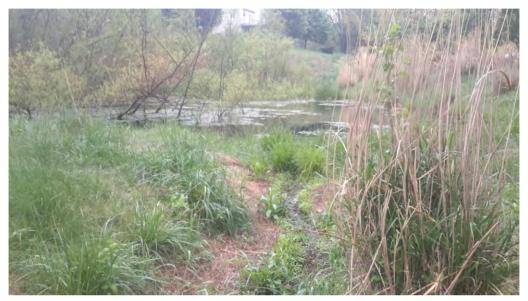
The proposed outfall stabilization is an eroded channel originating from the spillway of a stormwater management pond north of Stone Hollow Court. The channel erosion starts immediately downstream of the spillway with minor erosion for 25 ft. and then a 2 ft. headcut and insized channel for 20 ft., until it meets the Patapsco River. Site access is easy from the adjacent properties off Stone Hollow Court.

View of spillway with erosion facing south.

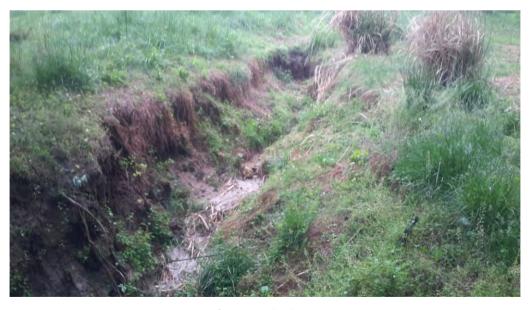
View of erosion looking upstream.

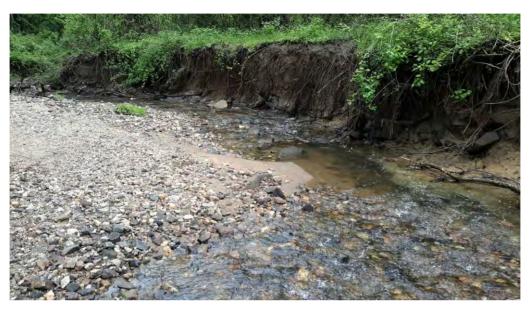
This site includes a portion of Sucker Branch and tributaries to Sucker Branch. The site is located on land owned by Howard County and Home Properties, Howard Crossing. The stream in this location has downcut and eroded laterally, resulting in many areas of bank erosion. A headcut is located on a short section of this project near the center of the apartment complex. The eroded banks along this reach are near vertical and have an average height of 5 ft. The banks are primarily composed of silt and have very low root density and very shallow root depth. Stream habitat is poor at this site, lacking both suitable cover for fish and stable substrates for stream insects. Habitat diversity is low, with the majority of the available habitat consisting of shallow pools with intermittent short, shallow riffles. The habitat is also impaired by a moderate amount of fine material covering the stream bed. The stream substrate is comprised mostly of sand, gravel, and cobble.

Typical erosion along the left bank

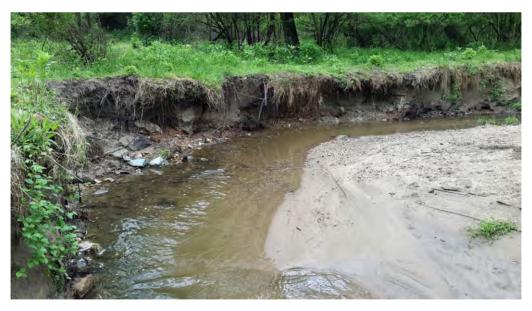
Typical erosion along the right bank

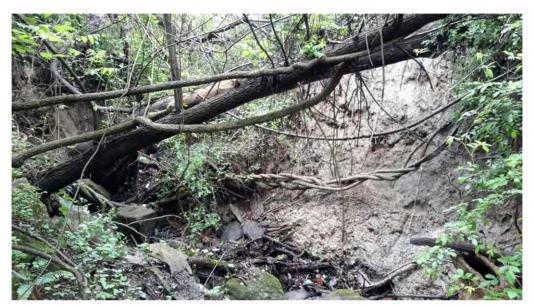
The proposed outfall stabilization is an outfall originating at a 24 in. concrete storm drain pipe draining Town and Country Boulevard. The eroded channel has 15 ft. high eroded banks and extends for 110 ft. until it meets Sucker Branch. The site is located immediately adjacent to a parking lot off Town and Country Boulevard, therefore access is easy and there will be minimal impact to trees.

View facing upstream eroded outfall channel.

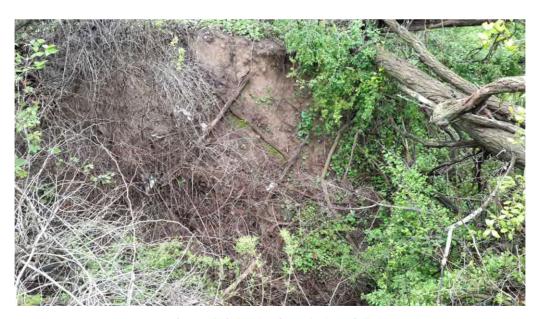
View facing left bank of eroded outfall channel.

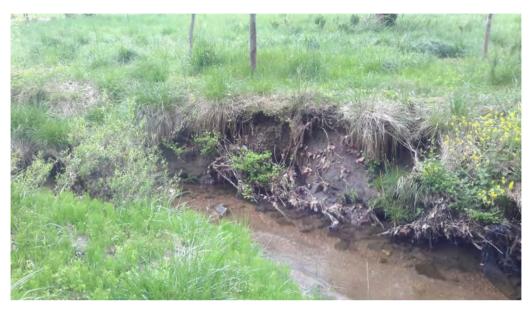
This site is located on a tributary to Tiber Branch. The site is located on land owned by Howard County and a private landowner. The stream in this location has eroded laterally, resulting in many areas of bank erosion. The eroded banks along this reach are near vertical and have an average height of 3 ft. The banks are primarily composed of silt and have very low root density and very shallow root depth. Stream habitat is poor at this site, lacking both suitable cover for fish and stable substrates for stream insects. Habitat diversity is low, with the majority of the available habitat consisting of shallow pools with intermittent short, shallow riffles. The habitat is also impaired by a moderate amount of fine material covering the stream bed. The stream substrate is comprised mostly of sand and gravel with some cobble present.

Typical stream bank erosion on the left bank

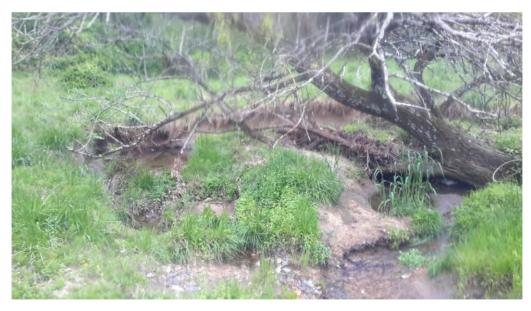
Stream bank erosion on the right bank and debris jam

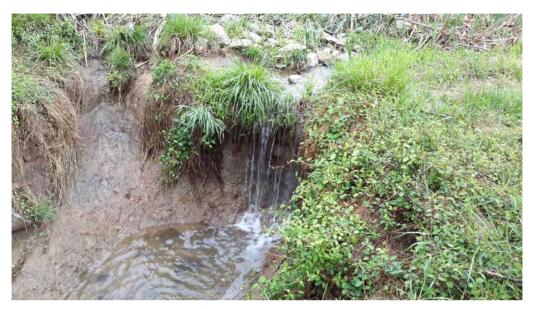
The site is located on property owned by a community association and on property owned by a private landowner. The stream in this location has downcut and eroded laterally, resulting in many areas of bank erosion. The eroded banks along this reach are near vertical and have an average height of 2 ft. in the lower half of the site and 5 ft. in the upper half of the site. The banks are primarily composed of silt and have low root density and very shallow root depth. A 4.5 ft. headcut is present within the reach and is threatening to undermine the outfall of an upstream stormwater management pond. Stream habitat is poor at this site, lacking both suitable cover for fish and stable substrates for stream insects. Habitat diversity is low, with the majority of the available habitat consisting of shallow pools with intermittent short, shallow riffles. The habitat is also impaired by a high amount of fine material covering the stream bed. The stream substrate is comprised mostly of sand and gravel with some cobble present. There is evidence that the channel was straightened in the past, and an old failing culvert is located in the lower third of the site. A new 3 in. pvc pipe and an old metal pipe were exposed in the upper third of the site.

Upper portion of headcut threatening SWM pond outfall

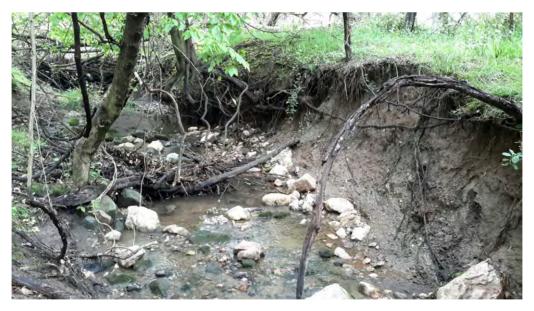
Typical stream bank erosion in upstream portion of site

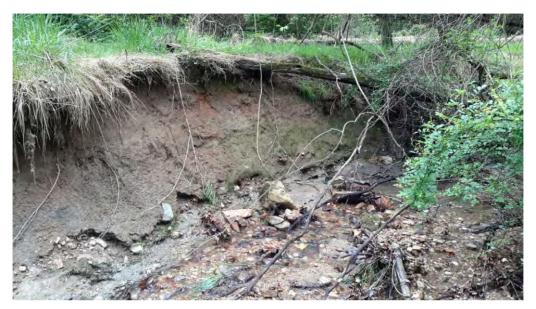
The site is located on property owned by Howard County Department of Parks and Recreation. The stream in this location has downcut and eroded laterally, resulting in many areas of bank erosion. The eroded banks along this reach are near vertical and have an average height of 5 ft. in the lower half of the site and 2.5 ft. in the upper half of the site. The banks are primarily composed of silt and have low root density and very shallow root depth. Stream habitat is poor at this site, lacking both suitable cover for fish and stable substrates for stream insects. Habitat diversity is low, with the majority of the available habitat consisting of shallow pools with some shallow riffles. The habitat is also impaired by a high amount of fine material filling the interstitial spaces of the stream bed. The stream substrate is comprised mostly of sand, gravel, and cobble. An old concrete structure, possibly from a milldam, was found along both banks at about the midpoint of the site. Near the top of the site an old damaged culvert was found in the stream and along the left bank.

Typical stream bank erosion along the lower portion of the site

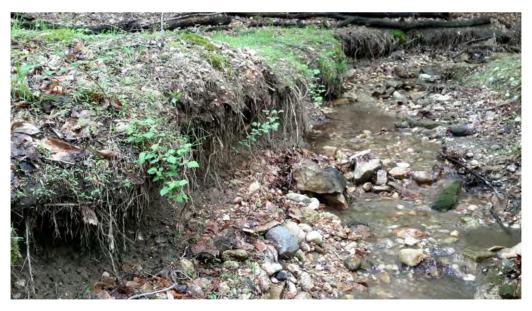
Typical stream bank erosion along the upper portion of the site

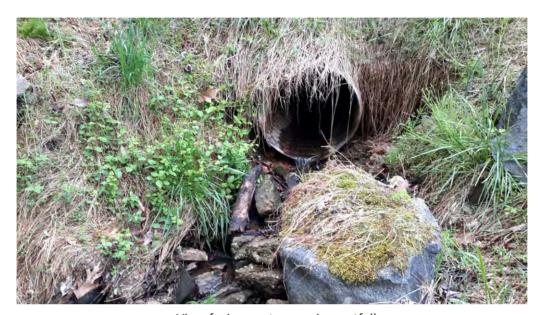
The proposed outfall stabilization is for the outfall channel of a 24 in. corrugated metal culvert in a sanitary sewer easement. The channel downstream of the culvert is eroding and has undermined the end of the culvert. Evidence of past stabilization attempts with rip rap appear to have failed as the eroded area is wider than the area where rip rap was placed. The outfall channel is eroded for approximately 77 ft. and drains to an unnamed tributary to the Patapsco River.

View facing upstream pipe outfall.

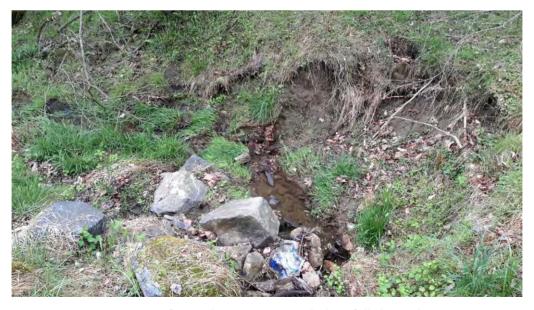
View facing downstream eroded outfall channel.

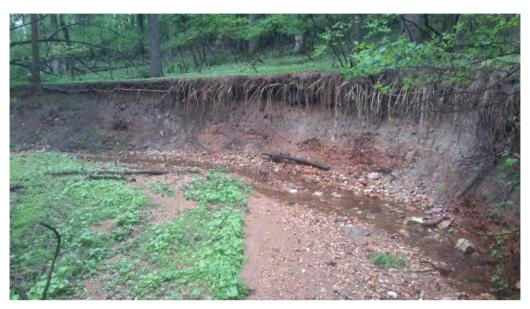
This site is located on an unnamed tributary to the Patapsco River. The site is located on property owned by multiple private landowners. The stream in this location has downcut and eroded laterally, resulting in many areas of bank erosion. The eroded banks along this reach are near vertical and have an average height of 7 ft. in the lower half of the site and 3.5 ft. in the upper half of the site. The banks are primarily composed of silt and have low root density and shallow root depth. Stream habitat is poor at this site, lacking both suitable cover for fish and stable substrates for stream insects. Habitat diversity is low, with the majority of the available habitat consisting of shallow pools with short, shallow riffles. The habitat is also impaired by a large amount of fine material filling the interstitial spaces of the stream bed. The stream substrate is comprised mostly of sand, gravel, and cobble.

Typical stream erosion on the left bank in the lower portion of the site

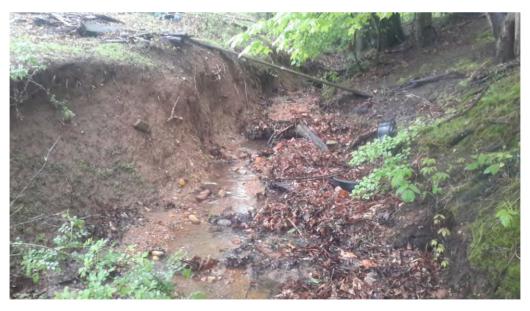
Typical stream bank erosion in the upper portion of the site

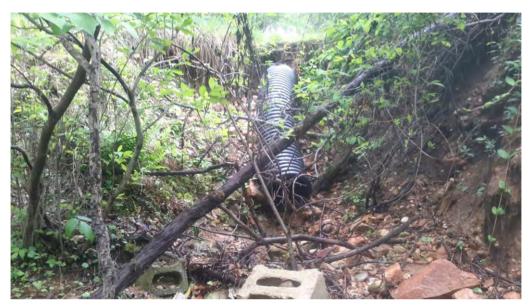
The proposed outfall stabilization is for a short, eroded outfall channel originating at a 18 in. corrugated HDPE pipe draining private property. The pipe is approximately 4 ft. above the outfall channel and much of the HDPE pipe is exposed. The channel is eroded for approximately 17 ft. until it meets an unnamed tributary to the Patapsco River. The site is on private property, but access is easy and the surrounding area is open.

View facing upstream of exposed outfall pipe and eroded channel.

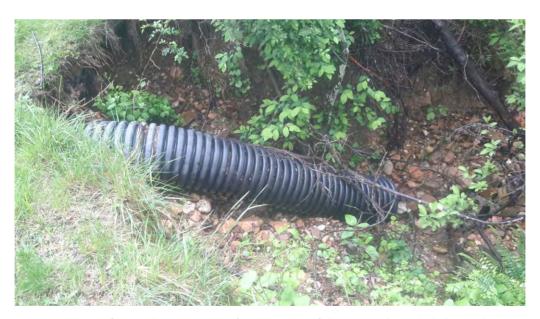
View facing downstream of exposed outfall pipe and eroded channel.

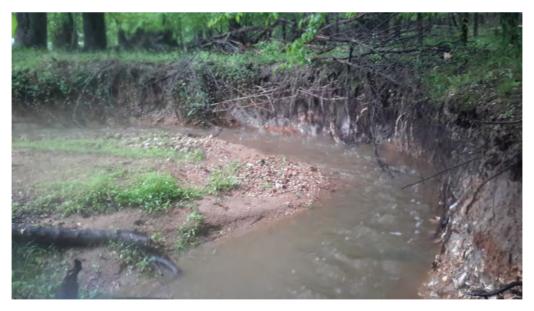
Typical stream bank erosion in the middle portion of the site

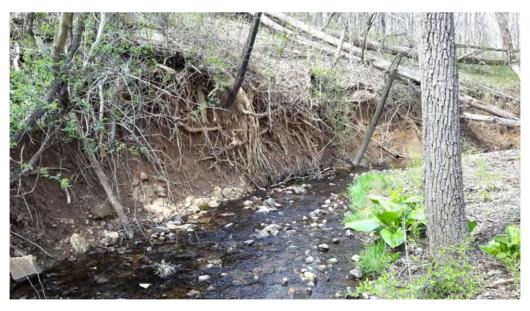
Typical stream bank erosion along the outside of a meander bend

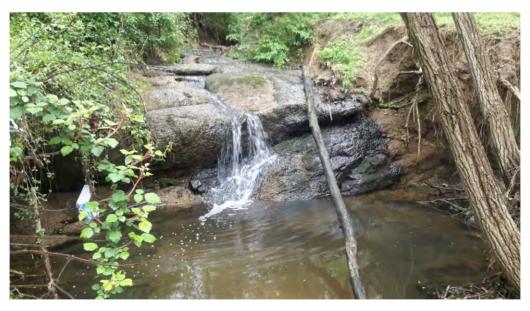
Facing upstream a cascade over bedrock near the downstream end of the site

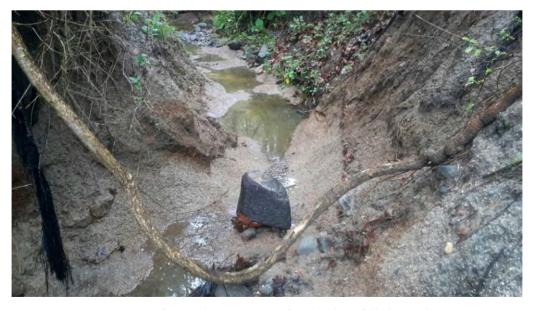
View facing downstream of eroded outfall channel.

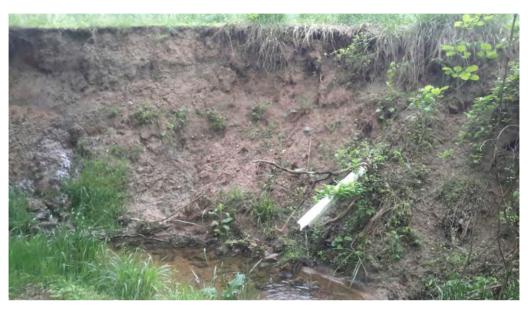
This site is located on an unnamed tributary to the Patapsco River and is owned by Howard County. Widening has occurred in this reach resulting in eroding banks throughout much of the site. The stream has eroded bank heights averaging 6 ft. along both banks. Sinuosity has increased, resulting in compressed meanders. The stream bank erosion is threatening an adjacent stormwater management pond. The banks are primarily composed of silt and have extremely low root density and extremely shallow root depth. Stream habitat is very poor throughout this site, lacking both suitable cover for fish and stable substrates for stream insects. The habitat is impaired by a high amount of fine material filling the interstitial spaces of the stream bed. Sand, gravel, and cobble comprised most of the stream substrate.

Typical stream bank erosion along the right bank

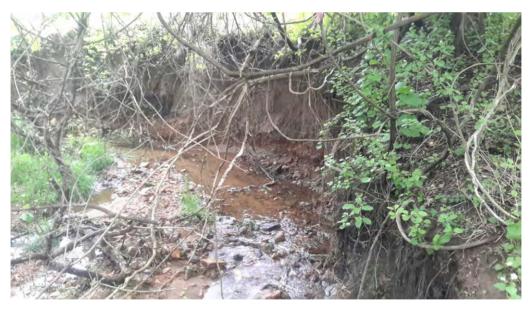
Typical stream bank erosion along the left bank

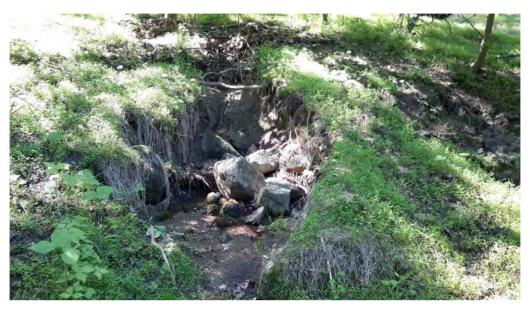
This site is located downstream of an outfall of a stormwater management pond on an unnamed tributary to the Patapsco River. The site is owned by Howard County Department of Parks and Recreation. Downcutting and widening has occurred at this location, and a headcut is progressing upstream near the midpoint of the site. Throughout this site the eroded banks average 4 ft. in height. The channel downstream of the headcut averages 5 ft. wide and upstream of the headcut the channel averages 3 ft. wide.

Facing upstream headcut near midpoint of site

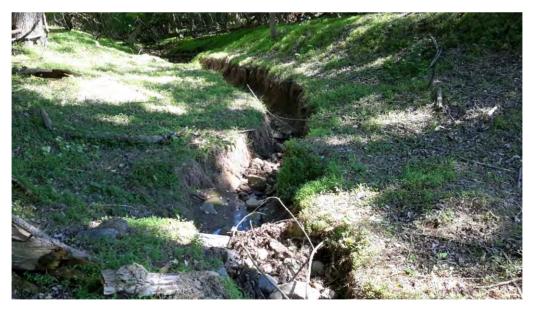
Typical downcutting and bank erosion facing downstream from upstream extent of site

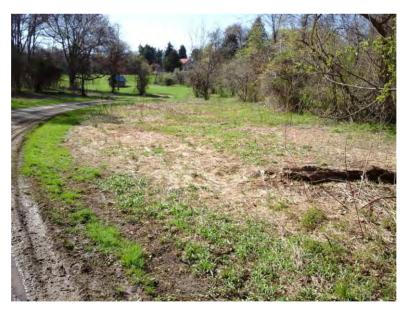
Proposed tree planting site LNB-TP-F550 facing west along park trail.

Approximately 0.92 ac. of riparian buffer can be planted with suitable tree species. No previous plantings appear to have occurred on this property. Coordination with County Parks and Recreation is recommended so that tree plantings do not interfere with the existing disc golf course. Selection of other suitable tree species will be determined in a planting plan if the project is selected for planting. Access to the site is generally easy, with foot, vehicle, and heavy equipment traffic able to enter the County property by a park trail that is located north of the Disc Golf Course Parking lot. Space for temporary storage and onsite material delivery is available. Volunteer parking and facilities are also available at Rockburn Branch Park.

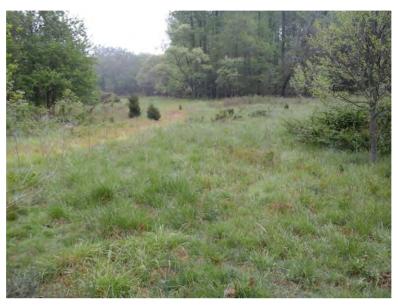
Proposed tree planting site LNB-TP-F552 facing north.

Approximately 0.71 ac. of planting area can be planted at the site with suitable tree species. It is recommended that American sycamore (*Platanus occidentalis*) be included as a suitable tree species since it is typically more resistant to deer browse. Selection of other suitable tree species will be determined in a planting plan if the project is selected for planting. Foot, vehicle, and heavy equipment traffic can access the site using the sewerline easement that is adjacent to Koffel Court. Access to the project will require coordination with private property owner from Koffel Court. Space for temporary storage and onsite material delivery is available. Volunteer parking and facilities are not available.

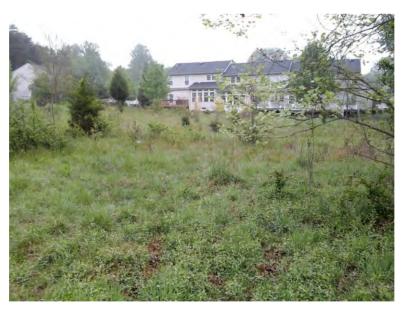
Proposed tree planting site LNB-TP-F552 facing west towards Koffel Court.

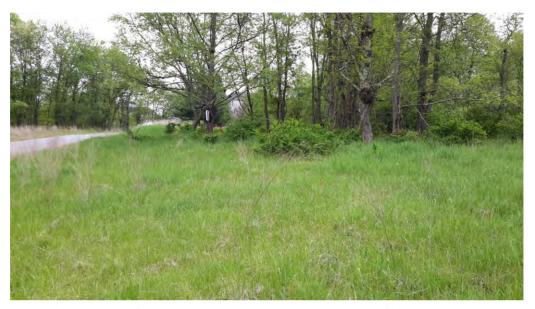
The proposed planting area is located on the southern side of the Old Frederick Road pumping station access road off the end of Dorsey Spring Court on Howard County property. This upland site is currently open turf that receives part to full sun. Approximately 30% of the site is covered in invasive species, including multiflora rose, Japanese honeysuckle, and Japanese barberry.

View facing east of open planting area next to access road off Dorsey Spring Court.

Invasive species removal and tree planting is proposed on a 0.51 ac. area. The multiflora rose, Japanese honeysuckle, and Japanese barberry should be removed prior to planting and the entire site will require mowing in preparation for the tree planting. A variety of native trees should be planted. Tree shelters should be installed to protect the trees from deer damage. Tree maintenance and inspections should be performed yearly, and should include the removal of invasive species and repair of tree shelters and stakes. The site can easily be accessed from the adjacent access road.

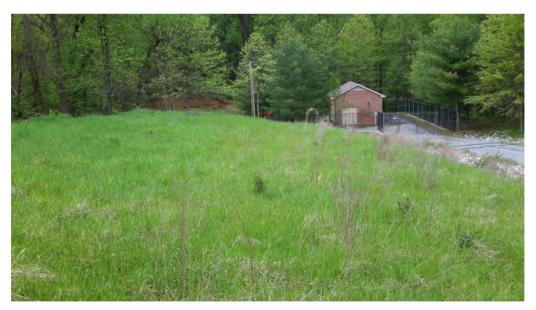
View facing west and downslope of open planting area and pumping station.

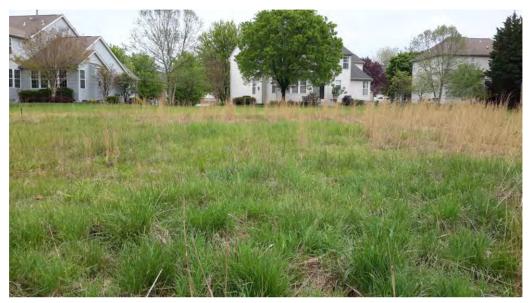
The proposed planting area is located on Howard County property south of Dorsey Spring Court and west of Millers Way Drive behind residential properties. This upland site is currently open turf that receives full sun. Only approximately 5% coverage of invasive oriental bittersweet and multiflora rose was found in the proposed planting area. A stormwater management facility is located southeast of the proposed planting area.

View facing north of open planting area behind residential properties on Dorsey Spring Court.

Invasive species removal and tree planting is proposed on a 1.18 ac. open area. The invasive oriental bittersweet and multiflora rose should be removed prior to planting and the entire site will require mowing in preparation for the tree planting. A variety of native trees should be planted. Tree shelters should be installed to protect the trees from deer damage. Tree maintenance and inspections should be performed yearly, and should include the removal of invasive species and repair of tree shelters and stakes. The site can be accessed from the pumping station access road off Dorsey Spring Court.

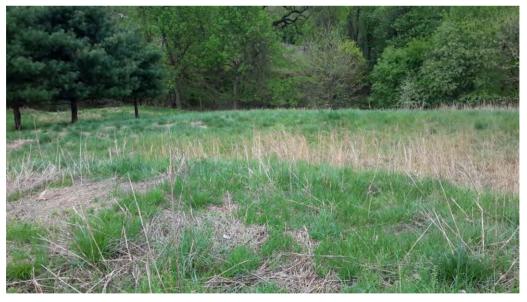
View facing south of open planting area and adjacent wooded areas.

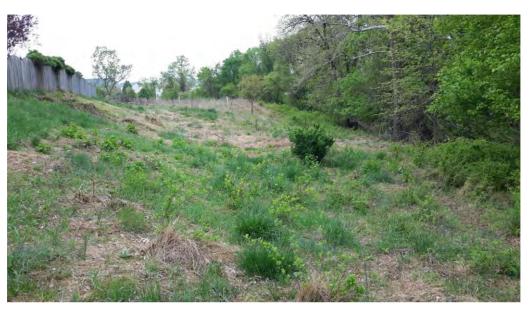
The proposed planting area is located on Howard County property north of Carroll Wind Drive behind residential properties. This upland and riparian site is currently open turf that receives full sun. This site had previously been planted, however the success rate was poor and there are many empty tree tubes remaining. Approximately 30% of the site is covered in invasive species, including garlic mustard, oriental bittersweet, Japanese honeysuckle, and thistle.

View facing north of open planting area adjacent to residential properties.

Invasive species removal and tree planting is proposed on this 1.94 ac. site. Garlic mustard, oriental bittersweet, Japanese honeysuckle, and thistle should be removed prior to planting and the entire site will require mowing in preparation for the tree planting. A variety of native trees should be planted. Tree shelters should be installed to protect the trees from deer damage. Tree maintenance and inspections should be performed yearly, and should include the removal of invasive species and repair of tree shelters and stakes. The site can be accessed from the easement in between residential properties on Milldam Court at the eastern side of the planting area.

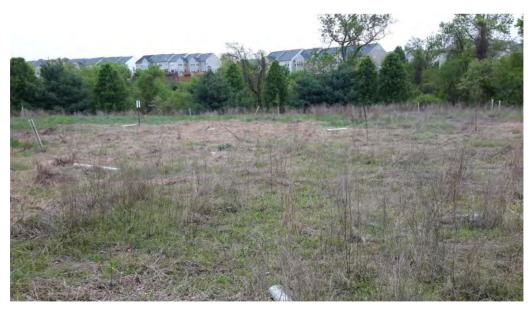
View facing north of previous unsuccessful planting at northern edge of proposed planting area.

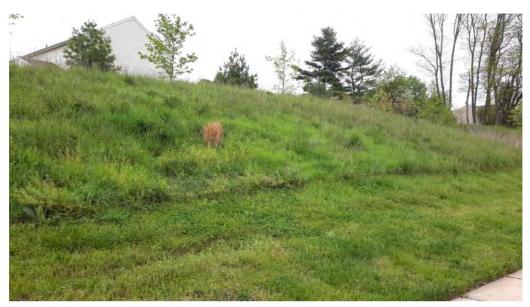
The proposed planting area is located north of Millers Way Drive at the intersection of Kidwell Place on Howard County property. The site is located on a slope adjacent to the sidewalk along Millers Way Drive. It is currently open turf that receives full sun. Approximately 10% of the site is covered in invasive species, including multiflora rose and Chinese lespedeza. The site is within a housing development and soil compaction is assumed to be moderate.

View facing north of western planting area on slope adjacent to Millers Way Drive.

Invasive species removal and tree planting is proposed on the 0.43 ac. area. The invasive multiflora rose should be removed prior to planting and the entire site will require mowing in preparation for the tree planting. A variety of native trees should be planted. Tree shelters should be installed to protect the trees from deer damage. Tree maintenance and inspections should be performed yearly, and should include the removal of invasive species and repair of tree shelters and stakes. A fire hydrant is located adjacent to the planting area which may be used for watering the trees. Access is easy since the site is immediately next to Millers Way Drive.

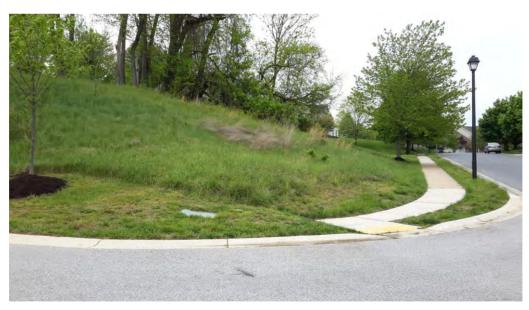
View facing east of eastern planting area on slope adjacent to Millers Way Drive and Kidwell Place intersection.

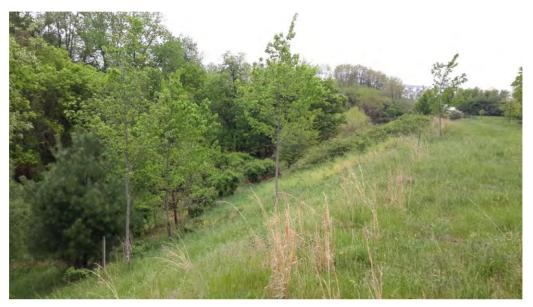
The proposed planting area is located south of College Ave in between residential properties on Village Crest Drive and Four Quarter Road. This riparian planting area has been planted in the past, but could benefit from supplemental planting to increase density of trees. The proposed planting area is currently low turf that receives full to part sun. Approximately 10% of the site is covered in invasive species, including multiflora rose, autumn olive, and wineberry. The site is adjacent to a housing development and soil compaction is assumed to be moderate in the higher elevation areas closer to the residential properties.

View facing south from center of proposed planting area, note open space in between trees from previous planting.

Invasive species removal and tree planting is proposed on this 3.14 ac. tract. The invasive multiflora rose, autumn olive, and wineberry should be removed prior to planting and the entire site will require mowing in preparation for the tree planting. A variety of native trees should be planted. Tree shelters should be installed to protect the trees from deer damage. Tree maintenance and inspections should be performed yearly, and should include the removal of invasive species and repair of tree shelters and stakes. The site can easily be accessed from several roads in the condominium complex off Village Crest Drive.

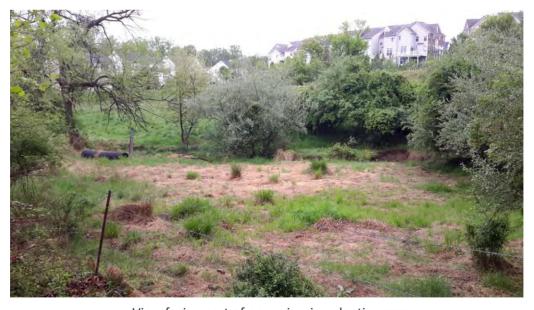
View facing east of open riparian planting area.

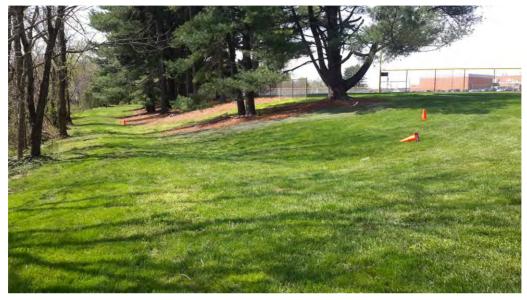
The proposed planting area is located on the eastern side of Mt. Hebron High School property. The proposed planting area is currently majority mowed turf that receives part sun. Approximately 10% of the site is covered in invasive species, including garlic mustard. During the field investigations, Greg Connor from Howard County Public Schools Grounds Services and the field crew walked the assessment area and determined areas suitable for planting that would not interfere with school activities. Before planting, additional coordination would be required to determine if a running/walking path is required; however leaving a small path would not significantly reduce the number of trees planted. A small portion of the proposed planting area at the southern end is within a wetland; however the majority of the site is upland.

View facing south from northern portion of proposed planting, site is currently open maintained turf.

Invasive species removal and tree planting is proposed on 1.92 ac. at the perimeter of the Mt. Hebron High School property . The garlic mustard should be removed prior to planting and the entire site will require mowing in preparation for the tree planting. A variety of native trees should be planted. Tree shelters should be installed to protect the trees from deer damage. Tree maintenance and inspections should be performed yearly, and should include the removal of invasive species and repair of tree shelters and stakes. The site can easily be accessed from the front parking lot of Mt. Hebron High School.

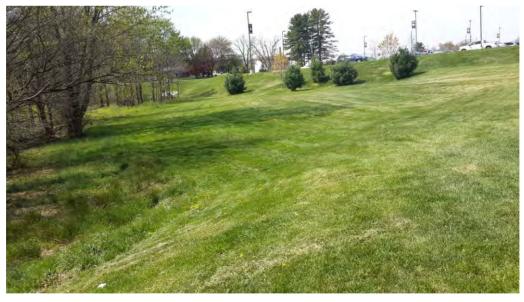
View facing south from southern portion of proposed planting area of open and mowed planting area.

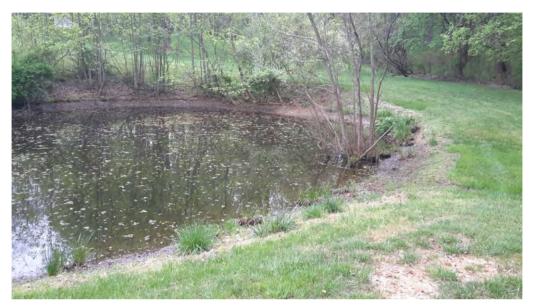
Facing upstream, the pond and point of overflow.

The objective for this project is to stabilize a headcut formed by a pond overflow. This will be accomplished by constructing a step pool storm conveyance (SPSC) connecting the pond to the stream. Realignment of the headcut channel will be necessary to ensure a smooth connection between the SPSC and the stream. This stabilization has the potential to reduce the amount of sediment supplied by the expanding headcut. The stabilization will also prevent further erosion and potentially a pond failure. This project should be done in conjunction with stream restoration project SBP-SR-F422. The SPSC would likely not be able to gain additional WQv credit due to it being in line with a storm water pond.

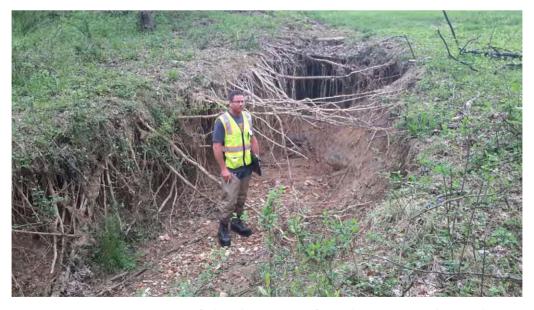
This outfall stabilization site is on the same property that stream restoration site SBP-SR-F422 is located. The pond is fed by stormwater collected on High Stepper Trail. The pond overflows over land towards the stream to the west. A 7 ft. headcut formed at the confluence of the overland flow path and the stream, it has moved 40 ft. upstream towards the pond forming a new channel. The headcut is not endangering the berm structure.

Facing upstream, a 7 ft. headcut moving from the stream to the pond.

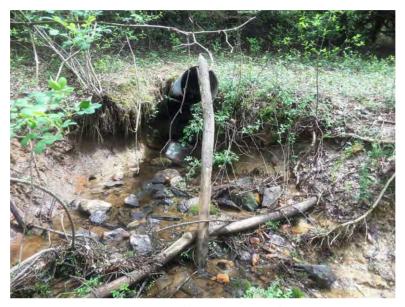
The project site is located at the outfall of a private farm pond at the headwaters of the tributary. Baseflow was observed during the assessment date. The outfall barrel is a 12 in. CMP with considerable corrosion, and joint separation. Piping below the barrel is probable, and currently the barrel is propped up with branches and make shift straps to prevent further collapse. The channel is eroded 3 ft. below the barrel with active headcutting back into the pond embankment.

Upstream view of 12 in. CMP outfall barrel.

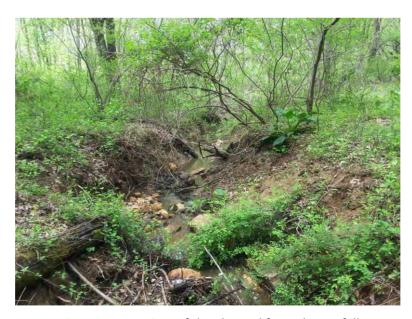
Downstream view of the channel from the outfall.

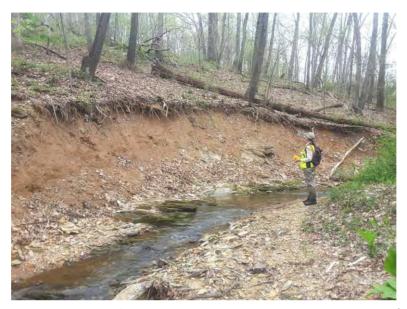
Photo facing upstream at 14 ft. high right bank with bedrock toe protection/stabilization.

The objective for this project is to reduce bank erosion. This project proposes the restoration of 1,600 lf. of bank stabilization/channel restoration. During the site reconnaissance for the concept development, the stream banks showed evidence of minor bank erosion throughout the stream length; however, this bank erosion was spotty and inconsistent. Because of this inconsistency, the proposed in stream work would consist of spot repairs of eroded banks and possibly the addition of some instream structures (riffles, vanes or rock/log spurs) in key locations to direct the flows of the bank. The addition of a continuous floodplain or hyporheic bench through the reach would be beneficial, but the benefit would need to be weighed against the potential tree loss associated with the grading. Due to the current condition of the stream, the proposed in stream work may not result in a net benefit to the stream condition. In order to access and construct along the stream, multiple mature trees would be lost. In addition, the surrounding wetlands could be impacted. Due to the patchy and minor nature of problems within the reach, this is not a priority project for channel restoration; however, this assessment is based on the current stream condition relative to the watershed's rural character. Should additional development occur in the watershed, the stream conditions may change and increase the priority for restoration.

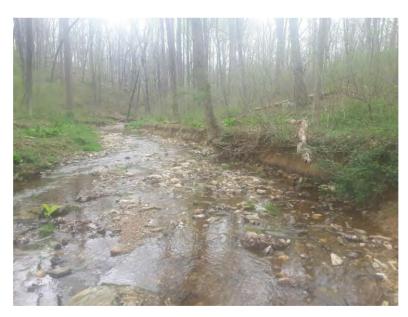
Photo facing upstream showing bank erosion along the left bank and showing the mature forest and wetland species that are currently stabilizing the banks.

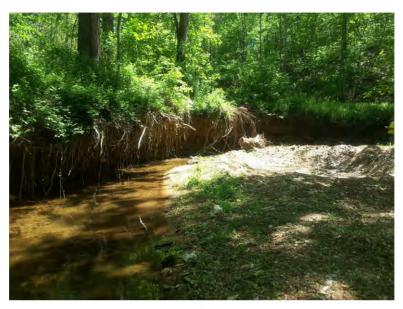
Typical tight meander bend with undercut bank facing downstream from midpoint of SBP-SR-F403A

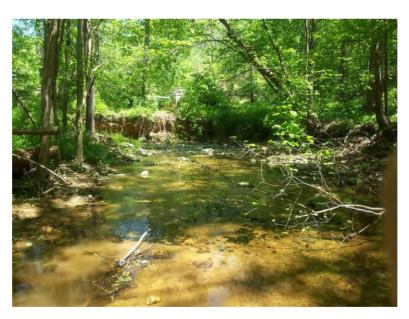
Upstream view from top portion of SPB-SR-F403A towards SBP-SR-F403B

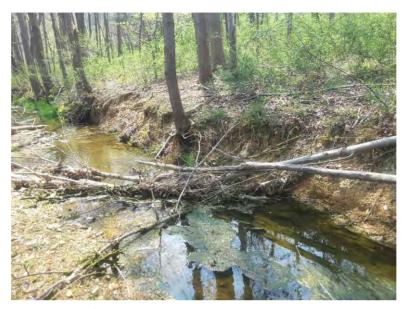
Photo facing downstream at left bank showing minor bank erosion with trees and vegetation helping stabilize.

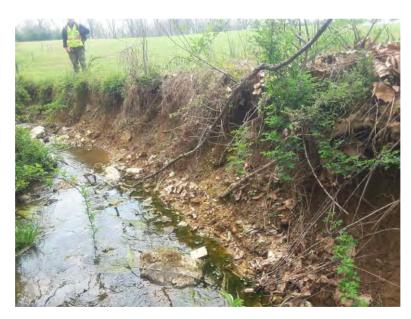
Photo facing downstream at left bank showing moderate erosion with no riparian forest buffer.

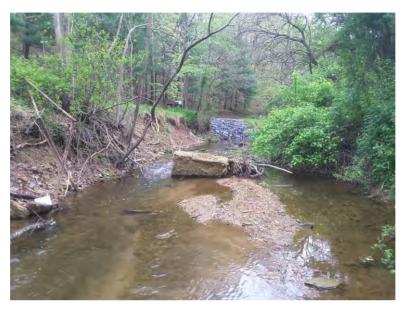
Facing upstream at riprap armored bank.

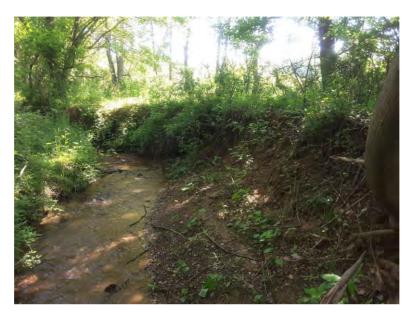
Facing upstream, showing erosion with some slumping visible.

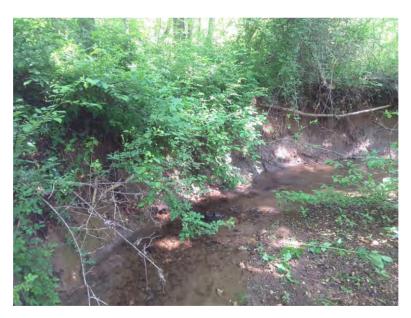
Facing downstream, showing erosion along an outside meander.

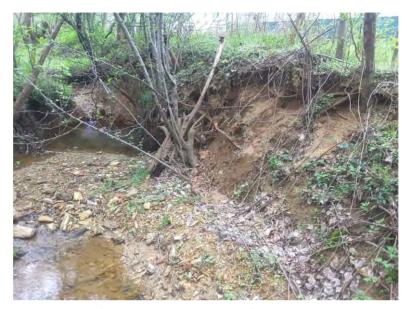
Photo facing upstream at 3.5' headcut showing the left bank erosion as a result of the headcut.

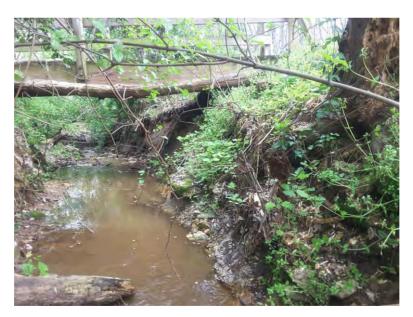
Photo facing upstream at left bank erosion associated with the bridge crossing. Stable restoration tie in point would be downstream of this location.

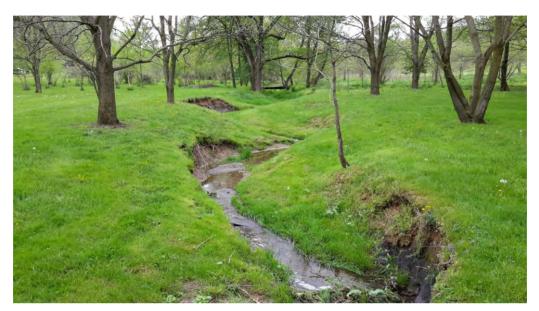
Facing upstream, displaying outside meander erosion and open floodplain with insufficent planting along the stream banks.

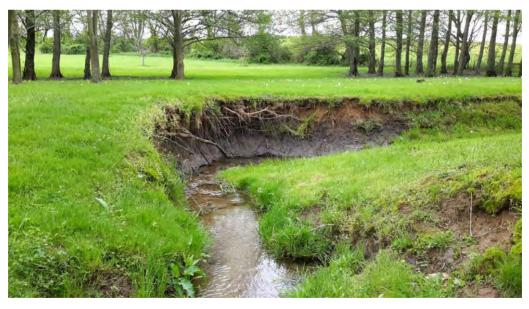
Facing the right bank, significant erosion cutting into a bank along an outside meander, showing tree roots are not fully capable of stabilizing the banks.

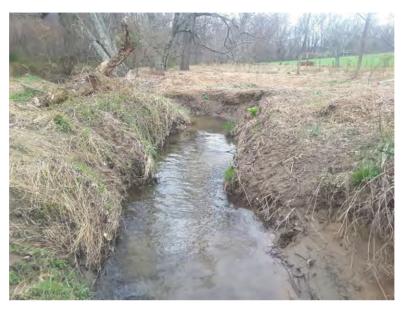
Facing upstream, displaying the poor bank protection and erosion.

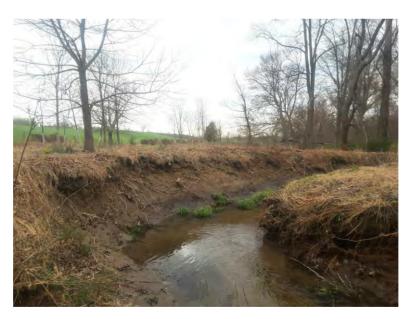
Facing downstream, at a tight bend, displaying the poor bank protection, erosion, and insufficient buffer.

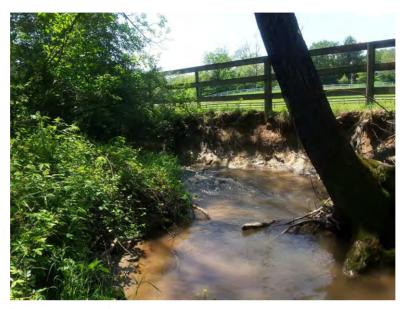
Facing the left bank, pasture fencing on the 14010 Forsythe Rd property at risk from erosion.

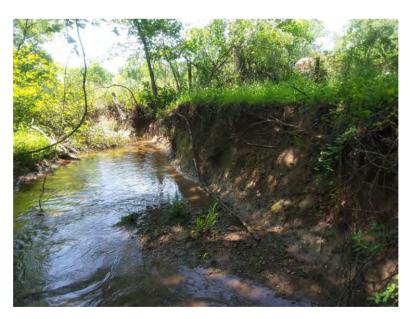
Facing upstream, moderate to severe erosion, 4.5 ft in height with little vegetative cover.

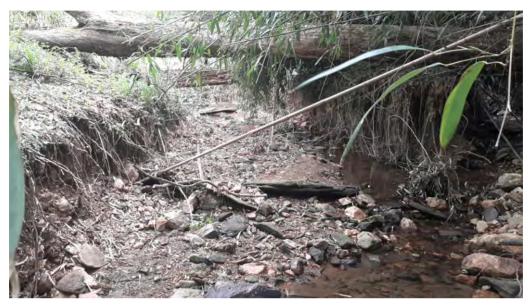
Facing upstream, moderate erosion with view of invasive bamboo stand.

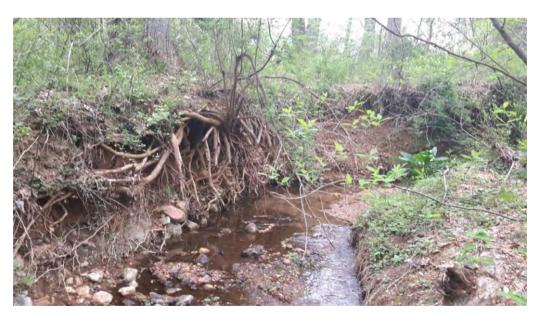
Site ID: SBP-SR-F422 Contractor: Biohabitats

Facing downstream, significant erosion on the outside meander.

The stream is located on multiple residential private properties. Stream restoration on this site will require landowner permission to perform restoration of the stream. There are possible significant impacts to mature trees along the stream, particularly in the upstream portion of the stream with a bamboo stand. No utilities were observed.

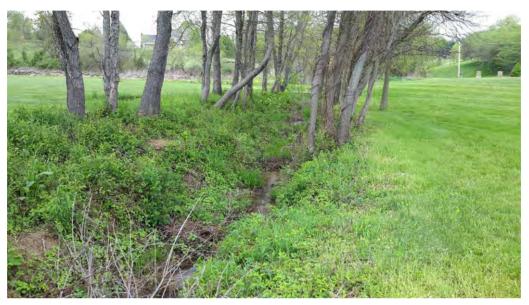
Tree planting area facing west along Chessie Crossing Way.

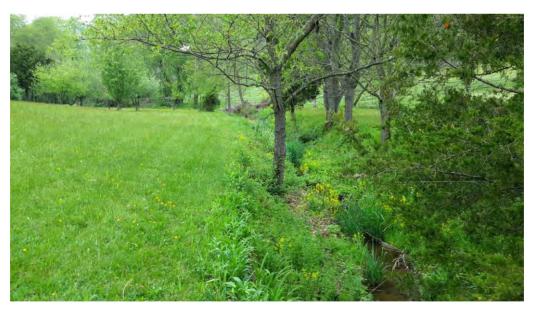
Tree planting area facing south along Morgan Station Road.

Constraints at the site include current mowing practices, multiple property ownerships and a DNR wetland at the southern edge of the planting area. A natural gas line is in proximity to the planting area; signs were observed along the edge of Morgan Station Road. No other utility constraints were observed and access should not be a limiting factor as there appears to be multiple points of entry across the entire project area. Avoidance of wildlife impacts should be considered to ensure planting success.

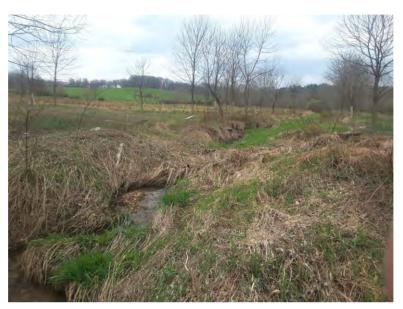
Tree planting area facing west at downstream end.

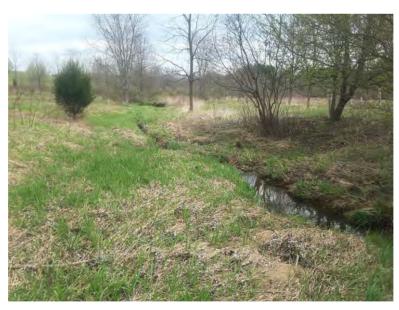
Tree planting area facing east from upstream end.

No utility constraints were observed and access should not be a limiting factor as there appears to be multiple points of access along the entire northern edge of the project area from Old Frederick Rd. Avoidance of wildlife impacts should be considered to ensure planting success. The site contains low lying areas adjacent to the stream that are wet, and portions of the planting site are within DNR Wetland boundaries. Current mowing practices and land owner consent may be potential constraints.
