PATUXENT RIVER

BRIGHTON DAM, ROCKY GORGE DAM, AND PATUXENT RIVER UPPER WATERSHED ASSESSMENT

January 2017

KCI Technologies
936 Ridgebrook Rd
Sparks, MD 21152

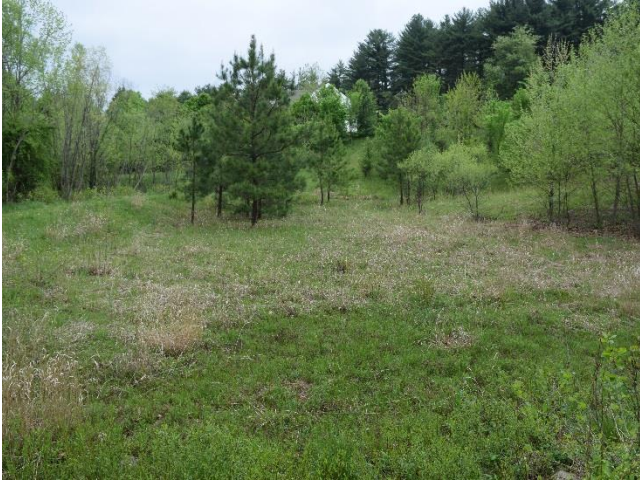
All BMP facilities evaluated for conversion potential were existing dry ponds or extended detention dry ponds (Figure 14).

Figure 14. Typical BMP conversion recommendation sites

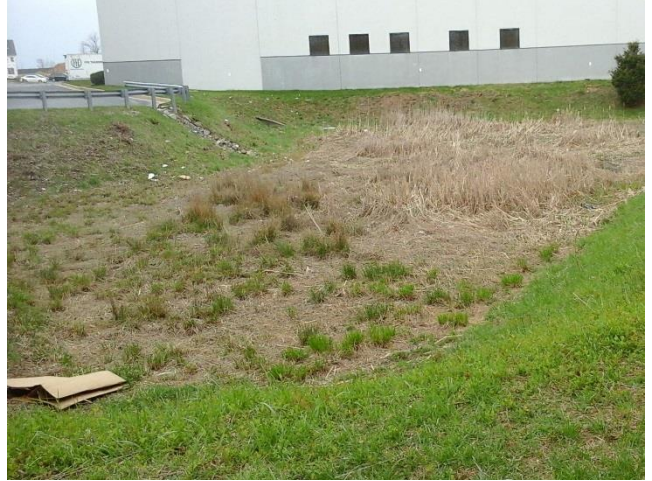
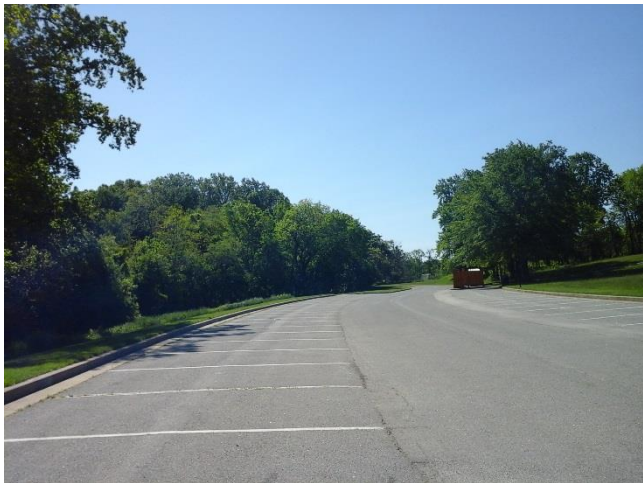
Figure 15. Typical new BMP recommendation sites

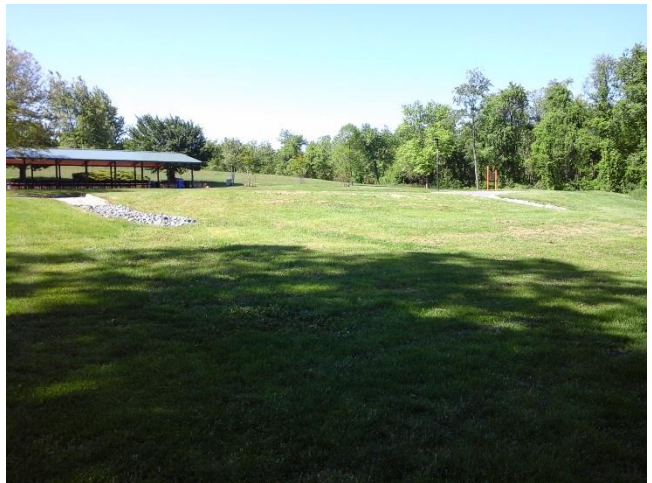
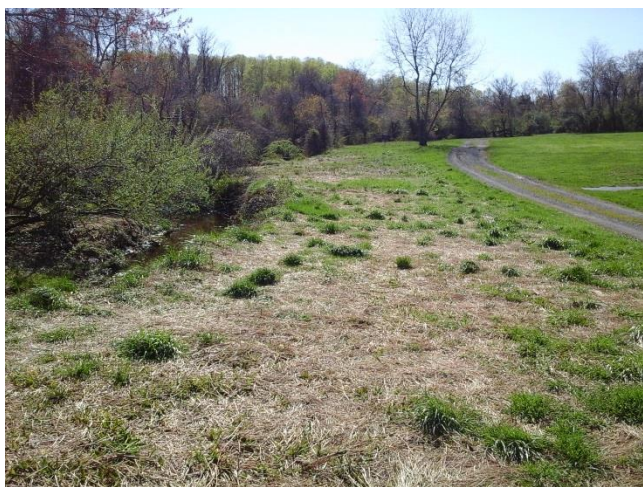
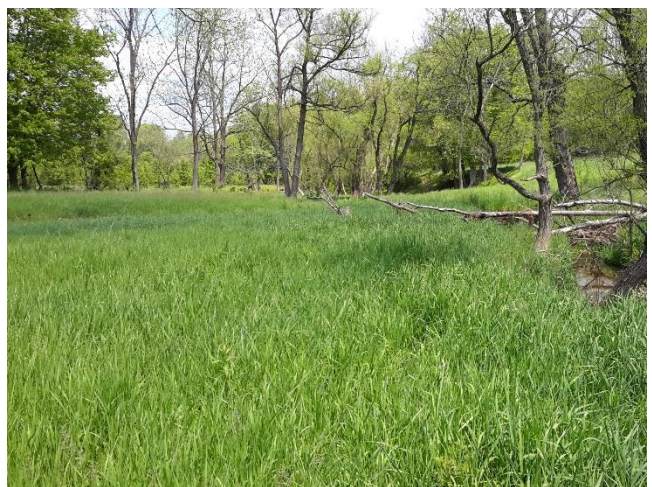
The majority of areas evaluated in the three watersheds were areas with absent or inadequate riparian buffers (Figure 16) and several tree planting assessments were conducted in riparian areas that were identified while conducting the stream restoration assessments.

Figure 16. Typical tree planting recommendation sites

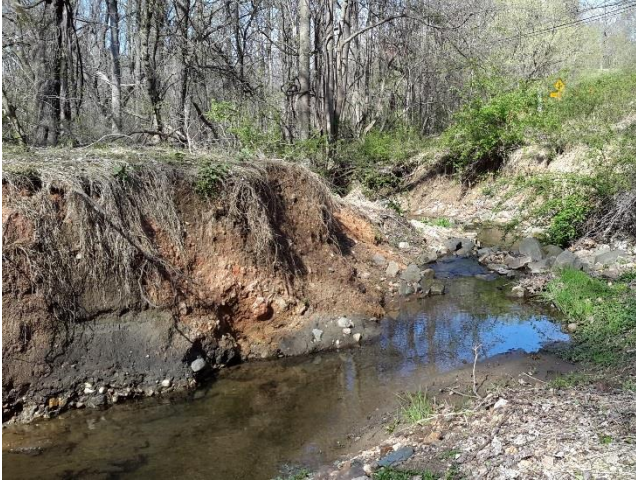
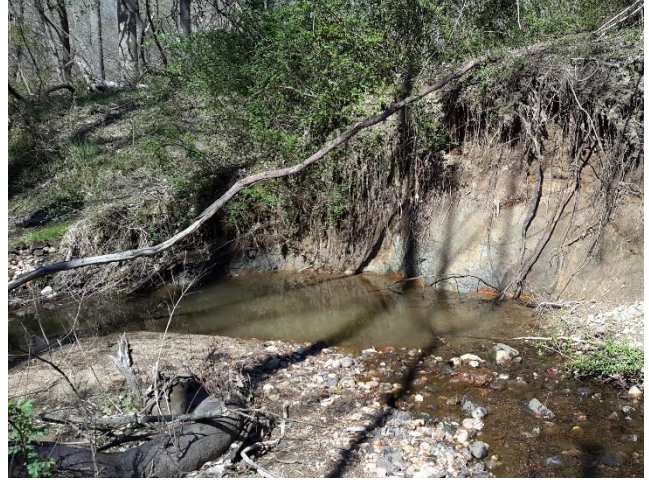
Areas of erosion were identified and considered for stream restoration projects (Figure 17).

Figure 17. Typical stream restoration recommendation sites

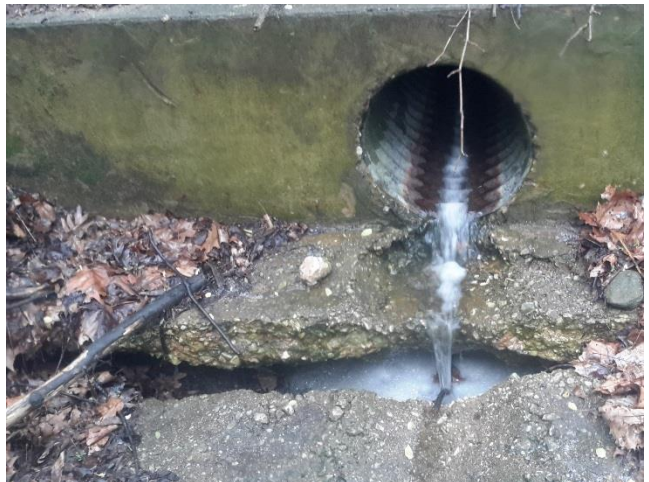
The majority of outfall stabilization assessments were located in the Patuxent River Upper watershed due to its higher density of impervious surfaces and stormwater infrastructure. Outfall sizes ranged from 12 to 36 inches. Photos of typical outfalls assessed are presented in Figure 18.

Figure 18. Typical outfall stabilization recommendation sites

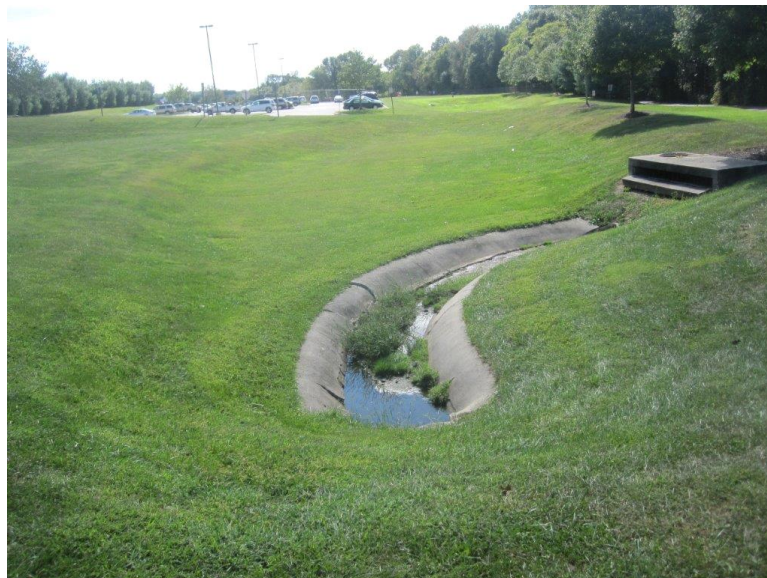
This facility, built in 1984, is designed as a dry pond to provide storm water management associated with an addition to Glenelg High School. Most of the development runoff is from parking areas, collected into a major storm drain system and discharges into a concrete channel within the pond, via a 21 in. RCCP pipe and to the riser at northwest of the pond. A 24 in. RCP spillway then discharges to a riprap channel which runs along Sharp Road before entering a stream on the west side of Sharp Road. No water quality improvement is being provided by the pond. No accumulated sediment or vegetation, other than mowed turf, observed.

Overall pond view.

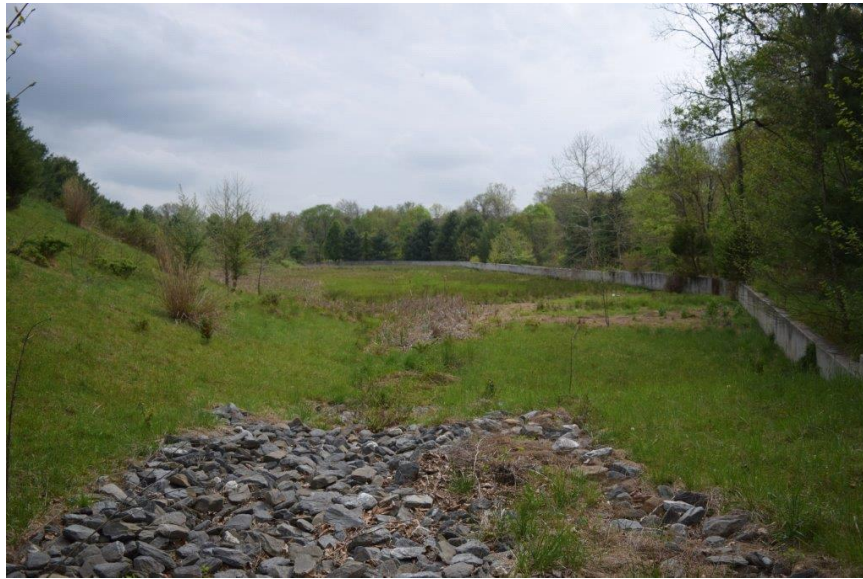
Currently, the facility is an extended detention dry pond (EDSD) built in 2000. A 54 in. HDPE pipe brings runoff to a 7600 cf. forebay with gabion outfall. A low flow channel takes forebay outflow to a 6.75 in. low-flow pipe at elevation 434.3 ft., 5 ft. weir at elevation 437.5 ft., 350 ft. weir at elevation 440.5 ft., and wall top at elevation 441.0 ft. The weir and orifice are part of a concrete retaining wall that serves to pond the 2 (437.93 ft.), 10 (440.31 ft.), and 100 (440.96 ft.) yr. runoff volumes. Wetland vegetation was observed along the low flow channel. The receiving channel is approximately 75 ft. from the wall. The current surface area of 50,000 sf. allows multiple conversion possibilities. Woody vegetation was observed along the retaining wall. The facility is owned by Cattail Country Club Inc.

Pond view from inflow riprap apron.

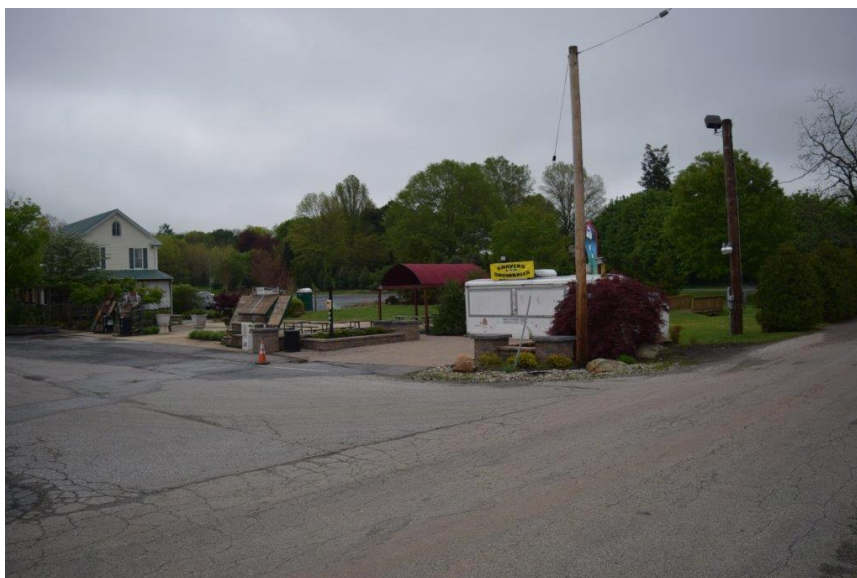
Contributing impervious area to rain garden footprint.

The proposed rain garden location will be placed on the grassed area between the concrete pad and stream. The 0.12 ac. drainage area consists of 62% impervious area collecting runoff from the upslope parking lot. The available surface area allows greater than 1.0-in. rainfall depth treatment. Direct discharge to the stream and soil infiltration designates no storm drain piping required. There may be an opportunity to partner with the landscaping company to complete the construction of this project on the property. If completed together then overall F102 site mobilization and design work cost is decreased.

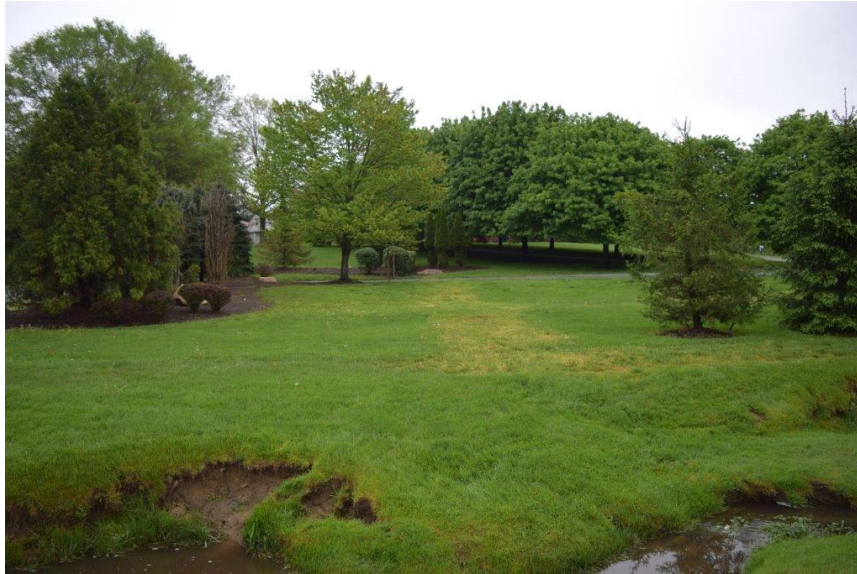
Grassed area for footprint area.

The proposed rain garden location is on the opposite bank from the business parking lot and building. The 0.13 ac. drainage area consists of 5% impervious area collecting runoff from upslope grassed area and gravel road. The available surface area allows greater than 1.0-in. rainfall depth treatment. Direct discharge to the stream and soil infiltration designates no storm drain piping required. Additionally, to maintain the 10,000 sf. maximum contributing drainage area for rain gardens, a diversion dike or swale will be required to bypass part of the upslope area to direct discharge to the stream. There may be an opportunity to partner with the landscaping company to complete the construction of this project on the property. If completed together then overall F102 site mobilization and design work cost is decreased.

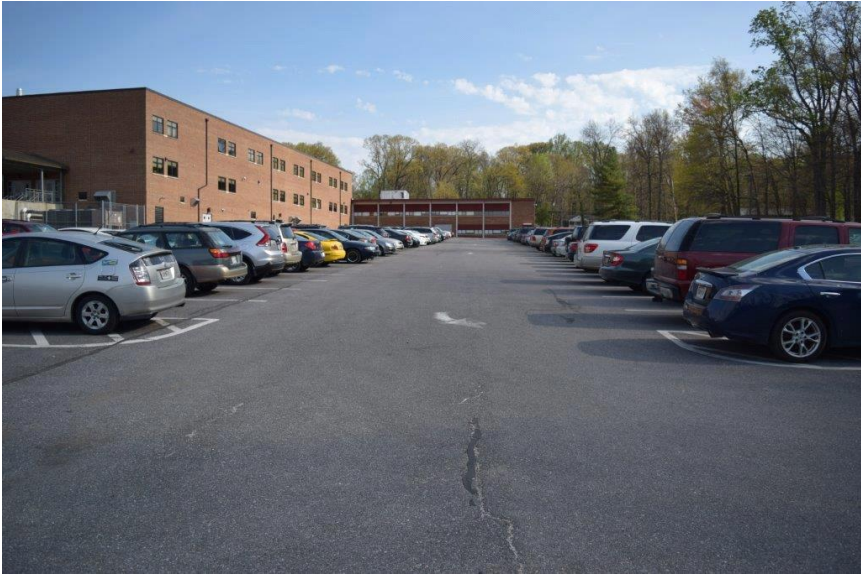
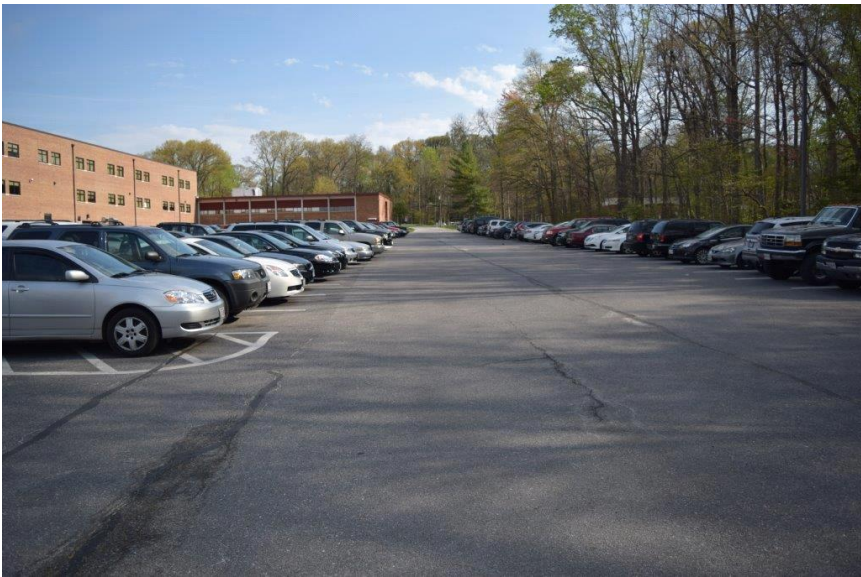
Existing parking lot two-way section width with one-way traffic flow arrows.

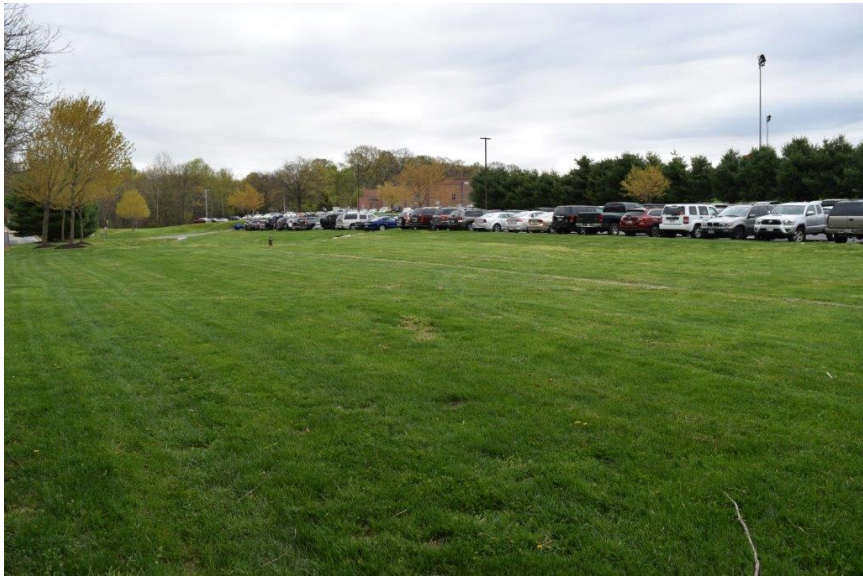
Possible site location in existing grassed field.

The proposed infiltration trench location collects parking lot runoff. Curb cuts and existing storm drainage removal or relocation are required to direct flow to the proposed facility. The 0.76 ac. drainage area consists of 57% impervious area collecting upslope pervious and paved lot runoff. Given available surface area, greater than 1.0-in. rainfall depth is treated. The bioretention discharges are piped under the down gradient road and to the adjacent stream. A soil boring and testing will be needed to ensure minimum infiltration requirements. Additionally, the existing BMP should be analyzed for water quality volume treatment and overall need for new BMP addition.

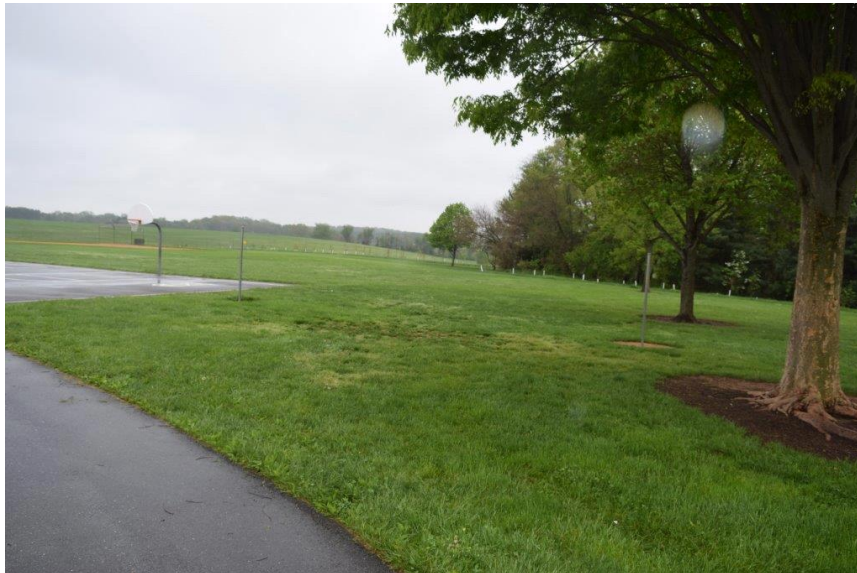
Southeast view of footprint site area from basketball court.

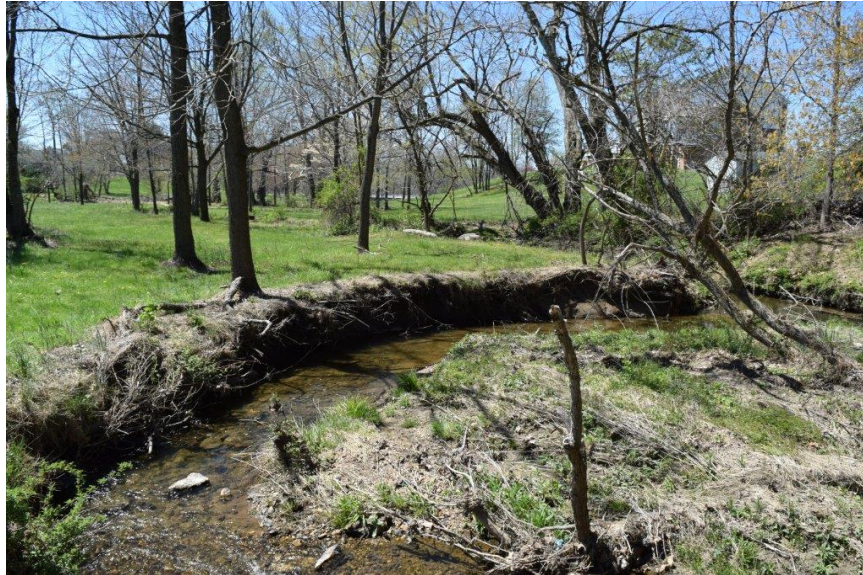
Looking downstream across the tight meander near the upstream property boundary of 3725 Shady Lane. Steeply eroded banks over 3 ft. in height are prevalent from the downstream extent to this point.

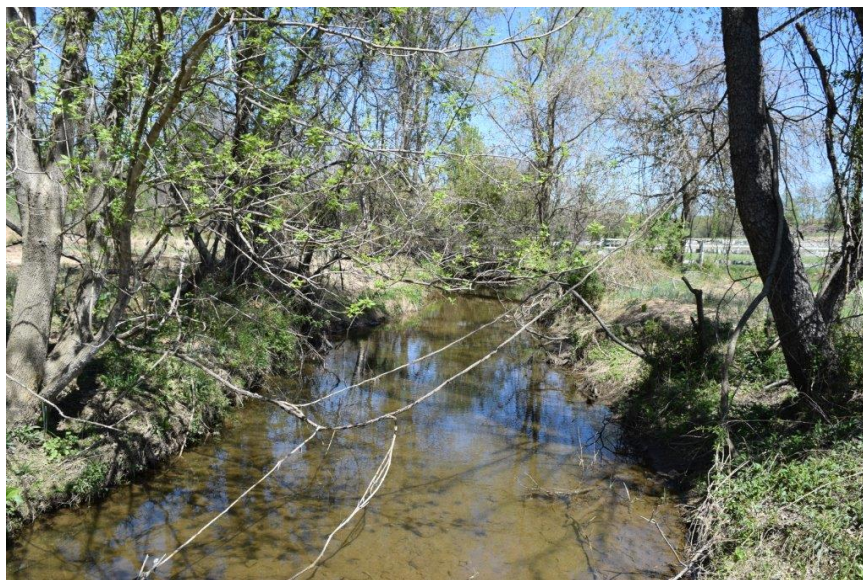
Looking upstream at the upstream end of the project reach. The stream is wider, slower, and straighter in this portion, with less erosion but little habitat variety.

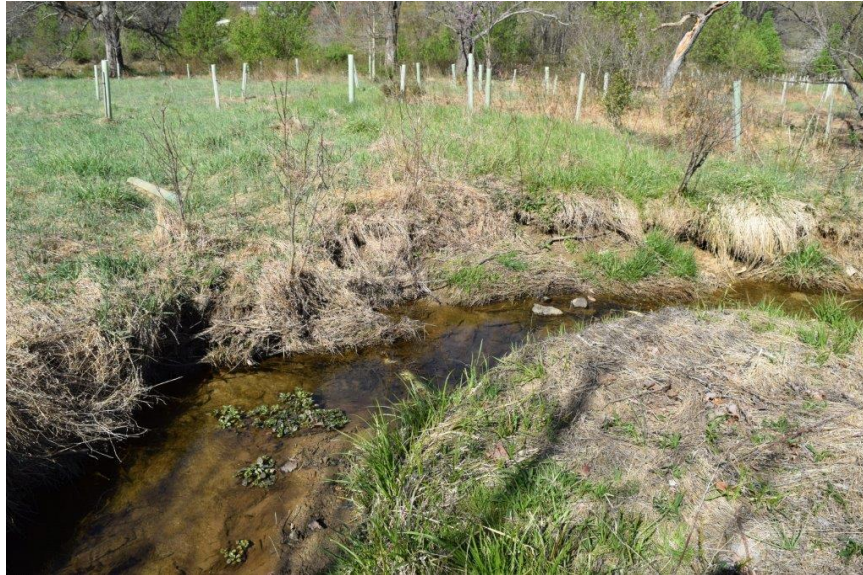
Exposed 6 in. PVC pipe crossing stream in the downstream restoration reach. Bank erosion height along this reach is typically 3 to 4 ft. Forest conservation tree planting in background.

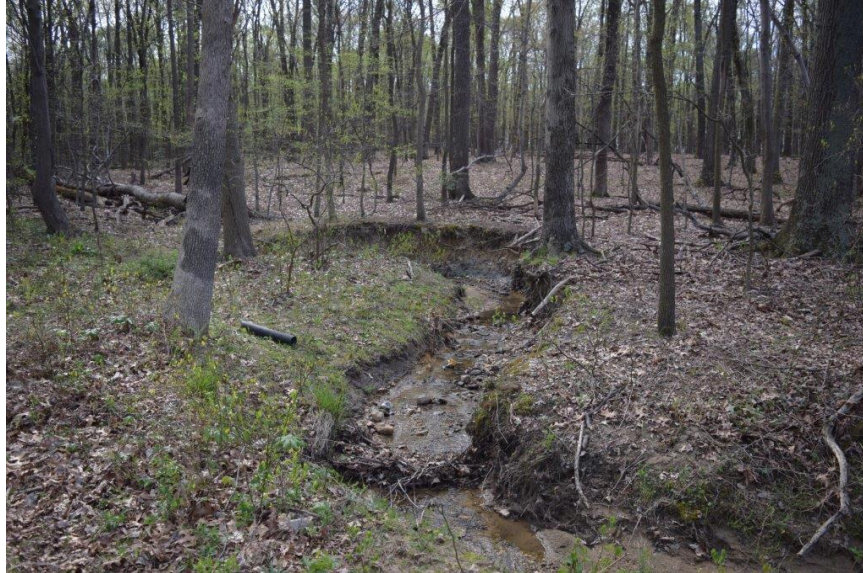
The upstream portion of the restoration site, through the forest conservation easement, has erosion between 2.5 ft. and 4 ft.

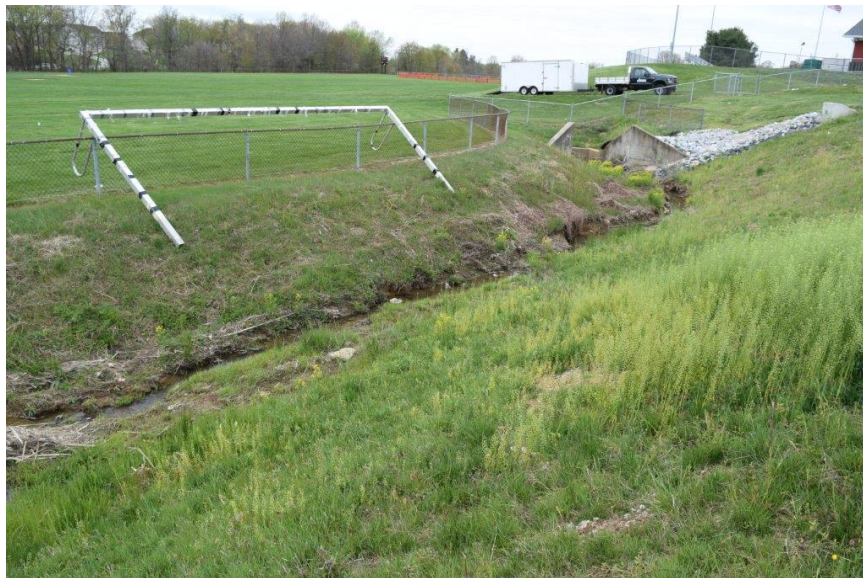
The downstream portion of the restoration site has bank erosion before it drops down an energy dissipator. Its location adjacent to the school parking lot and ball fields makes it a good location for a demonstration site.

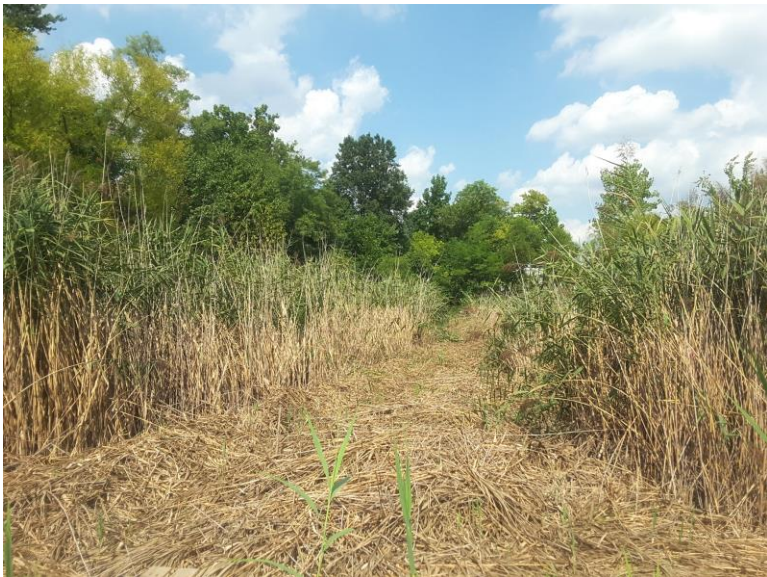
Overview of existing dry pond and phragmites

The existing dry pond could be converted to a retention pond (wet pond) by excavating to original ground by removing the existing 2 ft. phragmites mat. The existing outfall structure, a headwall and 12 in. RCCP, would need to be replaced with a riser structure and new outfall barrel. The existing sediment forebay would need to be excavated and the surrounding berm and gabion weir rebuilt.

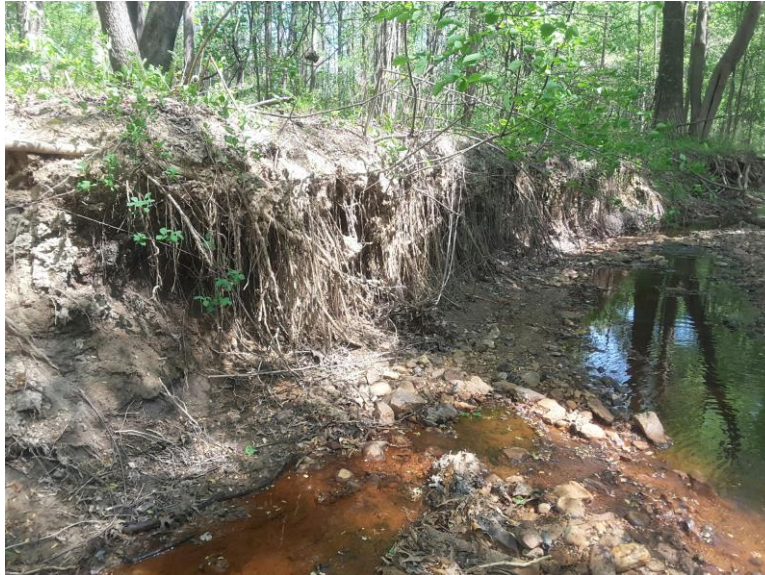
Photo facing downstream assessing the left bank and depicts a typical stream bank within the downstream limits of the assessed stream.

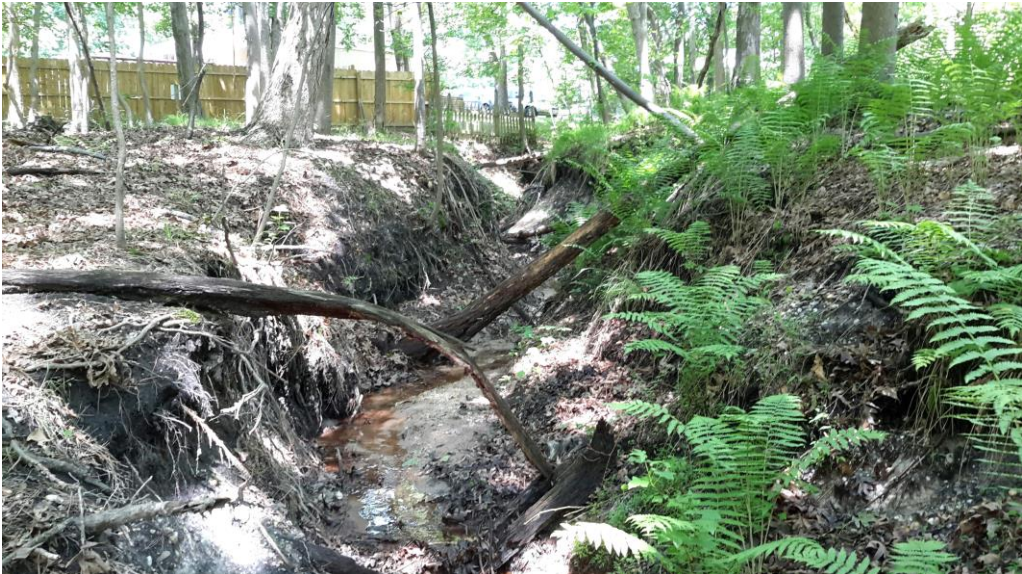
Facing upstream at typical site conditions

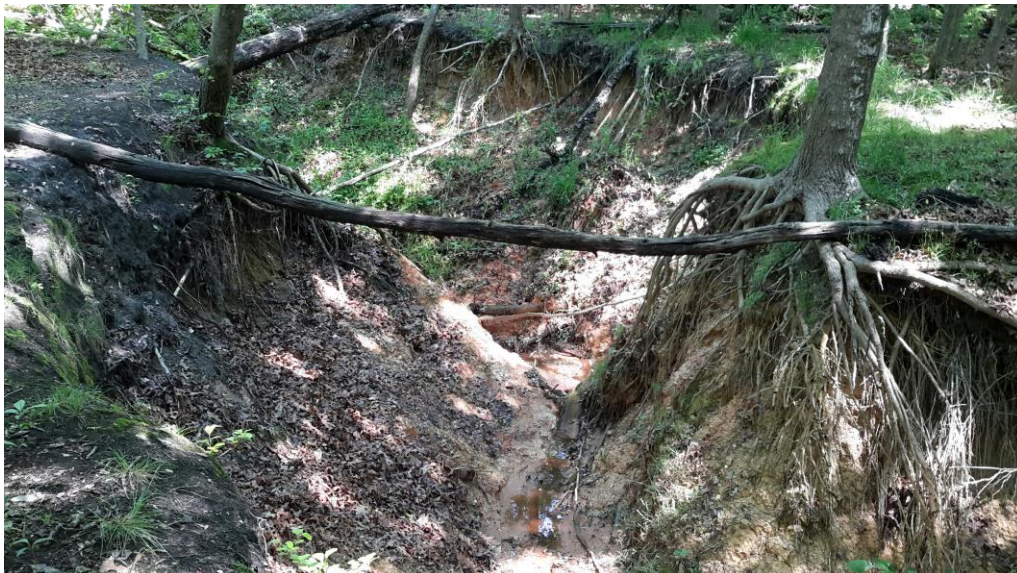
View facing upstream in the middle of the reach.

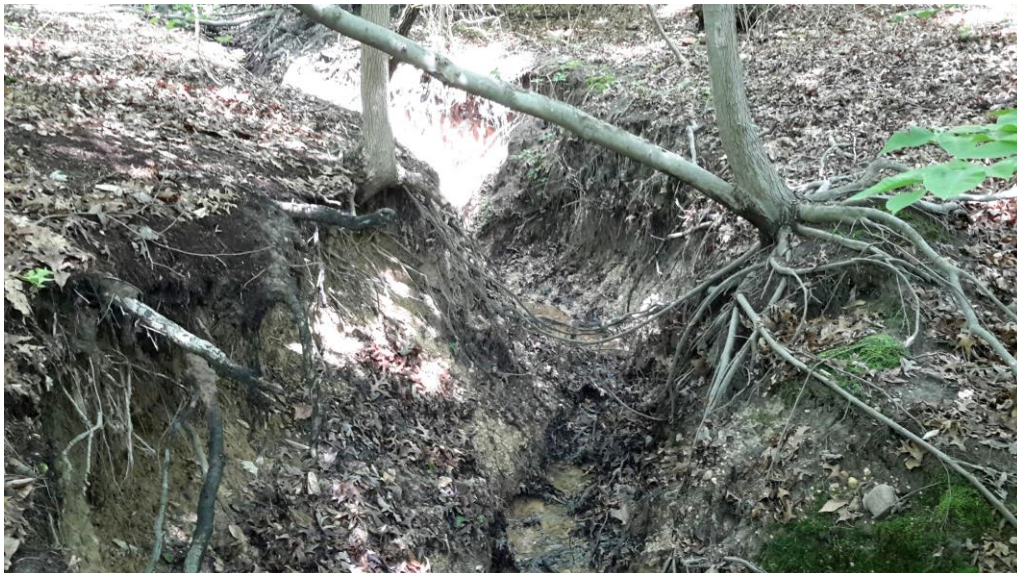
View facing upstream in the middle of the reach.

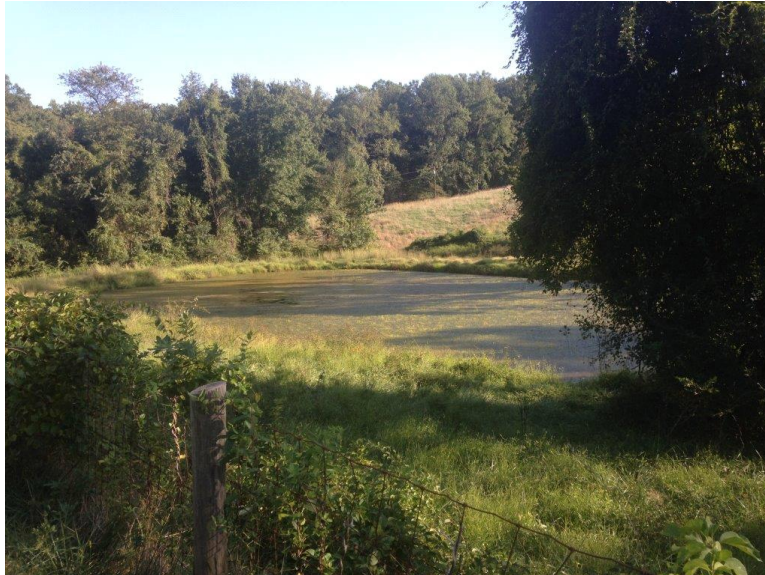
Agricultural pond in eastern field will be filled in to create wetlands. The stream is currently piped for approximately 250 ft. along the far (southern) side of the pond.

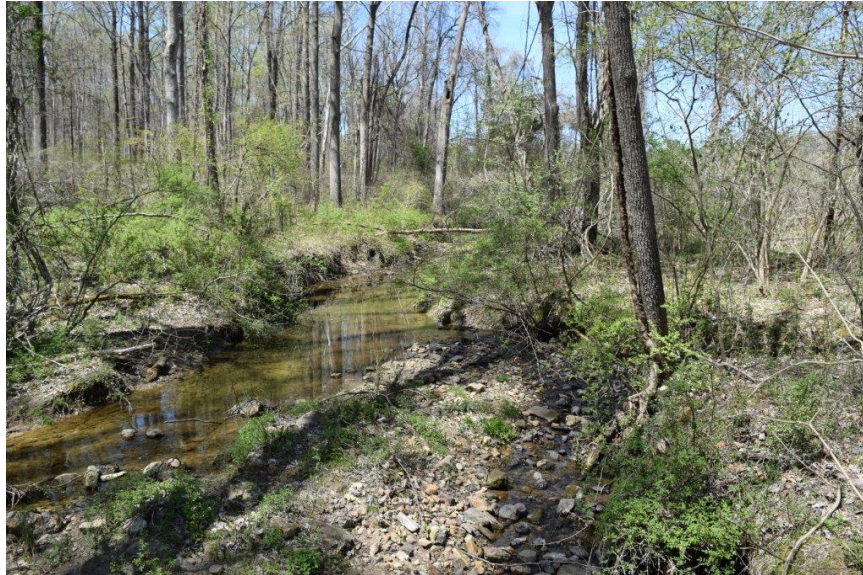
The downstream portion of the project site typically has a widened entrenched cross section and shallow flow.

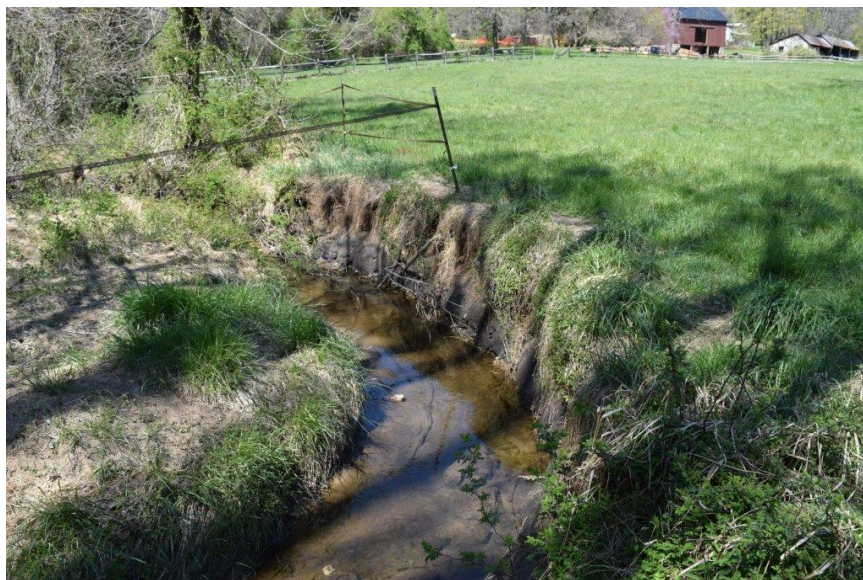
Erosion along the horse fields in the upstream portion.
